**MICHIGAN DEPARTMENT OF TRANSPORTATION
M•DOT**

**Bituminous Crack Filling Test Section
on US-10 near Evart**

**Testing and Research Section
Construction and Technology Division
Research Project 89 G-0273
Research Report No. R-1356**

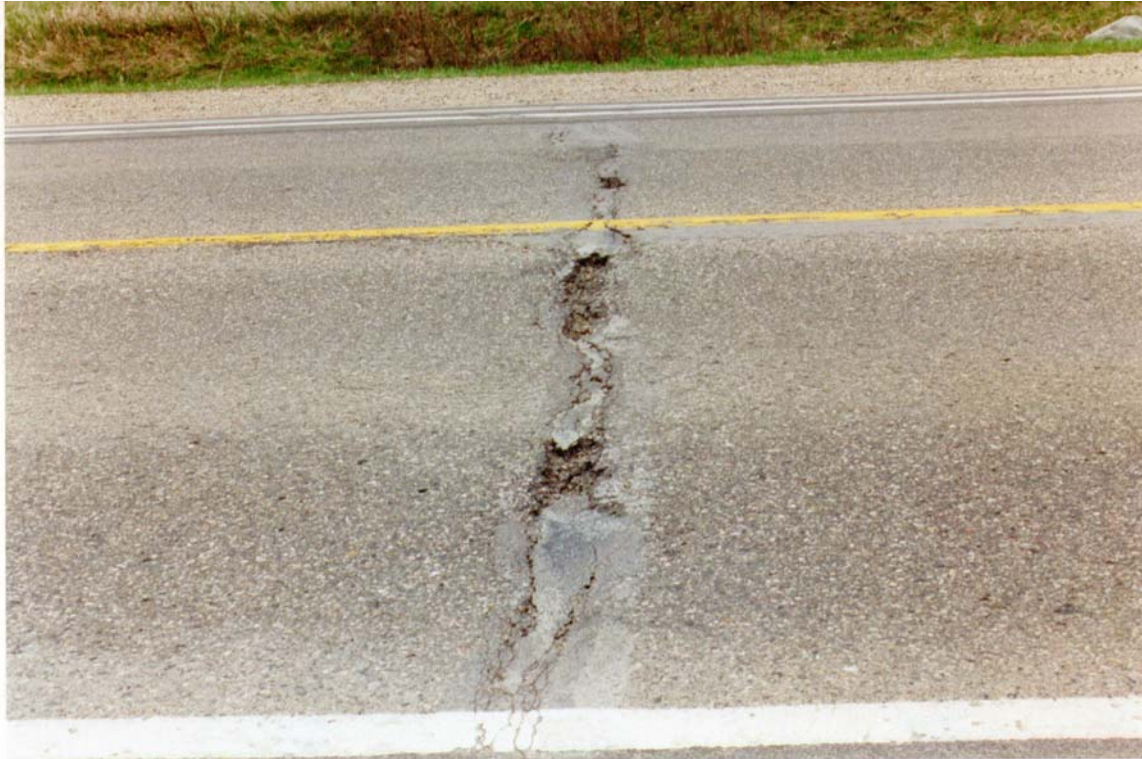
The test site is a 7.3 m wide composite pavement. The underlying concrete pavement was originally built in 1958 with the bituminous overlay placed in 1979. The ADT is 4200 vehicles with 9% of that being commercial traffic. Most of the transverse cracks have associated distress such as raveling, spalling, or potholes (See figure 2). Several transverse cracks experienced tenting from winter freeze-thaw cycles and had been bump-burned several months before crack filling (See figure 3).

Figure 2 Typical crack with associated distresses.

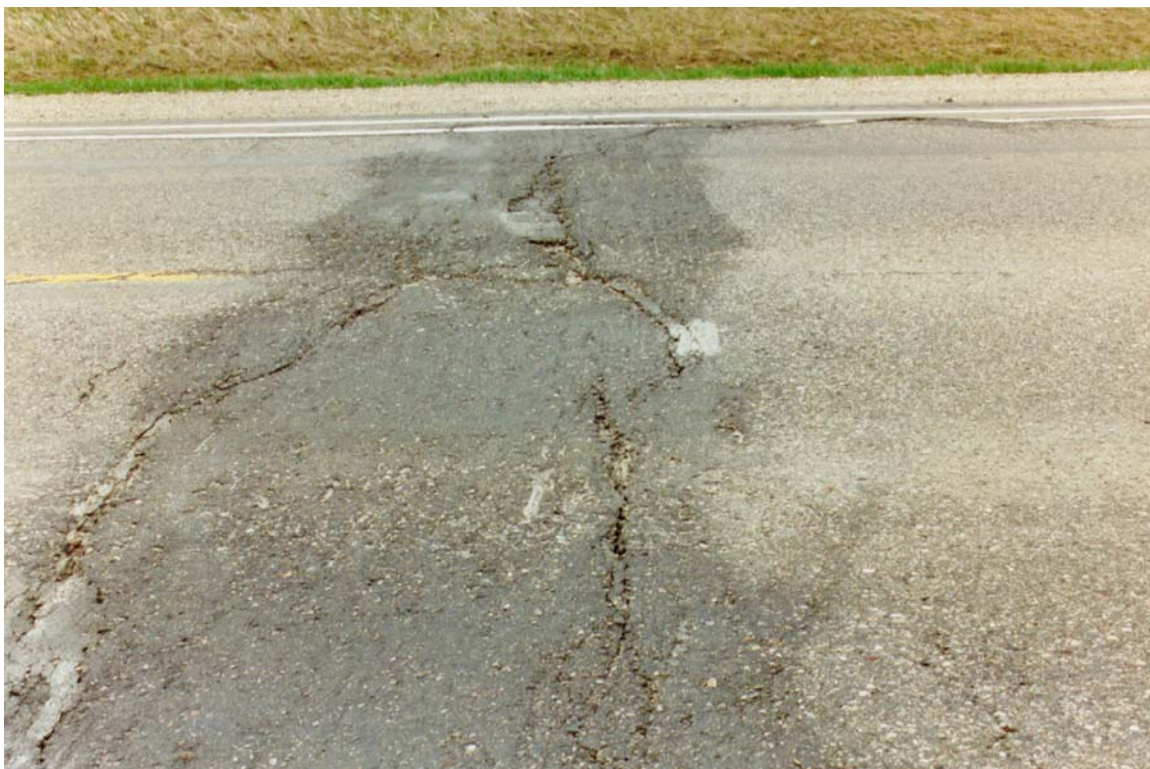
Figure 3 Typical bump burn area.
