EIGHT YEAR CORROSION TEST REPORT EIGHT - MILE ROAD INTERCHANGE

April 5, 1976

SUBJECT CORROSION RESISTANCE OF MAYARI R STEEL ON THE EIGHT-MILE ROAD BRIDGES AT DETROIT, MICHIGAN

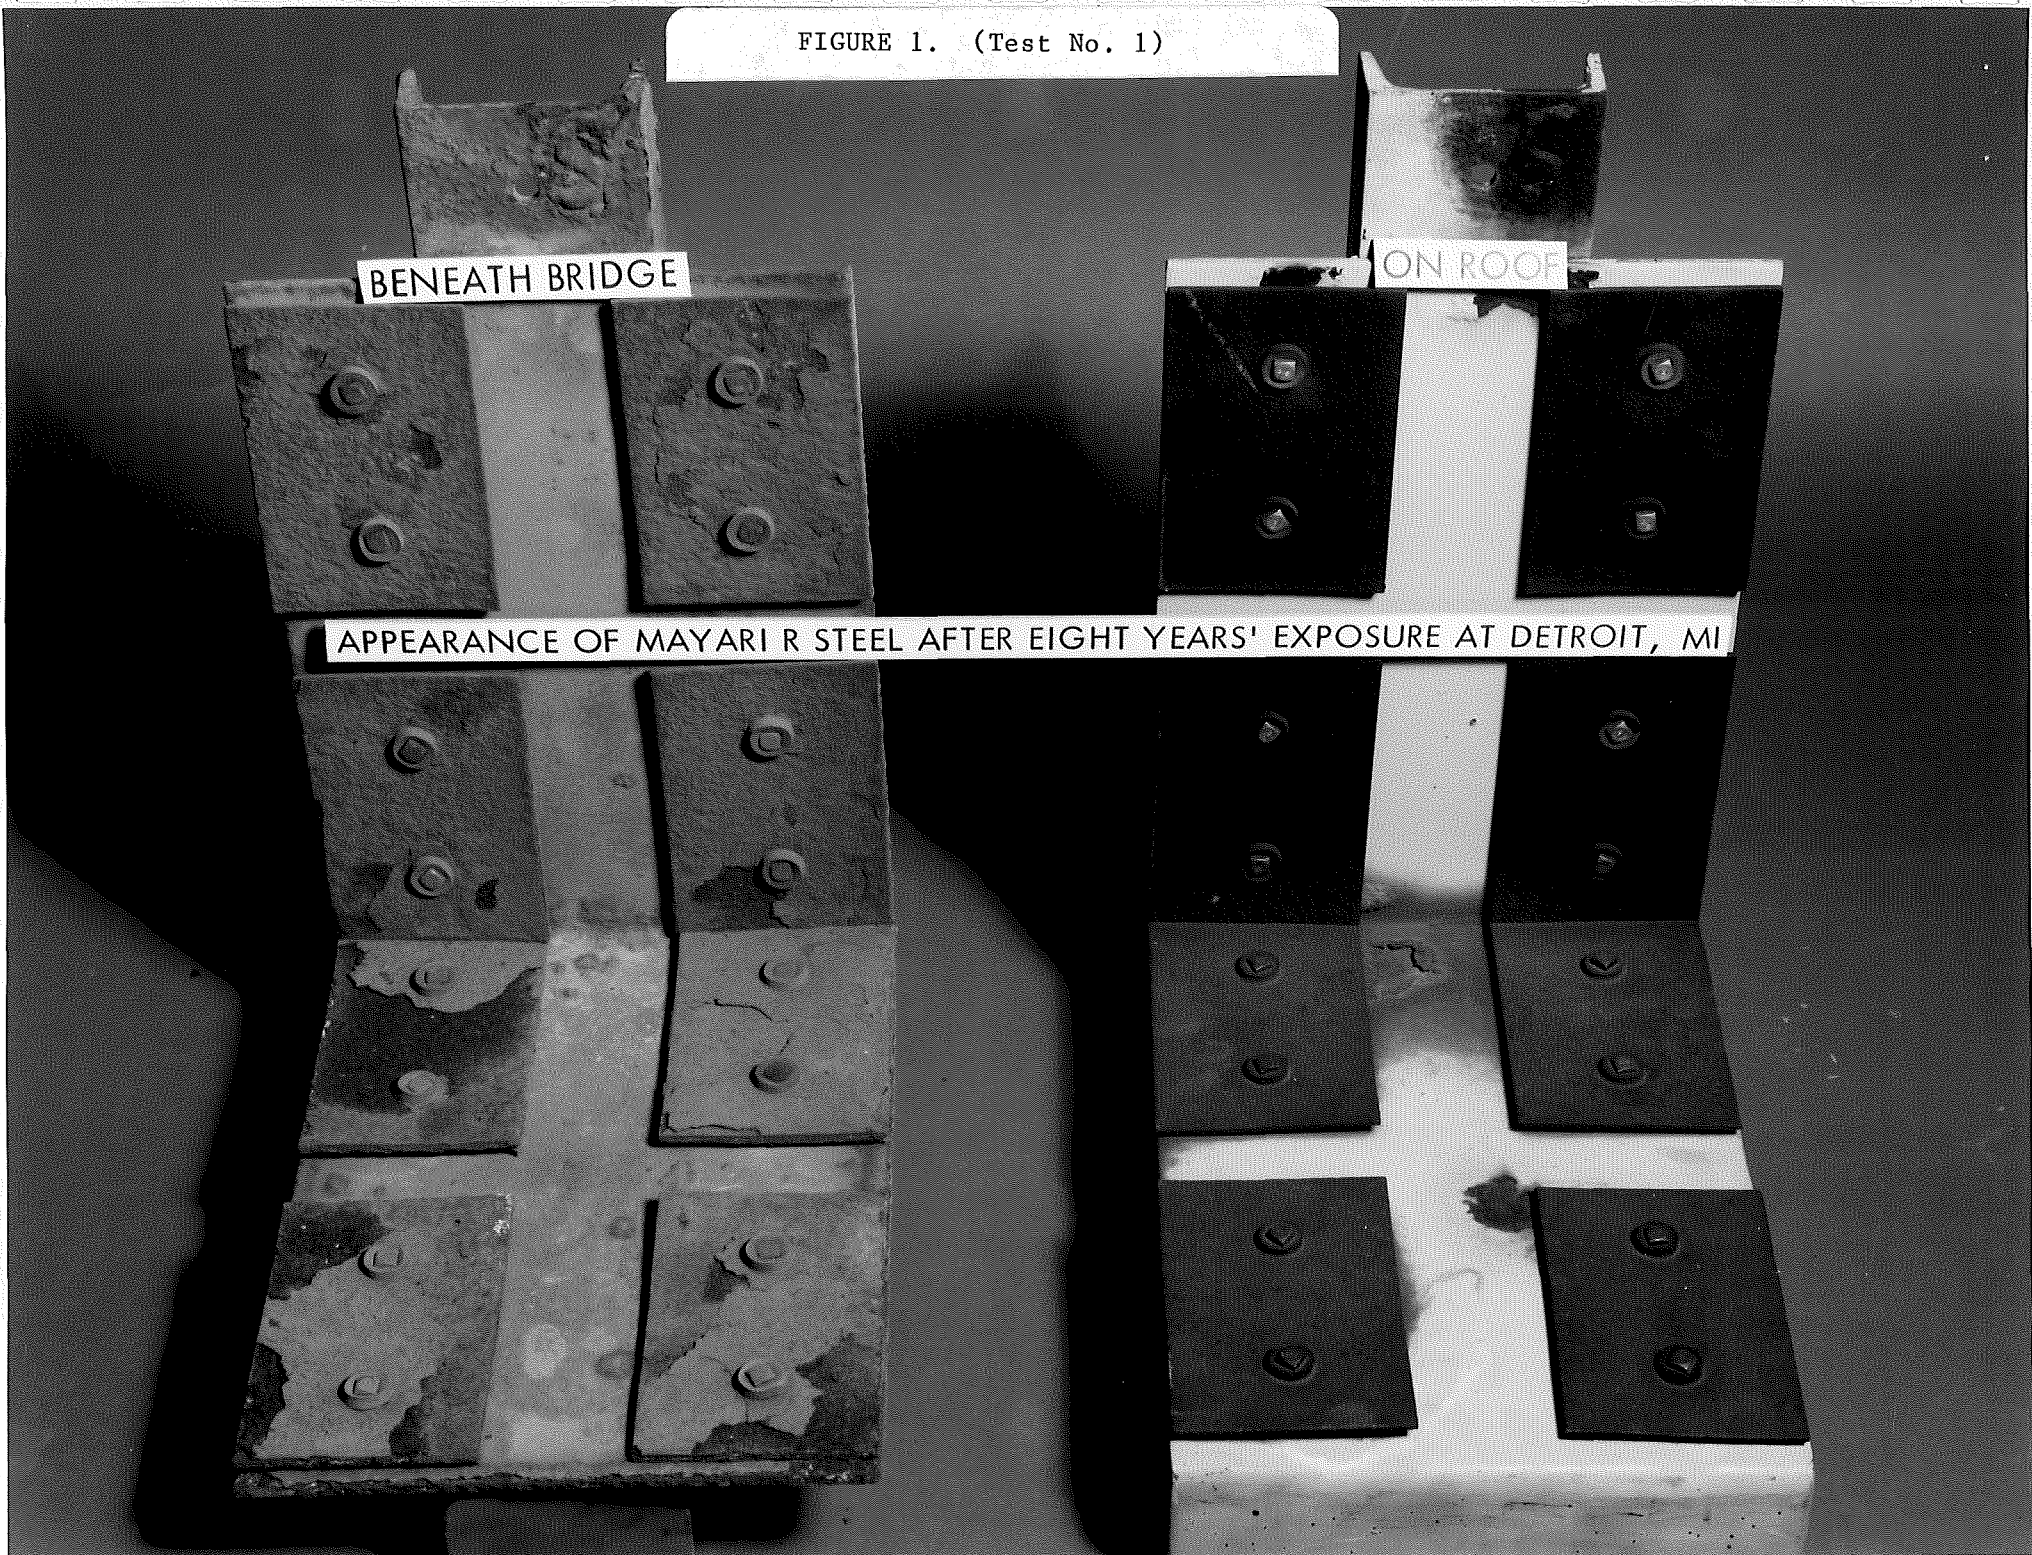
FIGURE 1. (Test No. 1)

Eight-year corrosion specimens were removed from corrosion racks on the Westbound Service Bridge and nearby National Guard Armory Roof for inspection, determining corrosion losses and for chloride analyses of the intermingled rust and soil on the panels. Figure 1 illustrates the appearance of specimens on painted corrosion racks. As on the 4-year panels, the 8-year specimens on the bridge continue to show flaking rust, a high corrosion rate (average of 1.23 mils per year) with corrosion increasing with time of exposure, while those on the Armory Roof have a uniform, tight protective rust layer,

The thickness of some of the undisturbed, intermingled rust-soil layer on the 8-year bridge panels was measured and analyzed for chloride content. The rust-soil layer was from 55 to 65 mils thick, about double that on the 4-year specimens, which was 25 to 35 mils thick. The surface underlying the flaky rust layer was relatively smooth and free of pits.

APPEARANCE OF MAYARI R STEEL AFTER EIGHT YEARS' EXPOSURE AT DETROIT, MI

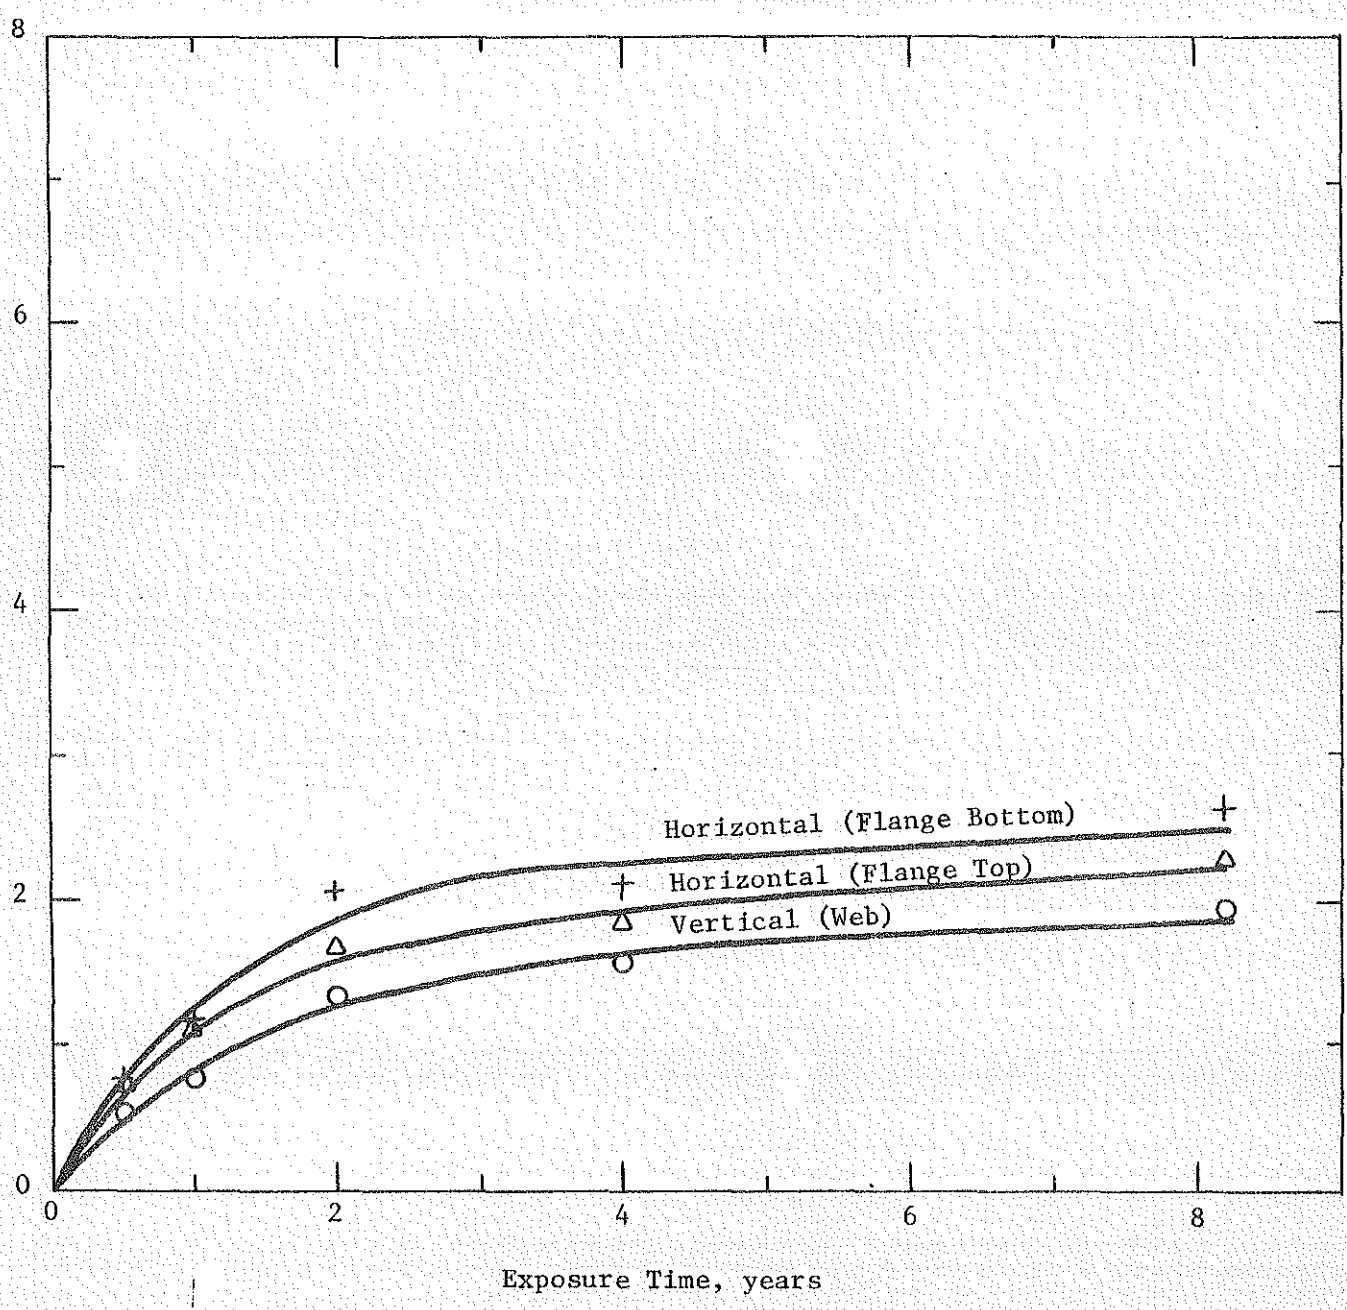
a low corrosion rate (average of 0.28 mil per year) with corrosion decreasing with time of exposure, cf. Tables 4 and 5 and Figures 2 and 3. As expected, the horizontal-top panels on the bridge, when there is greatest accumulation of solids, show the most corrosion.

FIGURE 2. WEATHERING-TIME CURVES OF MAYARI R STEEL SPECIMENS ON THE BUILDING ROOF IN DETROIT, MI (Test No. 1)

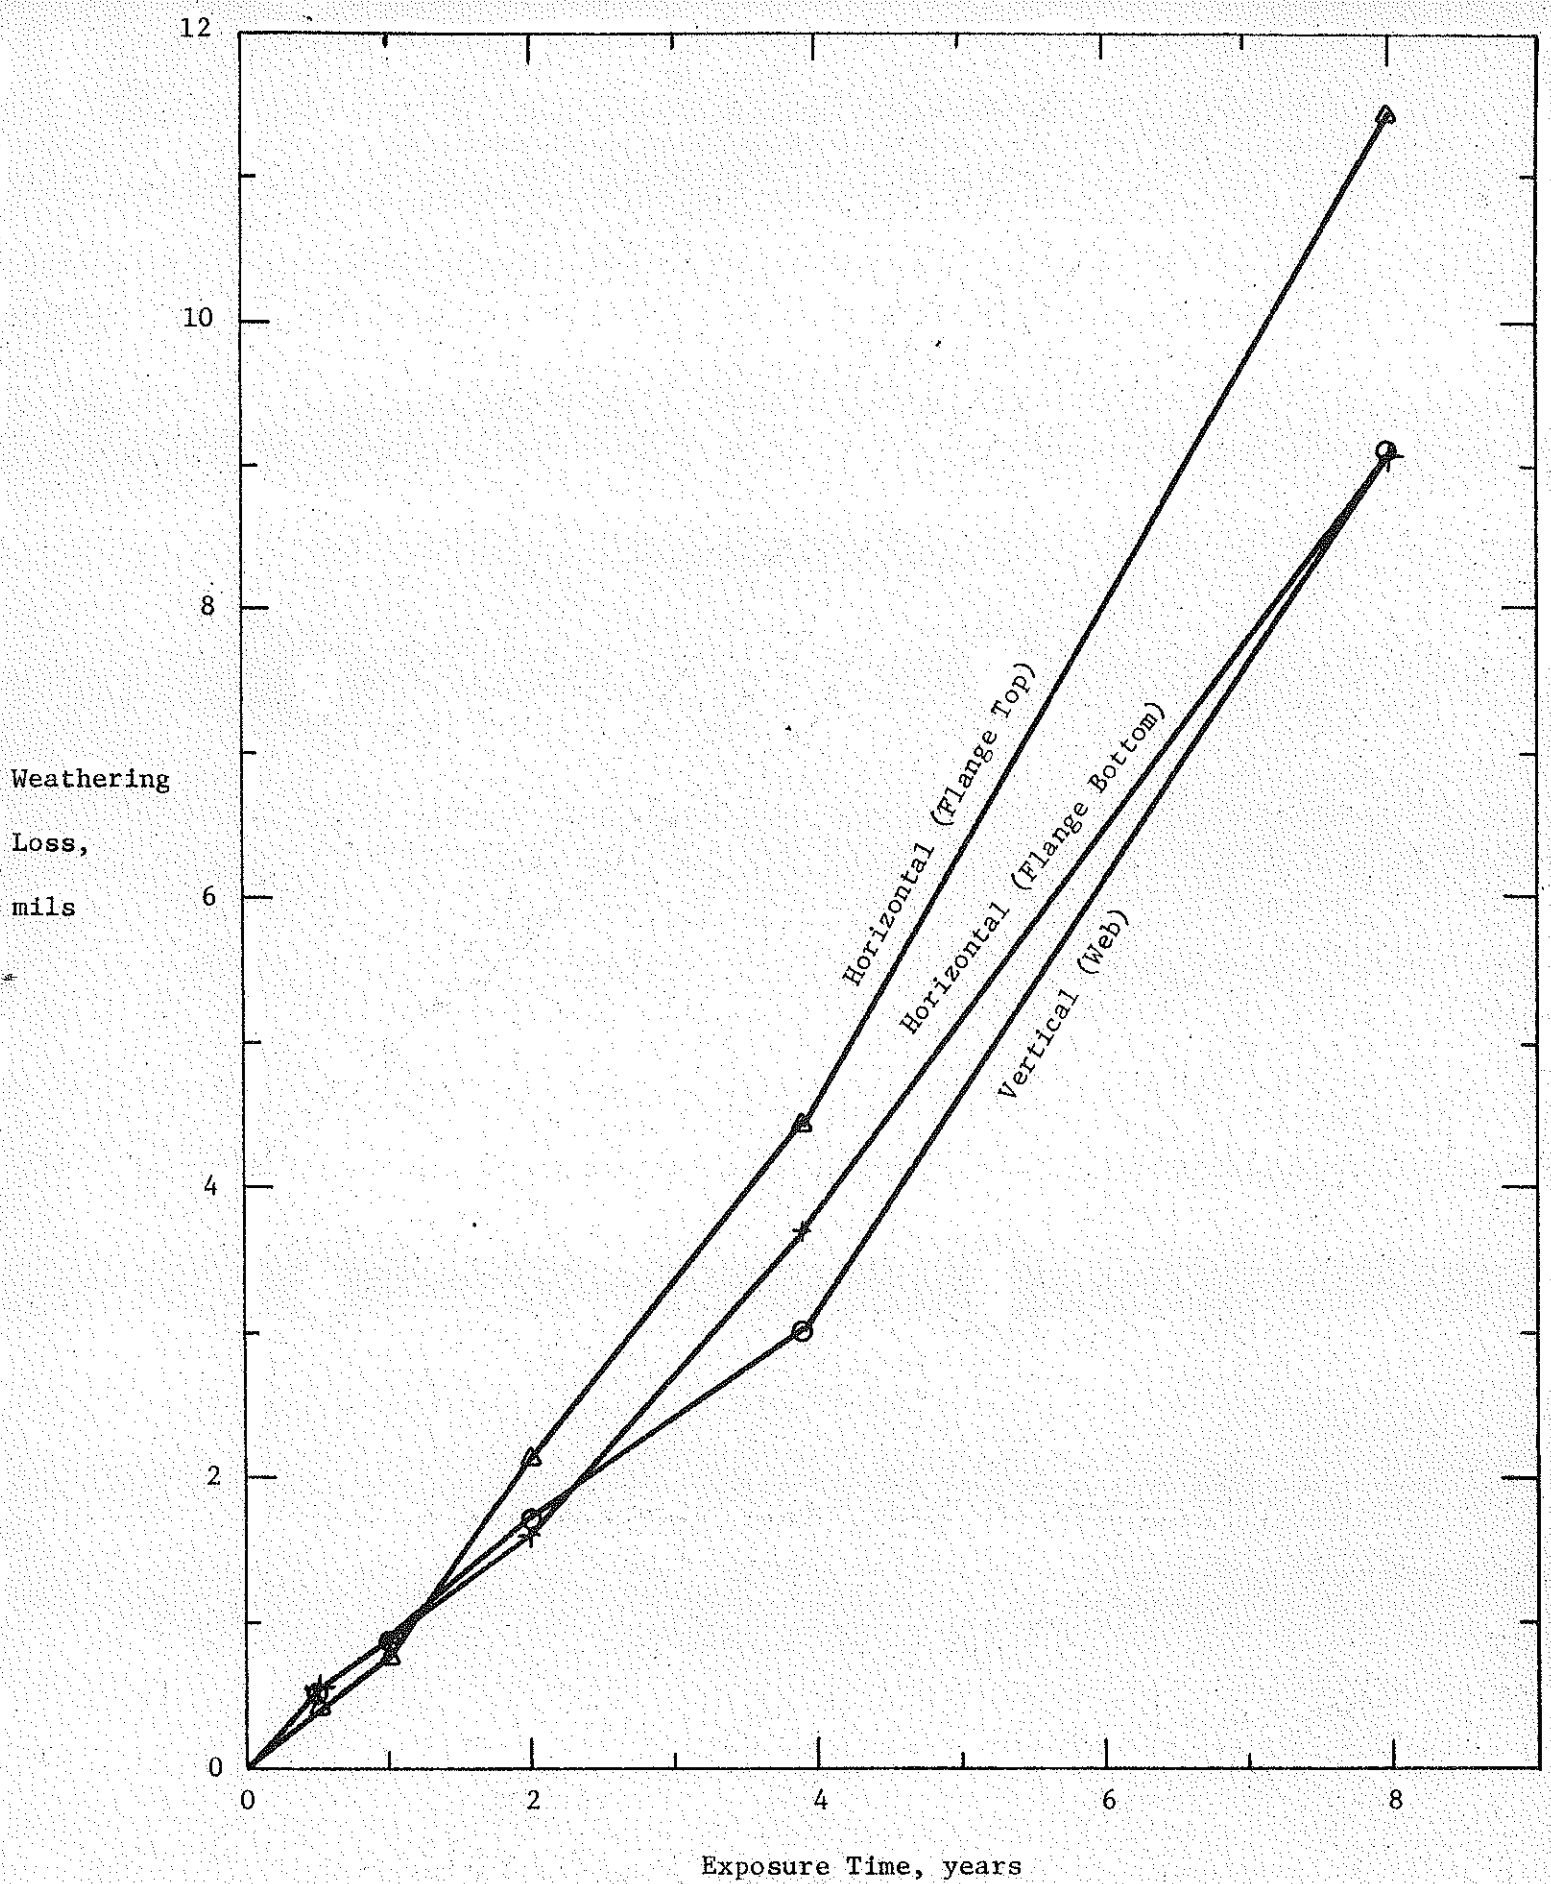
FIGURE 3. WEATHERING-TIME CURVES OF MAYARI R STEEL SPECIMENS BENEATH THE WESTBOUND SERVICE BRIDGE, DETROIT, MI (Test No. 1)

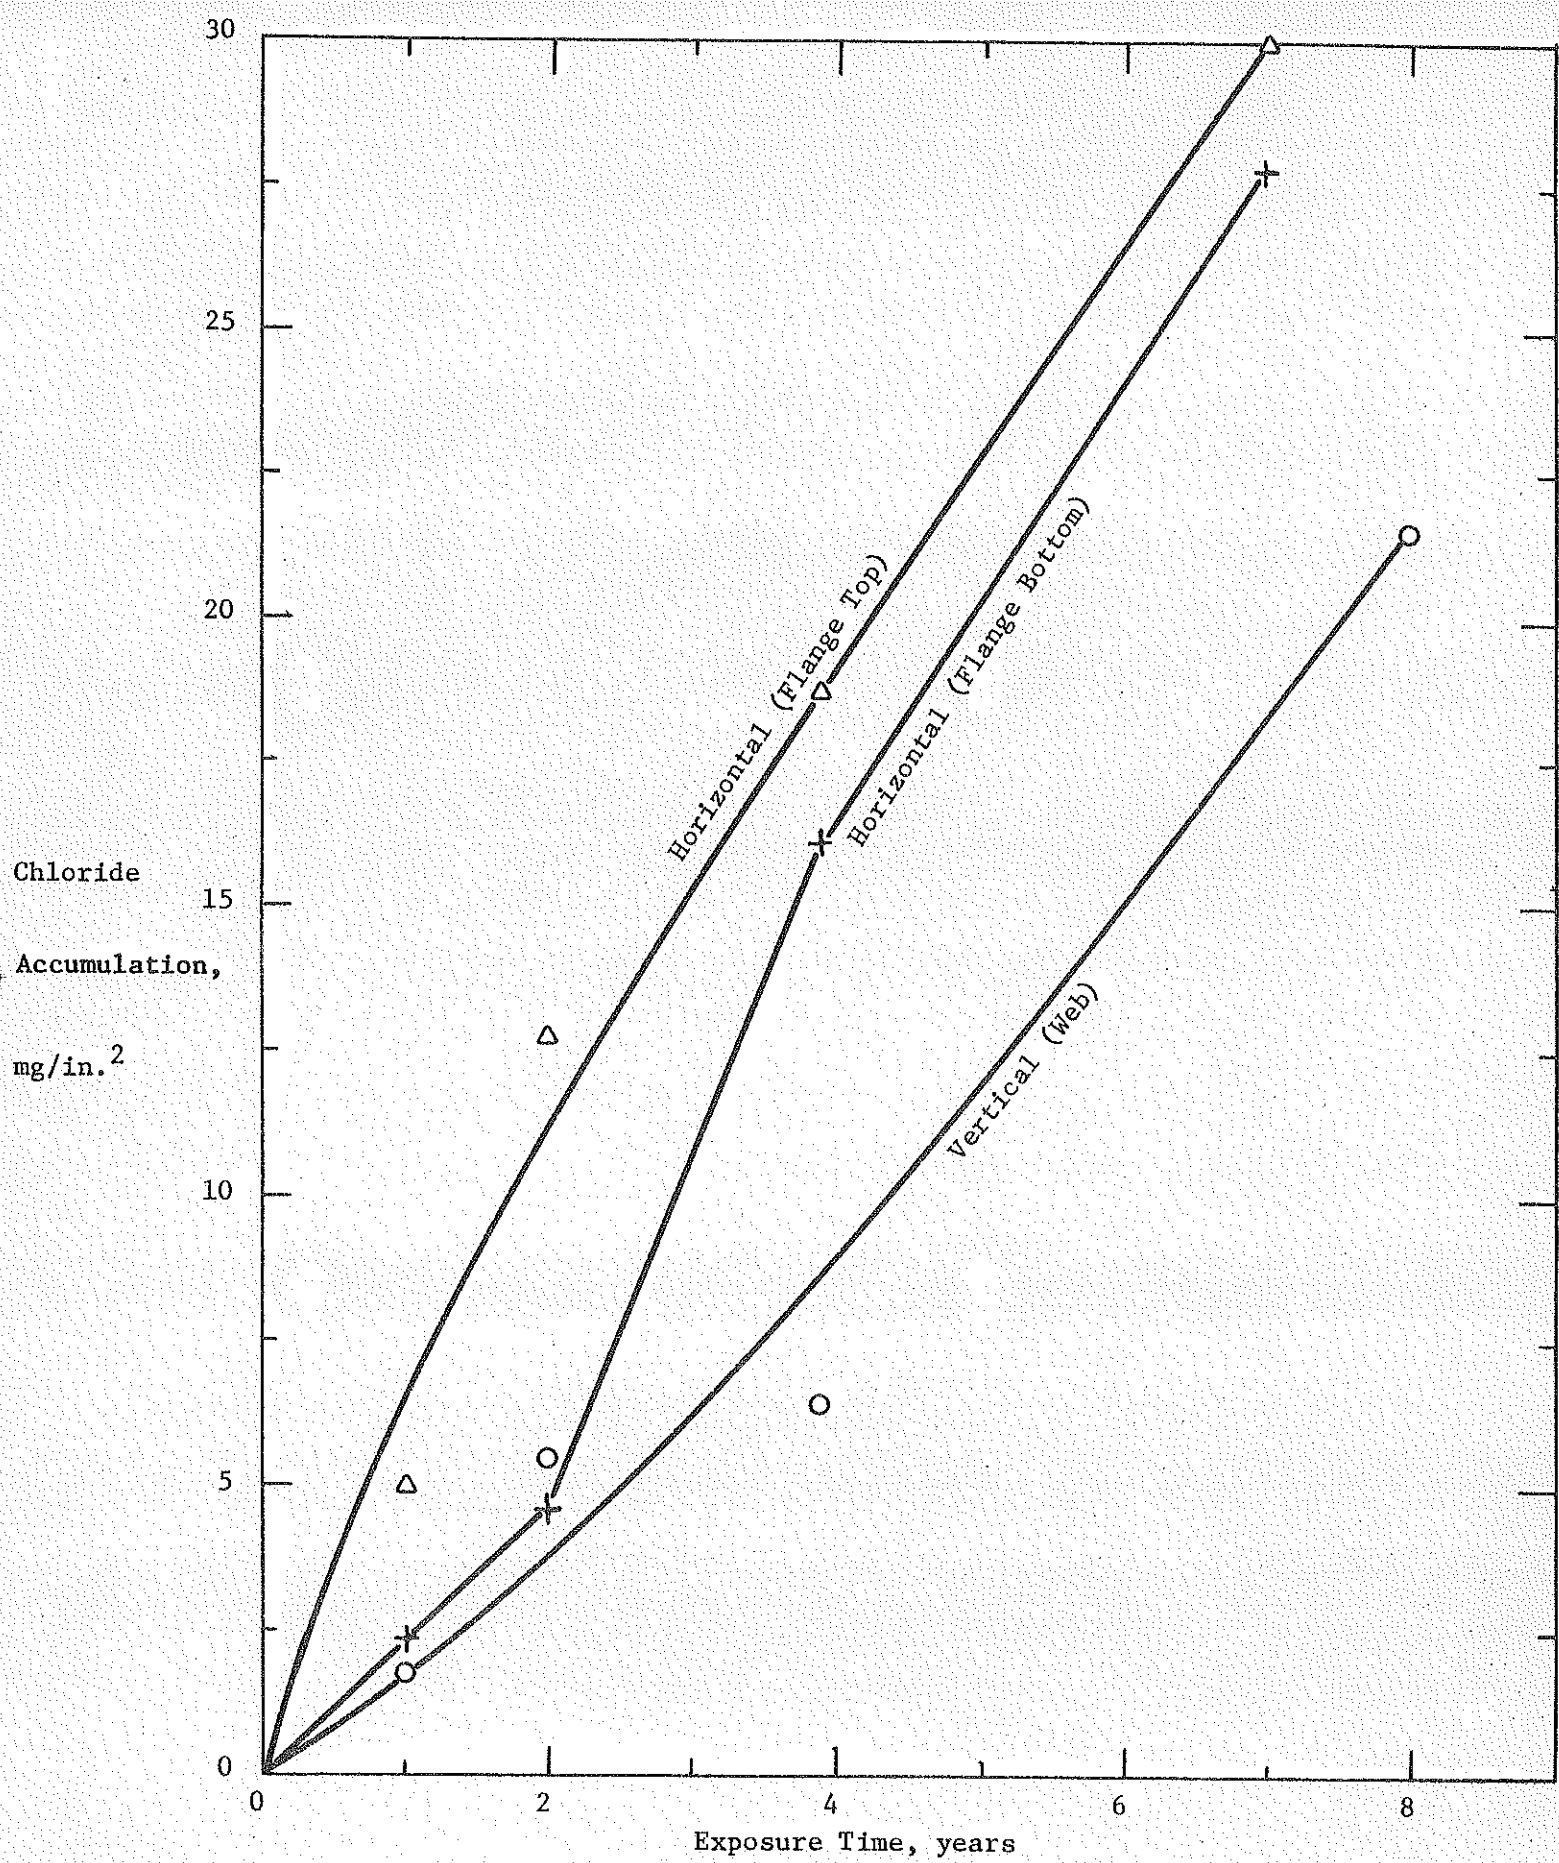
The accumulation of chlorides on the surface of the bridge panels over the 8-year period is shown in Figure 4. The chlorides increase with time as did the corrosion shown in Figure 3. Chlorides, being held in close proximity to the steel by the soil and cement dusts, are probably the major source of corrosion. In this respect, flaking rust and scale on the webs and bottom flanges may be beneficial as the corrosive agents are removed with flaking and scaling of rust. Unfortunately, the new surfaces are quickly contaminated again by road spray, salts and dirt, and deposits are not removed from ledges and horizontal surfaces.

FIGURE 4. CHLORIDE ACCUMULATION ON STEEL PANELS BENEATH THE WESTBOUND SERVICE BRIDGE, DETROIT, MI (Test No. 1)

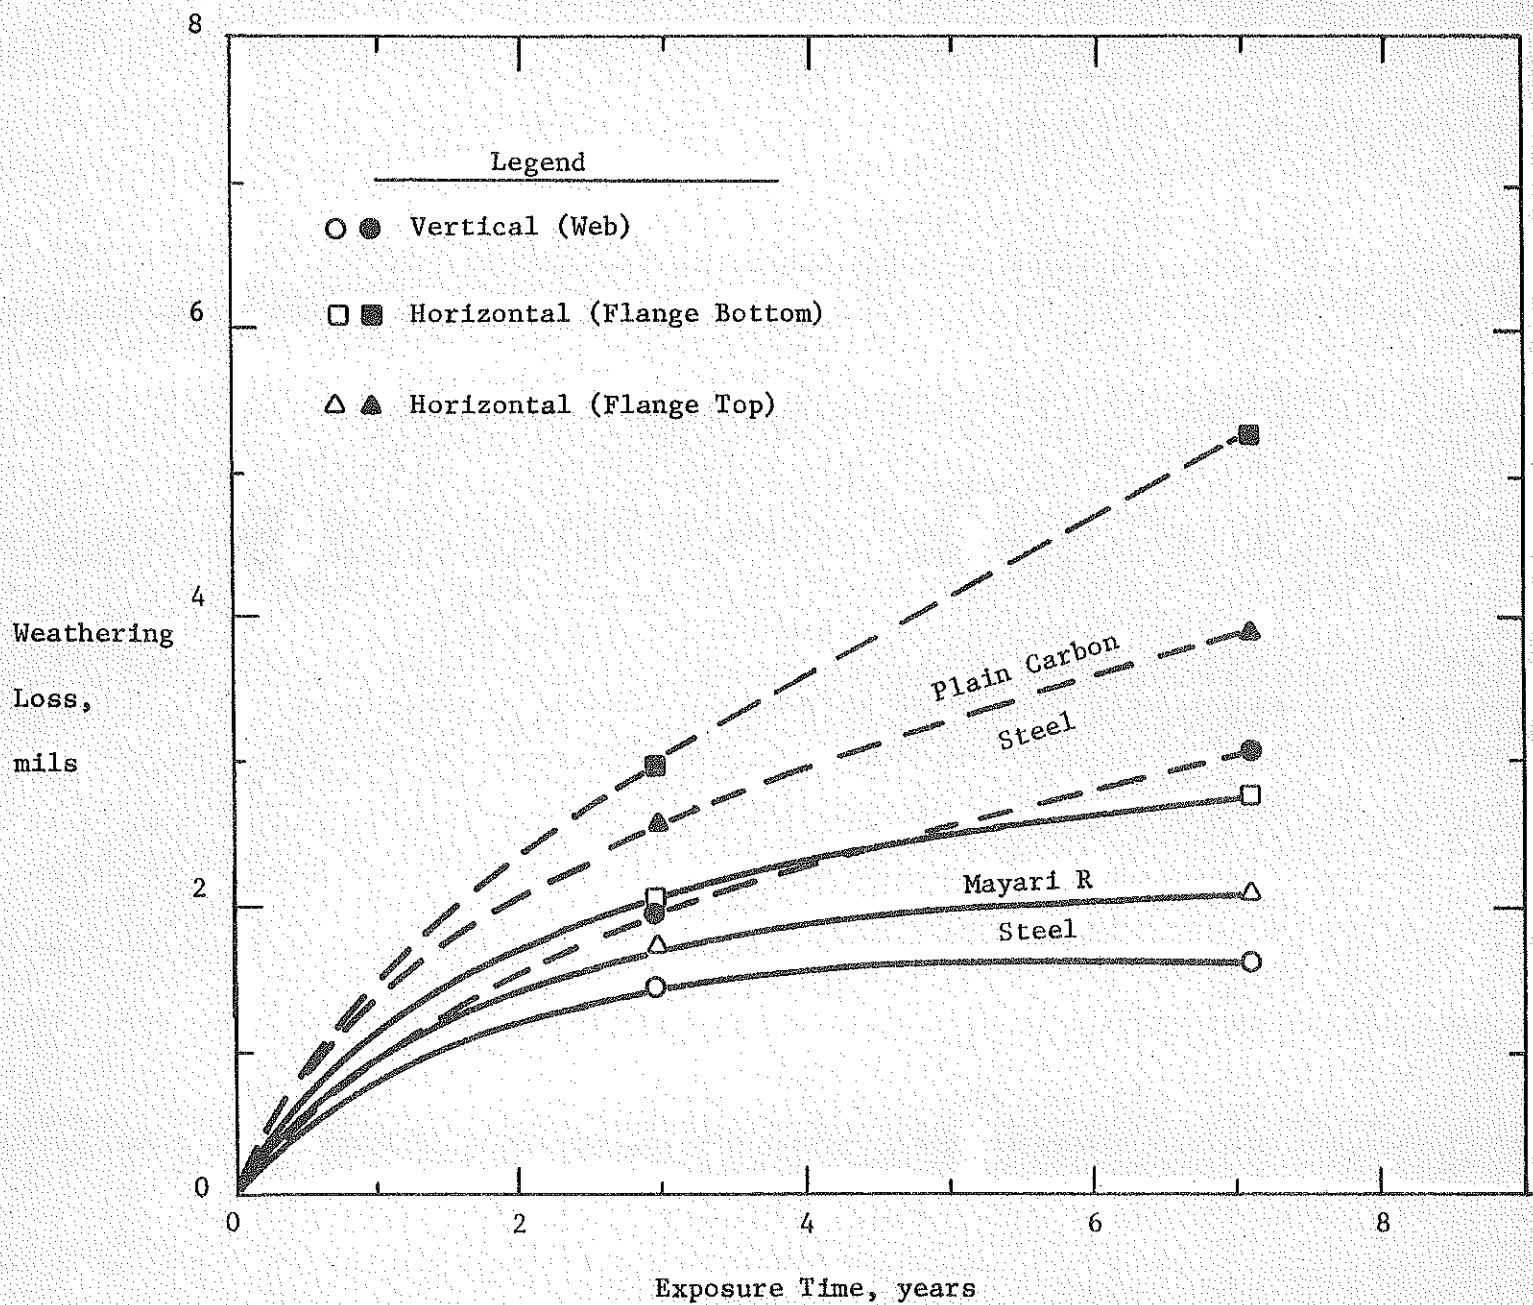
Based on a comparison of 3- to 7-year slopes, the Mayari R steel shows an average of 4 times the corrosion resistance of plain carbon steel. Moreover, on the basis of the curvatures evident in Figure 5, we expect the superiority of Mayari R to increase further with time.

FIGURE 5. WEATHERING-TIME CURVES OF MAYARI R AND PLAIN CARBON STEEL SPECIMENS ON THE BUILDING ROOF IN DETROIT, MI (Test No. 2)
