MICHIGAN  
DEPARTMENT OF STATE HIGHWAYS

August 4, 1967

**Subject:** Inspection Report of Field Applications of "Speed Crete" Patching Mixtures. Research Project 65 NM-140. Research Report No. R-646.

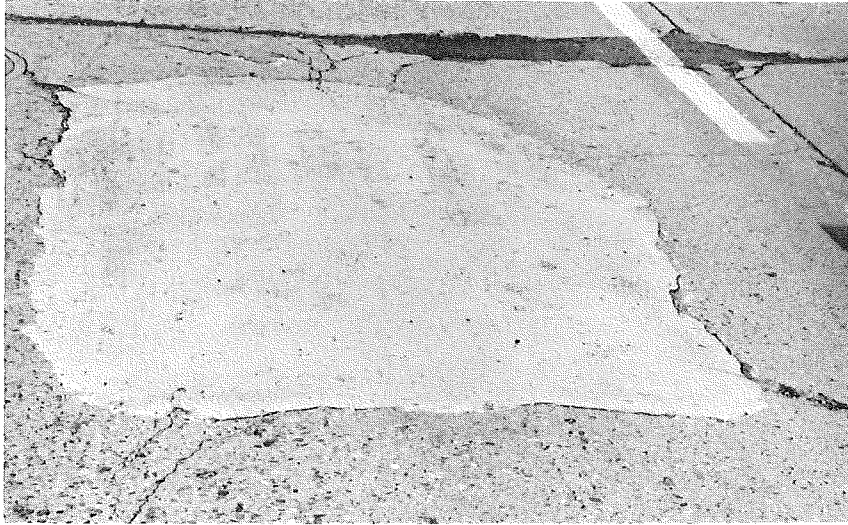
This full-depth patch was placed in mid-April 1966, and inspected on June 6, 1967. Figure 1 shows the general appearance of the patch with numerous large cracks in the surrounding concrete. The patch appeared fairly sound but some hollow areas around the perimeter, and some fine surface crazing or shrinkage cracks, were present. The hollow regions indicate that it may be losing bond with the old concrete.

Figure 1. Full-depth pavement patch in northbound US 23 BR, (view looking south), placed in mid-April, 1966.

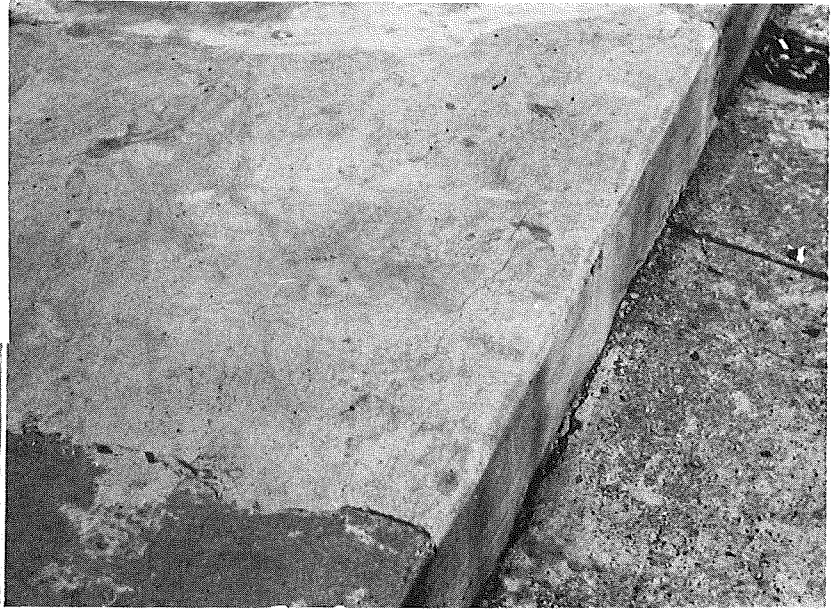
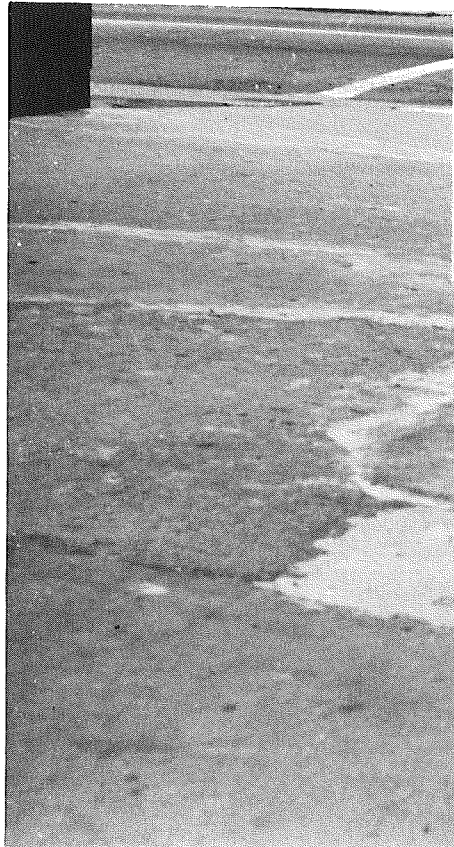
This area was patched in front of the Gladmer Theater on April 29, 1966. Two views of the patched sidewalk are shown in Figure 2. The original patch of April 29, was inspected on June 13, 1967, and found to contain a number of fine cracks and sounded very hollow when checked with a hammer. It appears to have lost bond with the older underlying concrete although the patch remains in place. Newer patched areas, placed about September, 1966 by the Lansing DPW adjacent to the original, can be seen in the general view of Figure 2. These areas also contained many hollow or loose portions.

Figure 2. Close-up of patch placed 4-29-66 in front of Gladmer Theater showing shrinkage cracks near corner. Second view shows original patch and additional ones placed in September, 1966, by Lansing DPW.

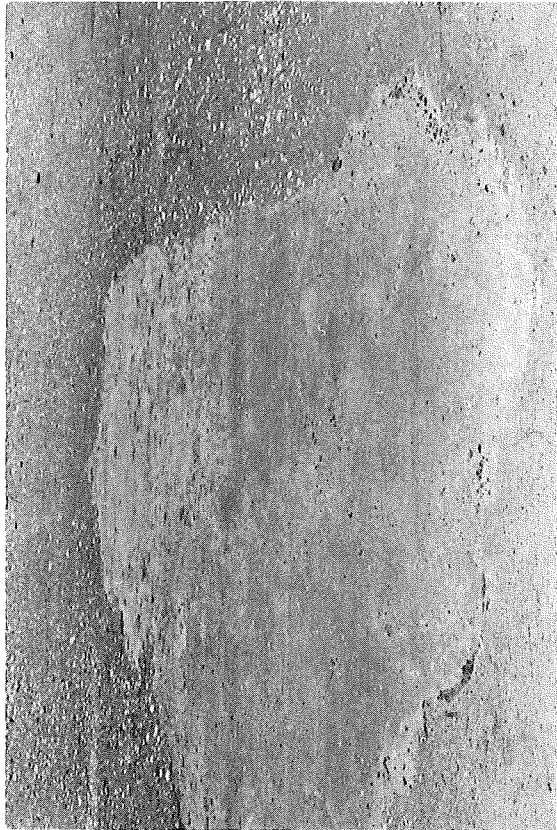
One large, and one smaller patch, were placed July 27, 1966, near the north end of this structure close to the east curb. These were inspected June 6, 1967, and the largest patch is shown in Figure 4. This larger patch had a small hollow area toward the west end, and the smaller patch had a hollow region on the south perimeter. Otherwise, the patches appeared in good condition and didn't exhibit the fine surface cracking observed in many of those on the US 127 structure at Jackson.

Figure 4. Large patch near east curb of northbound half of deck; placed 7-27-66. Pennsylvania Ave. over NYCRR.

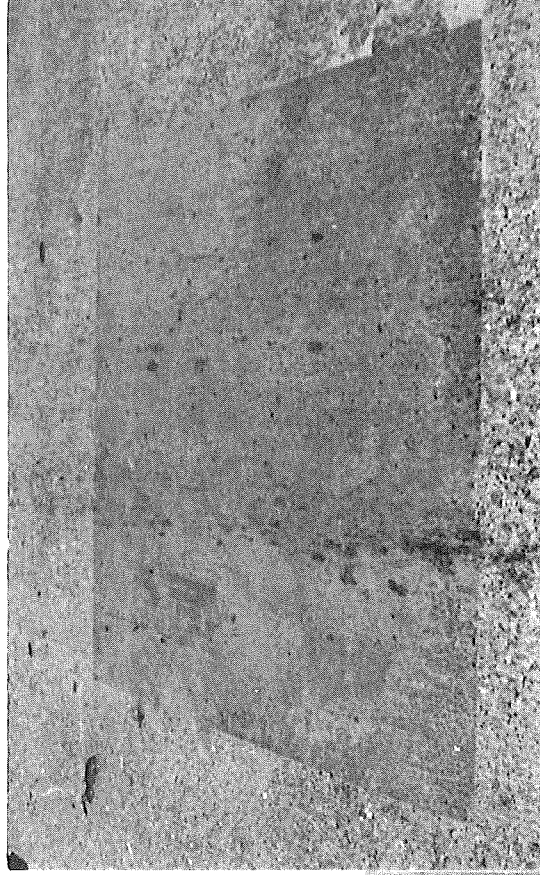
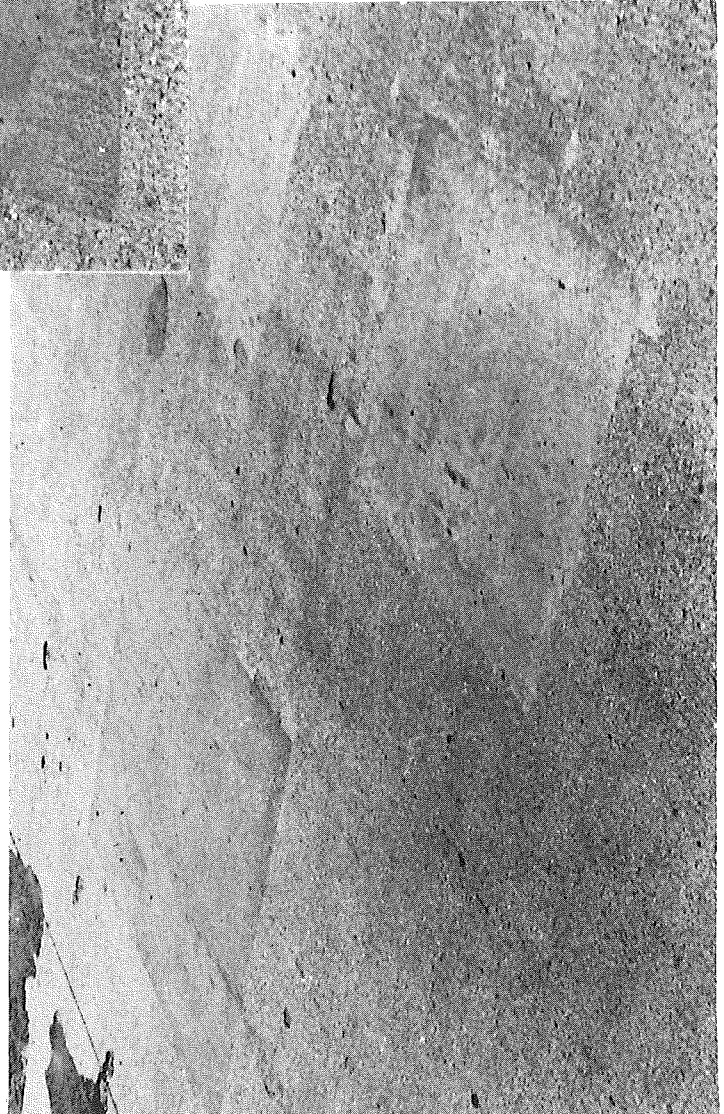
Since the first Report (No. R-618) was published, details of deck patching placed July 26, 1966, by the City of Kalamazoo were obtained. These patches were inspected June 21, 1967, with C. H. Voss, District Engineer, and are shown in Figure 5. The areas patched are on the westbound side of the east end span, near pier three. These patches differ from all the ones previously mentioned, in that the boundary of the patches was saw-cut about one-inch deep before chipping out the spalled concrete. These patches were about 3 by 3 ft, 2-1/2 by 2-1/2 ft, and 1-1/2 by 2 ft in size, and were a maximum of about 1-1/2 to 2-in. deep. About 4-1/2 bags of "Speed Crete" were hand-mixed in a wheelbarrow and sprayed with a clear curing compound after finishing. The patches were opened to traffic in about one hour. All three patches were sound, with no hollow areas and didn't contain shrinkage cracks.

Figure 5. Patches placed 7-26-66 in Paterson St. bridge over Kalamazoo River in Kalamazoo. Over-all view shows three patches in north half of east end span near pier three. Close-up shows largest patch, about three-feet square, and sawed perimeter.
