EVALUATION OF A POLYCARBONATE  
VEHICULAR TRAFFIC SIGNAL

TSD-233-74

**TRAFFIC and  
SAFETY  
DIVISION**

**DEPARTMENT OF STATE HIGHWAYS  
STATE OF MICHIGAN**

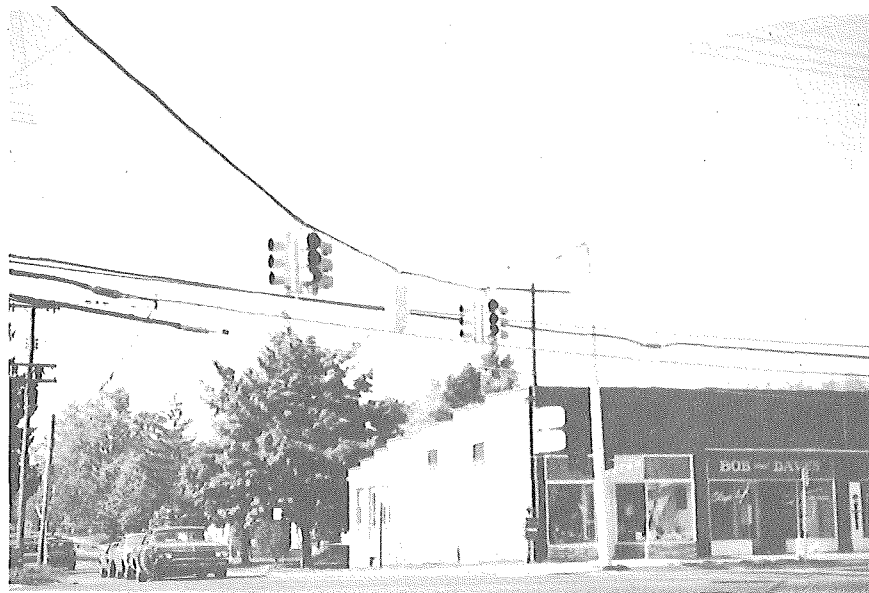
Photograph #3 - Field Evaluation Site, Cedar Street  
(I-96BL) And Cavanaugh Road - City  
Of Lansing. Polycarbonate Signal on  
Left.
