MICHIGAN
STATE HIGHWAY DEPARTMENT
Charles M. Siegler
State Highway Commissioner

EFFECT OF FOREIGN MATERIAL ON QUALITY OF
CONCRETE ON PROJECT F 47-16, C2

Research Project 48 B-22

Research Laboratory
Testing and Research Division
Report No. 114
June 10, 1948

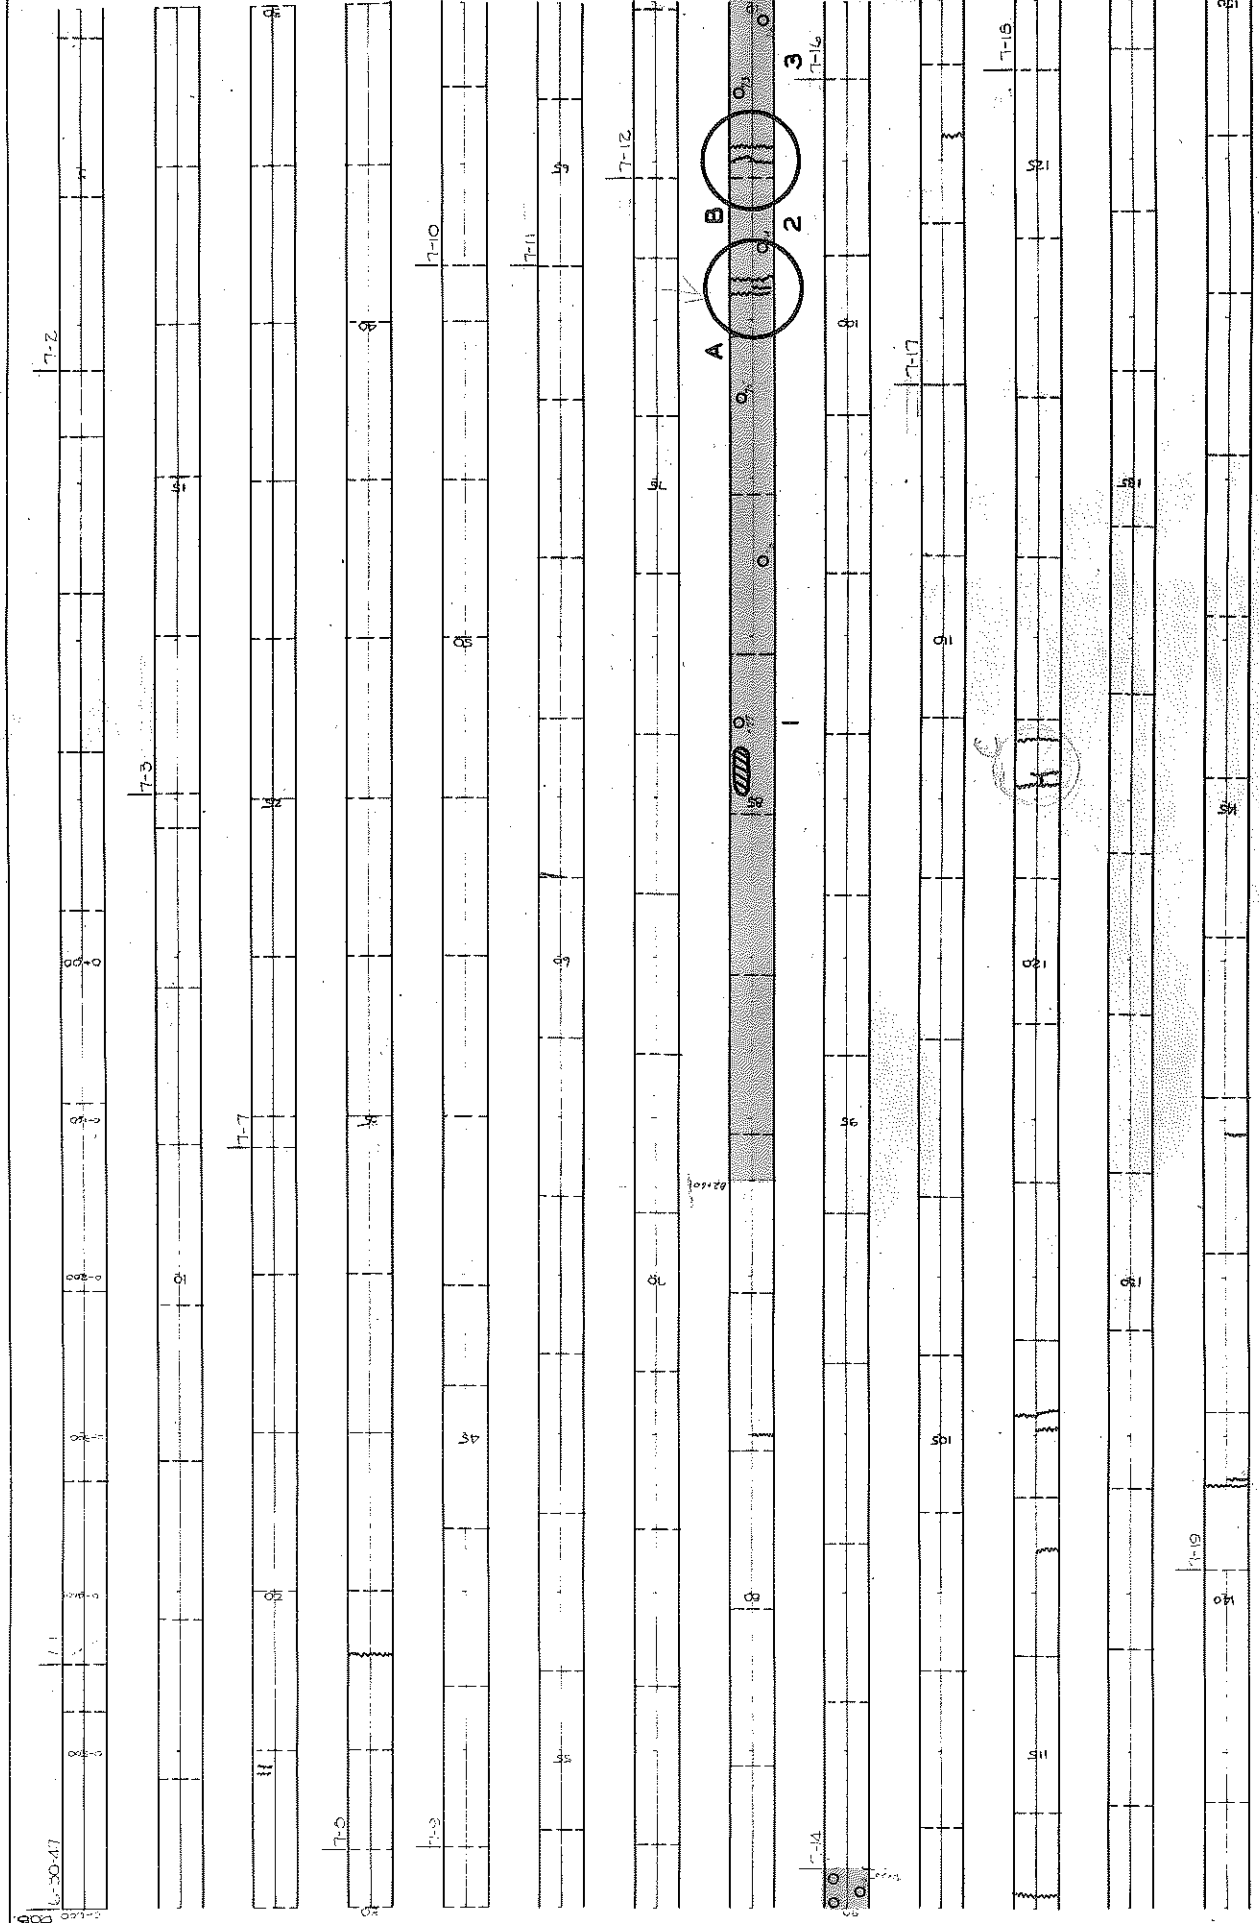
CONDITION SURVEY # 2 (9-30-47)
 Research Project EAS-16, C2, L159, C3
 US-10 West of Reed City
 Sheet 1 of 2 Sta 0+000.4 to 150+00

Results From Condition Surveys: The physical condition of the pavement with respect to cracking revealed by both surveys is illustrated in Figure 2. In the 1947 survey, cracking was noted in the affected area at Stations 88+20 and 89+10. At that time the pavement was not discolored. The survey in 1948 revealed the same amount of cracking, but the pavement had become badly discolored in those two areas. See Figures 3 and 4. In addition, scaling has taken place over a small area at Station 88+30. These areas are shown in Figures 4 and 5. Excretion of white material was also noted at a few localized areas as shown in Figure 6, and rose discoloration has appeared at Station 88+40 (Figure 7). From a visual examination the most seriously damaged pavement is in the vicinity of Stations 88+20 and 89+00, designated areas A and B in Figure 2. However, other weakened areas may develop with time.

Results From Core Studies: Nine cores were taken from the affected section of pavement. Their location and identification are shown in Figure 2. The results of laboratory tests for strength and durability in freezing and thawing are given in Table 1. The core strengths tie in very well with the general performance of the pavement. The strength values of cores 88, 75, 76 and 77 are relatively low and they were taken from the three slabs most seriously affected.

AREAS A - B MOST SERIOUSLY DAMAGED, (SEE PHOTOGRAPHS)

From the available facts at the time of this writing, it may be concluded that the slabs of concrete pavement most seriously damaged from the presence of the soda ash are those designated 2 and 3 in Figure 2. Their respective stationings are 87+00 to 88+00, and 89+00 to 89+05. However, the slab designated 1, between Stations 84+00 and 85+00, has started to show discoloration and the core strength was below average. It is possible that in this slab the effect of the soda ash may develop at a later date. This may also be true for other concrete adjacent to the areas most seriously affected.

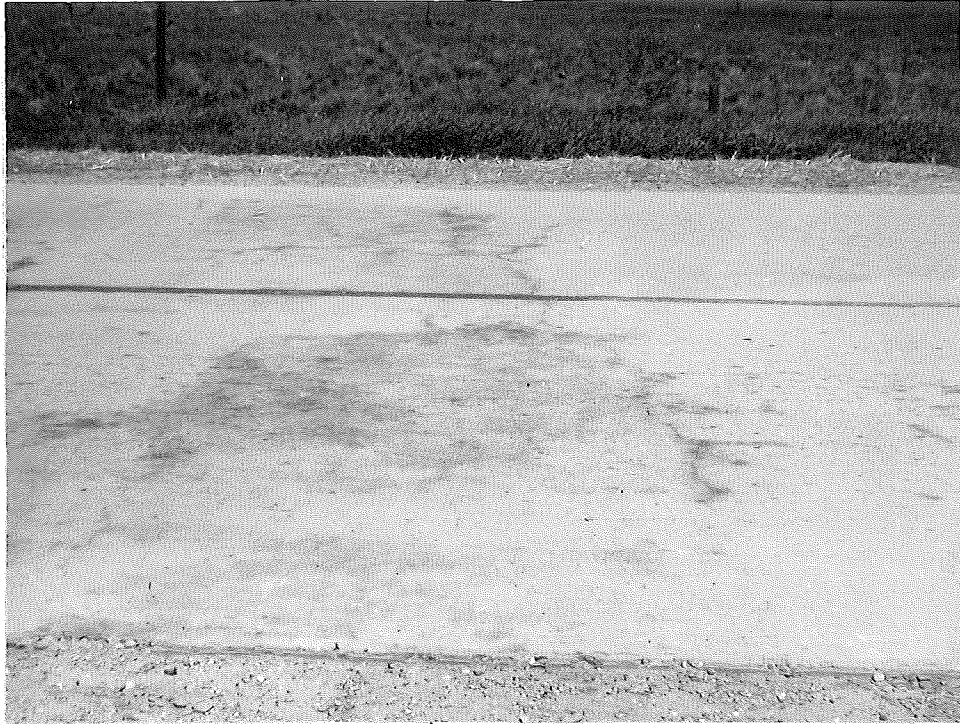
Figure 3. Appearance of pavement from Station 89+00 to 89+10. Note discoloration and hair checking of concrete.

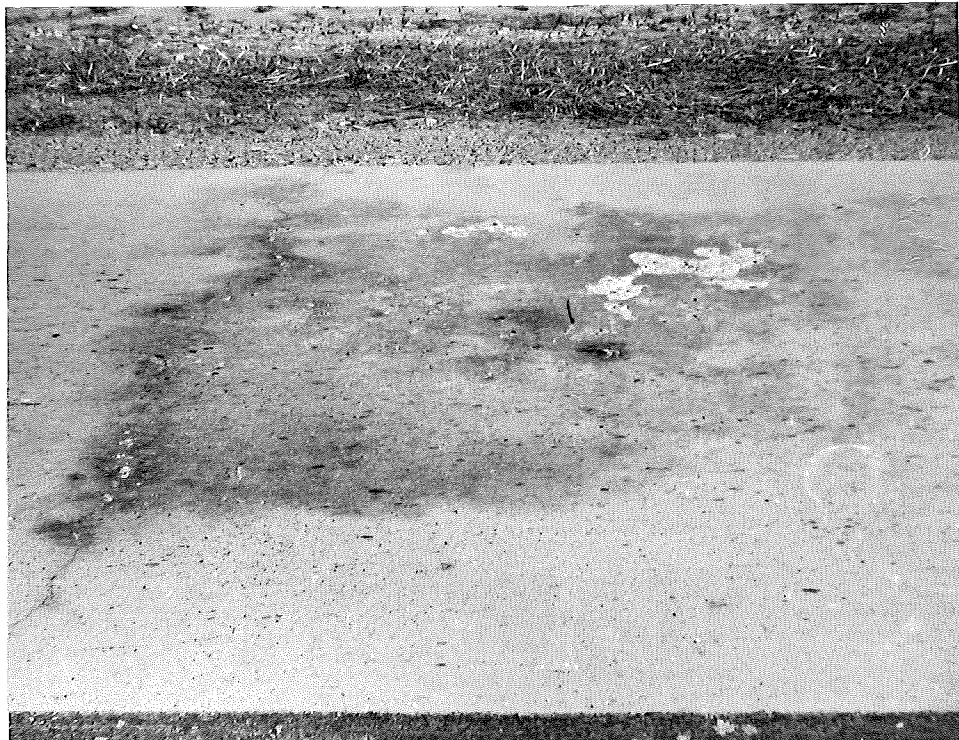
Figure 4. Appearance of pavement between Station 88+20 to 88+25. Concrete discolored and scaled in north lane only. Cracking extended across entire pavement.

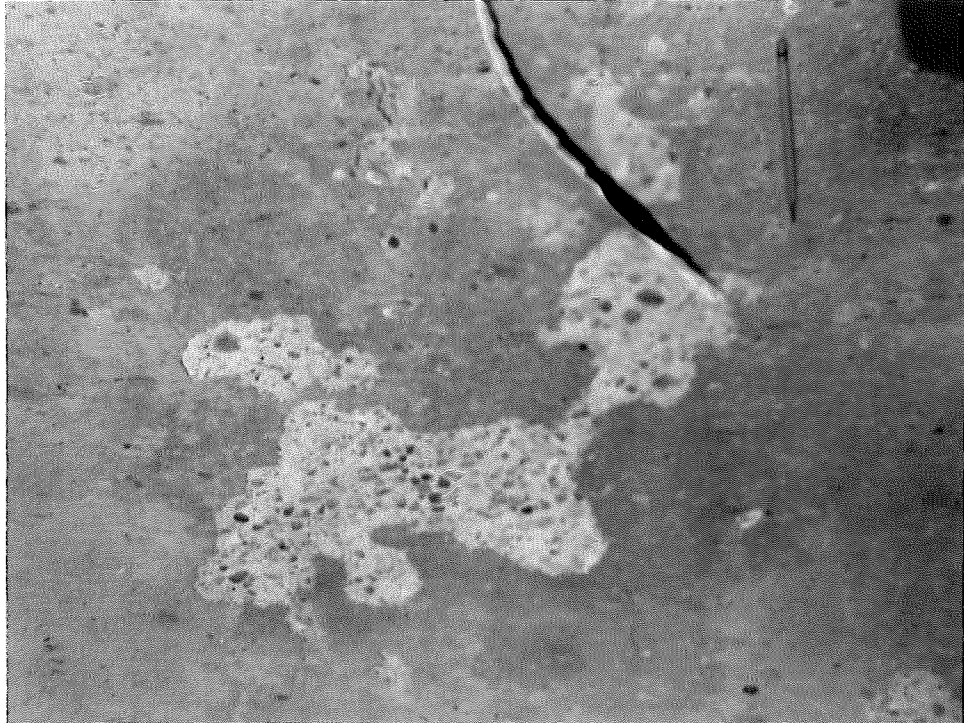
Figure 5. View of scaled area at Station 88+20.

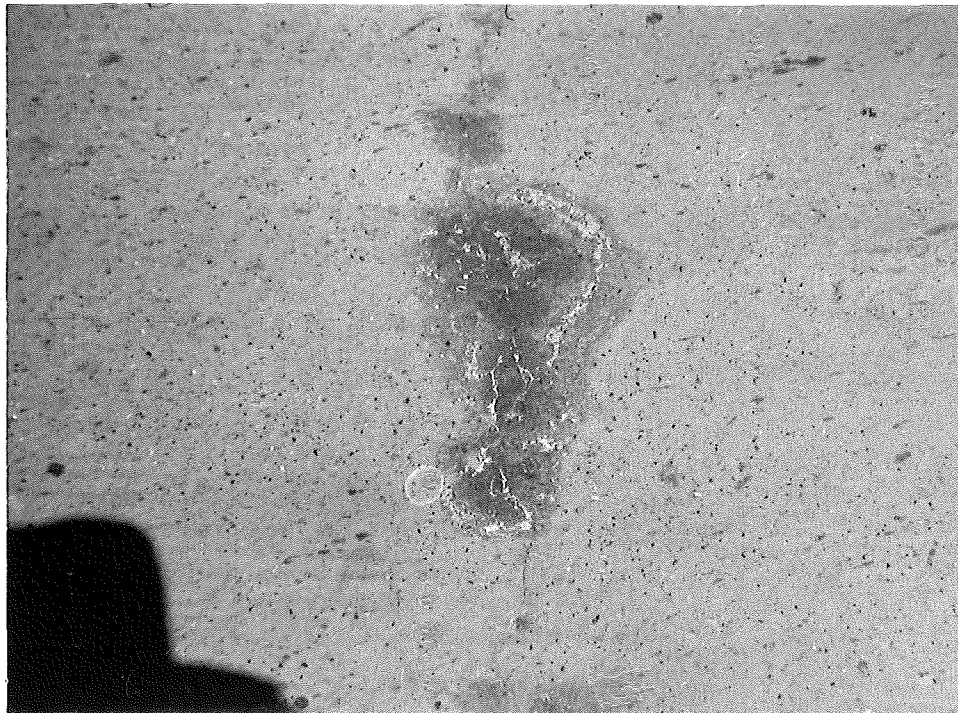
Figure 6. Excretion of white material in localized areas.
Station 88+05.

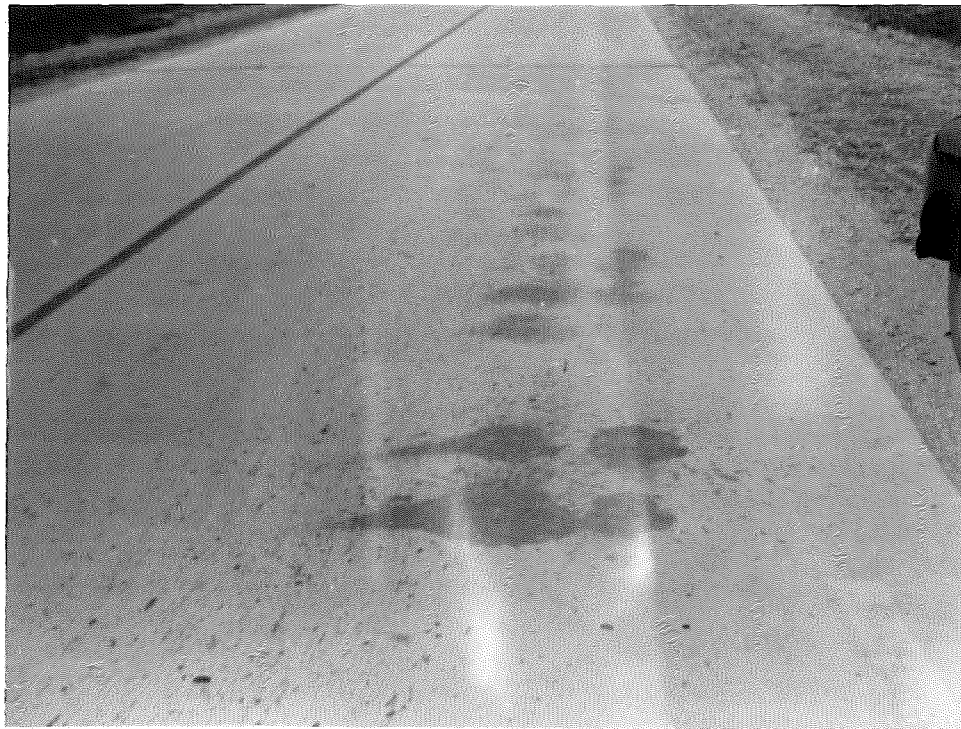
Figure 7. Discoloration in north lane, Station 85+40. Concrete not cracked or checked in dark areas.
