**MICHIGAN DEPARTMENT OF TRANSPORTATION  
M•DOT**

**Investigation of Calcium Hydroxide Depletion as  
a Cause of Concrete Pavement Deterioration**

**Research Laboratory Section  
Construction and Technology Division  
Research Project 94 B-0108  
Research Report No. R-1353**

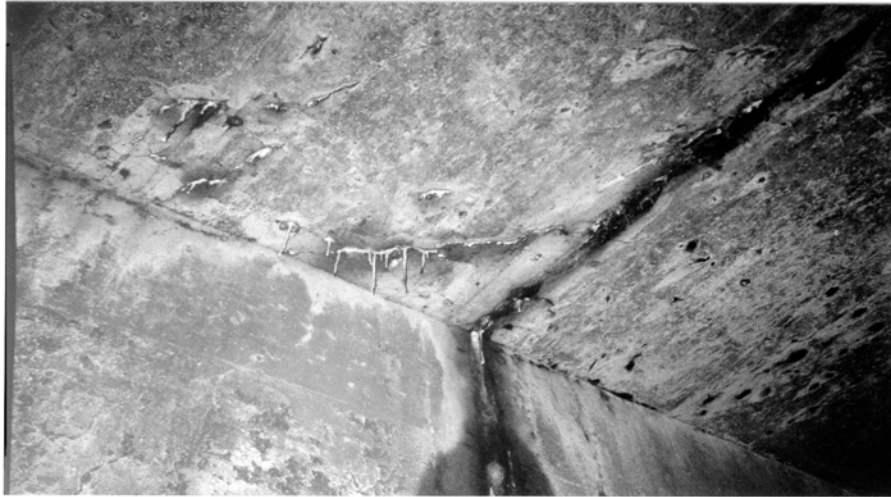
Figure 1 shows an example of the deterioration of portland cement of a structure caused by the leaching of calcium hydroxide from the deck concrete. The calcium hydroxide leachate has migrated through cracks to form calcium carbonate deposits on the underside of the bridge deck.

Figure 1 . Calcium carbonate deposits on underside of bridge deck.

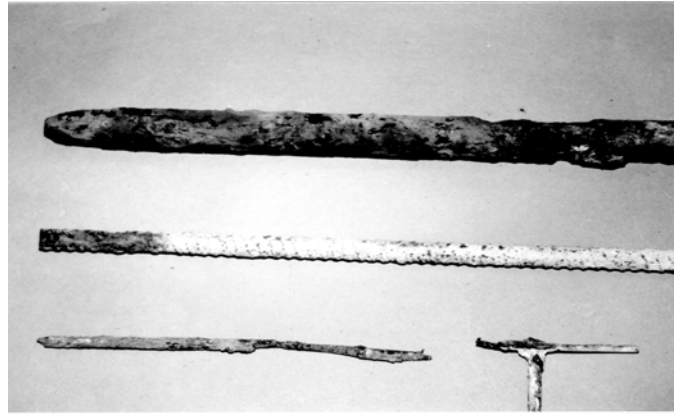
Figure 2 shows an example of severely corroded welded wire reinforcing steel obtained at one of the open cracks on the I-69 roadway and an example of corroded longitudinal reinforcing steel removed from a repair site on the I-196 roadway (see Appendix B/C). The figure also includes a deeply corroded load transfer dowel bar from a reconstruction site on US 23 in Monroe County as an example of the severity of corrosion that can occur at pavement joints.

Figure 2. Corroded reinforcing steel and dowel bar from zones of carbonated concrete at cracks and at a joint.

Corroding steel undergoes a considerable volume increase as the iron converts from a metallic form to an oxide. The volume increase can readily cause disruption of the adjacent concrete that has already been weakened by loss of calcium hydroxide.

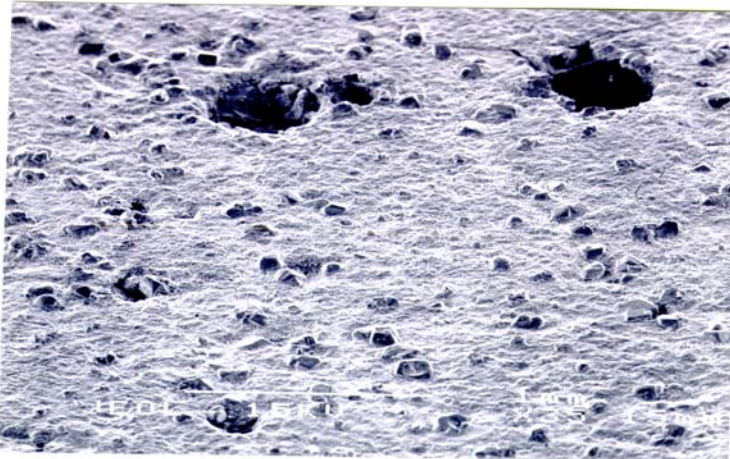
Figure 6. SEM micrograph of concrete after boiling to simulate leaching.

The results of the SEM examinations indicates that some, but not all, of the calcium hydroxide was removed during the boiling process. This is consistent with the reduction in solubility of calcium hydroxide at higher temperatures discussed earlier.
