CORROSION OF ALUMINUM POSTS FOR BRIDGE RAILINGS

Research Laboratory Section
Testing and Research Division
Research Project 72 TI-130
Research Report No. R-848

This report presents results of the sampling and metallurgical examinations of portions of the aluminum railing installed on a pedestrian overpass (Structure PO8 of 82194) located just south of the River Rouge high-level bridge on I 75. The investigation was initiated at the request of M. N. Clyde, Testing and Research Engineer.

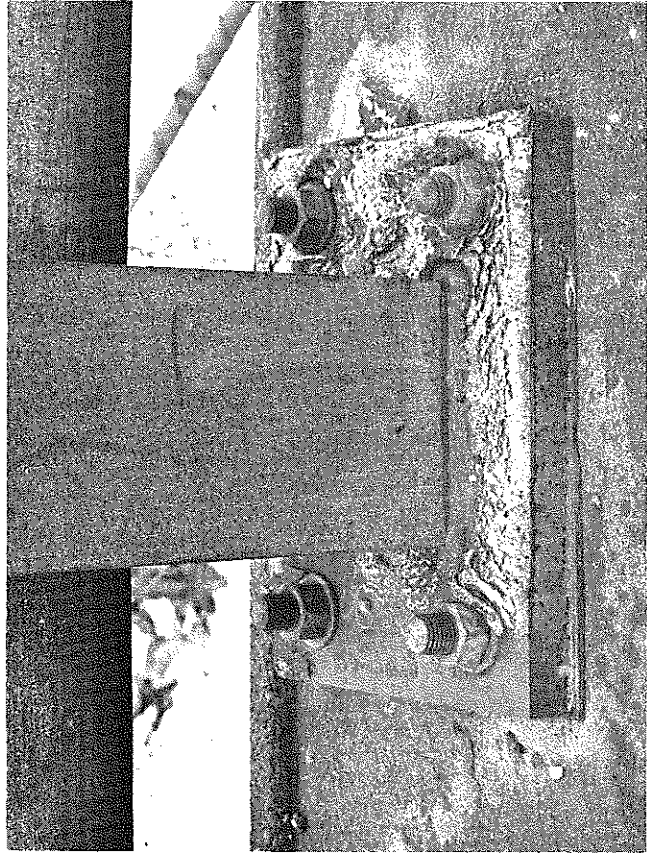
The purpose of this investigation was to determine the cause of the severe corrosion problem being experienced by the baseplates of the railing at this structure, and provide possible solutions. Figures 1 and 2 show the extent of corrosion on the baseplate of the posts. As can be seen in Figure 2, at some locations the corrosion progressed to the point where the posts have broken loose from the baseplates. As of this writing, temporary repairs have been performed by cleaning the corroded baseplates and re-welding the posts (Fig. 3).

As can be seen from the results of the chemical analysis, the heavily corroded baseplate was determined to meet requirements for aluminum wrought alloy 2024. The plan details of the bridge railing for the subject structure clearly state that the railing assembly (posts, baseplates, rails, and rail caps) should have been constructed of aluminum wrought alloy 6061.

Aluminum alloy 2024 is a high copper content alloy; not the high magnesium, silicon alloy specified. On a descending A to E corrosion scale¹, alloy 2024 is rated E (lowest) for plates thicker than 1/8 to 1/4 in., while alloy 6061 receives a B rating for corrosion resistance when exposed to corrosive environments. In addition to the alloy initially having a very poor resistance to corrosion, the problem was aggravated by the welding process, the highly corrosive atmosphere present at this site, and by the periodic salt applications to the ramp during the winter months.

The problem evidently is the result of the use of improper materials by the fabricator.

Figure 1. Corrosion of baseplate.

Posts with corroded baseplates should be replaced since they will be a source of future problems. Deteriorated posts could be repaired by removing faulty baseplates and replacing them with new ones of alloy 6061, using proper welding procedures (improper welding can lead to further corrosion problems); however, the cost of such an operation would be considerable.

District Maintenance personnel have indicated that they have a source for used posts in good condition that can be obtained for replacement purposes. This seems to be the most reasonable course to follow.

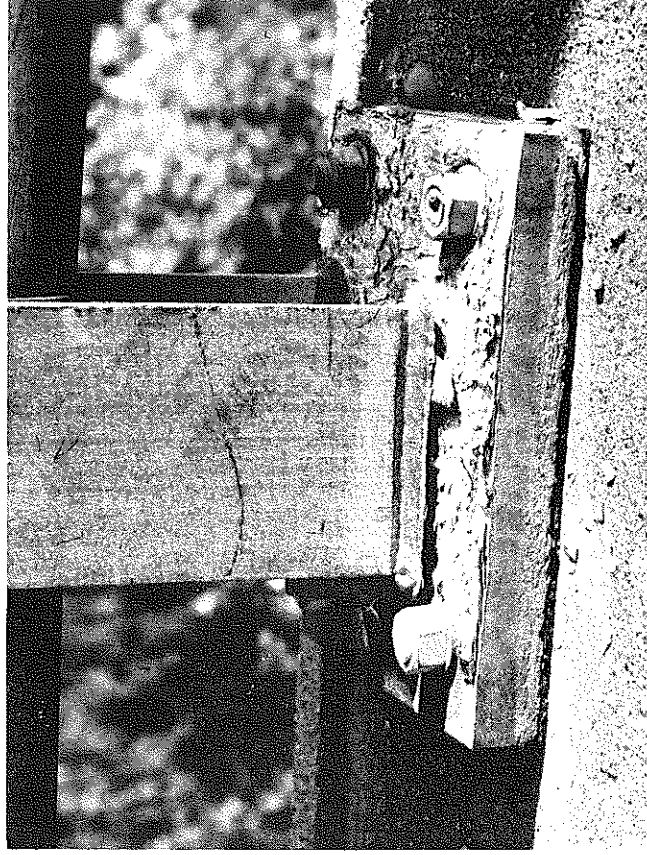
Figure 2. Corrosion has progressed to such a point that the post has broken loose from the baseplate.

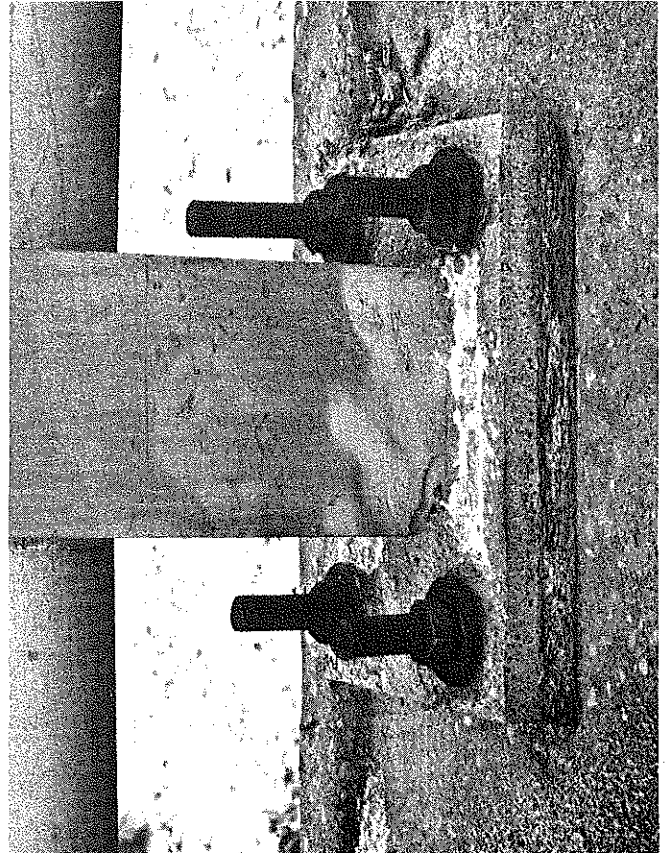
Figure 3. Baseplate-to-outpost connection after re-pair.
