***INVESTIGATION OF STEEL  
BOX GIRDER PIER CAPS  
ON  
S05 OF 63103***

RESEARCH LIBRARY  
M.D.O.T.  
CONSTRUCTION & TECHNOLOGY  
DIVISION

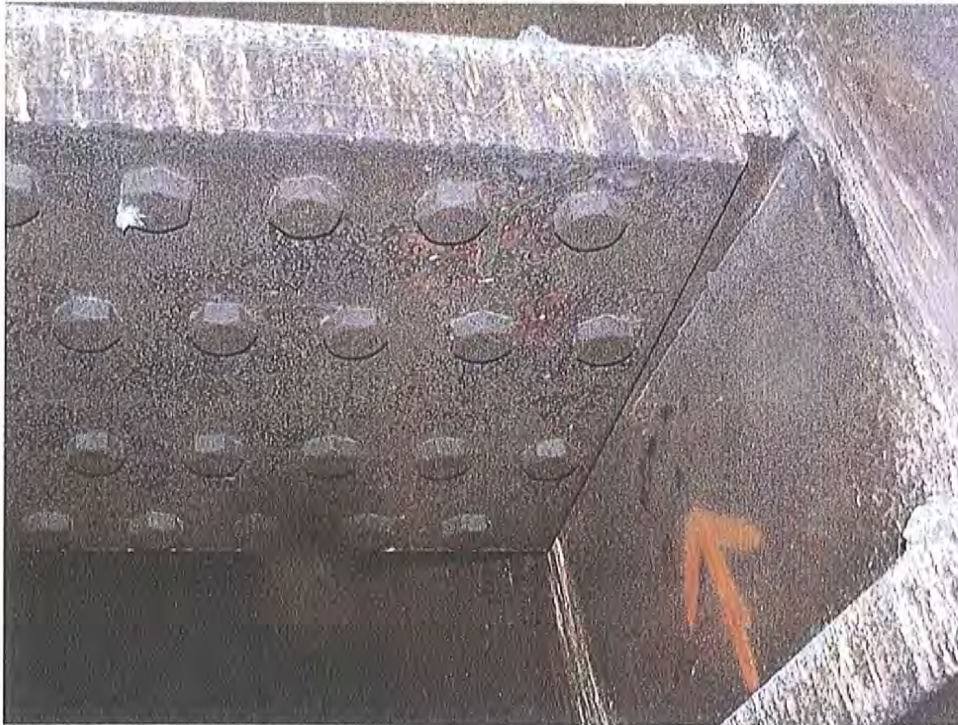
**Figure 5** - Bolted field splices connect the girders to the pier cap. Crack in the face of the bottom fillet weld

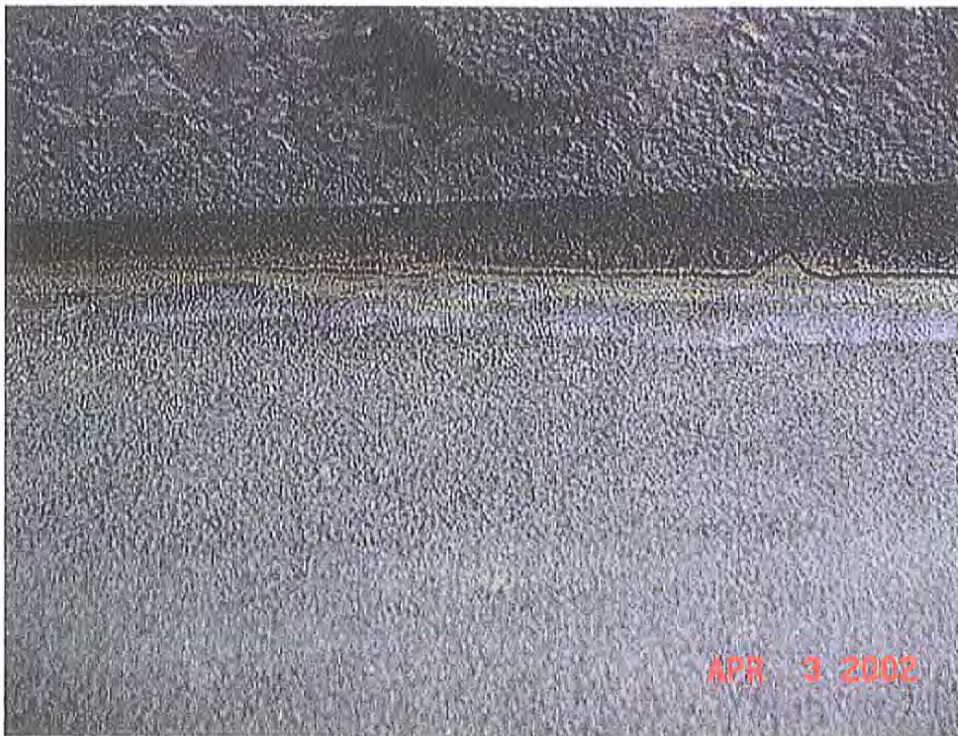
**Figure 6** - Crack in the face of the bottom fillet weld

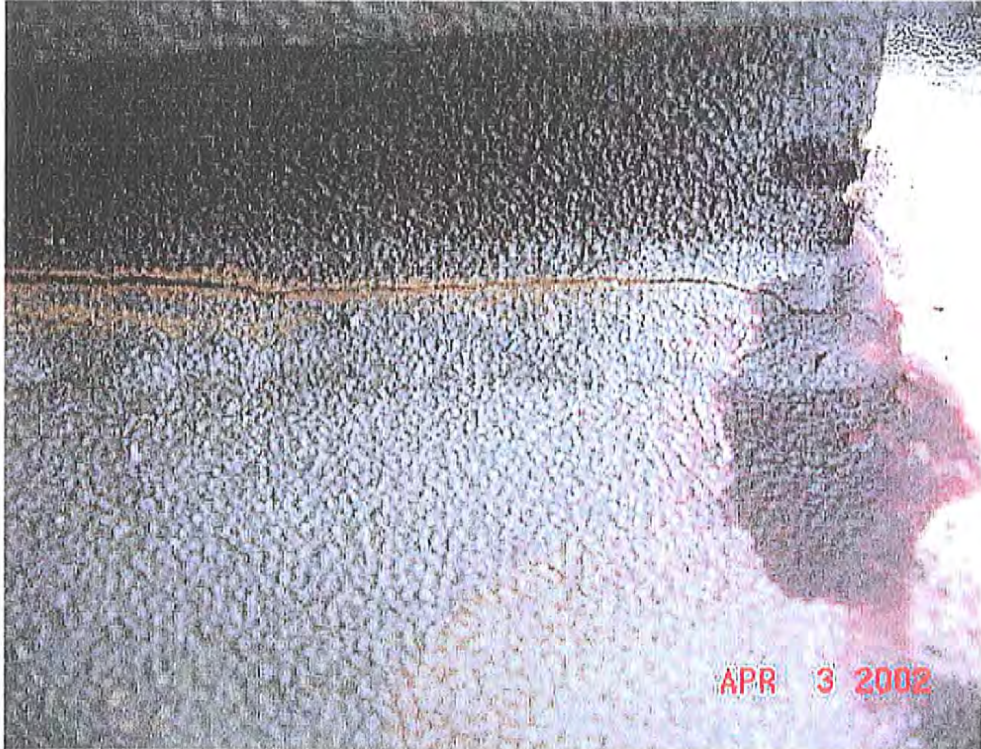
**Figure 7 - Crack in the face of the bottom fillet weld**

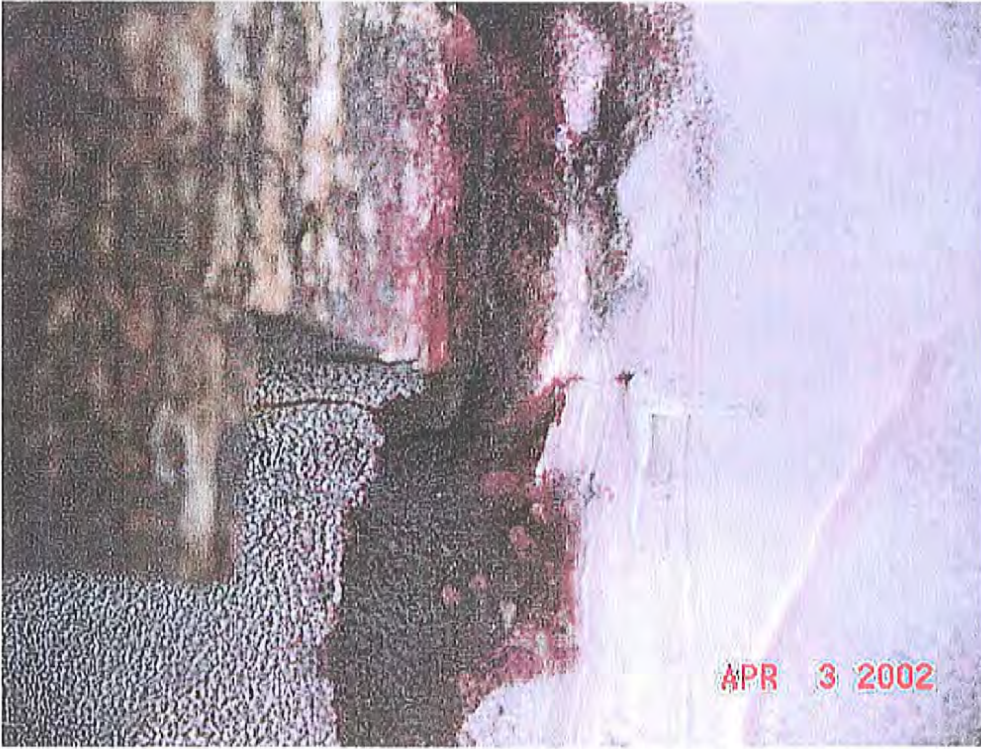
**Figure 9 - Dye penetrant applied to the crack area in the web**

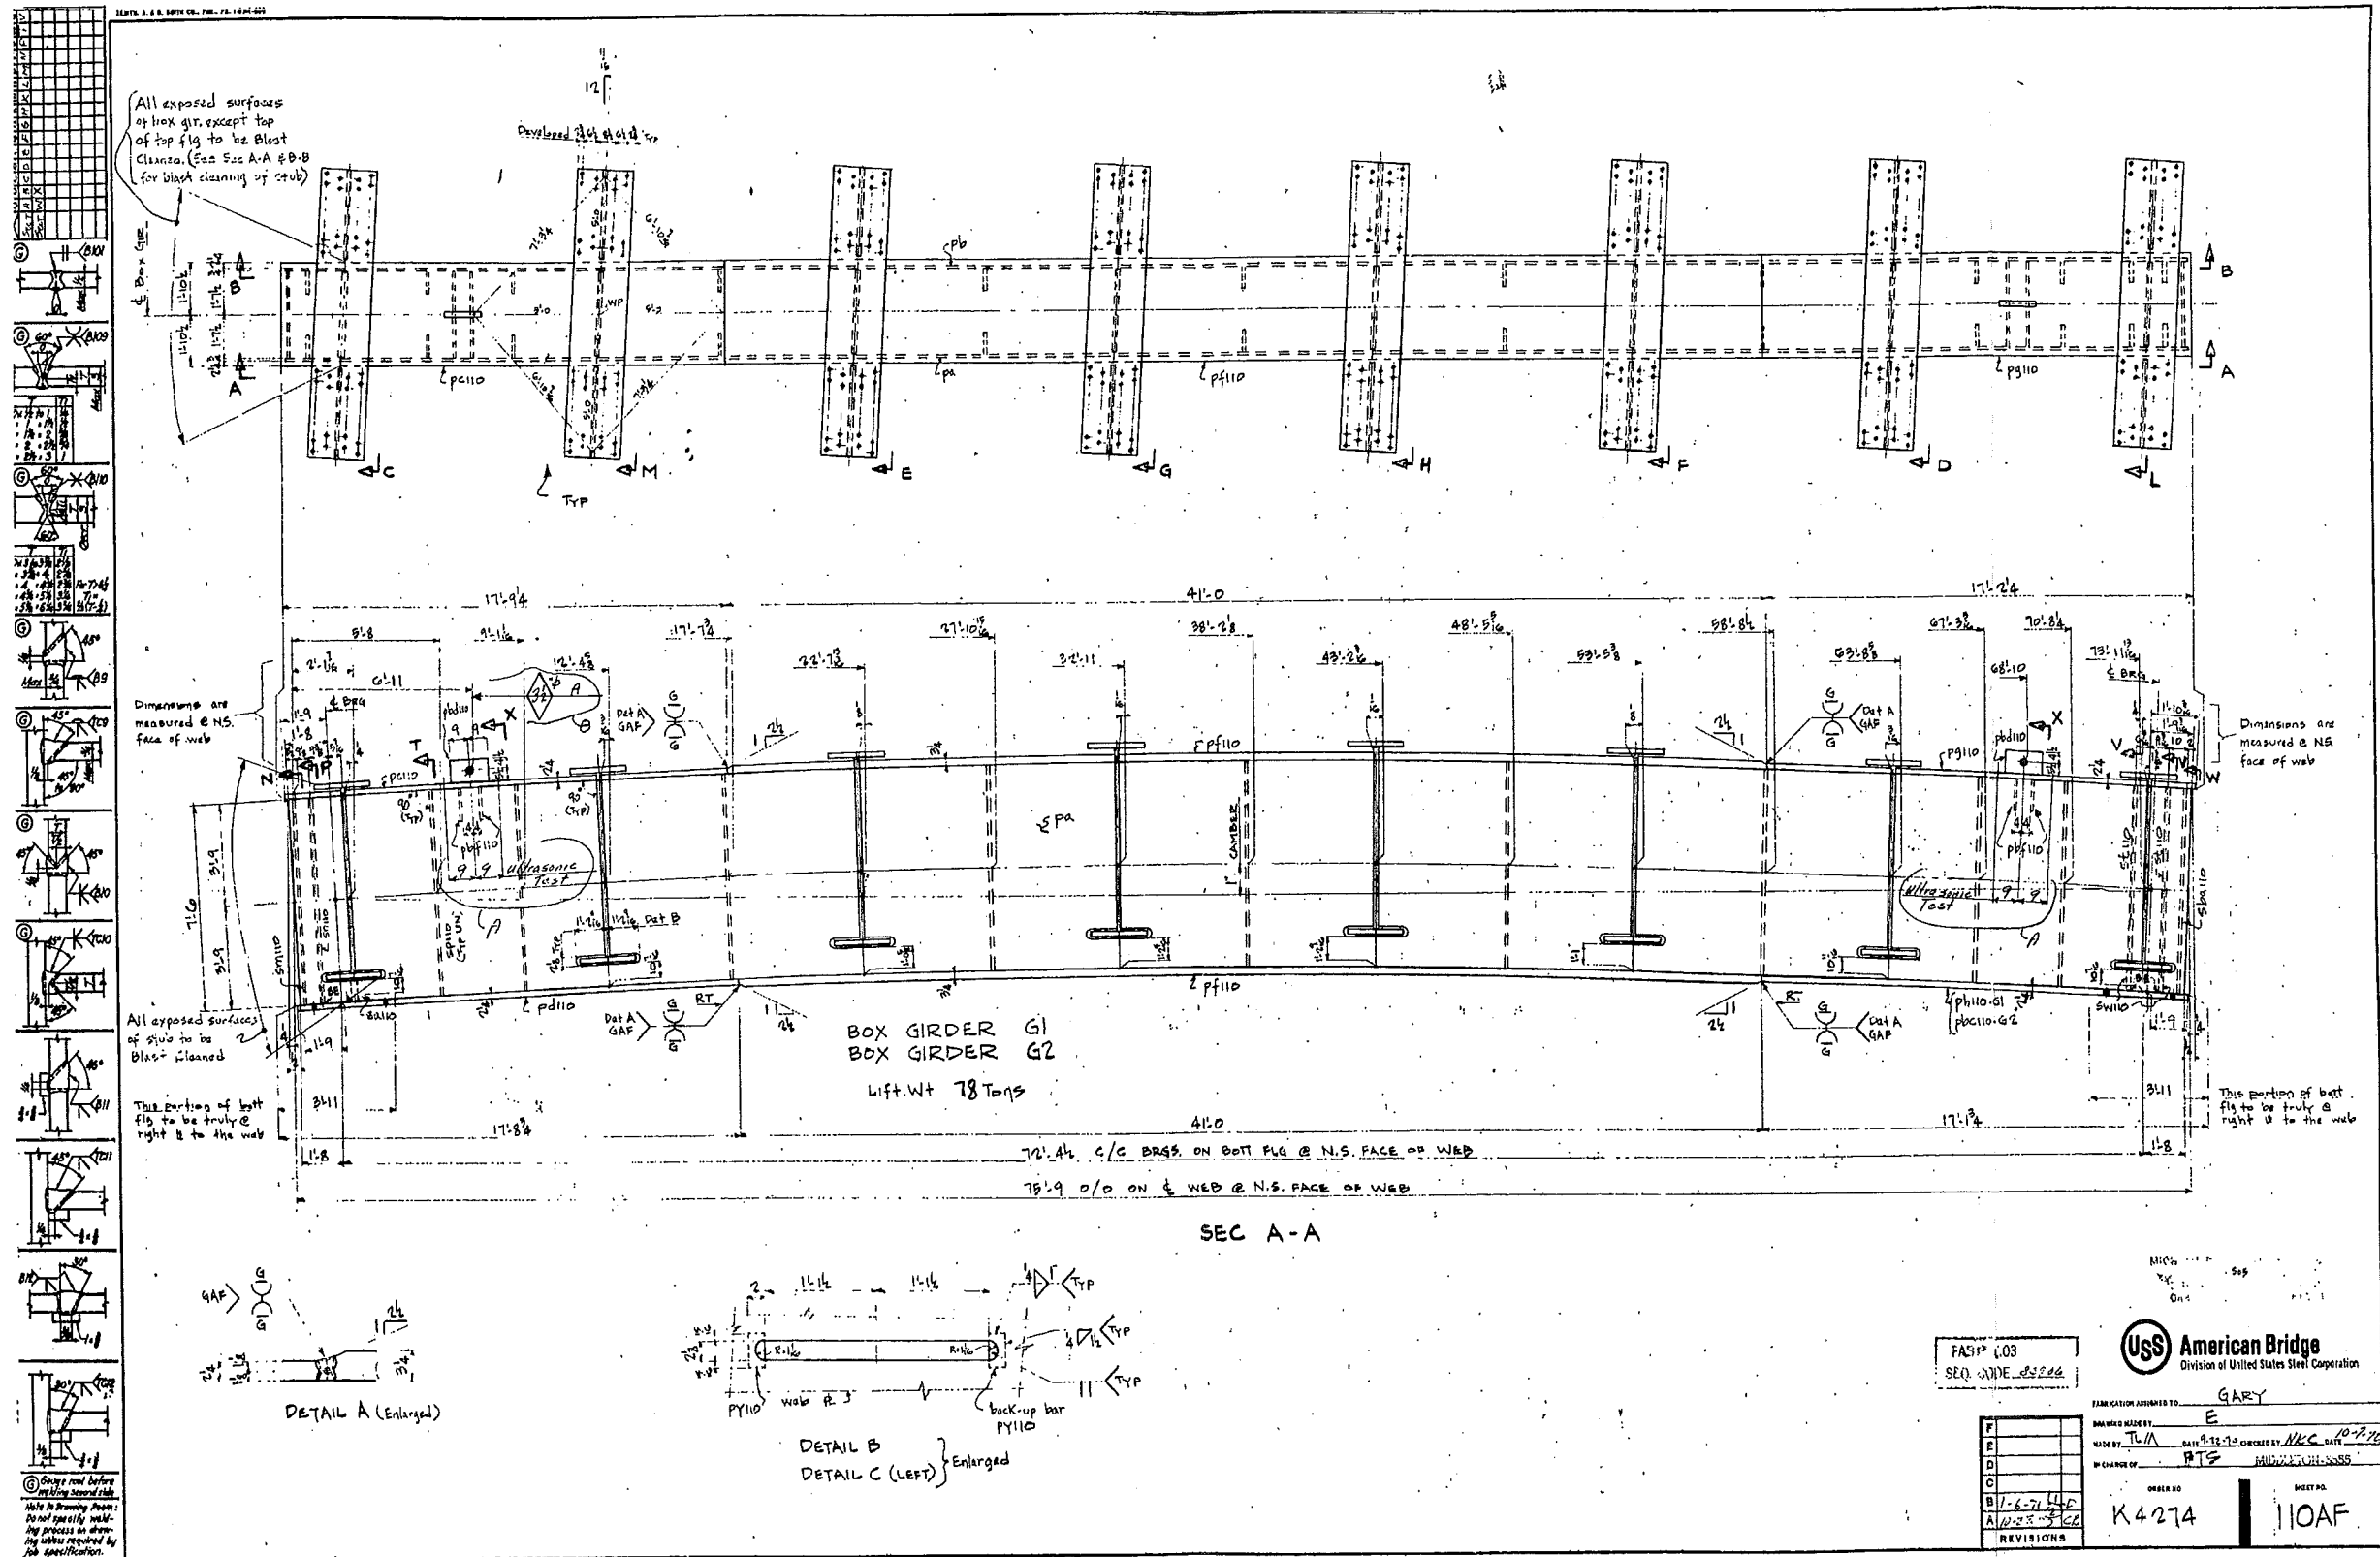
Figure 8 - Steel box girder details

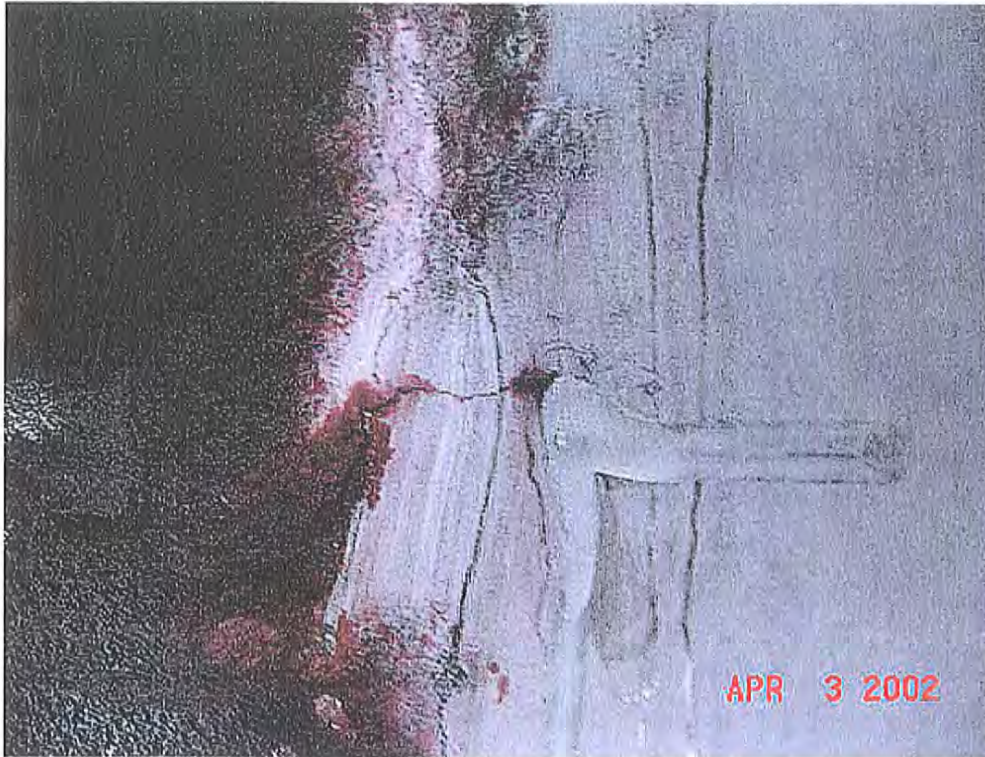
**Figure 10 - Dye penetrant applied to the crack area in the web**

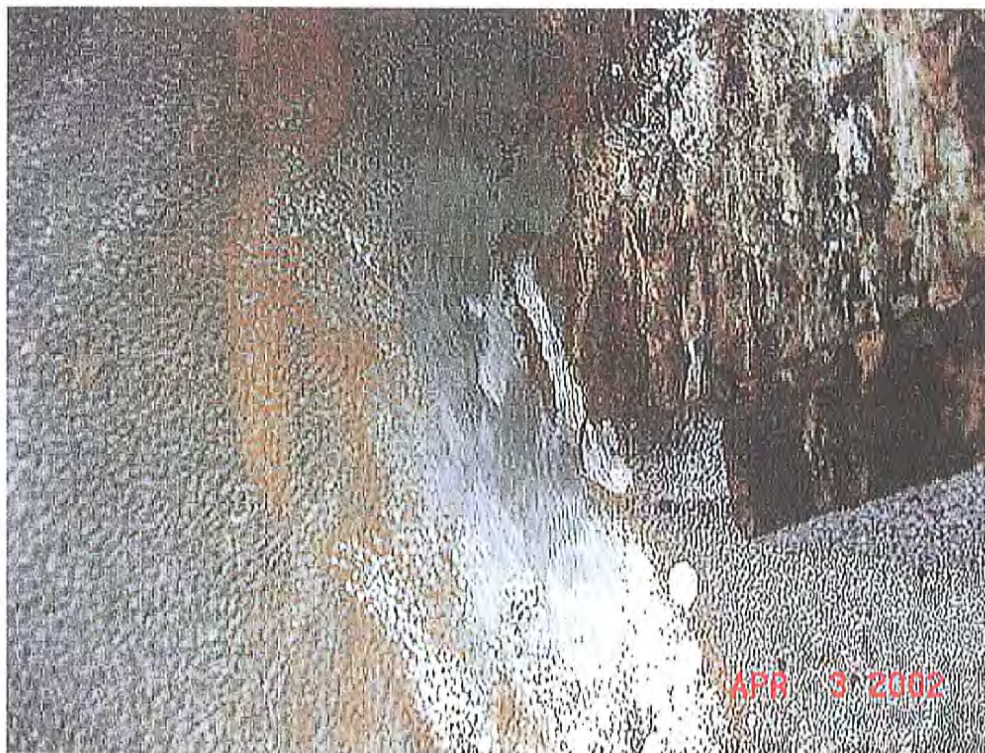
**Figure 11 - Opposite end of flange ground and no cracks were found**

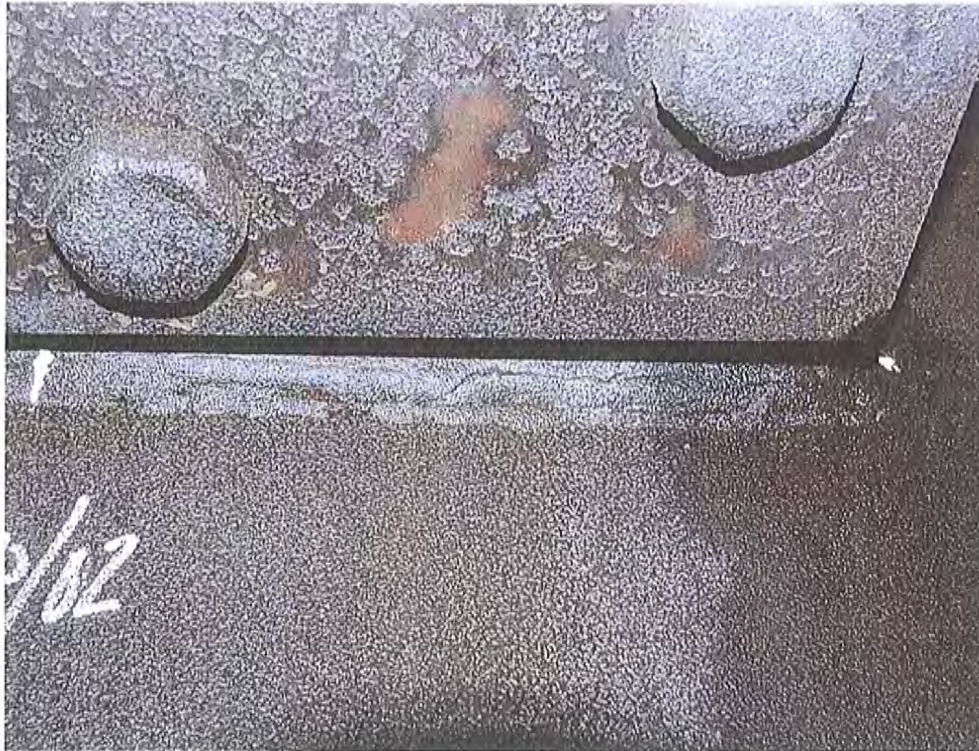
**Figure 12** - Crack in the face/toe of the bottom fillet weld

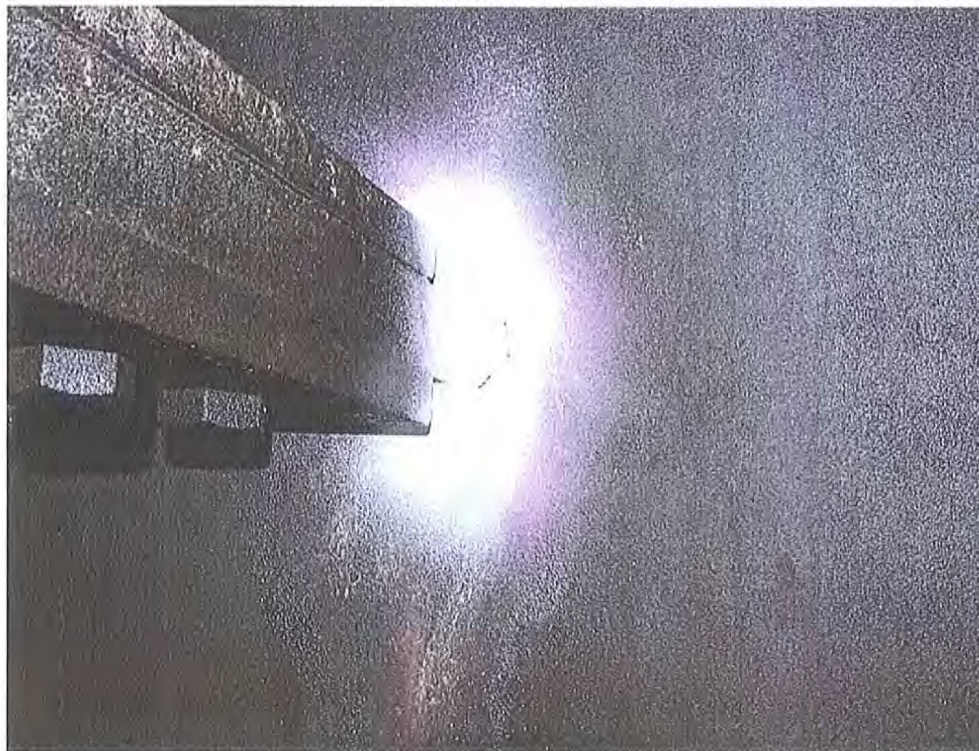
**Figure 13** - Crack in the plug weld at the end of the flange

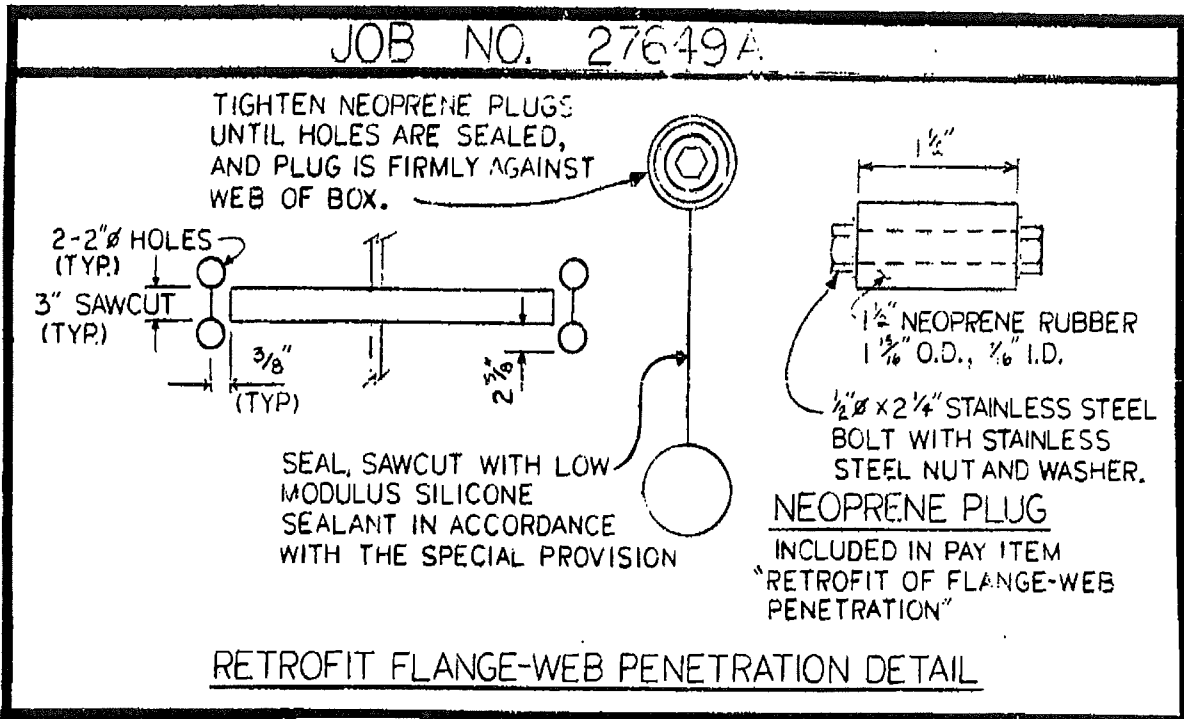
Figure 15 - Retrofit detail used on S02 of 82123
