OFFICE MEMORANDUM

MICHIGAN
STATE HIGHWAY DEPARTMENT
JOHN C. MACKIE, COMMISSIONER

September 22, 1964

Subject: Application and First Inspection of "Epoxeal" Penetrating Sealer
on Lansing Area Bridge Decks. Research Project 63 NM-83.
Research Report No. R-476.

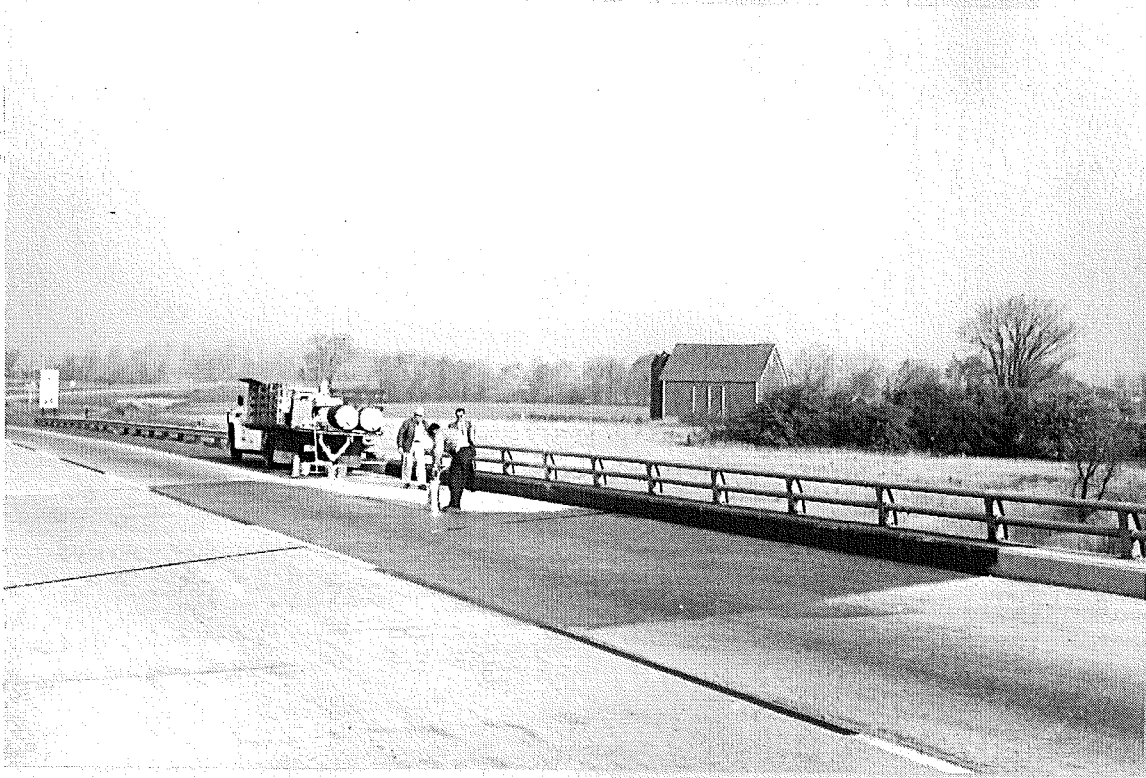
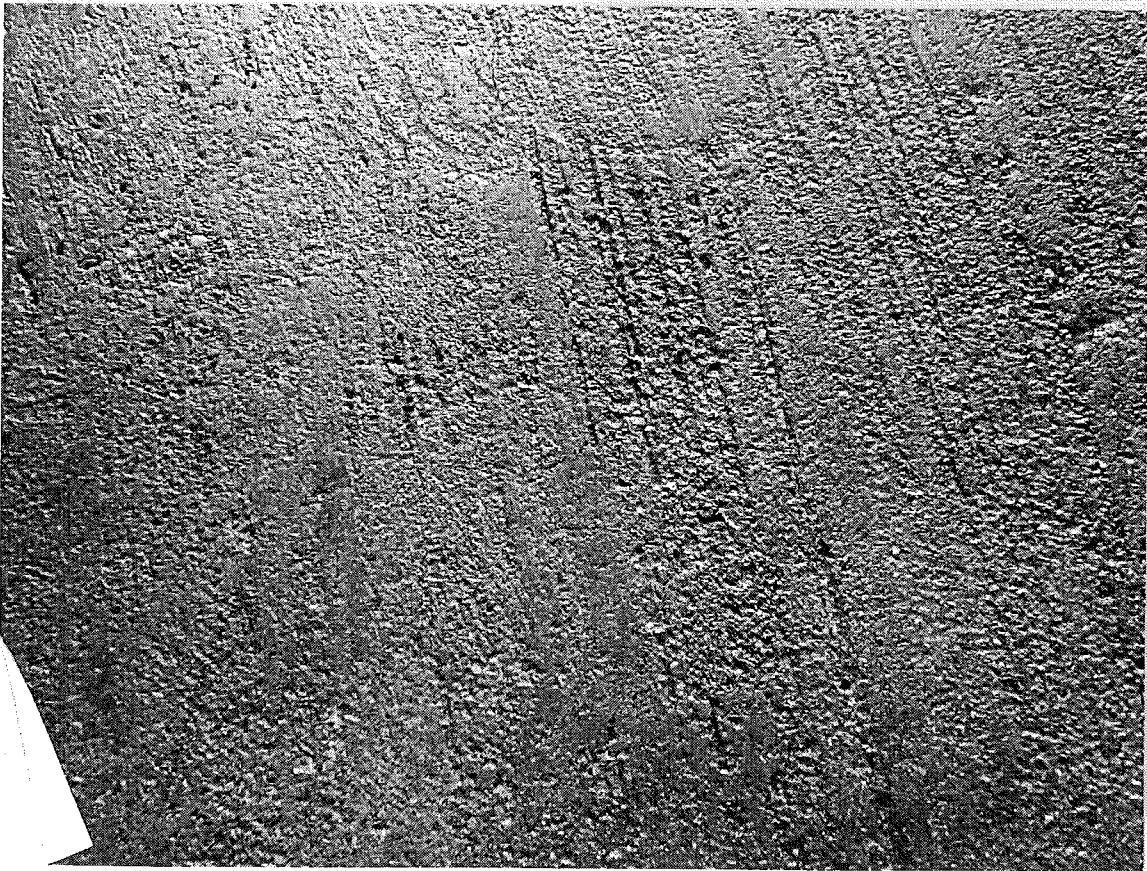
The I 96 bridge had been in service for one winter, and exhibited some cracking and light scaling. Its deck, as well as curb faces and walks, were sealed October 22, 1963, by A. Johnson and R. Demert of Protective Products, using garden sprayers of 3-gal capacity (Fig. 1). The two-component Epoxeal was premixed 1:1 by volume before spraying. R. Merrill and F. Bashore observed the operations for the Department.

Figure 1. Application of epoxal penetrating seal using a garden sprayer (westbound I 96 over Canal Road); appearance soon after application is shown at bottom (photo: 10-22-63).

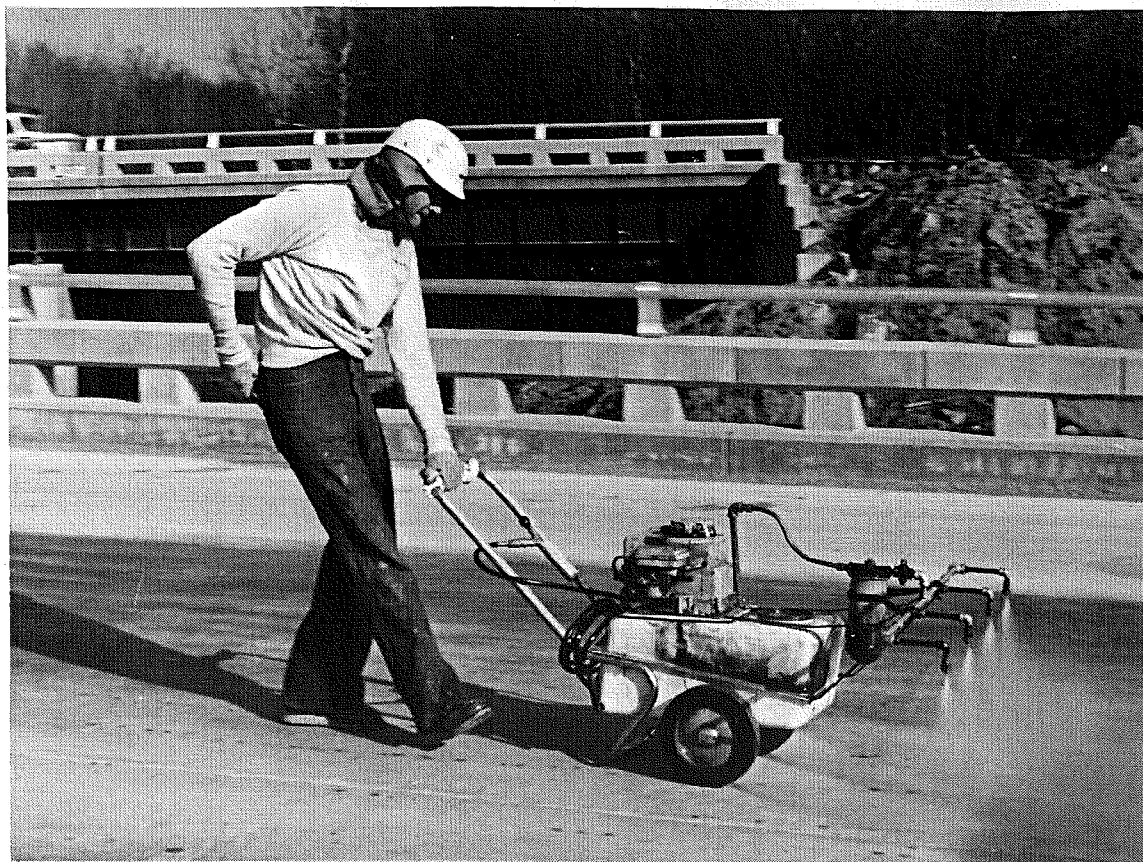
The I 496 bridge deck, which had been poured August 27-28, 1963, was sealed November 16 by J. Kovarik and D. Maxwell of Protective Products, with F. Bashore as observer. A gasoline-powered centrifugal pump with four spray nozzles were used (Fig. 2), with a hose and hand gun attached in place of one nozzle for curb face spraying. The sealer was premixed at the same ratio as in October.

Figure 2. Epoxeal application with power sprayer on I 496 railroad overpass (photo: 11-15-63).

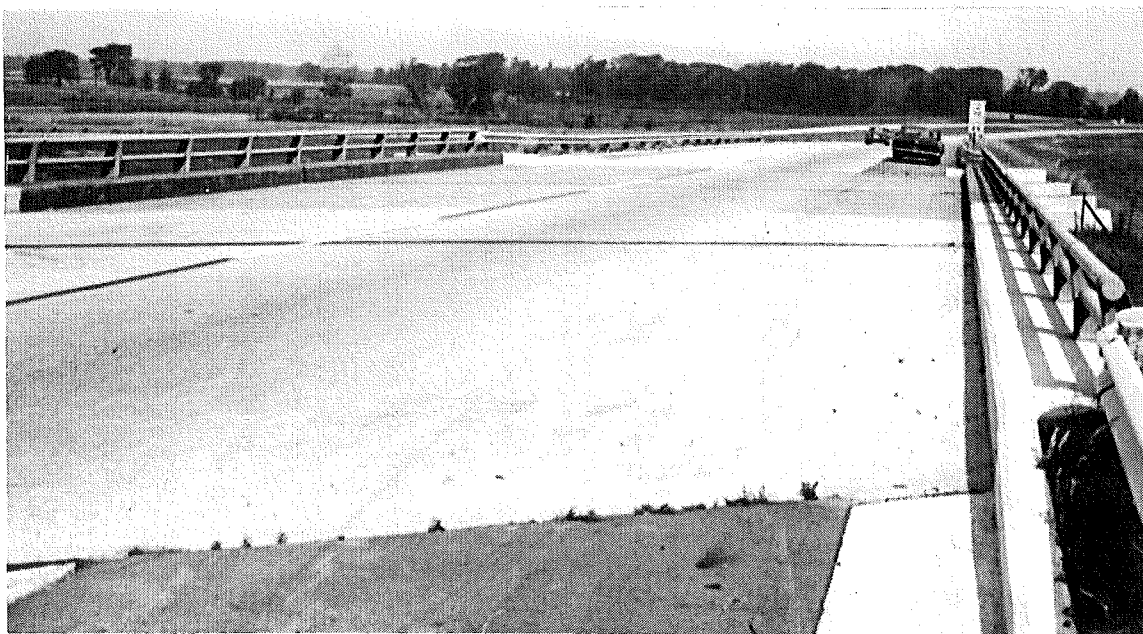
I 96 westbound over Canal Road. The surface coating appears to be nearly worn off in the traffic lane, but is still in evidence in the passing lane, on curbs, and on walks (Fig. 3). From inspection of upper and lower surfaces of the deck, it appears that all cracks are sealed (Fig. 4). Light localized scaling has progressed along the south gutter, probably due to standing water. A few scattered popouts have occurred since the coating was applied. The uncoated section shows continued leakage through cracks.

Figure 3. Canal Rd. bridge deck eight months after epoxeal application; control area in foreground and darker, sealed deck and curbs in background.

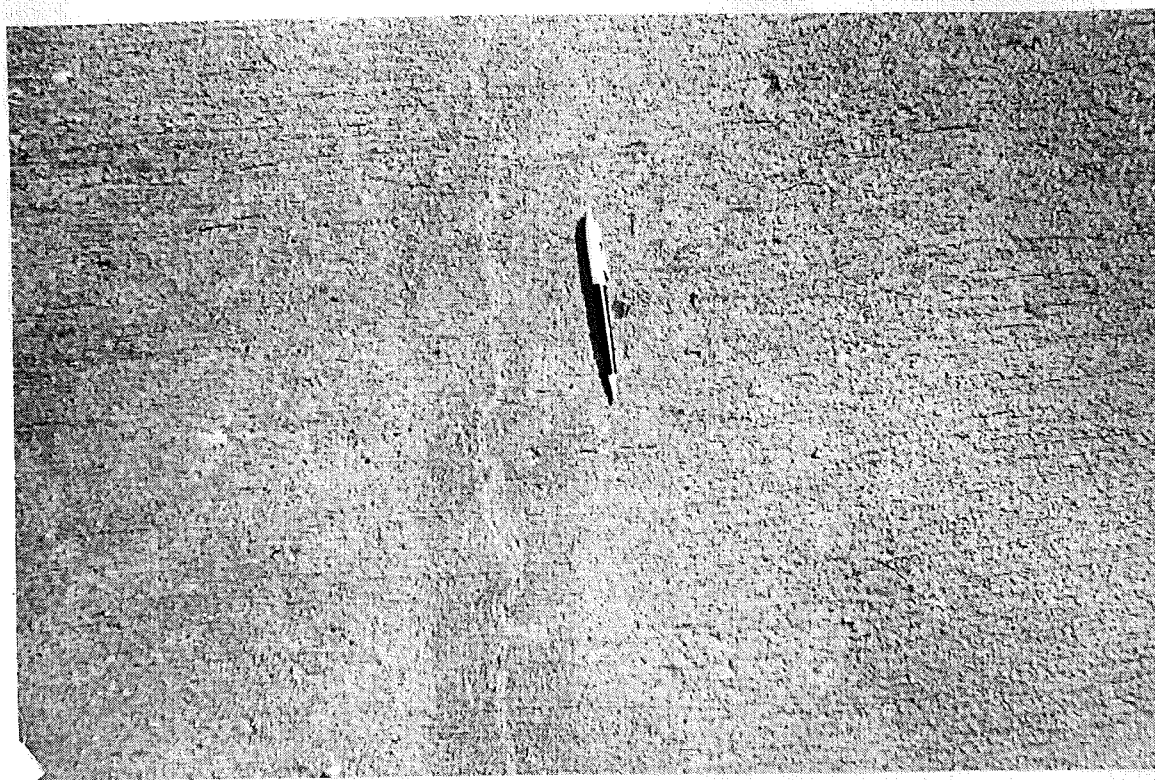
Figure 4. Appearance of Canal Rd. bridge deck surface eight months after epoxeal application; crack appears to be scaled.

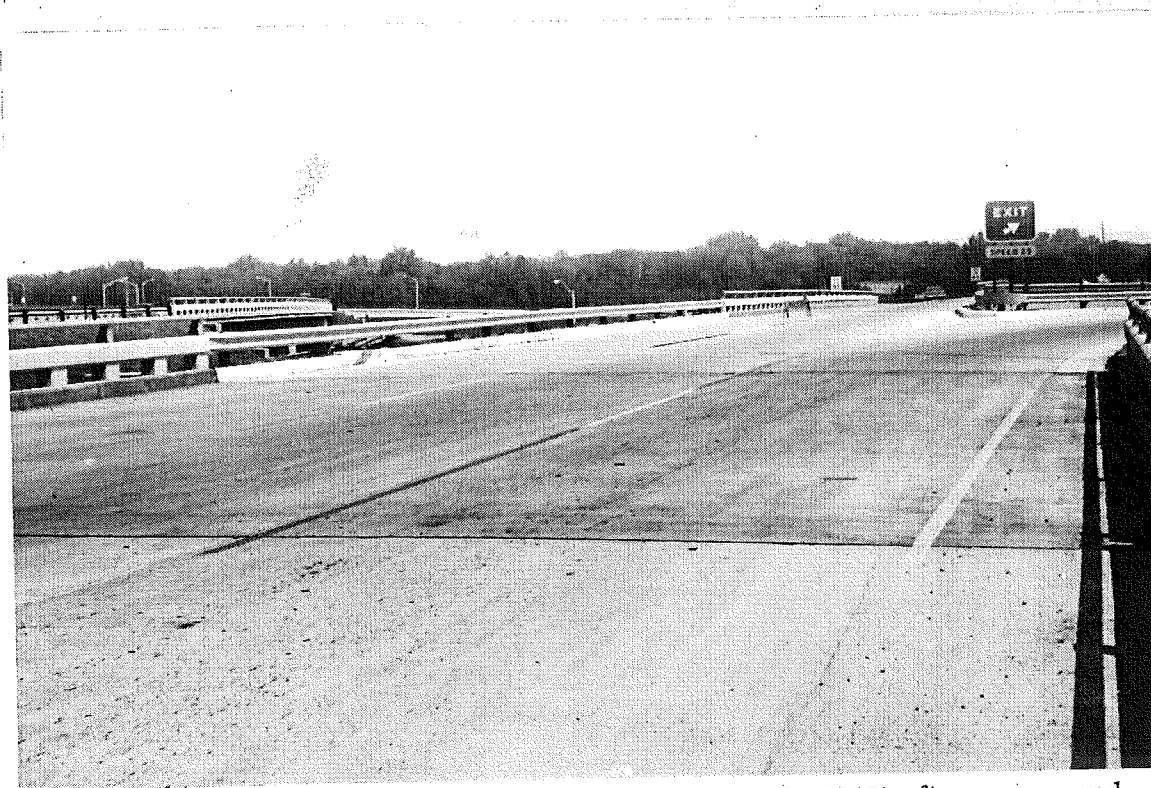
I 496 over GTW RR. The coating appeared to be in very good condition, except for some scaling along the east gutter (Fig. 5) due to a heavy coating of laitence. This scaling will probably continue. The uncoated control section (middle span) looks good although some pitting has occurred in the east gutter.

Figure 5. I 496 test bridge deck and curbs (X06 of 33045) after seven and one-half months of service; control area in foreground and darker, sealed area in background.
