**CONTINUOUSLY REINFORCED BITUMINOUS RESURFACING
Detroit Industrial Expressway (I 94), West of Ypsilanti**

**Research Laboratory Division
Office of Testing and Research
Research Project 54 D-20(3)
Report No. 365**

**Michigan State Highway Department
John C. Mackie, Commissioner
Lansing, January 1962**

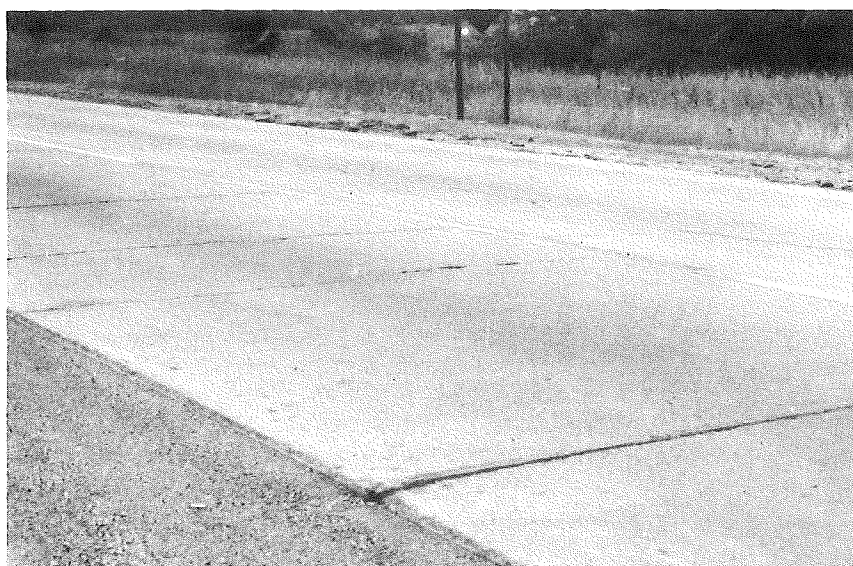
Figure 1. Typical appearance of original 1943 concrete pavement in July 1955.

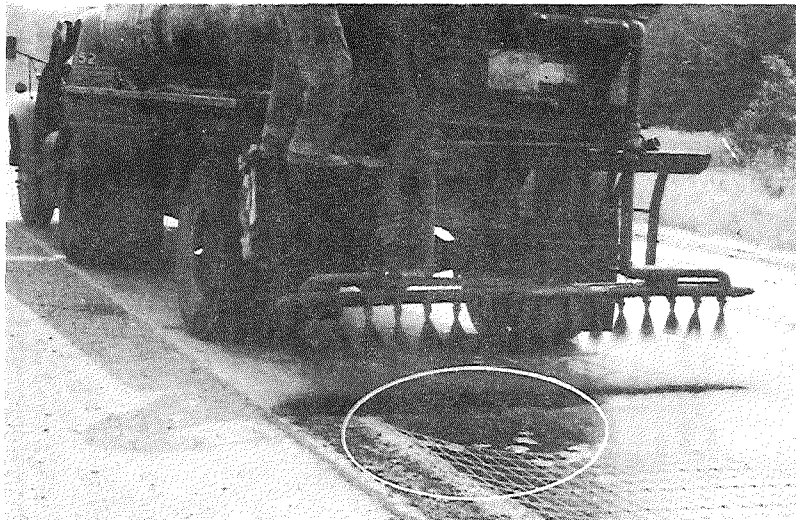
Spraying on asphalt emulsion bond coat; note curling on long edge of sheet.

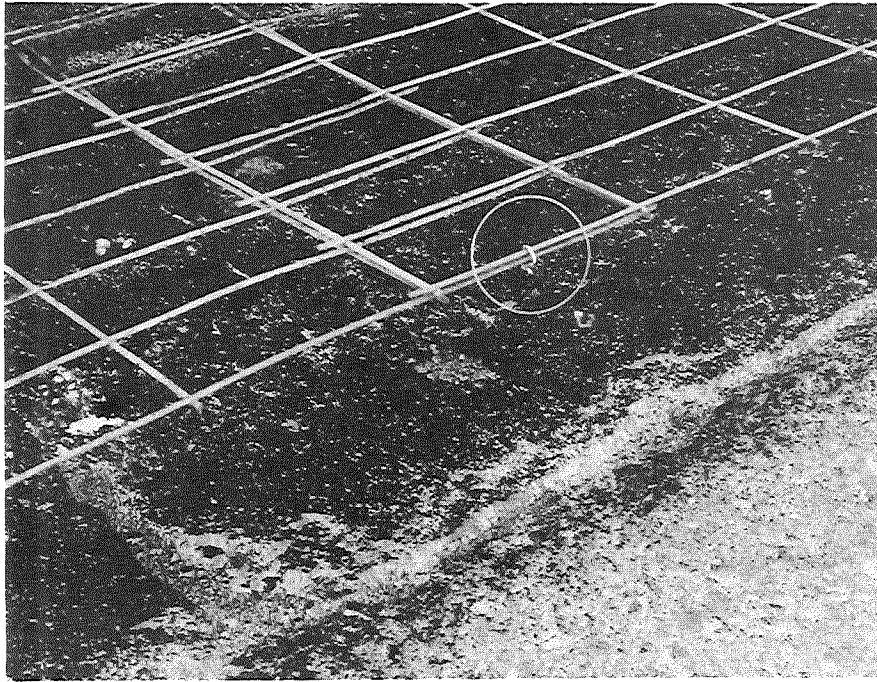
intermediate points (Fig. 5). It was soon clear, however, that these five ties across the lap prevented free lateral movement of the steel by construction workers for correction of alignment. From then on, the side ties were omitted, and instead three ties were made at intermediate points in the lap.

▲ Figure 5. Lapped sheets in place on bond-coated base concrete, showing hog-tie on edge wire as used on first day of placing resurfacing.

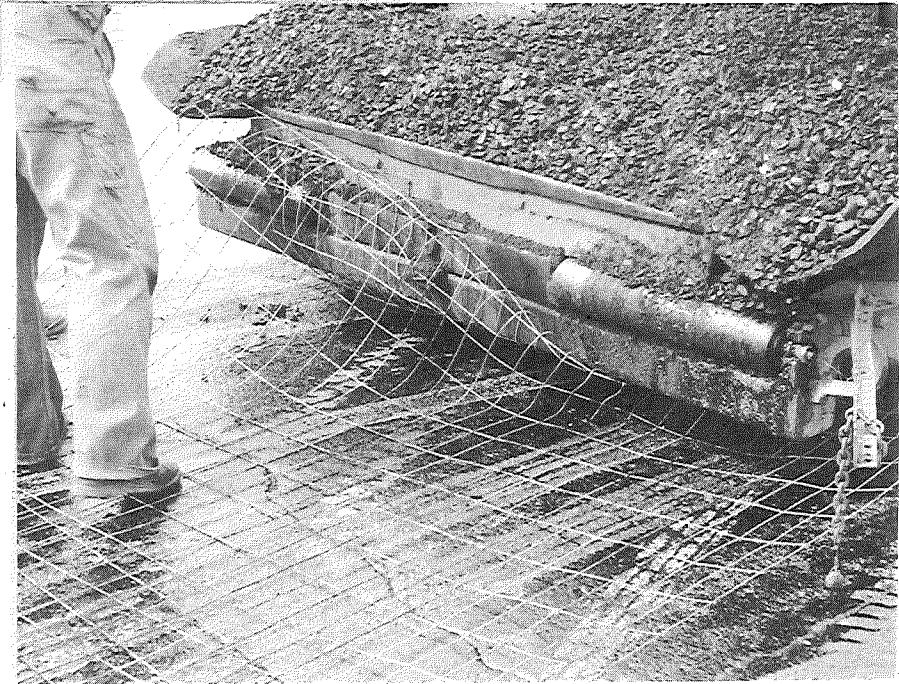
The major problem during placement of the reinforcement was buckling of sheets ahead of and behind the paver (Fig. 7). The only solution at 69 locations where the buckling was particularly bad was cutting and removing the warped steel. A typical sequence of these steps is shown in Fig. 8. In both Sections 1 and 3, where buckling occurred across the full sheet width of 7.5 ft, the deformed steel was generally replaced with new mesh; in smaller areas, buckled reinforcement was generally not replaced. The tabulation of removal and replacement of reinforcement in the Appendix shows that of the total area of 78,464 sq ft in Section 1, about 2 percent (1685 sq ft) had reinforcement removed. Reinforcement was replaced in 815 sq ft of this area. By correcting position and adjusting the mats in Section 3, better results were obtained and only 218 sq ft of reinforcement was removed in the total area of 180,120 sq ft (0.2 percent). Reinforcement was not replaced in these 25 areas of Section 3.

▶ Figure 7. Buckling of reinforcing sheet ahead of paver.

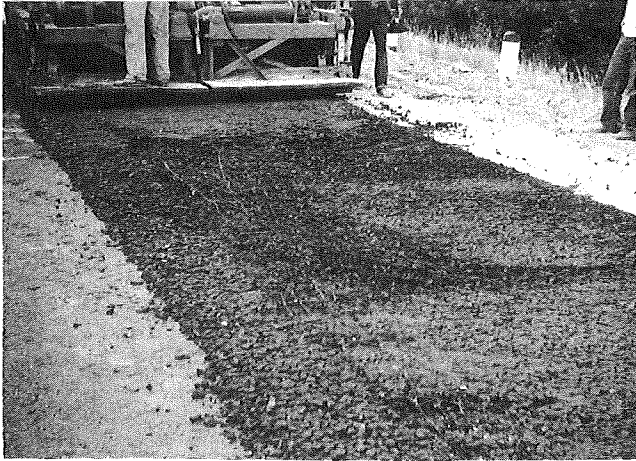
Extreme buckling of reinforcing steel behind the paver, protruding through binder course.

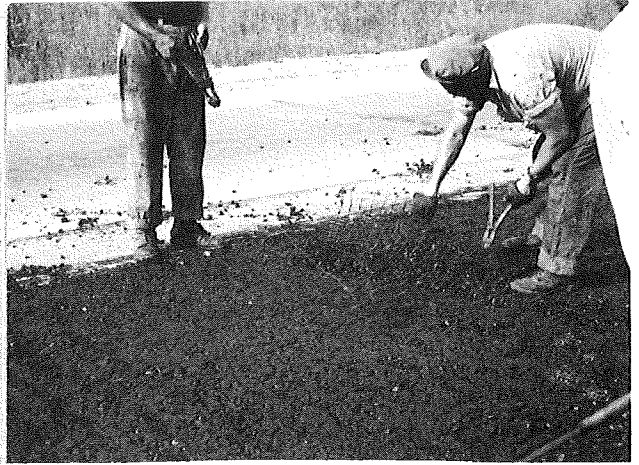
Smaller area of buckled steel.

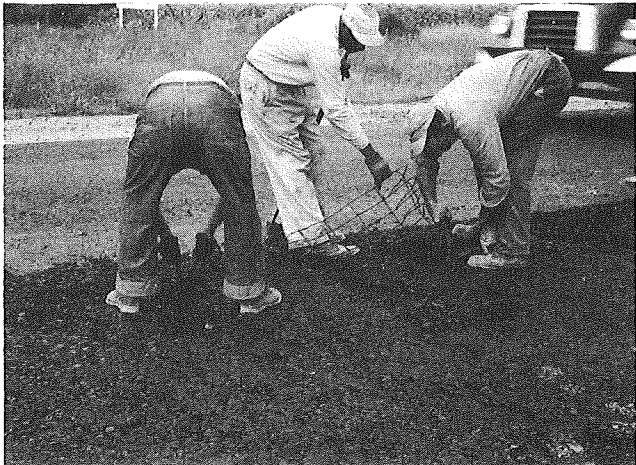
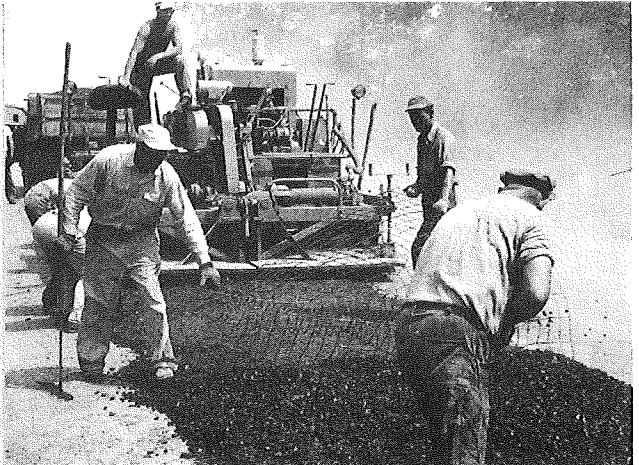
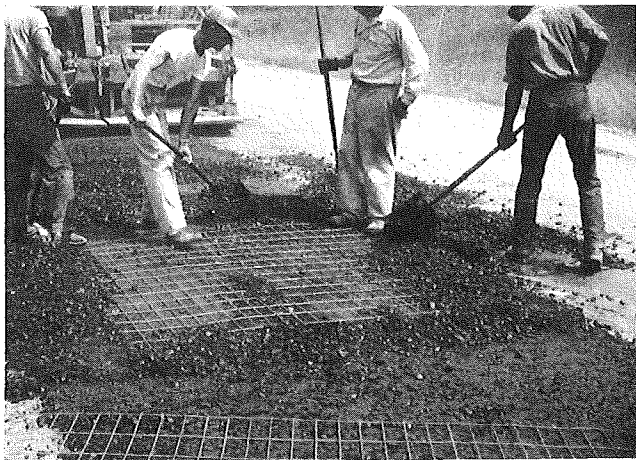
Figure 8. Typical sequence of steps in removing and replacing buckled steel.

Wire cutting at edge of an area of buckled steel.

Removal of full width of buckled sheet from binder course.

Installing new full width sheet to replace buckled steel, and replacing bituminous concrete by hand.

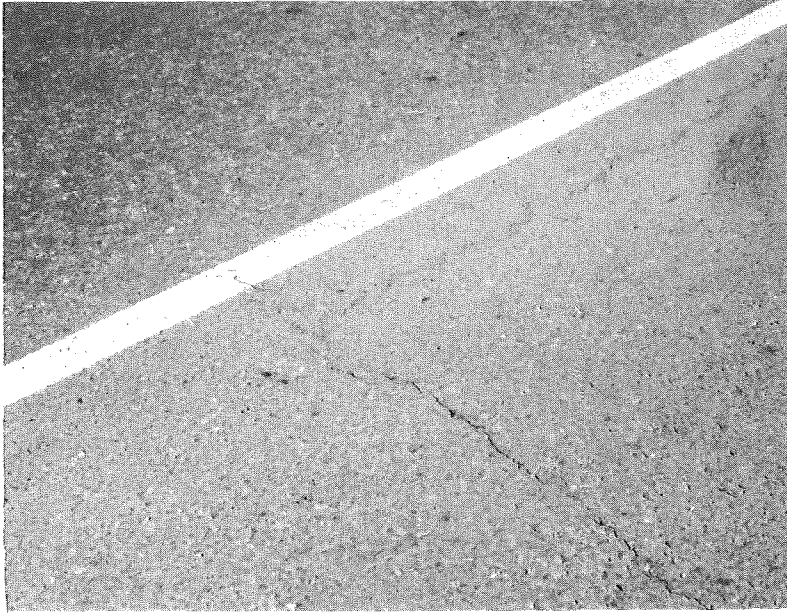
The old base pavement pattern of transverse and longitudinal joints (Fig. 9), the longitudinal joint formed by the widening strip beneath the resurfacing (Fig. 10), the old transverse cracks, and the staggered and lapped edges of the reinforcing sheets (Fig. 11), all were reflected on the wearing course surface.

Figure 9. Right-angle reflection cracking in non-reinforced resurfacing, over intersecting transverse and longitudinal joints in the old base concrete pavement, after eight months service (May 1956).

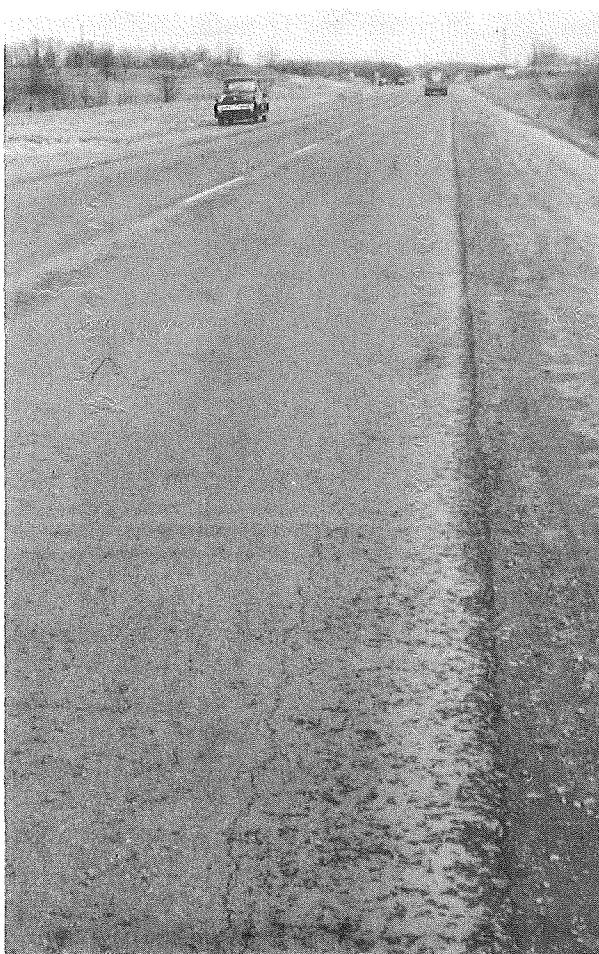
Figure 10. Reflection crack in non-reinforced resurfacing over longitudinal construction joint between old base pavement and 2-ft widening strip (April 1956).

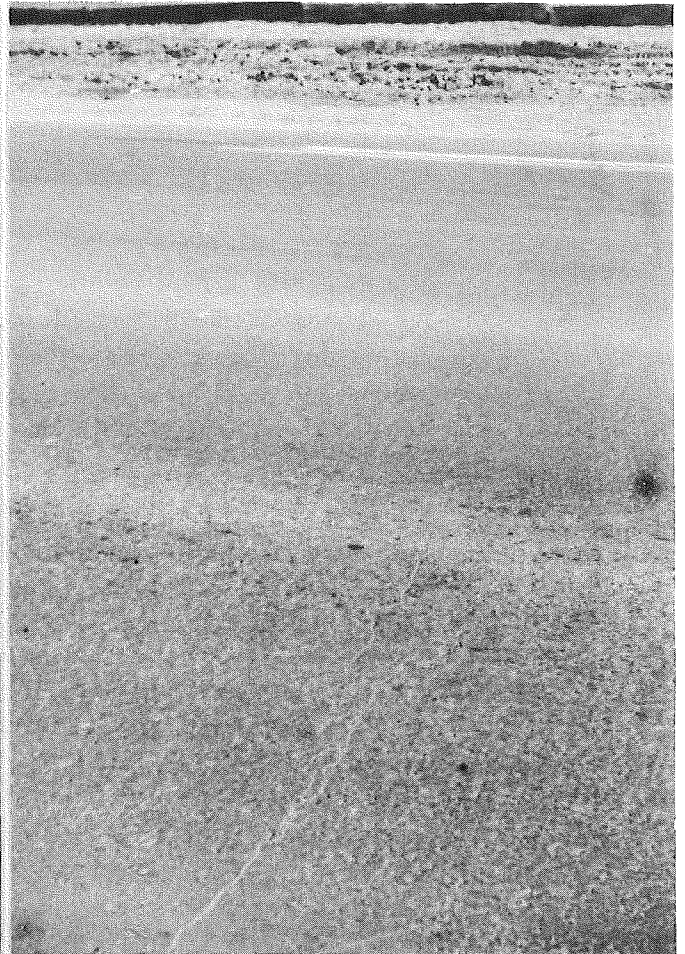
In addition to reflection of joint and cracks in the base pavement, cracks developed in the reinforced sections over the lapped edges of the reinforcement itself. It may be noted in Table 4 that transverse cracks have been identified over 23 percent of the lapped transverse edges of

Figure 11. Reflection crack in continuously reinforced resurfacing section, showing staggered pattern of leading edges of adjacent mesh sheets (turn-off lane for US 23 at far edge). (May 1956)

reinforcing sheets in Section 1 and over 11 percent of the laps in Section 3, for a total of 258 individual cracks of this type. These are conservative figures, representing only clear instances of regular straight-line cracks not over old transverse joints or cracks, appearing at the 14.5-ft intervals where sheet laps occurred. If a more precise record were available of specific locations of laps for cut or shortened sheets, these figures would undoubtedly be much higher.

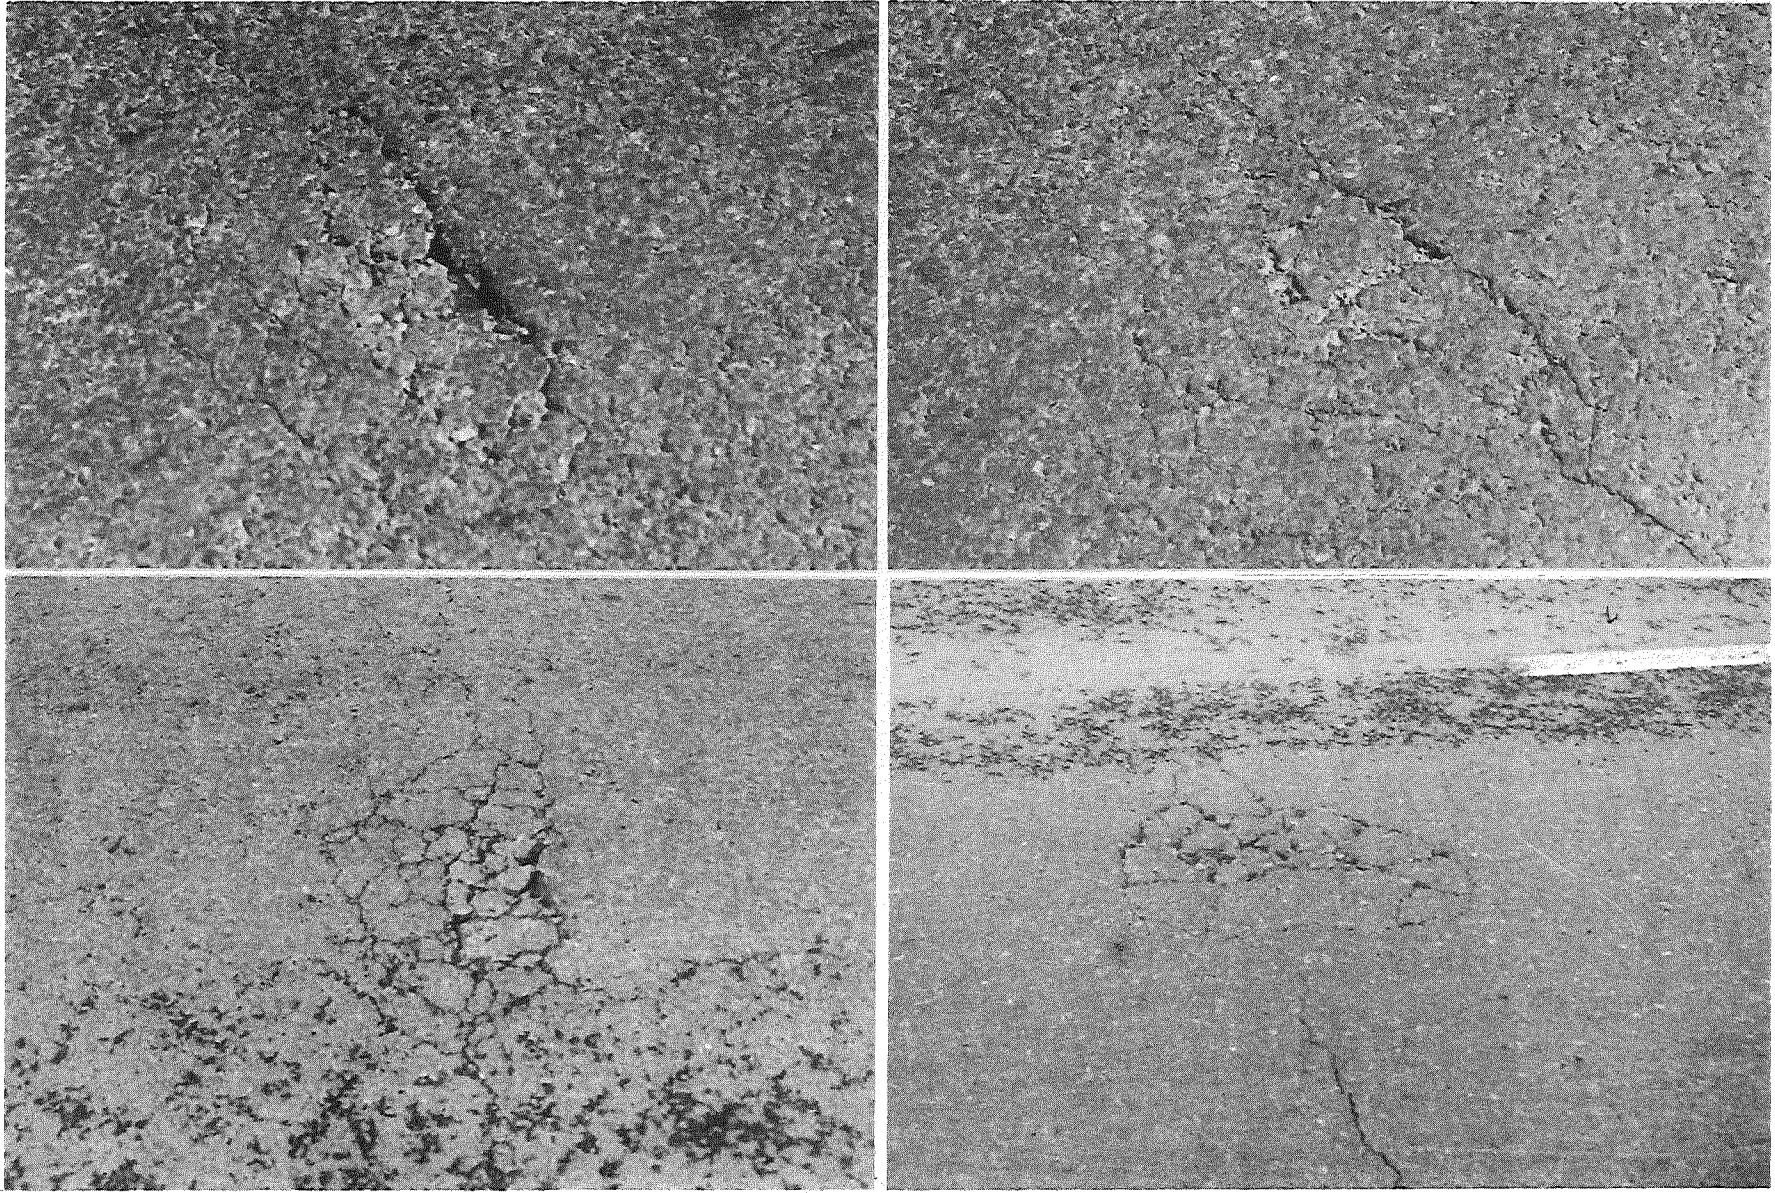
One form of deterioration found only in the reinforced test sections, and cited in the literature as occurring on similar projects, is pothole deterioration proceeding from so-called "alligator cracking" on the wearing surface. This cracking appears to originate where loose material has collected in pockets under steel that is curled or rippled within the overlay course. Then, as moisture enters through these surface cracks, a distinctive circular or oval area of springy, unstable bituminous material develops, spreading rapidly under traffic. Vertical and horizontal movement of the curled reinforcement under traffic occurs within this spreading area until the surface cracks widen to allow pothole spalling and breakaway of surface material. The reinforcement curling or rippling can sometimes be traced back to rolling pressure by pavers and other heavy construction equipment while the resurfacing is being placed. In other cases, poor gradation of aggregates or coarse mix density may cause development of these loose pockets or "hollow spots" in the reinforcing courses, as well as permitting infiltration of excessive moisture.

On the Michigan project, these potholes began appearing almost immediately after pavement was opened to traffic, and continued to develop during the five years of service (Table 4). Typical potholes are shown in Fig. 12, and after repair in Fig. 13.

Figure 12. "Alligator" cracking and pothole spalling of bituminous concrete in continuously reinforced test sections (Spring 1956).

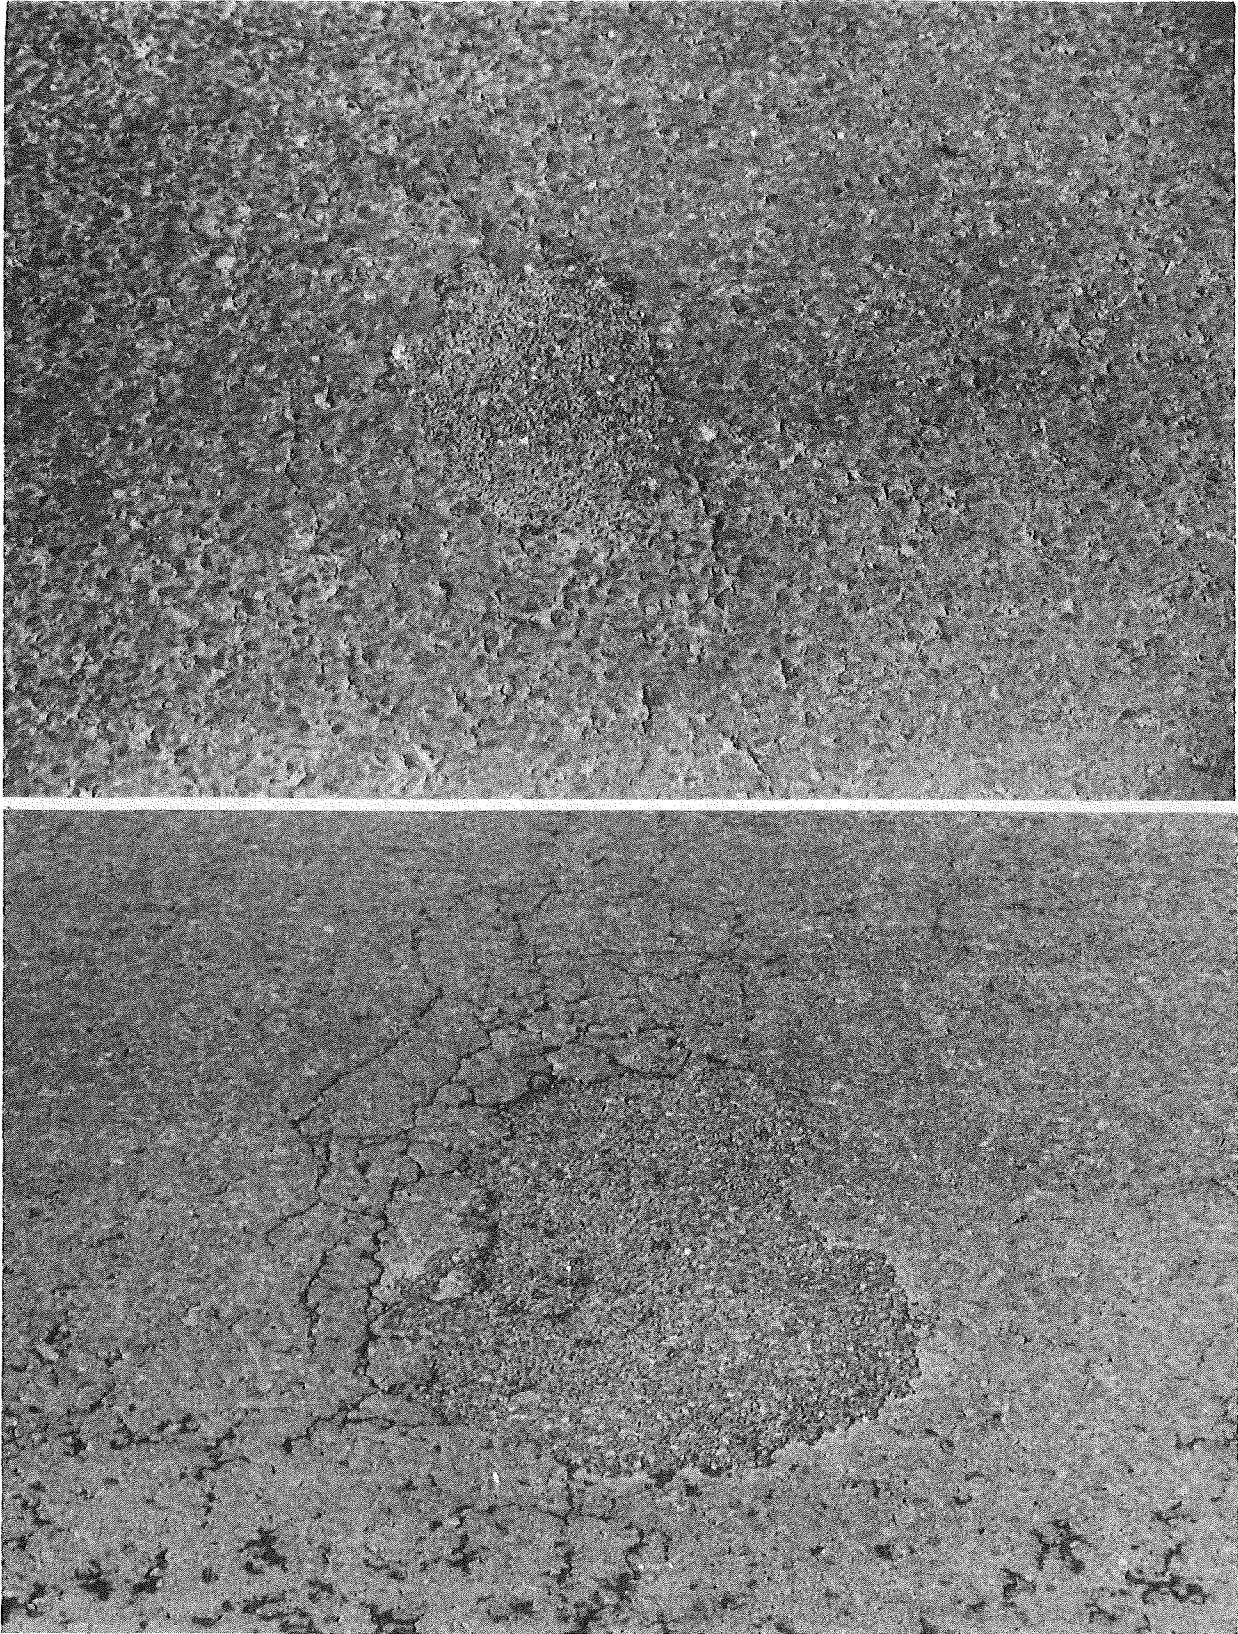
Figure 13. Bituminous concrete patches at potholes and further alligator cracking in reinforced test sections (April 1956).

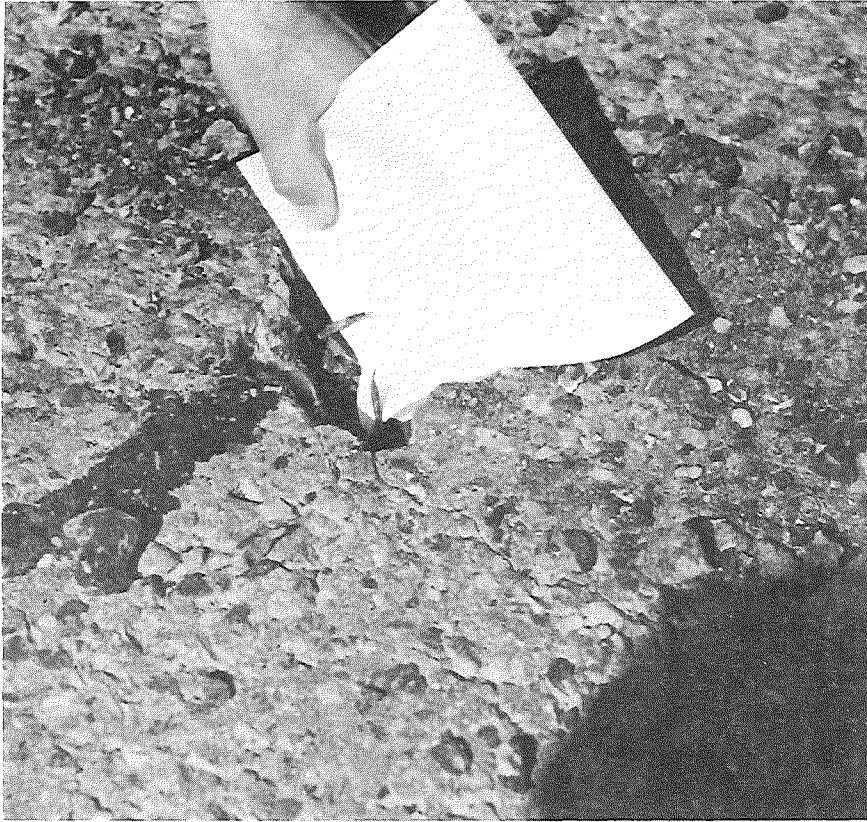
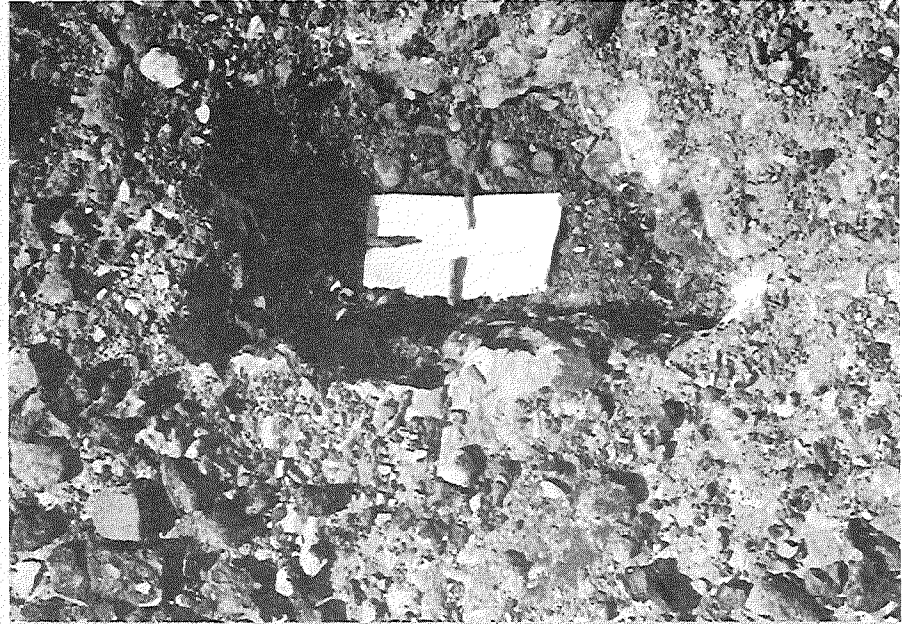
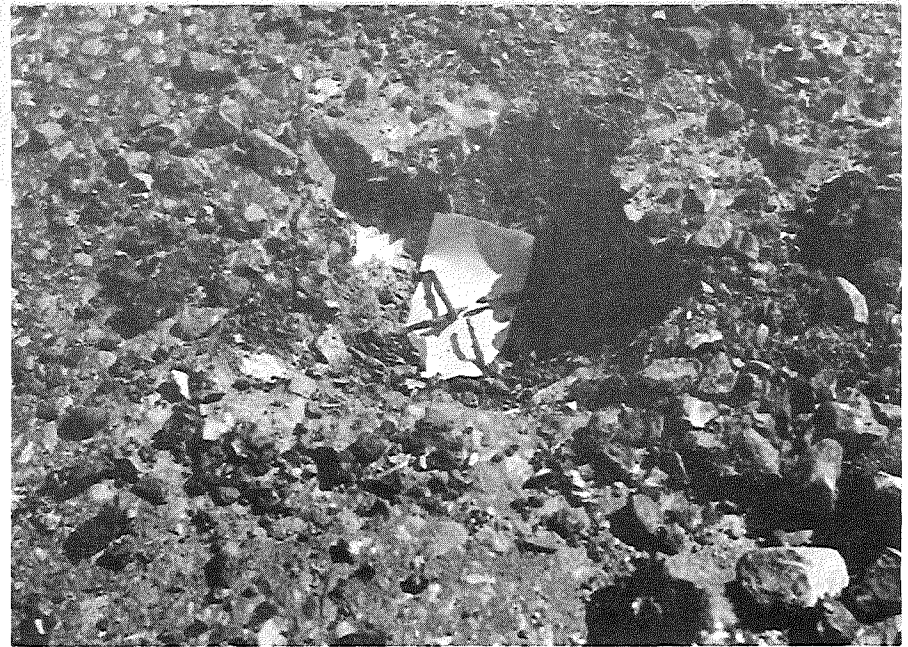
During final inspections in the fall of 1961, bituminous concrete was removed from potholes and at other locations to expose the reinforcement. As was anticipated, wires were fractured and severely rusted in potholes over intersections of transverse and longitudinal joints in the old pavement, indicating infiltration of moisture from below and also through

Figure 14. Fractured and rusted steel exposed in potholes located at intersecting transverse and longitudinal reflection cracks (left above), and from beneath sound surface areas (right above and below).

overlying reflection or alligator cracks (Fig. 14). However, steel exposed at other locations, where no surface deterioration had occurred, was similarly deteriorated, suggesting that the sheets had in effect been reduced throughout the overlay to disconnected networks of broken and corroded wire fragments (Fig. 15).

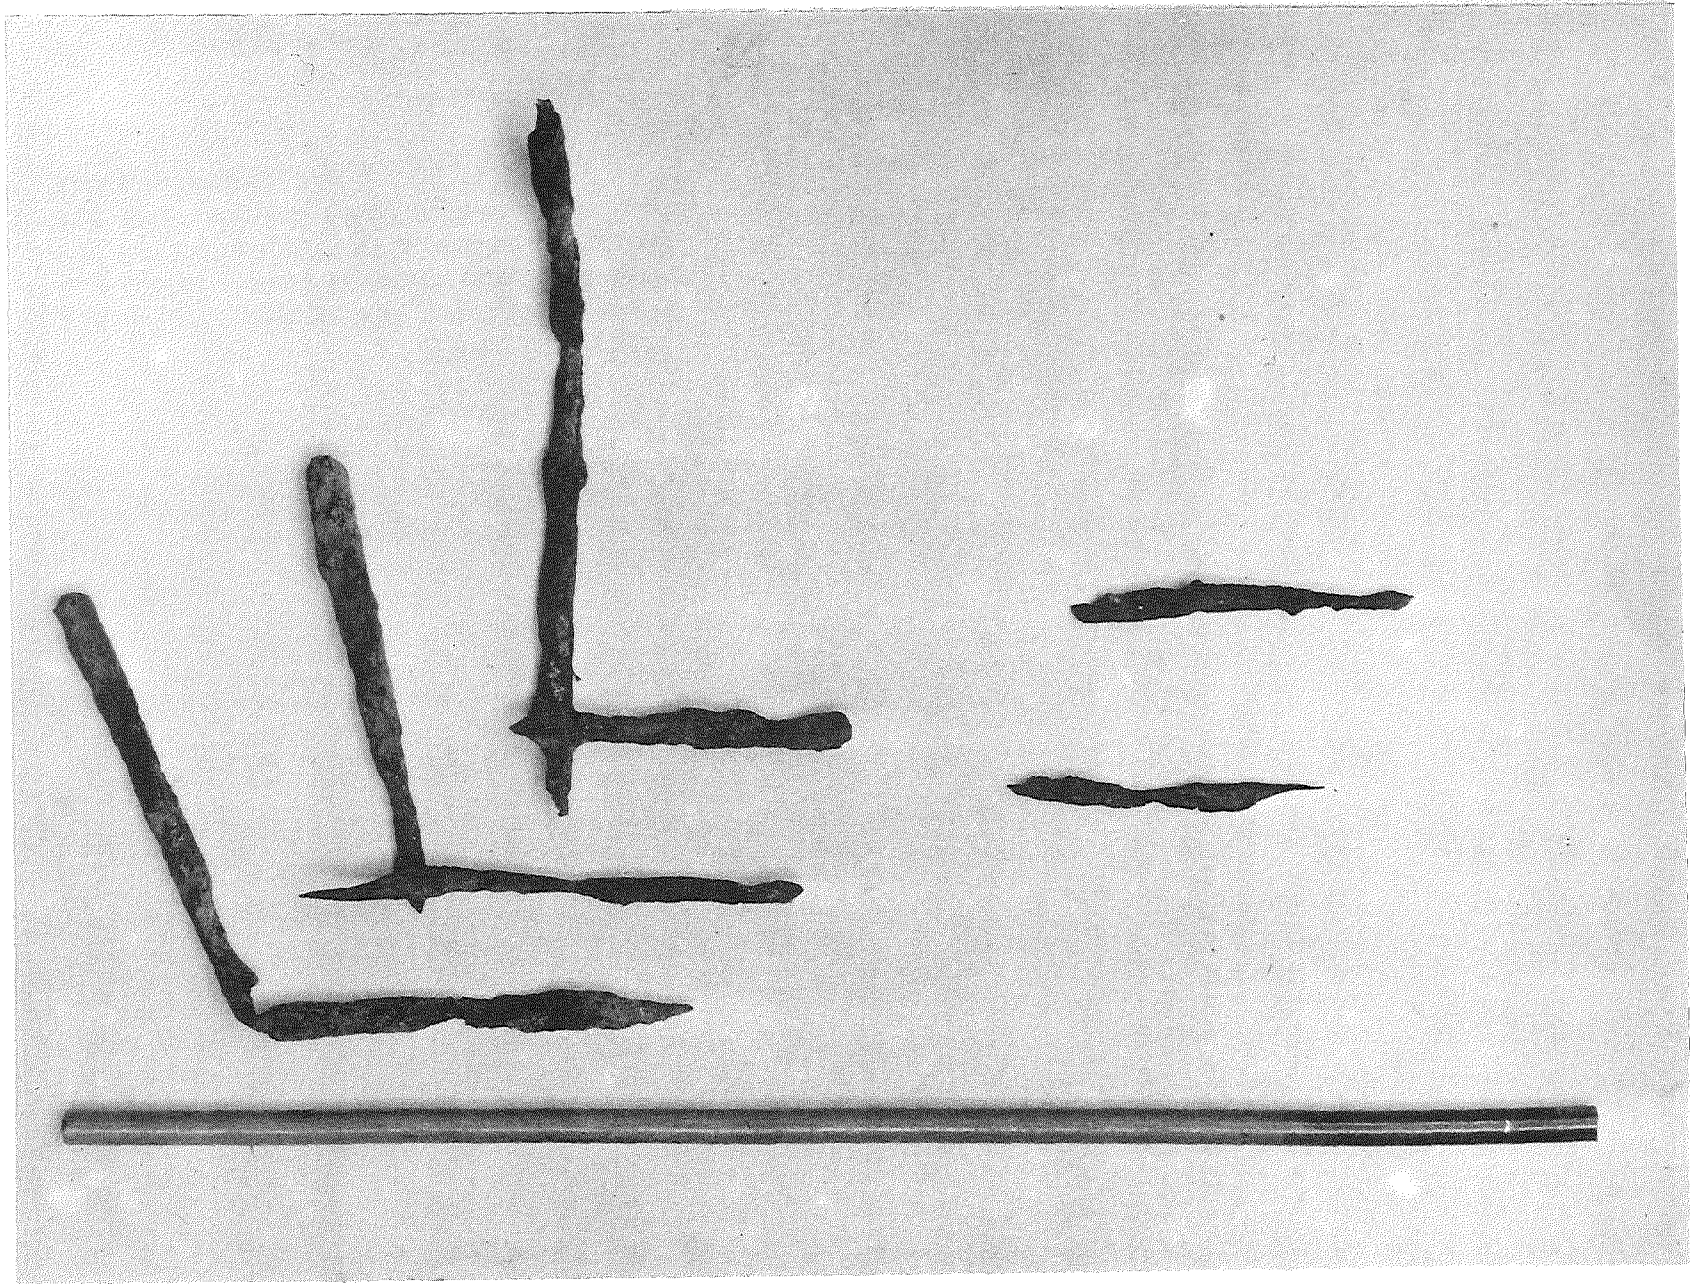
Figure 15. Specimens removed from locations shown in Fig. 14, with sample of new No. 10 gage wire at bottom.

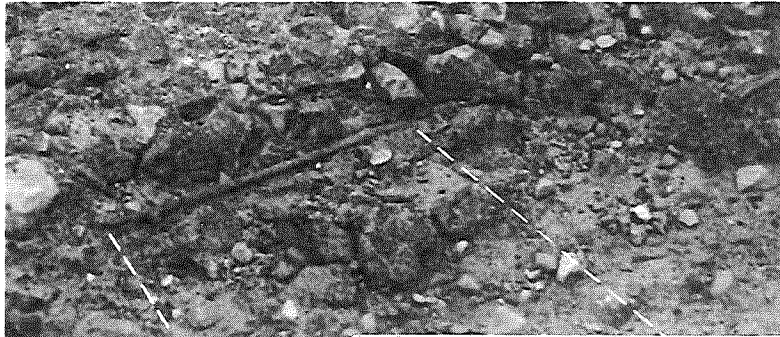
Of all the steel examined, the best-preserved was a lightly rusted short length that had not even been covered during construction, but had been left exposed to the weather at the pavement edge. This exposed wire was actually in better condition than parts of the same sheet that had been covered with bituminous concrete (Fig. 16). The examples illustrated show that steel was notably deteriorated near the welded intersections of transverse and longitudinal wires.

Figure 16. Lightly rusted wire protruding at pavement edge before excavation (left), and adjacent corroded wire after excavation (right).
