Research Record

Issue Number 92

July 2001

Michigan's Link Plate and Pin Assemblies MDOT Examines Current Performance, Use, Repair, and Maintenance Procedures

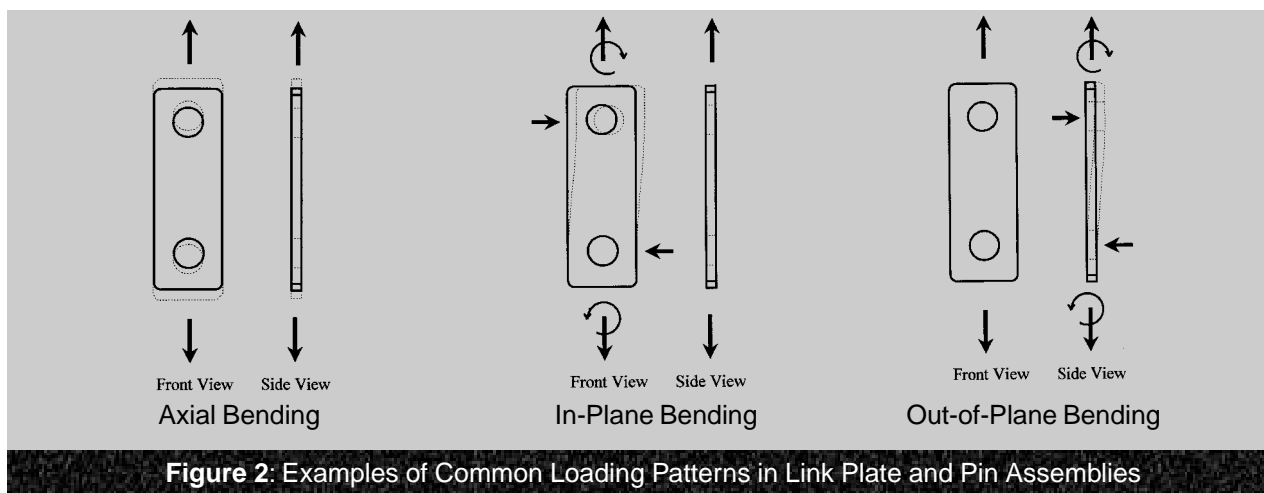
Figure 2: Examples of Common Loading Patterns in Link Plate and Pin Assemblies

Axial loading is a load passing concentrically through the body of the link plate as shown in Figure 2. This is the type of load that is assumed when a link plate is designed. Because stress concentrations occur at the pin holes, the net section of the link plate across the pin hole is the critical section of the link plate for carrying load. For static design strength, the American Association of State Highway Transportation Officials (AASHTO) Bridge Specification requires that the net section be sized 40% larger than otherwise required to account for the stress concentration.

As mentioned, a known problem with link plate and pin details is corrosion. Over time, corrosion product causes resistance to rotation of the link plate about each pin. Corrosion buildup between the link plate and the beam web also causes the assembly to bind up. As a result, in-plane bending occurs in the link plate when large loads are applied, such as trucks driving over the bridge, or with changes in temperature. Please refer to Figure 2.

This refers to the weak-axis bending. This is caused by vehicles impacting an expansion joint that is at an angle to traffic flow, from thermal forces on skewed and horizontally curved bridges, from differential deflection of the adjacent beams, radial force exerted by a vehicle on a horizontal curve, and from misalignment of the beam web. Please refer to Figure 2.
