MICHIGAN  
STATE HIGHWAY DEPARTMENT  
LANSING 13

December 2, 1952

SUBJECT: Condition survey of Bituminous Concrete Projects  
Containing Wallace Stone  
Research Project 51 A-12: Report No. 186

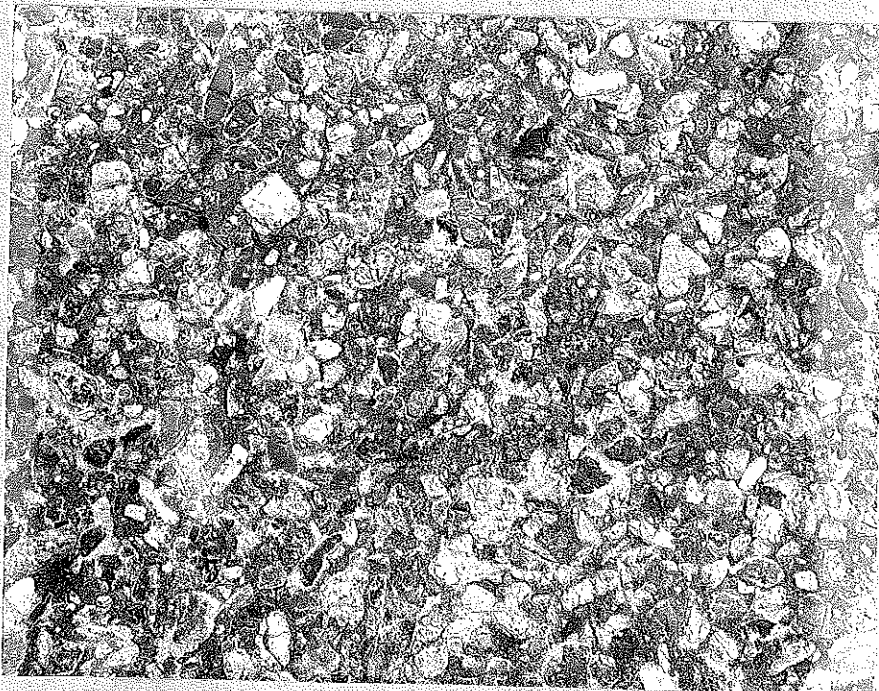
B. View of surface showing typical condition of aggregate  
Wallace stone 26A modified R-25-4, C11, 1948, US-10 Dort  
Highway Flint just No. of Carpenter Rd., Center two lanes  
of a four lane highway.

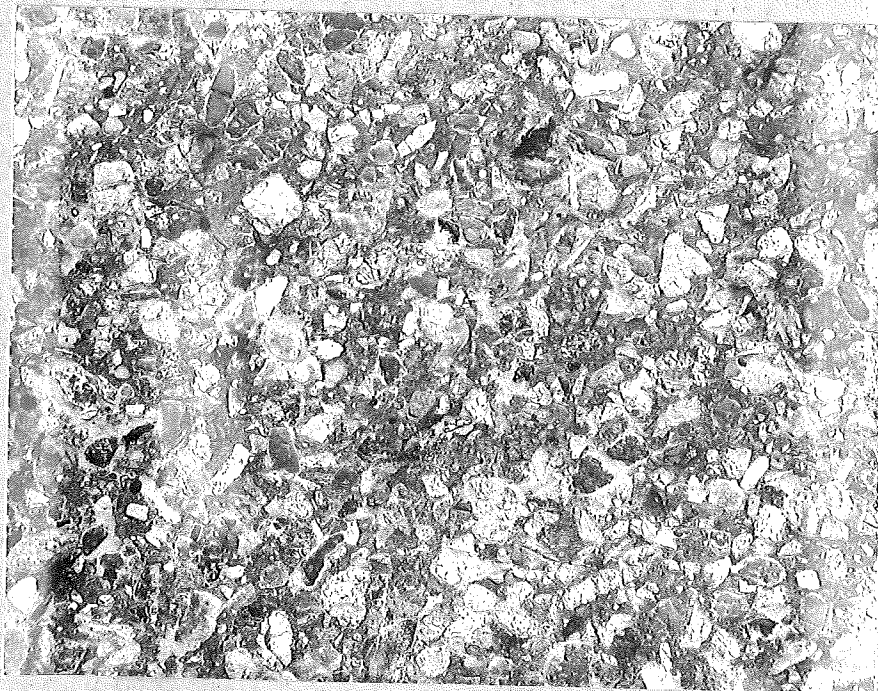
B. View of surface showing typical condition of aggregate  
Wallace stone 26A modified R-25-4, 011, 1948, US-10 Dort  
Highway Flint just No. of Carpenter Rd., Center two lanes  
of a four lane highway.

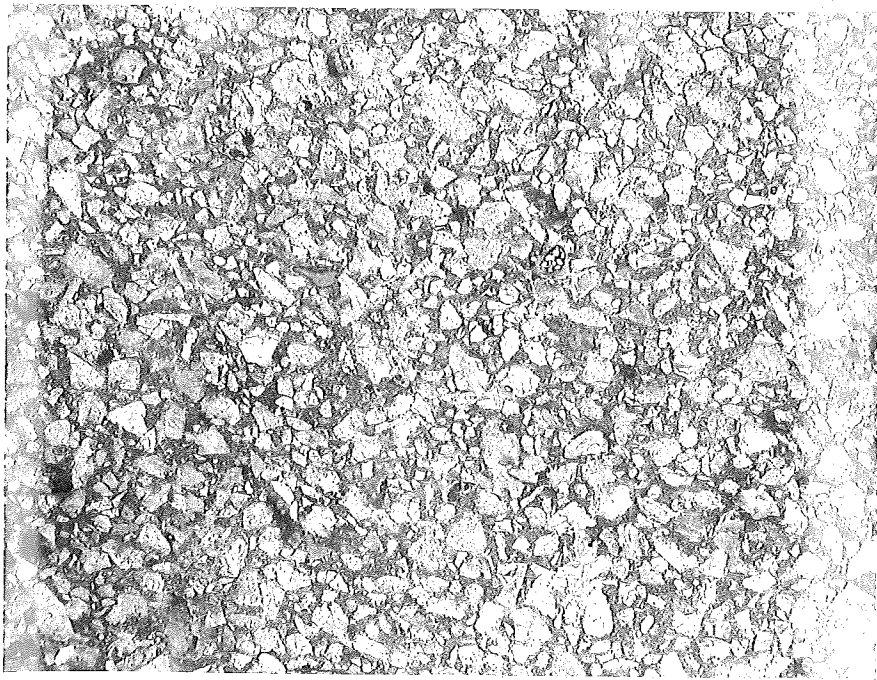
B. View of surface showing typical condition of aggregate  
Wallace stone 26A modified S 25-9,02, 1948, M-21A (Belsay  
Road) West of M-15.

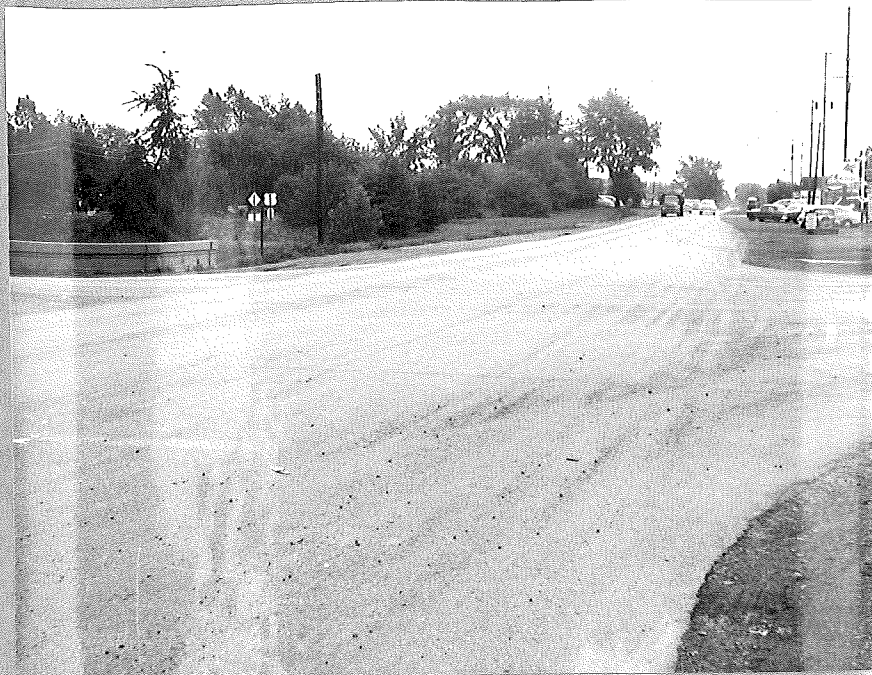
A. Typical condition of surface. No pitting. Shows signs of slight abrasion due to material brought onto intersection by traffic.

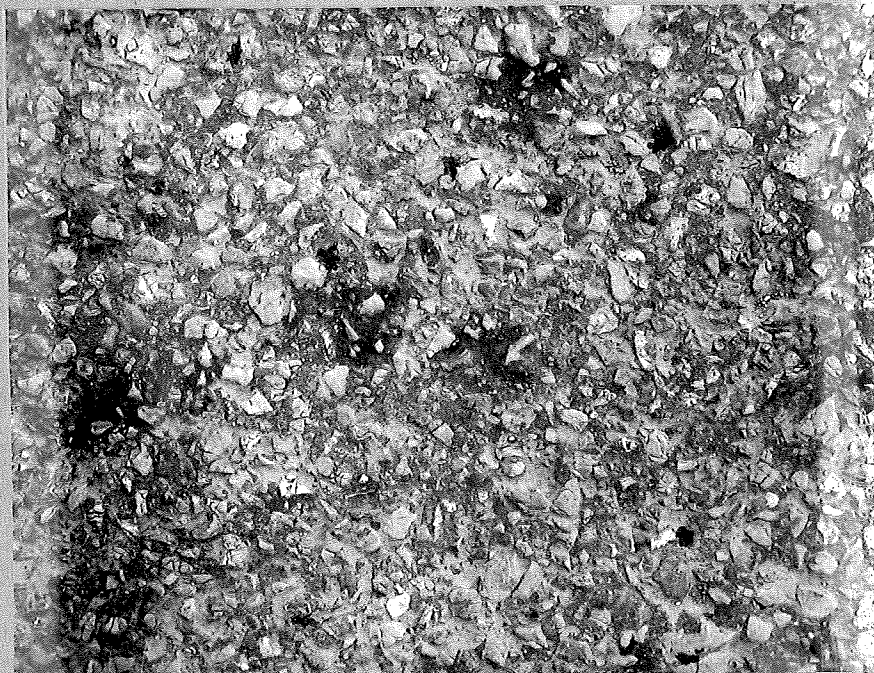
B. View of surface showing typical condition of aggregate Wallace stone 26A Modified M 25-38, 03, 1948, Intersection of US-23 & M-121 in Flint.

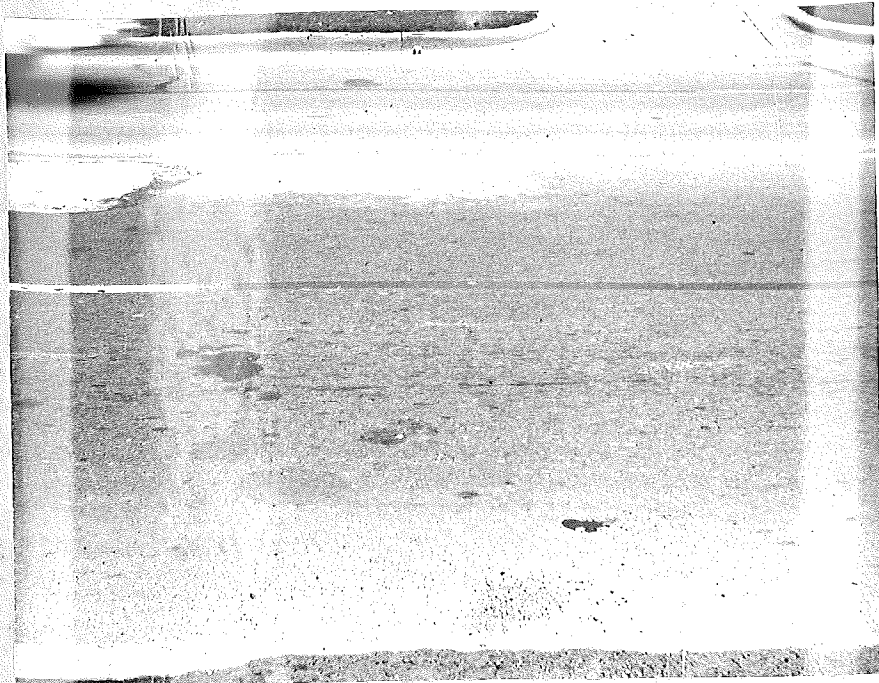
A. Typical condition of surface. No pitting.

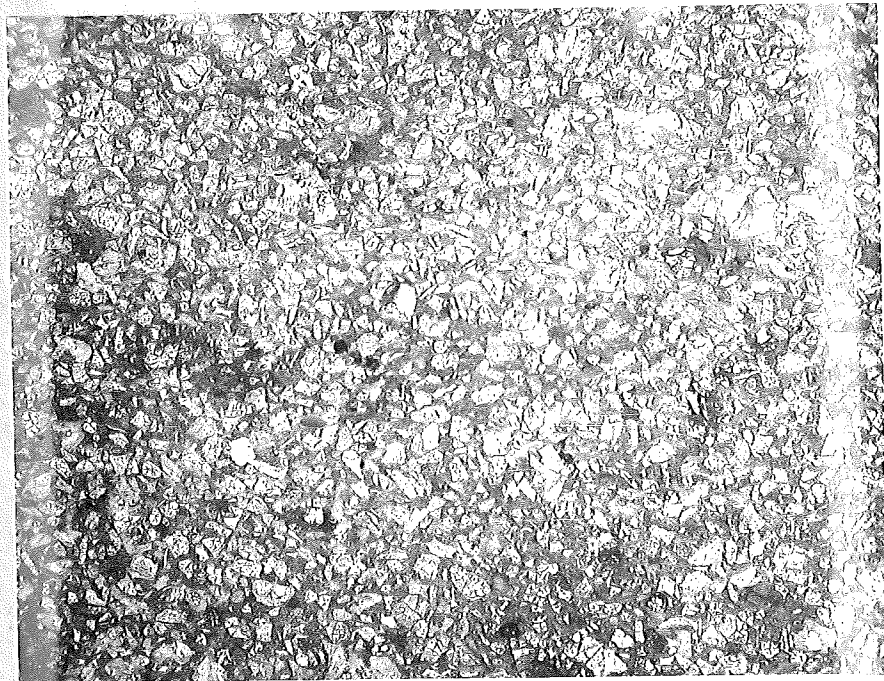
B. View of surface showing typical condition. Wallace stone 26A Modified M-25-36, 01 - 1949. On US-23 So. from M-21 in Flint.

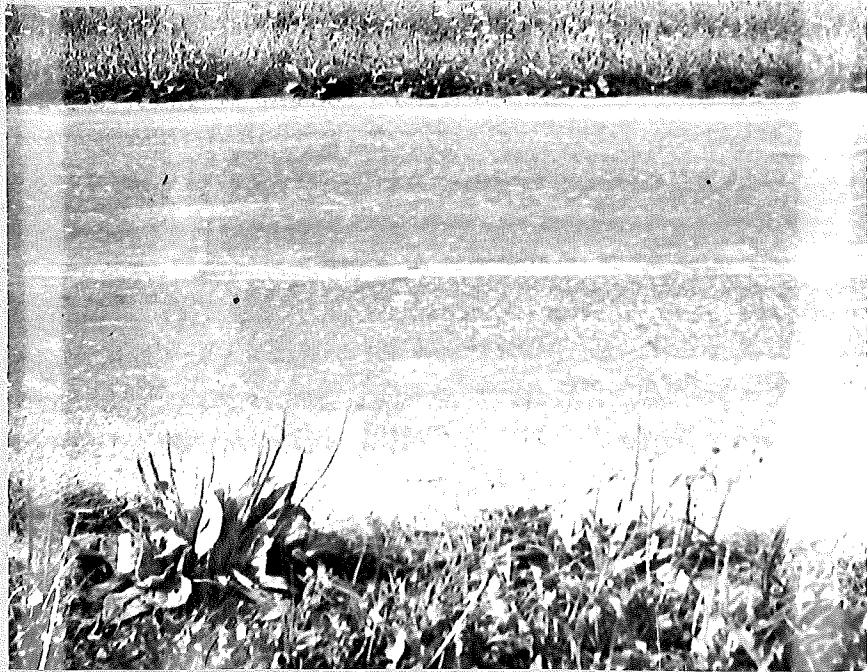
A. Typical condition of surface. No pitting.

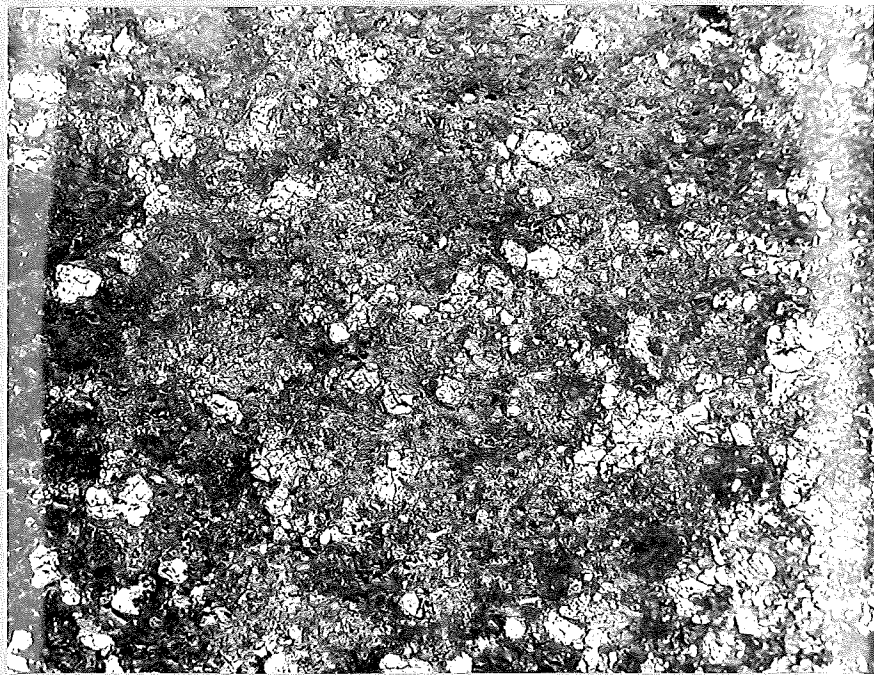
B. View of surface showing typical condition of aggregate. Wallace stone Co. Spec. Note large size of aggregate on Janes Road between Outer drive and N. Portsmouth Rd., Saginaw Co. This road has carried heavy traffic from local coal mine for years and also was used as detour for trunk line Constr. Still a good riding surface. County job 1922.

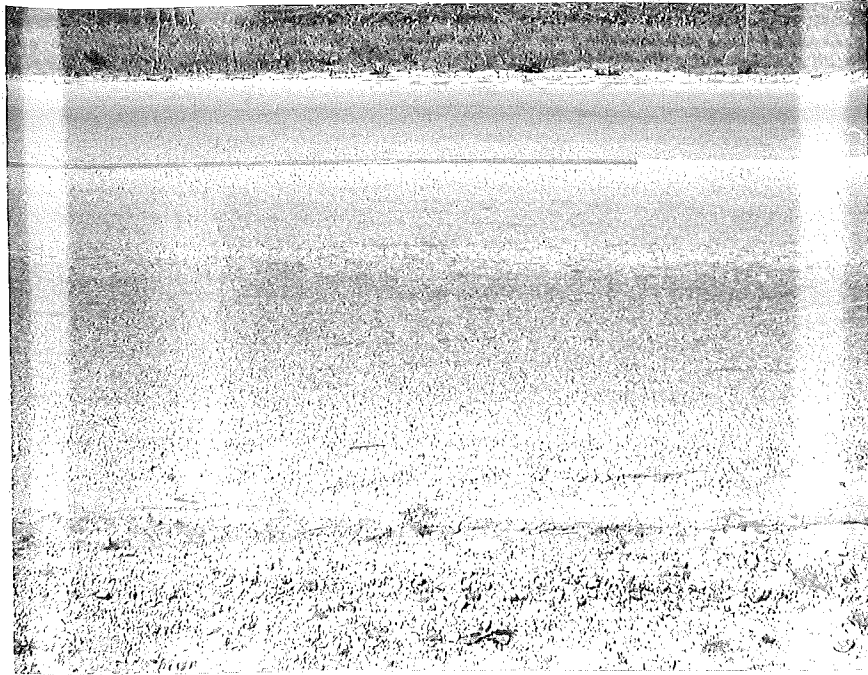
A. Typical condition of surface. No pitting.

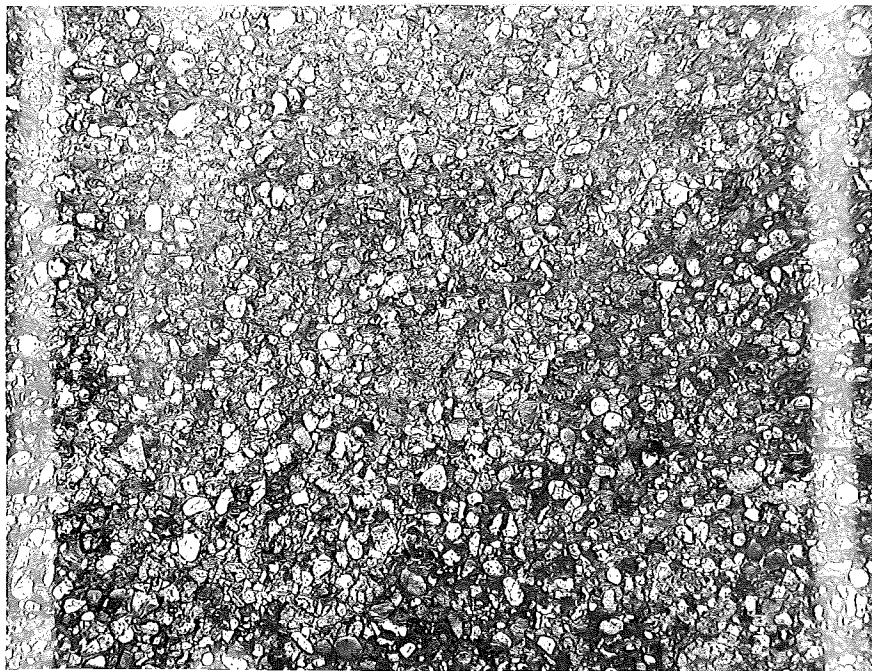
B. View of surface showing typical condition of aggregate. Resealed Wallace stone in 1940 (from Maintenance Engr.) State Reward 4145 1920 M-47 2 miles So. of M-46, So. 1 Mile.
