CONCRETE PAVEMENT RESTORATION
Construction Report

J. E. Simonsen
A. W. Price

Research Laboratory Section
Materials and Technology Division
Research Project 86 G-267
Research Report No. R-1292

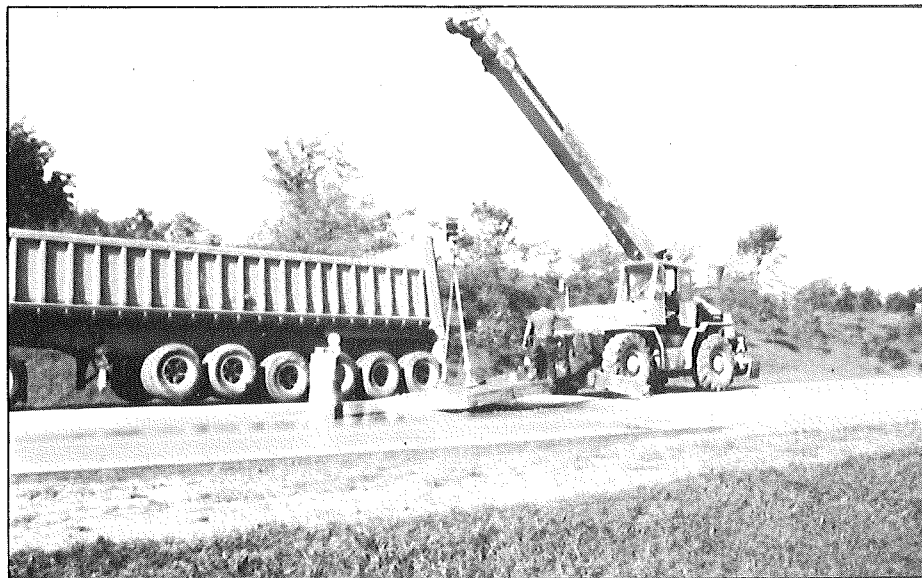
◀ Figure 1. Removing distressed pavement section.

The end limits of the repairs were sawed full-depth using a diamond bladed saw and the larger sections of the distressed concrete slab were lifted out without disturbing the base material (Fig. 1). After final clean out by hand the dowel holes were machine drilled. Two groups of five

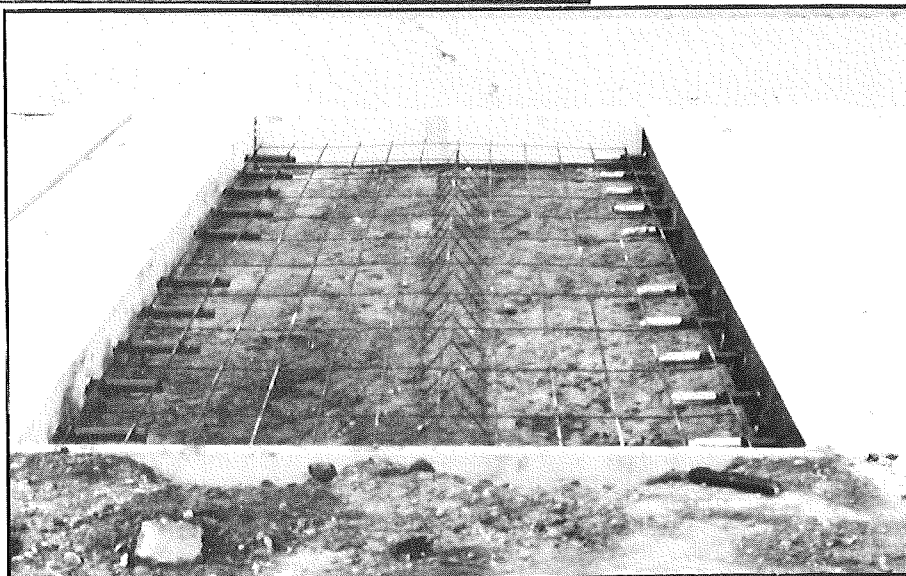
Figure 2. Repair area ready for concrete placement. (Contraction joint on the left, expansion joint on the right). ▶

Once the treatment of the dowels or deformed bars was completed the repair area was formed and the reinforcement installed (Fig. 2). A 9-sack ready mixed concrete was used to reconstruct the failed areas. The concrete was consolidated using a hand-held immersible vibrator, screeded off, floated, broomed, and a curing compound applied. The transverse joint grooves were formed using a 1 by 1-in. wood strip inserted in the fresh concrete just prior to screeding the concrete surface. The joint grooves were sandblasted and cleaned with oil-free compressed air just prior to sealing with a low-modulus hot-poured sealant. Figure 3 shows a typical finished repair.

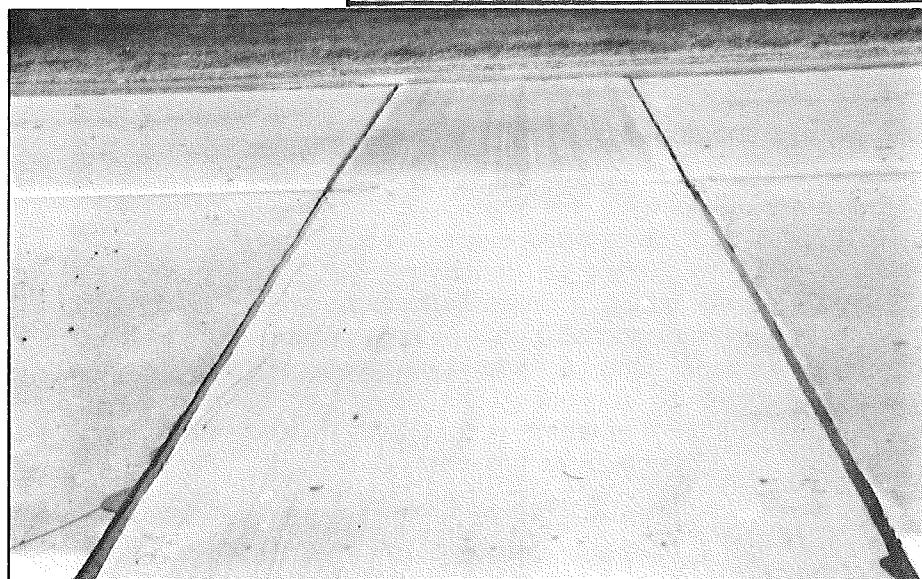
◀ Figure 3. Finished concrete repair.

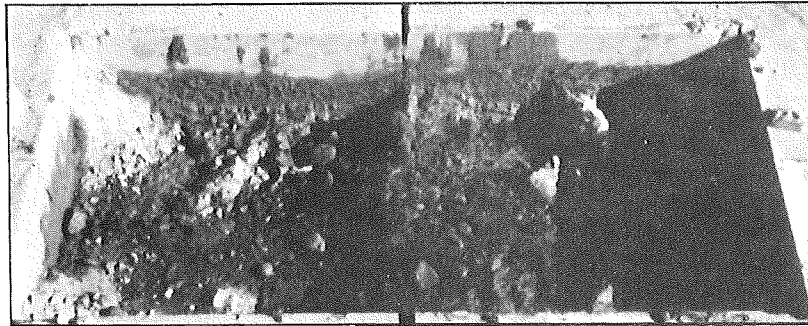
Figure 6. Deteriorated concrete in bottom of repair area.

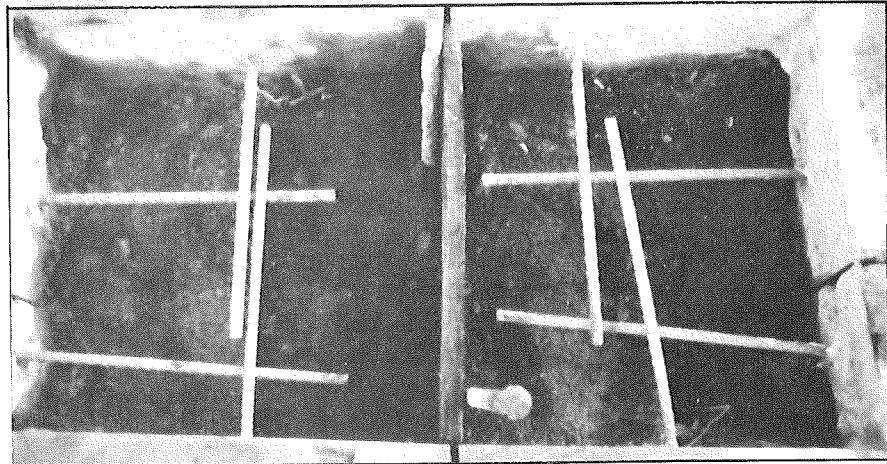
Figure 7. Joint intersection ready for concrete placement.

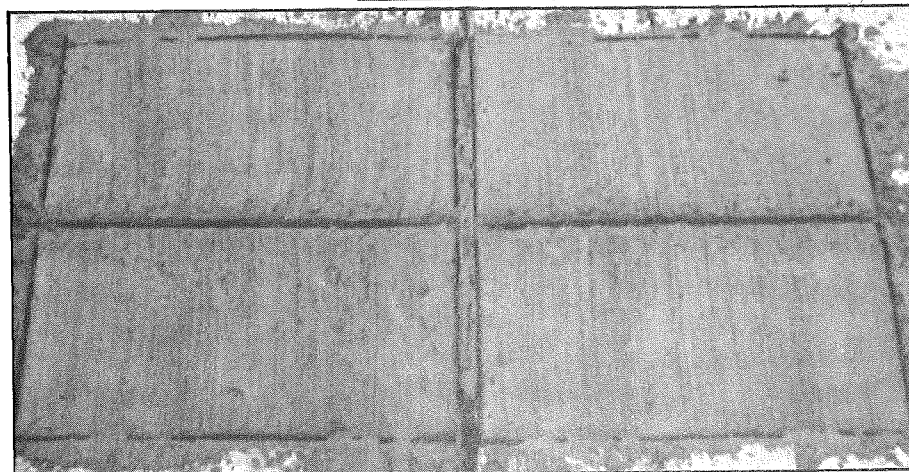
Figure 8. Finished repair before sealing joints.

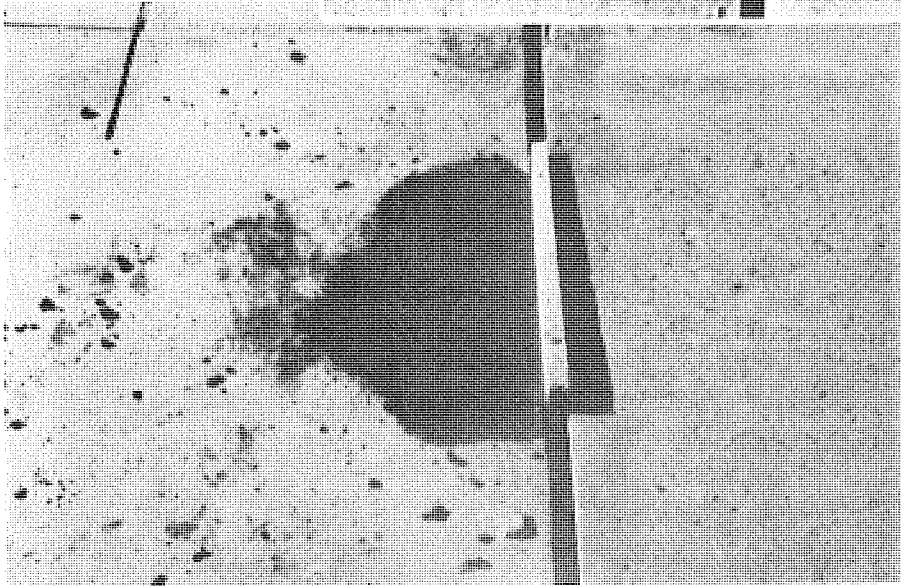
Several thousand feet of partial-depth repair were made on the centerline joint in 1984 on a project on I 69 near M 71 in Shiawassee County. Both bituminous and concrete were used to replace the deteriorated concrete. A documentation of those repairs is included here, rather than build such repairs at the Calhoun Co. site where they were not needed. First, the unsound concrete was removed to a depth of about 1-1/2 in. and a width of 12 in. using a cold milling wheel with carbide teeth. The resulting edges were badly ravelled. The area was cleaned with oil-free compressed air. For the concrete repairs, the mix was placed and finished, and a plastic strip was inserted at the centerline location to form the plane-of-weakness joint. Bituminous repairs were made with a sand type mixture, placed and levelled by hand, and compacted with a roller. A recent inspection revealed that both repair types have cracked severely and separation and raveling along the edges have occurred. Figures 22 through 25 illustrate the condition of the repairs. It is evident that this procedure is not satisfactory and better repair techniques are needed.

Figure 22. Typical condition of centerline joint on I 69 repaired with bituminous material in 1984.

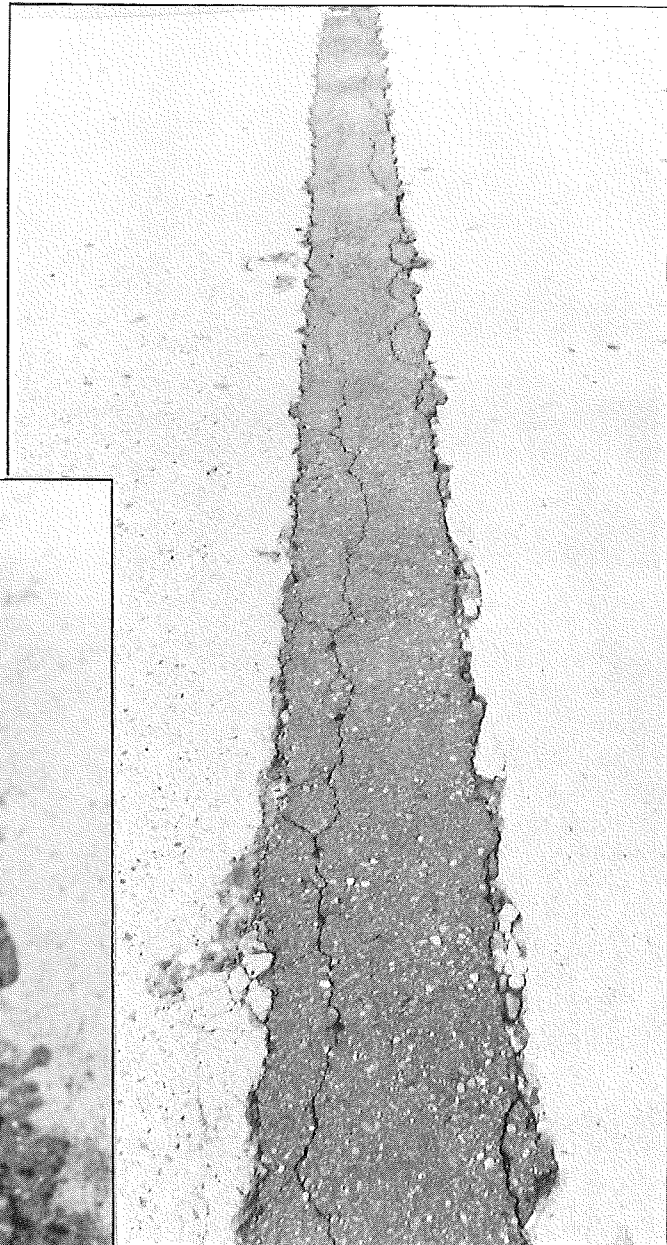
Figure 23. Ravelling along edges and cracking over plane-of-weakness crack.

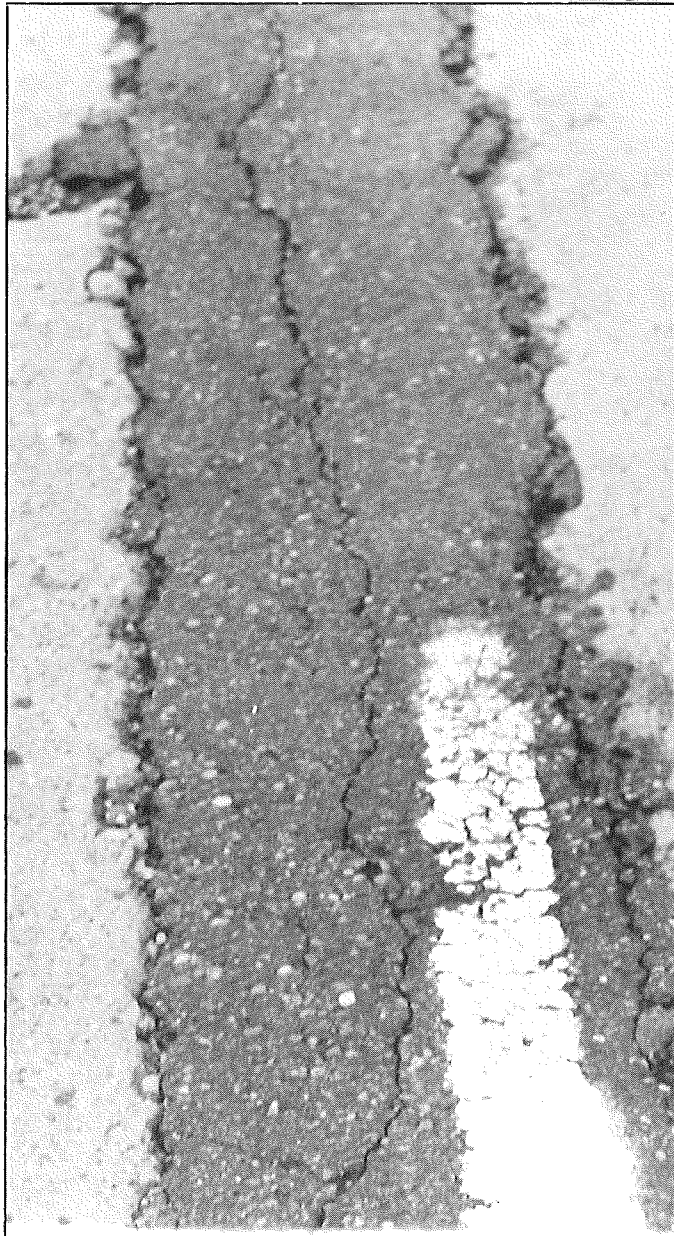
Figure 24. Typical condition of centerline joint repaired in 1984 on I 69 using concrete.

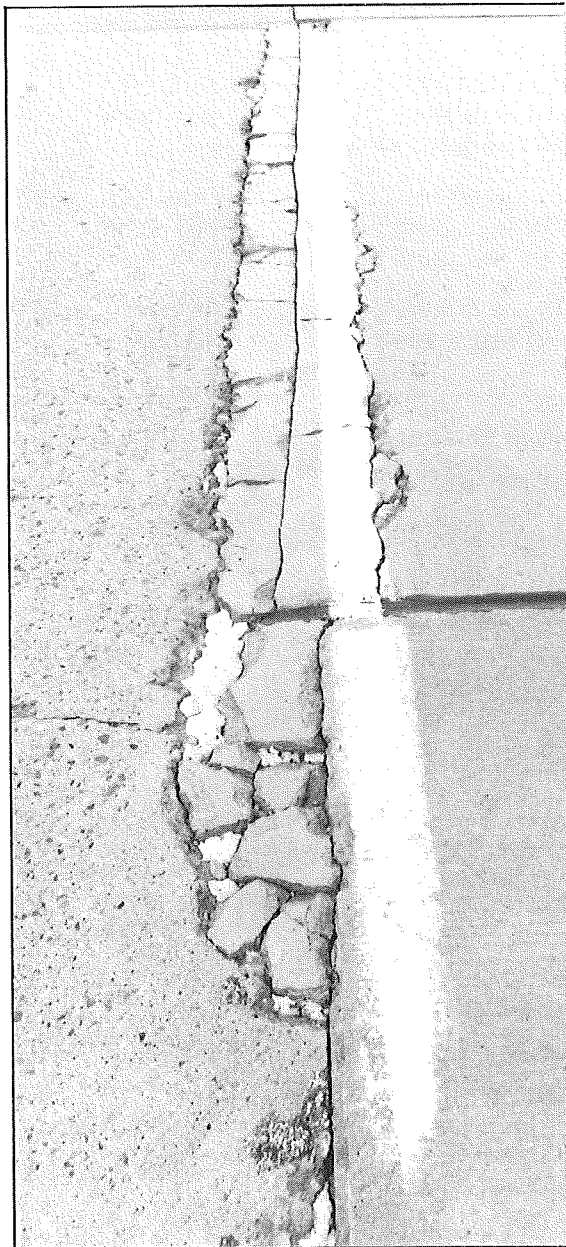
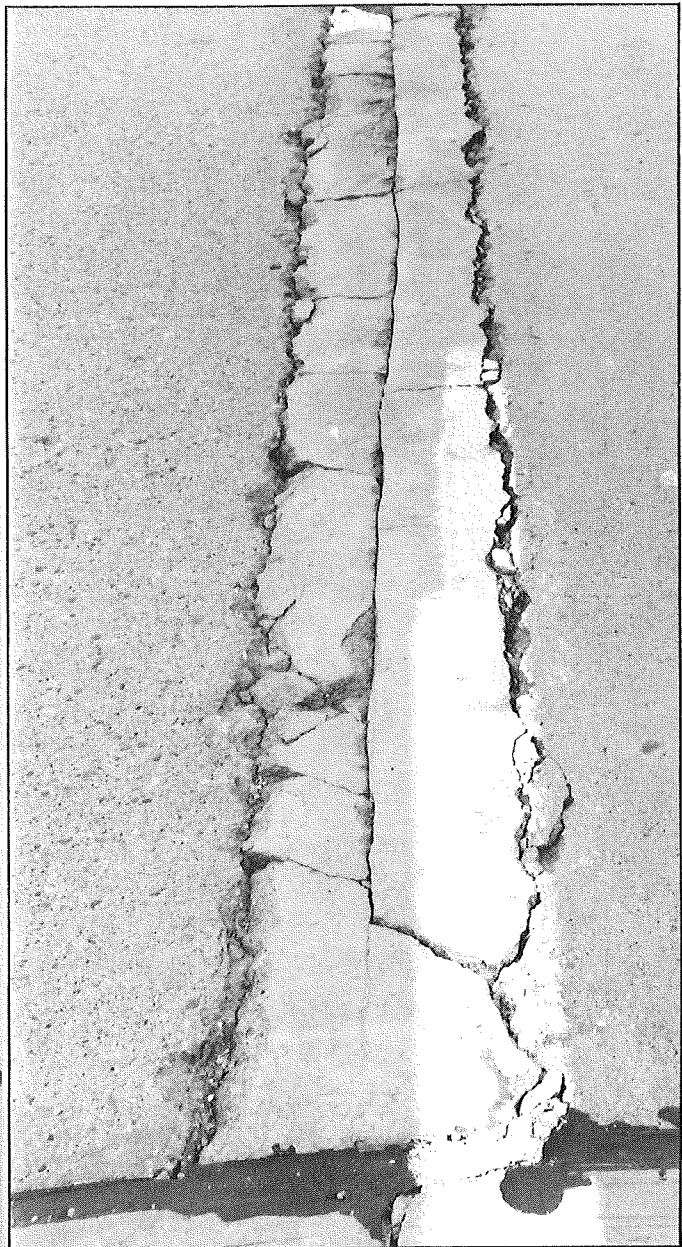
Figure 25. Ravelling along edges and severe cracking have occurred. Some of the concrete pieces are missing.

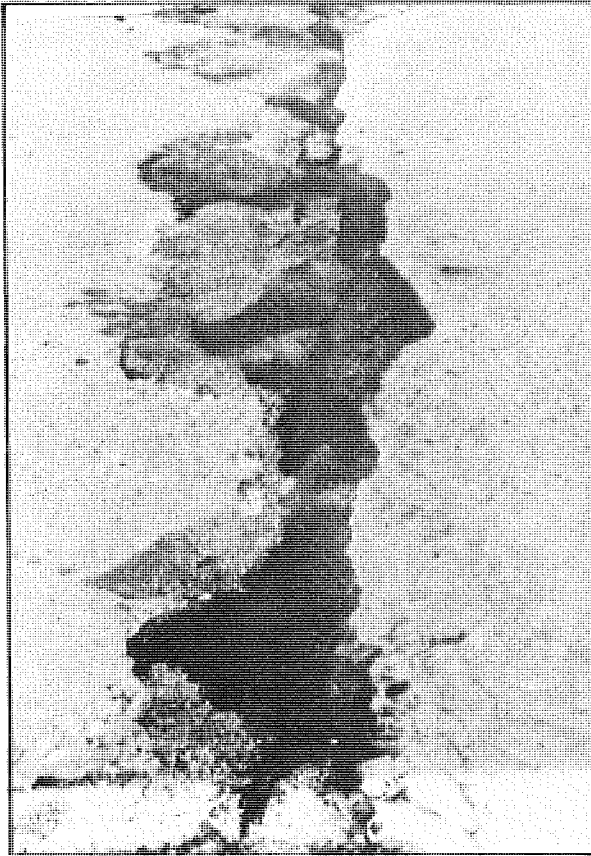
◀ Figure 1A. Transverse joint compression failure.

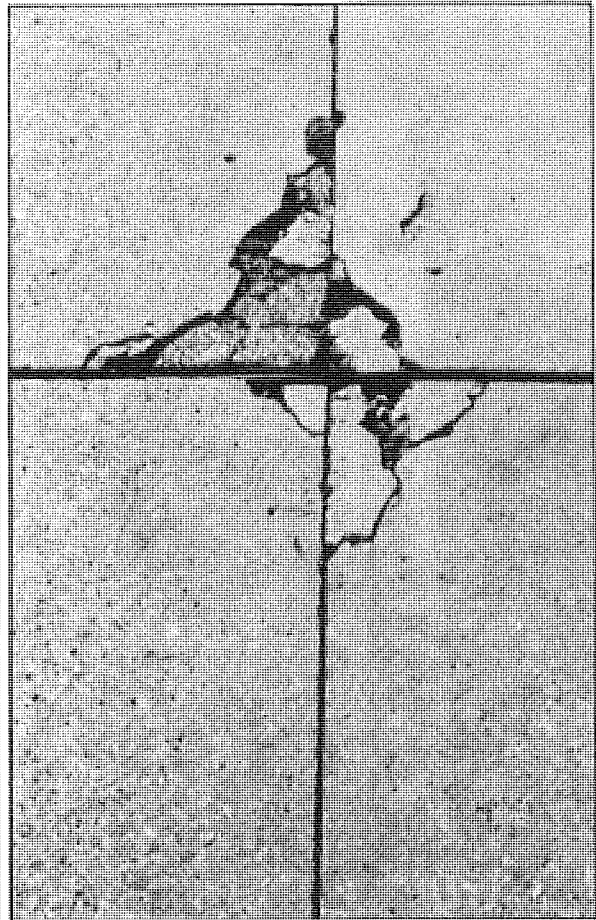
▲ Figure 2A. Failure at intersection of the transverse and longitudinal joint.

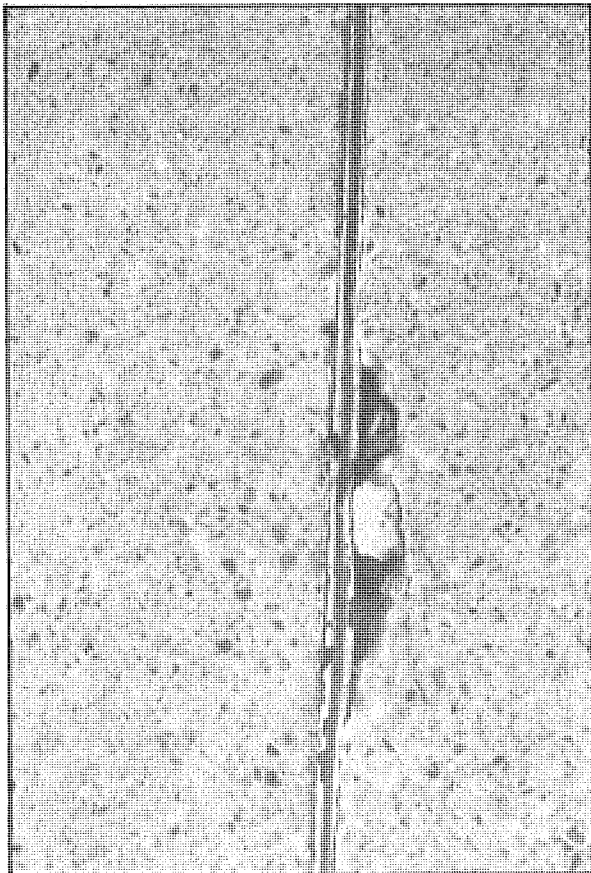
◀ Figure 3A. Joint groove spall.

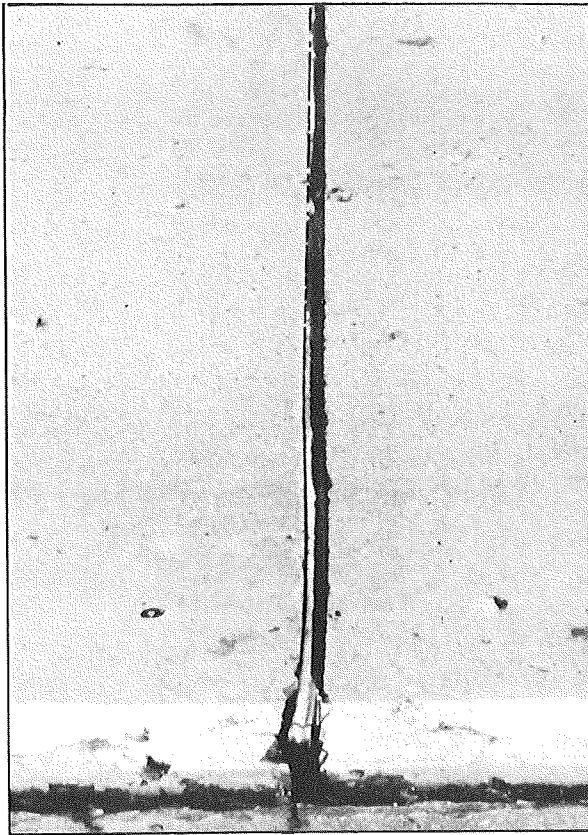
Figure 5A. Transverse crack with fractured steel.

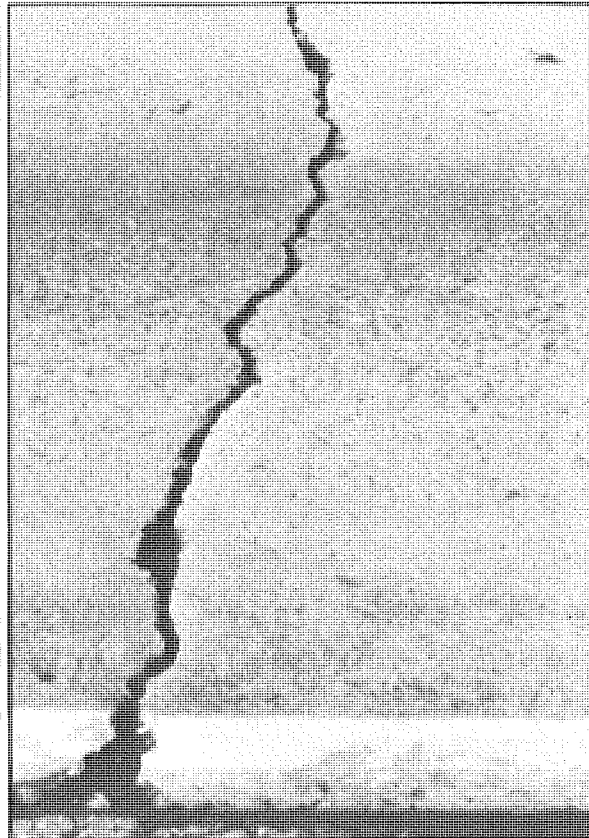
Figure 6A. Transverse crack with reinforcement intact.
