DECK RIPPLING ON VARIOUS MICHIGAN BRIDGES  
Third Progress Report

Research Laboratory Division  
Office of Testing and Research  
Research Project 66 F-88  
Research Report No. R-608

State of Michigan  
Department of State Highways  
Lansing, October 1966

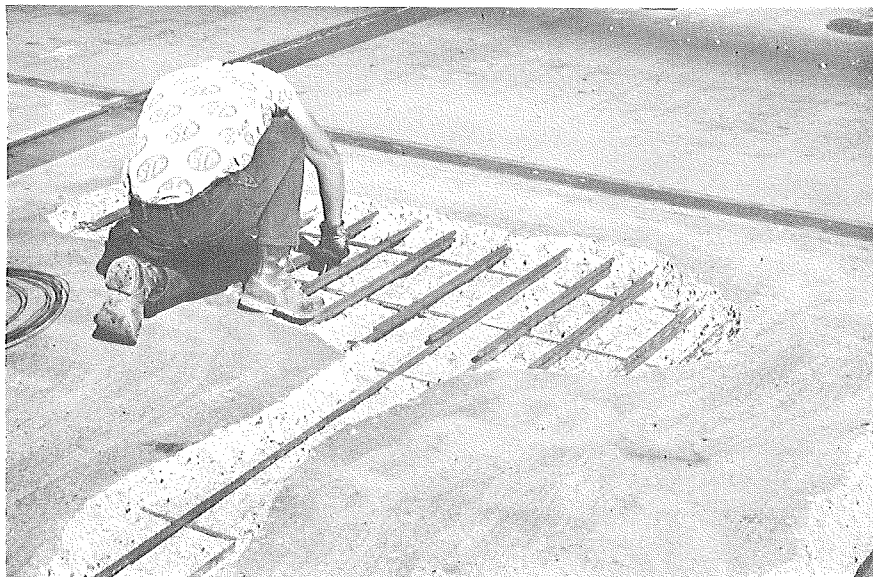
There seems to be no correlation whatever between the use of the longitudinal finisher and the occurrence of ripples. Two local structures (the Bogue St. Bridge at MSU and the Oakland St. Bridge here in Lansing) were finished longitudinally and show no rippling. Several other structures on I 96 and I 496 in the Lansing area show rippling to varying degrees, although finished with a transverse machine. Figure 1 shows ripples nearly 1/8 in. deep that occurred in widening of a structure on I 94 near Benton Harbor that was hand finished with transverse strike-off. Note the similarity of the wave form to that found on the Rouge Deck. The I 94 bridges were widened under traffic, and therefore received severe vibration during cure.

Figure 1. General view and closeup of deck rippling on S16 of 11015, an I94 structure near Benton Harbor, where widening was hand finished with transverse strike-off. Heavy traffic continued to use the structure during construction and curing.

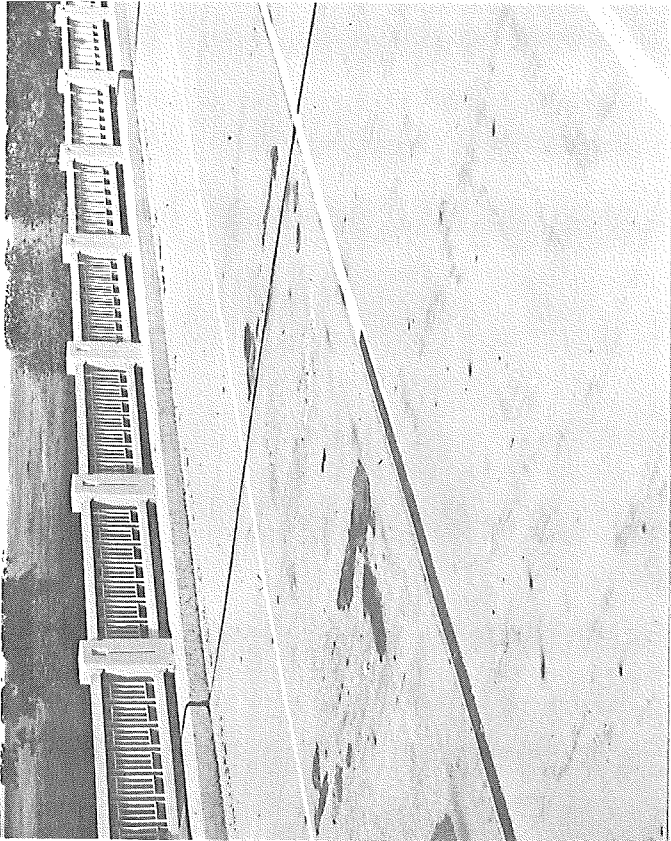
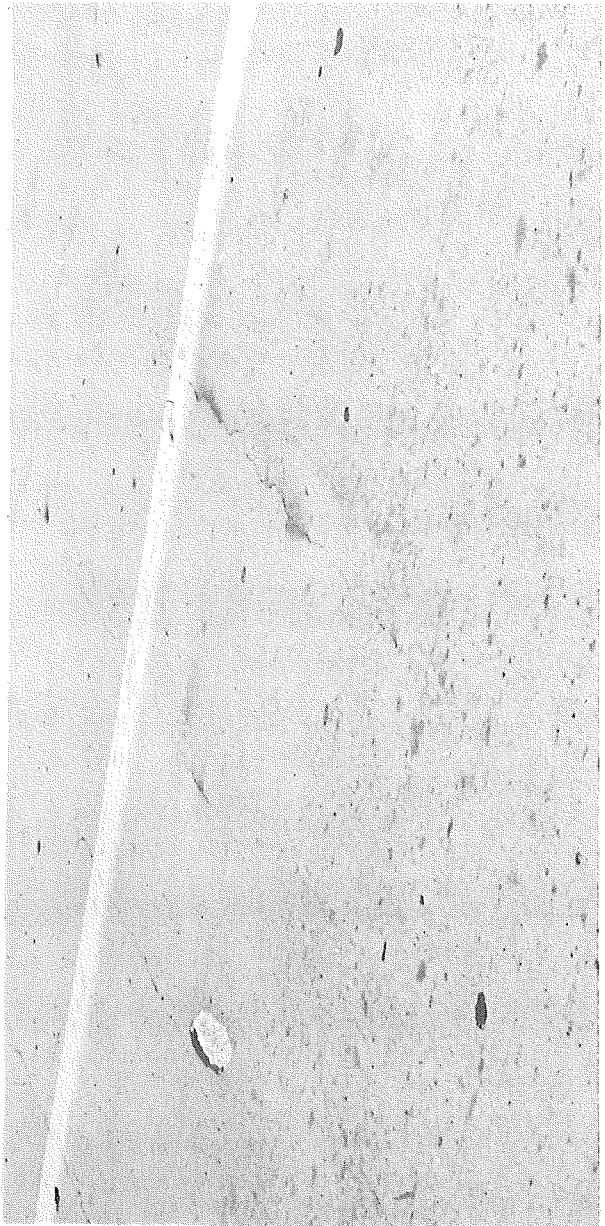
Another structure currently under repair is S05 of 38111, on US 127 over I 94 northeast of Jackson. This structure was built in 1958, and has extensively cracked and spalled areas on the deck as shown in Figure 3, also obtained from M. G. Brown. Note that slight deck rippling is apparent in these photos, especially in the foreground of Figure 3b. The pothole in the left of Figure 3c is probably the result of the fracture-plane cracking previously mentioned. Concrete cover on this bridge is reportedly 1-1/4 in. or slightly less.

Figure 3. Three views of deck condition on S05 of 38111, showing ripples (foreground, right) with cracks in troughs, and cracking that appears to follow bars (lower left). Pothole at left may be evidence of fracture plane cracking.

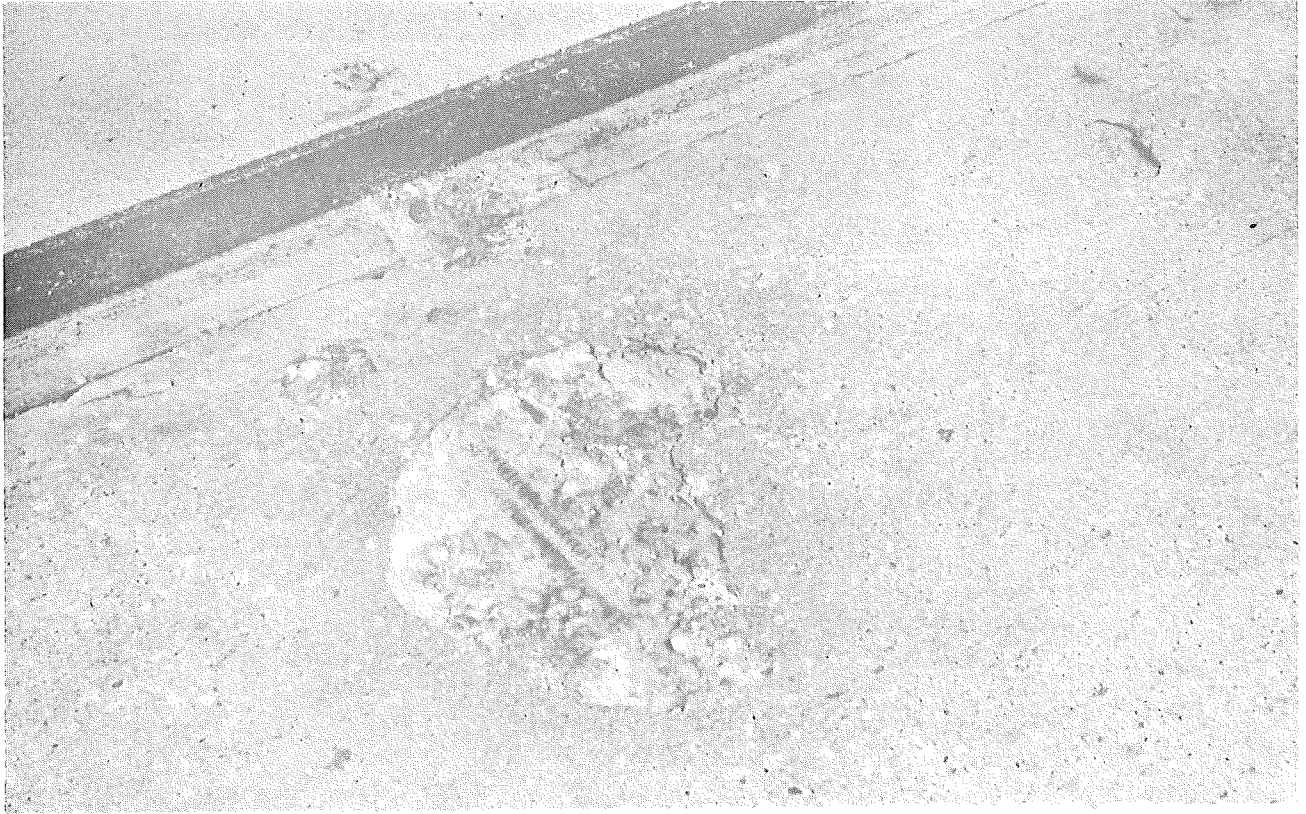
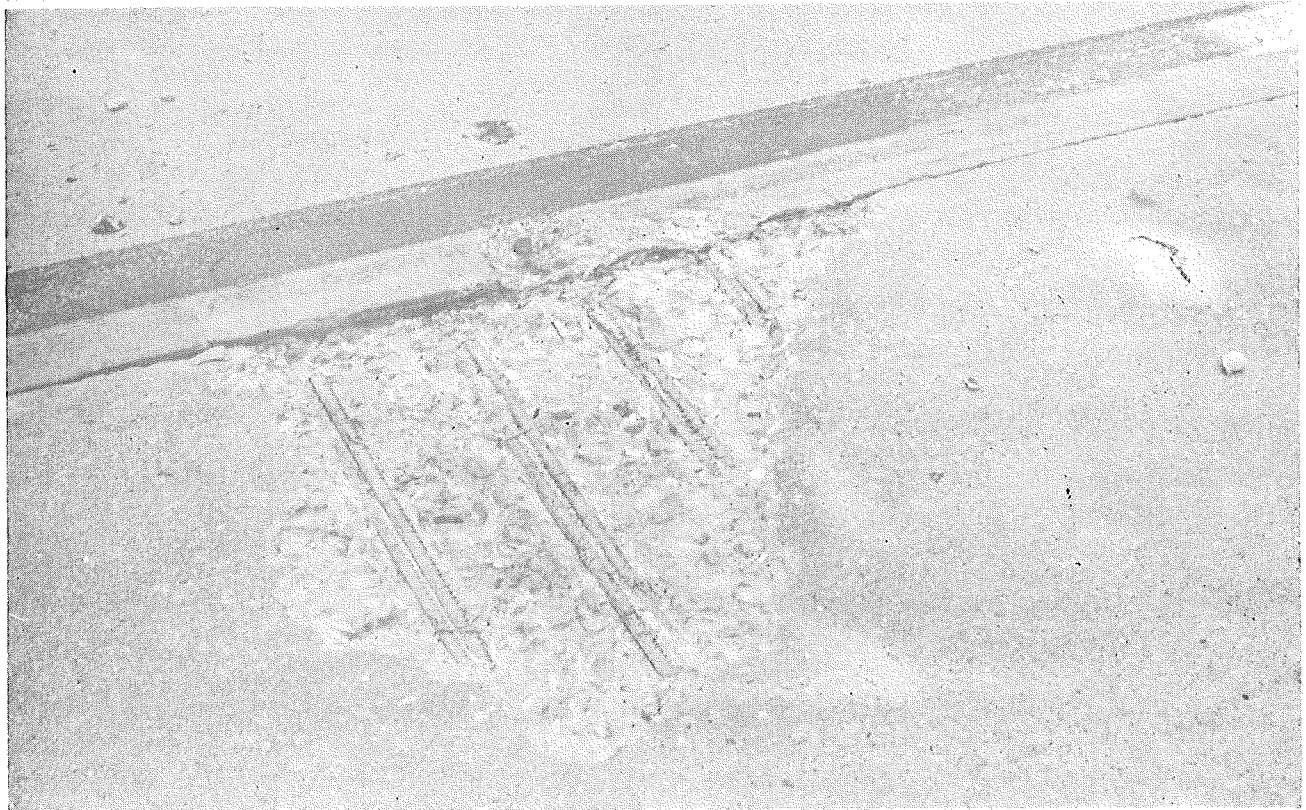
Figure 4 was also obtained by M. G. Brown, and shows a portion of deck deterioration on X01 of 38131, on US 127 over NYCRR north of Jackson, before and after the removal of loose concrete. This structure was built in 1957. Here again some of the first areas to spall away were over bar splices. Similar failures occurred on S02 of 38131, on M 50 over US 127.

Figure 4. Deck failure over bar splice, before and after removal of loose concrete for repair (X01 of 38131).
