EXPERIMENTAL RESEALING OF JOINTS ON M-83
SECOND CONDITION SURVEY

Saginaw County, Projects 73-25, C3 and 4

Highway Research Project 53 C-9
Final Report

Research Laboratory
Testing and Research Division
Report No. 239
October 12, 1955

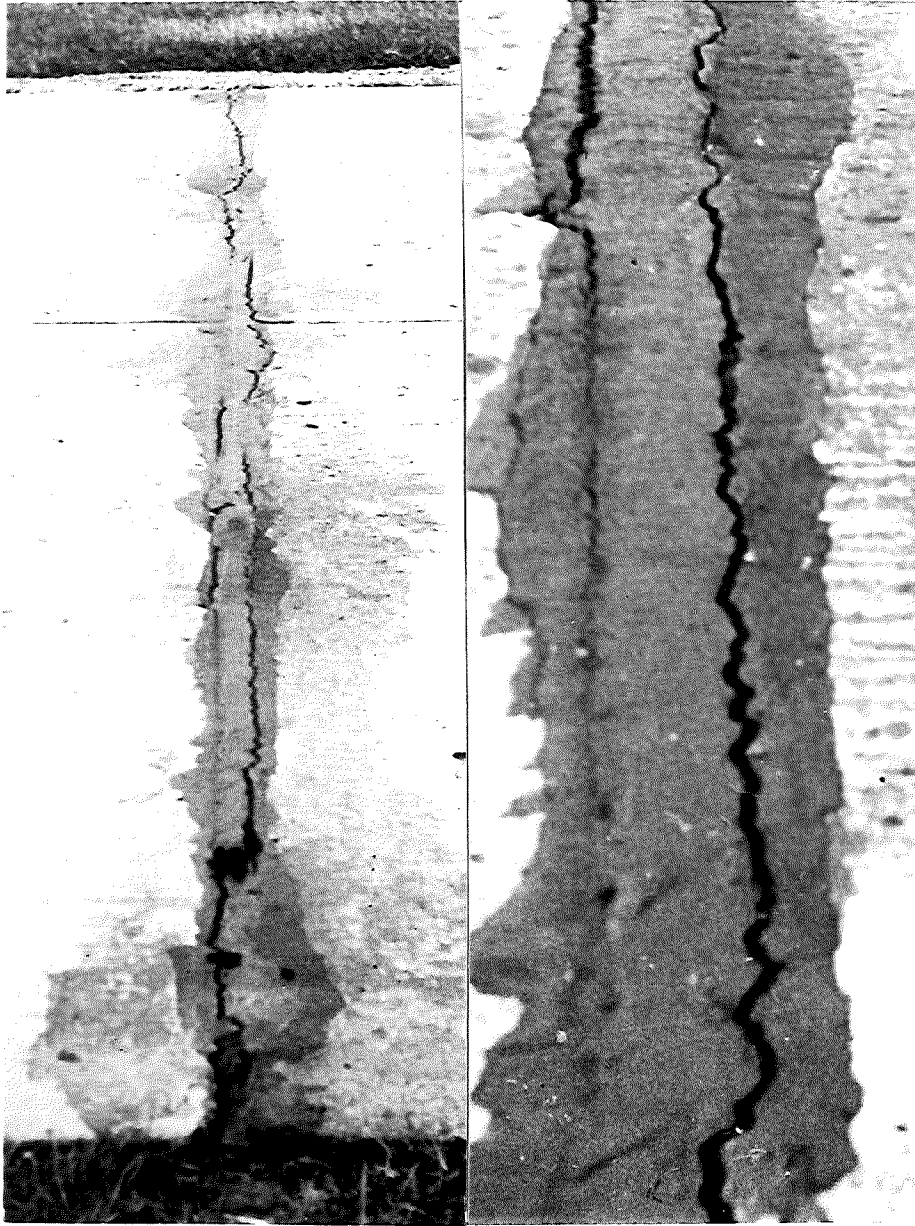
The current survey indicated that, after approximately one year of service, Brand A sealer had also failed. The material had become very stiff and hard, pulling loose from the joint faces when the slabs contracted. Figures 1 and 2 illustrate typical examples of this adhesion failure. The Brand A sealer had also failed in open cracks where there was movement as in joints, Figure 3, but was still intact in closed cracks and in the longitudinal joint, Figures 4 and 5.

▲ FIGURE 1. STA. 138+00. EXPANSION JOINT RESEALED WITH BRAND A SEALER. FAILED IN ADHESION.

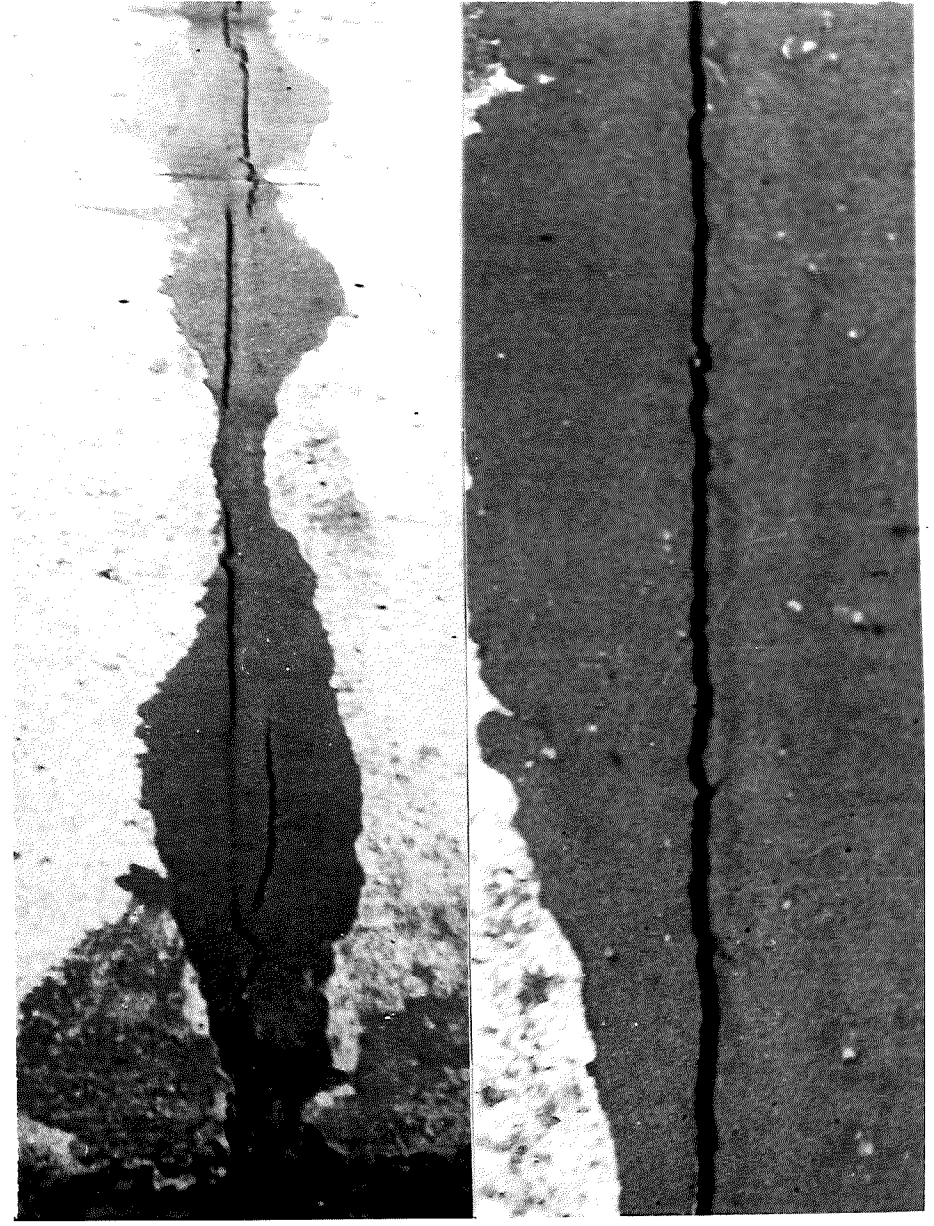
▲ FIGURE 2. STA. 137+00. EXPANSION JOINT RESEALED WITH BRAND A SEALER. FAILED IN ADHESION.

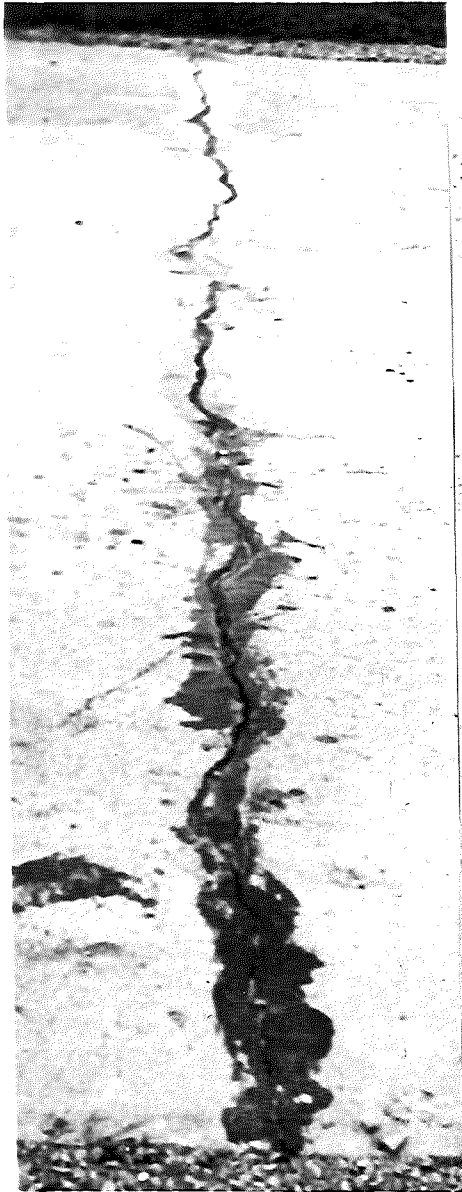
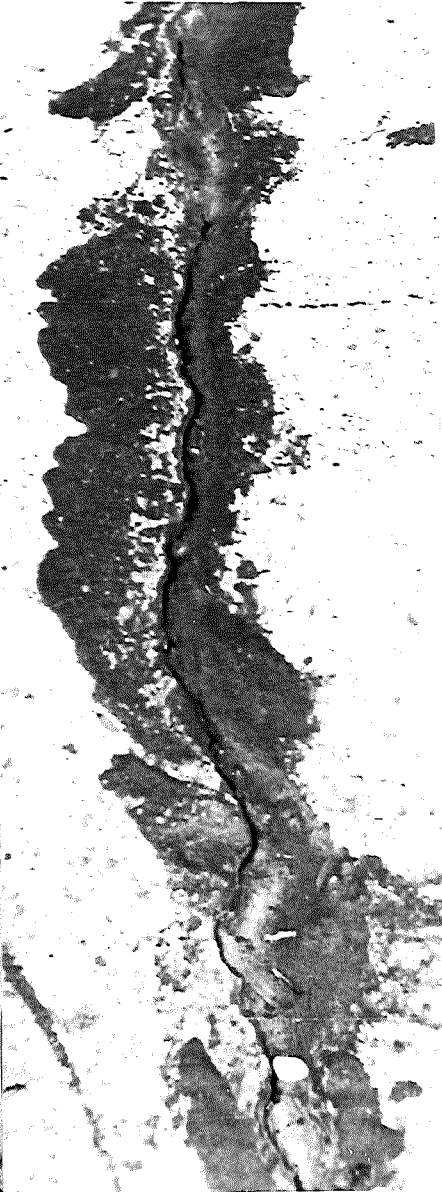
▲ FIGURE 3. STA. 132+45. OPEN CRACK SEALED WITH BRAND A SEALER. SEAL HAS FAILED AND CRACK IS AGAIN OPEN.

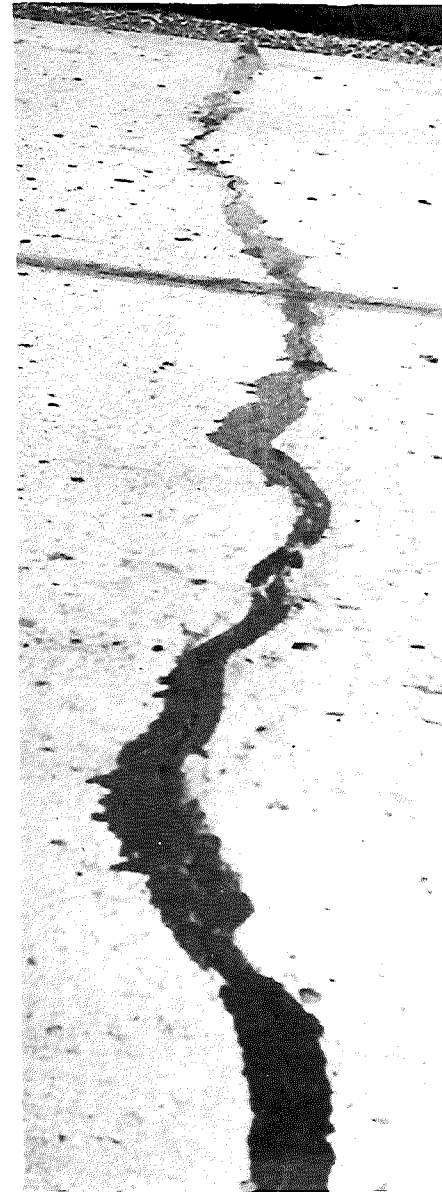
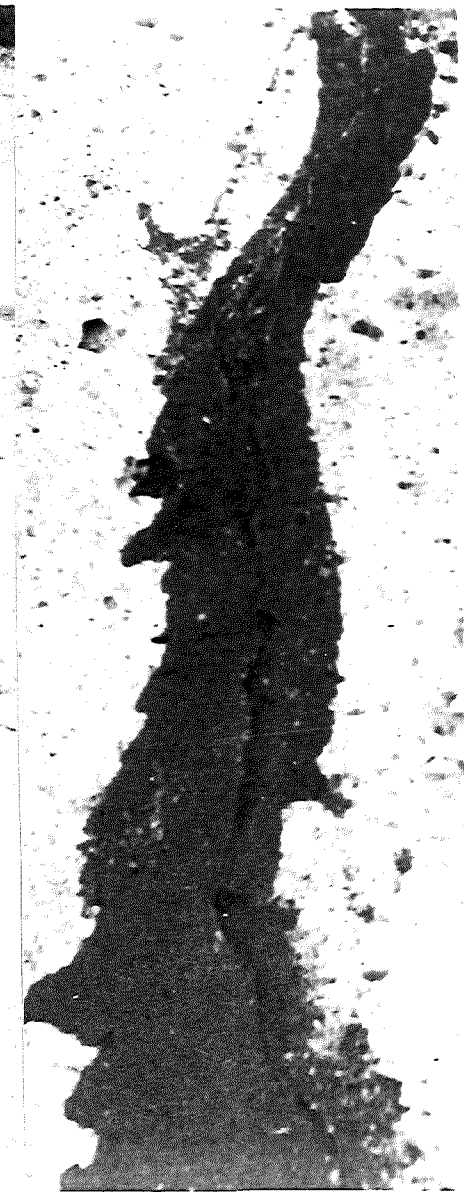
▲ FIGURE 4. STA. 135+35. FINE CRACK SEALED WITH BRAND A SEALER. SEAL INTACT.

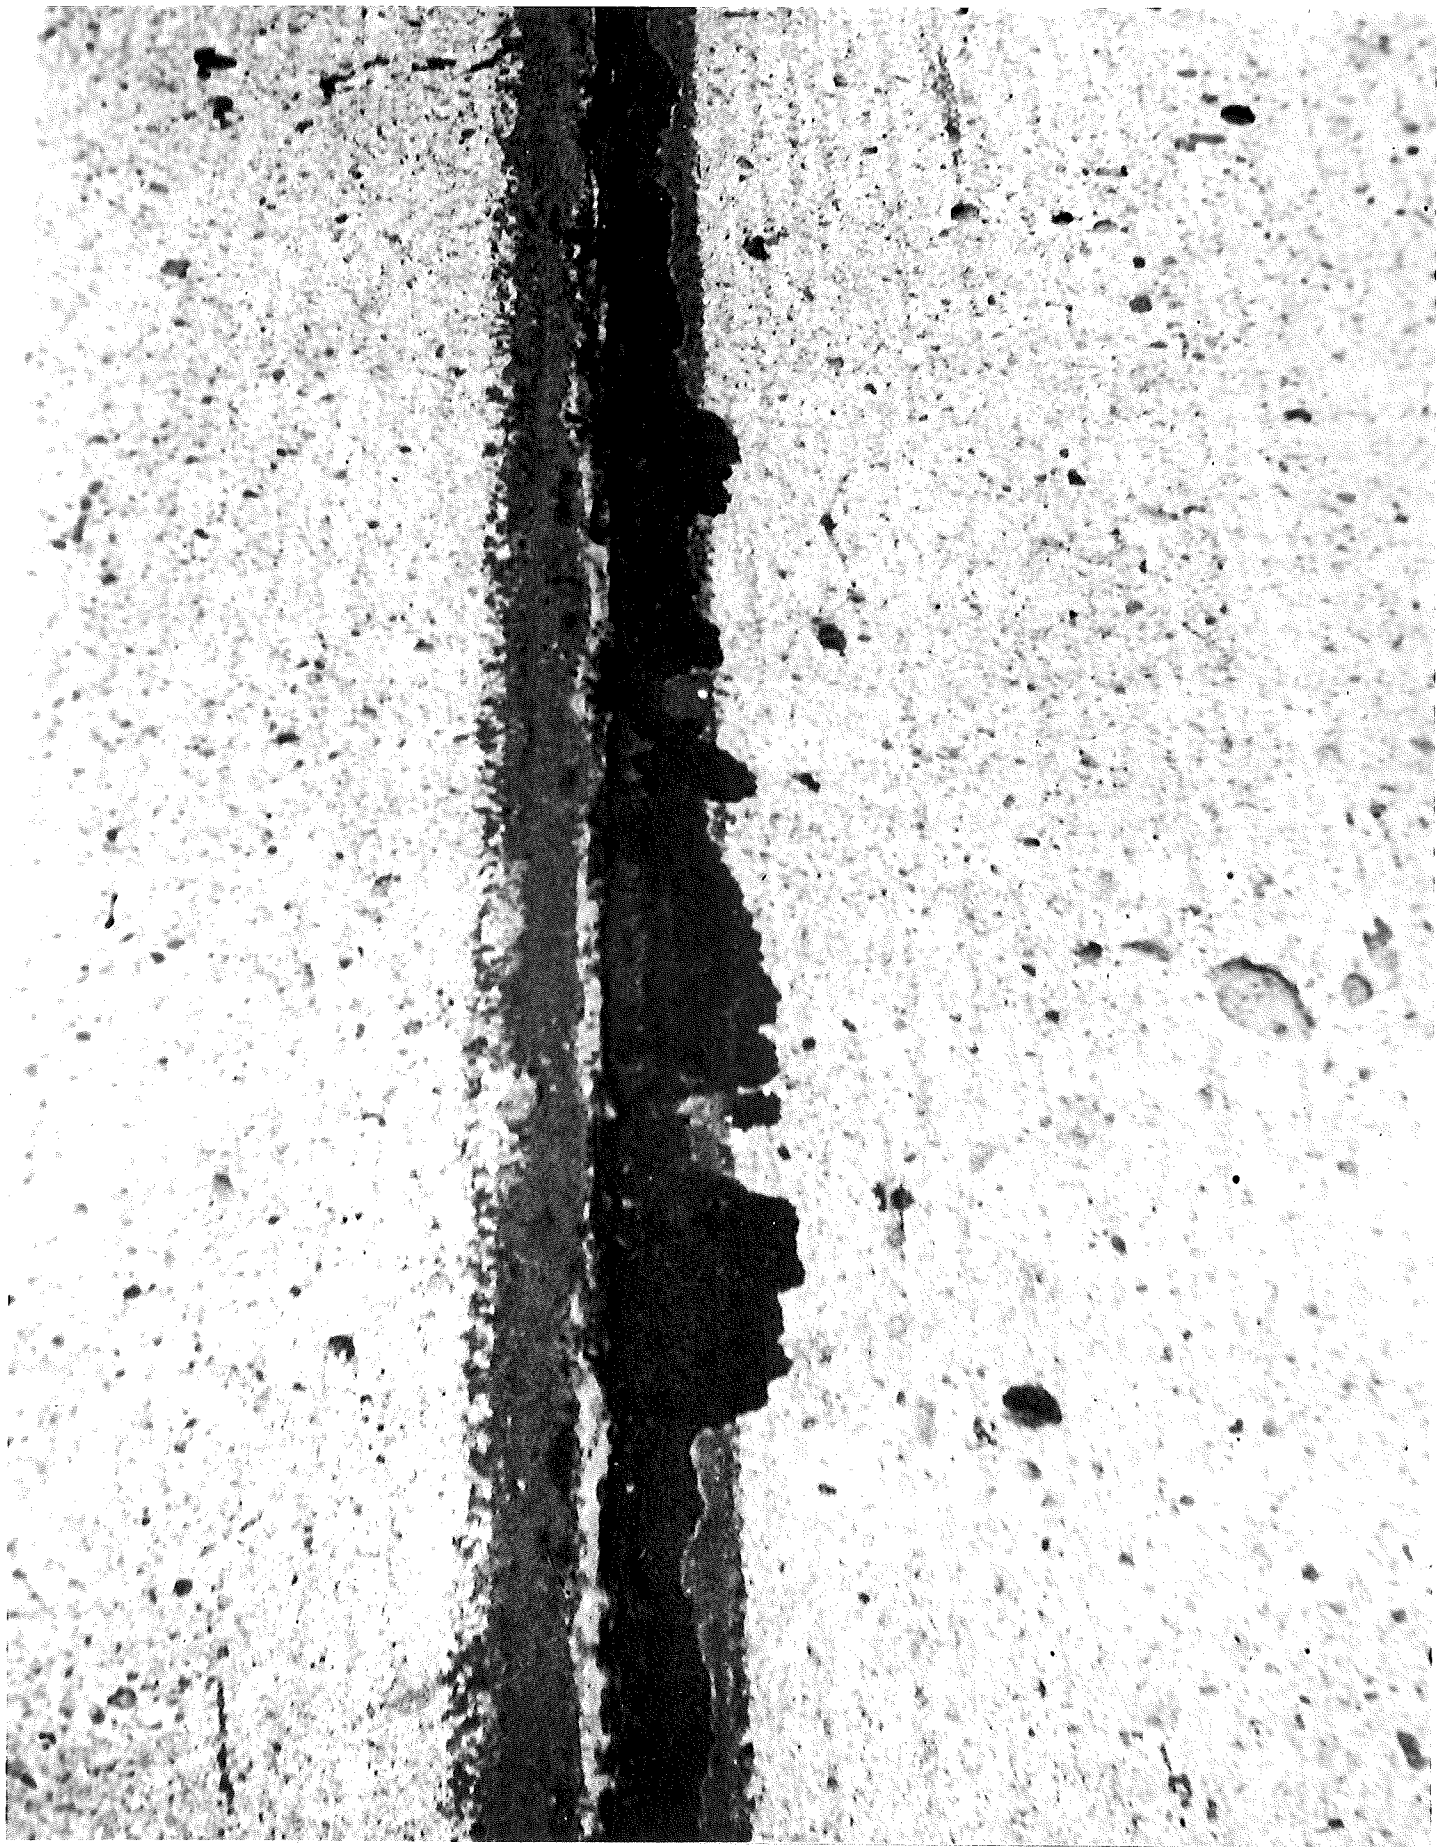
FIGURE 5. STA. 135+00. LONGITUDINAL JOINT RESEALED WITH BRAND A SEALER. SEAL INTACT.

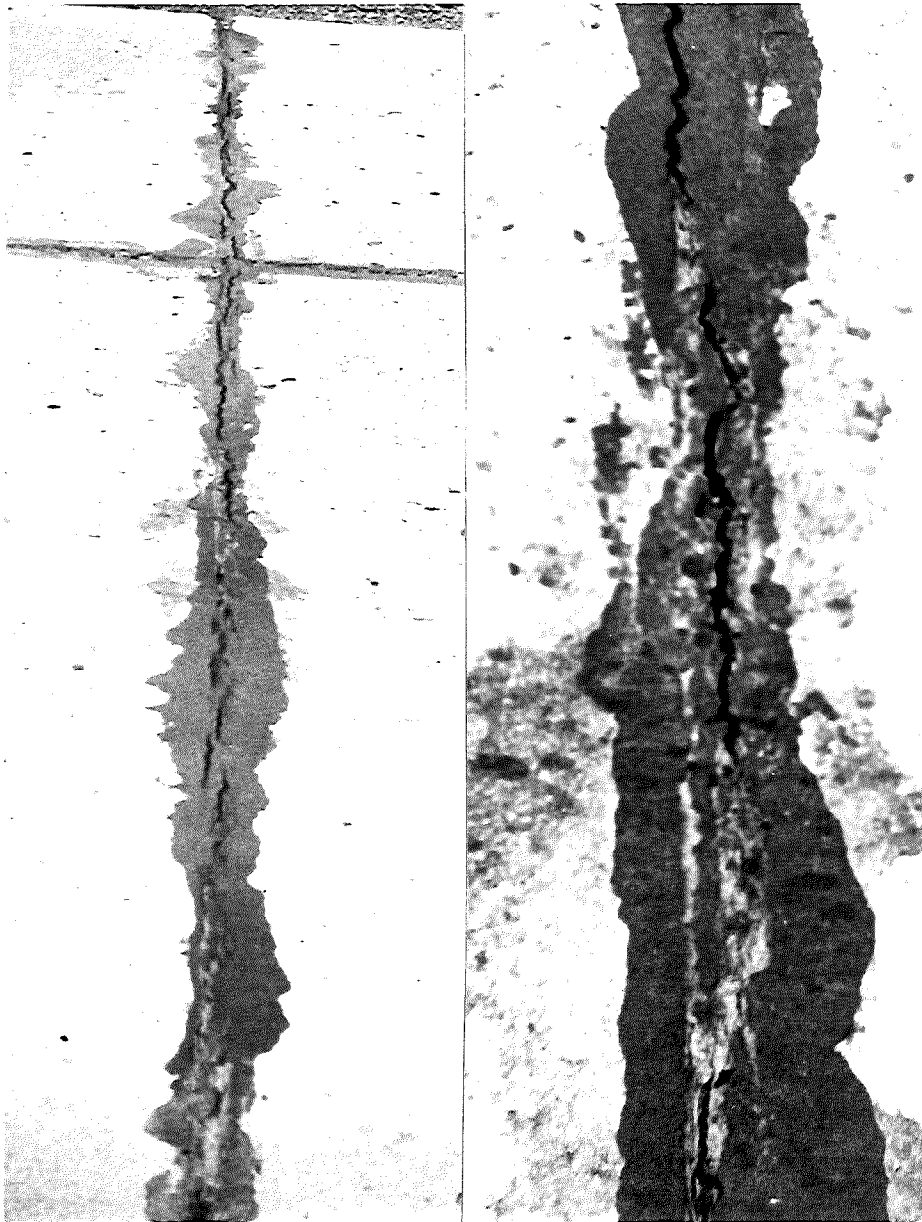
The other materials, which had all failed after six months service, are shown in Figures 6 through 9 as they appeared after 1 year of service.

▲ FIGURE 6. STA. 145+15. EXPANSION JOINT RESEALED WITH BRAND B SEALER SOA ASPHALT. FAILED IN BOTH ADHESION AND COHESION.

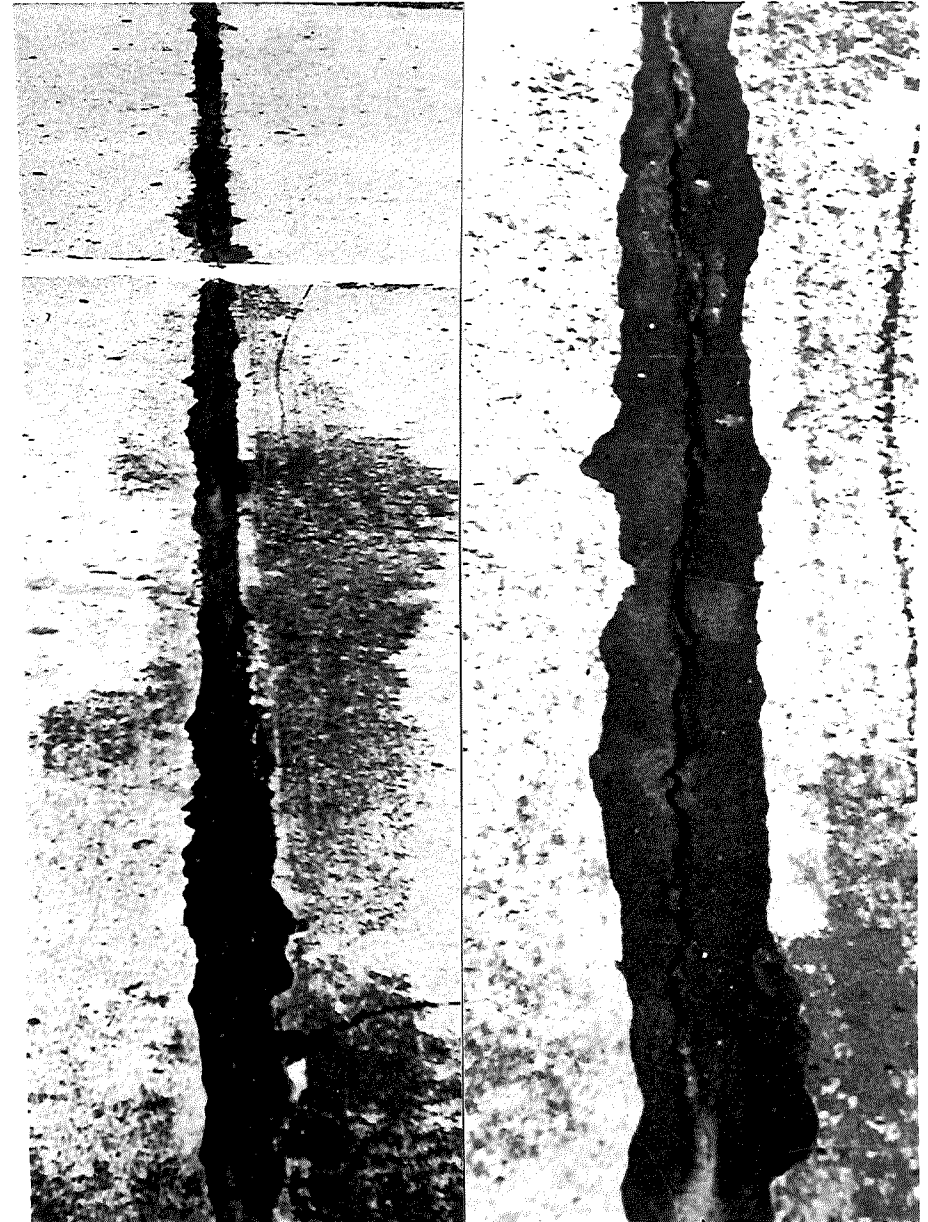
▲ FIGURE 7. STA. 204+60. EXPANSION JOINT RESEALED WITH BRAND C SEALER.

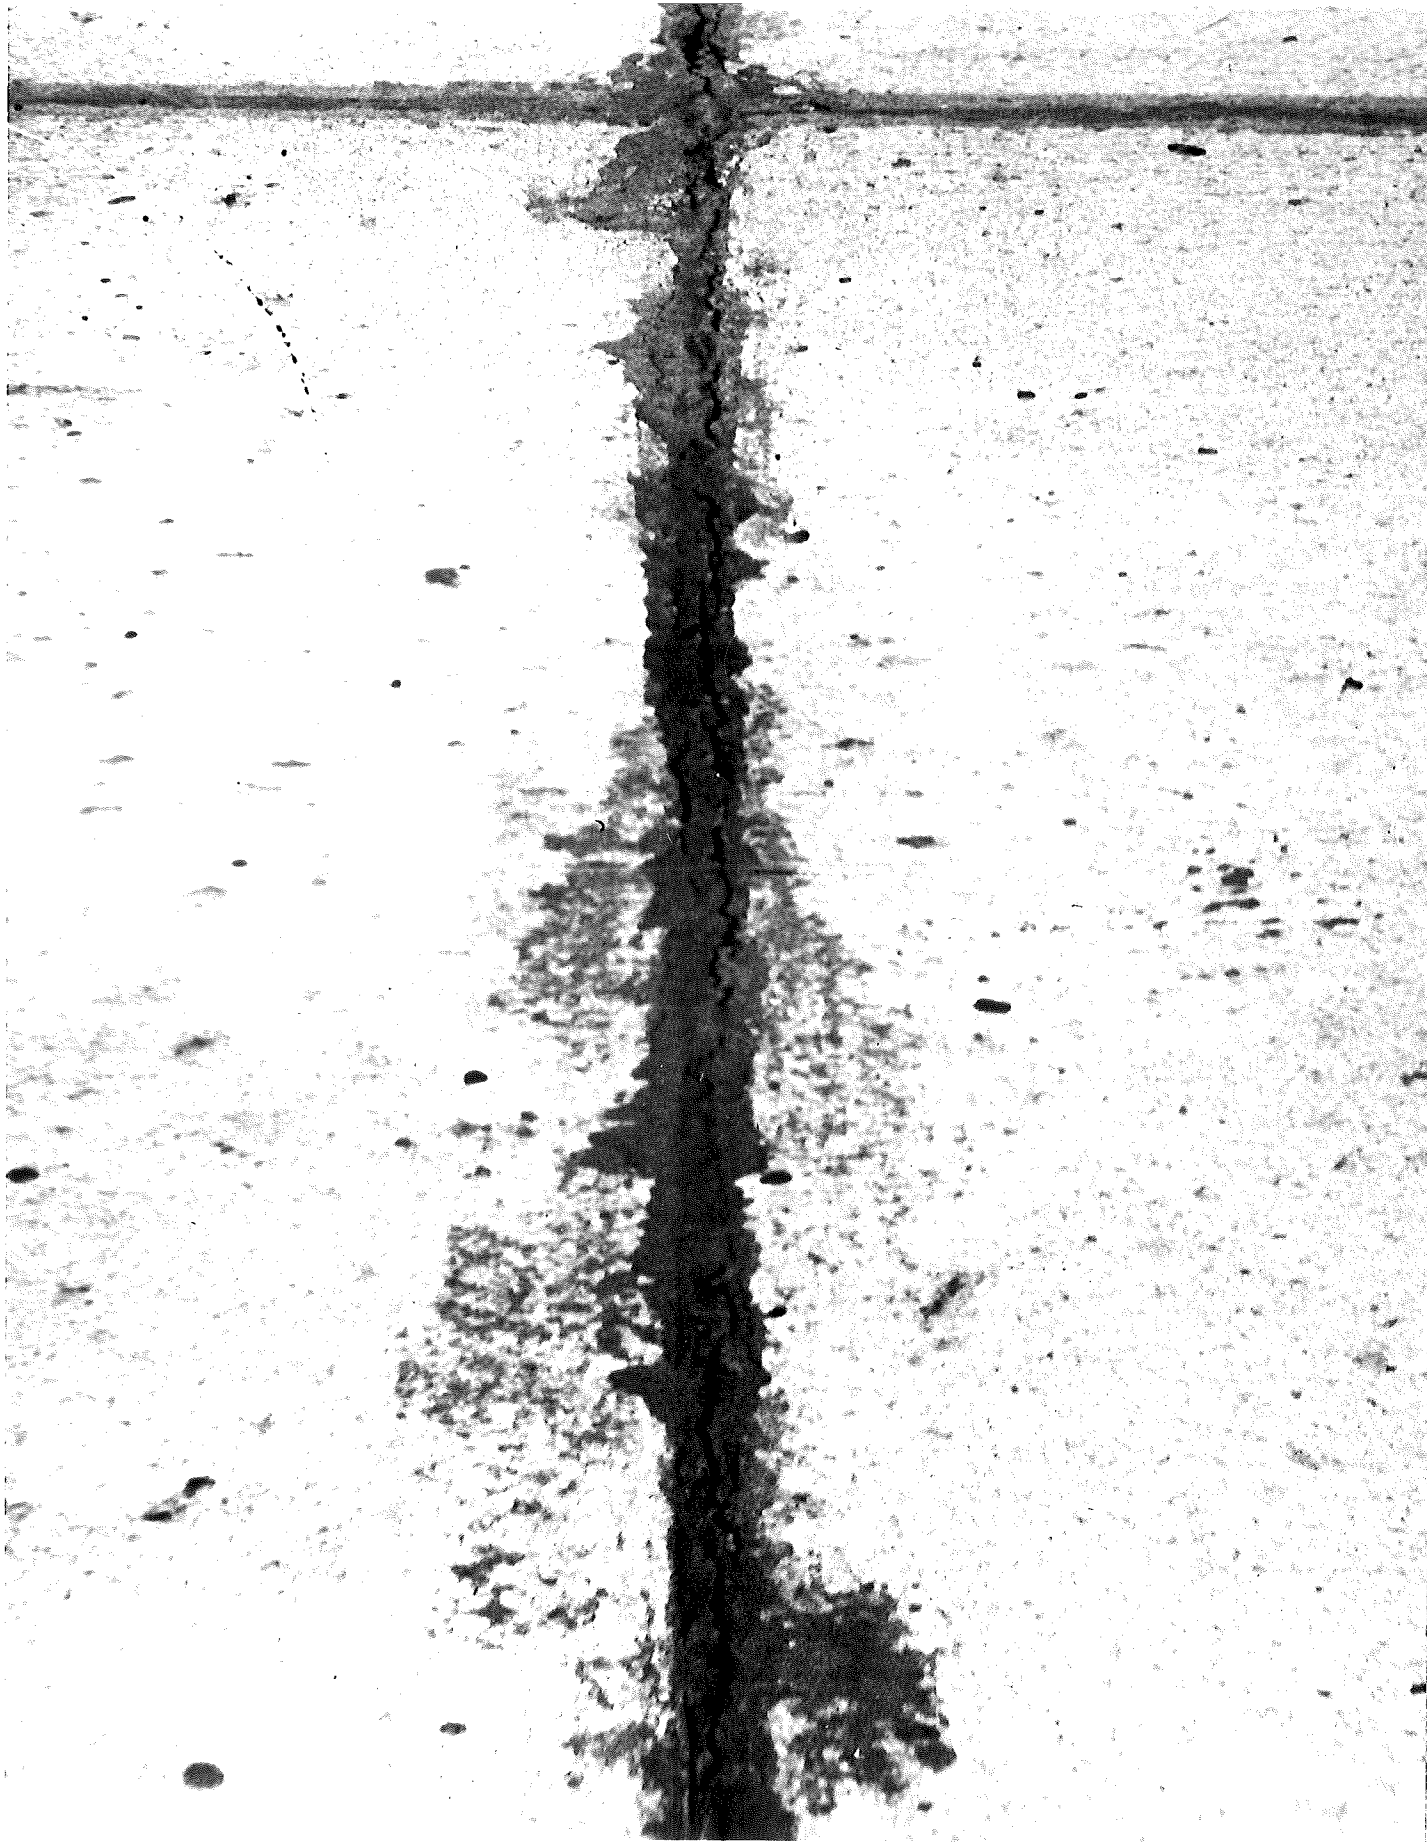
▲ FIGURE 8. STA. 280+32 EXPANSION JOINT RESEALED WITH BRAND D SEALER.

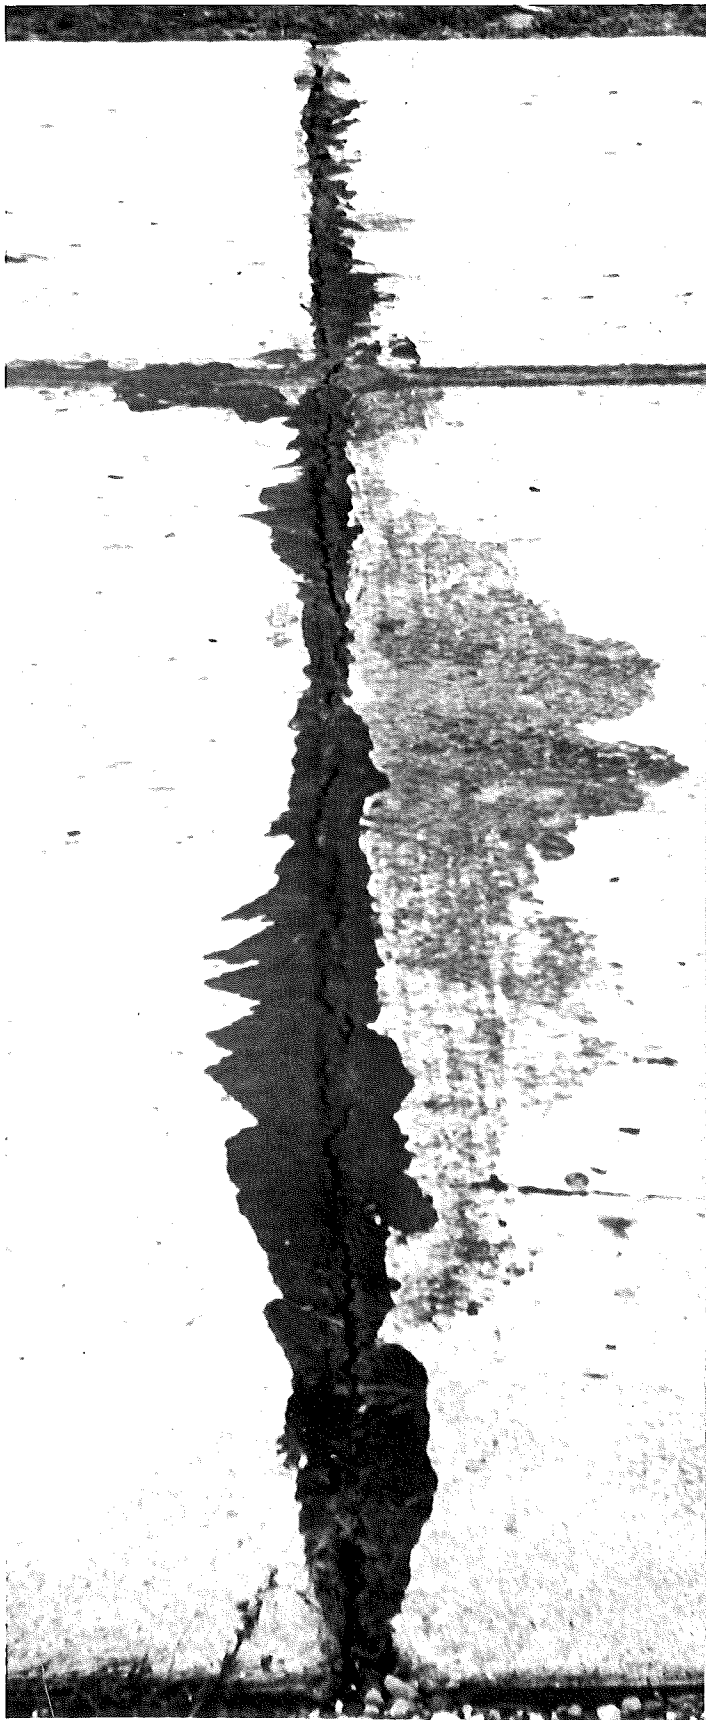
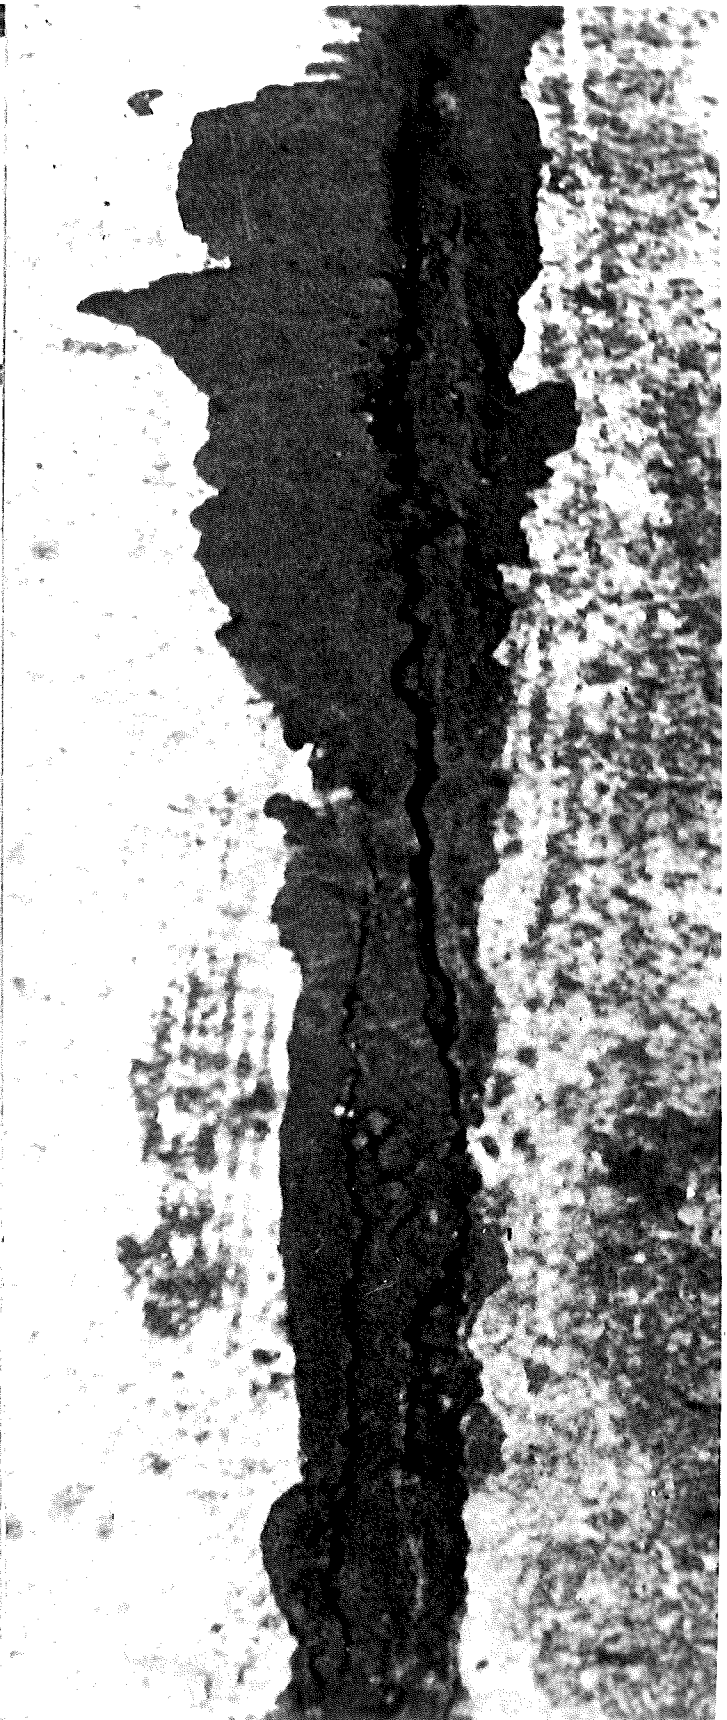
▲ FIGURE 9. STA. 356+00, EXPANSION JOINT RESEALED WITH BRAND E SEALER.
