EVALUATION OF NOISE BARRIERS ON I 275
FOR STRUCTURAL AND VISUAL INTEGRITY
(I 96/I 275 Interchange, Northeast Quadrant and
I 275 From Koppernick Rd to Edw. Hines Dr)

EVALUATION OF NOISE BARRIERS ON I 275
FOR STRUCTURAL AND VISUAL INTEGRITY
(I 96/I 275 Interchange, Northeast Quadrant and
I 275 From Koppnick Rd to Edw. Hines Dr)

Research Laboratory Section
Testing and Research Division
Research Project 82 TI-799
Research Report No. R-1202

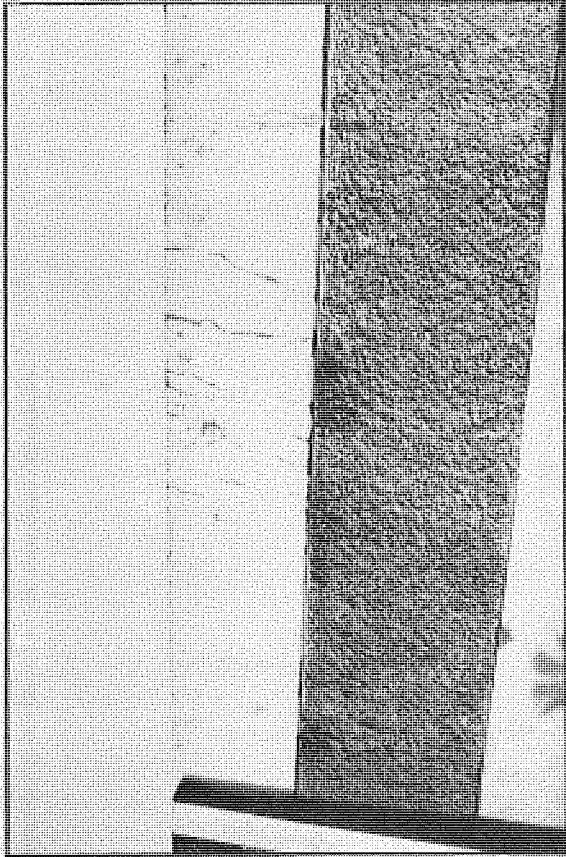
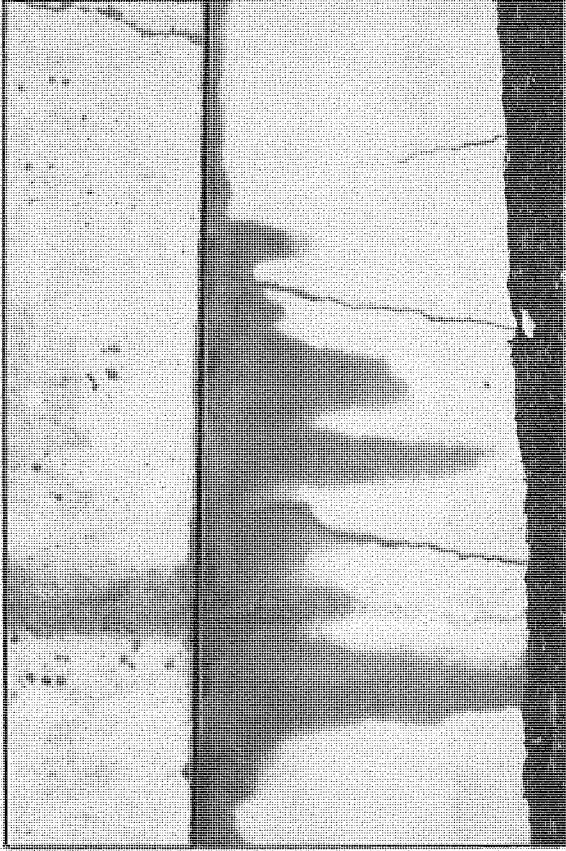
Tables 1 through 8 are summaries of the survey. The cracks in the concrete panels were fine or hairline cracks and were evident only on the smooth side of the panels. A majority of the cracks were found in top panels. Figure 1 shows typical cracking.

Cracks were visible on 7 and 5 percent of all the panels on freeway and property sides, respectively (Table 9). All cracks were being held tightly together by reinforcing steel.

Figure 1. Typical cracks in an upper (left) and bottom (right) panel.

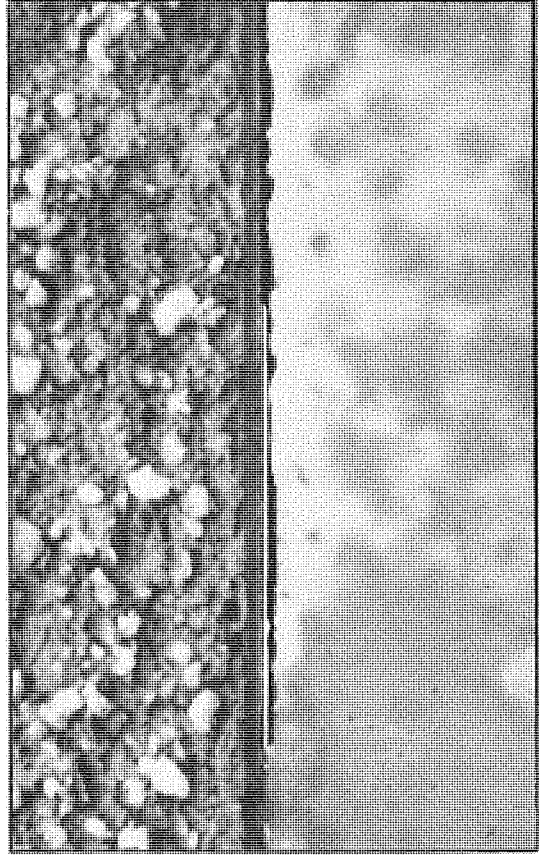
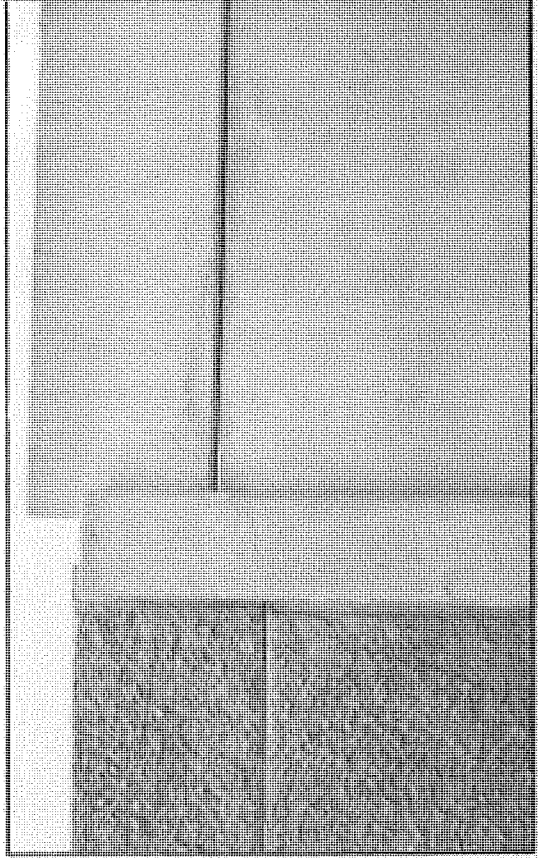
Gaps between the panels appear to be caused by improperly fitted panels or by improperly formed tongues or grooves, or both. Figure 2 shows examples of these gaps. Gaps also were found between panels and posts. Corners of some panels spalled away leaving holes in the wall as shown in Figure 3.

Gaps in the wall were found in 13 percent of the sections. Many of these gaps seriously affect the noise attenuation characteristics of the walls. Gaps as large as 35 sq in. were found in the walls. This is 2 percent of the area of a section that is 10 ft high. If the expected attenuation of the wall section was 17 dbA, 5 ft from the wall, 4 dbA of attenuation would be lost. Some gaps had been filled and were not counted in this evaluation. If gaps larger than 9 sq in. were filled, remaining gaps would not significantly affect noise attenuation.

Figure 2. Typical gaps between panels; at mid-panel (left) and near post (right).

Gaps in the wall larger than 9 sq in. should be filled. Holes larger than 9 sq in. in the wall reduce the wall's noise attenuation a measurable amount.

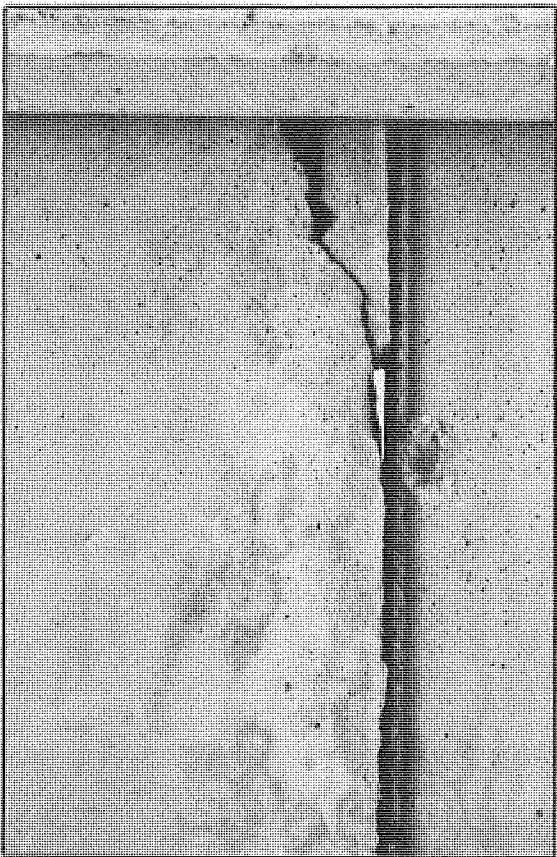
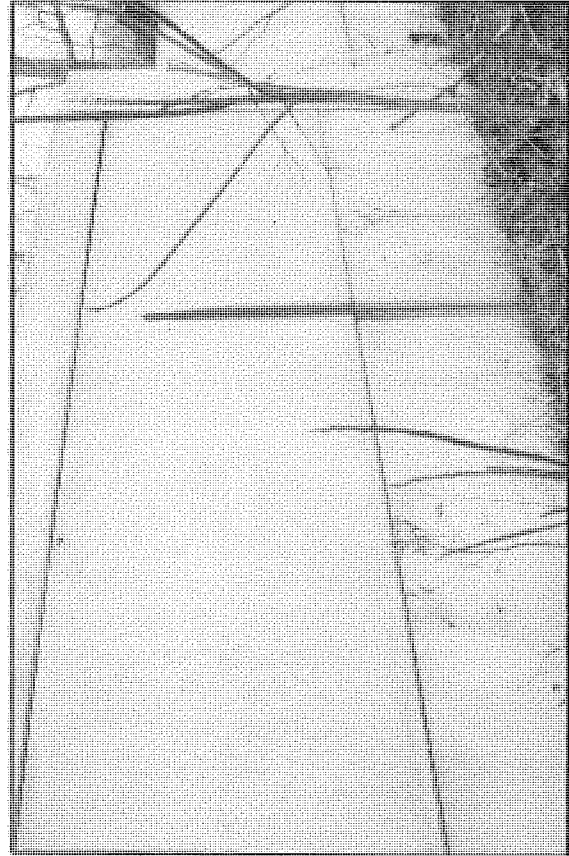
Nearly all of the rust stains were caused by iron-bearing materials used as aggregate in the concrete. The technicians found only three locations where the reinforcement was the probable cause of rust stains. Figure 4 shows rust stains caused by iron-bearing materials.

Rust stains affect the appearance of the wall. There were rust stains on 17 percent of the panels on both freeway and property sides, and 4 and 5 percent of the posts on freeway and property sides, respectively. Of these rust stains, only three were caused by reinforcing rods. The rest of the stains were caused by iron-bearing materials used as aggregate in the concrete.

Figure 4. Typical rust staining from iron-bearing aggregate on the rough (left) and smooth surfaces.

In future noise barrier walls, formed out of concrete, specifications should be revised to reduce the amount of iron-bearing materials permitted in the aggregate.

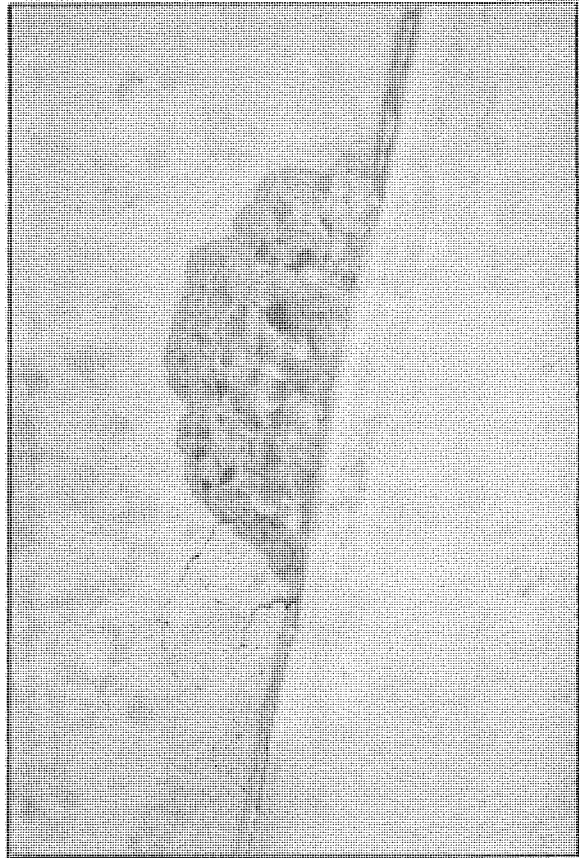
Surface spalls were found mostly on smooth panels along the edge of seams (Fig. 6).

Surface and corner spalls could have been caused by rough handling of the panels and posts during manufacture, transportation, and construction. Surface spalls were found on 3 and 2 percent of the panels on the freeway and property sides, respectively. Posts exhibited less than 1 percent spalling on the property side. No surface spalls were found on posts on the freeway side. Corner spalls were not counted but were included as gaps when a piece had broken away from the main panel.

Figure 6. Surface spall (about 6 in. long).

The walls should be periodically inspected for spalling. If spalls occur, they should be patched.

Surface and corner spalls can be minimized by better concrete forming methods, more care in transporting and handling, and closer inspection of the finished wall.

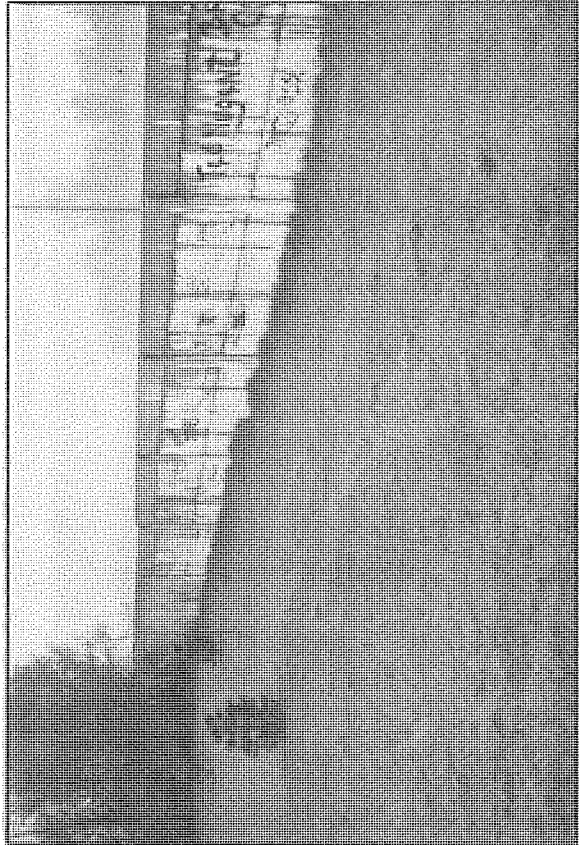
Notes on graffiti are given in Tables 1 through 8. Several areas with graffiti had already been covered with cement colored paint and were not included in the survey. There were very few cases where graffiti was found on the rough side of the panels. In these areas, large amounts of paint were simply splashed on the wall. Figure 5 shows examples of graffiti (the most vulgar examples not shown).

Graffiti was found on 3 and 5 percent of the panels on the freeway and the property sides, respectively. Posts were defaced on 1 and 2 percent of their number on the freeway and property sides, respectively. Three wall locations had 1 percent or fewer panels with graffiti. Those locations were Koppernick Rd to Joy Rd, west wall, and Joy Rd to Ann Arbor Rd, both west and east walls. The Ann Arbor Trail to Edw. Hines Dr, west wall had no graffiti on the freeway side but had seven panels with graffiti on the property side. Only one of these panels was near a residence. The Ann Arbor Trail to Edw. Hines Dr, east wall was a situation similar to that of

Figure 5. Typical graffiti on wall.

Graffiti on walls is a continuing problem, especially where the wall surface isn't close to a residential area. Noise barrier walls in the future should have rough surfaces. A rough surface seems to discourage vandals from painting graffiti on walls. The walls on I 275 presently have several areas of graffiti needing cover.

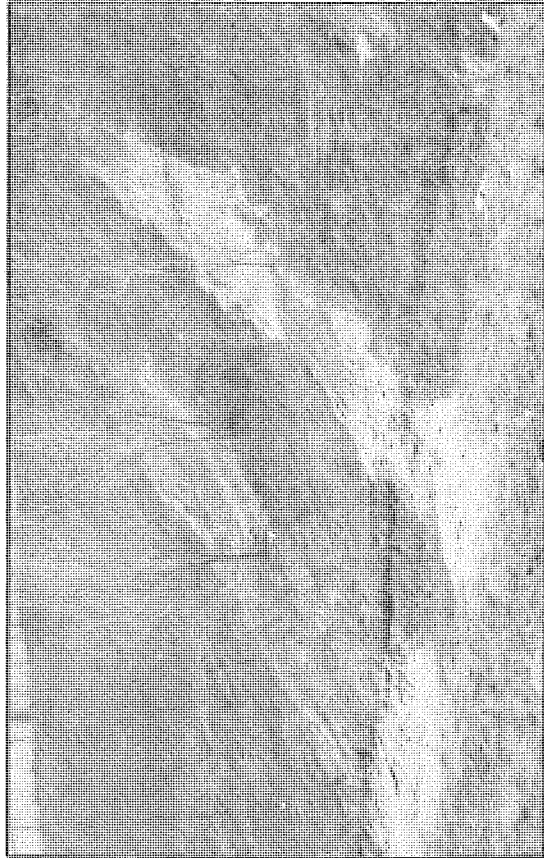
Notes on erosion or settlement are included in Tables 1 through 8. Erosion under the wall and under a paved bicycle path (Fig. 7) has occurred in the east wall area between Ann Arbor Rd and Ann Arbor Trail. In this case, the bottom panel shows hairline cracking. Severe erosion found under the west wall between Ann Arbor Trail and Edw. Hines Dr is shown in Figure 8. The photographs, taken on the freeway side at the end of Gilbert St, show that the erosion has formed a tunnel several feet beneath the bottom of the wall. In this area, a resident has built his drive up to the wall as shown in Figure 9. A drain is needed to collect the water from the drive and yard area and transport it to the freeway ditch below. Figure 10 shows animal burrows under the wall.

Figure 8. Erosion near end of Gilbert St.

Two locations mentioned on page 2 should have foundation improvements and repairs made in the near future. Other erosion or holes caused by animals are not currently reducing the effectiveness of the wall's noise attenuation or reducing the visual integrity of the wall.

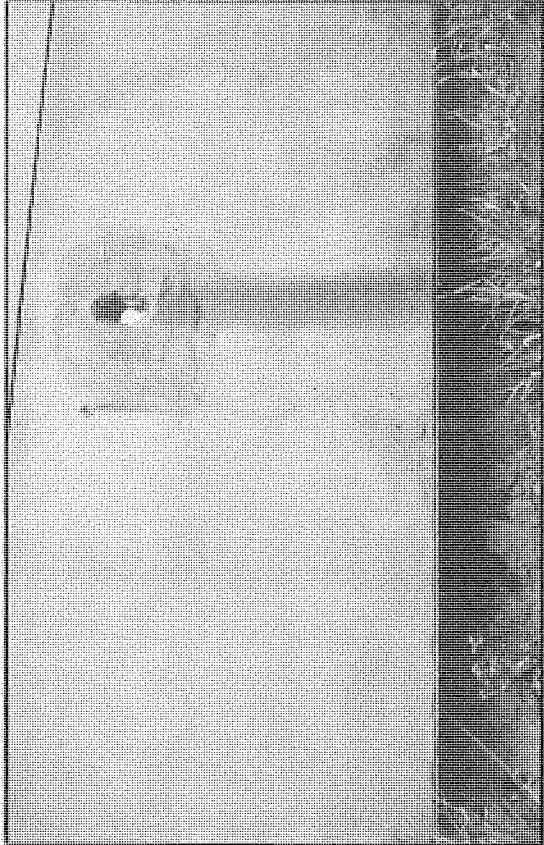
Figure 7. Erosion under wall (hole in wall is for bicycle path drainage).

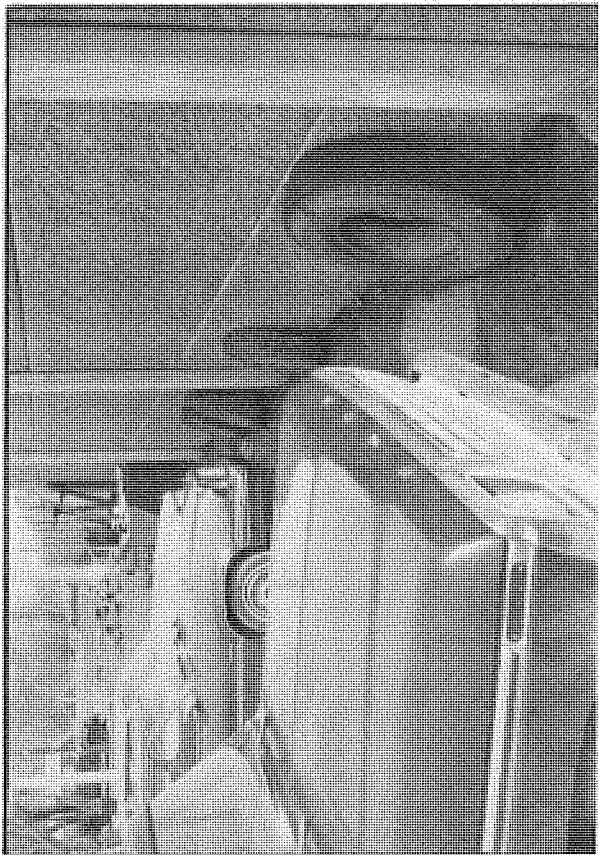
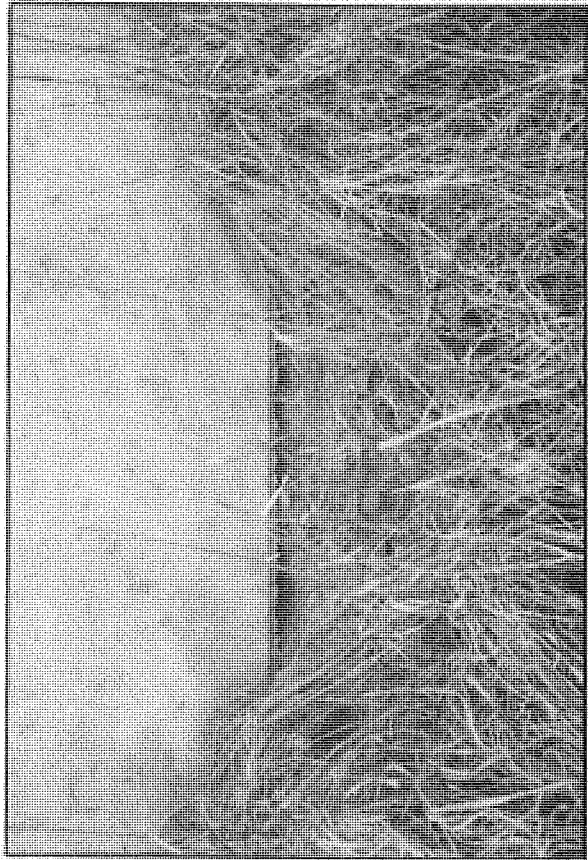
Locations of soil erosion were found at 2 and 1 percent of the bottom panels on the freeway and property sides, respectively. Most of the erosion was caused by animals (probably woodchucks) digging under the wall.

Figure 10. Woodchuck hole (left) and another animal excavation.

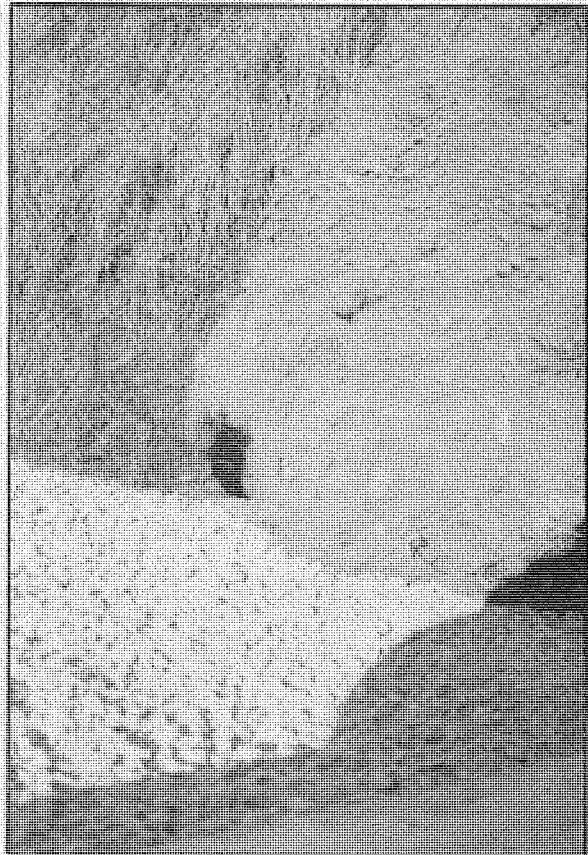
Figure 9. South drive at end of Gilbert St.

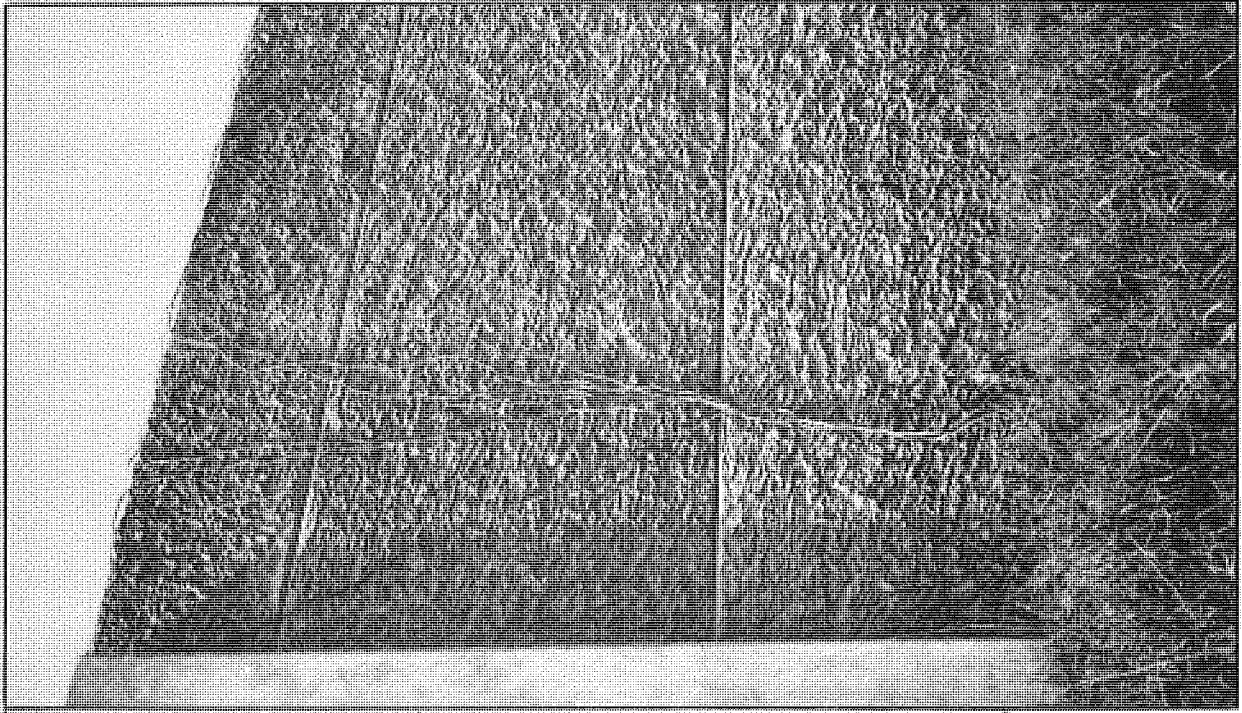
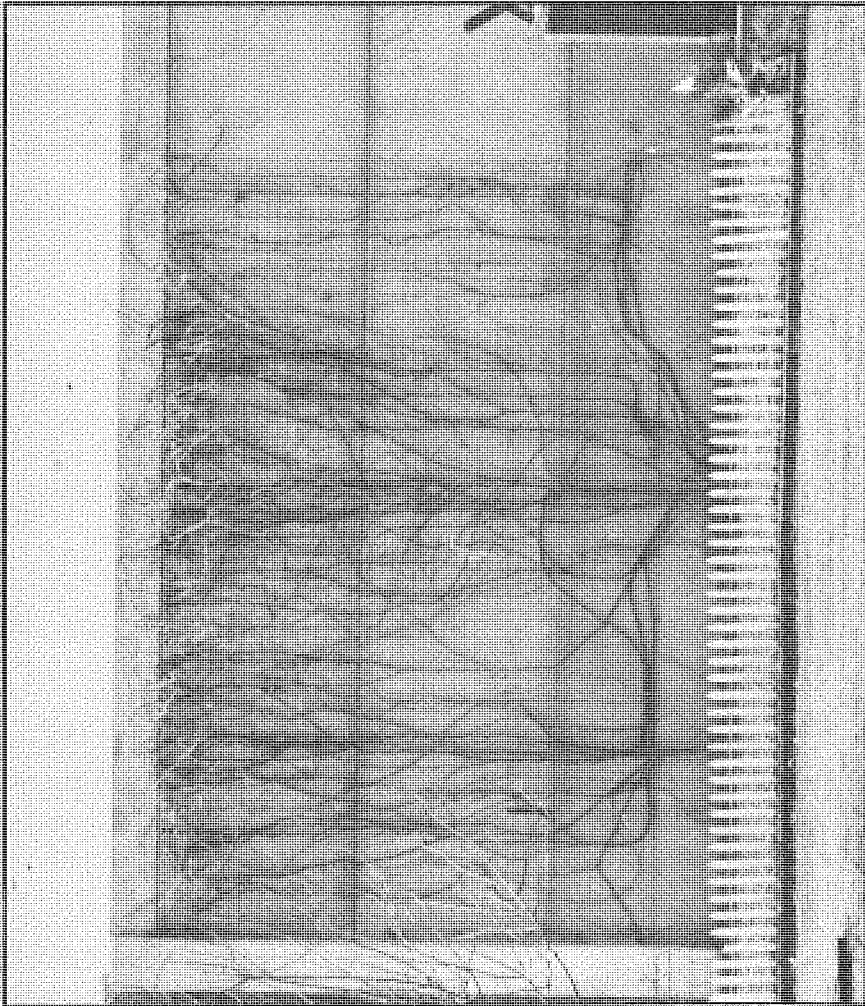
Notes concerning frequency of vine growth are listed in Tables 1 through 8. Figure 11 shows examples of vines growing on the walls. Vines, when well established, seem to have the earliest and greatest impact in softening the barriers and blending them into the surrounding landscape. Plantings other than vines do provide some softening effect but their impact will not be fully realized until they begin to mature over a period of years.

Vines are growing on 5 and 12 percent of the sections on the freeway and the property sides, respectively. As would be expected, vines that were planted on the property side and cared for by residents are much larger than the other vines.

Figure 11. Vine planted and tended by resident (above) and vine located on freeway side.

Greater effort should be made to establish vines on both sides of this type of barrier on future projects. The time it takes for plants to be effective in reducing the visual impact of the noise barrier, makes it important that landscaping be done immediately after barrier construction. Ideally, landscaping should be a part of the noise barrier contract.
