OFFICE MEMORANDUM

STATE HIGHWAY DEPARTMENT

Subject: Joint Failures on Eastbound I 94 Parma to Jackson (Construction Project 38-48, C9). Research Project 39 F-7(14). Research Report No. R-536.

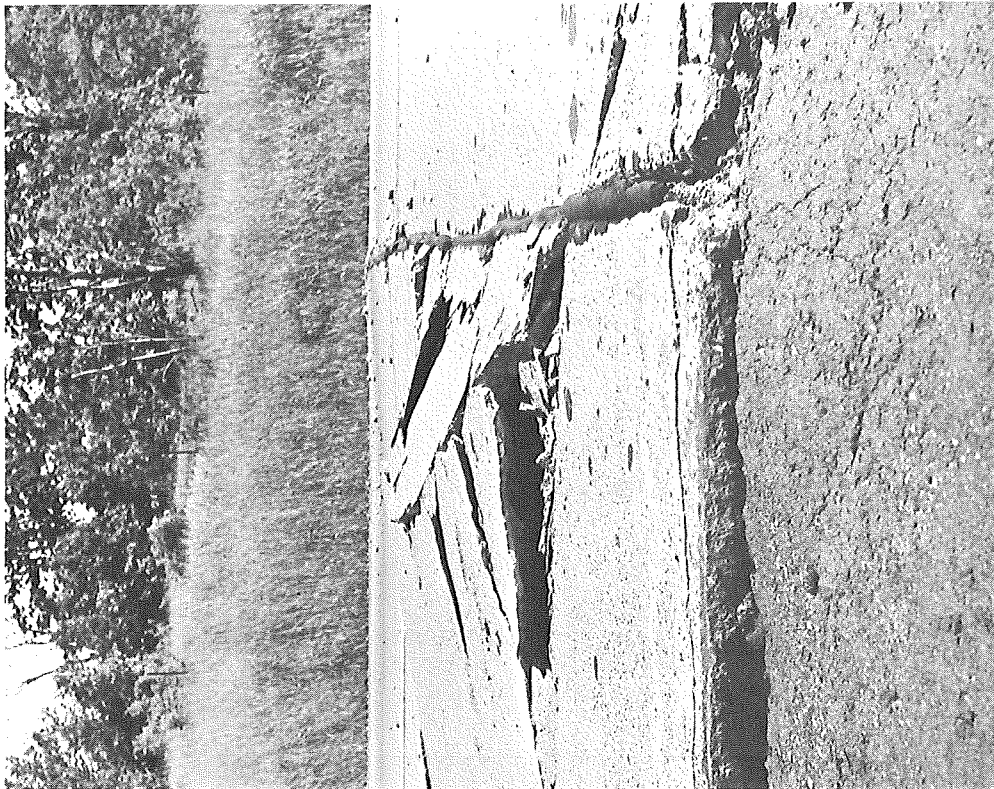
Sta. 316+40 EB

A total of three joint failures were inspected at Stas. 316+40 and 327+03 just west of Parma, and at Sta. 606+75 west of the off-ramp to the rest area. The failure at Sta. 316+40 involved both lanes and had occurred at 3 p.m. on the day of the inspection. The failures at the other two locations had occurred the day before and were confined to the passing lane. At these latter two locations, the traffic lane also had failed the previous year and had been repaired with bituminous material.

A common characteristic of the blow-ups is the shear and tensile failure of the concrete as a result of buckling of the slab at the reduced section below the bottom of the joint groove and above the top of the dowel bar. The failure plane originates at about the level of the dowel and extends from 1 to 8 ft back from the joint. Fig. 1 shows the failure condition at Sta. 316+40, and illustrates the limits of the failure plane at Sta. 327+03.

Figure 1. Appearance of one joint immediate after blowup (left), and limits of horizontal failure plane during repair at another (right).

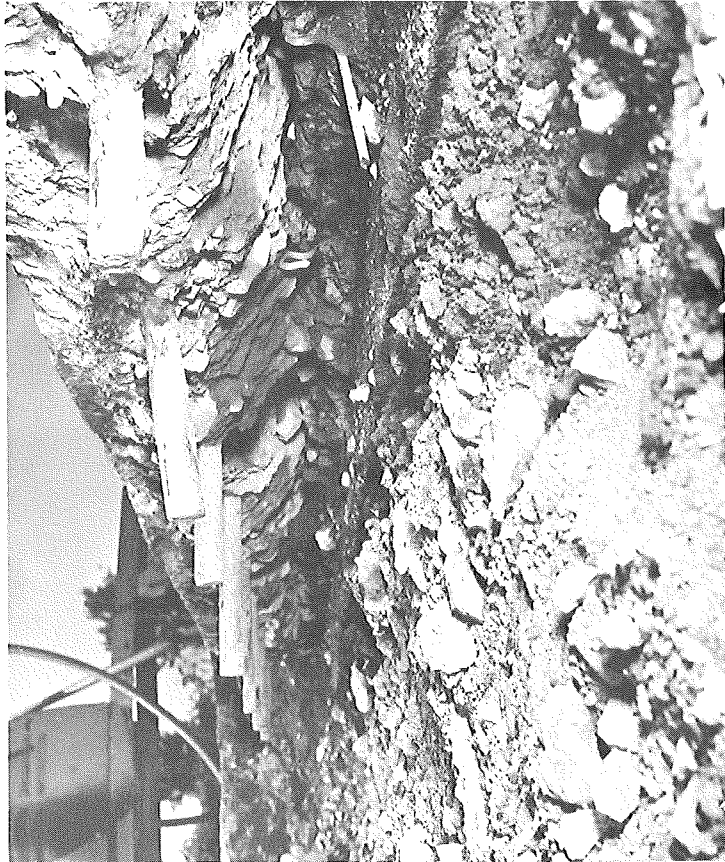
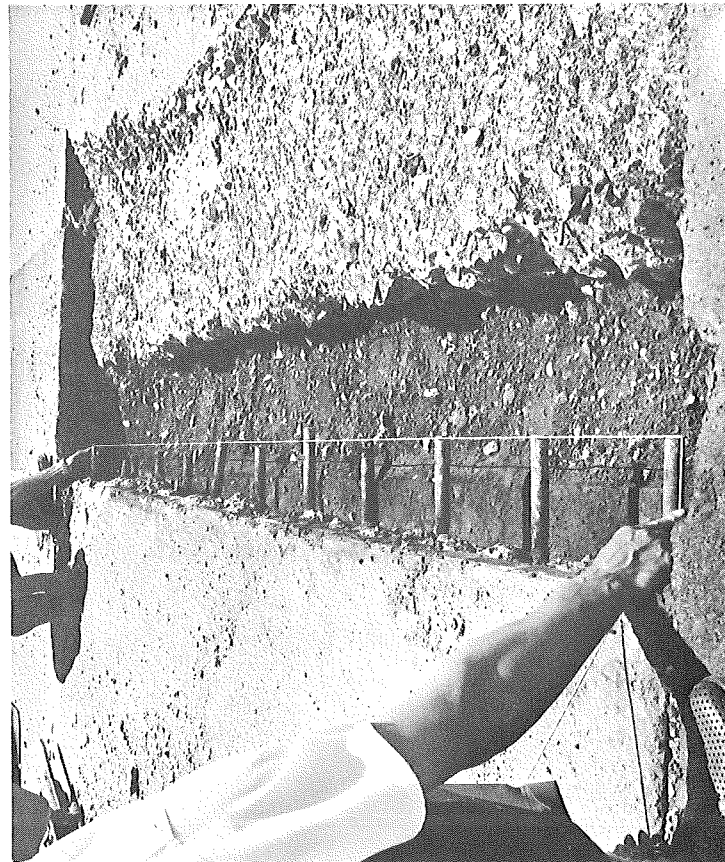
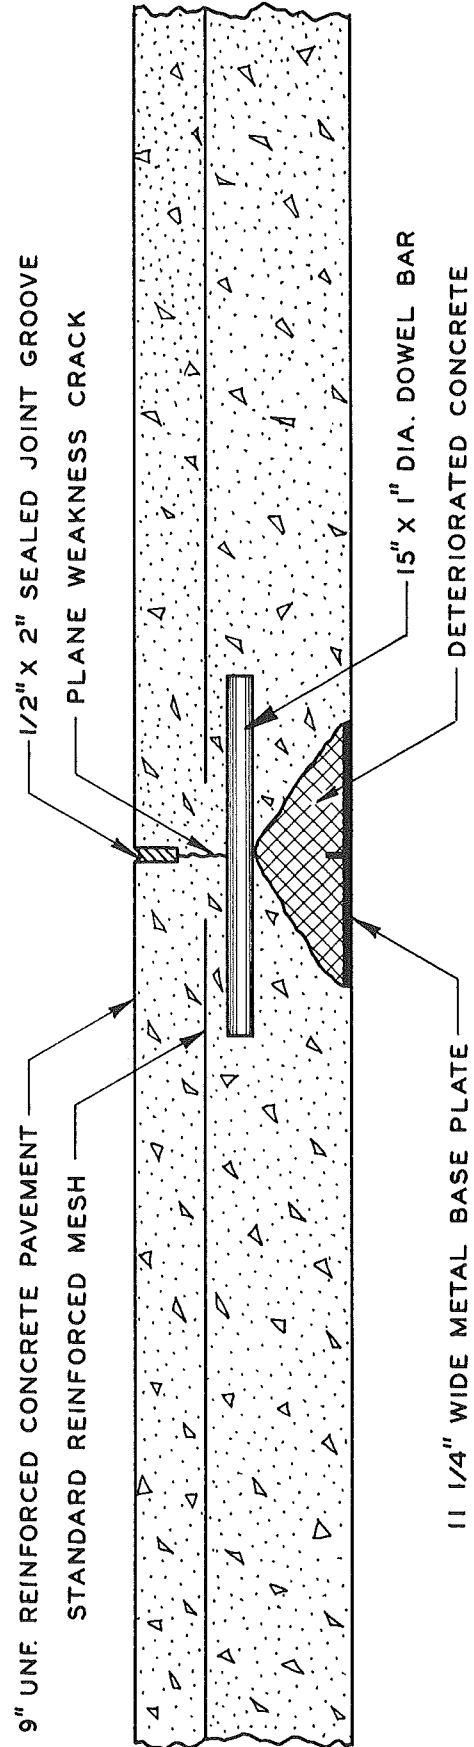
Observation of the repair at Sta. 327+03 revealed that the dowel bars were out of alignment both laterally and vertically, and that the joint groove was not constructed symmetrically over the base plate parting strip (Fig. 2). The

concrete below the dowel bars was moisture-saturated and completely deteriorated. The area of deterioration is shown photographically and schematically in Fig. 2. The repair crew stated that this condition had been observed for several previously repaired joint failures. This was also probably the case at Stas. 316+40 and 605+75.

Figure 2. At Sta. 327+03 EB, dowel and joint groove misalignment observed during repair (upper left), concrete deterioration found below dowel bars (upper right), and schematic cross-section of deterioration (below).

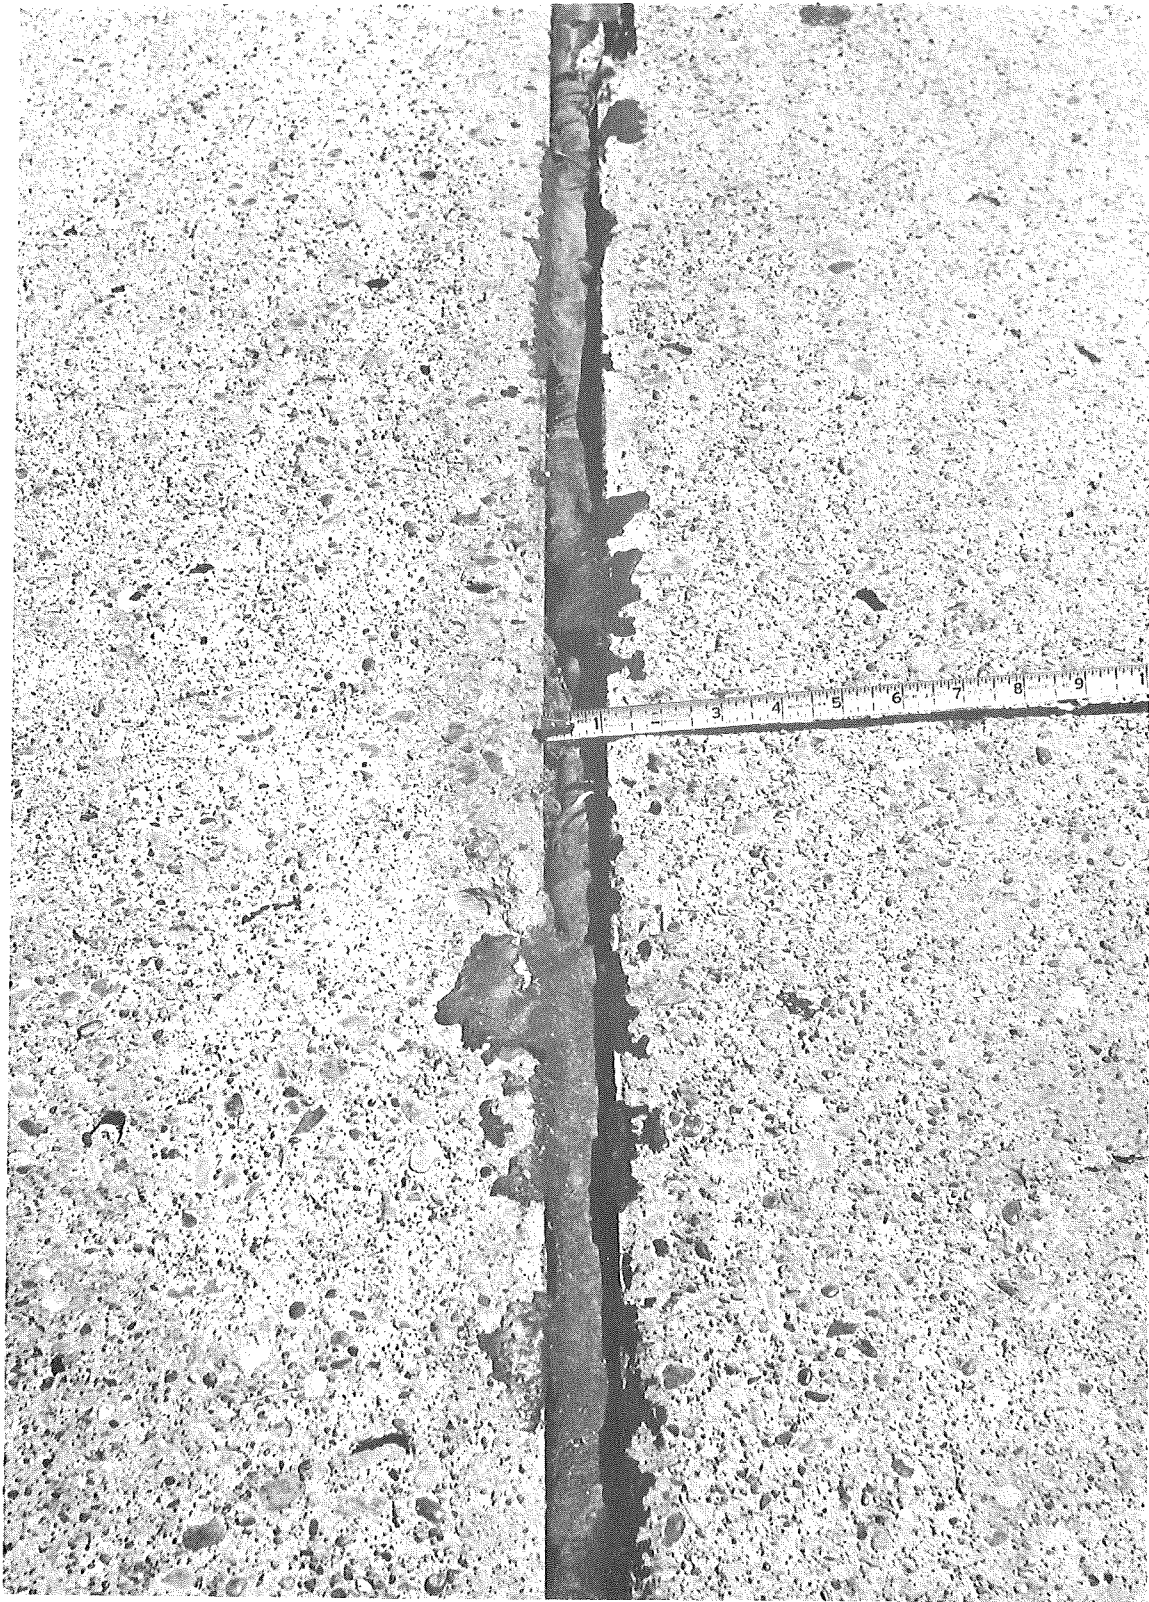
A general inspection of pavement in the vicinity of these three failures showed that joint widths ranged from 3/4 up to 1 in. , although the air temperature was above 80 F. A typical joint groove is illustrated in Fig. 3. As can be seen, the seal is ineffective in sealing against moisture and dirt infiltration. During winter ice and snow removal, joint seals in this condition offer little resistance to seepage of chloride solution into the joint. A count of repaired joint failures on the western 3.5 miles of the project revealed that 9.5 percent of the joints had been completely repaired in at least one lane and 2.5 percent extensively patched.

Figure 3. Typical joint width and sealant condition.
