Asset Management for Retaining Walls

Final report

Michigan Department of Transportation
ORBP Number OR15-114

March 2020

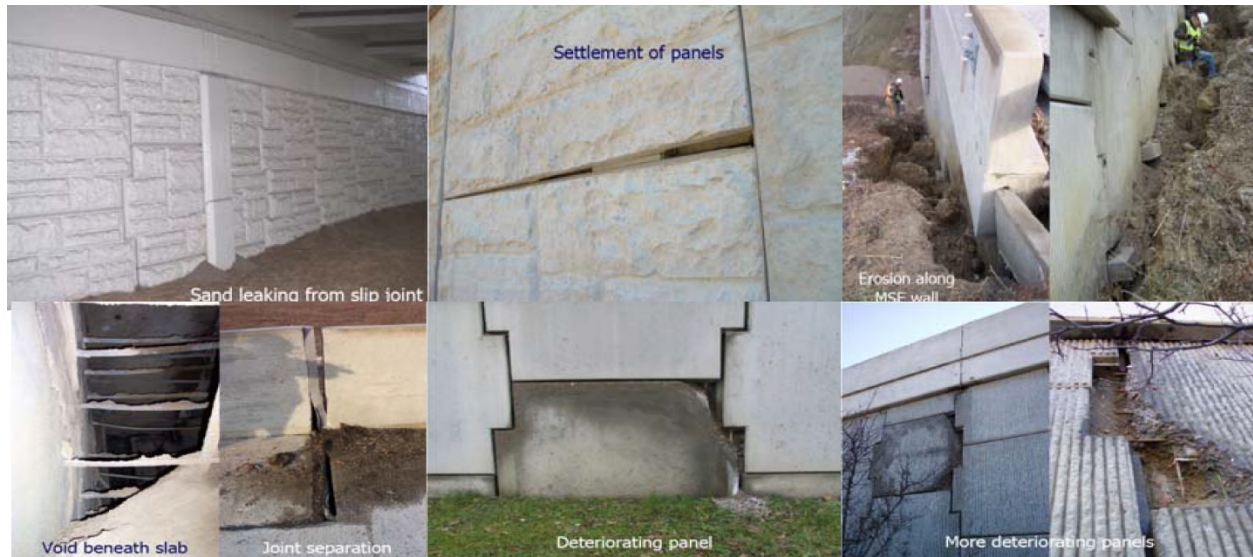
Figure 1.9. Observed problems in MSE walls (Narsavage 2006)

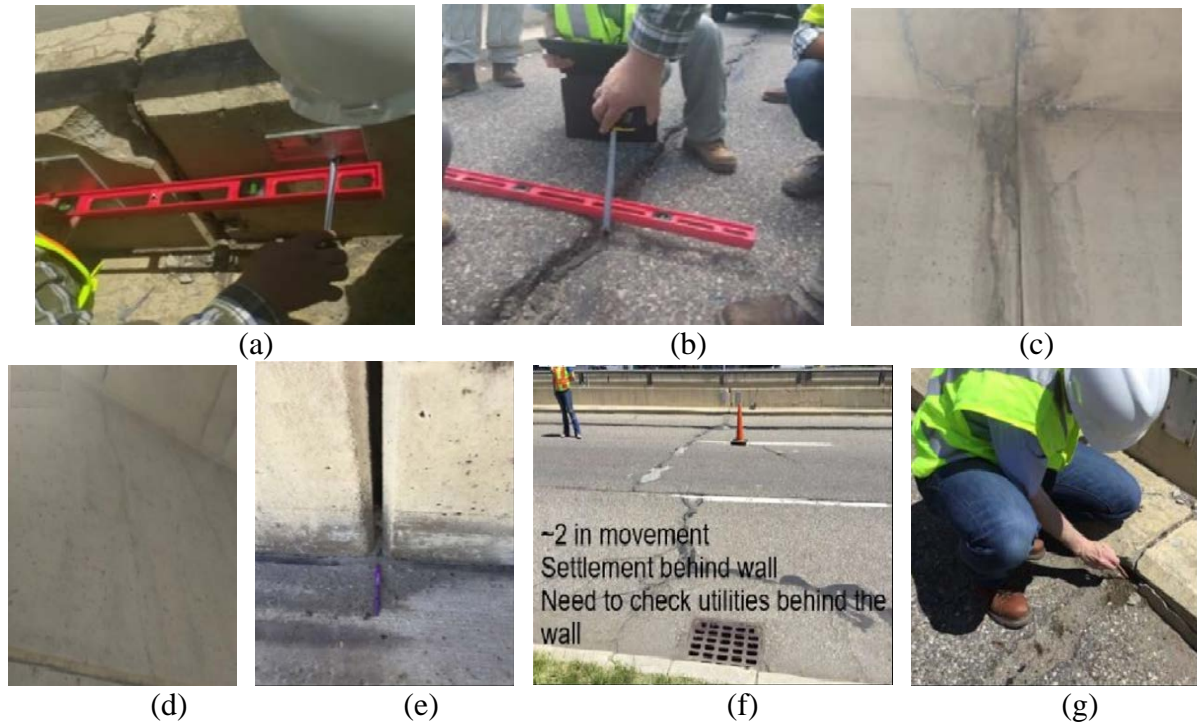
Figure 2.2. M-10 retaining wall system distress (June 2017): (a) wall tilting observed at the wall top; (b) severe lateral cracking of the service road pavement; (c) leakage stains on the wall face at the top of the wall; (d) vertical cracking of the wall face; (e) joint movement between wall panels; (f) distress of storm water pipe behind the wall; and (g) backfill soil evident at the wall joints.

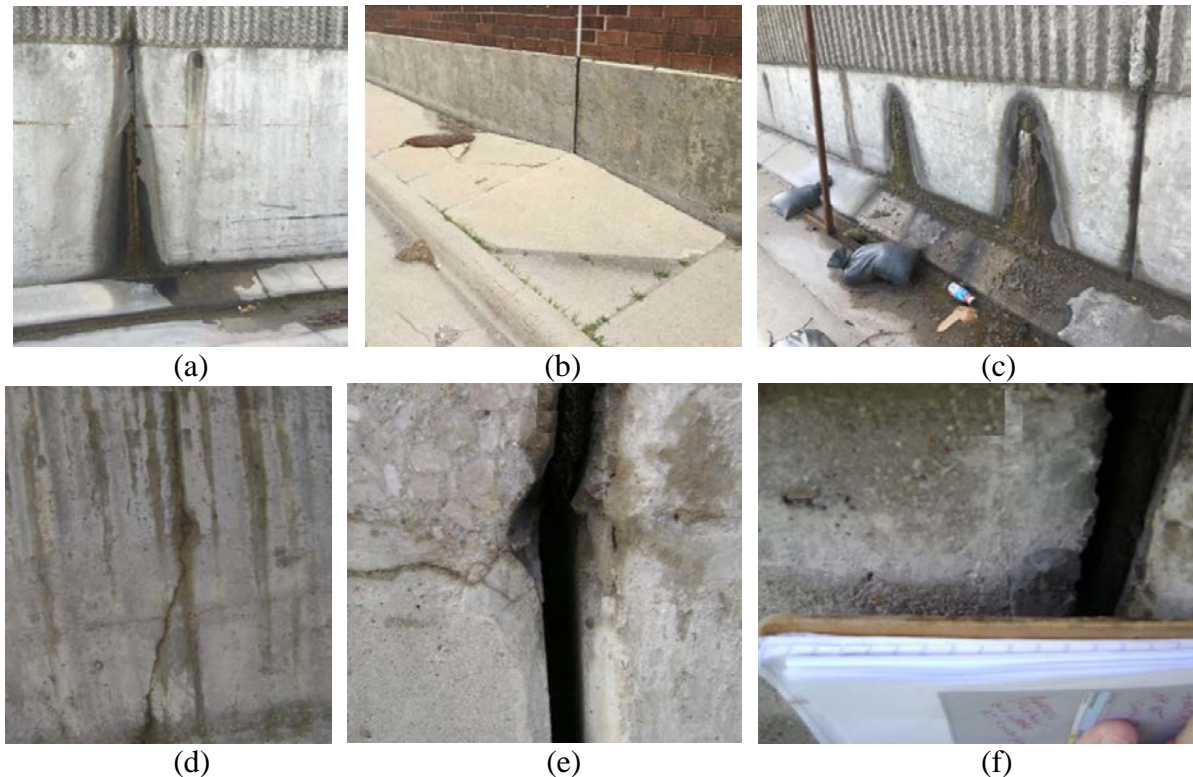
Figure 2.3. Issues observed on I-696 wall panels (June 2017): (a) water leakage via the lower portion of the wall expansion joint; (b) walkway failure on the top of the wall back fill; (c) prolonged and severe weeping through drainage holes; (d) moderate levels of vertical cracking; (e) excessive wall expansion at panel joints; (f) differential tilt of adjacent panels.

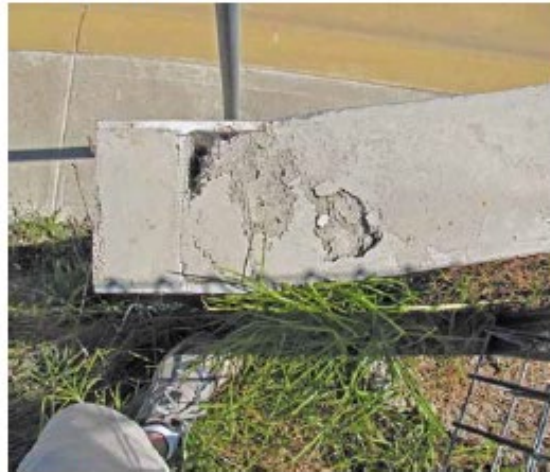
Incomplete filling of concrete around supporting steel posts with potential for water penetration and corrosion

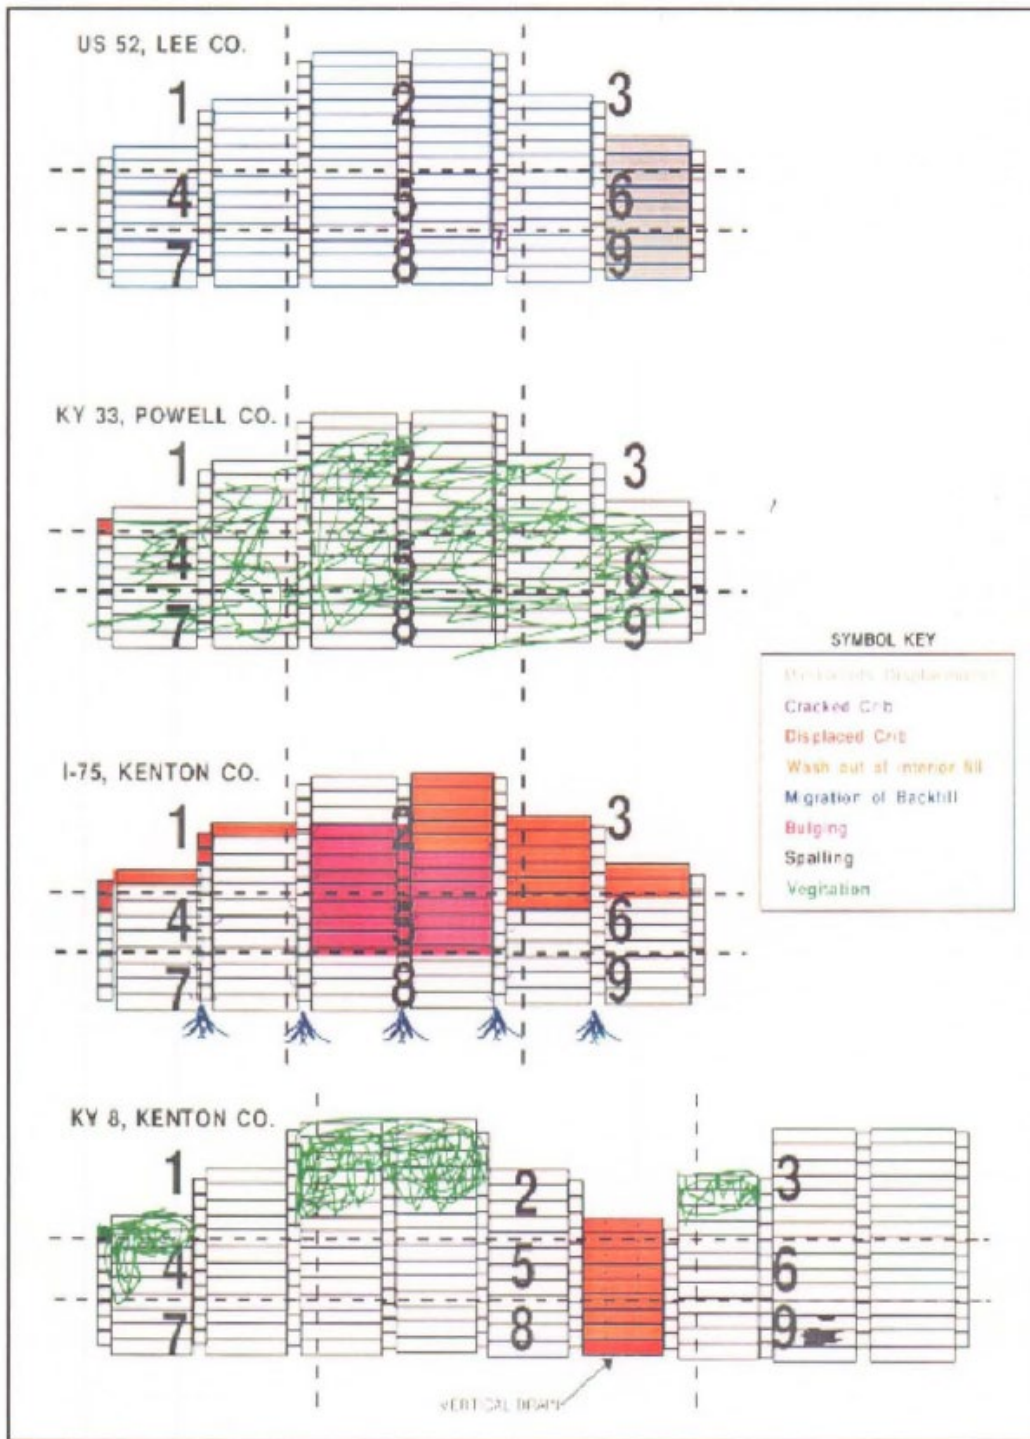
Figure 12: Distress Observed on Concrete Crib Walls

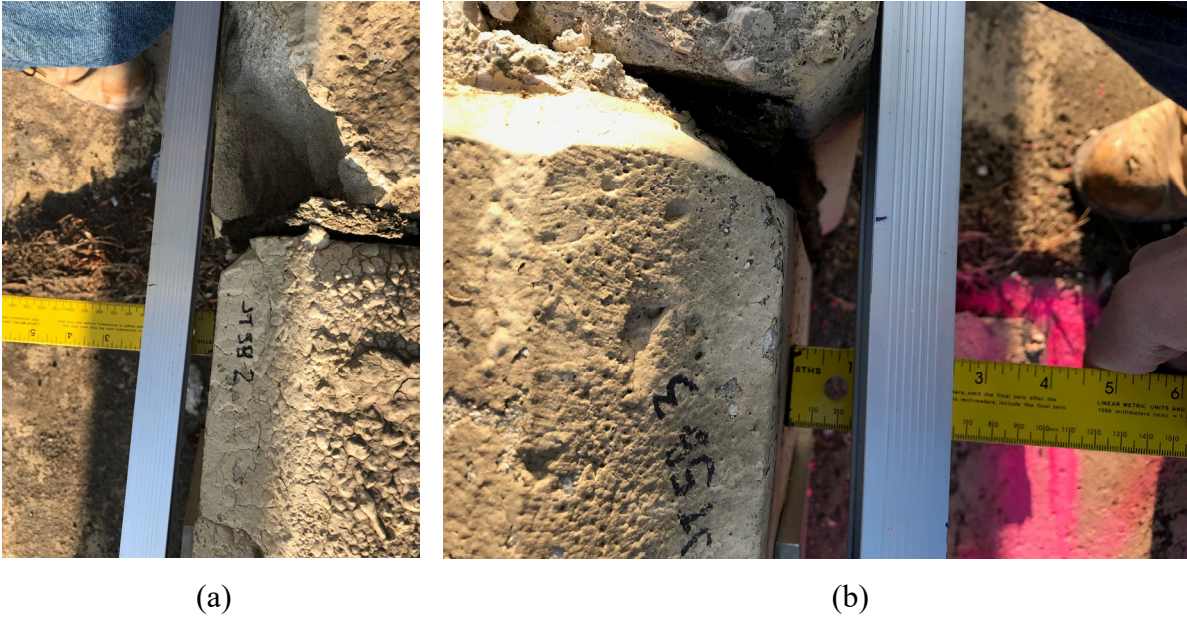
Figure B.1. Manually measured movement of the M-10 wall panel at the top wall parapet in January 2020.

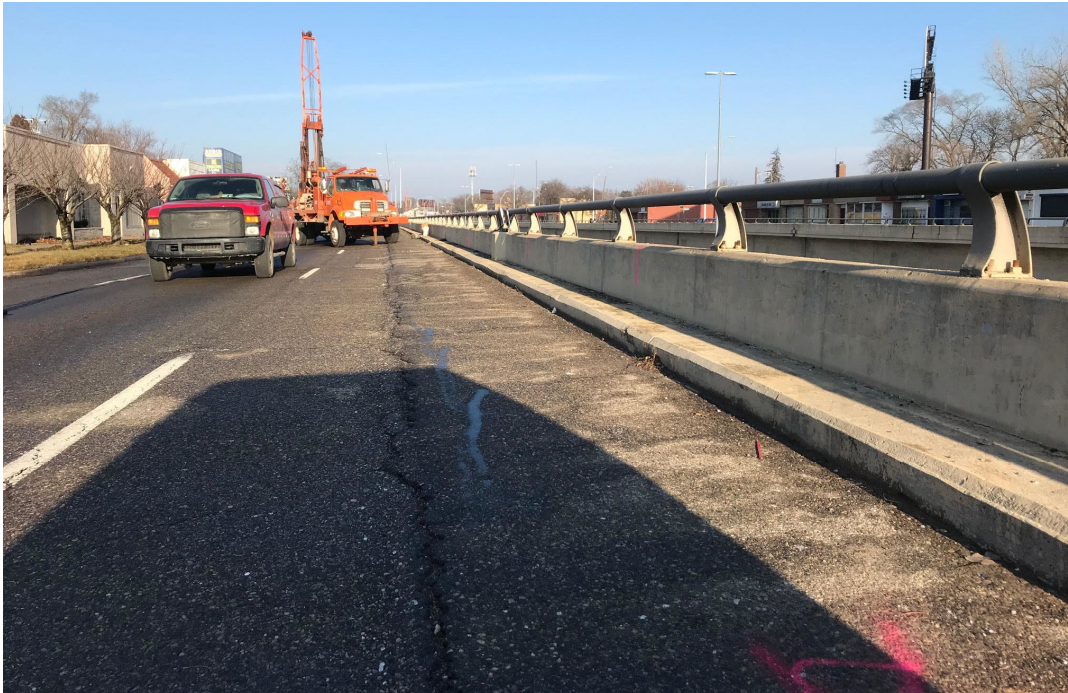
Figure B.2. Top road surface at the top of the suspected failed M-10 wall panel (January 2020); major tensile crack in asphalt surface evident parallel to wall face.

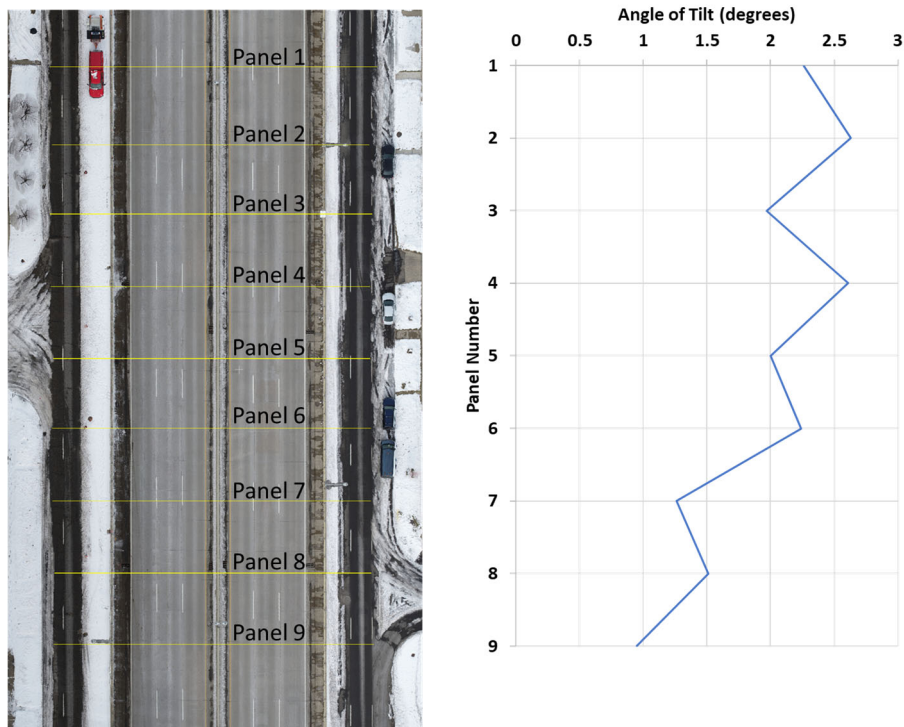
Figure B.6. (Left) plan view of 3D point cloud model with nine panels of the M-10 retaining wall system identified; (right) measured angle of tilt of the wall at each panel.

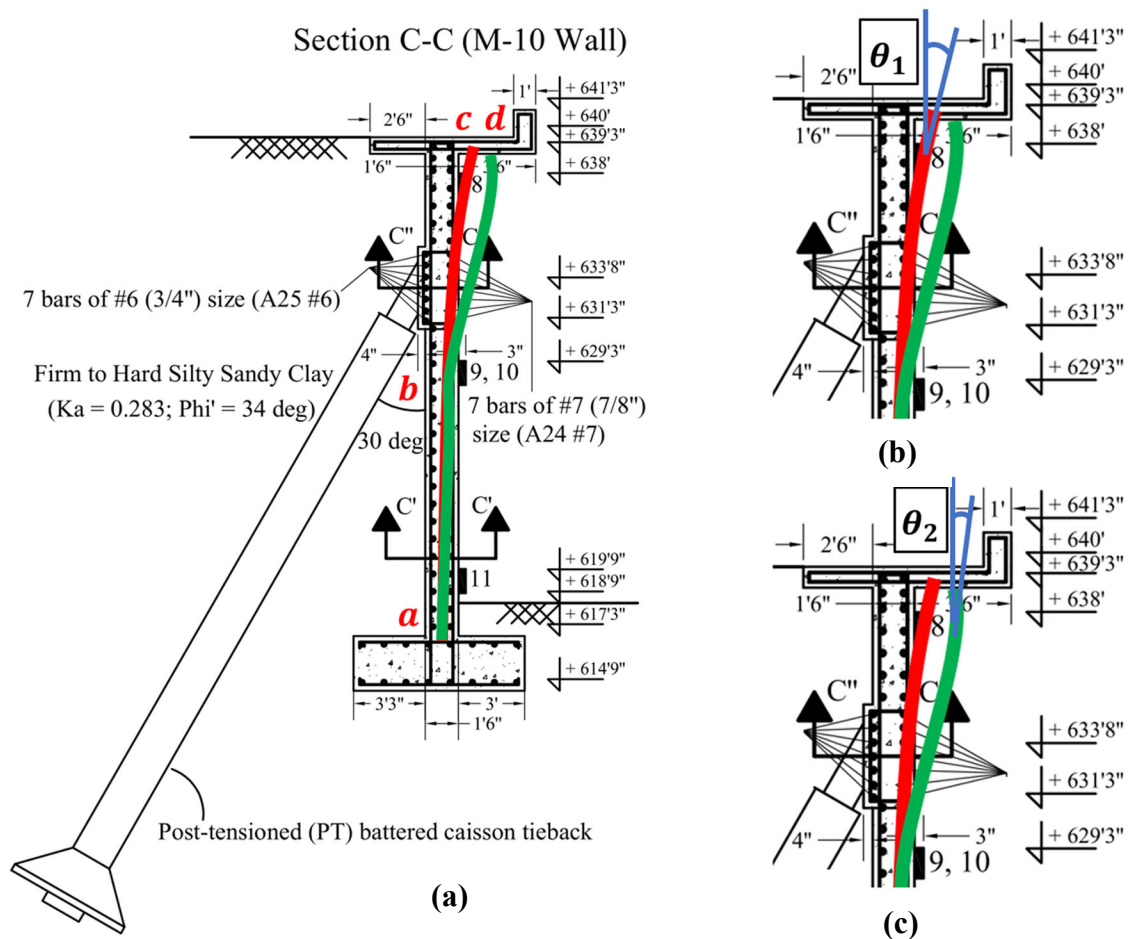
Figure B.7. Deformation curves of the drifted M-10 retaining wall system with the tieback caissons shown: (a) hypothesize deflection curve of the wall panel before the major rain event (a-b-c) and during high hydrostatic pressures immediately following the rain (a-b-d); (b) top-level rotation of retaining wall panel before movement showing a large tilt toward the freeway; (c) top-level rotation of retaining wall panel after the buildup of hydrostatic pressures resulting in displacement and reduced top tilt of the panel. The wall returns to deflected shape (a-b-c) after hydrostatic pressure is relieved.

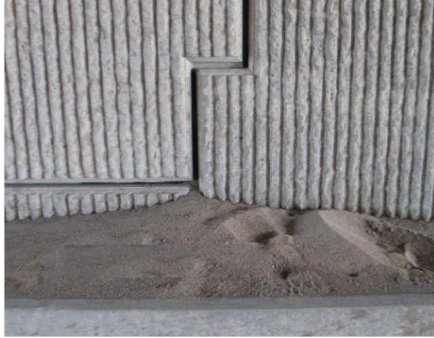
Loss of Backfill

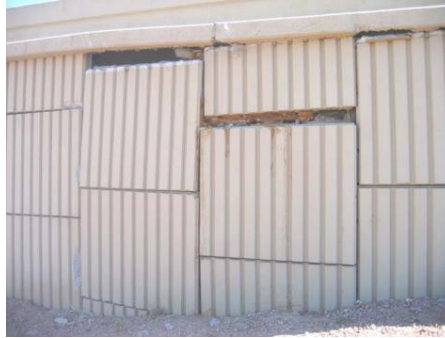
Joint Spacing

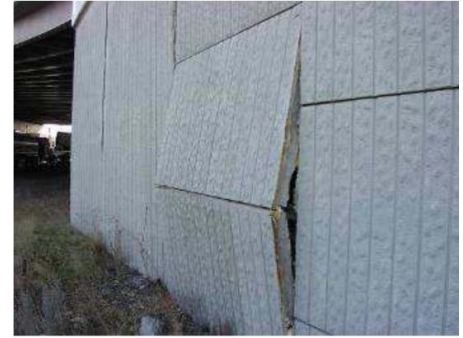
Panel Bowing
