A FIVE-YEAR EVALUATION OF
PREVENTIVE MAINTENANCE CONCEPTS
ON JOINTED CONCRETE PAVEMENT
(I 75 AND I 696 IN OAKLAND COUNTY)

C. J. Arnold
M. A. Chiunti
K. S. Bancroft

Research Laboratory Section
Testing and Research Division
Research Projects 71 F-122
and 74 F-140
Research Report No. R-1185

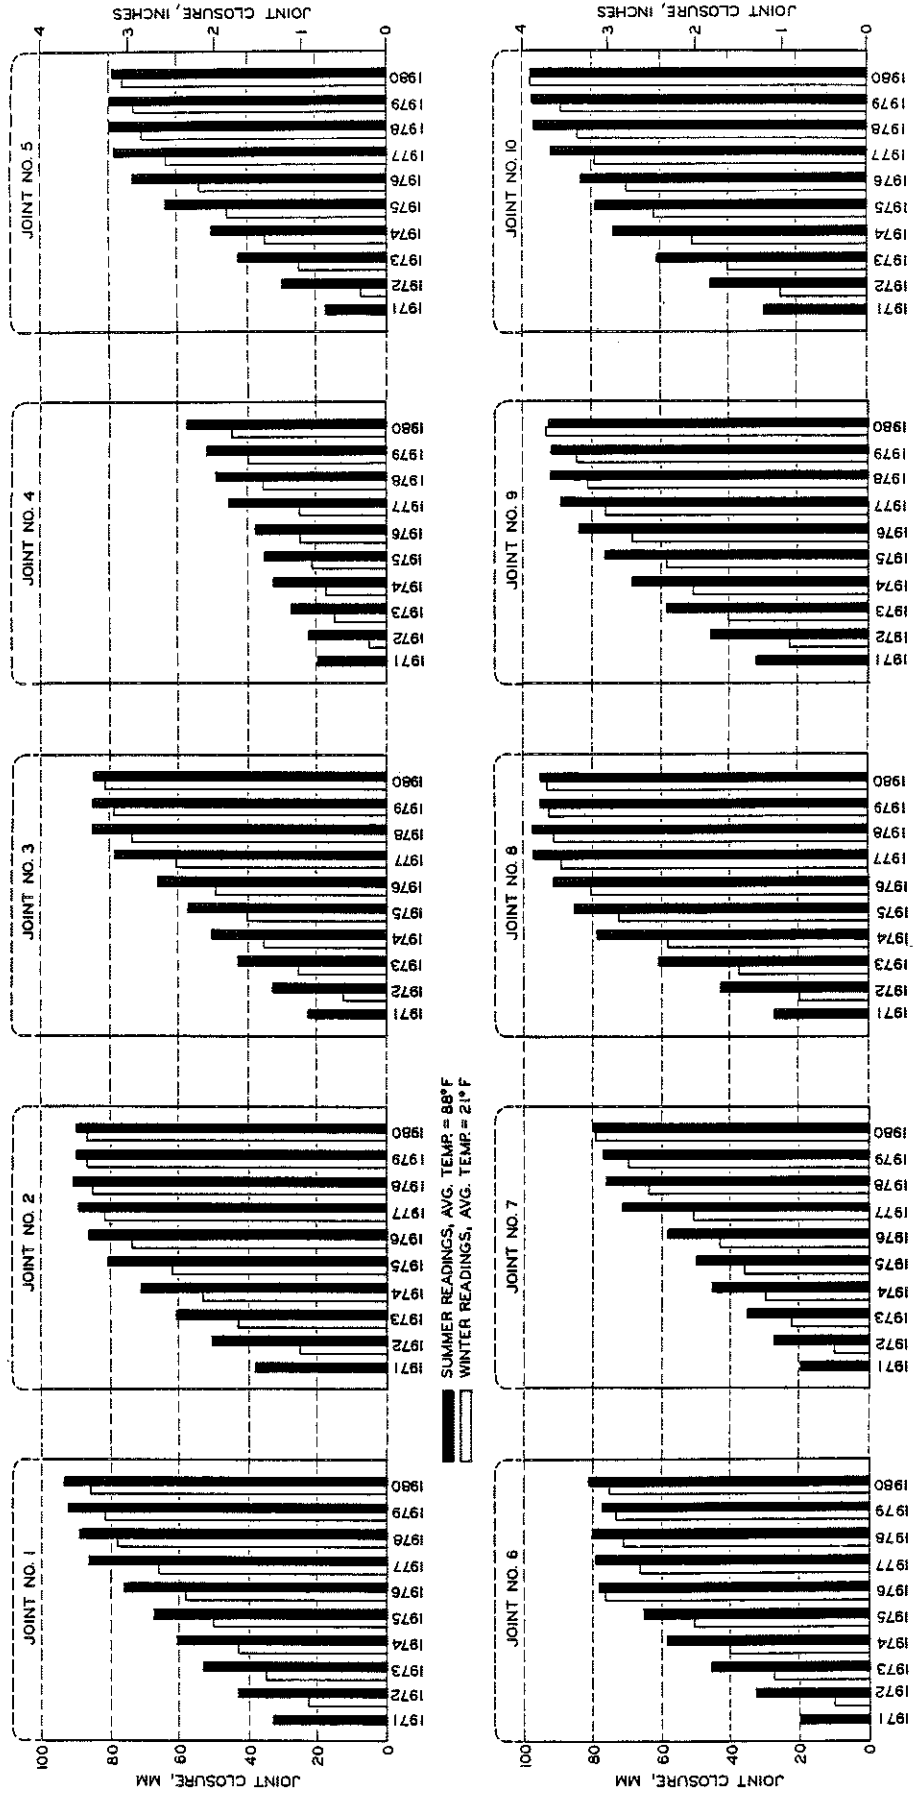
Figure 2. Location of pressure relief joints and total closure (US 23).

Figure 2 shows the data from the experimental installation on US 23, indicating the rate at which the pavement utilizes the additional expansion space provided. It was noted from this project that mid-slab fractures tend to open and collect incompressibles quite rapidly, since the load transfer dowels at joints make it easier to pull open a crack than to open a joint.

However, most adjacent joints do tend to open more and more as time goes on. Once open, the cracks and joints collect incompressible materials that prevent them from reclosing, thereby using up the extra space that has been provided, and forcing the PRJ (or expansion space at a repair) ever more tightly closed until all available compression space has been utilized. The foam filler in the PRJ allows the joint to open during cooler weather without allowing incompressible material to enter, so that the PRJ can close again the next summer. Similarly, the seal in an expansion joint at a repair helps to eliminate incompressibles for the same purpose.

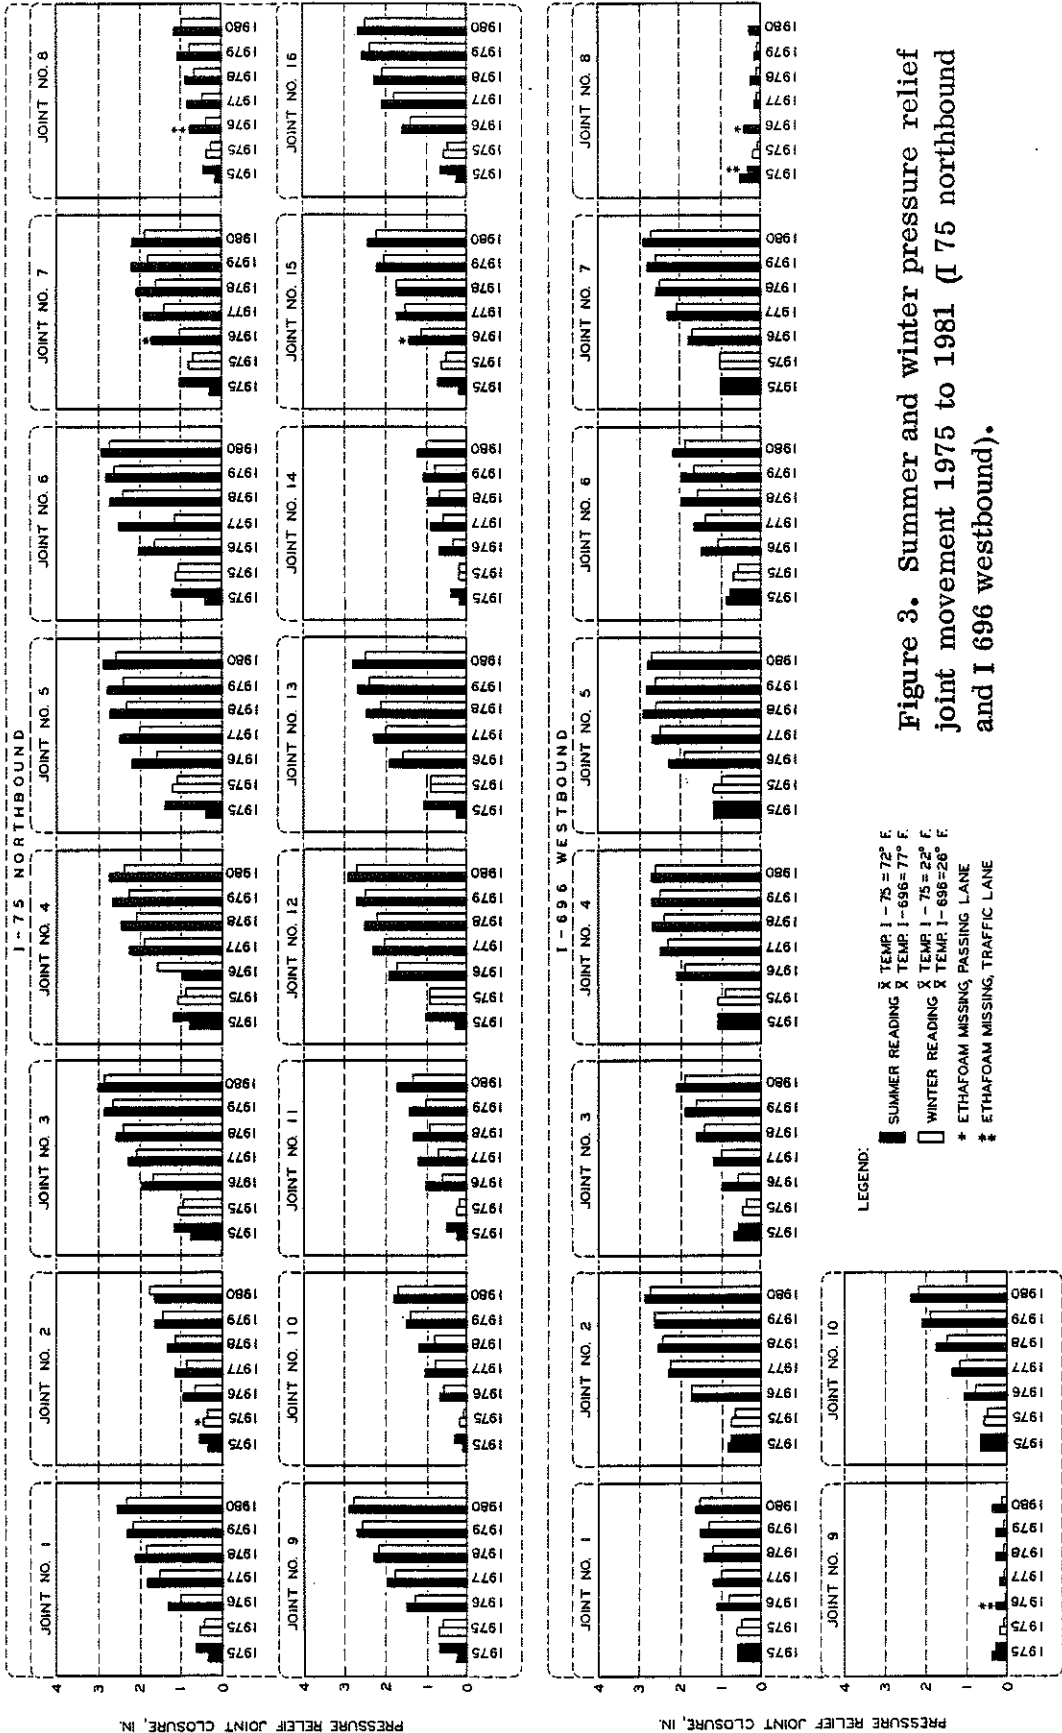
Figure 3. Summer and winter pressure relief joint movement 1975 to 1981 (I 75 northbound and I 696 westbound).

During the construction of the preventive maintenance repairs, 16 PRJs on I 75 and 10 on I 696 were instrumented so that measurements could be made on the rate of closure. Spacing between pressure relief locations was 850 ft maximum, with some of the relief provided at repairs. Figure 3 shows the amount of closure that has occurred on the instrumented PRJs. Note that the closure rates are somewhat similar to those shown in the previous figure for US 23; and that none of the instrumented joints had been closed to the maximum amount in the five-year period.

Problems with loss of ethafoam filler from PRJs has been reported previously. The figure shows the effect of such loss in some joints. All measurements were made on reference points installed at the outside edge of the traffic lane. Once the filler is lost from the PRJ, closure stops, and the joint is no longer effective because of incompressible materials entering the joint. In instances where the filler was lost only from one lane, the other may continue to close only by shearing off the old lane ties between the lanes. It would seem worthwhile to clean joints and replace lost fillers, either by maintenance forces, or as a part of later repair contracts.

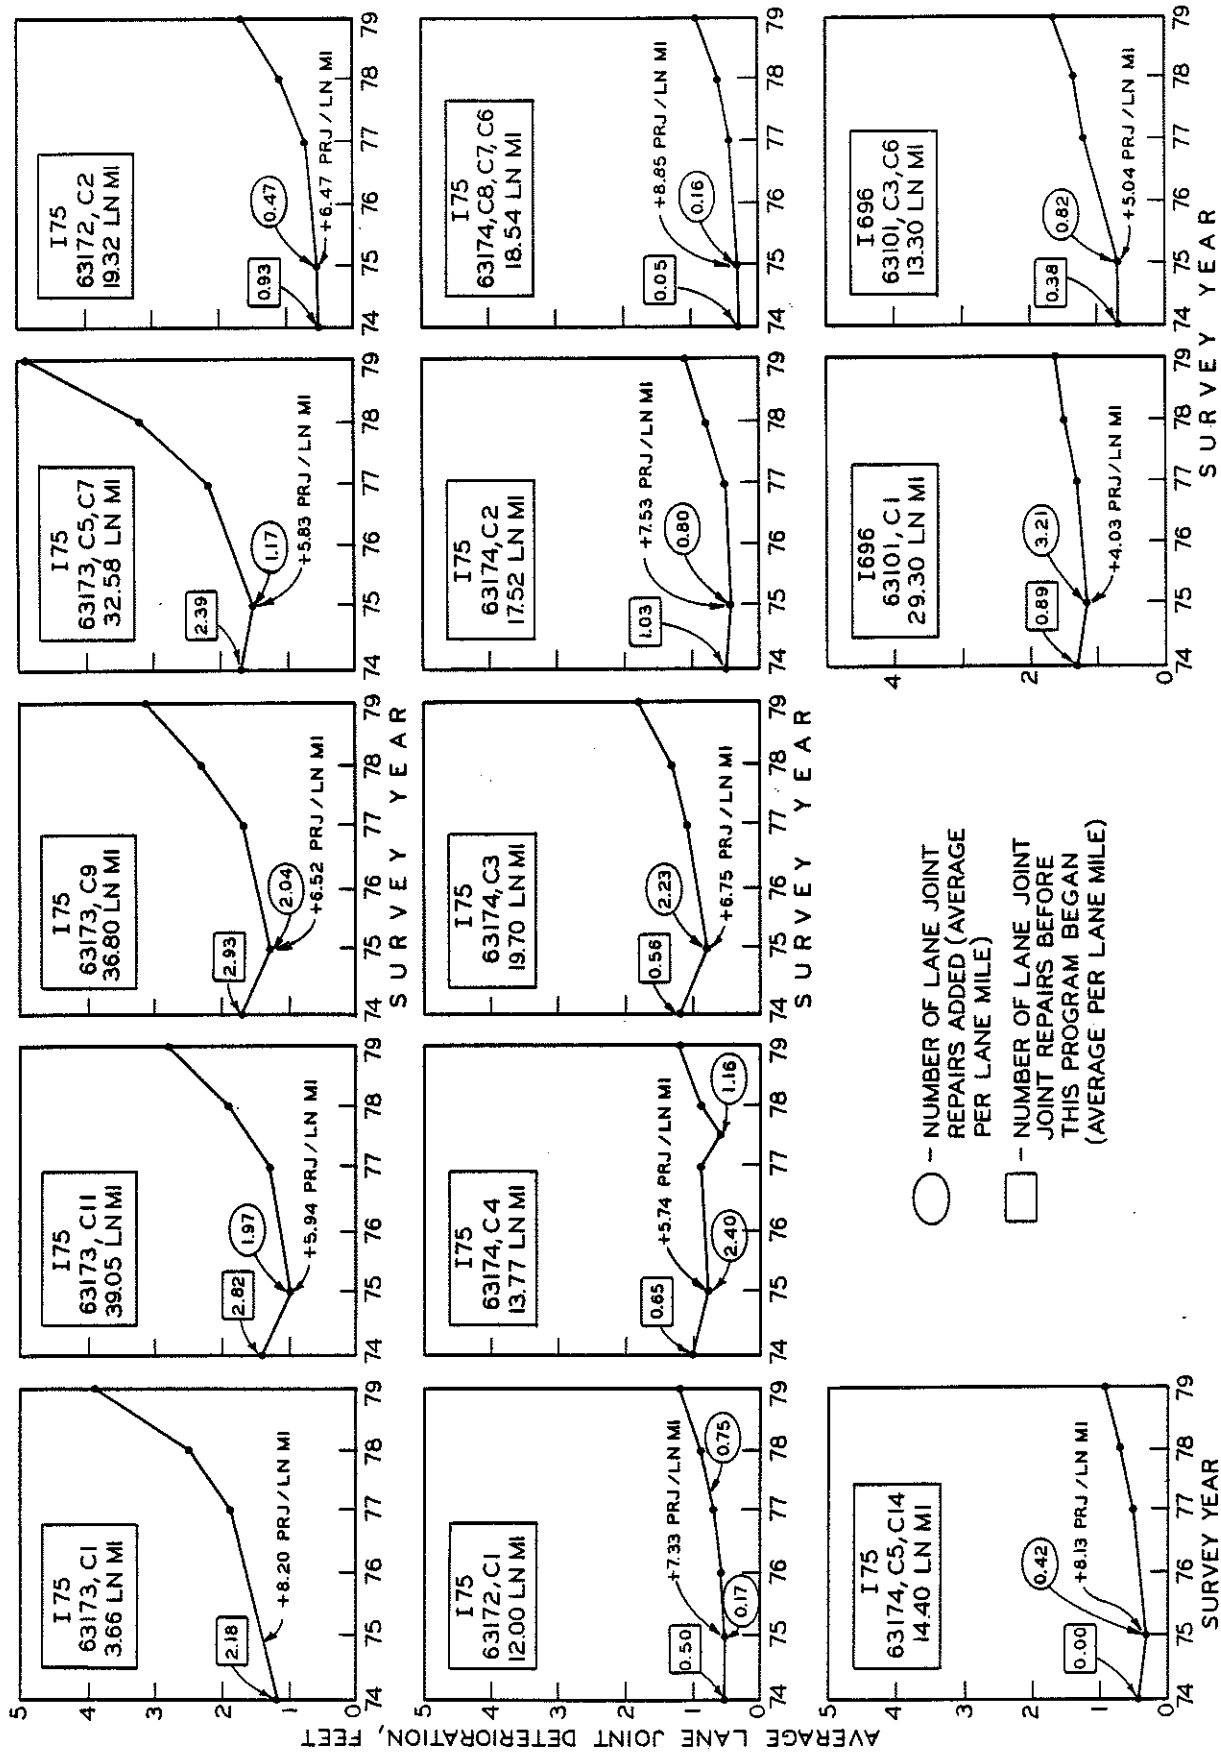
Figure 5. Average lane joint deterioration before and after joint repairs.

In Figure 5, average lane joint deterioration is being plotted, so an increase or rise in the curve represents increased deterioration or poorer condition; a rating of 4 ft on the vertical scale means that the average joint would have a total of 4 ft of spall (exceeding 4 in. width) and/or corner breaks. A glance at the curves shows that four of the 13 projects appear to be deteriorating at a rate that is considerably faster than the others. A check of the square boxes also indicates that all four had considerably more joint repair done prior to the preventive maintenance contract. These are both indications of relatively poor performance. The other nine projects have plots that show more comparable relative performance one to another, although two are noticeably better than the others. Those two are on I 75, 63174 C8, C7, C6 and 63174 C5, C14. In contrast the two worst are I 75, 63173 C1 and 63173 C5, C7.

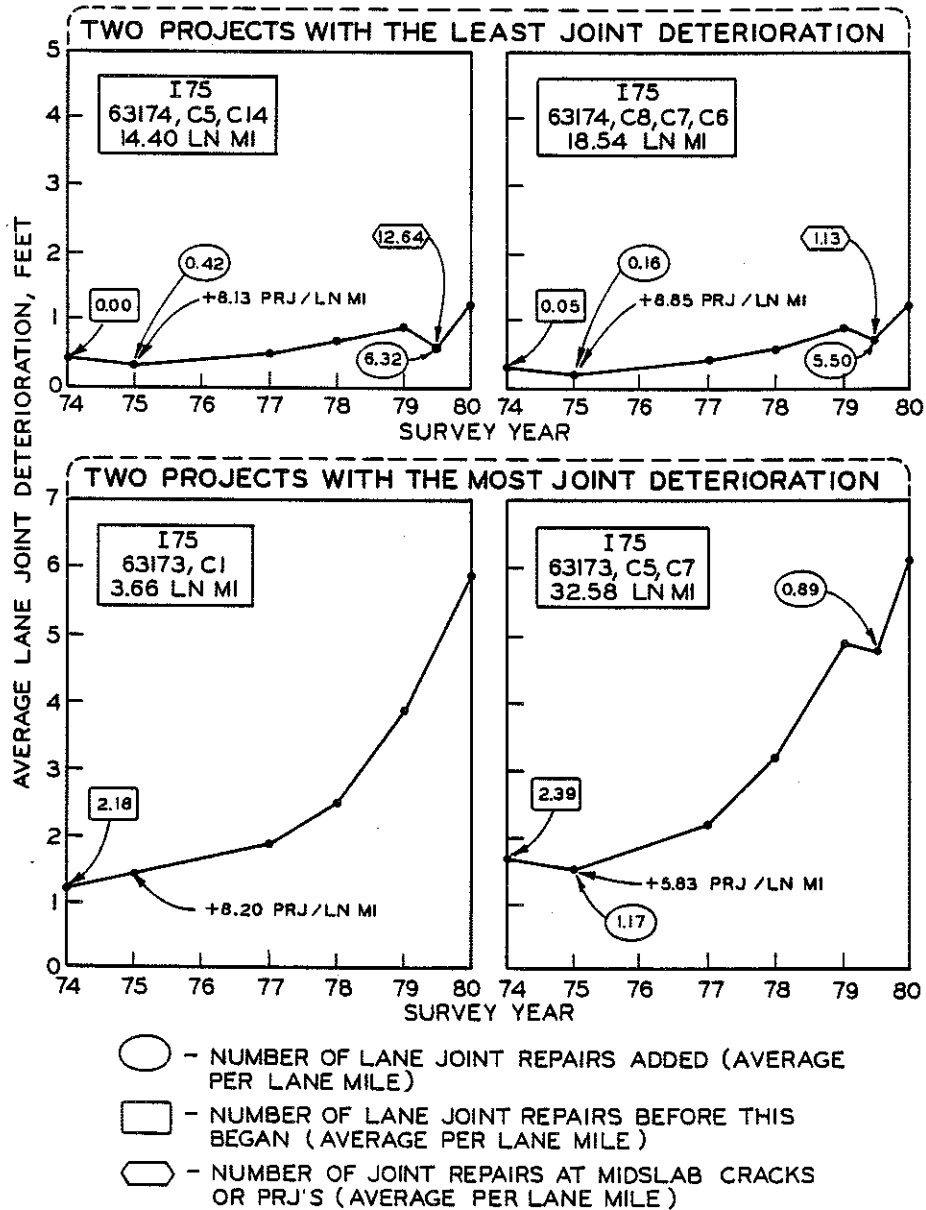
Figure 6. Average unrepaired lane joint deterioration for four preventive maintenance projects showing best and worst performance of the 13 projects evaluated.

Since there are budget limitations and personnel shortages, it was decided during the last year to concentrate on these four projects, rather than making ratings on all of the projects. Compilations of the data for the total five-year period for these four projects are shown in Table 2, and the associated average unrepaired lane joint deterioration plots are shown in Figure 6. It seems somewhat ironic that nearly 400 repairs were placed on 33 miles of the two best projects during the past year, while only 29 were placed on 36 miles of the worst projects. It is also interesting to note that the average joint on the two worst projects now has reached the level '6 ft' of deterioration that was used as the criterion for selection of the isolated joints that were repaired at the beginning of the preventive maintenance work. The average amount of deterioration still is climbing steeply as well. It is obvious that these projects are in need of extensive work in the near future, at nearly every joint and undoubtedly at many mid-slab cracks as well.

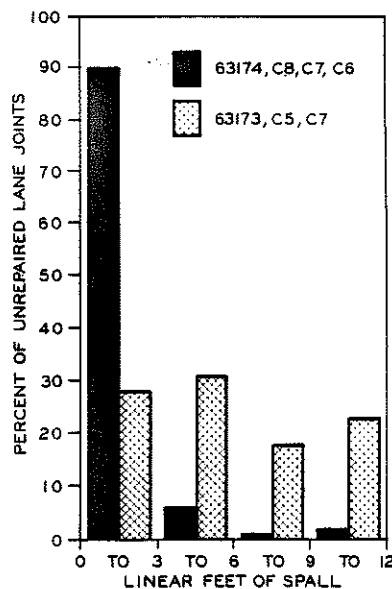
Figure 7. Condition of unrepaired lane joints on two contrasting projects on I 75 (1979 data).

Figure 7 shows the same type of information in a slightly different format, for a best and a worst project. It shows that although the best project has 90 percent of the lane joints with less than 3 ft of deterioration, only about 28 percent of the joints in the worst project are in this category. Conversely, if we sum the two right hand bars of the graph, the worst project has 40 percent of the joints with more than 6 ft of deterioration, while

the best project has only 5 percent of the joints in this poor condition at the time of the survey. Again, it is obvious that the one project can continue to serve with only isolated repairs, while the other will require a considerable expenditure for both patrol patching and contract repair.

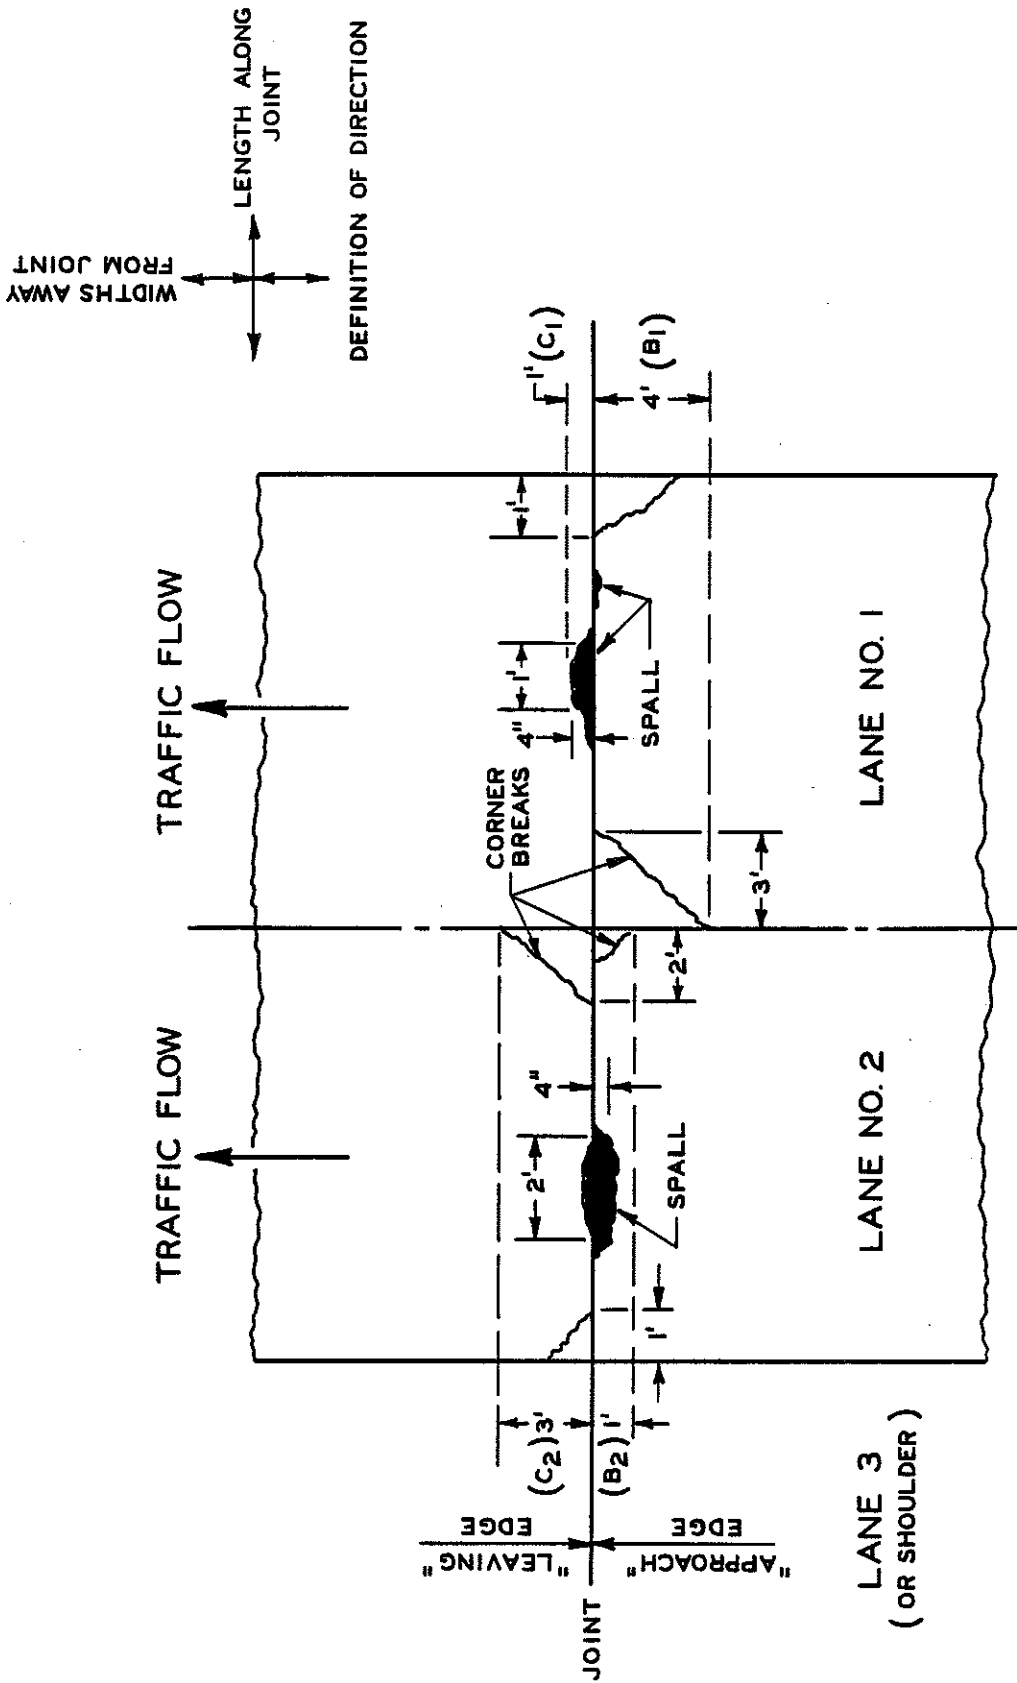
RATING - LANE 1, 1 + 1 + 3 = 5 (A1)
 LANE 2, 2 + 2 + 1 = 5 (A2)

Example of deteriorated joint in two-lane one-way road.
