PCC PAVEMENT JOINT RESTORATION
AND REHABILITATION
(Federal Highway Administration NEEP Project 27)
Final Report

J. E. Simonsen
A. W. Price

Research Laboratory Section
Materials and Technology Division
Research Project 79 F-159
Research Report No. R-1298

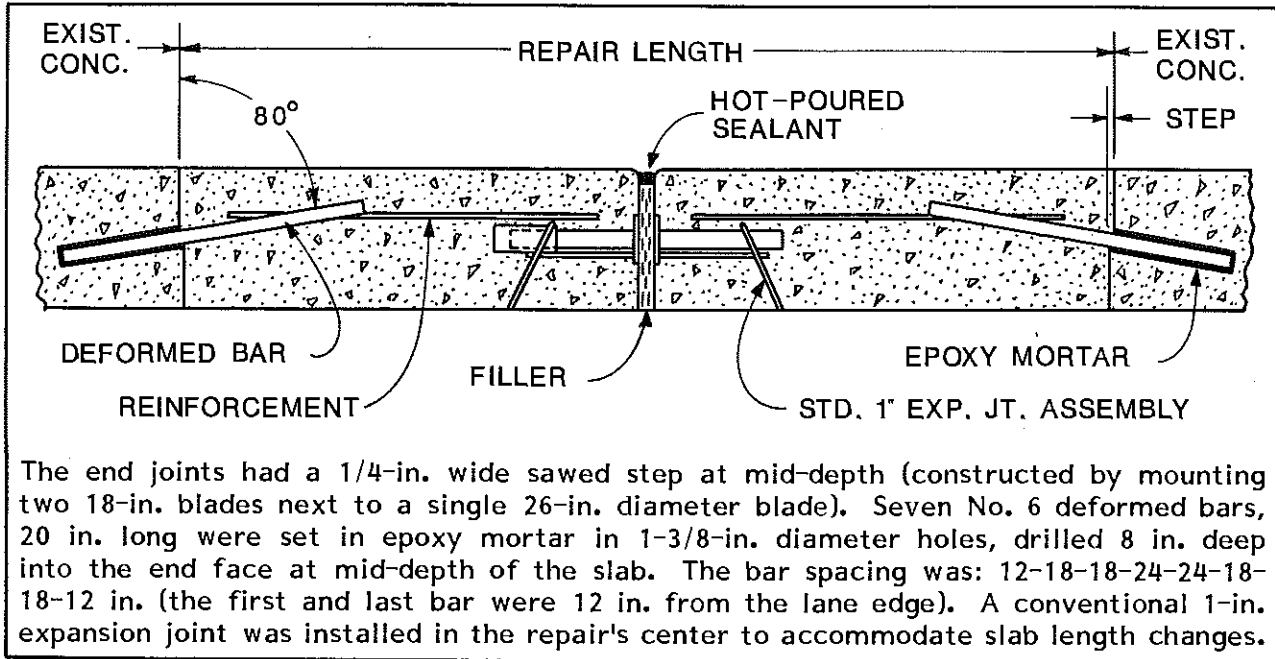
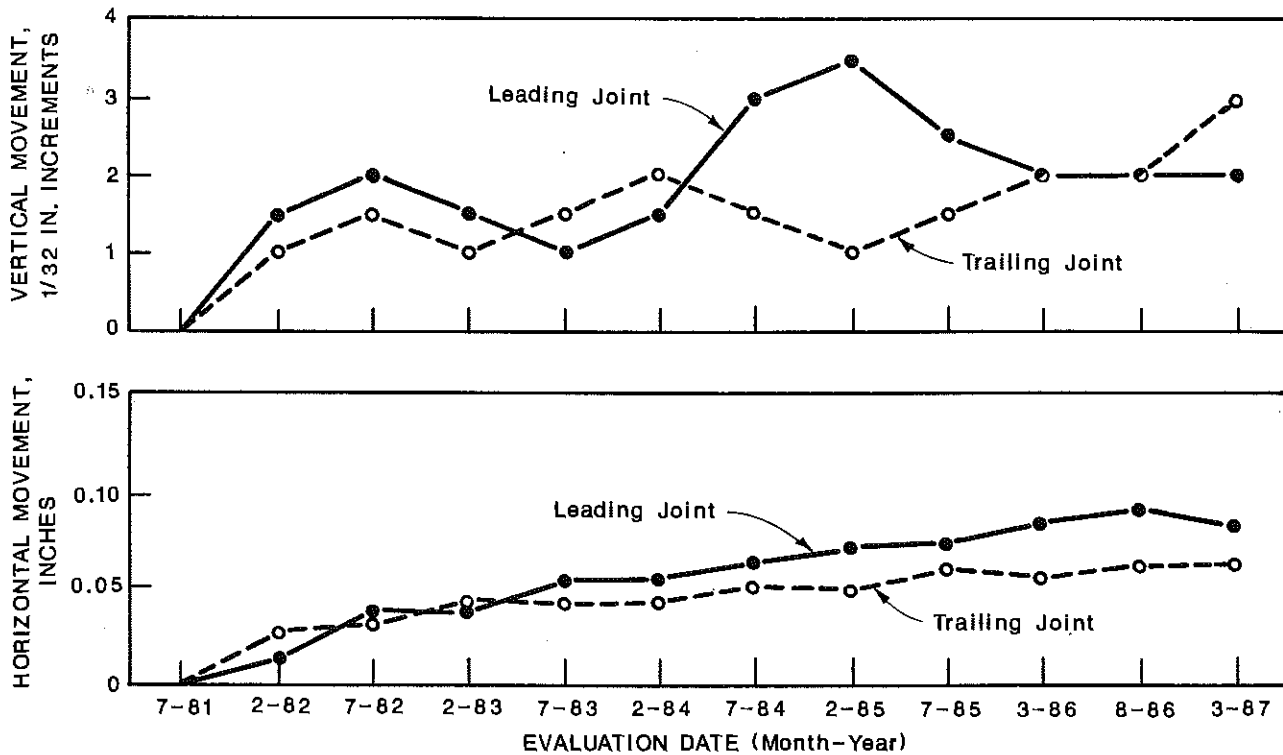
Step-cut tied end joints (expansion joint in center)

Figure 3. Joint design and average vertical and horizontal movement at step-cut joints (stage 1 repairs on US 127, subjected to 520,000 ESALS).

A total of four experimental repairs (eight lane repairs) were constructed. Two had step-cut end faces and two had their end faces coated with an epoxy bonding agent prior to concrete placement. Figure 3 shows a stepcut end joint and gives a description of the joints, along with a graph showing the movement changes that have occurred through the winter of 1987. The same information is given in Figure 4 for the joints treated with the epoxy bonding agent. The step-cut and epoxy coating were utilized to reduce the number of tie bars required to provide adequate load transfer.

As can be seen in Figures 3 and 4, the joint movements indicate that they are still performing satisfactorily. The vertical movement has cycled between 1/32 and 3/32 of an inch and the horizontal surface measurements have increased somewhat since 1981 and were in the 0.07 to 0.08-in. range when the last measurements were taken in 1987. The surface condition of a repair with step-cut joints and one with epoxy bonded joints are shown as they appeared in early 1989 in Figure 7.

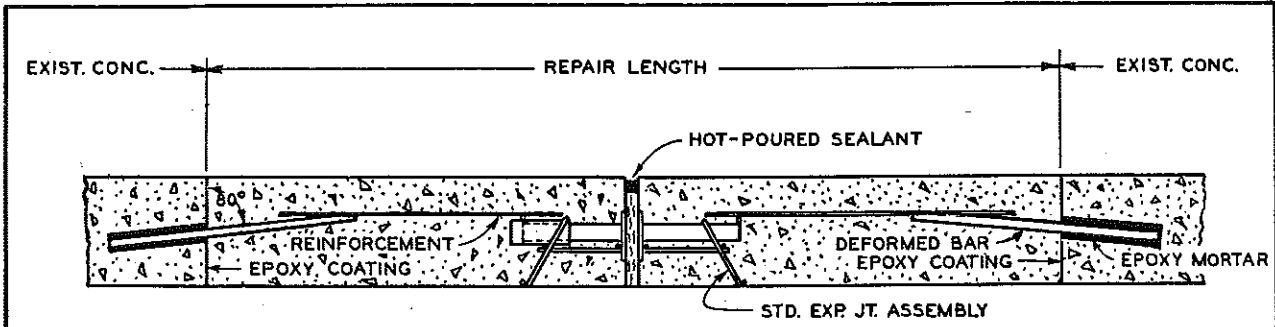
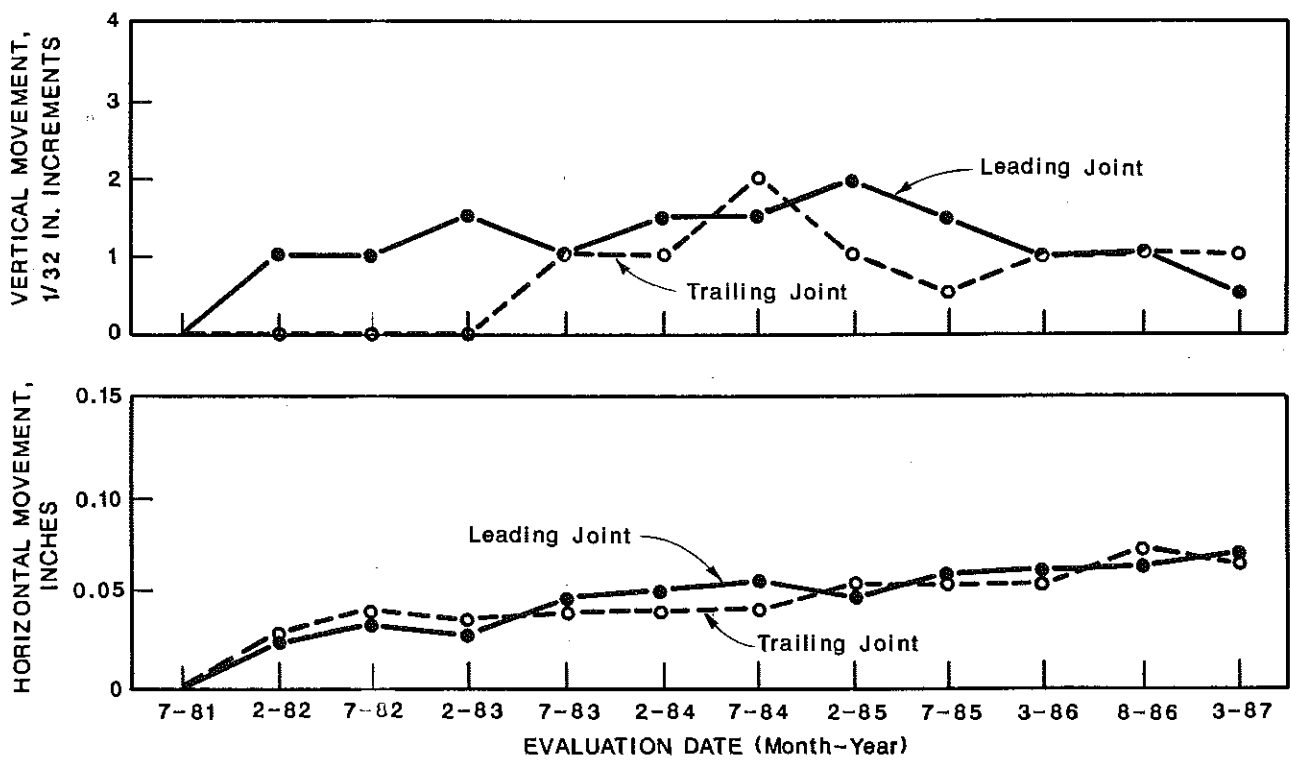
Repair with epoxy coated end limits

The end joints were sawed full-depth and an epoxy bonding coat applied to the end faces prior to concrete pouring. Seven No. 6 deformed bars, 20 in. long were set in epoxy mortar in 1-3/8-in. diameter holes, drilled 8 in. deep into the end face at mid-depth of the slab. The bar spacing was: 12-18-18-24-24-18-18-12-in. (the first and last bar were 12 in. from the lane edge). A conventional 1-in. expansion joint was installed in the repair's center to accommodate slab length changes.

Figure 4. Joint design and average vertical and horizontal movements at epoxy coated joints (stage 1 repairs on US 127, subjected to 520,000 ESALS).

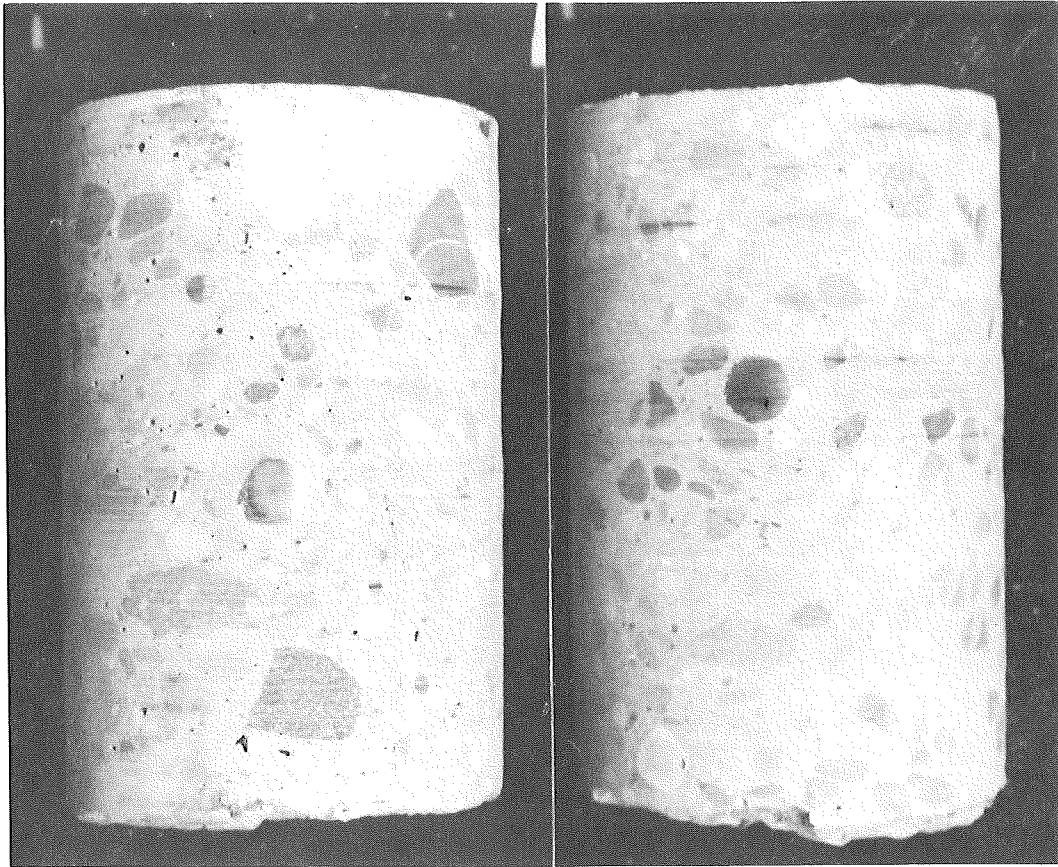
As a first step in evaluating the joints' performance, cores were taken through the tie bar locations to verify proper bonding of the bars in both the new concrete and the epoxy grout. As can be seen in Figure 5, the bars were found to be properly bonded to the concrete and also to the epoxy grout. Cores were also taken through the joints to examine the width of the joint between the new and existing concrete. It was found that at one of the joints, the epoxy bonding coat had failed (Fig. 6) but at the other three joints the bond was good. The joints with the step-cut were tight at the bar level and below but noticeably wider at the surface (Fig. 6).

Figure 5. Cores taken through the tie bar location to examine bonding characteristics. The left core shows the bar properly embedded in the epoxy grout and the right core shows proper bonding in the new concrete.

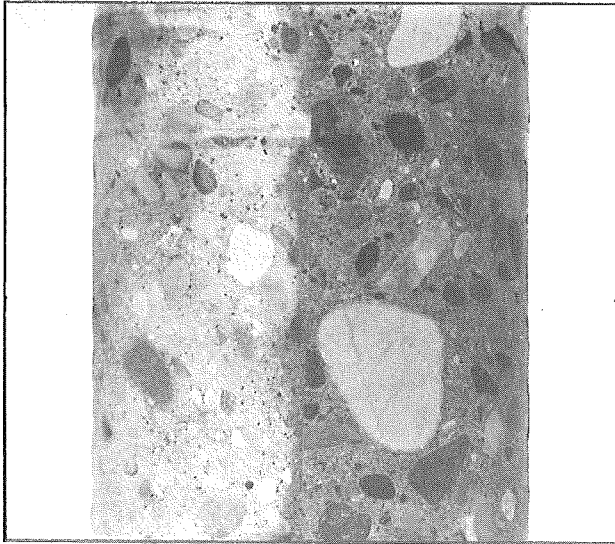
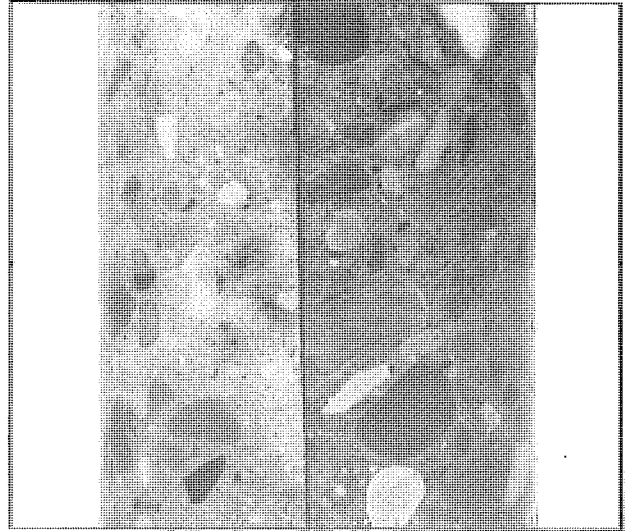
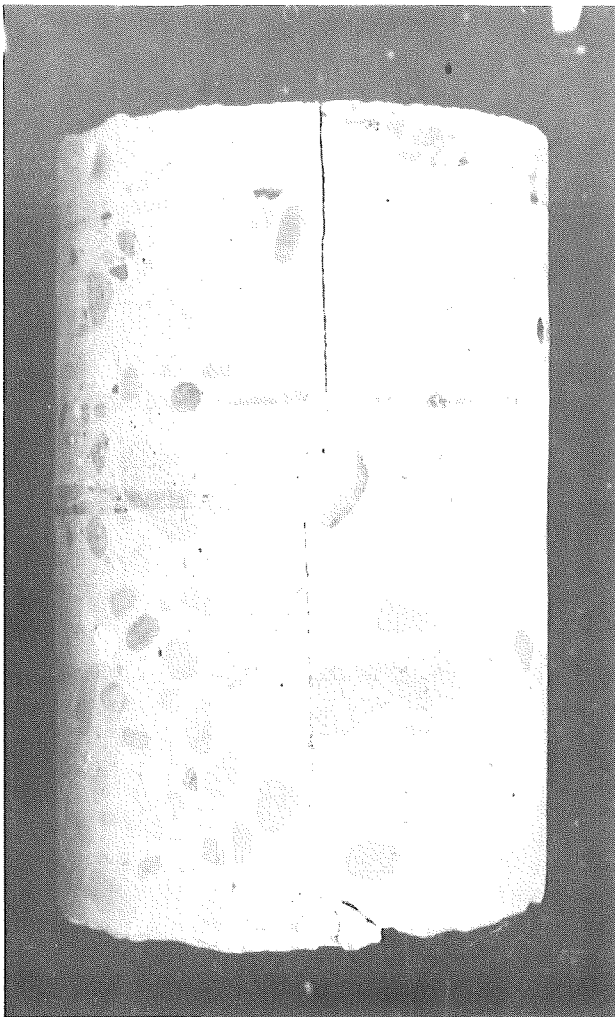
Figure 6. Cores taken through joints. Good epoxy bond (a), failed epoxy bond (b), and typical tied joint showing decreasing width from top to bottom (c).

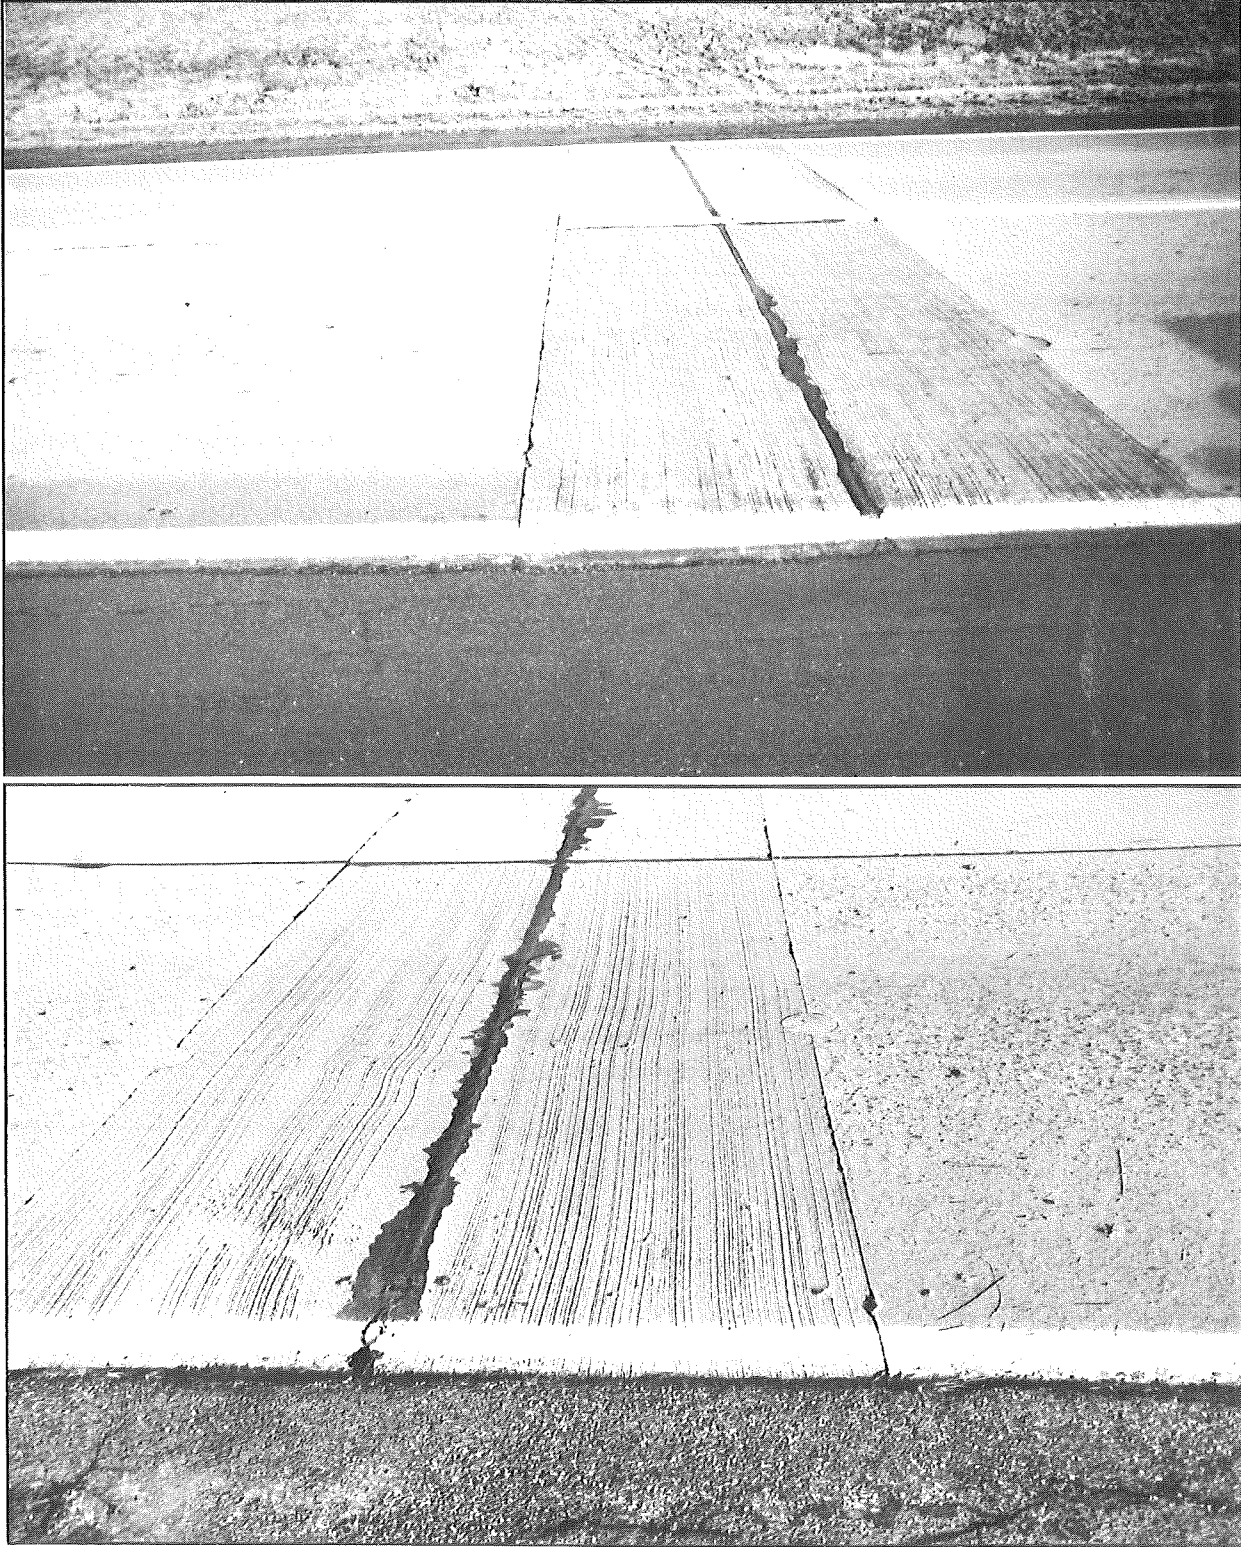
Figure 7. Condition of stage 1 repairs on US 127, after eight years service. Epoxy bonded joints (top), step-cut joints (bottom).

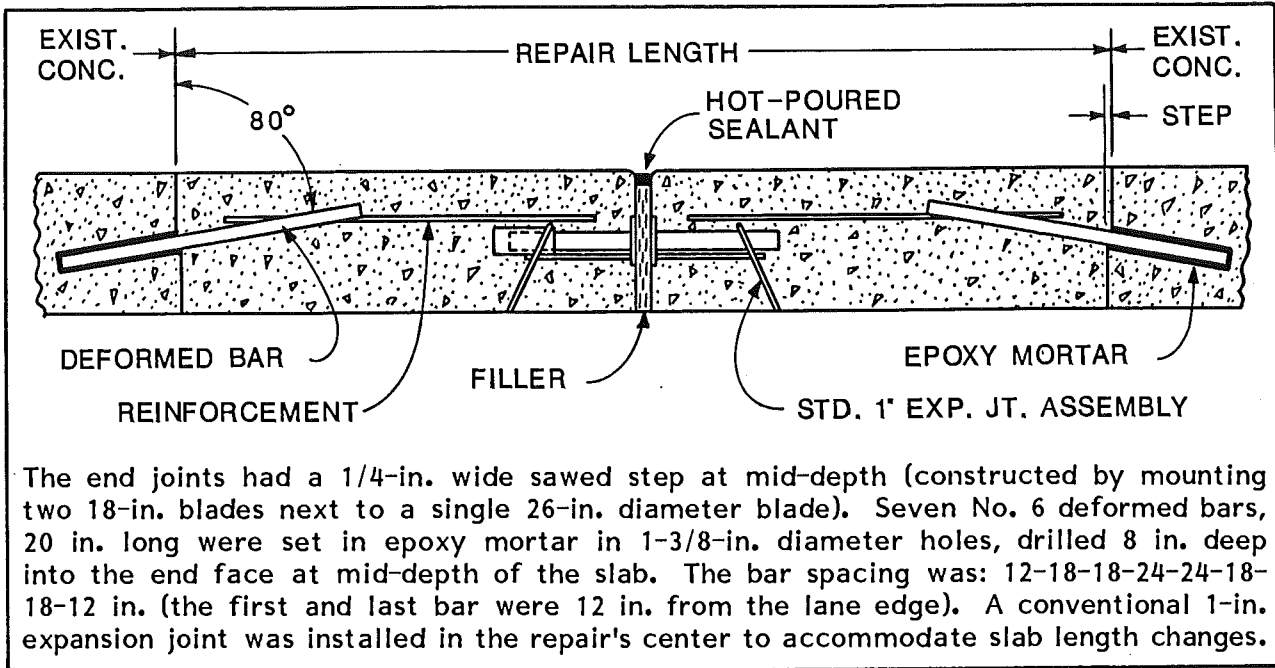
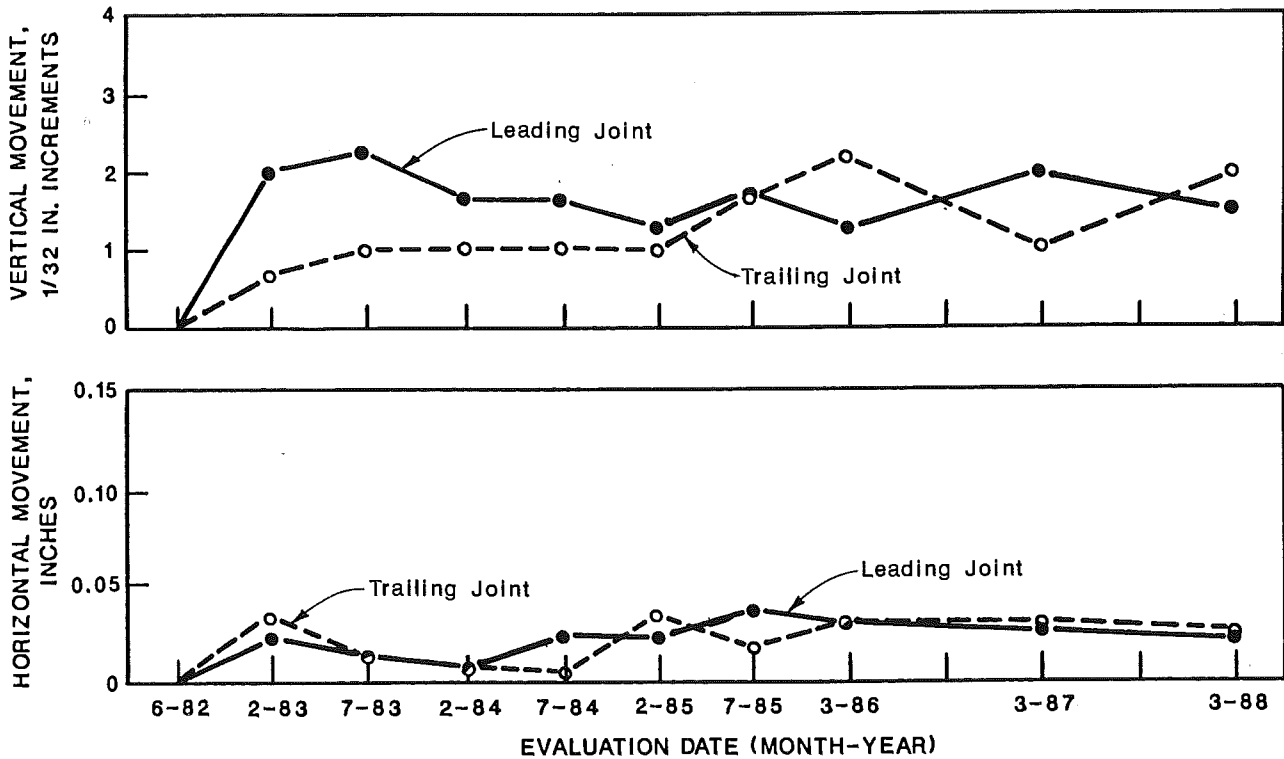
Step-cut tied end joints (expansion joint in center)

Figure 8. Joint design and average vertical and horizontal movement at step-cut tied joints (stage 2 repairs on I 94, subjected to 1,800,000 ESALS).

Two of the repairs utilizing step-cut tied joints have failed, one in 1983 and one in 1984. The failures occurred as a result of slippage of the tie bars grouted into the existing concrete. Joint openings as large as 0.5 in. were measured at the time the failures were noted. The remaining joints of the third repair have functioned properly with the horizontal movements not exceeding 0.04 in. (Fig. 8). The graph in Figure 8 showing the vertical movement includes the measurements at the failed tied joints; however, as shown the maximum average offset measured was just slightly over 1/16 in.

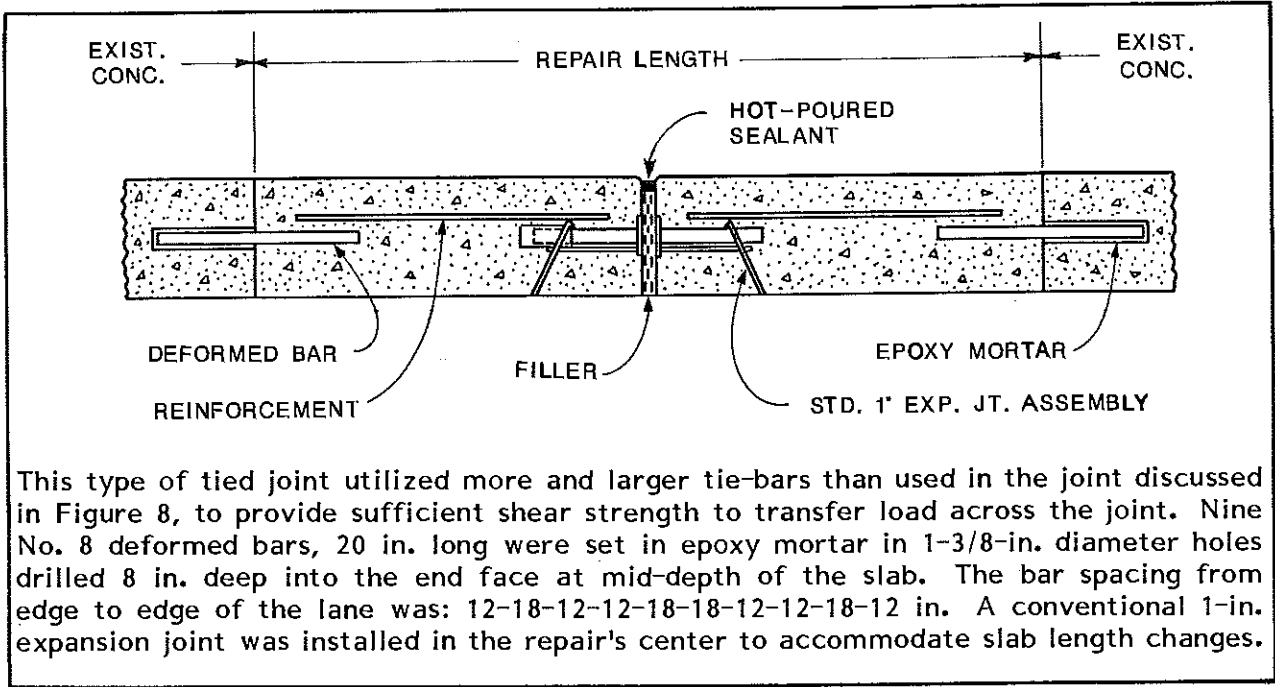
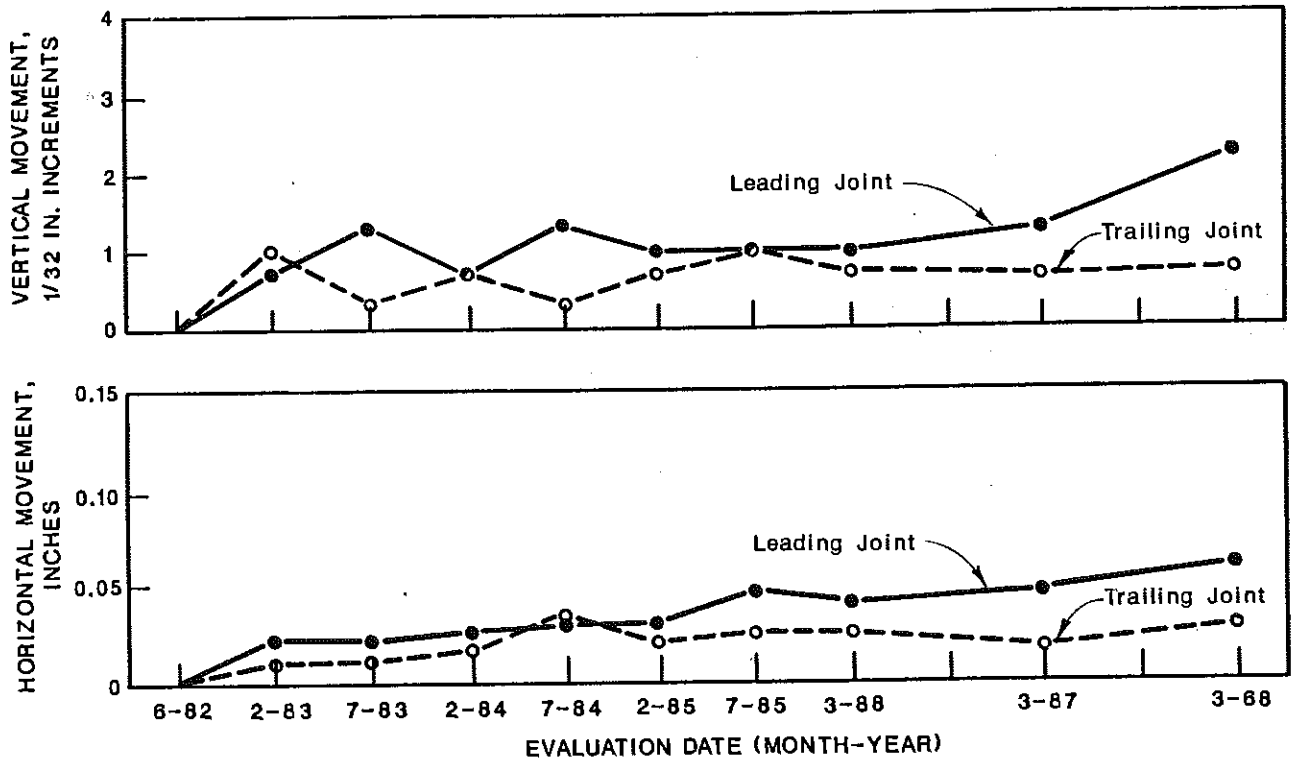
Straight cut tied end joints (expansion joint in center)

The repairs with the straight-cut end faces (Fig. 9) utilizing nine No. 8 deformed bars performed very well. As can be seen, both the vertical and horizontal movements remained quite small while the repairs were in service.

Figure 9. Joint design and average vertical and horizontal movements at straight-cut tied joints (stage 2 repairs on I 94, subjected to 1,800,000 ESALS).

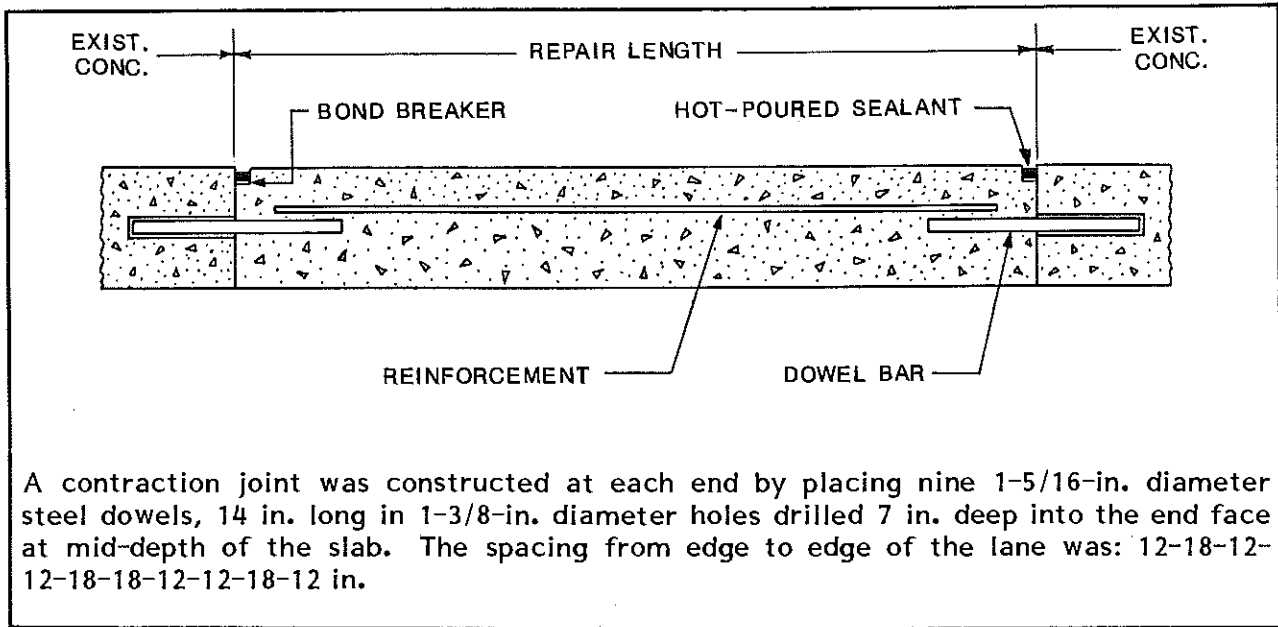
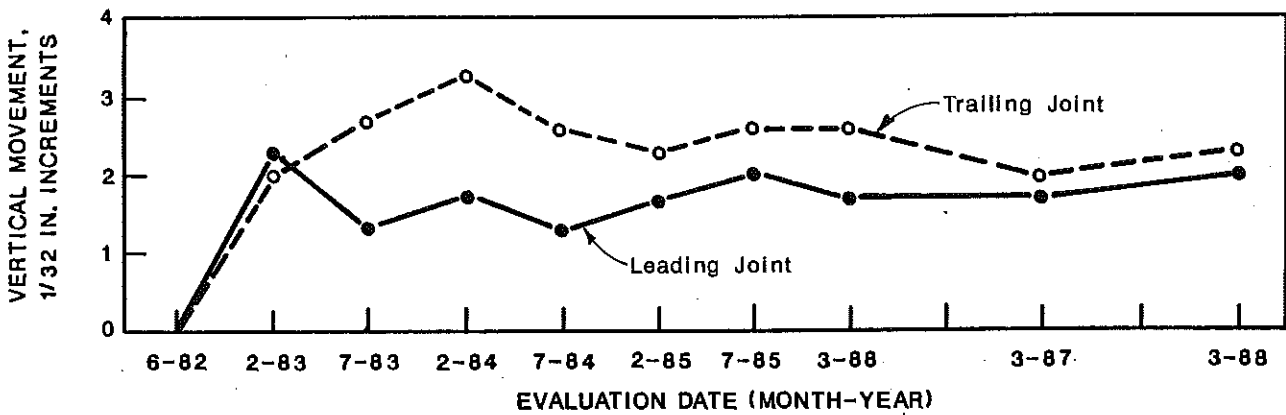
Dowelled contraction joints

The dowelled contraction joints (Fig. 10) and the dowelled expansion joints (Fig. 11) have moved in a quite similar manner. Both showed a 1/16-in. vertical offset at the first winter measurement and since then have varied from 1/32 to slightly over 3/32 in.

Figure 10. Joint design and average vertical movement at dowelled contraction joints (stage 2 repairs on I 94, subjected to 1,800,000 ESALS).

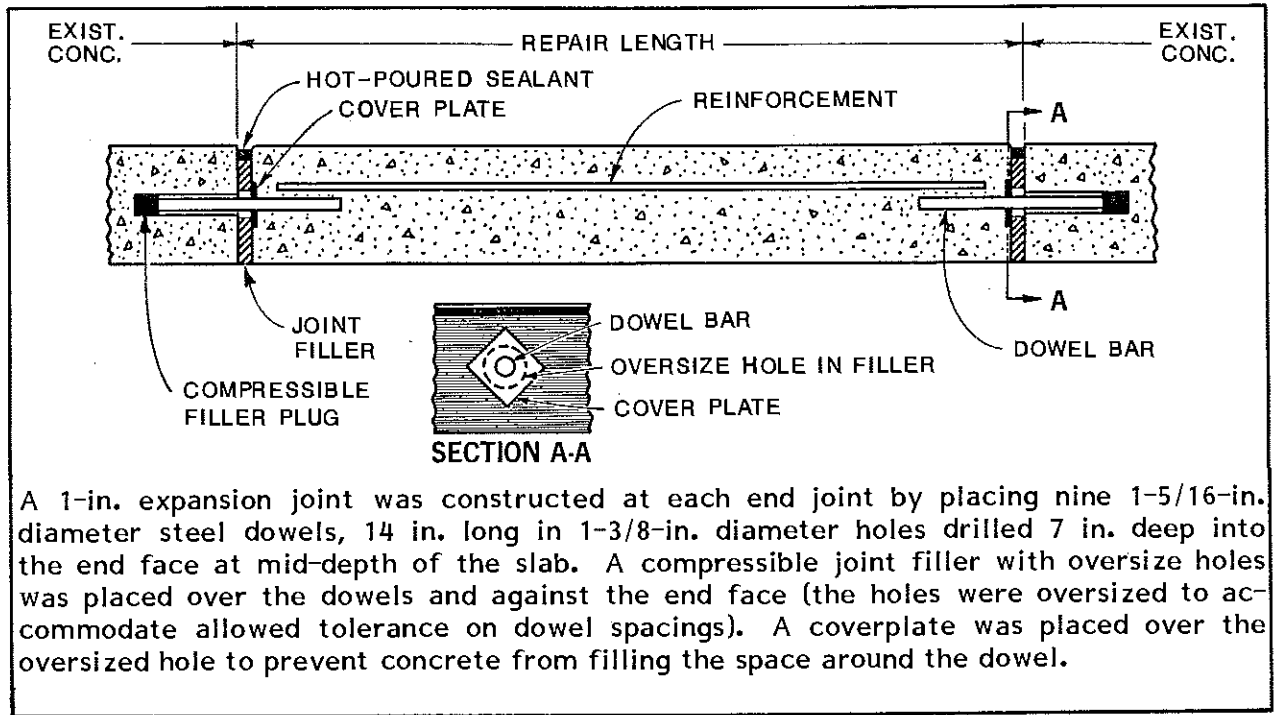
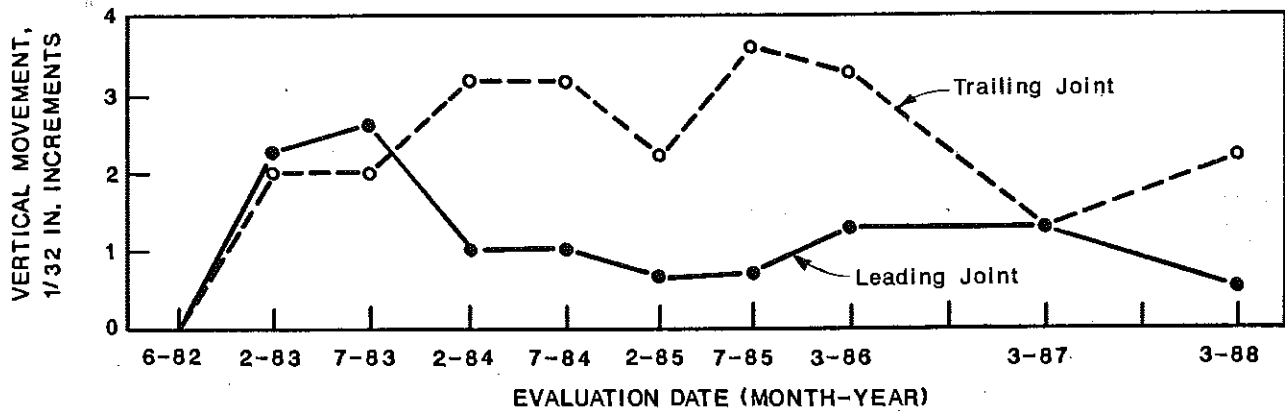
Dowelled expansion joints

Figure 11. Joint design and average vertical movement at dowelled expansion joints (stage 2 repairs on I 94, subjected to 1,800,000 ESALS).

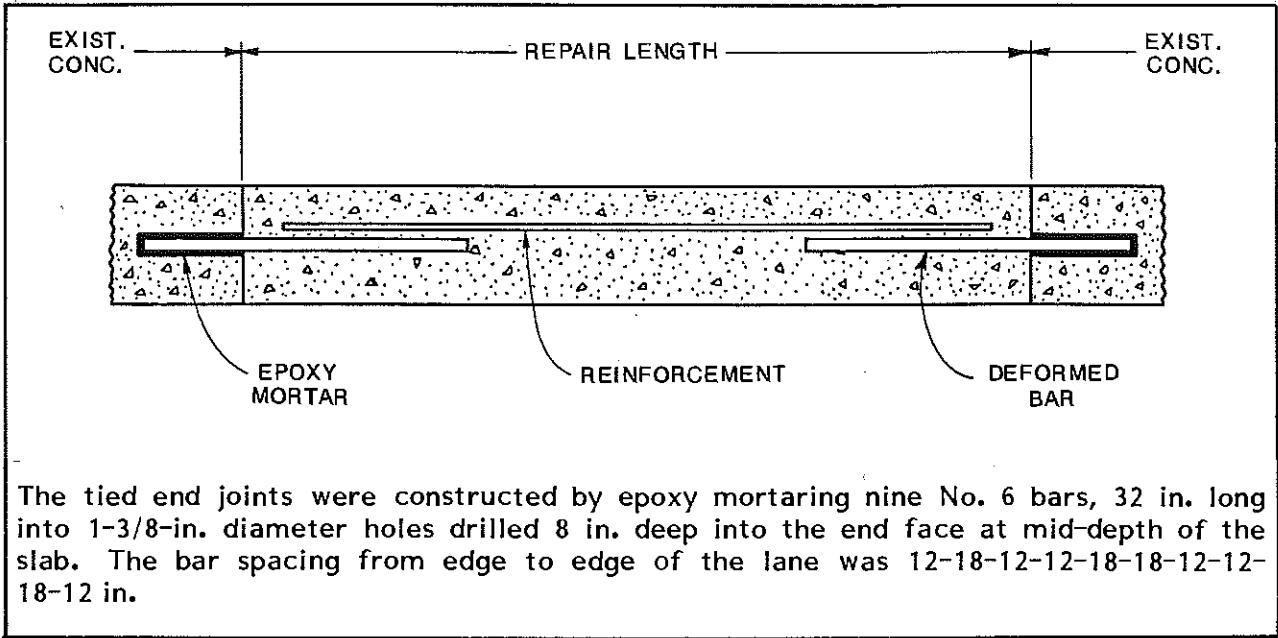
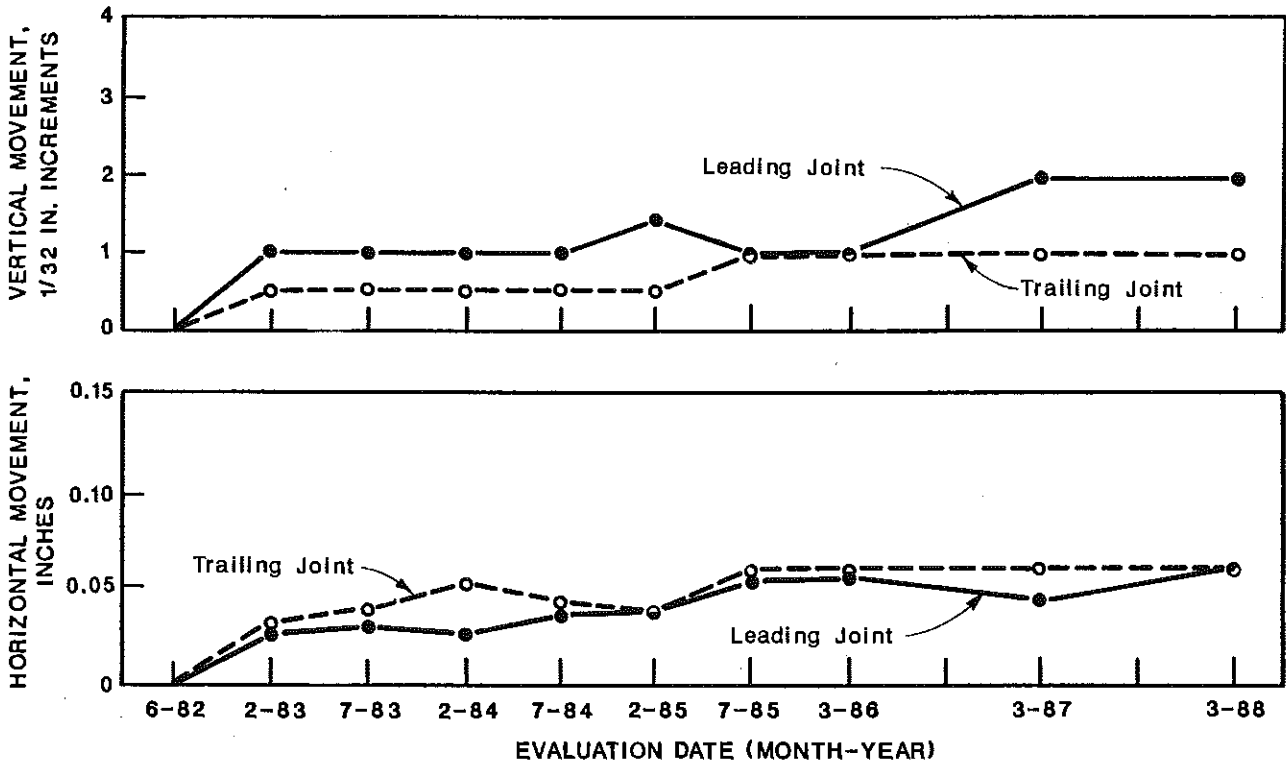
Tied end joints

The joints constructed with nine No. 6 deformed tie bars (Fig. 12) have performed just as well as the tied joints where No. 8 bars were used. The vertical movements have been in the 1/32 to 1/16 in. range and the horizontal movements stabilized at 0.06 in. in 1985.

Figure 12. Joint design and average vertical and horizontal movement at tied joints (stage 2 repairs on I 94, subjected to 1,800,000 ESALS).

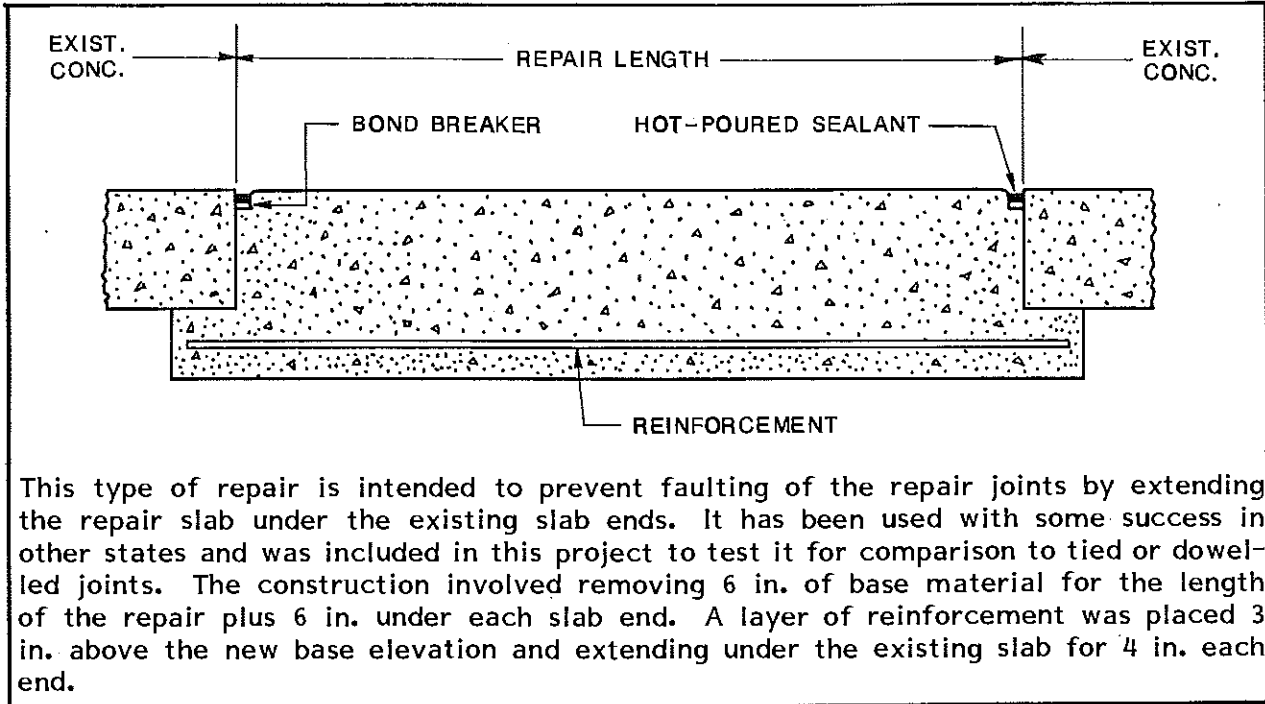
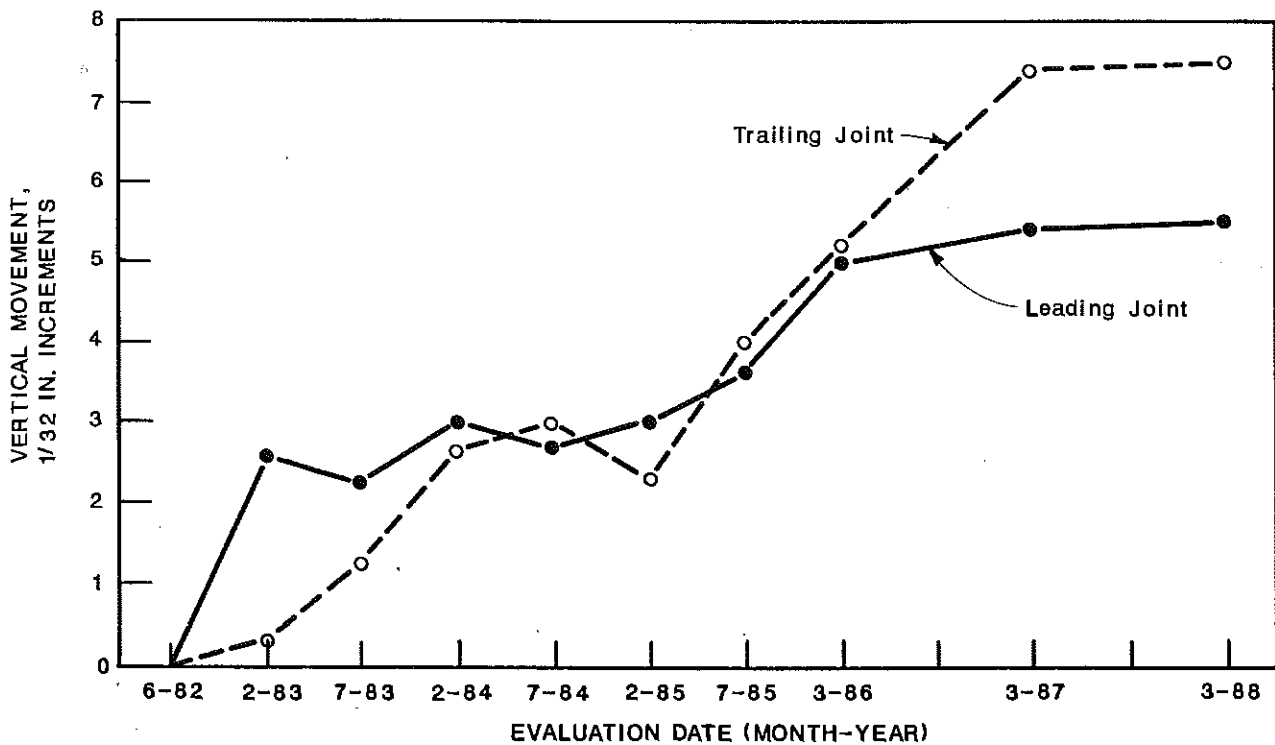
Inverted T-slab repair

The greatest vertical offset was measured at the inverted T-slab joints (Fig. 13). By the time the pavement was recycled the offset measured slightly over 5/32 in. at the leading joint and slightly more than 7/32 in. at the trailing joint.

Figure 13. Joint design and average vertical movement at inverted T-slab joints (stage 2 repairs on I 94, subjected to 1,800,000 ESALS).

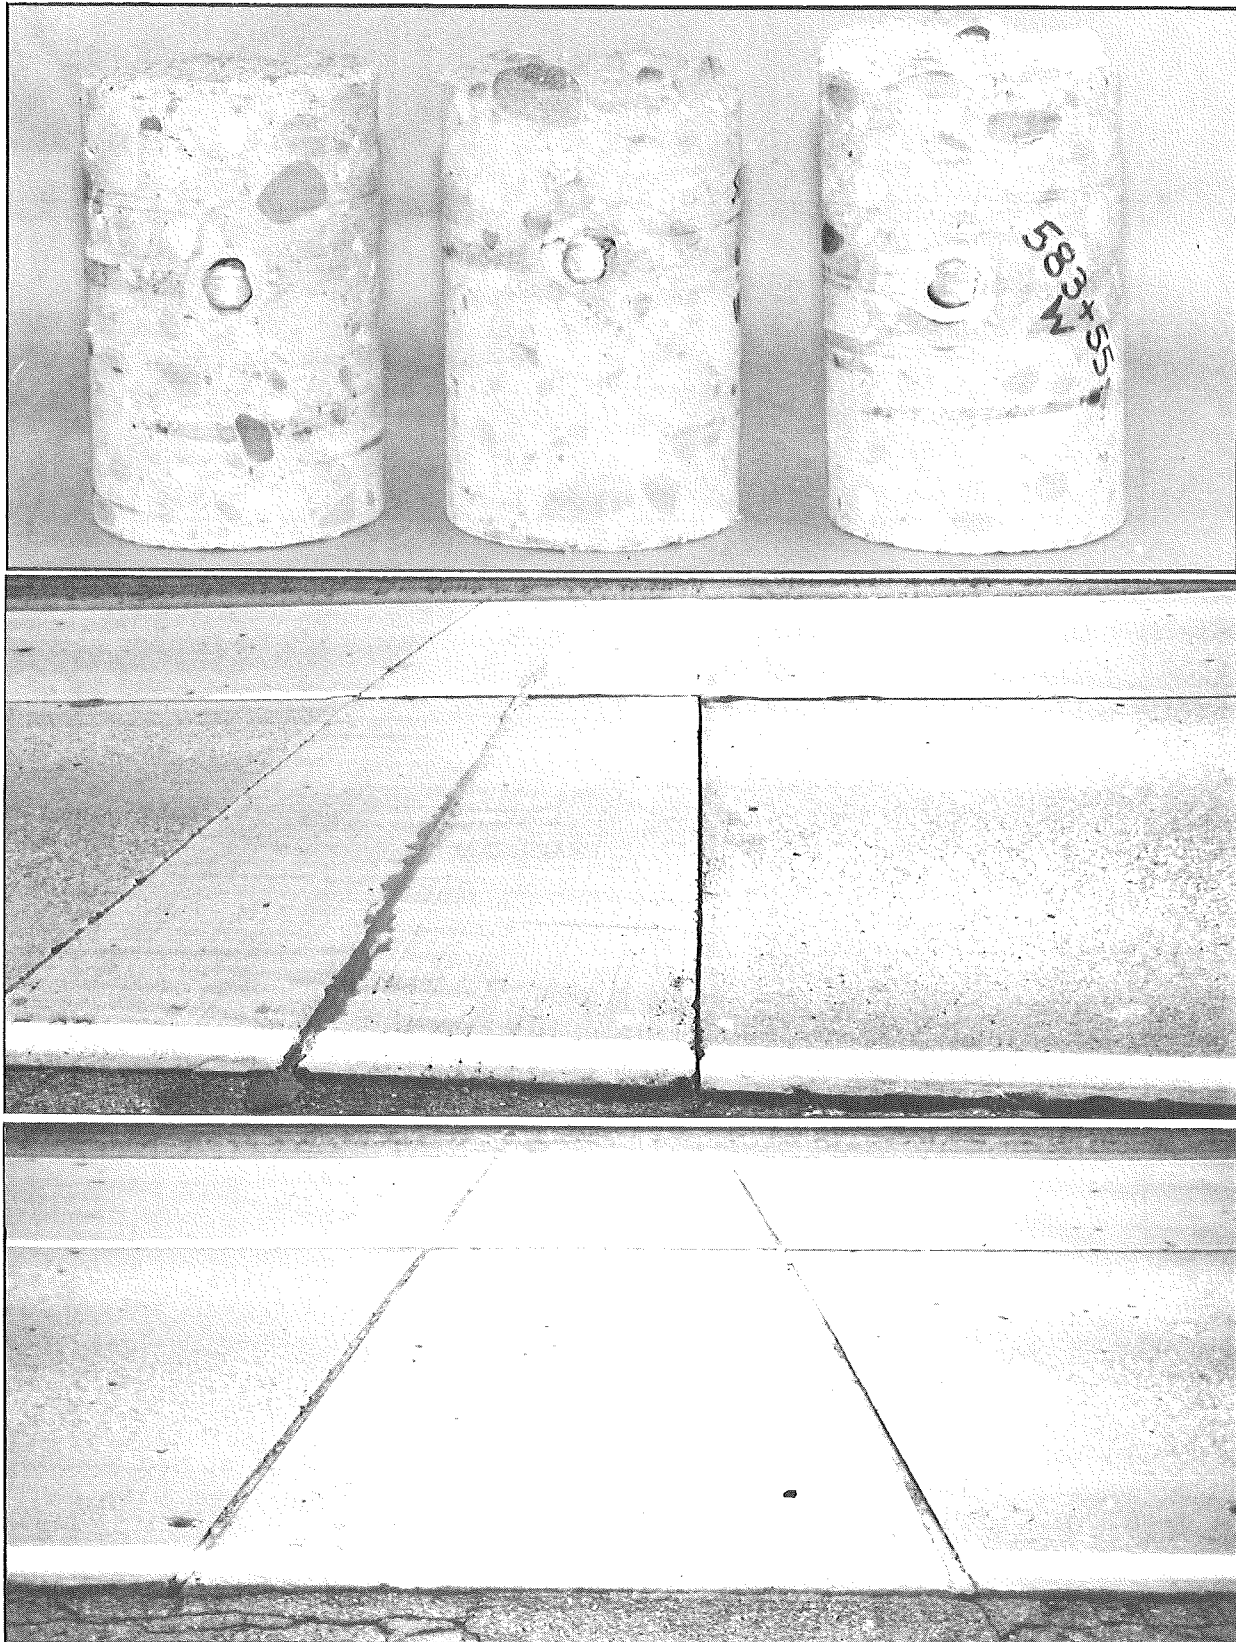
The performance of the tied end joints has been disappointing, because of their inability to prevent movements. The opening of the joints beyond the width of the step-cut negated their ability to prevent faulting. Based on the measurement of instrumented joints, the number of failures has progressed with time. After one year, 4 percent of the repairs had failed and now after six years of service 72 percent have failed. In contrast, the dowelled contraction joints have all performed excellently by maintaining their smoothness.

An investigation by coring through the tie bar locations revealed that the cause of the tie bar failure was an insufficient amount of epoxy grout placed in the holes prior to inserting the bars. In a few cases the failures were caused by improper proportioning of the two epoxy components used in the grout mix, which resulted in its remaining in a semi-plastic state. Figure 15 shows cores with failed bars, a failed tied joint repair after six years of service, and a good performing six-year old contraction joint repair.

Figure 15. Failed tie bars caused by insufficient amount of grout around the bars (top), condition of repair with open and faulted tied joints after six years service (center), and condition of good performing six-year old dowelled repair (bottom); stage 3 repairs on I 94 in Jackson County, subjected to 3,500,000 ESALS.

Advances in the grouting technology during the past few years practically eliminate the problems experienced on the I 94 contract project. Equipment is now available that dispenses the grout components accurately and mixes them in a special nozzle. The nozzle is of sufficient length so the grout can be deposited in the back of the horizontal holes and it is possible to calibrate the equipment so the exact amount of grout is placed in each hole. Thus, when the bar is inserted, a good bond along the entire length of the embedment is assured.
