PCC PAVEMENT JOINT RESTORATION
AND REHABILITATION
(Federal Highway Administration NEEP Project 27)
Final Report

J. E. Simonsen
A. W. Price

Research Laboratory Section
Materials and Technology Division
Research Project 79 F-159
Research Report No. R-1298

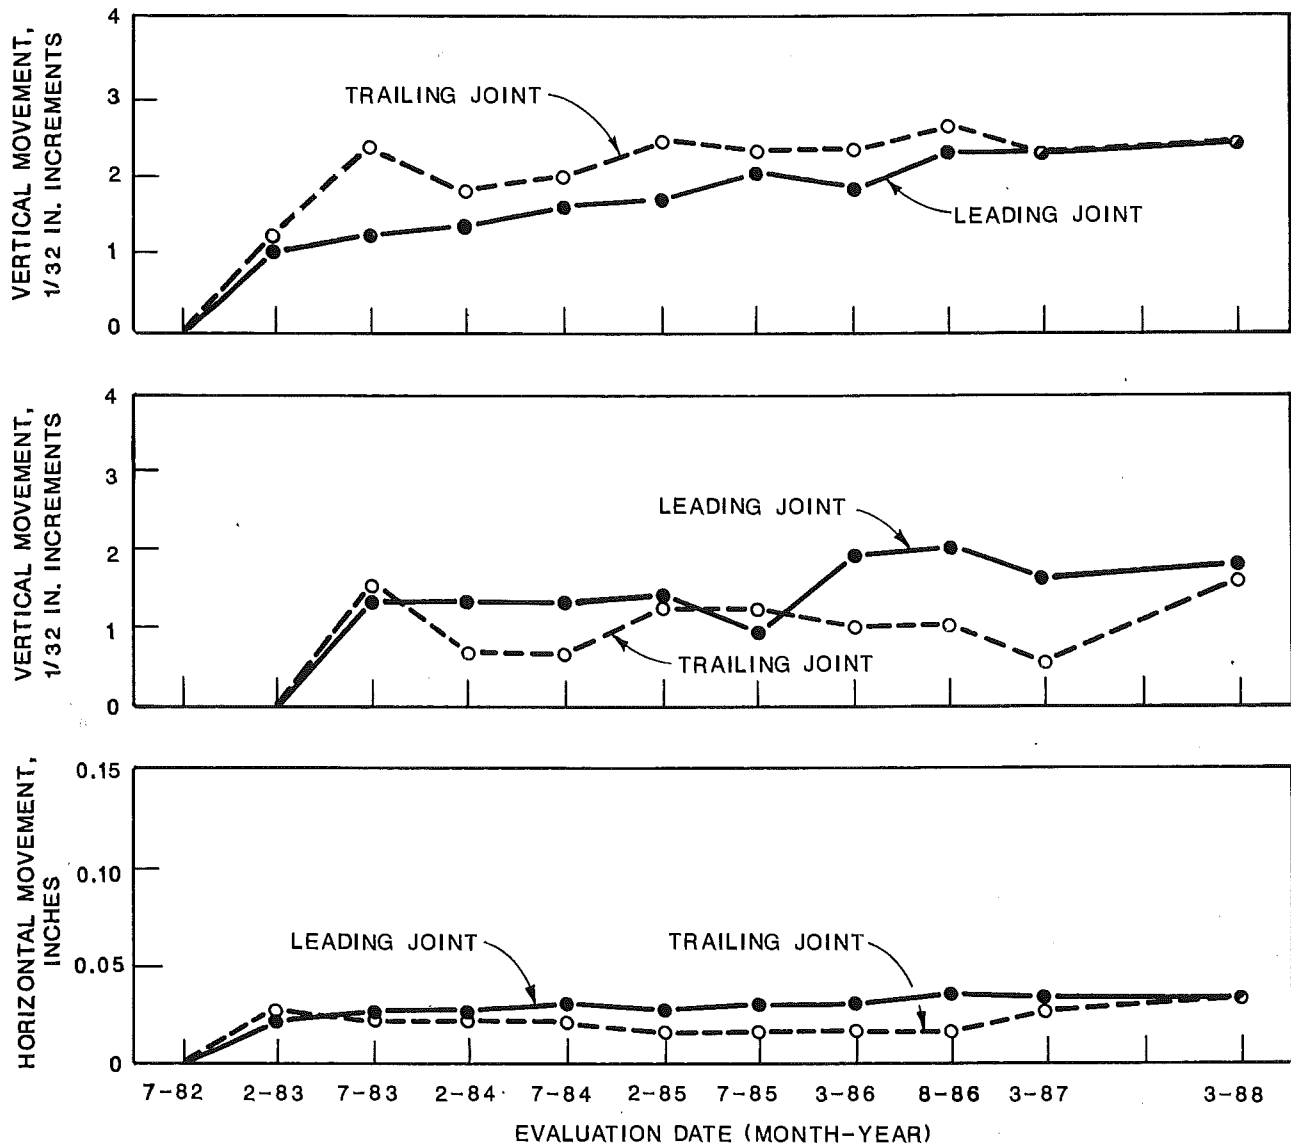
The performance of dowelled contraction joints and step-cut tied joints (with properly grouted bars) is shown graphically in Figure 16. As can be seen, the vertical offset at the dowelled joint has varied between 1/32 to slightly more than 1/16 in. throughout the performance period. Both the vertical and horizontal movements at the tied joints have been very small. The vertical offset has been less than 1/16 in. and the horizontal movements have never exceeded 0.04 in.

Figure 16. Average vertical movements at dowelled joints (top), at tied joints (middle), and horizontal movement at tied joints (bottom) on stage 3 repairs (I 94 in Jackson County), subjected to 3,500,000 ESALS.
