TRANSVERSE JOINT PROBLEMS

**Report No. 327
Research Laboratory Division
Office of Testing and Research
Research Project 39 F-7(14)**

**Michigan State Highway Department
John C. Mackie, Commissioner
Lansing, April 1960**

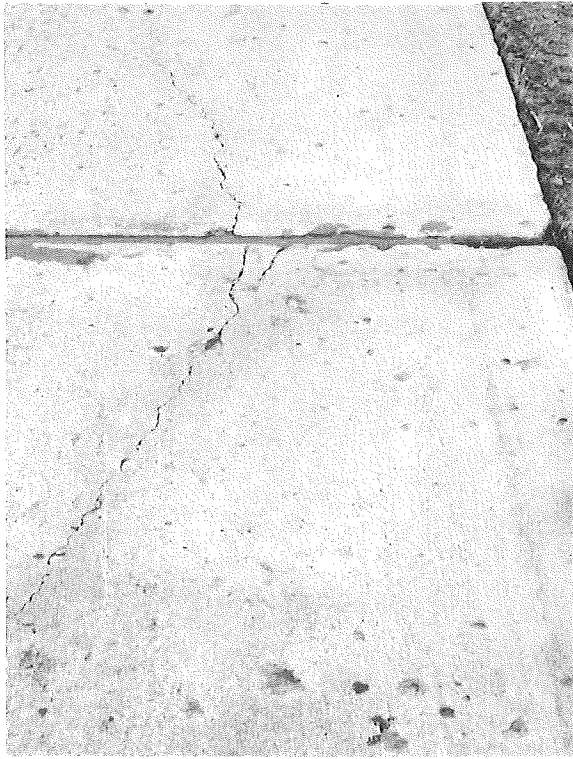
Sta 201+16, Proj 47-26, C6; constr 1949
(Nov '56)

Longitudinal cracks appear at various distances from the pavement edge and not necessarily over dowels. They usually develop and remain parallel to the pavement edge, extending from the joint face for only a few feet. The cracks are held tight by reinforcement. Typical examples of longitudinal cracking are shown in Figure 1.

Figure 1. Typical longitudinal cracking.

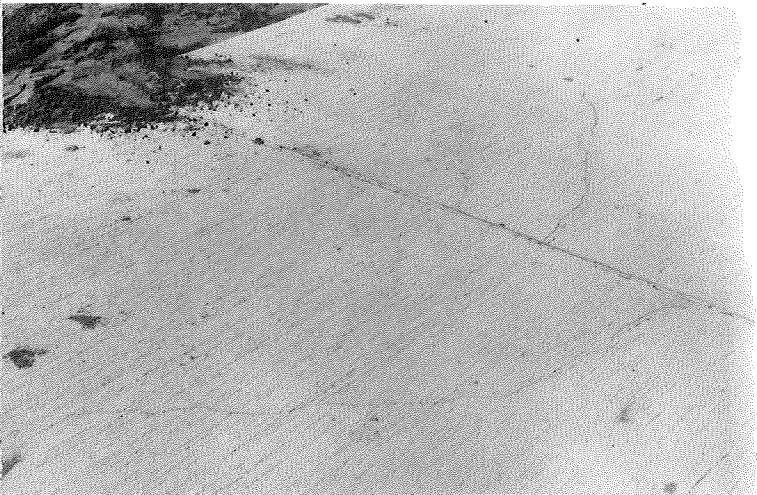
Sta 298+76, Proj M 23-17, C14XI, constr 1957
(July '57) Corner cracking before opening to
traffic, possibly caused by construction equipment.

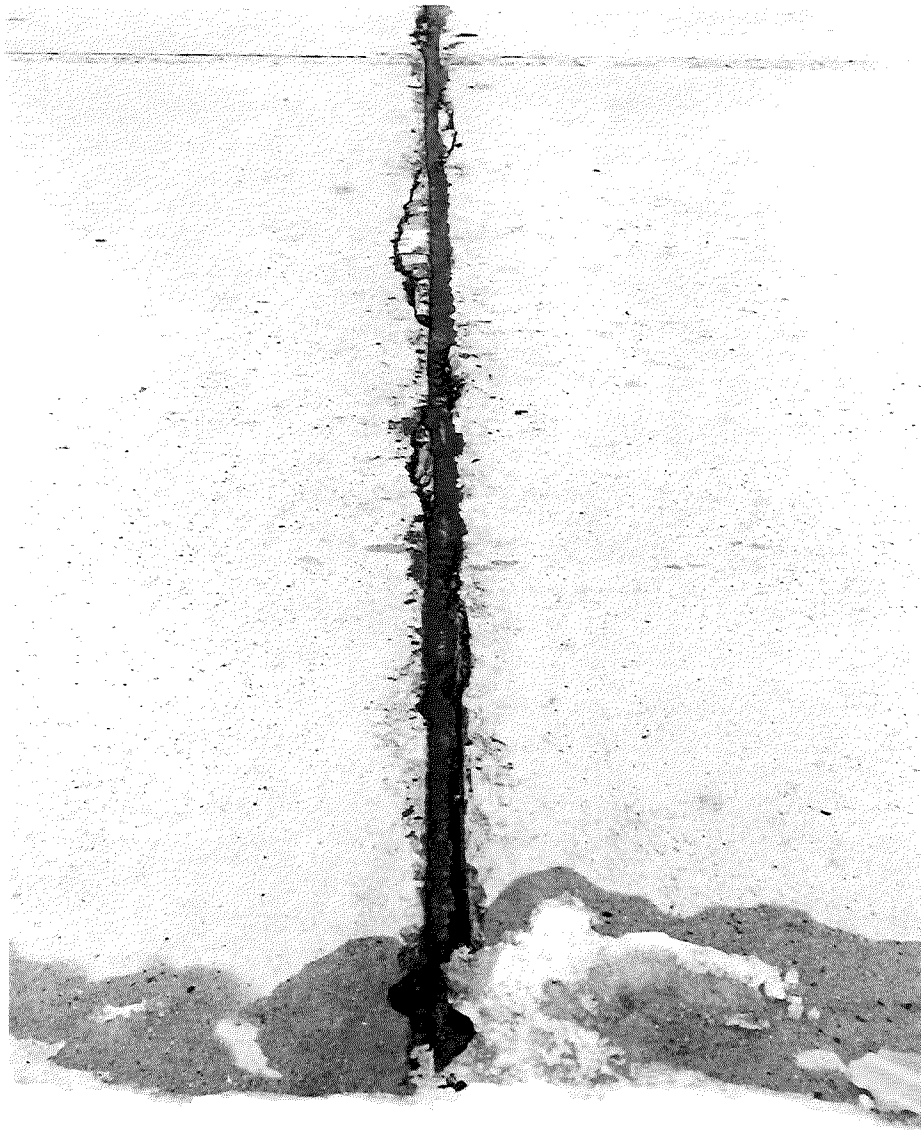
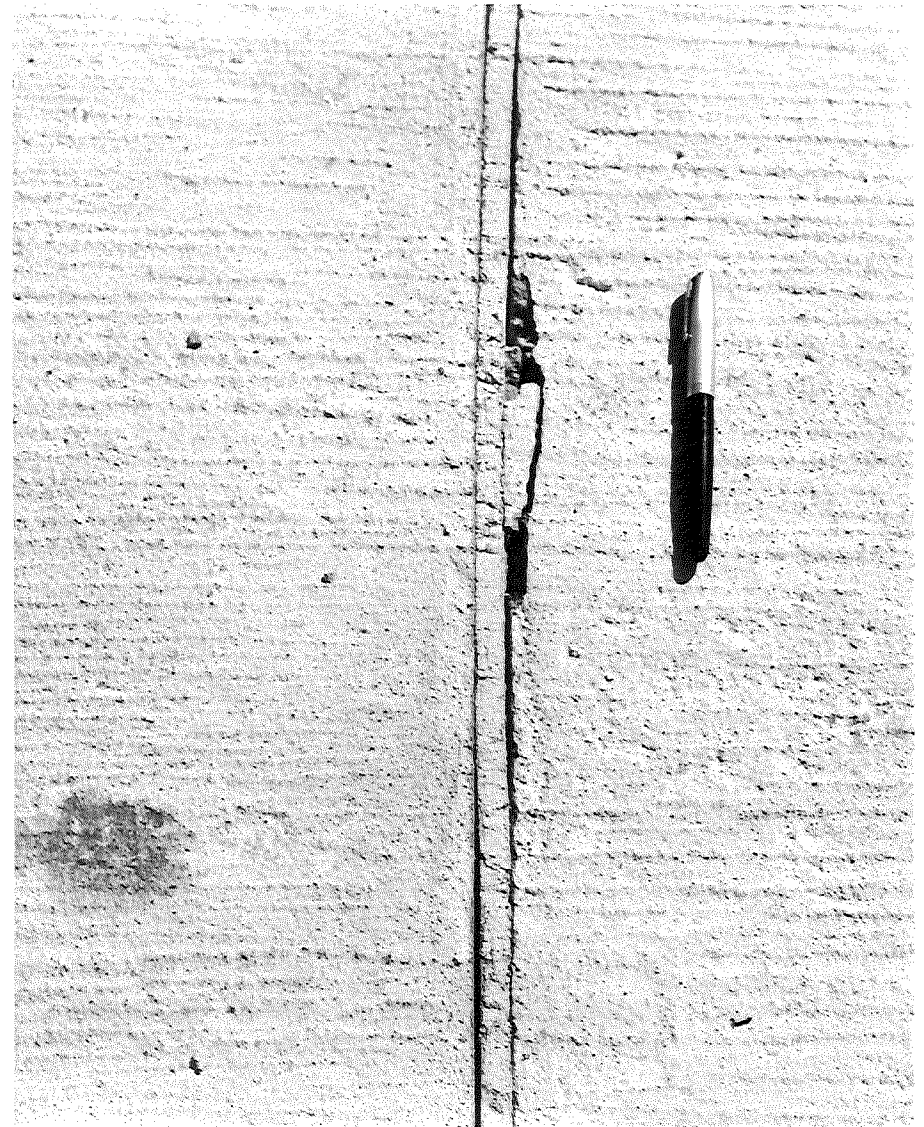
At transverse contraction joint grooves, spalling may occur whether a joint was formed by inserting a mandrel as was formerly the standard practice, or formed with styrofoam as is now customary (Fig. 2).

Figure 2. Spalling at groove edges of transverse contraction joints formed by inserting a mandrel (left) or styrofoam strips (right).

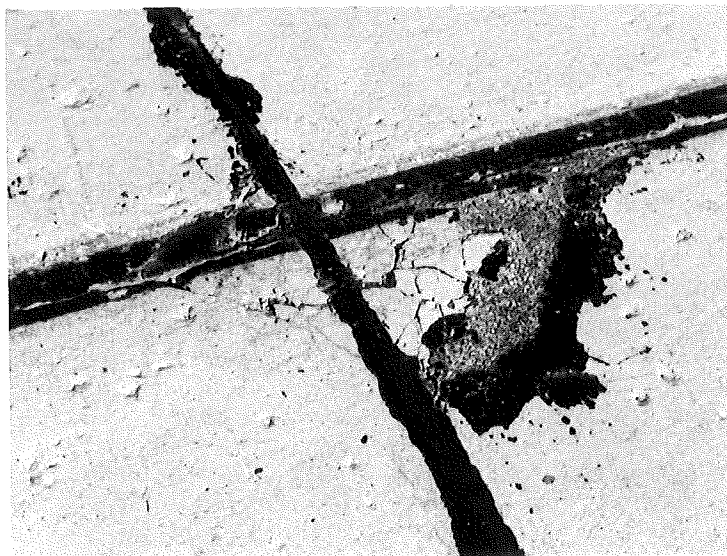
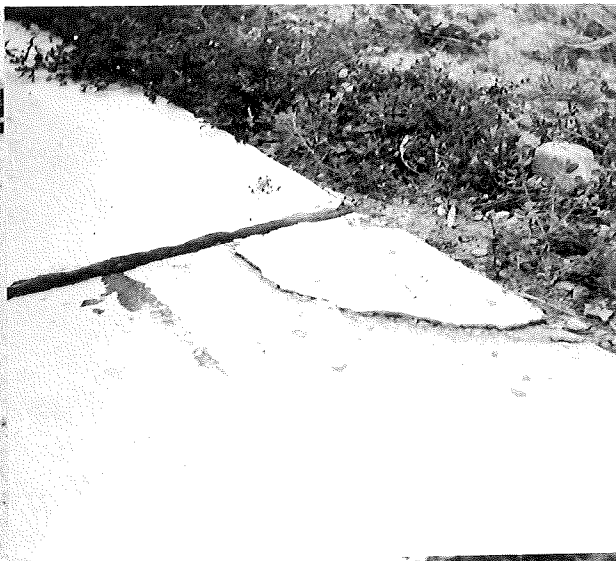
Figure 3 illustrates typical spalling at the intersection of transverse and center longitudinal joints. This type of spalling is more prevalent than transverse joint groove spalling, and can become a serious maintenance problem.

▲ Figure 3. Typical spalling at intersecting transverse and longitudinal joints. Sta 76+13; Proj 28-38, C2; constr 1948 (July '56)

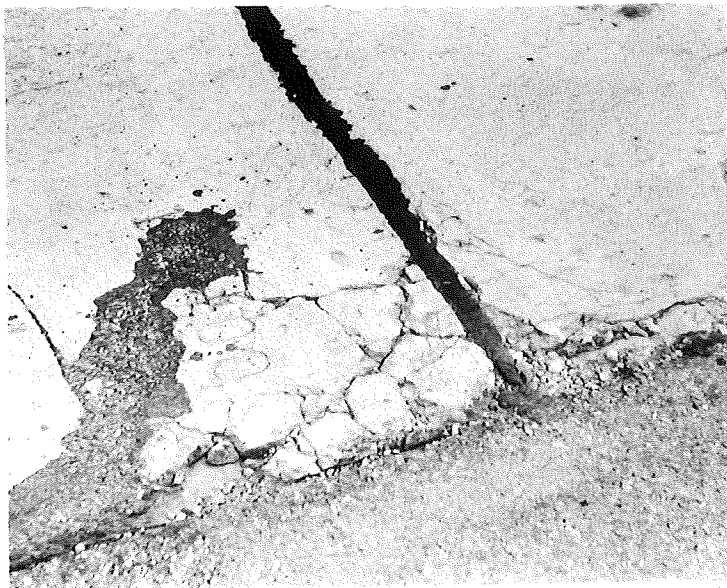
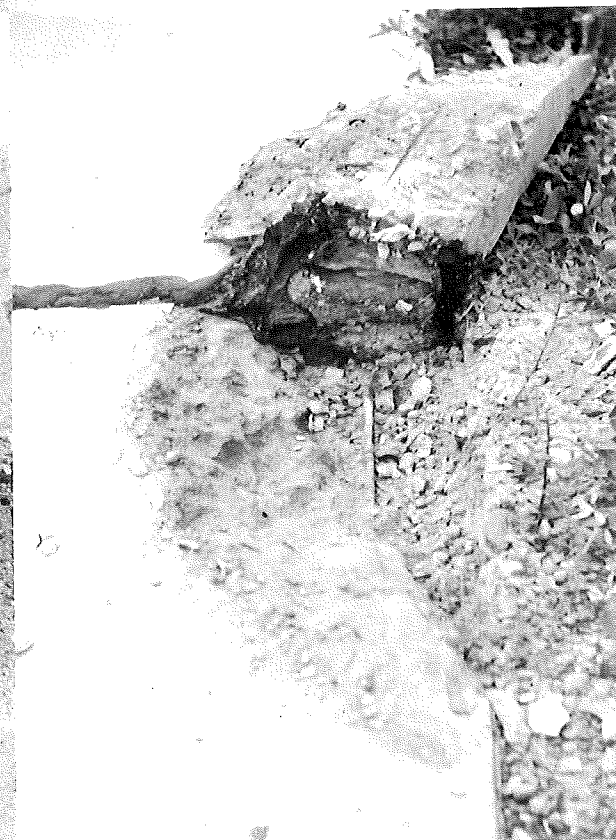
This common spalling type may appear to be superficial, but further examination may show a serious impairment of the structural soundness of the pavement slab, as in Figure 4. Other examples are shown in Figure 5.

▲ Figure 4. Surface appearance of a pavement edge spall (top), with view of same joint after removal of spalled concrete (bottom). Sta 1016+83, Proj 39-40, C4; constr 1954 (Nov '54)

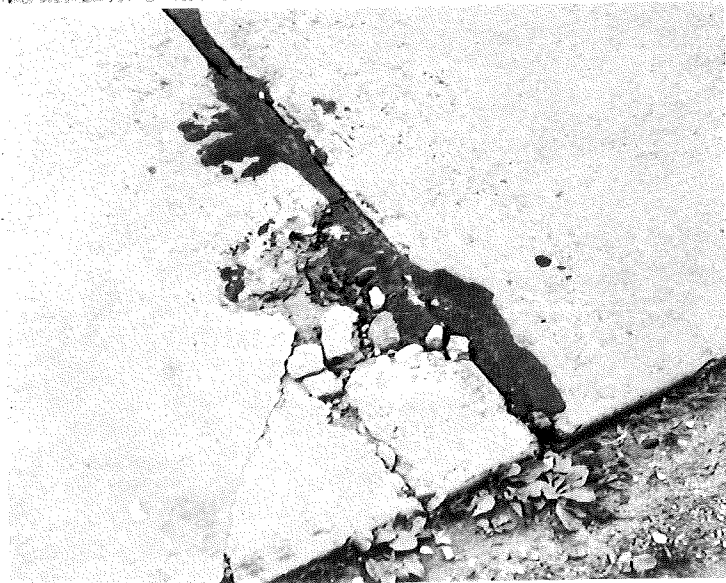
◀ Figure 5. Surface appearance of two pavement edge spalls on a 10-year-old project. Proj. 17-7, C6; constr 1947 (Sept '57)

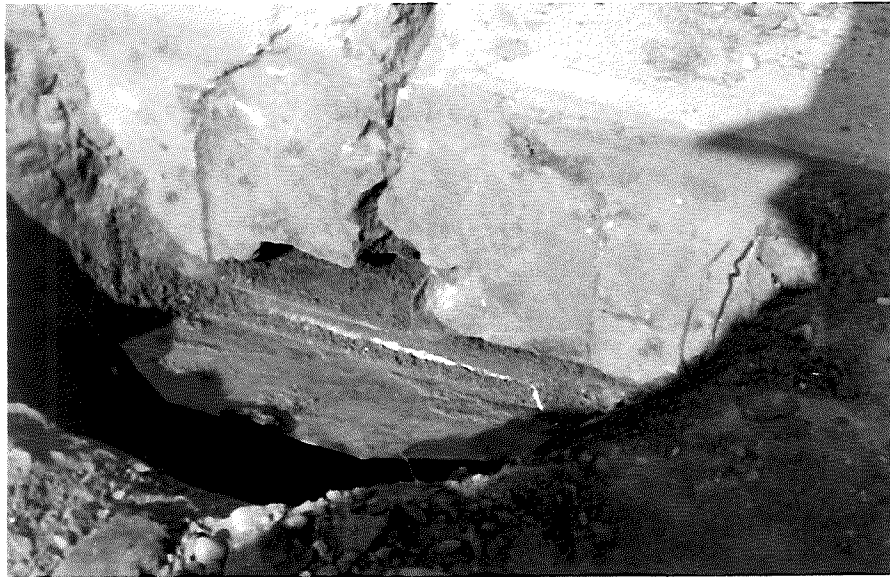
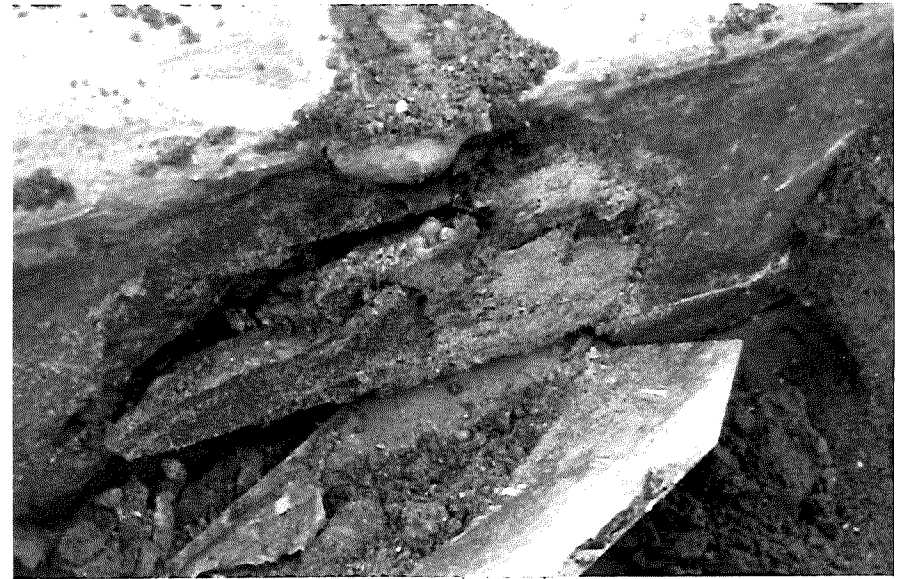
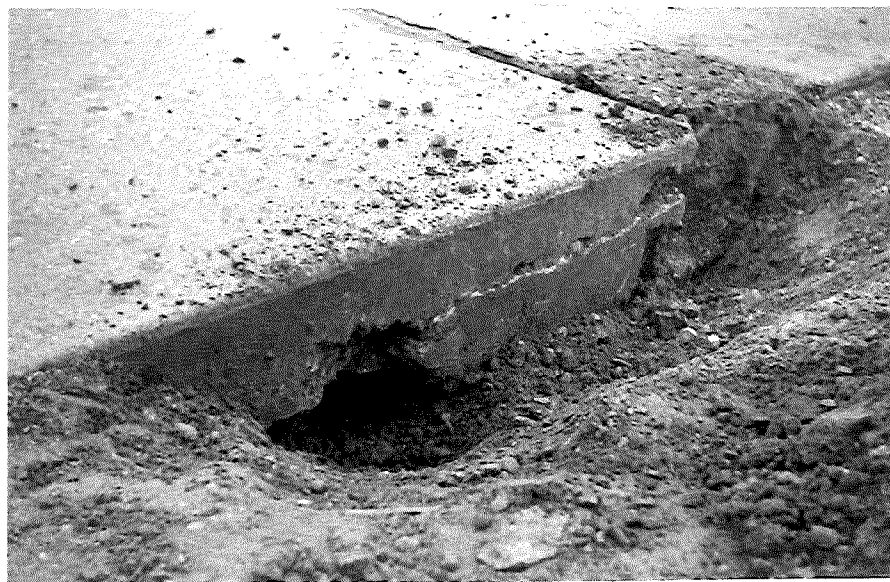
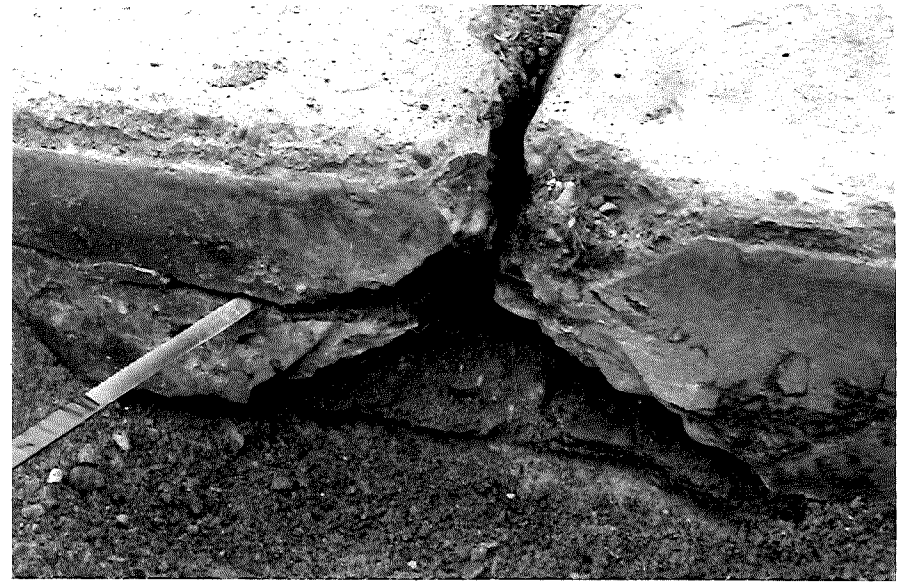
Examination of several projects has revealed serious spalling at the bottom edges of slabs at transverse contraction joints. This spalling condition has several aspects, a few of which are illustrated in Figure 6. In most cases, this condition may exist for some time without affecting the normal appearance of the slab surface, and thus escape detection.

Figure 6. Slab bottom spalling at four joints, exposed by excavating; pavement ages of 3, 4, 7, and 8 years.

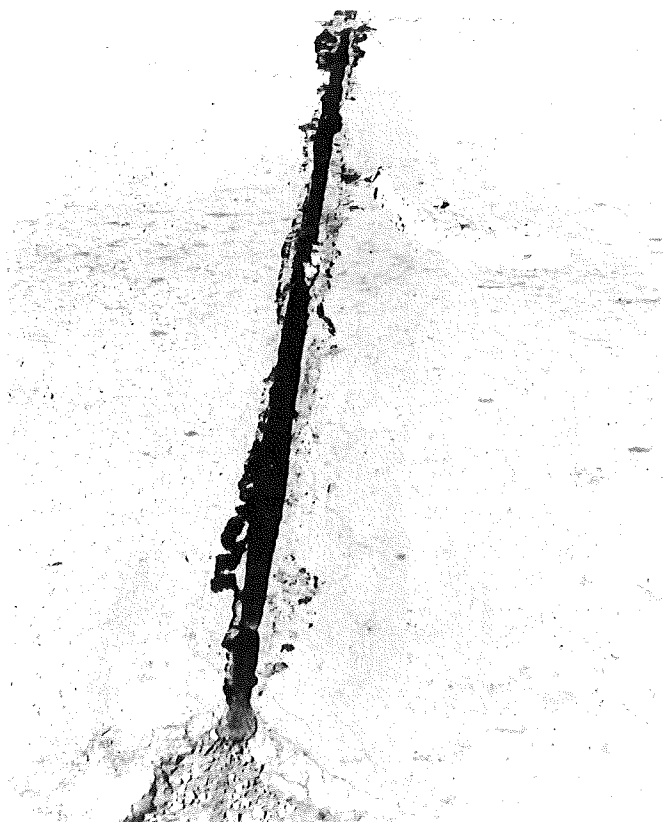
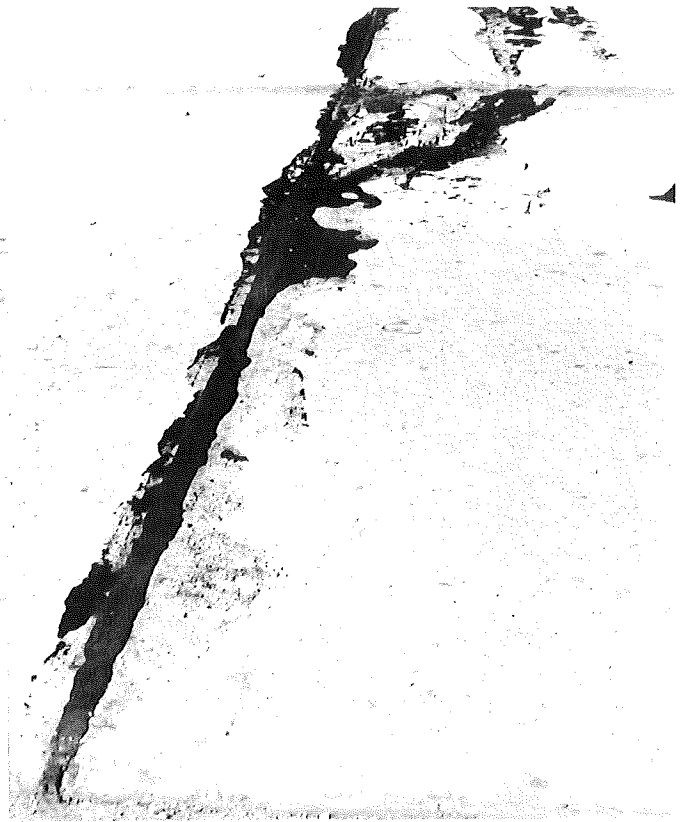
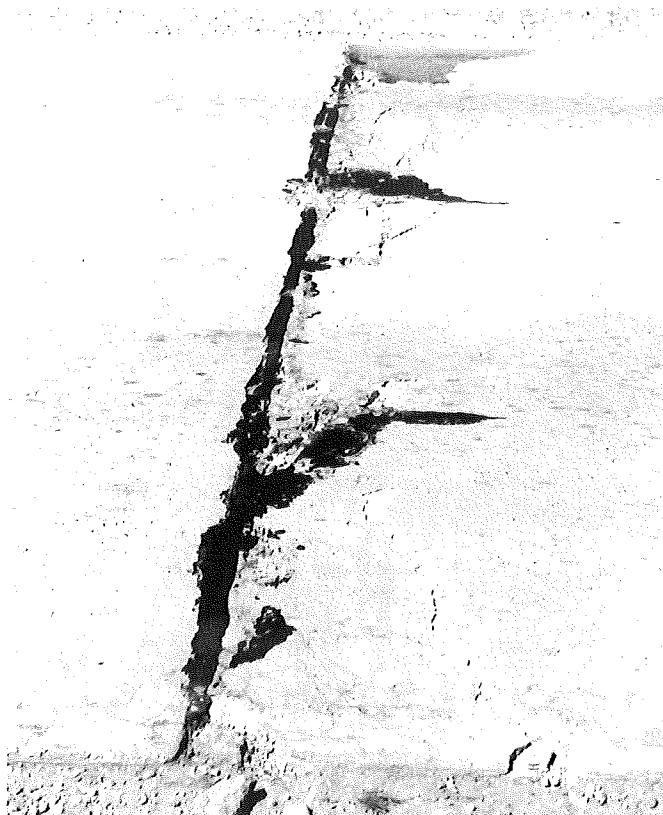
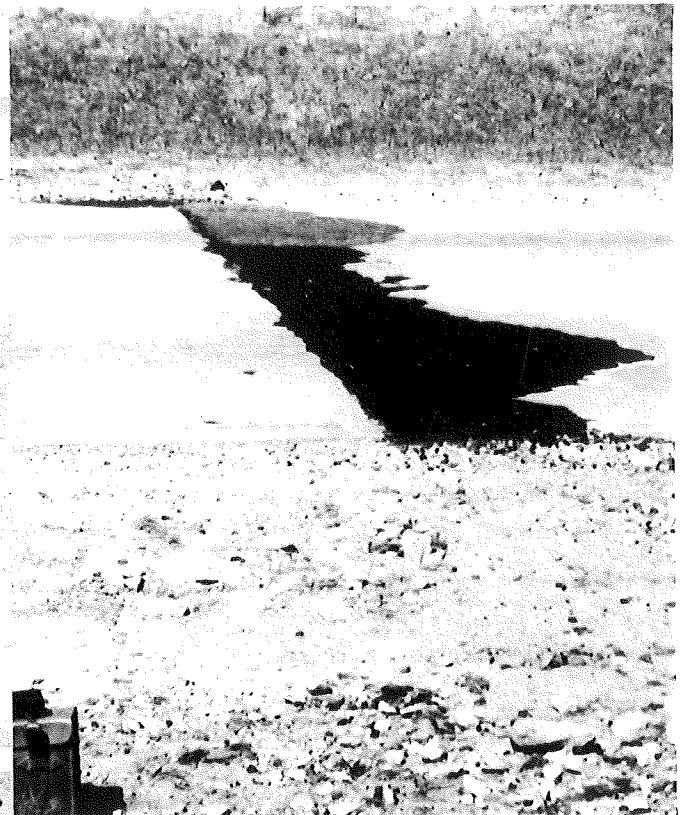
Figure 7. Typical steps in concrete "blow-up" failure: 1) initial spall, 2) progressive spalling, 3) concrete breakdown along the transverse joint, and 4) removal of crushed concrete for local patching. Note typical failure along only one edge of the joints in this 10-year-old pavement.
Project 72-7, C5; constr 1947 (May '57).

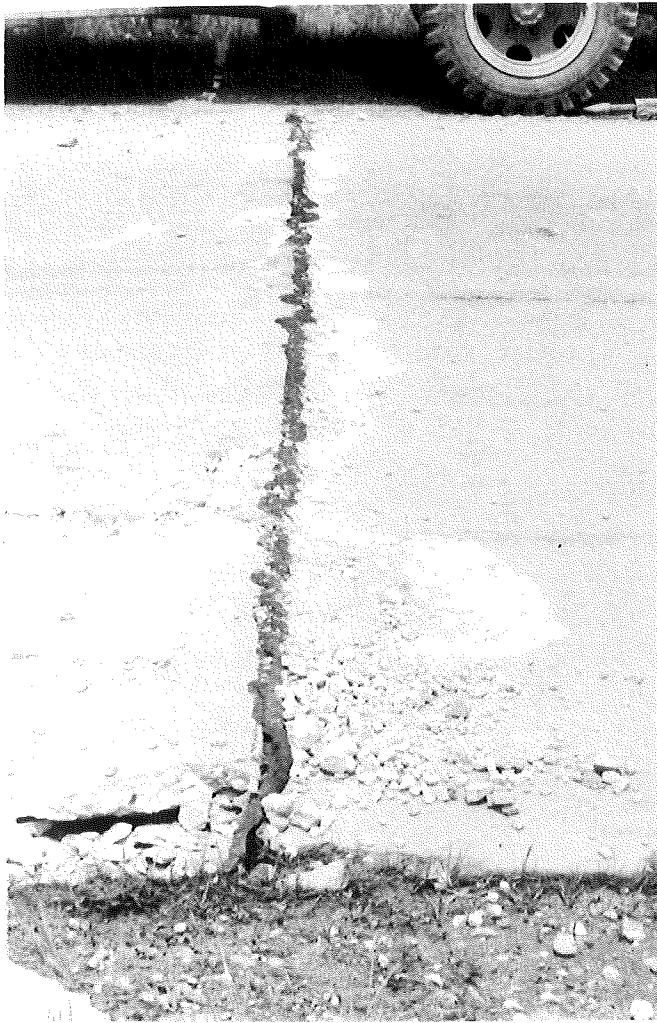
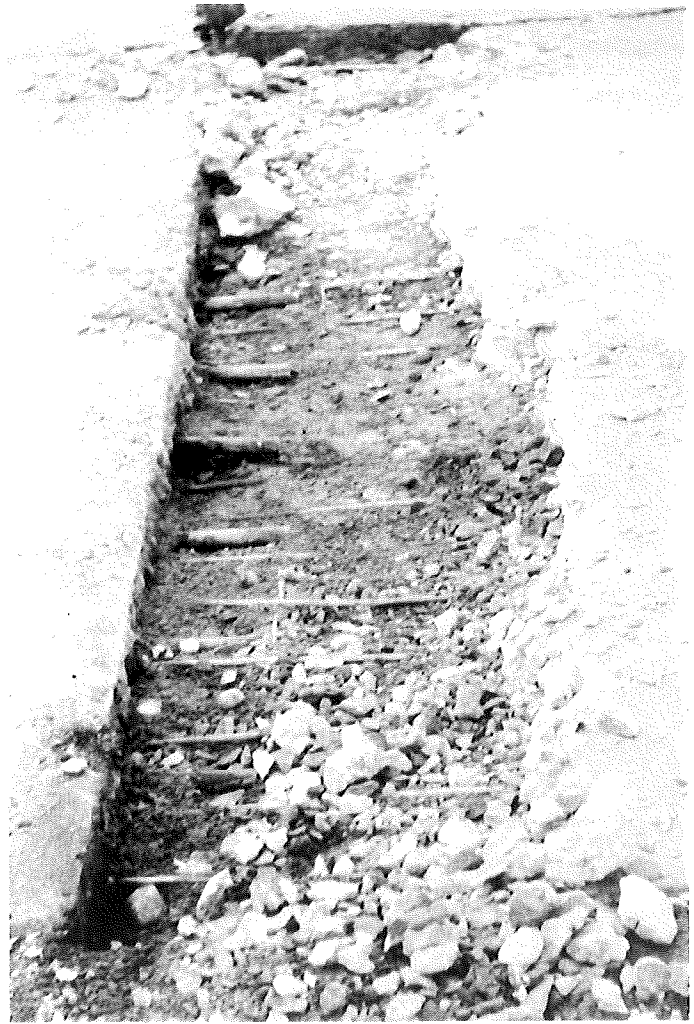
The use of inferior or imperfect dowel assembly devices in the past has complicated the joint failure picture. Assembly devices which do not hold the dowels securely in place permit the entire assembly of dowels to push upward, splitting the slab at the plane line of the dowels as shown in Figure 8; note how the entire assembly of dowels has moved vertically out of the dowel holding clips. Further, dowel assemblies incapable of holding the dowels firmly in place during placing of concrete can also cause trouble (Fig. 9). Finally, misplacement of dowel assemblies can cause joint failures (Fig. 10).

Figure 8. Joint failure in which dowel assembly device pushed upward, splitting the slab (left), with view after removal of overlying concrete (right). Proj 38-48, C5; constr 1952 (June '57).

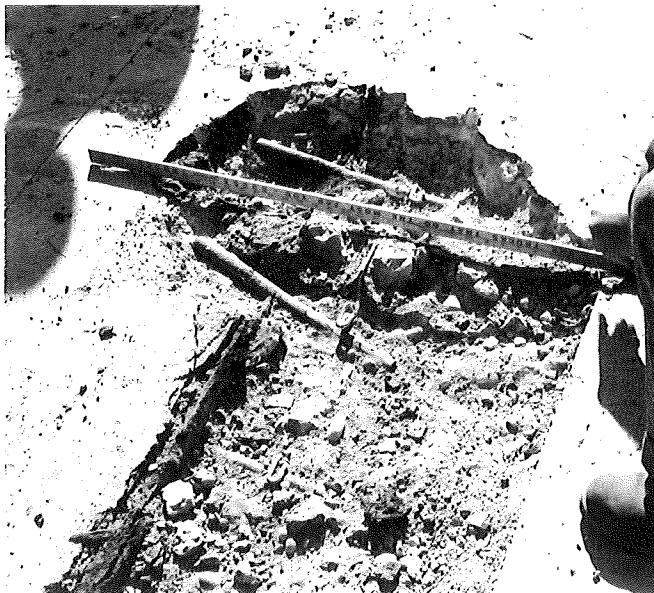
▲ Figure 9. Dowel misalignment during concrete placement, due to inability of assembly to hold dowels in place. Sta 56+27, Proj 63-67, C4; constr 1947 (Oct '52)

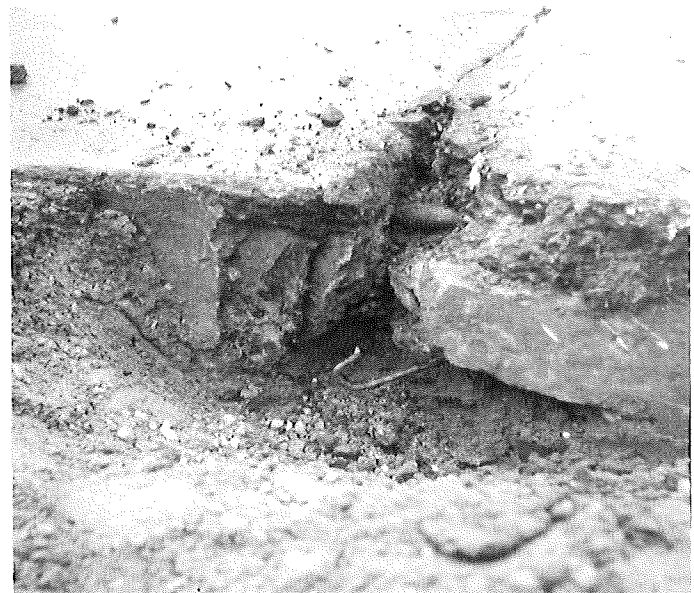
▲ Figure 10. Blow-up at joint with dowels and bar assembly too close to surface. Sta 297+22, Proj 72-7, C5; constr 1947 (Nov '54)

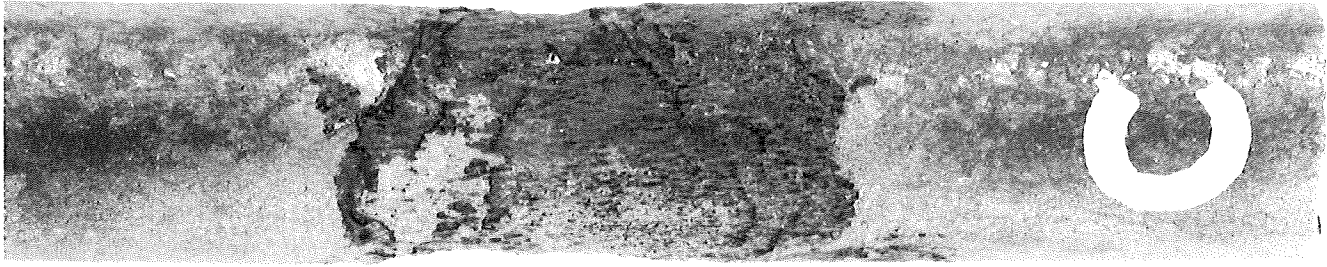
The extent to which dowel corrosion may influence joint failures has been difficult to determine; however, evidence gained from examining joint failures indicates that this factor may have had considerable effect in certain cases (Figs. 11 and 12).

Figure 11. Corroded dowel bar taken from joint shown in Fig. 8, recovered after about 5 years in pavement.

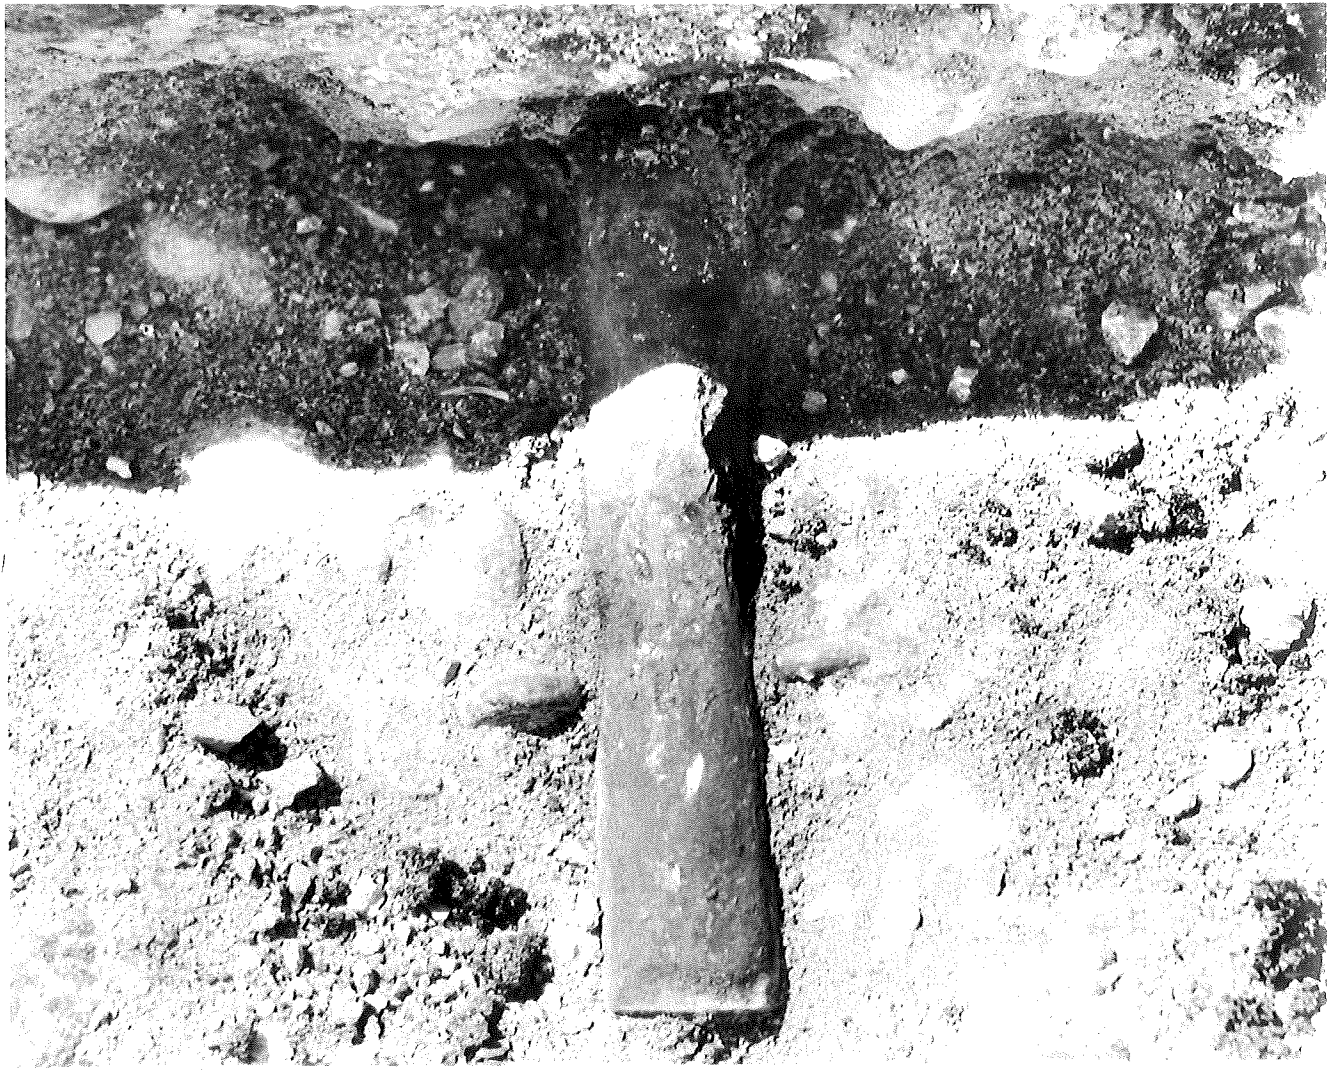
Figure 12. Corroded dowel in place in 9-year-old pavement. Sta 496+25, Proj 72-7, C5; constr 1948 (May '57).

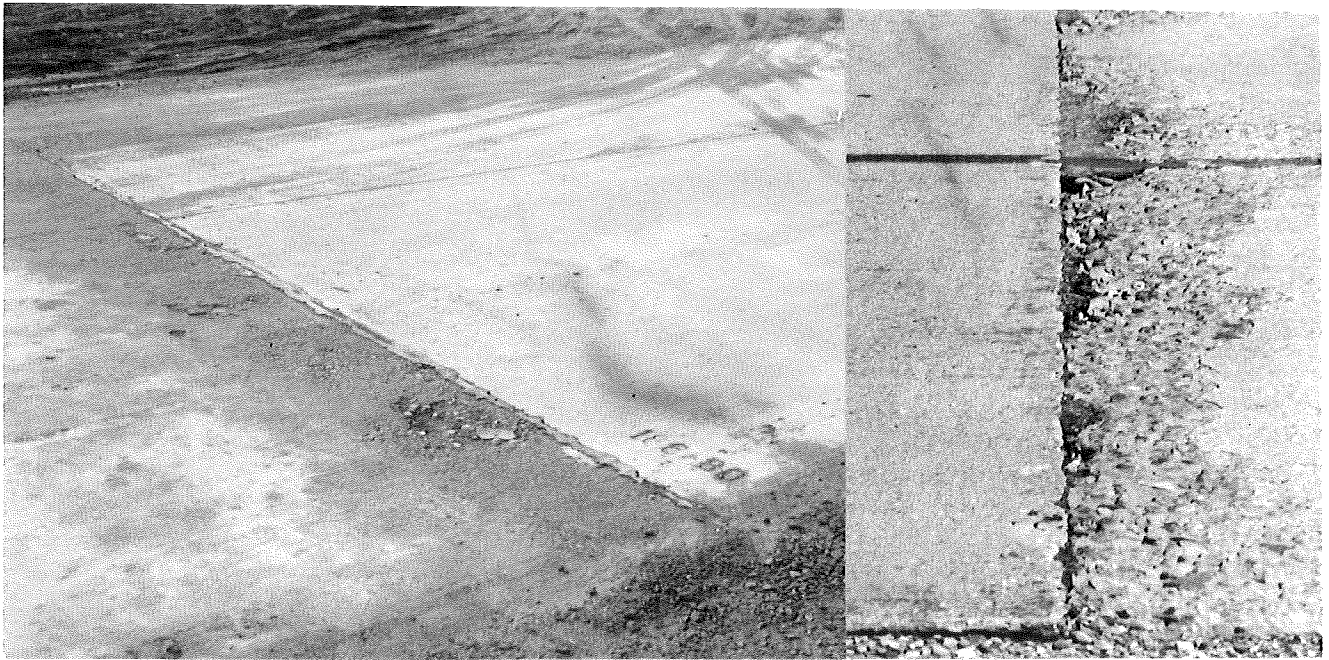
First, invariably it seems that the concrete placed at the end of a day's run is inferior to that placed at the beginning of the next day's pour. This weakness is not so easily discernible in the case of air-entrained concrete, but eventually when a failure does occur at a construction joint, concrete in the slab at the end of the previous day's pour almost always fails first.

The visible difference in concrete quality for separate pours is demonstrated in Figure 13, which shows both air-entrained and non-air-entrained pavements. On concrete without air entrainment, the difference in concrete quality is usually more pronounced.

Figure 13. Views of construction joints, showing different concrete qualities of two day's pours, in air-entrained pavement (left) and non-air-entrained pavement (right).

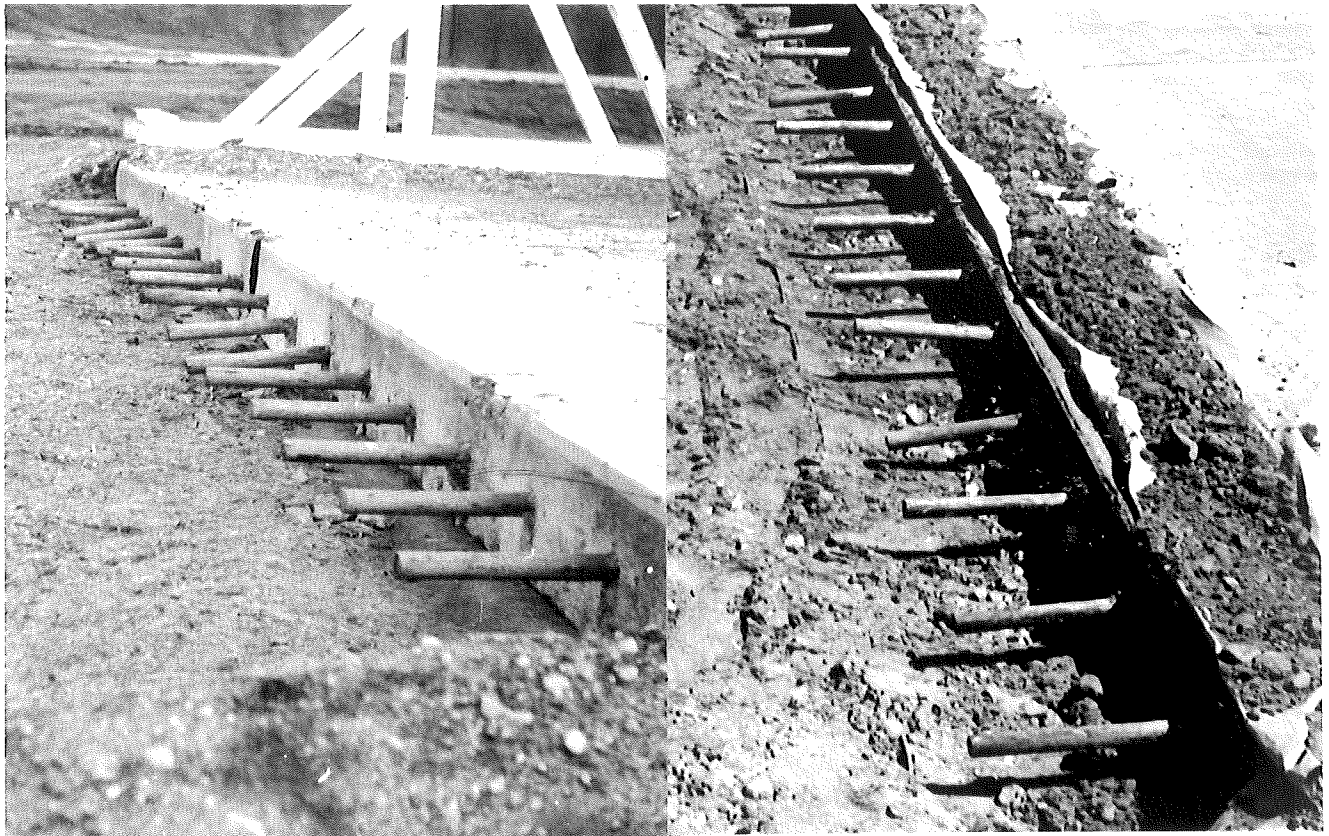
Second, the misalignment of dowels at a construction joint often triggers a joint failure. Examples of poor dowel installations at construction joints are illustrated in Figure 14.

Figure 14. Typical dowel misalignment at construction joints on two projects.

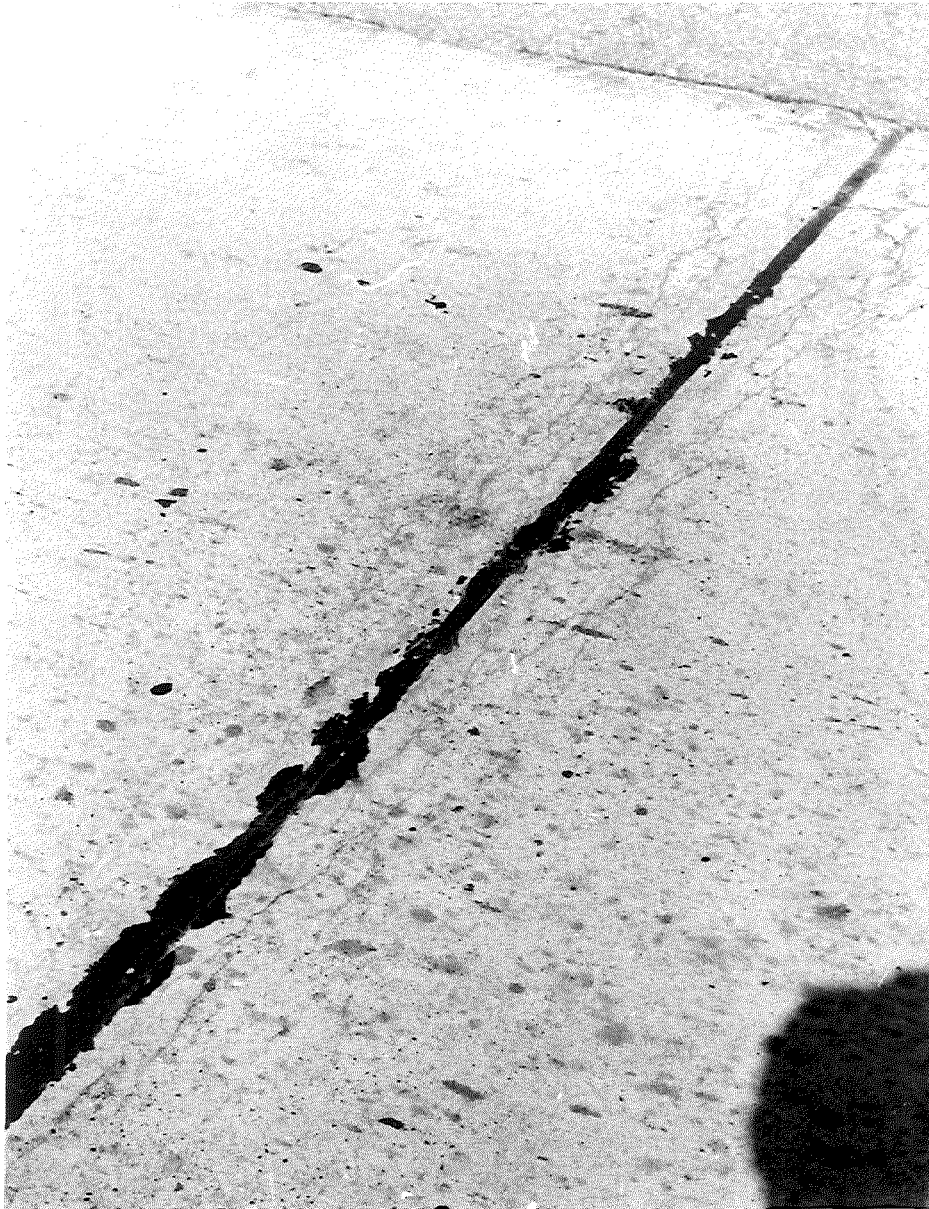
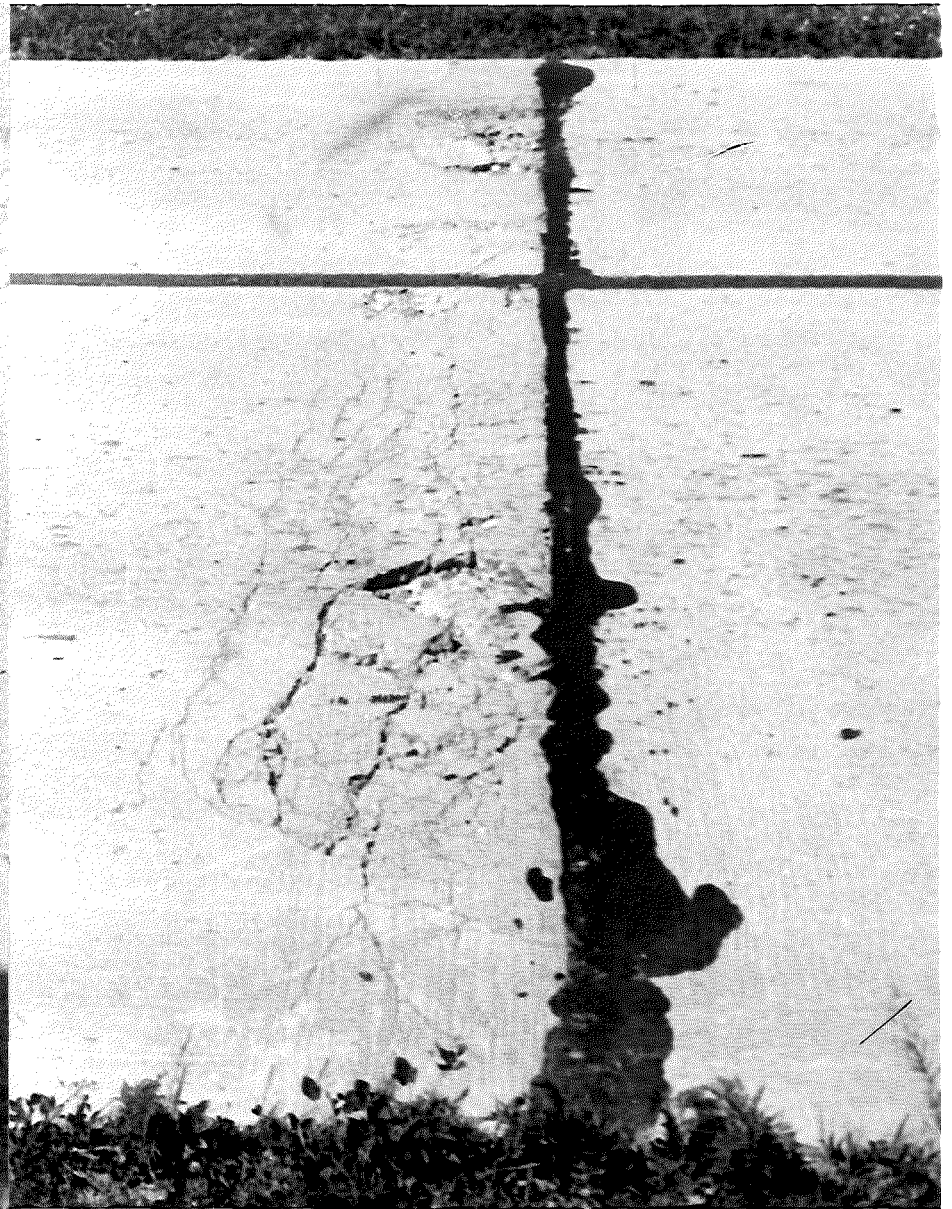
The causes of compression cracking are unknown, but this phenomenon may be associated with the physical properties of the concrete in relation to faulty joint construction and high-concentration compressive stresses. Figure 15 shows compression cracking parallel to two transverse joints, at early and advanced stages of development.

Figure 15. Compression cracking at two joints, at early (left) and advanced (right) stages of development.

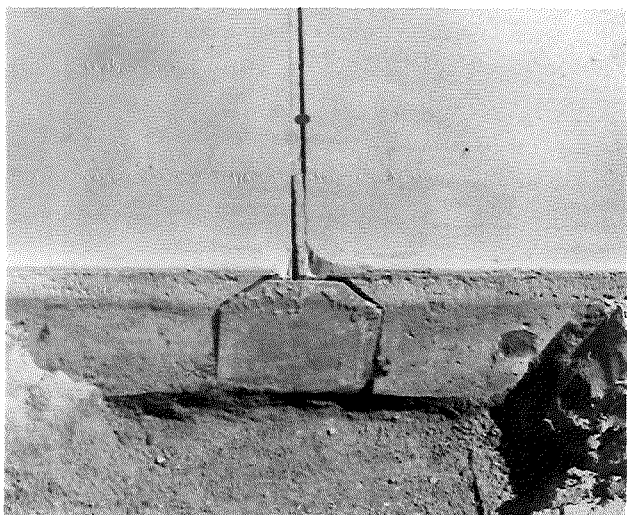
The shoulder face of a transverse joint was excavated.

Figure 16. Examination of a joint ready for sealing on a new project.
Sta 208+76, Proj 23-17, C14RN; constr 1956.

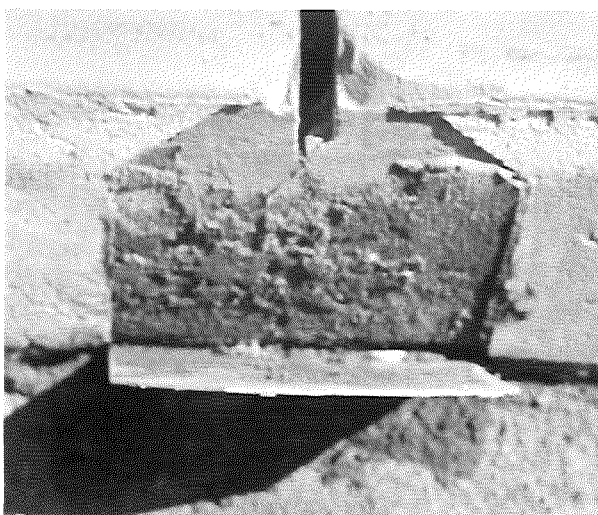
The steel end plate was turned down, revealing a deposit of packed fine sandy soil.

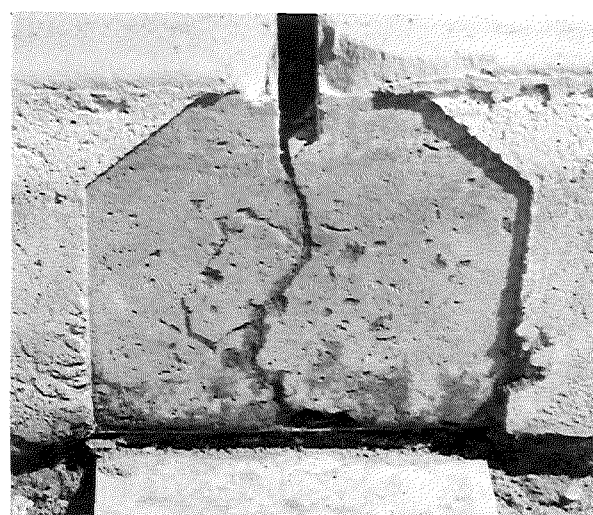
When this excess soil was removed, additional compacted soil was found in the joint crack.

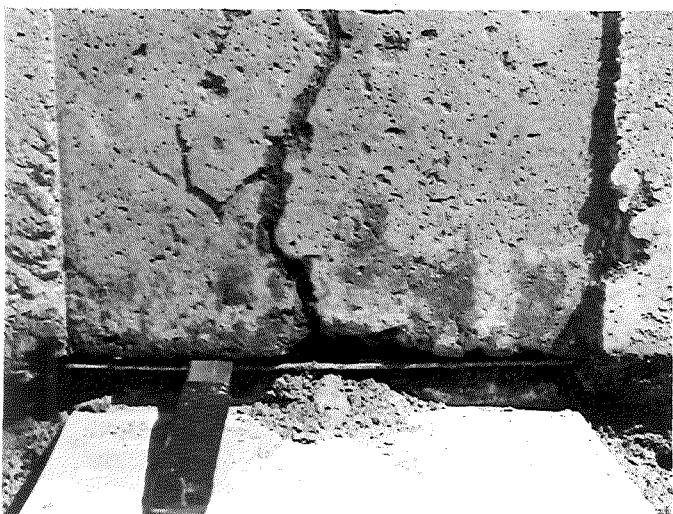
An example of what can take place is shown in Figure 16. Soil material filtering in between the slab and base plate, or compacting within the joint crack, or collecting in the joint groove, under proper circumstances could induce early joint spalling at the pavement edge and so-called longitudinal restraint cracking.

The base plate was found to be depressed, and the space between the plate and slab filled with fine soil.

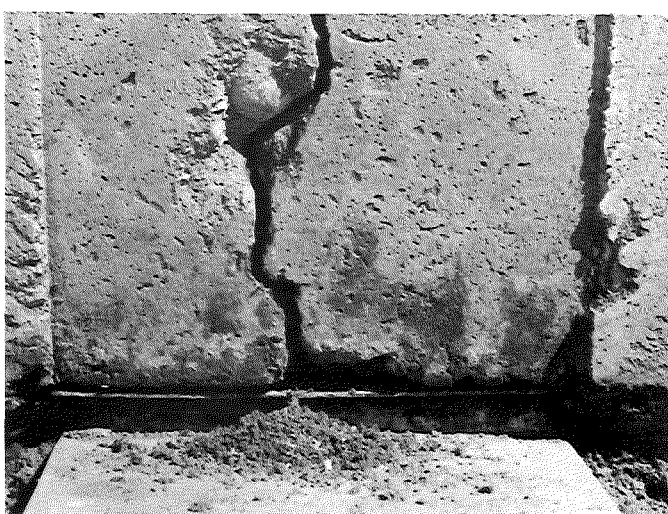
The joint crack after removal of soil material near the slab edge.

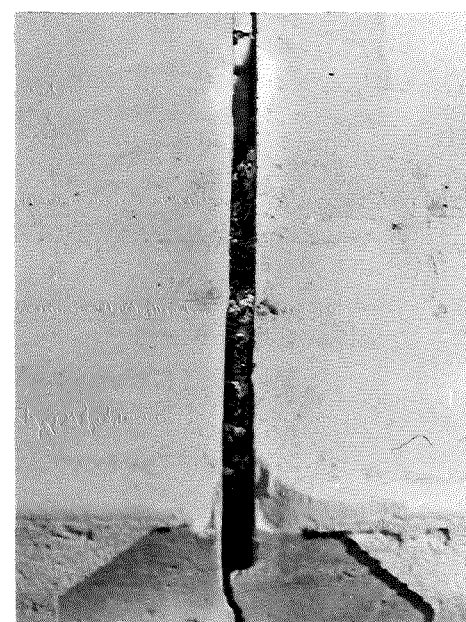
Additional material was found to have filtered in around the styrofoam material in the joint groove.
