TRANSVERSE JOINT PROBLEMS

**Report No. 327
Research Laboratory Division
Office of Testing and Research
Research Project 39 F-7(14)**

**Michigan State Highway Department
John C. Mackie, Commissioner
Lansing, April 1960**

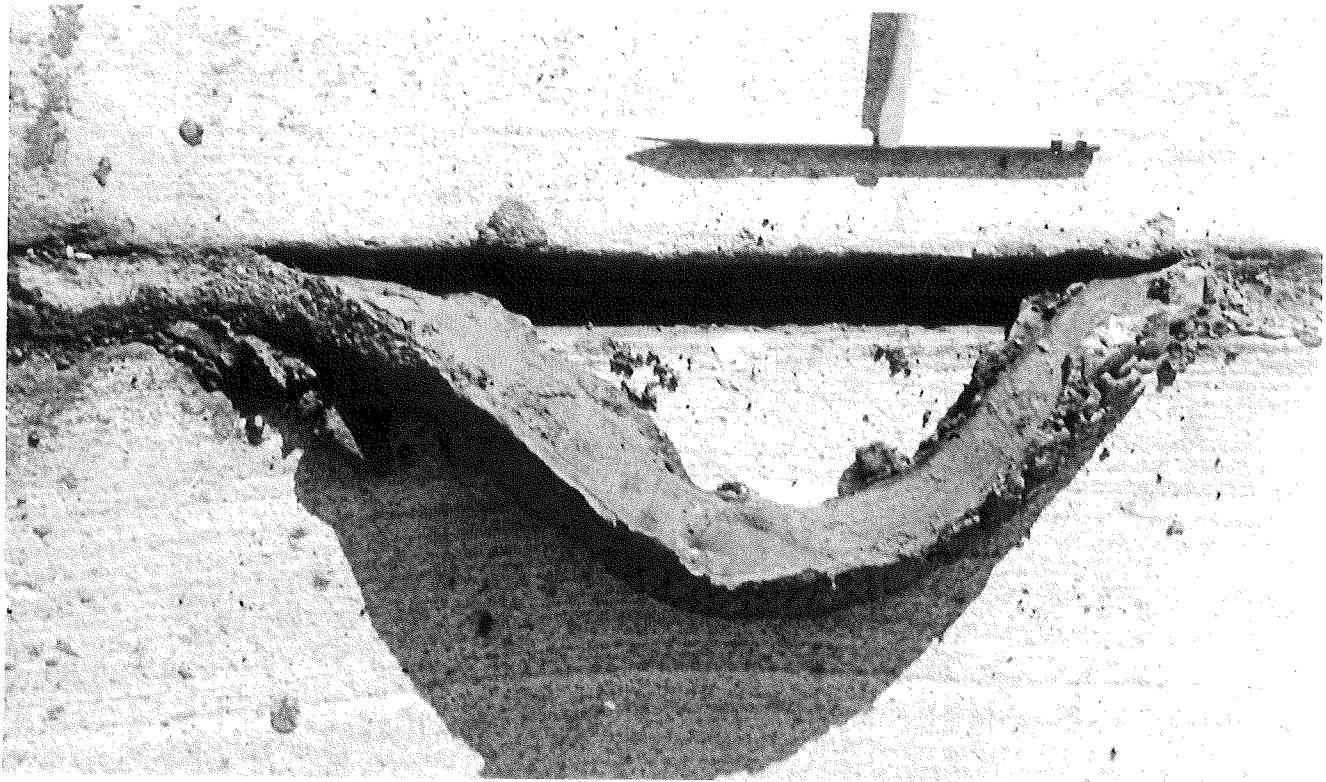
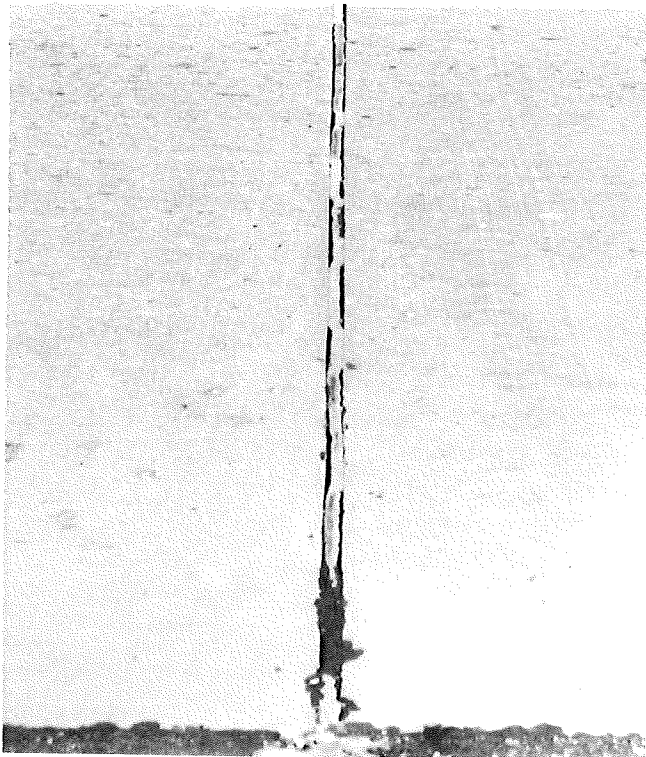
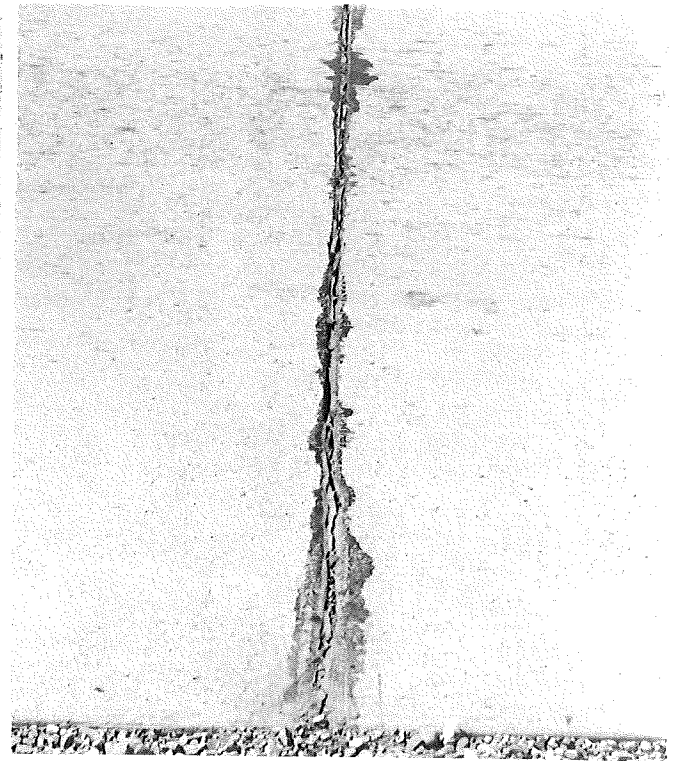
The performance of specification rubber-asphalt joint sealers is not up to expectations. Typical failures for three types of joint sealers are illustrated in Figure 17.

Figure 17. Typical failures of a two-component cold-pour sealer, PRC (left), of a normal hot-pour rubber asphalt sealer (above) and a single component cold-pour sealer (right).

Theoretical considerations, backed by recent field and laboratory studies by outside agencies, definitely indicate that in order to seal a joint at all adequately with specification materials, the joint groove width should be established on the basis of slab length, and the depth of sealer should be approximately equal to the joint width.

Measurements of joint width openings on several experimental pavements in Michigan indicate that under normal conditions, joint width movements of around 0.2 to 0.3 in. may be expected. Considering this fact in conjunction with the data above, it is indicated that the formed joint opening should be 3/4-in., instead of 1/2-in. as now constructed.
