MICHIGAN
STATE HIGHWAY DEPARTMENT

Subject: Survey of I 94 Bridge Crossing Clinton River Cutoff Canal (B01 of 50111).
Research Project 65 B-78. Research Report No. R-520R.

Inspection of April 28, 1965

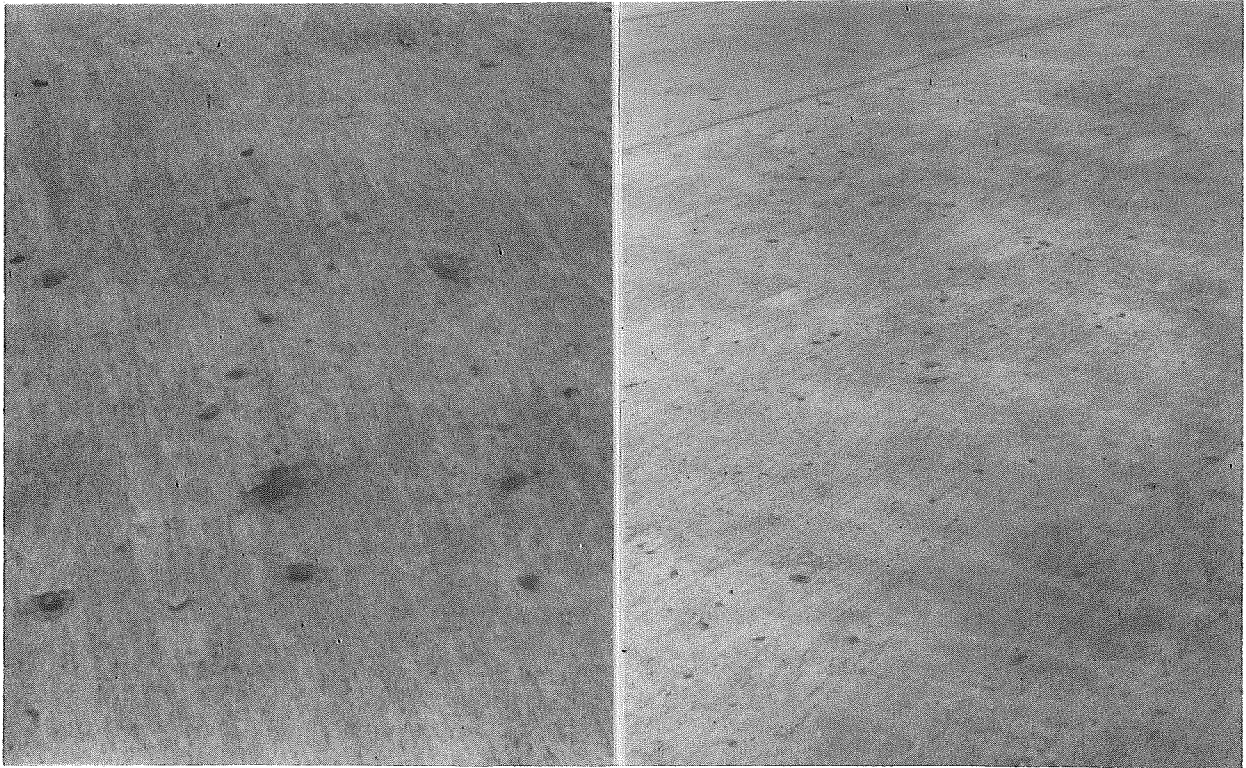
Deck and median concrete surfaces exhibited numerous randomly scattered popouts (Figs. 1 and 2). The overall popout incidence was as great two years ago, before

The frequency of popouts appeared to involve two factors: 1) a relatively large quantity of chert and iron-bearing clay in the coarse aggregate, and 2) use of 1-1/2 in. coarse aggregate in the mix. Since these deficiencies are not related to traffic, the popouts and hairline cracks would probably have occurred regardless of whether the bridge was open to traffic. The inspection of 1963 indicated that a majority of popouts had occurred in the first four years, without traffic or winter maintenance. Some cracks observed in 1965 may have been present in 1963, but in an incipient stage and not plainly visible. The large number of popouts is a good example of the need for using premium aggregate (6AA) in exposed structural concrete.

Figure 1. Typical scattered popouts on roadway pavement, four years after construction but before opening to traffic (left) and after two years of service (right).

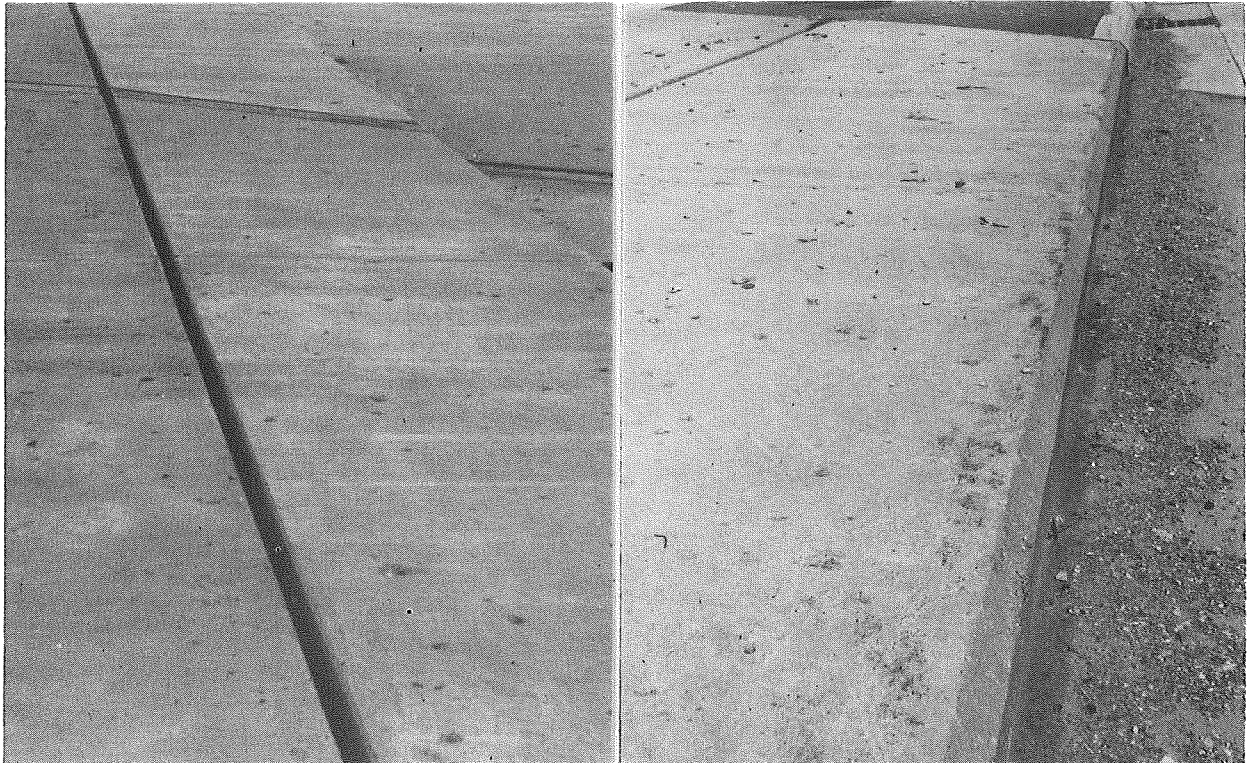
Figure 2. Typical scattered popouts on raised median.

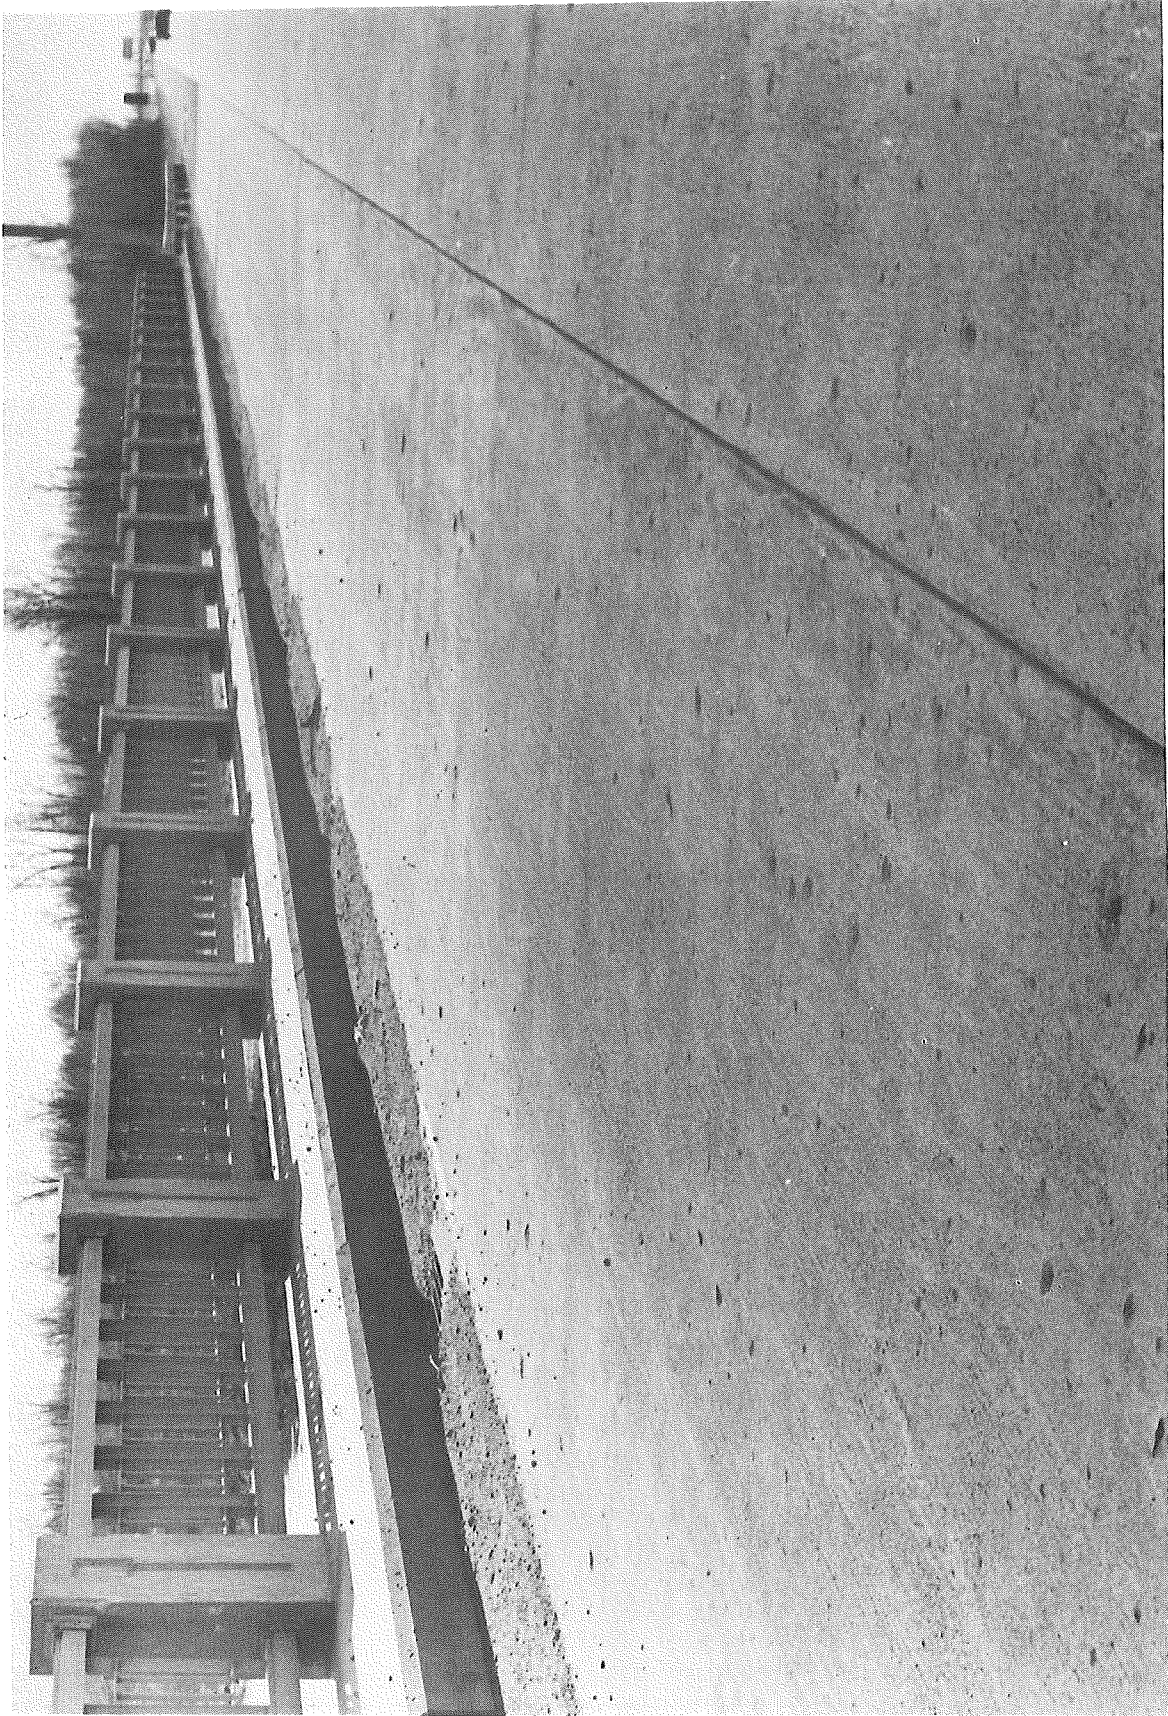
the bridge was opened to traffic or had received applications of de-icing chemicals, as now. Further, popouts are as frequent on the surface of the easternmost lane (Fig. 3), which carries less traffic, as on the other six lane surfaces.

Figure 3. Looking south from bridge's easternmost lane, note alignment with shoulder on approach pavement, suggesting lighter traffic on this lane than the other six lanes. Incidence of popouts, however, is approximately the same.

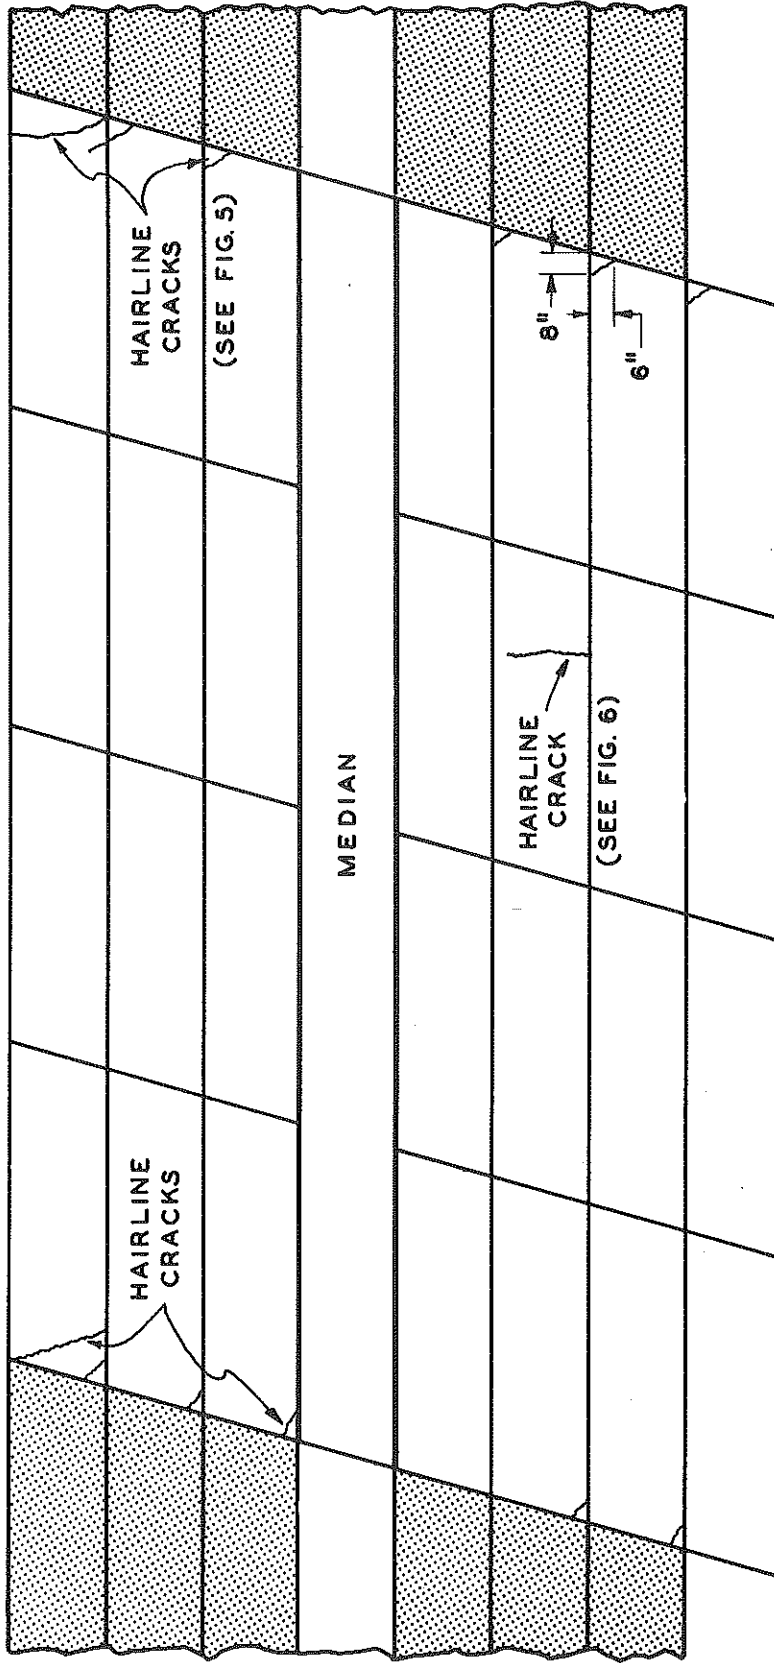
Fig. 4 shows the locations of 13 hairline cracks visible on the deck. Ten of these occurred on end spans, diagonally crossing the small tips formed by the acute angle of the skewed pours. This type of cracking has been noted frequently on skewed bridges and research by others has shown that it is generally associated with slab warping of these acute angle corners and subsequent resulting strains. Only one of these tip cracks was visible in 1963 (Fig. 5), at the north abutment line in one southbound lane. Fig. 6 shows the present appearance of the only full-lane-width transverse crack on the deck.

Figure 4. Deck plan showing crack locations.

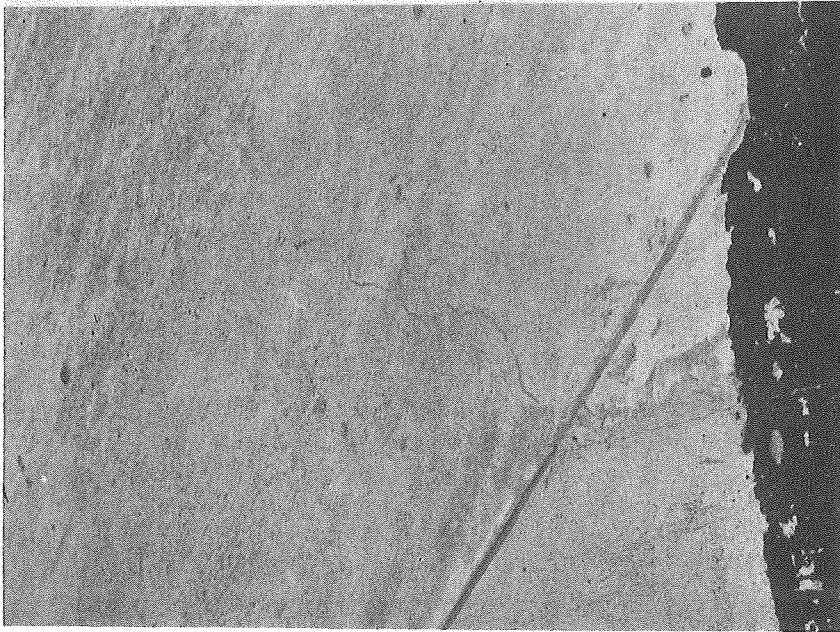
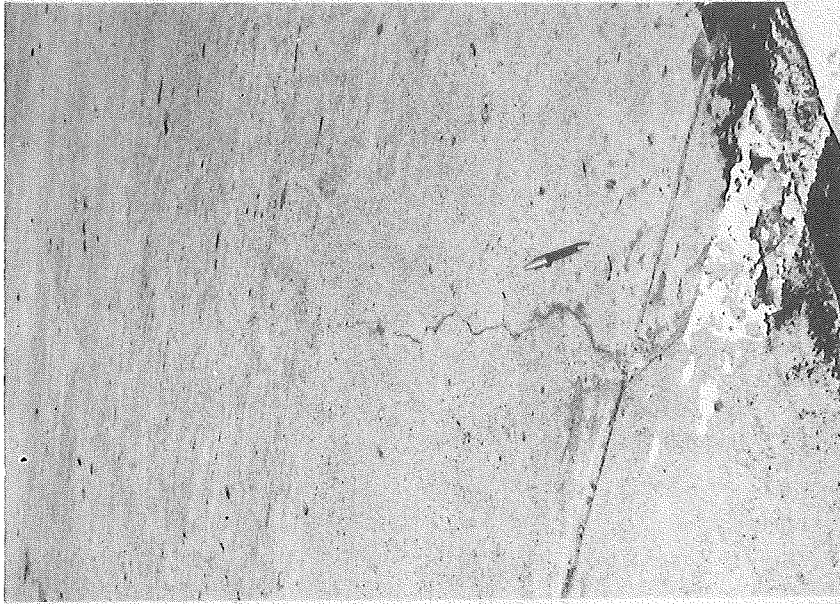
Figure 5. Typical short diagonal crack across tip of skewed pour (foreground), in this case continuing into adjacent pour where it appears longer and more prominent after opening to traffic (right).

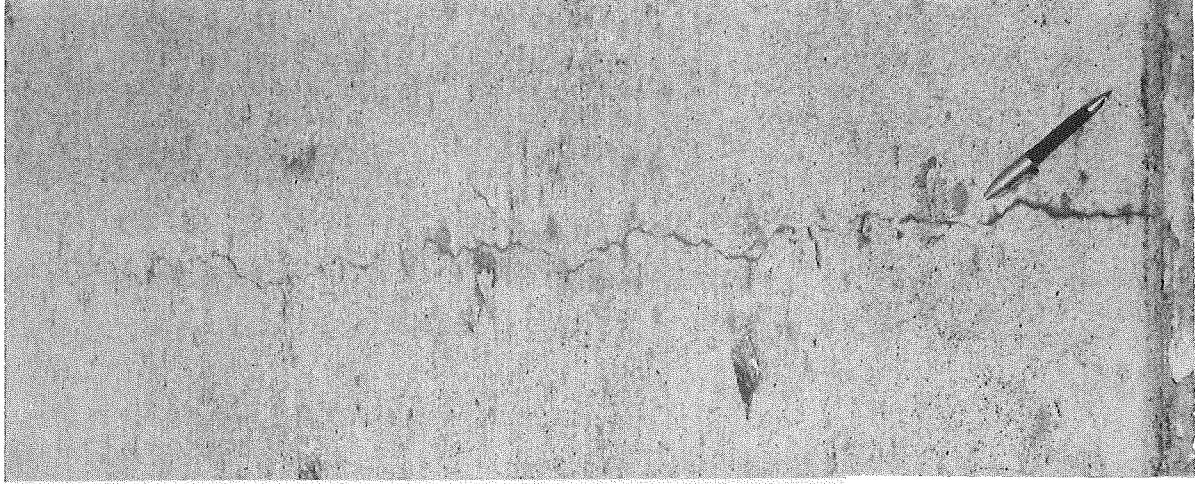
Figure 6 (right). Transverse crack in northbound roadway.
