PROTECTIVE COATINGS FOR HIGHWAY METALS

MICHIGAN DEPARTMENT OF STATE HIGHWAYS

**A. J. Permoda
A. R. Gabel**

**Research Laboratory Section
Testing and Research Division
Research Project 49 G-50(5)
Research Report No. R-916**

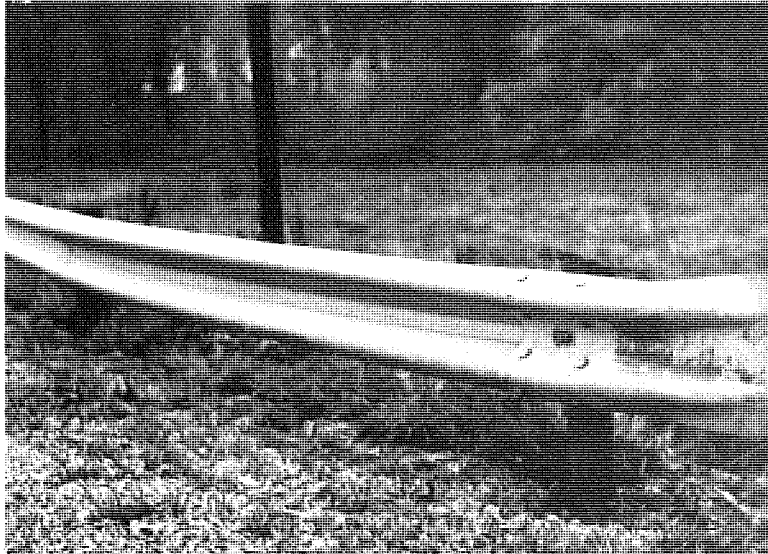
Figure 1. Typical 12-year old galvanized guard-rail, showing spotty weathering-away loss of zinc coating (brown rusting) on the top portion, spreading from the cut ungalvanized long edge (June 1969).

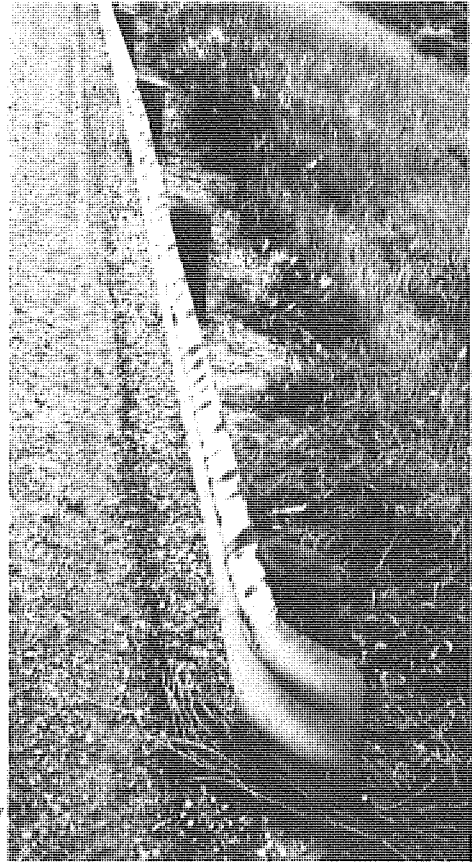
Figure 2. During its first year of installation, guardrail end-shoe on I 94 west of Kalamazoo shows spotty loss of galvanizing (dark areas = brown rusting) and some white rusting while the adjoining long railings are in good condition (November 1960).

Within a couple of years of adoption of galvanizing for the guardrail, sporadic complaints were received concerning localized deterioration of the galvanized coatings. Figure 2 shows one such complaint area where the end-shoe showed spotty loss of zinc coating, while the abutting straight rail was in the normally good condition for installations less than one year old. Incidentally, about 72 end-shoes were installed under this contract with about one-third of them showing some deterioration at a survey time in November 1960. All of the latter showed white rust attack with the four worst ones showing some brown rusting as well (base metal corrosion signifying complete loss of galvanizing). The worst end-shoe of the four is shown in Figure 2.

Returning to the complaint shown in Figure 2, it was evident that deterioration of galvanizing on the end-shoes did not occur after installation because the adjoining sections of guardrail showed no corrosion. Consequently, it had to happen before installation. We analyzed the problem of the "white and more severe brown rusting" on some of the end-shoes as being due to improper storage either at the producer's or after delivery at the construction site. Perhaps a contributing factor was the overstressing and consequent faulting of the coating on the pregalvanized sheet (ASTM A93) during the forming of the end-shoe. To correct this, the Department issued a directive to project personnel to check for improper storage of guardrail (and culverts) at the construction site, and setting guidelines for the acceptance and rejection of galvanized materials showing white rusting. The producers were informed of the directive in order to minimize white rusting in their storage facilities. In addition, we requested that end-shoes be hot-dip galvanized after forming.

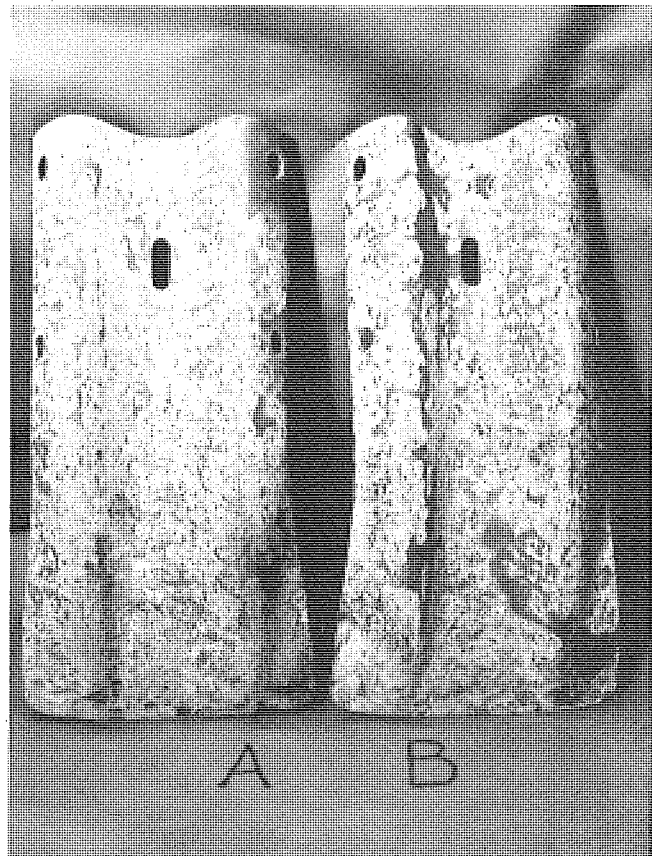
Figure 3. Example of "white rust" formed on galvanized guardrail during first winter of exposure on I 96 at Grand Rapids. Rusting was not confined to end-shoes, though photo shows faces of a dismantled pair brought into the Lab for study (March 1962).

In the spring of 1961, and particularly in 1962, localized aggressive deterioration of galvanizing was noted on some new installations, the latter notably on the currently designated I 96 between Grand Rapids and Muskegon. This roadway, an Interstate freeway, is about 40 miles long; with most of it opened to traffic in late 1961. Much of the galvanized guardrail was installed shortly before the opening. In March-April 1962, as the snow piled against the guardrail began to melt and compact, areas of guardrail were revealed having incrustations of white rust, a bad case of which is

shown in Figure 3. The occurrence of this was spotty, with the spots varying in length from inches to perhaps 100 ft. About 10 percent of the total guardrail footage showed some coating deterioration, evidenced mostly by the white rust. Generally, when this was scraped off a zinc underlayer was revealed; occasionally a black underlayer was revealed which we dubbed the "inner zinc-alloy layer," thereby signifying a more severe or deeper corrosion. A small percentage of the affected area exhibited the brown rusting signifying complete loss of the galvanized coating.

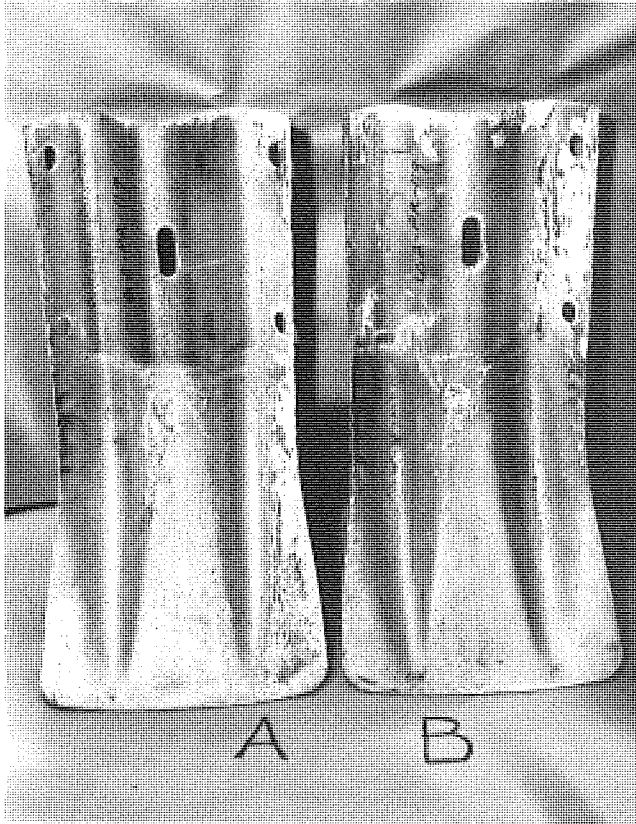
Figure 4. Backs of end-shoes shown in Figure 3. White rusting is non-existent or very light as compared to faces (March 1962).

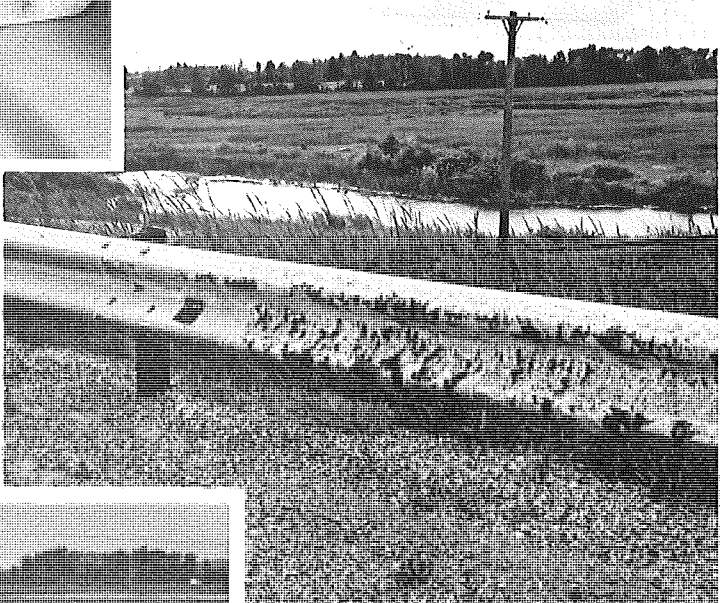
Figure 5. Galvanized guardrail shows white and brown rusting when photographed after about 7 years of service. Left rail is unaffected showing spotty variability of attack. Abutting rails on right (not shown) were affected. Rails are on on-ramp to US 27 near Ithaca; on the west side of a north-south roadway (July 1967).

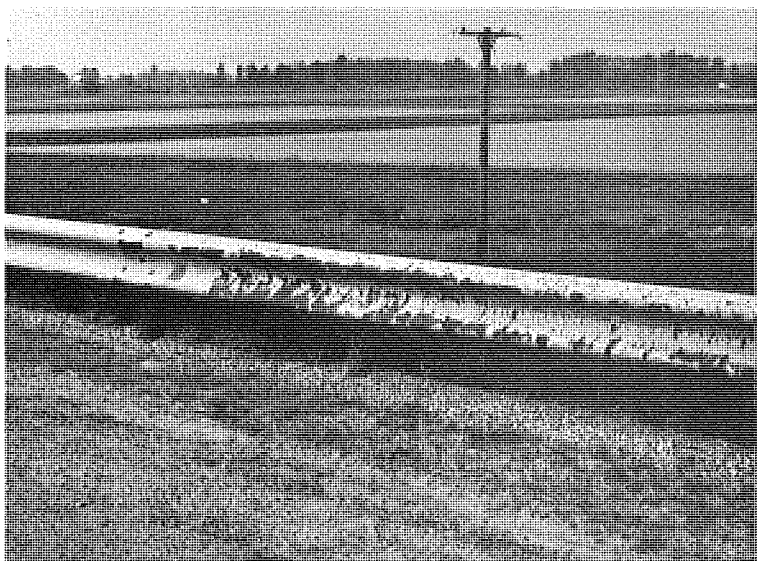
5) White rust product (a mixture of zinc hydrates and carbonate, with a trace of chloride) sloughs off during additional weathering and may, if attack is not severe, give little visual evidence of its original presence within a few years. Unquestionably, the weathering away loss of galvanized coating had been accelerated during the interim. Brown rusted areas do enlarge slowly (Fig. 6).

Figure 6. Same as Figure 5, after 12 years of service, showing that additional loss of galvanizing is not rapid. Dark rectangle near guardrail post carries study identification number (June 1972).

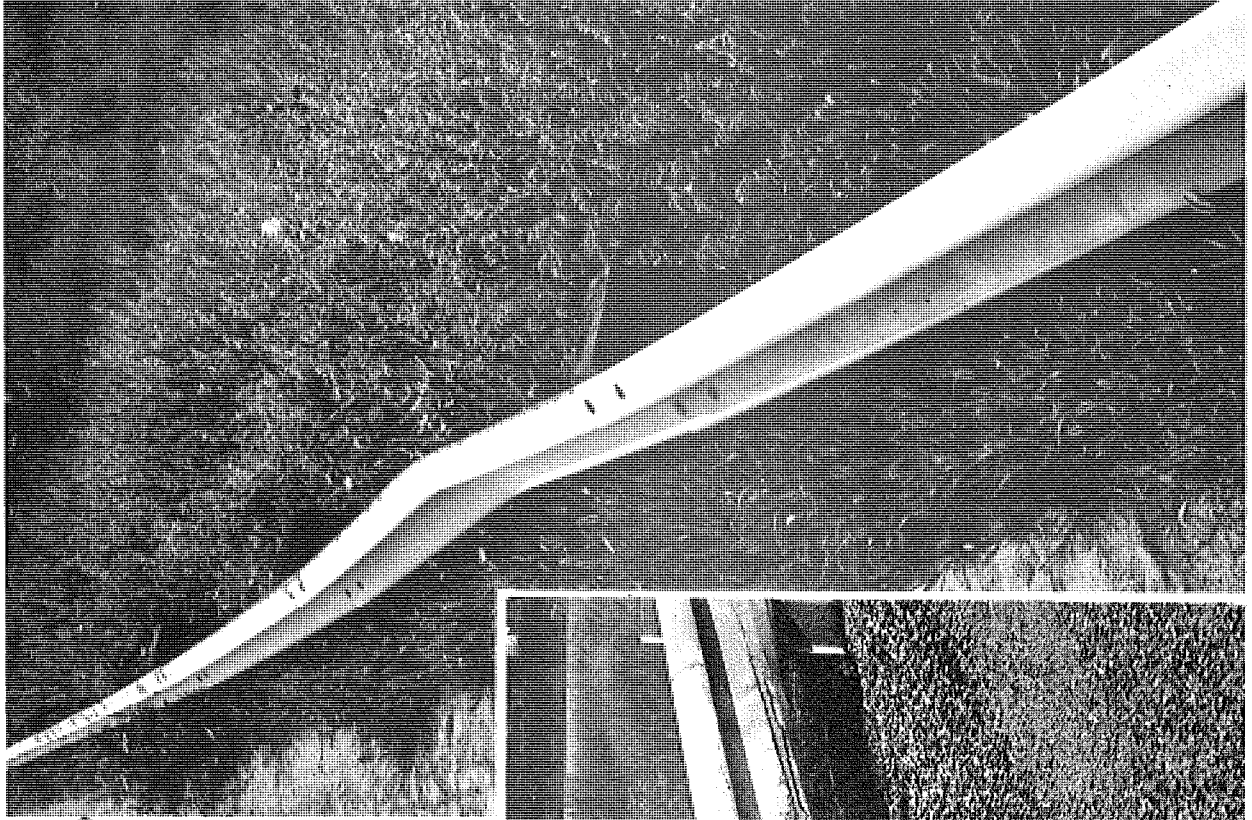
re-installed on the M 78 project, east of Lansing. Since then, there have been minor differences in the performance of the paint topcoats (and some rails have been replaced because of collision damage) but, generally, all remaining have significantly increased the life of the galvanizing, perhaps have almost doubled it (Fig. 7).

Figure 7. Galvanized guardrail installed on M 78 in 1957. Foreground rail was topcoated, with line at mid-length the terminus of different systems. Background rails, not coated, show galvanizing loss along tops, as in Figure 1. Rail dent shows mild collision damage (August 1972).

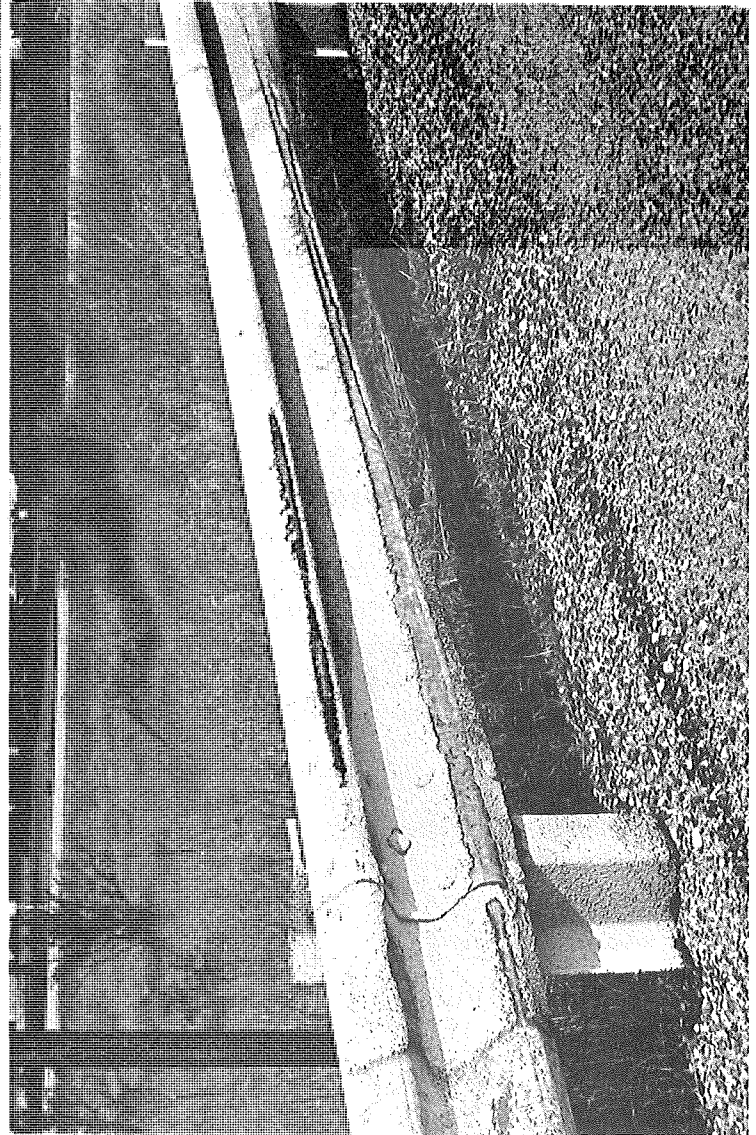
After the white rusting attack on galvanizing of guardrail on I 96 mentioned earlier, the Department, in 1963, instituted project 63 NM-90 to evaluate the merits of a fairly heavy, composite asphalt-aggregate, shingle-type, coating on two corroded areas of guardrail on I 96. Other states were also evaluating the coating. Field applications of the coating on the installed guardrail consisted of; cleaning, spray application of the bituminous binder, and modified sandblast blowing-in of the gray aggregates. The coating proved much more susceptible to scraping damage from traffic and snowplows than the galvanized coating, though in other respects it was performing satisfactorily during four years of service when the project was terminated (Fig. 8).

Figure 8. Test composite asphalt-aggregate coating is removed from ridges of guardrail by traffic and/or snowplows during 4 years of service. Short area of uncoated railing, at left, still shows effect of white rusting attack of 1961-62 winter (June 1967).

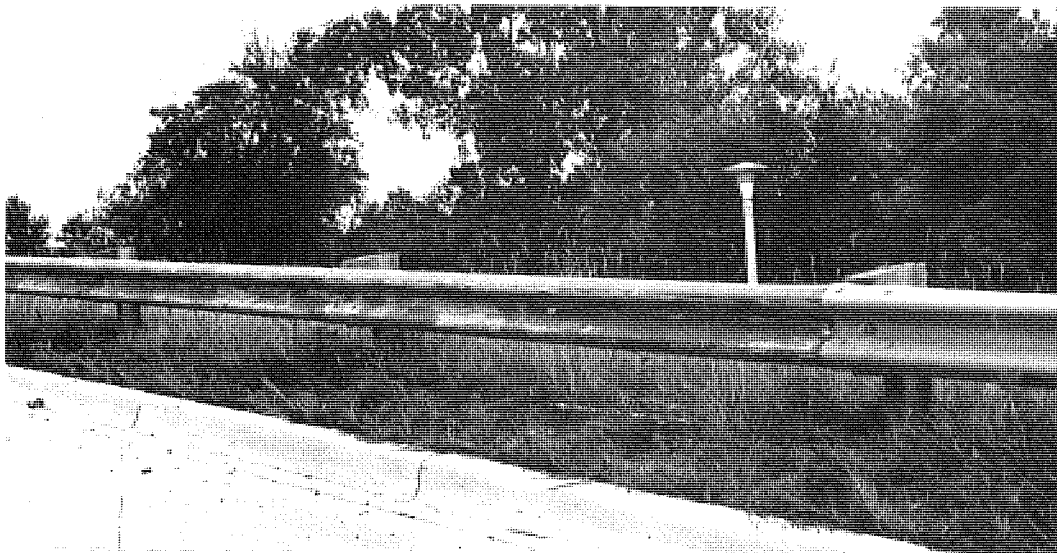
Figure 11. Aluminum pigmented petrolatum-base coating darkens and shows blotchiness as it weathers away, facing north. Partial rail, on right, is untopcoated galvanizing used for comparison; neither shows white rusting. Service exposure was minus two years in August 1972.

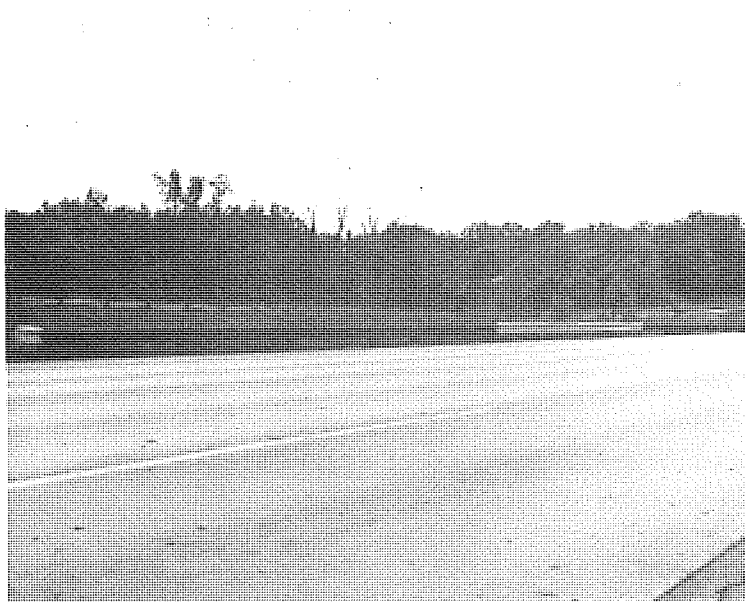
Figure 13. Test unpainted alloy steel guardrail on southbound I 75 north of Pontiac flanked by galvanized rails with four in center being damage replacements. Daytime appearance after 6 years of service (June 1969).

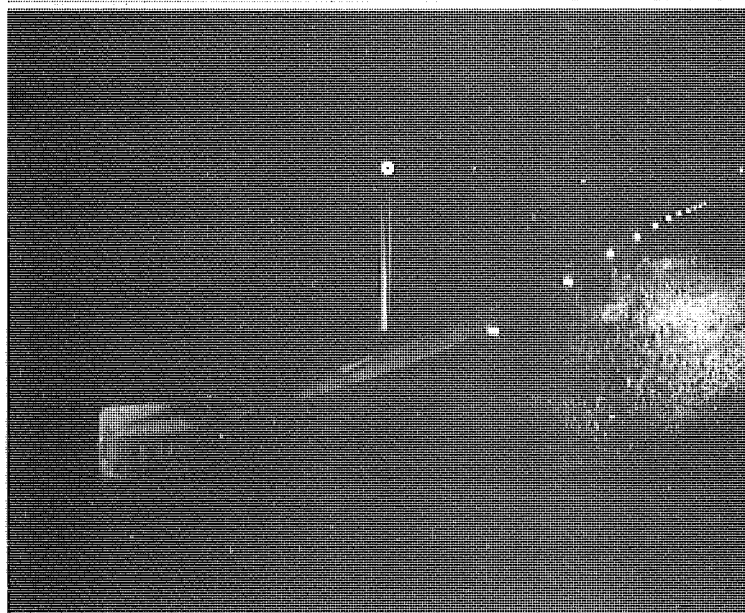
Figure 14. Nighttime appearance of mixed guardrail on I 96 at M 99. End-shoe and curved section (left) are galvanized, 10 straight rails (right) with reflective washers are low-alloy corrosion resistant steel. Curved galvanized section shows two ovate areas on ridges ("Storage Stains" during face down nesting) (July 1965).

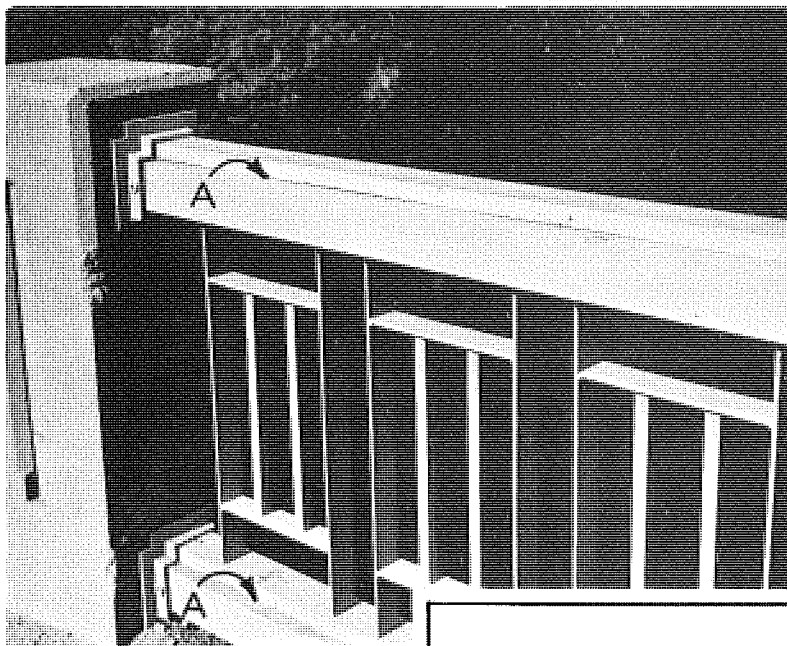
Figure 16. Close-up of above bridge railing, supported by concrete posts. Junction of elements on top and bottom rails (A) was a point of coating weakness (see Fig. 17).

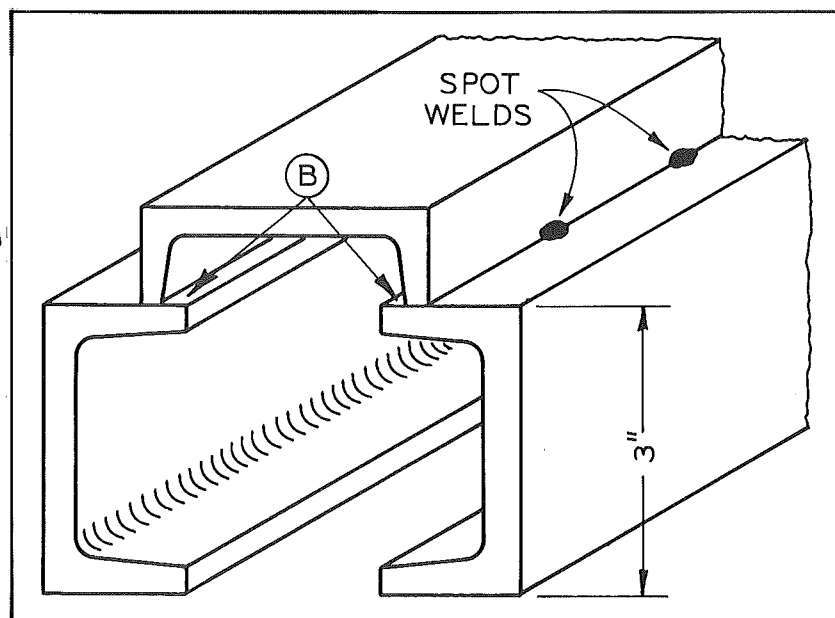
Figure 17. Top and bottom bridge rails are composed of 3 channels spot-welded together. Condensation generally on unpainted inner ledges (B) sometimes seeped through and undercut coating.

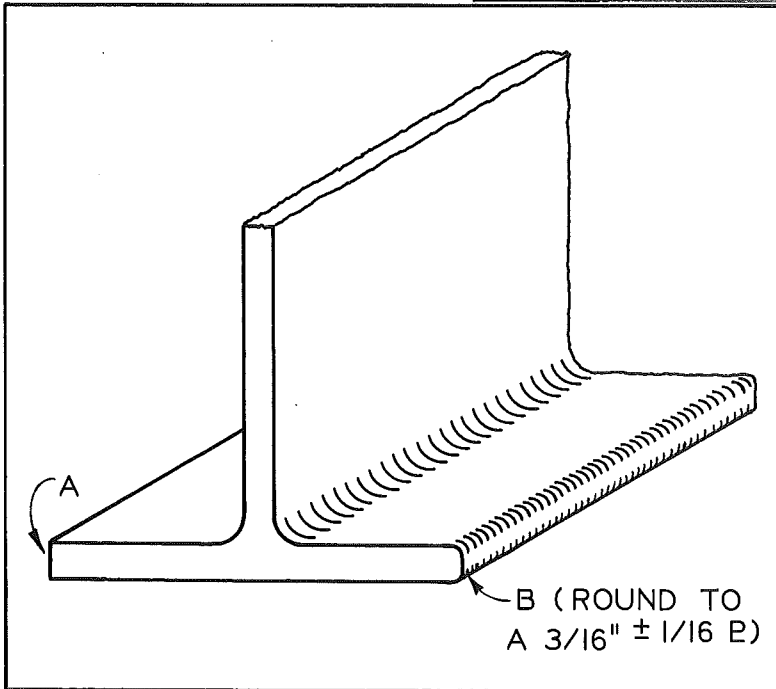
Figure 24. Standard rolled beam girder has square flange edges (A) often upset to a chisel ledge, most difficult to coat to proper thickness by brush. New Department specs required the corners (B) to be rounded, by grinding as shown.

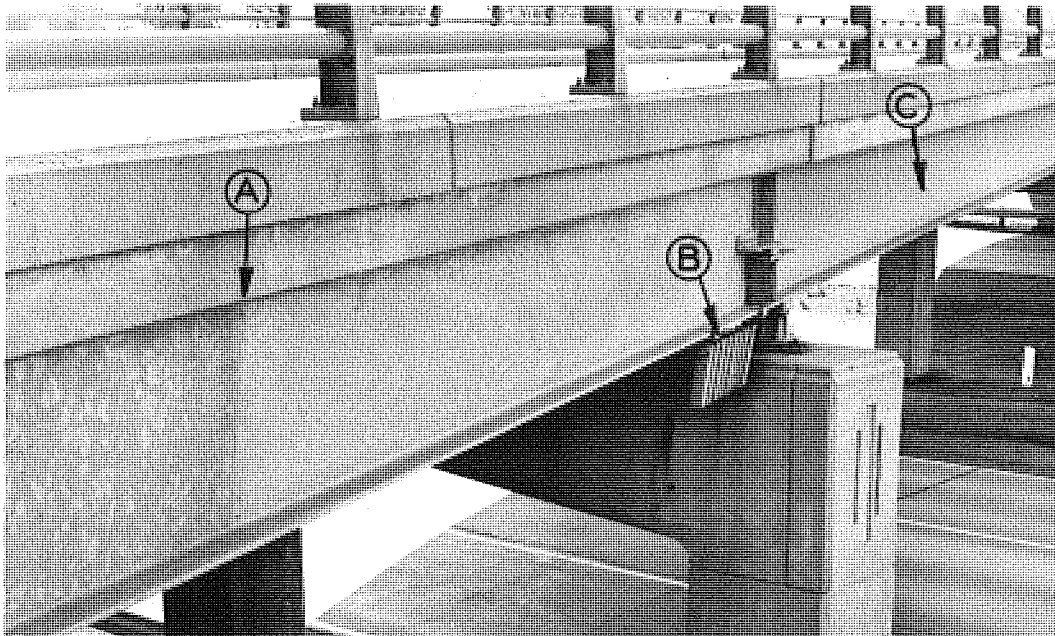
Figure 26. Galvanized 34-ft long beam shows juncture (A) of dipping from either end to complete coating on end span of test bridge. (B) shows field exposure of all specimens of 8 test coatings being evaluated on bridge. (C) is a test painted beam, much longer than galvanized beam. Coatings completed late in 1960 (June 1972).

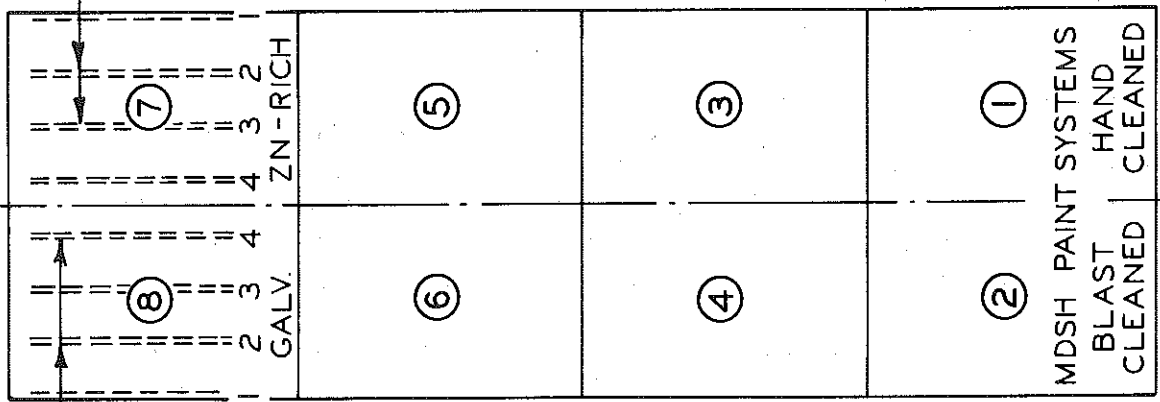
Girders 2 and 4 show a fairly heavy white rusting on lower flange from joint leakage run-off.

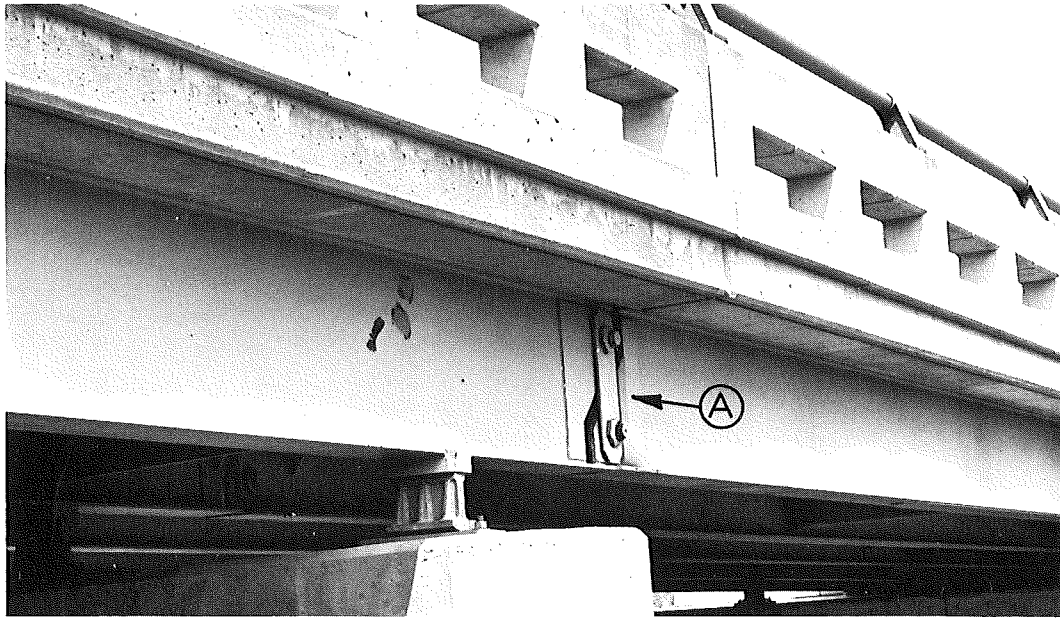
Figure 30. South fascia, west-span on S04 of 72013 shows spots of topcoat peeling off Zinc-Rich primer, over the pier. The cantilever beam-joints configuration (A) catches deck leakage, deteriorating beam coatings (July 1973).

primed systems because of less initial rusting along the lower flanges of the beams. For some reason, the latter are not giving us the cathodic protection, on initial film breaks, that obtained on the first test series using the zinc-rich primers. In addition, the two bridges utilizing zinc-rich primer No. 2 are showing progressive delamination of the field applied vinyl-alkyd second coat indicating a wrong coupling of paints (Fig. 30).

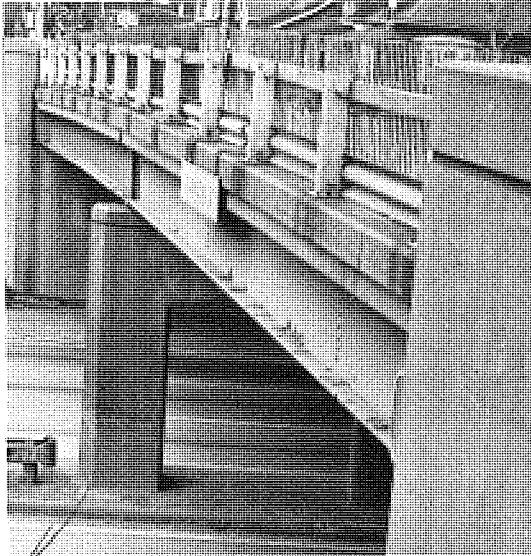
After eleven years of service, a 1973 inspection of the two structures showed the paint systems to be performing comparatively well with the coatings on the Addison structure better than on Lonyo. The former was showing only initial spot failure and rusting, mostly in the lower flange area of the beams while the latter was showing that, plus blister failure, on fascia lower flanges (Fig. 31) and more extensive failures under leaky deck joints.

Figure 31. Top of lower flange of fascia beam shows blister and delamination failure 12 years after maintenance repainting. Note barricade at bridge railings while old painted rails are being galvanized (March 1974).
