***STUDY OF MICHIGAN'S
LINK PLATE AND
PIN ASSEMBLIES***

1. Report No. Research Report R-1358	2. Government Accession No.	3. Recipient's Catalog No.	
4. Title and Subtitle Study of Michigan's Link Plate and Pin Assemblies		5. Report Date April 1998

Study of Michigan's Link Plate and Pin Assemblies

**Testing and Research Section
Construction and Technology Division
Research Project 93 TI-1683
Research Report No. R-1358**

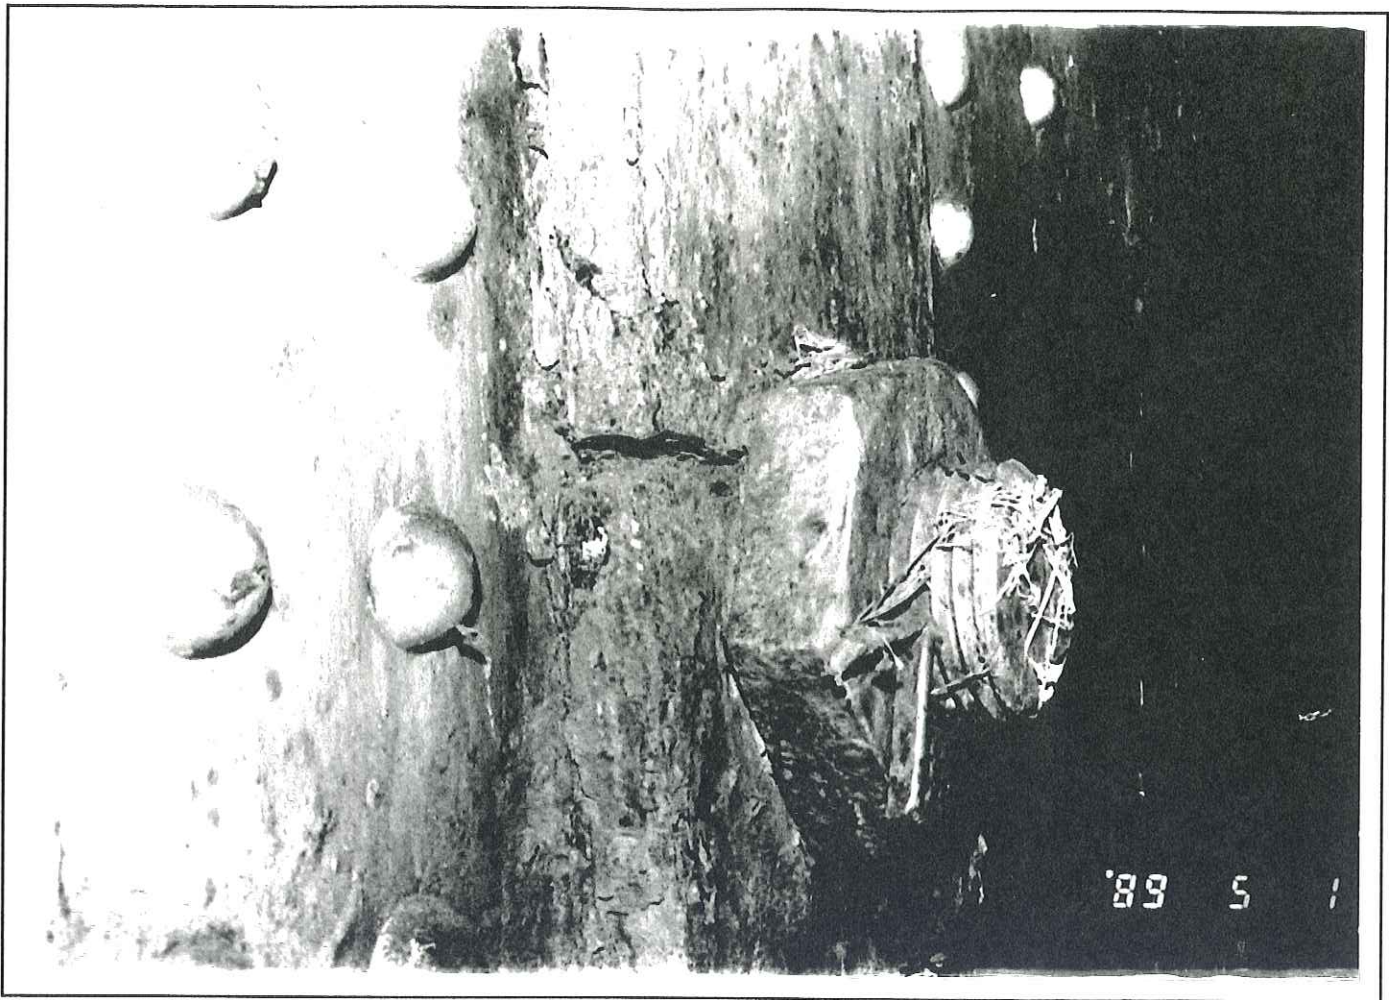
Fractured Link Plate. Michigan has at least one known experience where a link plate has fractured. This occurred on the structure carrying M-46 over the Tittabawassee River, 6.4 km west of Saginaw (Structure Number - B02 of 73062). The bridge has seven spans with 14 steel beams supporting a reinforced concrete deck with a longitudinal open joint running along the center line of the bridge. There are three suspended spans supported by link plate and pin assemblies. A department bridge inspector discovered the fractured link plate, shown in Figure 3 during a routine inspection of the bridge. The link plate was broken near the top of the bottom pin hole. Since the structure was scheduled for link plate and pin replacement, the link plate was repaired temporarily with a welded plate crossing the fracture. No further analysis was done to determine the cause of the fracture, although the bridge inspector observed that the expansion joint at the link plate had closed causing the diagonal portion of the beam webs across the link plate to push against each other.

FIGURE 3
M-46 over Tittabawassee river (Structure Number B02 of 73062)
Showing 1/4 in. wide crack in link plate at bottom pin. Span 3
east bound at center longitudinal joint.

Fractured or Cracked Link Plates. Look for cracking in the link plate near the pin hole. If a crack is suspected, it should be confirmed by ultrasonic inspection. If a crack is confirmed, the beam should be supported and the fractured link plate should be replaced immediately. The link plate should be investigated to determine the cause of the fracture; i.e., - fatigue, over stress, bending, section loss, corrosion product. The remaining link plates should be inspected for cracking or signs of distress. Most likely, if one of the link plates has fractured the remaining link plates will require replacement.

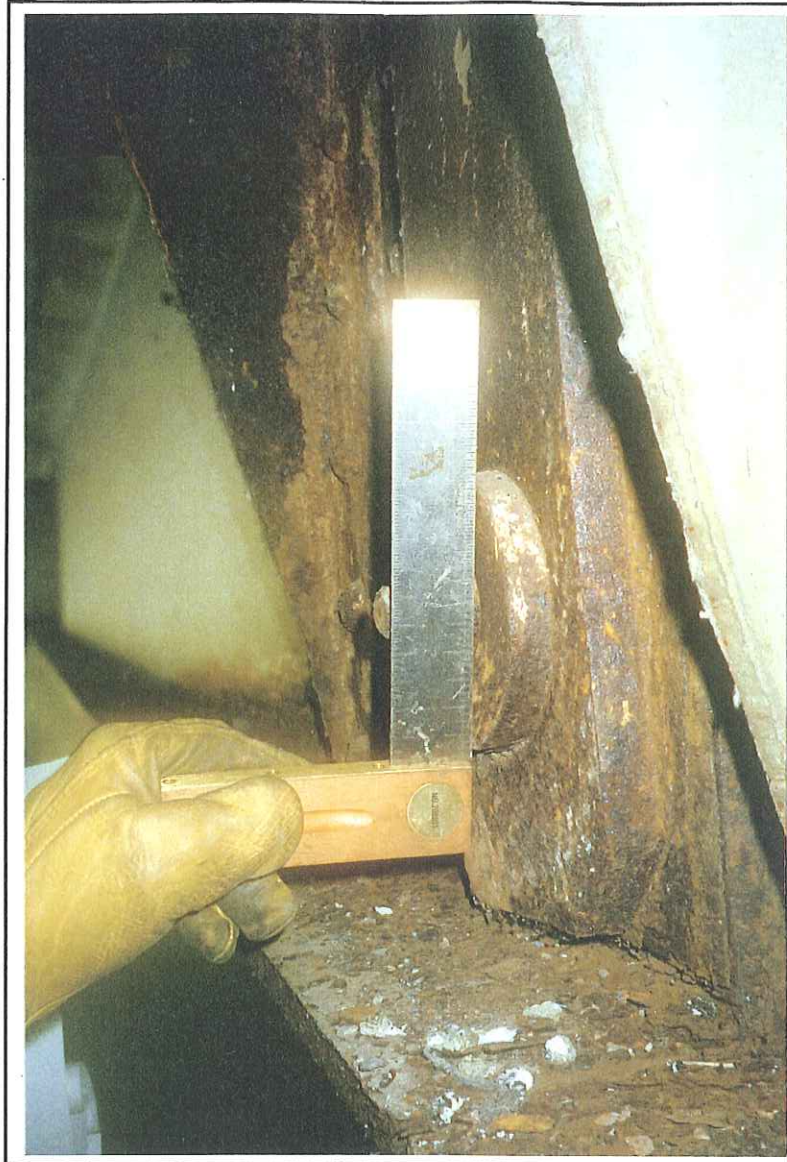
Corroded Link Plates. This is the most common problem associated with link plate and pin assemblies. Expansion joints above the detail leak water contaminated with road salts on to the link plates causing them to corrode. Similar to the Mianus River incident, Michigan has experienced corrosion build-up between the link plate and the beam web. On the bridge carrying I-75 over the Huron River (Structure Number - B04 of 58152), a department bridge inspector discovered this problem on several of the link plates. As shown in Figure 4, the corrosion product caused the link plate to move outward causing the pin end cap to *cup*. We have also seen that corrosion products can cause fixity against rotation. On I-75 over Toledo/Dix Avenue, discussed later in this report, we measured in-plane bending in the link plates as a result of corrosion products.

Figure 4. Structure Number - B04 of 58152. Corrosion build-up between the link plate and beam web is causing the link plate to move to the end of the pin, resulting in “cupping” of the pin cover plate.

Corroded Link Plates. This is the most common problem associated with link plate and pin assemblies. Heavily corroded link plates and pins should be replaced. Deck expansion joints that are leaking water onto the link plates should also be replaced.

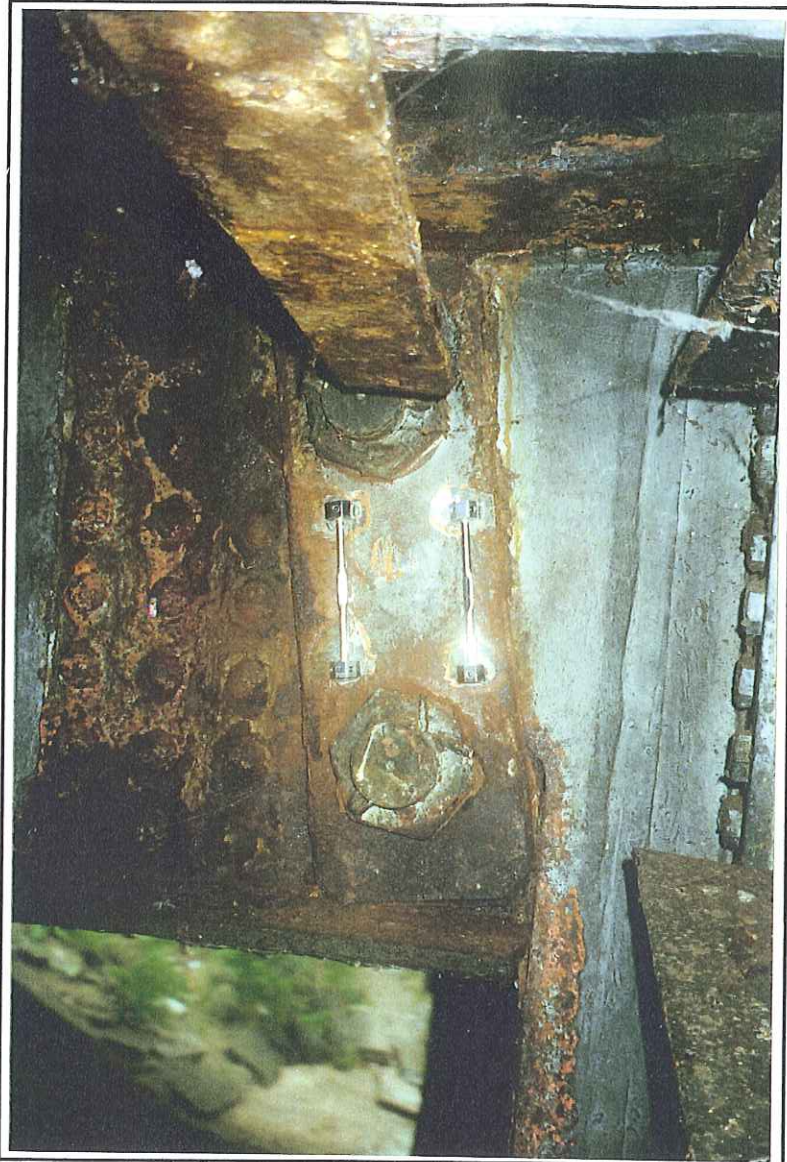
FIGURE 5 - Expansion joint has closed causing the beam ends to push against each other. (Structure Number B02 of 41027).

Beam Ends in Contact. When the beam ends are in contact, the link plates and the beam ends should be inspected for distress. Types of distress that are known to occur are, the link plate is cracked or fractured, the beam web may bulge or buckle near the link plate and pin assembly, out-of-plane bending of the link plate, and general movement of the link plate and/or pin (link plate *walking* off the pin). Besides inspecting the link plates and the immediate vicinity nearby, the inspector should also look at other portions of the bridge for signs of distress that could be related to problems with the link plates. Two things to check are, tilting of the rocker bearings on adjacent piers and the beams pulling out of the abutments. These two events often accompany, or are the cause, of the closed expansion joints. This may be a sign that the expansion joint above the link plates may close in the future. If greater than 50 percent of the beam ends make contact and three or more of the beams in contact are adjacent, or if there are signs of distress to the link plates, pins, or the beams, corrective action is needed. The type of corrective action is dependant on the individual site conditions and the amount of distress evident in the link plates, pins, and beams. Some possibilities are:

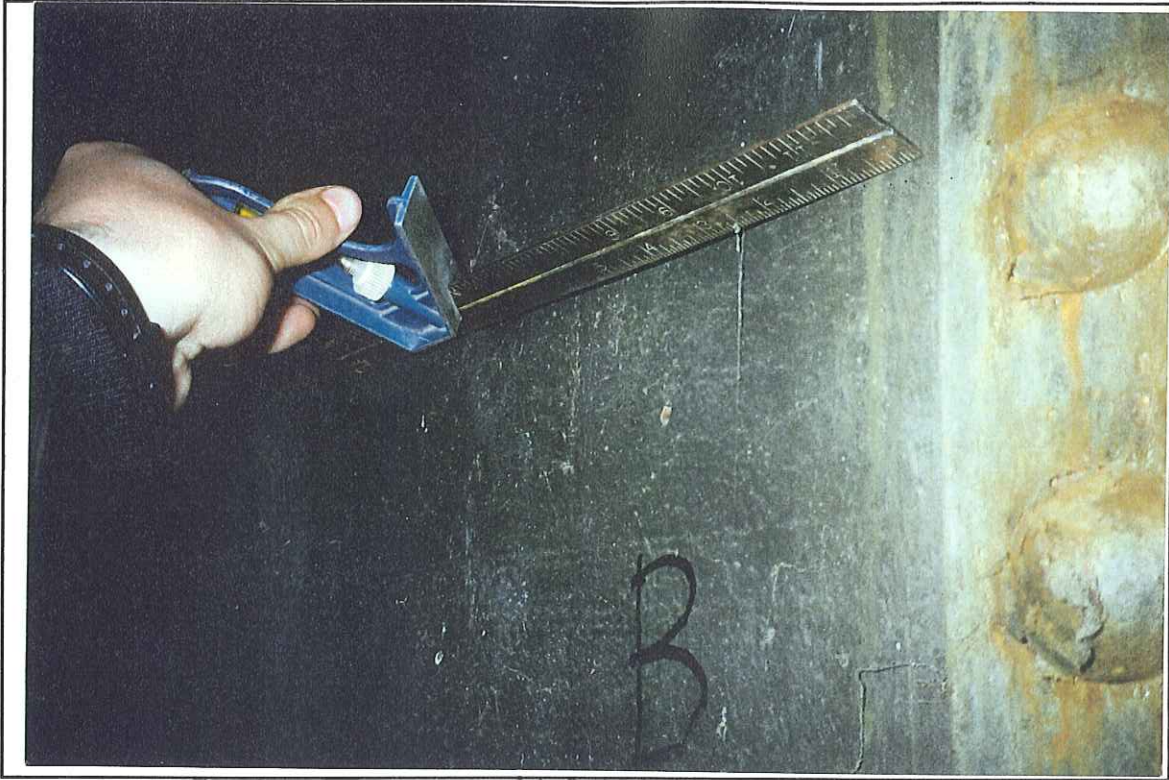
As several bridges with the beam ends in contact were inspected, signs of high stress became evident. If a large compressive force is present in the beam web across the beam ends the web may bulge as shown in Figure 7, or the beam web may buckle causing a bend in the bottom flange as shown in Figure 8. On the structure carrying I-275 over M-153 near Detroit, Michigan (Structure Number - S08 of 82292), the buckled beam web caused the link plate to become disengaged from the pin, shown in Figure 9. The beam web had buckled slightly at the first web stiffener/diaphragm connection plate causing misalignment of the beam webs beneath the link plates. Figure 10 shows how out-of-plane bending resulted in the link plates which in turn caused one of the link plates to *walk* off the pin, shearing the cotter pins in the process. On this bridge, we found several link plates and pin assemblies had varying degrees of beam web misalignment and link plate movement. We also found the beams adjacent to the problem areas had closed expansion joints with the beam ends touching.

Figure 7. Concave side of bulged beam web resulting from beam ends pushing against each other. (Structure Number - B02 of 41027)

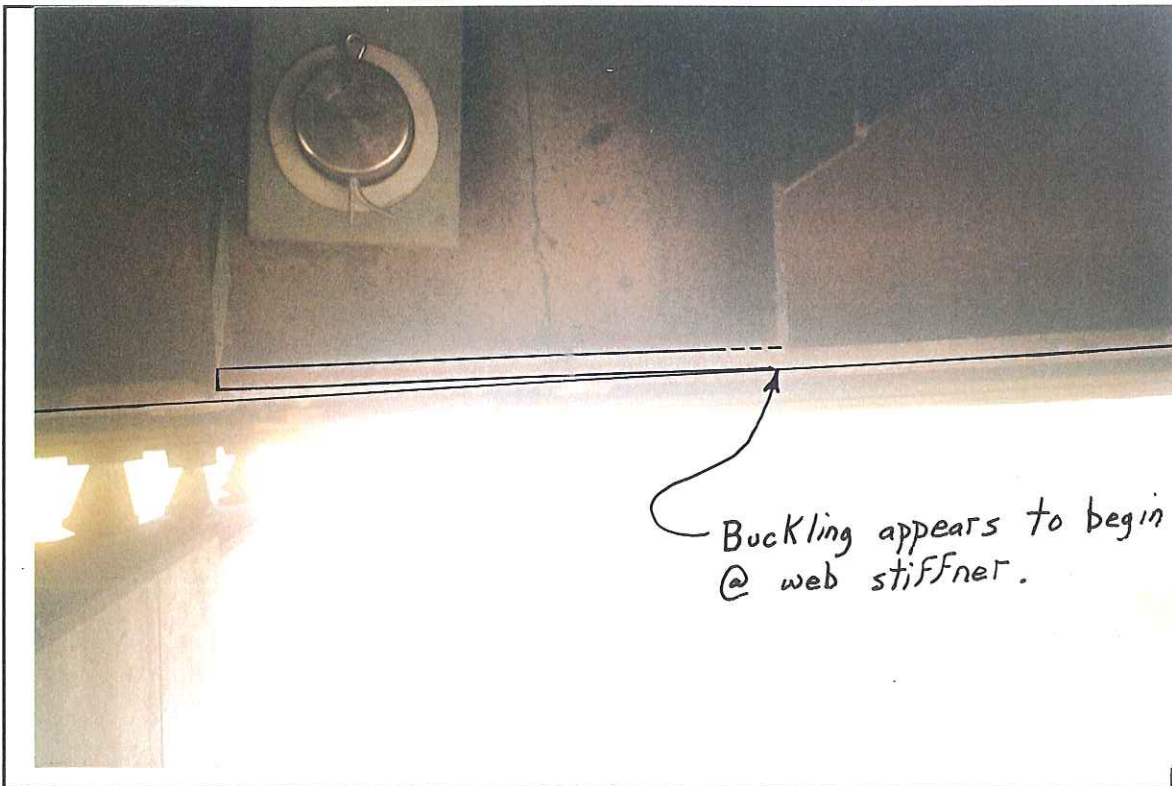
Figure 8. Buckling of the suspended span beam web. (Structure Number S15 of 82292)

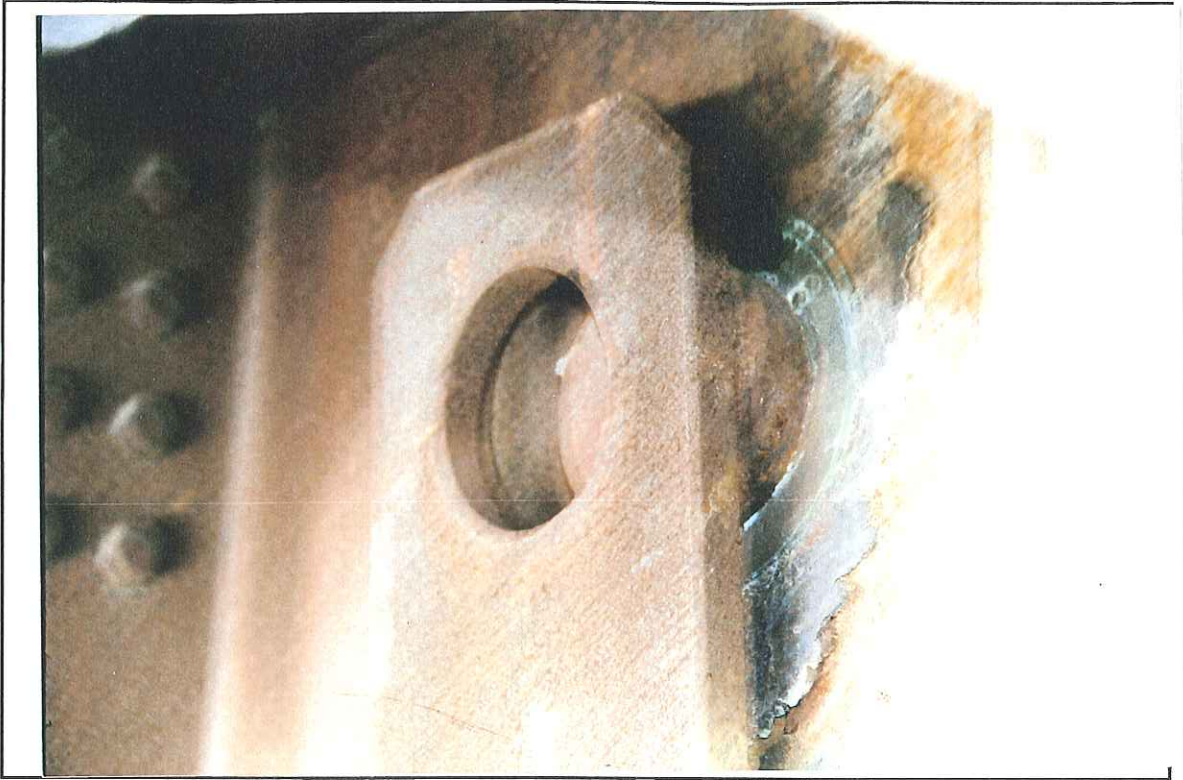
3. **Beam Ends in Contact.** Bridge inspectors have found several bridges where the expansion gap between the beam end closed at the link plates. When the superstructure wanted to expand during warm weather, the beam ends pushed together causing distress in the beams and additional stress in the link plates. On one bridge we measured 2.3 MPa increased stress per degree Celsius, and we found the beam webs bulged from the compressive loads. On another bridge the beam web buckled causing the bottom flange to bend, and the beam webs to be out-of-plumb and misaligned to one another. This produced out-of-plane bending in the link plates causing one of the link plates to move and eventually disengage from the pin.

Figure 9. Link plate disengaged from pin. (Structure Number S15 of 82292)

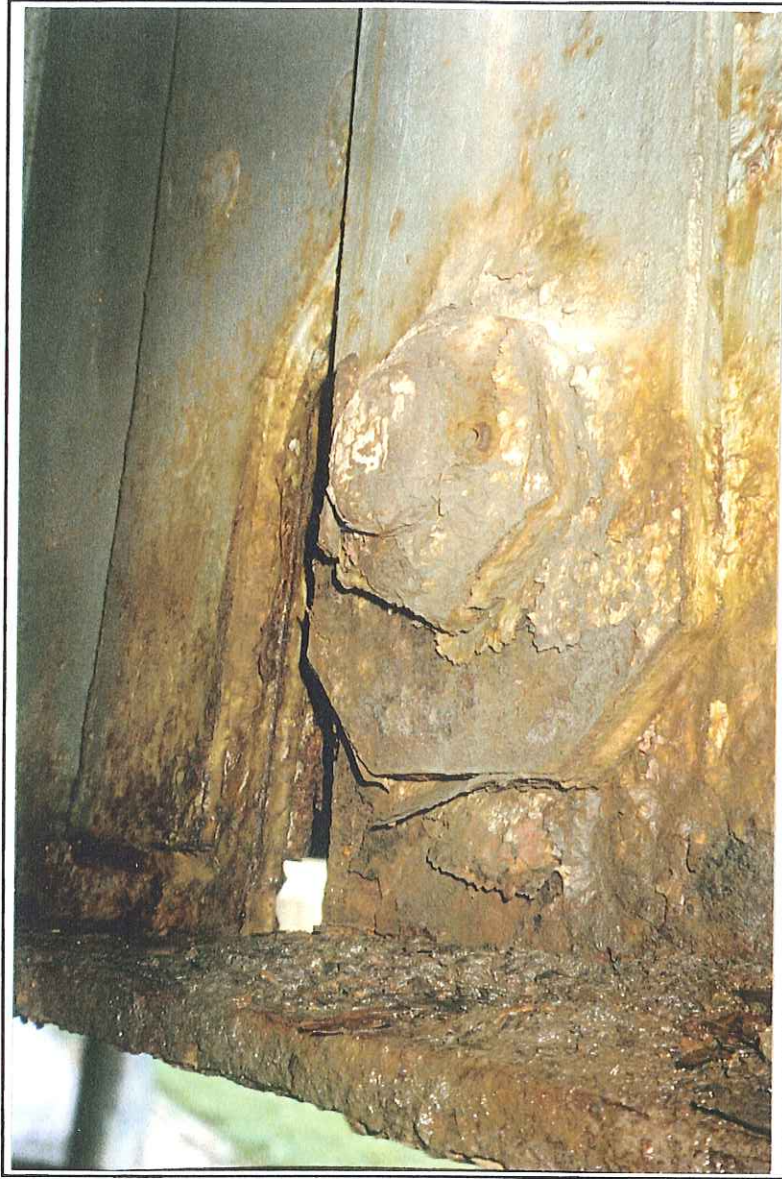
The third and final bridge chosen for testing was I-75 over Toledo/Dix Avenue south of Detroit. It is a 10 span structure with 8 steel beams supporting a reinforced concrete deck. The bridge carries three lanes of traffic in each direction. Five of the spans are supported by link plates and pin assemblies. Span 8, which was chosen for testing, has a skew of 37 degrees to the substructure and a span length of 20.1 m. The bridge is on a 12 degree horizontal curve. This bridge, built in 1963, has its original link plates and pins, shown in Figure 37, which are corroded and most likely frozen in place.

Figure 37 - Link Plate. I-75 over Toledo/Dix Highway.
