MICHIGAN
STATE HIGHWAY DEPARTMENT
Charles M. Ziegler
State Highway Commissioner

INVESTIGATION OF BICHLER BROTHERS GRAVEL

Highway Research Project 54 A-16
First Progress Report

Research Laboratory
Testing and Research Division
Report No. 234
July 12, 1955

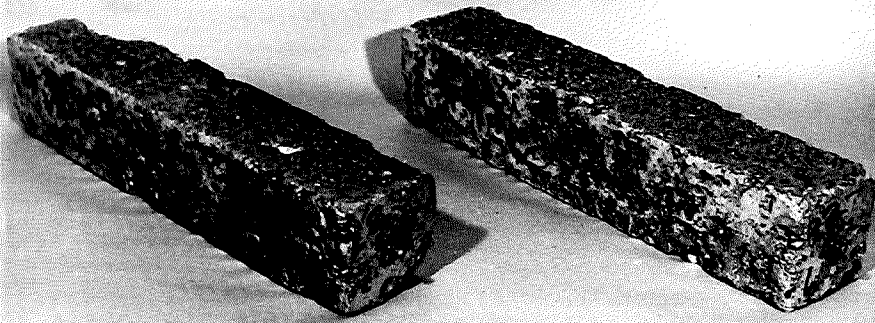
These beams held up quite well for over 260 cycles of freeze and thaw before dropping to 70 percent of original dynamic modulus. When compared to the performance of other gravel sources as graphed in Research Report 195, dated September 3, 1953, the Bichler gravel beams would be among the best in durability insofar as resistance to slow freezing and thawing in water is concerned. Two of the three beams are shown in Figure 1 after 300 cycles. One of the three beams failed at about 260. At the conclusion of this test the beams had lost three percent of their original weight from scaling and small pop-outs.

▲ FIGURE 1. AIR-ENTRAINED CONCRETE BEAM CONTAINING BICHLER COARSE AGGREGATE AFTER 300 CYCLES OF SLOW FREEZE AND THAW IN WATER.

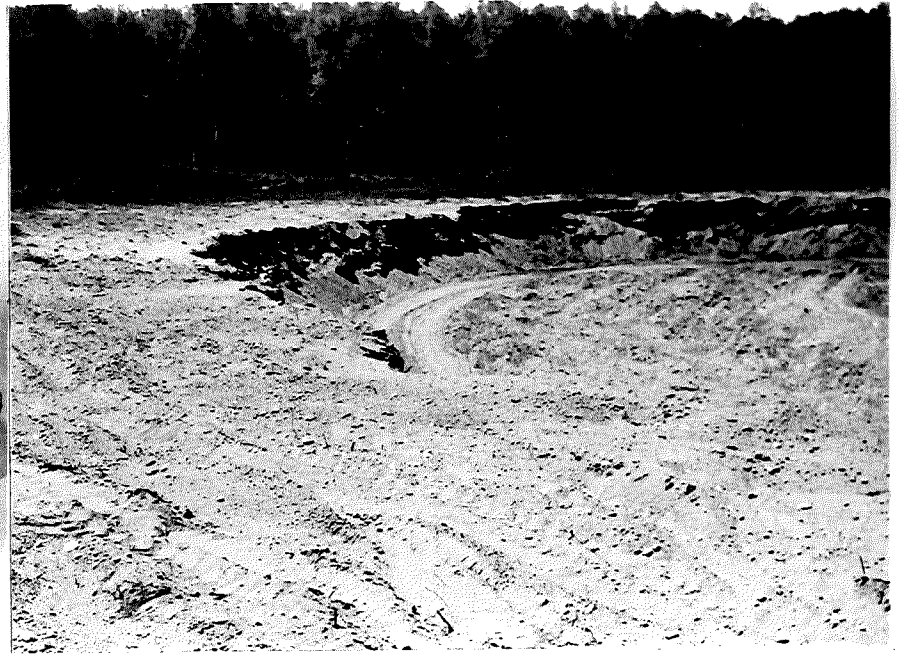
▲ FIGURE 2. SOUTHWEST CORNER OF BICHLER PIT 21-12 SHOWING AREA OF LEACHING INFLUENCE CONTAINING SOFT NON-DURABLE SANDSTONE AND SANDY LIMESTONE .

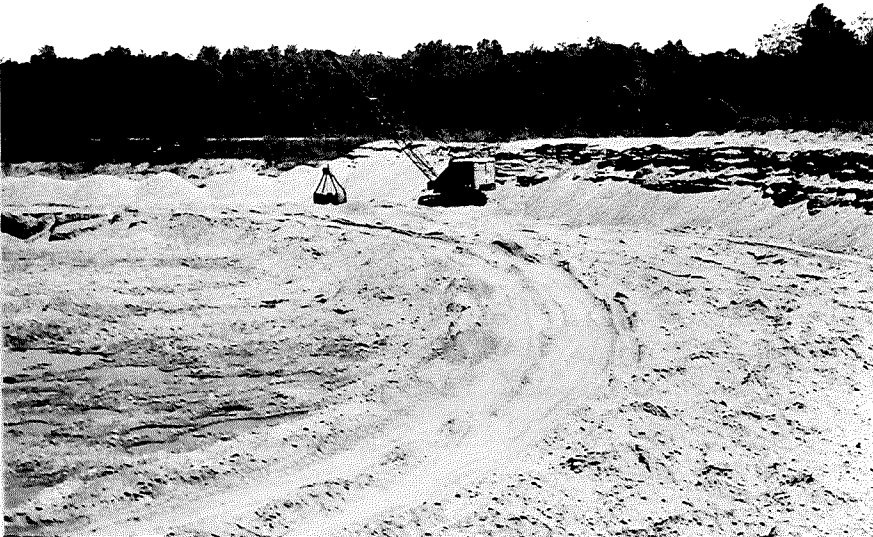
The Bicher gravel pit, (21-12), was visited on July 15, 1954, and the gravel deposit was studied. The present area of better material was being depleted and it was learned that in the spring of 1955 the plant will be located 1/4-mile to the east where gravel from that area will be used for production. In the southwest corner of the present locality, there appeared to be a darker coloration to the gravel bank due, presumably, to leaching and oxidation by swamp or marsh water in this area. Some of the absorbent stone in this spot could be broken up in the hands. This location is shown in Figure 2. The 1954 production was coming from gravel to the east of this bed area and along the south portion of the pit, Figure 3.

◀ FIGURE 3. SOUTH PORTION OF BICHLER PIT WHERE 1954 PRODUCTION WAS BEING TAKEN .

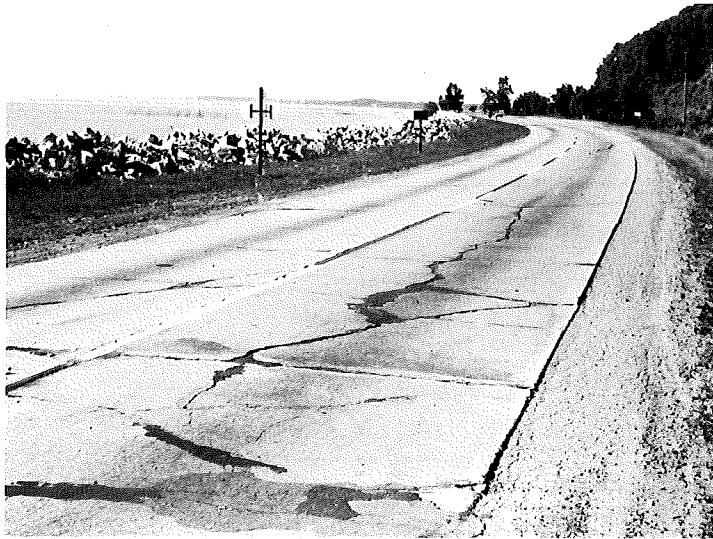
FIGURE 5. SECTION OF 21-6-C10 CONTAINING MANY TRANSVERSE CRACKS. 23 YEARS OLD.

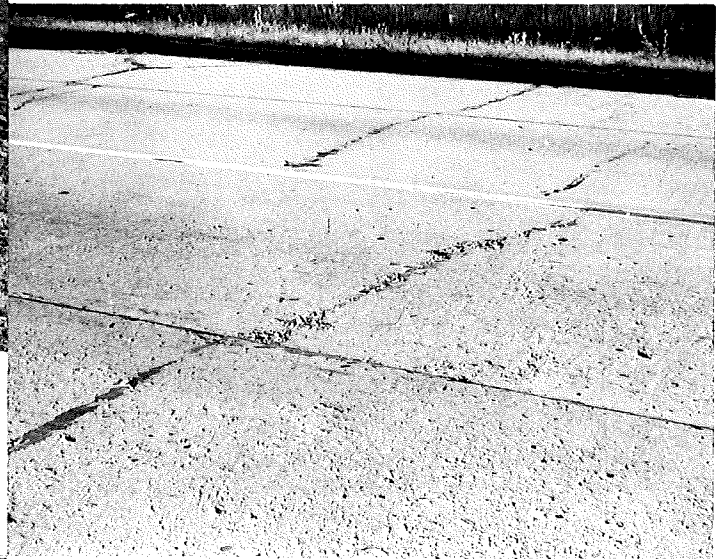
A field survey has been made in Delta County of eleven paving projects which contain Bichler aggregates. See Table 4. The older pavements contained quite a bit of transverse and longitudinal cracks as shown in Figures 4 and 5. The first four projects having 100-foot slabs and all expansion joints

FIGURE 4. BADLY CRACKED AREA IN PROJECT 21-6-C3 NORTH OF ESCANABA ON US-2. PAVEMENT 25 YEARS OLD.

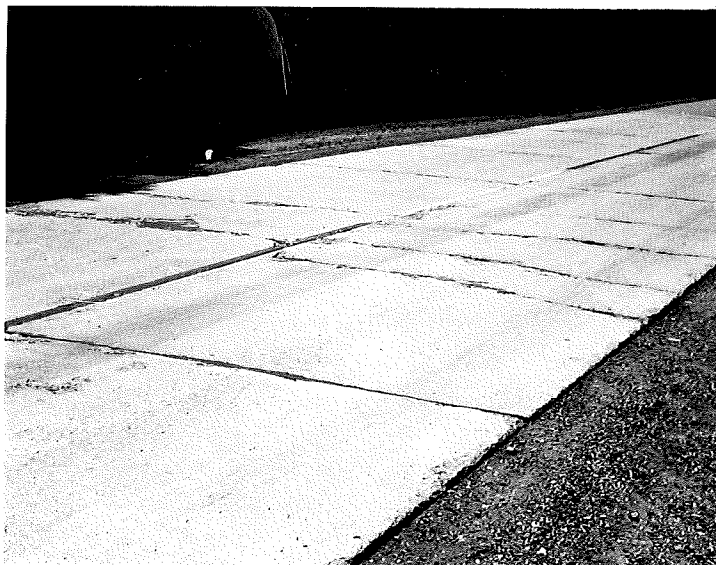
FIGURE 7. EXAMPLE OF PRE-WAR PAVEMENT IN GOOD CONDITION WITH NO CRACKING AND VERY LITTLE SCALING. CONCRETE ABOUT 18 YEARS OLD.

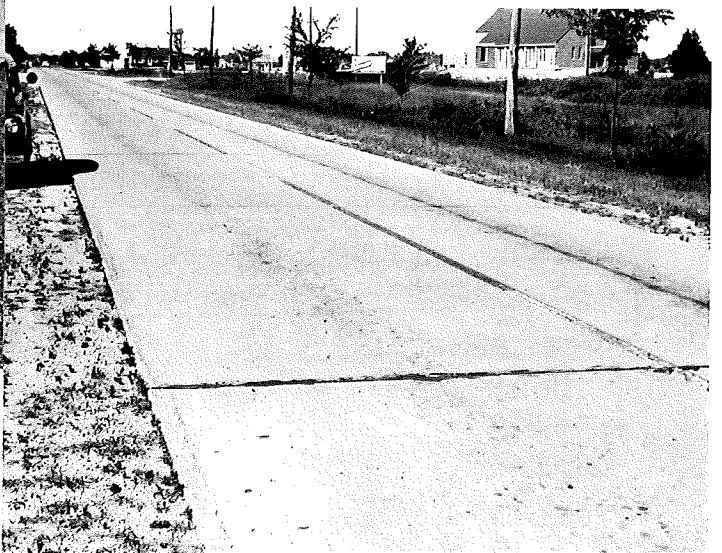
contained most of the transverse cracking, averaging about two to three per slab. The newer air-entrained concrete pavements with the same slab length exhibited very little or none of this cracking. However, some of the old projects contained patched sections of limestone concrete which were cracked and scaled as badly or worse than the original pavement (see Figure 6). Poor subgrade conditions undoubtedly contributed to the very badly cracked areas in the older pavements. Although the older pavements of long slab length contained a good deal of transverse cracking, the concrete itself appeared to be quite sound. Most of the scaling present was found to occur along the cracks and around some of the transverse and longitudinal joints. An example of an older pavement in good condition is shown in Figure 7, Project 21-32,C2, about 18 years old. The postwar pavement projects appear to be in good condition throughout.

FIGURE 6. PATCHED AREA WITHIN PROJECT 21-28-C2 CONTAINING LIMESTONE AGGREGATE, CRACKED MUCH WORSE THAN OLDER BICHLER PAVEMENT. MORE RECENT THAN 19 YEAR OLD PROJECT.

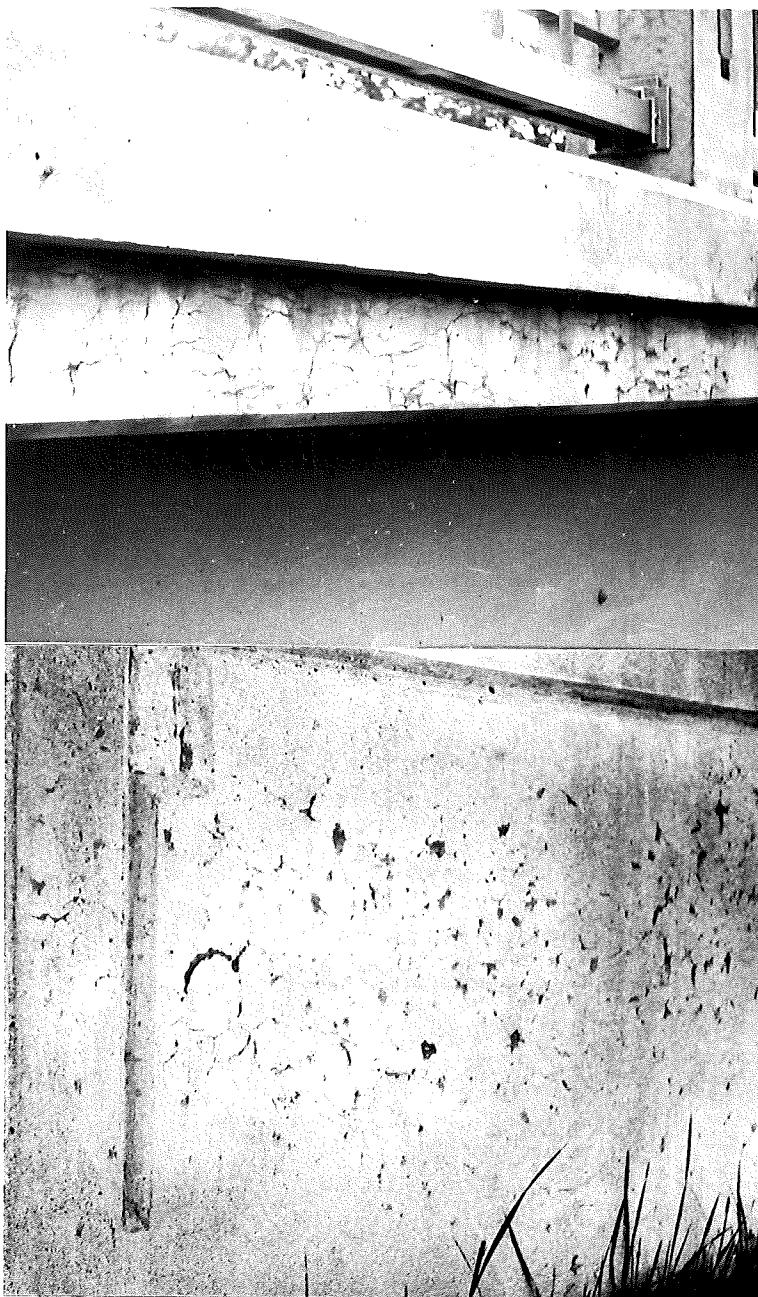
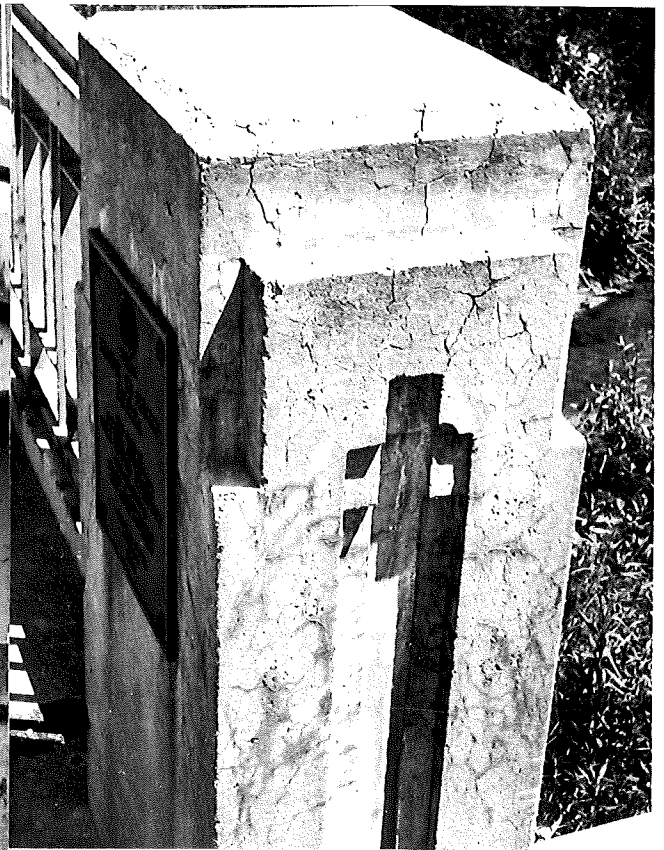
In general, the bridge projects, totaling 17 surveyed and listed in Table 5, were in good shape except for occasional deterioration exemplified by Figures 8, 9 and 10. This sort of breakdown consisted of sporadic areas of yellowish stained cracks and, in some cases, spalling along these cracks. About seven of the seventeen structures contained this type of defect. This condition was probably caused by freeze and thaw action on numerous absorptive sandstone and limestone particles in the coarse aggregate and consequent leaching and oxidation to produce the yellow stain. Figure 11 illustrates one of the ten structures of seventeen surveyed, which was found to be in sound condition and containing no unusual defects of the concrete in particular.

▲ FIGURES 8 AND 9. EXAMPLES OF YELLOW STAINED CRACKS IN BRIDGE SURFACES DUE TO LIMONITIC SANDSTONE IN IN COARSE AGGREGATE. B2 OF 21-9-12 AND B1 OF 21-14-2, BRIDGE 18 AND 19 YEARS OLD RESPECTIVELY.

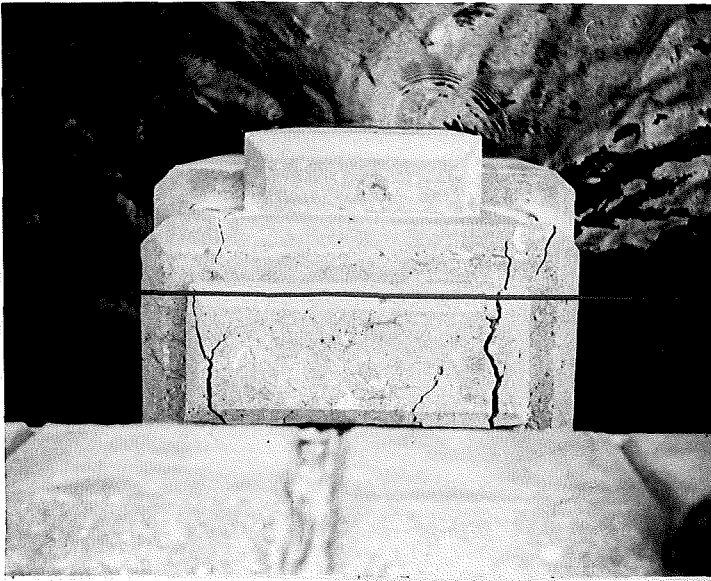
Project B4 of 21-11-12 exhibited extensive damage due to a feature of design rather than through any fault of the concrete. Figure 12 illustrates the

design of the load-bearing portion of all four piers. The use of 100-lb A.R.A. rail for the bearing points in pier tops has been discontinued for some time. This type of construction has produced large cracks over the entire length on both sides of all four piers along the top corners. Top views of the pier ends are shown in Figures 13 and 14. A side view is shown in Figure 15. These cracks carry right up through the deck edge and many of the pilasters. This damage should be repaired before more advanced deterioration takes place from freezing and thawing within the cracks now present, such as is shown in Figure 16, or additional cracking of the piers occurs.

FIGURE 12. CROSS SECTION OF ALL FOUR PIERS SHOWING LOCATION OF 100 LB. RAIL IN PIER TOP FOR BEARING LOAD OF BRIDGE DECK.

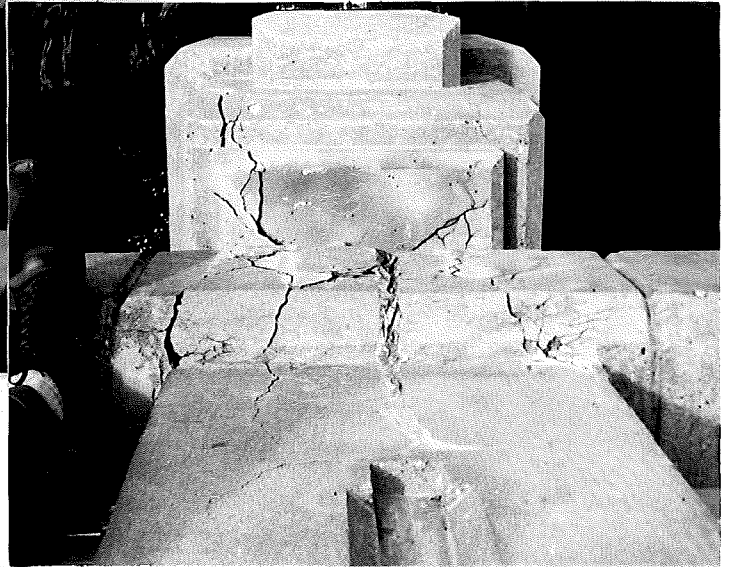
FIGURE 13. TOP VIEW, NORTH END OF 2 ND. PIER FROM WEST END OF BRIDGE SHOWING CRACKING DOWN THROUGH CORNERS. B4 OF 21-11-2. BRIDGE 18 YEARS OLD.
