**PROOF LOAD TEST OF R01 OF 61131
M-37 OVER CSX RAILROAD, SOUTH OF BAILEY, MICHIGAN**

David A. Juntunen, P.E.
Michael C. Isola, P.E.

Research and Technology Section
Materials and Technology Division
Research Project 94 TI-1731
Research Report No. R-1336

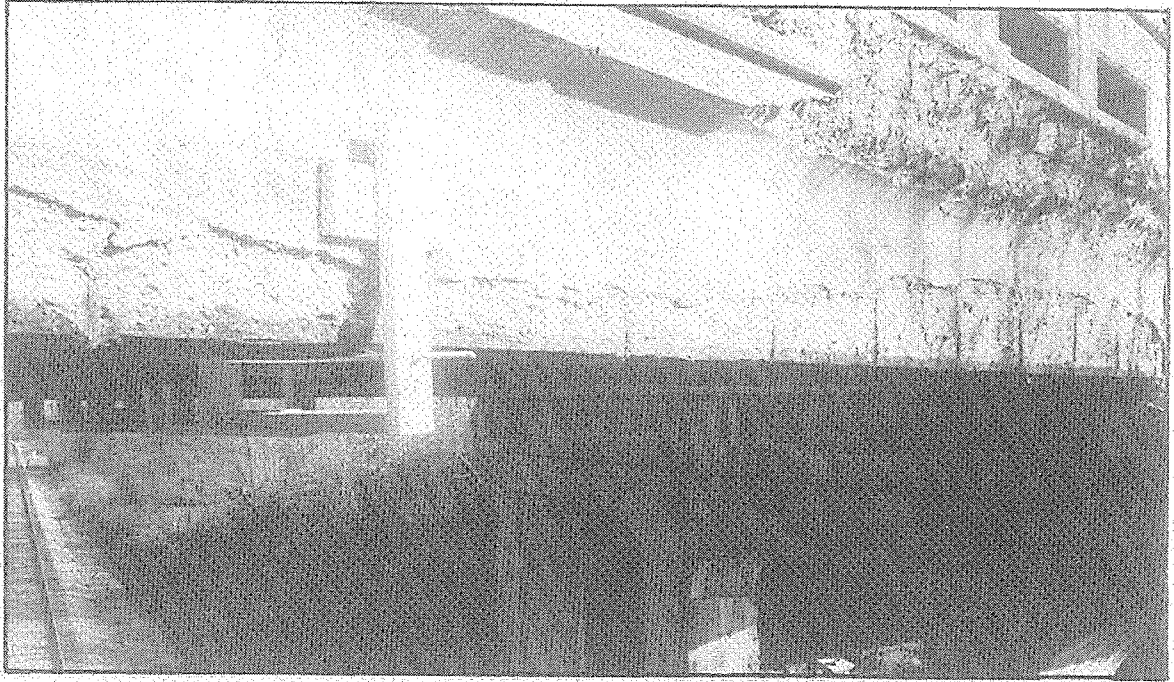
Figure 7: South Fascia Beam (Beam 9) Exposed Reinforcement Full Length of Span 2.

We rated both fascia beams (beams 1 and 9) as serious condition. Clearly, the south fascia beam (beam 9) is in the worst condition of the two fascia beams. Because the bottom row of reinforcement is fully exposed, it cannot be considered in the analysis of the beam because there is little bond of the bars to the concrete for development of strength. As a result, this leaves only one reinforcing bar in the second row of the section to provide resistance, which can cause a significant loss in load carrying capacity of the beam. In fact, this was verified during the load test. When reviewing the deflections (shown in Tables 12 and 13, and Figures 29 and 34), we found beam 9 has less relative stiffness than beam 1, a clear indication that the load carrying capacity of beam 9 has been reduced due to deterioration of the reinforcement. Therefore, the live load normally carried by this beam is being redistributed to the first interior beam (beam 8), which was rated in fair condition.

If the structure remains in service for more than five years we recommend that the department repair the two fascia beams and the interior beams that

are in poor condition, and retest the structure to detect further deterioration and consequent loss of load capacity.

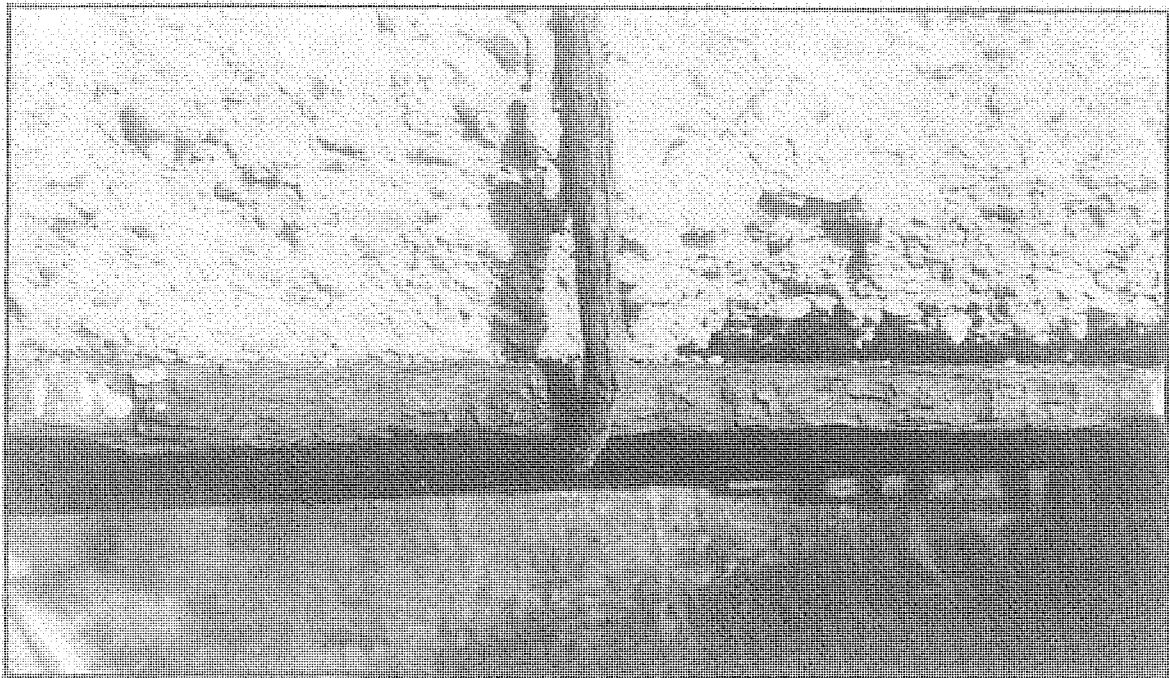
Figure 8: Exposed 1-1/4" Square Reinforcing Steel. Beam 9, Span 2.

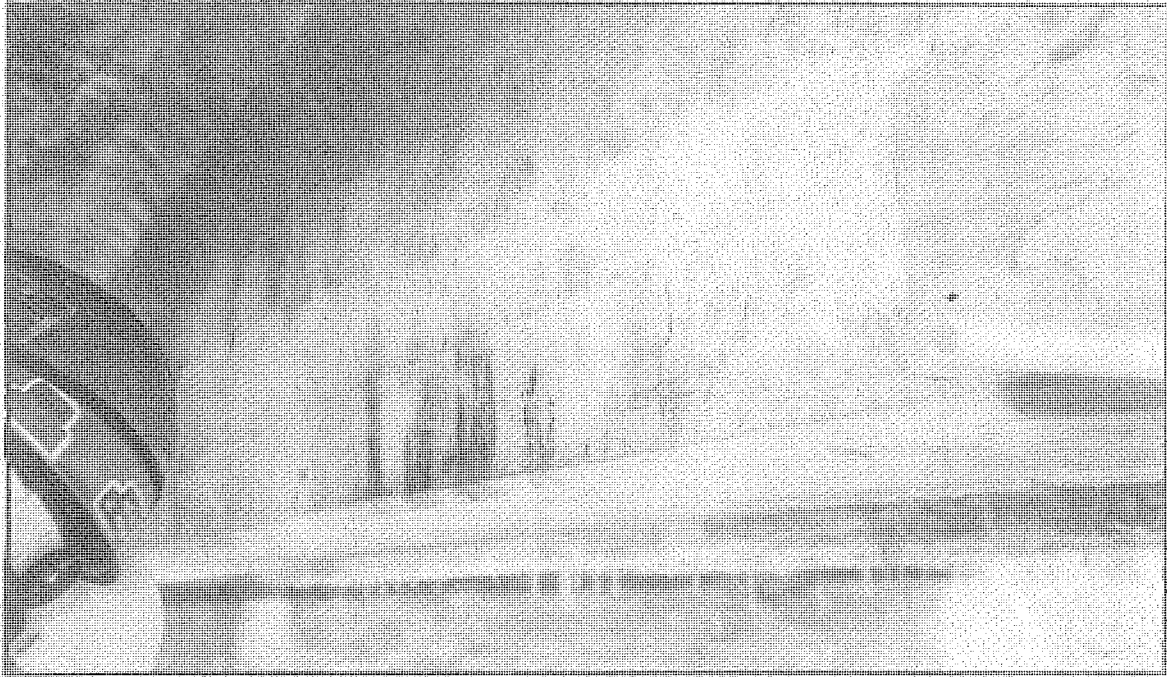
Figure 9: Interior Beam, Span 2, in Good Condition.

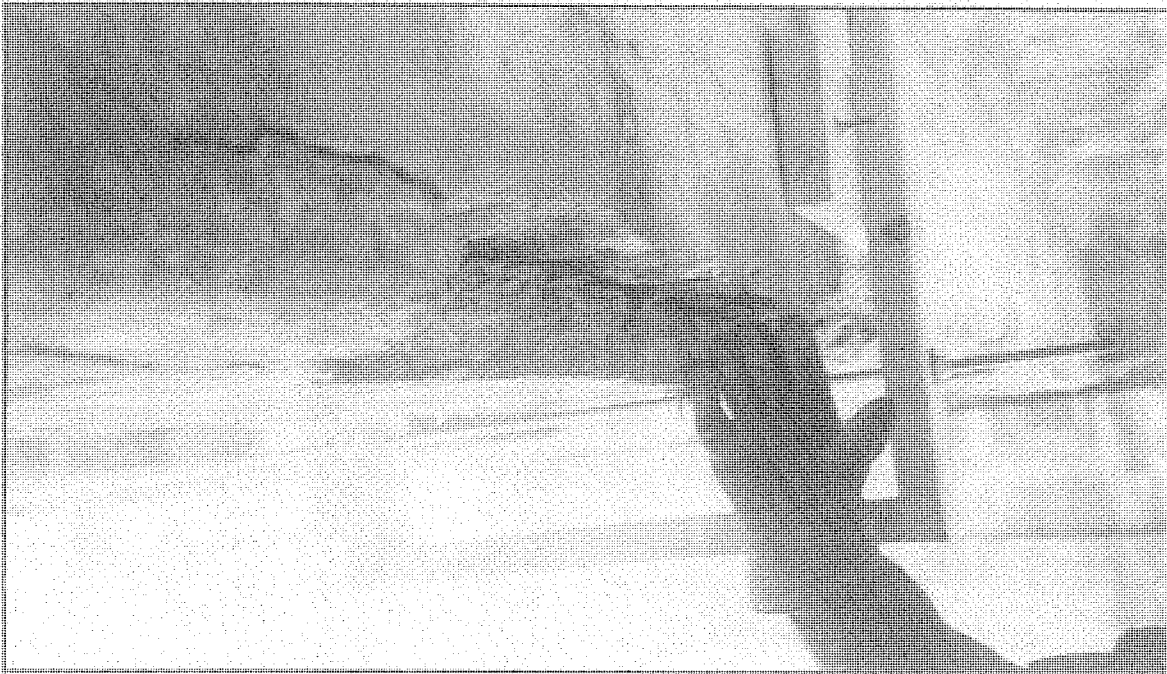
Figure 10: Beam 3, Span 2. Large Spall, Exposing Steel Reinforcement at Bottom of Beam.

The pre-test inspection showed that five out of seven of the interior beams (2, 4, 6, 7, and 8) are in fair condition, while beams 3 and 5 are in poor condition. However, the load test demonstrated that the beams have far greater strength than Bridge Management estimates. The beams were stiffer than estimated, and all beams, with the exception of beam 3, which showed a permanent deflection of .004 inches, immediately returned to their original positions upon removal of the load. The pre-inspection rating of beam 3 as poor supports the theory that this beam may also have permanent deformations due to the load test.

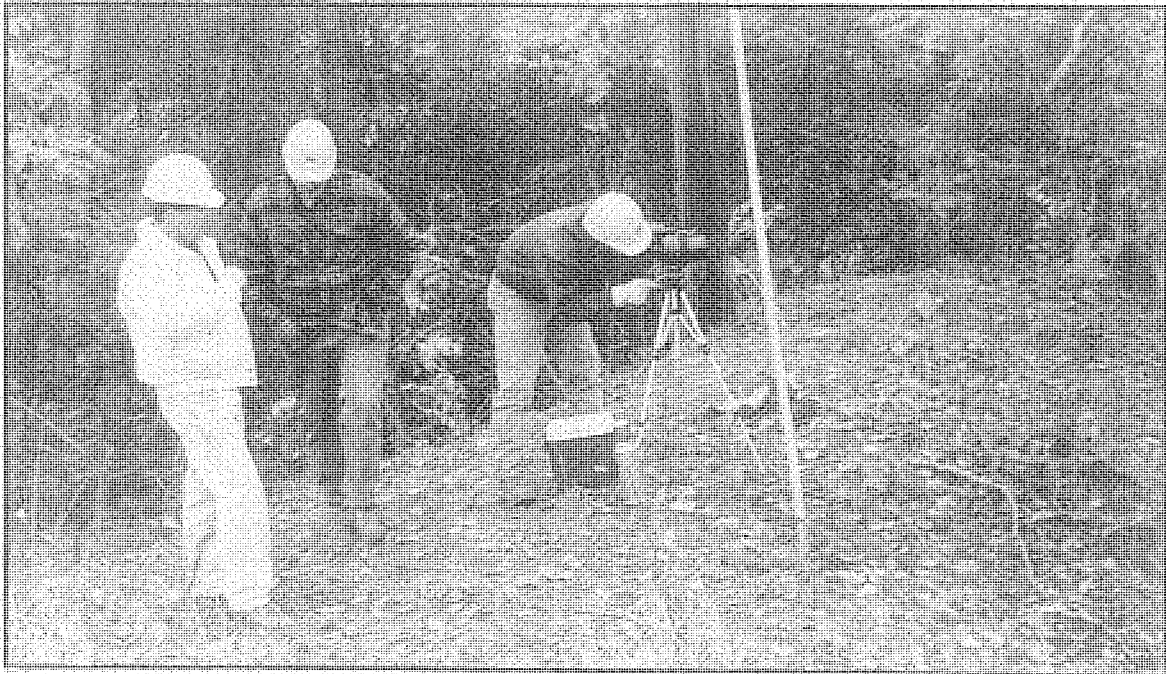
The Structural Research Unit used a Celestron 30X Spotting Scope to observe the fascia beams during the loading sequence for changes in crack dimensions, as shown in Figure 19. We also monitored the bridge deck for changes of crack widths and for initiation of new cracks.

Figure 19: A Spotting Scope Was Used to Monitor Cracks in the Fascia Beams.

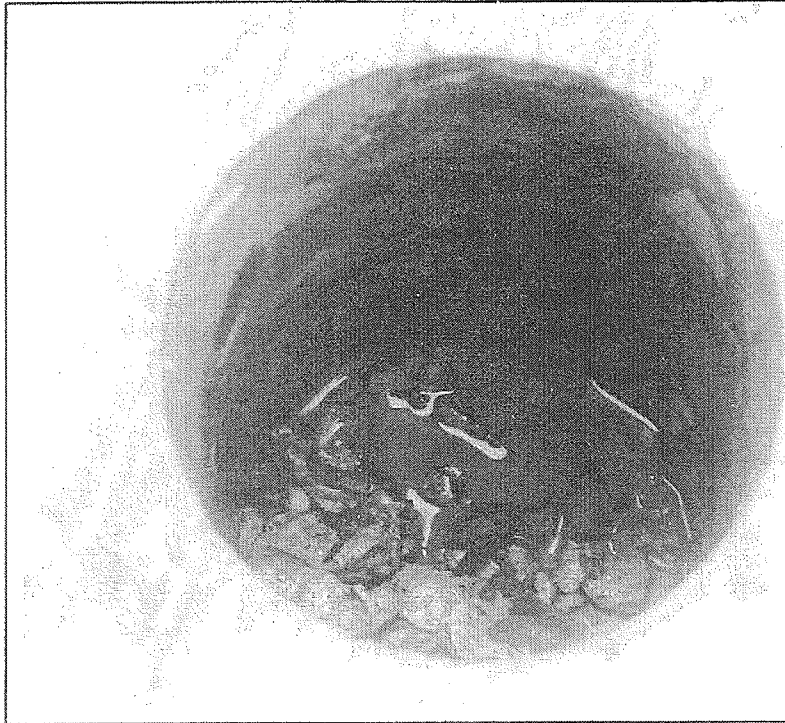
Figure 36

In May 1995, the Structural Research Unit inspected the bridge deck, and used cores removed from the deck to perform a "pull-off bond test" to determine the bond strength between the new concrete overlay and the existing deck. We did this test to see if the freeze-thaw action during the winter of 1995 deteriorated the composite action between the overlay and the existing deck. During our inspection, we found extensive cracking in the concrete overlay where the average width of the cracks were .02 inches to .025 inches (see Figures 37 and 38). When drilling cores for the "pull-off bond test" each core fractured at the concrete overlay/existing deck interface. We inspected the core holes and found loose concrete debris at the bottom of the hole (see Figure 36). Feeling the edges of the core hole, we found a void between the overlay and existing deck. From this inspection, it is clearly evident that there is little bond between the new concrete overlay and the existing deck.

4" Diameter Core Hole for Pull-off Bond Test Showing Loose Aggregate at Bottom of Hole.

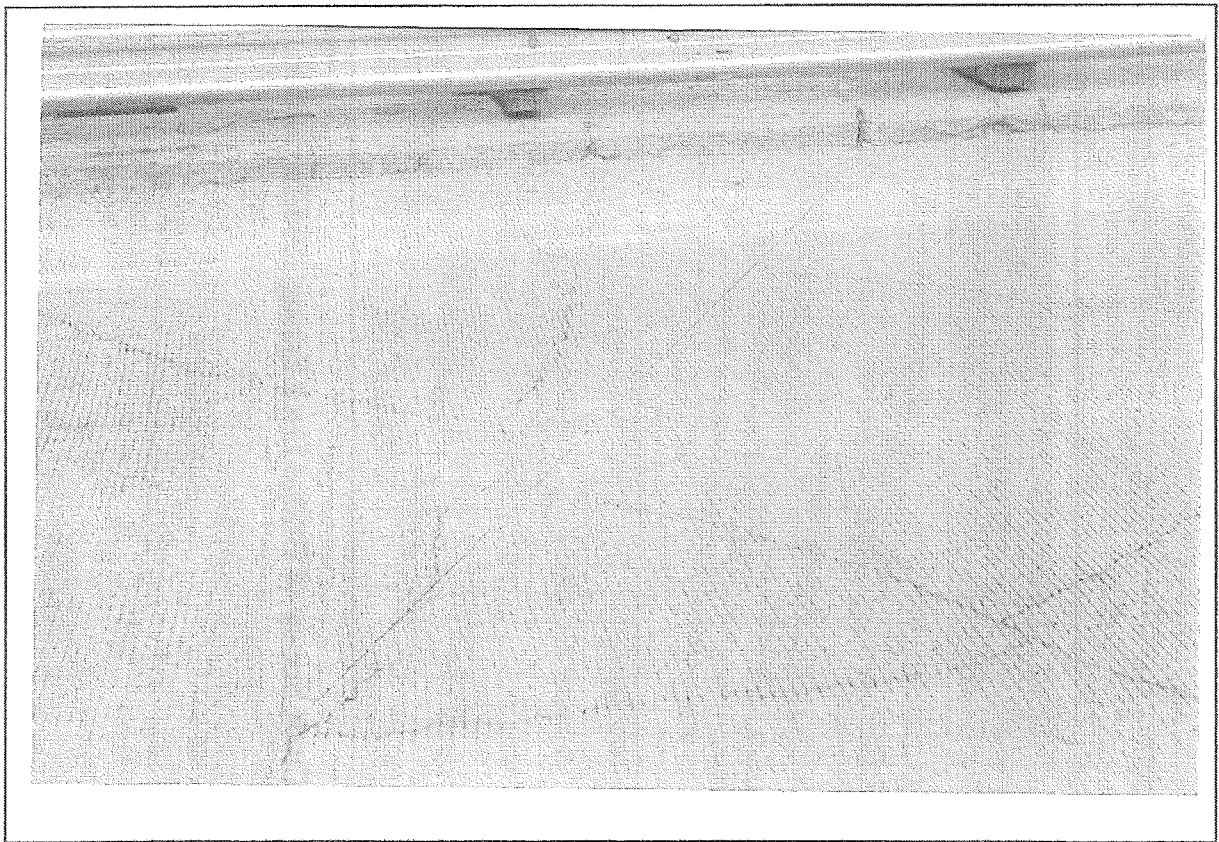
Figure 37 - Showing Cracked Bridge Deck. Spring 1995 Inspection

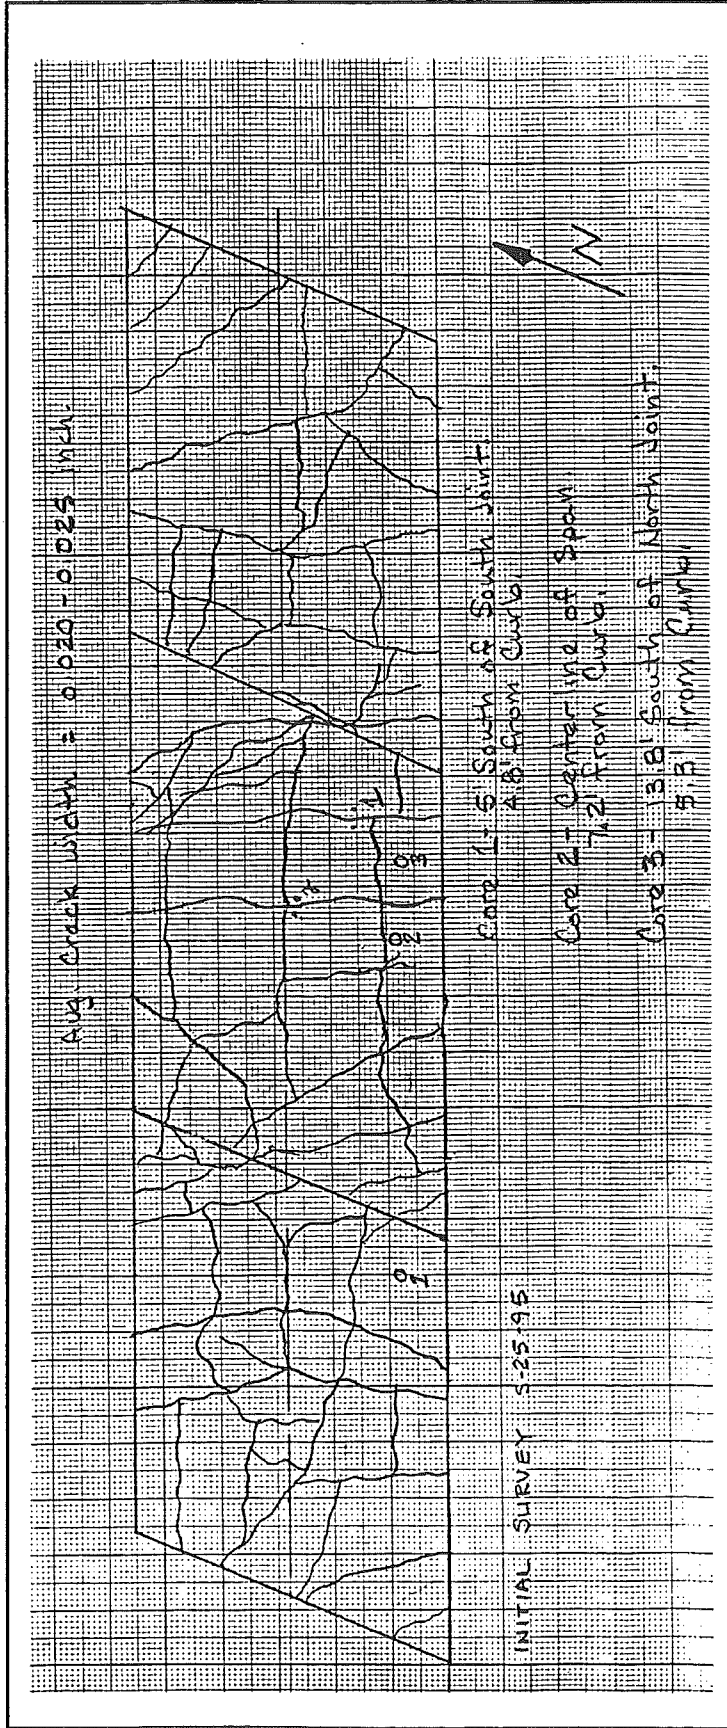
Figure 38 - Crack Survey of Bridge Deck Spring 1995 Inspection.

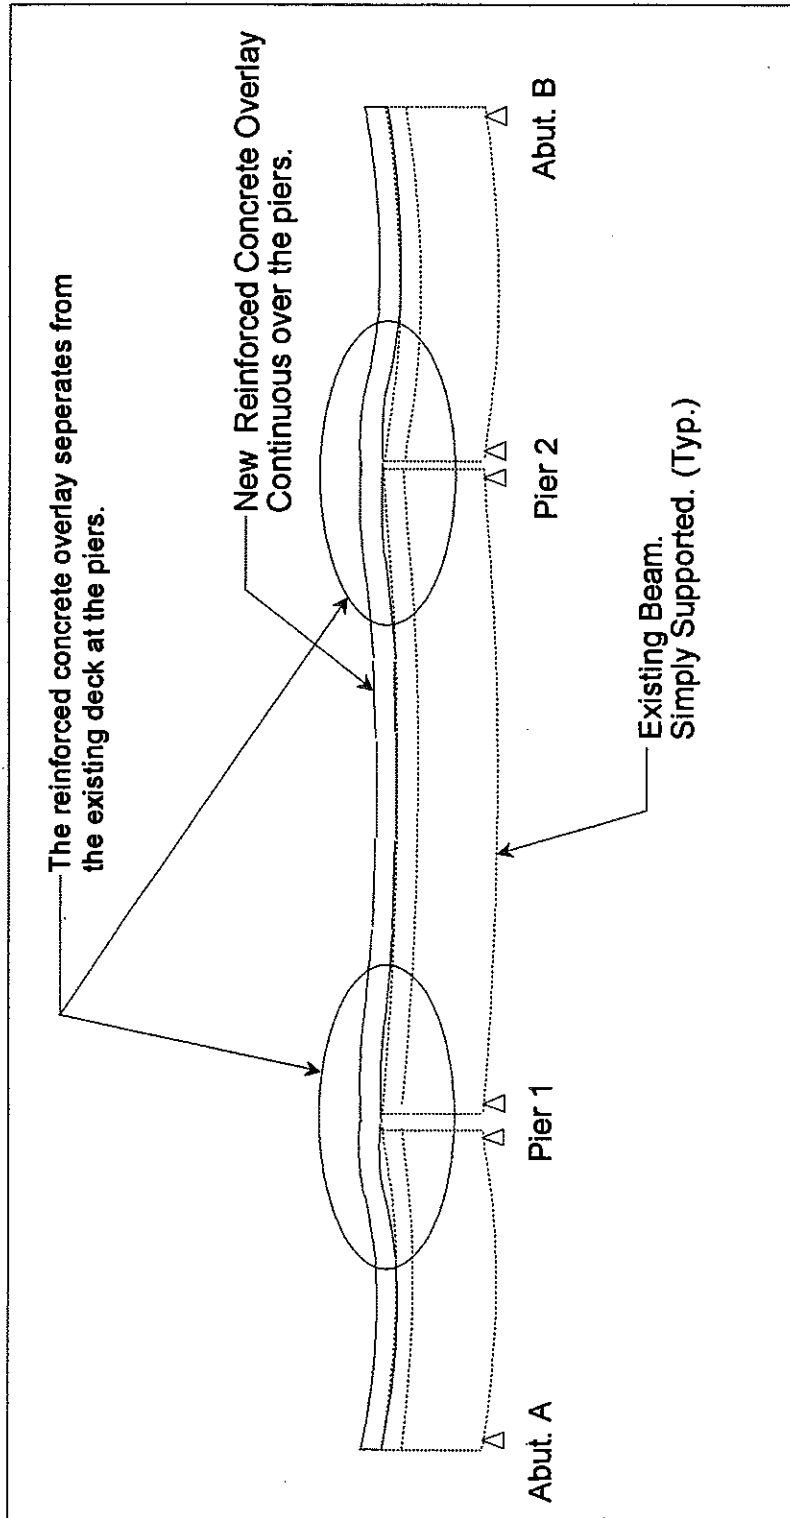
the structure will respond to load in the future, we needed to determine why the concrete overlay, which is made of good strong concrete and reinforcing steel, is deteriorating so quickly, and why it is separating from the existing deck. We feel when the bridge receives live load, negative moment created by the overlay's reinforcing steel that extends through the expansion joint at each pier causes uplift of the overlay, causing it to separate from the existing deck. Large moments are developed in the overlay, thus causing it to crack. In the end-spans near abutment A and abutment B, and in the center portion of span 2, there is no uplift force; thus less cause for the overlay to separate from the existing deck.

Figure 39. Showing the reinforced concrete overlay separating from the existing deck.
