FINAL REPORT ON EVALUATION OF A RUBBER
PAD RAILROAD CROSSING

J. E. Simonsen

Research Laboratory Section
Testing and Research Division
Research Project 64 G-134
Research Report No. R-901

Michigan State Highway and Transportation Commission
E. V. Erickson, Chairman; Charles H. Hewitt,
Vice-Chairman, Carl V. Pellonpaa, Peter B. Fletcher
John P. Woodford, Director
Lansing, February 1974

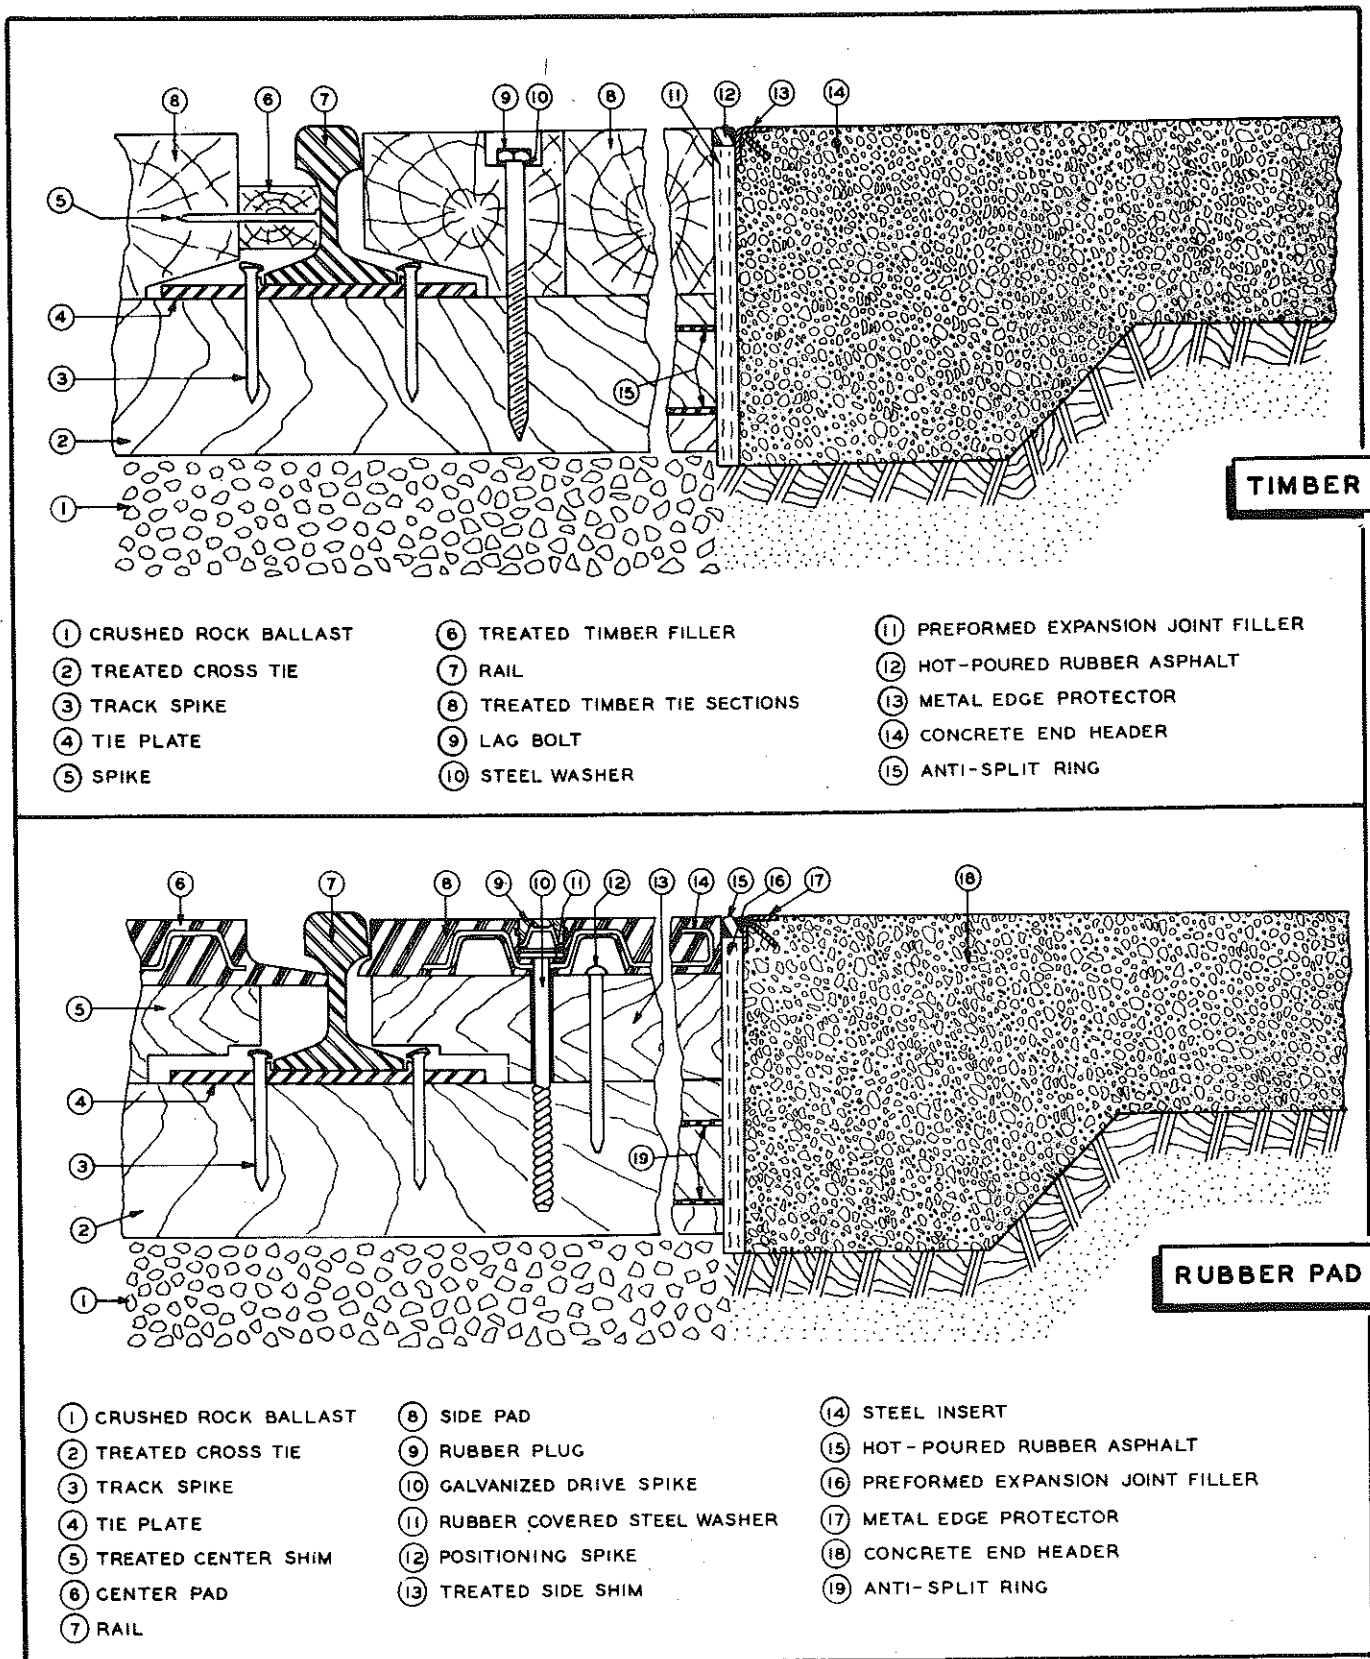
Figure 1. Cross-sectional detail drawings of railroad crossing components.

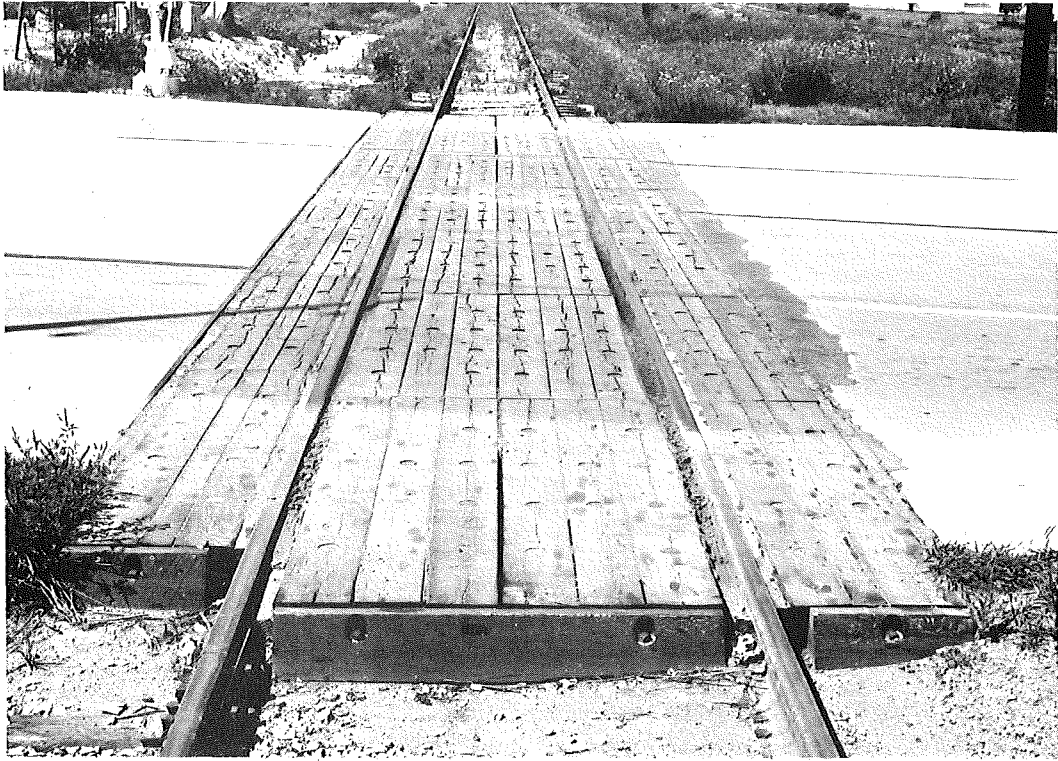
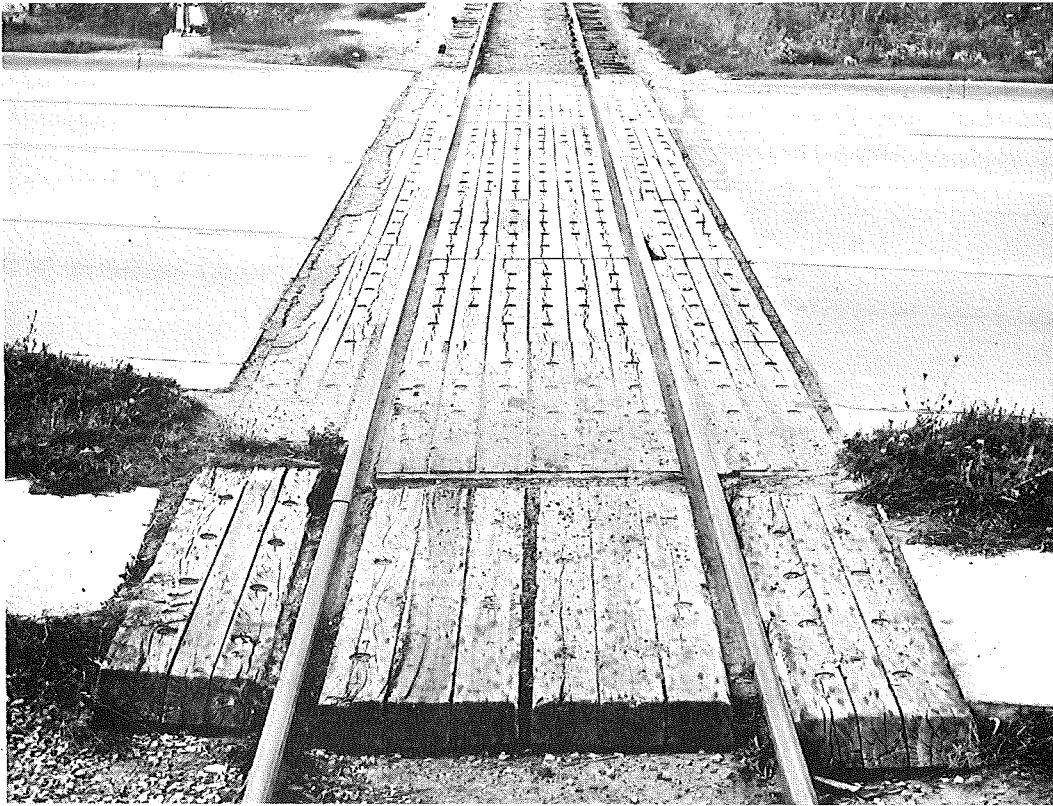
Timber Crossing -- The first inspection of the timber crossing was made in August 1964. It was noted that the south side of the crossing was from 1/2 to 1 in. low with respect to the pavement and that the north side was high by about the same amount. A 6 to 12-in. wide bituminous transition strip had been laid at the north side to provide a smoother crossing. The timbers were in good condition and neither they nor the rails were loose. The 1965, 66, and 67 inspections revealed no noticeable changes. During the March 1968 inspection it was noted that the crossing had settled. The south side was found to be about 2 in. lower than the pavement and the north side was nearly at the same elevation as the concrete slab. The 1968 summer inspection disclosed no further settlement. Inspection in 1969, 70, 71,

Figure 2. Views of timber crossing one year after installation (top), and 10 years after installation (bottom).

72 and in the summer of 1973 revealed no significant change in elevation between pavement and crossing. The timber ties are beginning to show wear (estimated to be about 1/8 in.) and one of the ties next to the rail in the center lane is split and a piece broken off. The crossing elements are still securely fastened and no deflection of the crossing is noticeable when vehicles pass over it. Figure 2 shows the condition of the crossing after one year and 10 years of service.

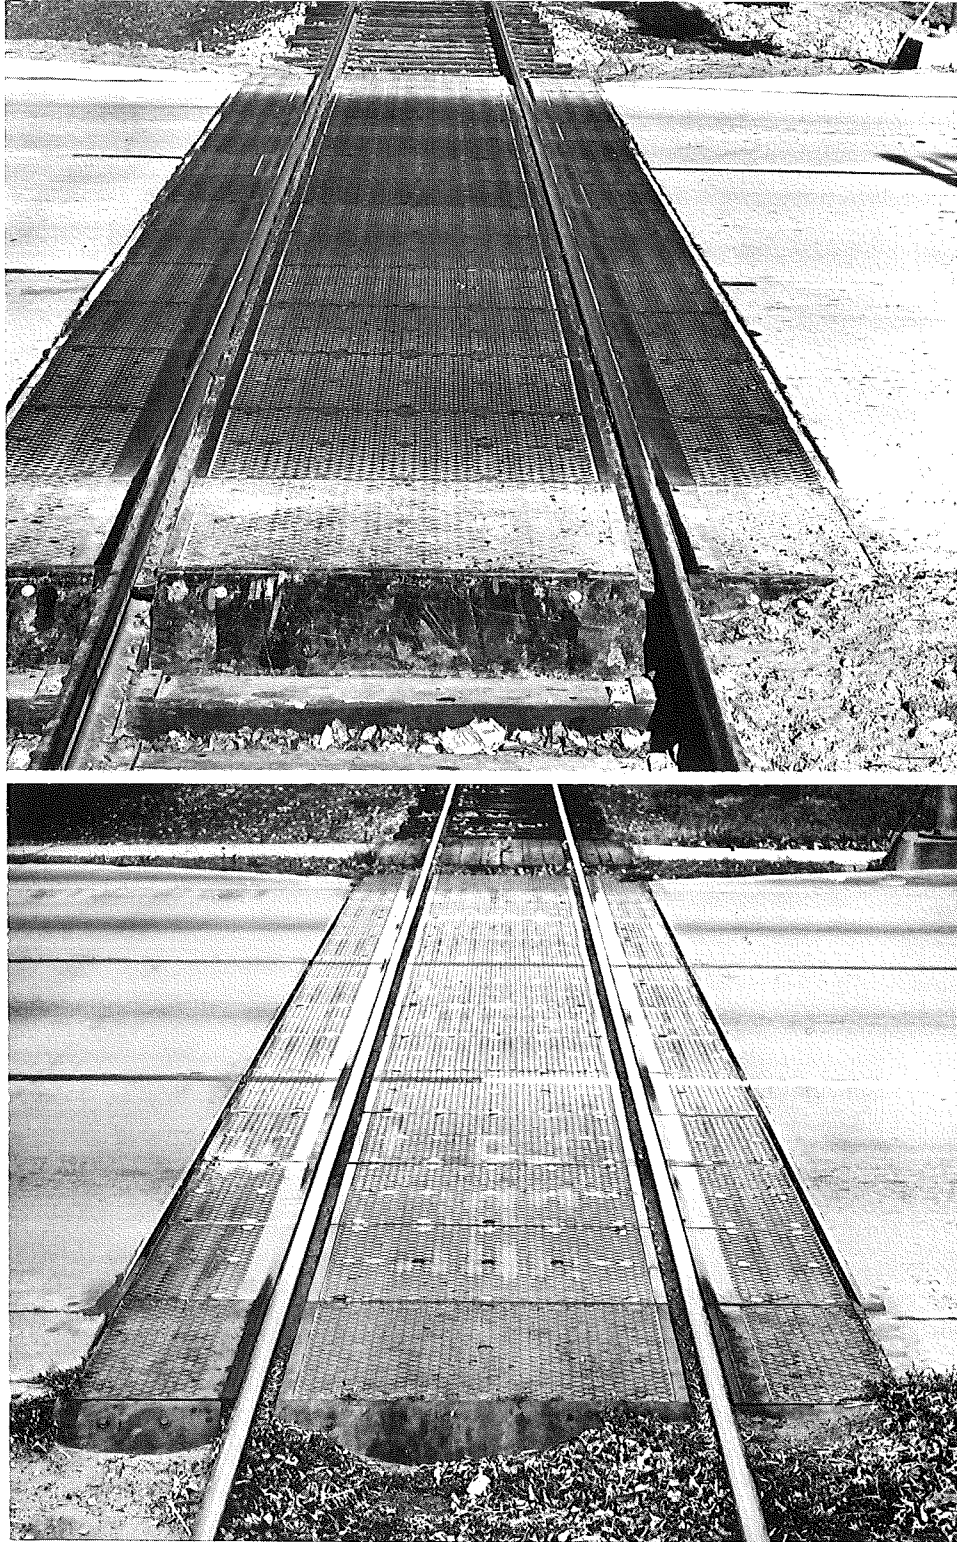
Rubber Crossing -- The rubber crossing was inspected for the first time in the winter of 1966 and was found to be in excellent condition. The 1966 summer inspection revealed that seven bolt-hole rubber caps had been lost, presumably due to snow removal operations. These caps have never been replaced. No change in condition was noted at the 1967 winter inspection, but a slight deflection of the approach side of the crossing in the right hand lane was noted during the summer inspection when vehicles passed over the crossing.

By the time of the 1968 summer inspection this small deflection at the approach edge was evident in all three lanes. However, during the following five years until now there has been no further increase in amount of give and the smoothness of the crossing has not been impaired by it.

The sealant along the crossing edges showed signs of adhesion failure in 1968, and has now failed for the entire length. The pads have shown excellent resistance to wear and after nine years of service the amount of wear is minute. The pads, shims, and rails are securely fastened to the ties, and the crossing has remained smooth since installation. Figure 3 shows the crossing condition when installed and its condition after eight years of service.

Figure 3. Views of rubber pad crossing. As constructed (top), and eight years after construction (bottom).

d) The joints between the crossing and the roadway should be constructed to a width of 1 in. and the seal should be maintained to limit the amount of moisture entering the foundation.
