A TRAFFIC ACCIDENT ANALYSIS
AND TRAFFIC CONTROL DEVICES INVENTORY
IN THE CITY OF ST. JOSEPH

Report TSD-215-73

**TRAFFIC and
SAFETY
DIVISION**

**DEPARTMENT OF STATE HIGHWAYS
STATE OF MICHIGAN**

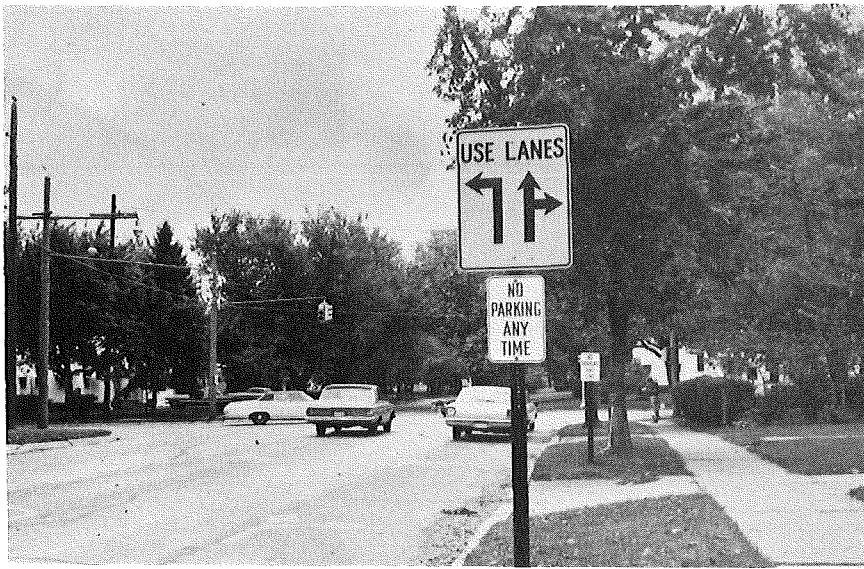
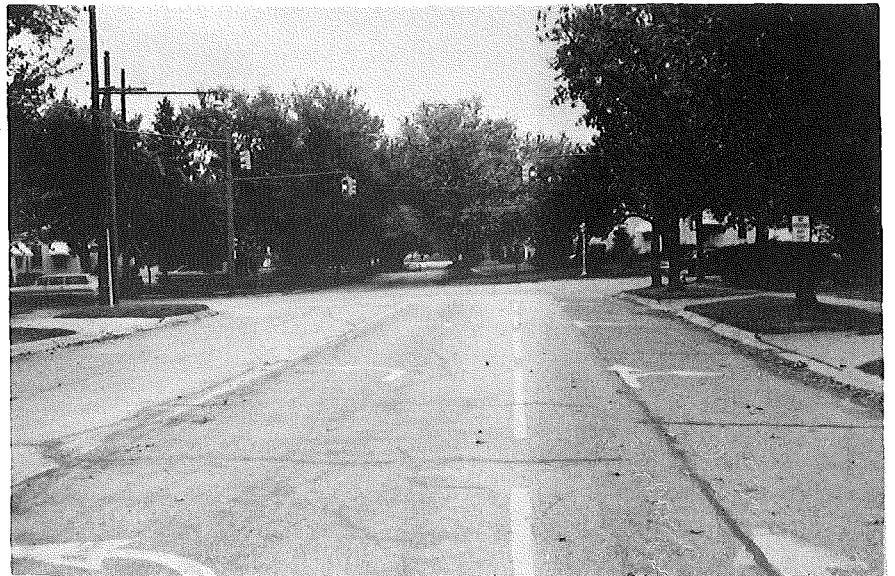
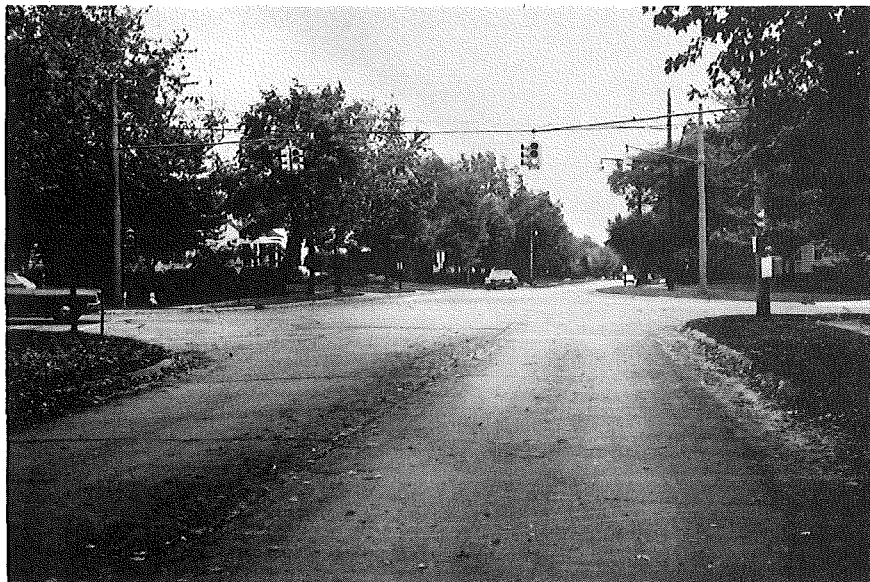
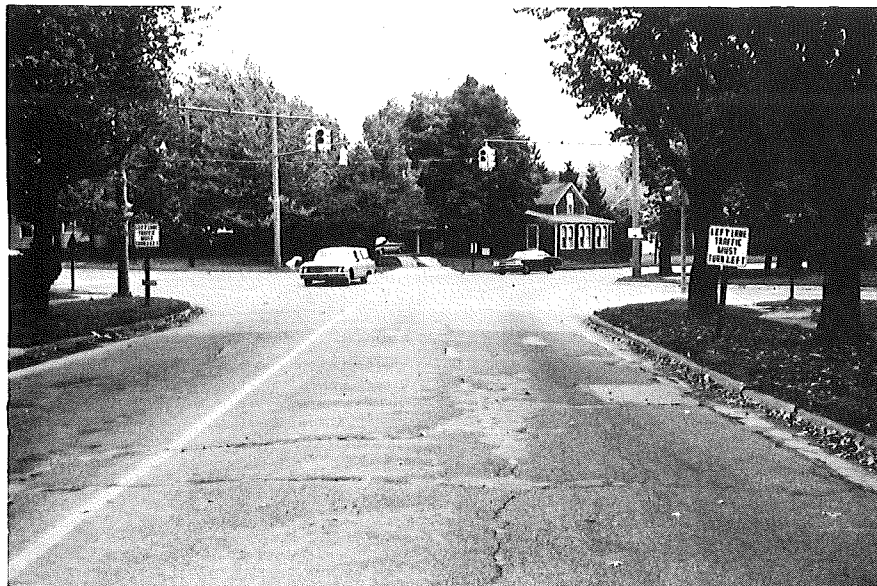
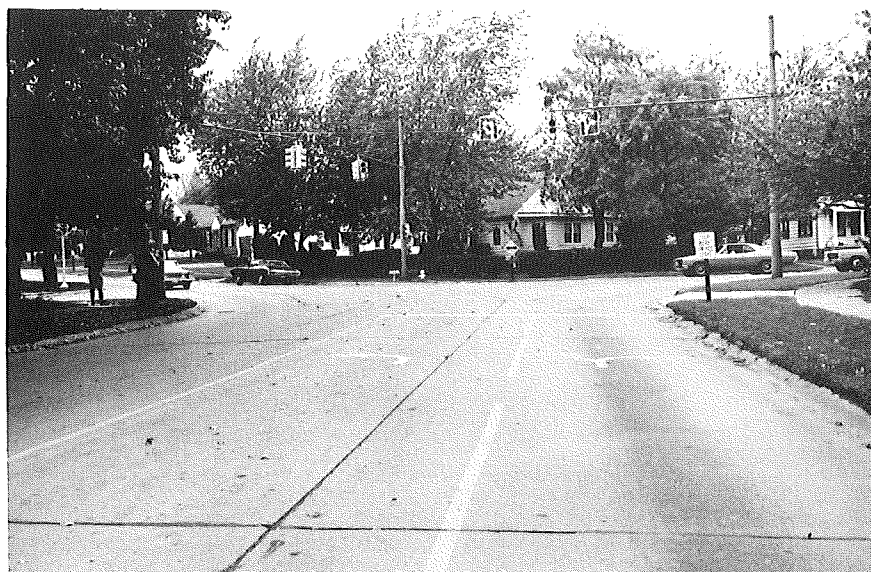
FIGURE 7

Napier and Langley Avenues form a four-legged intersection that is under signal control. The west leg of Napier Avenue has a 32 ft. wide bituminous cap that was placed on a concrete pavement. The bituminous surface has worn away in spots exposing the old pavement. The southeast leg of Napier Avenue has a three lane, 40 ft. wide concrete pavement. The horizontal alignment of Napier Avenue from east to west consists of a left hand curve. Langley Avenue northeast of the intersection has a three lane, 40 ft. wide pavement that is both concrete and bituminous. Langley Avenue southwest of the intersection has a two lane, 30 ft. wide concrete pavement. Parking at this intersection is allowed only on the west side of the southwest leg of Langley Avenue.

There was a total of 45 accidents at this location during the five-year study period. Twenty six of these accidents occurred on dry pavement, thirteen occurred on wet pavement and six occurred on snowy pavement. Rear end collisions accounted for twenty of the total accidents. Nine of the rear end accidents occurred on wet pavement and three others occurred on snowy pavement. Careless driving was reportedly the cause of eight of the rear end accidents. The next highest accident category involved sideswipe collisions. Six of the ten sideswipe accidents involved improper lane usage. The remaining accidents at this location consisted of five head-on left turns, four involving improper backing, two ran-off roadways, one involving improper passing and one involving a pedestrian.

Fourteen of the 19 accidents that occurred on wet or snowy pavement happened on Napier Avenue. Ten of these accidents were rear end collisions. It appears from the above figures that this street becomes slippery when wet. Thus, it is recommended that skidometer tests be conducted on Napier Avenue through the intersection. If

There were 10 sideswipe accidents at this intersection during the study period. Six of these accidents occurred on the southeast leg of Napier Avenue with five of them involving improper lane usage. The overhead lane assignments for this leg are difficult to see due to the absence of a dark background behind the white arrow indications (Figure 8, p. 20). It is recommended that standard overhead Lane-Use Control signs employing the proper background be erected in place of the existing signs.

The west leg of Napier Avenue had only two sideswipe accidents during the study period. However, the proper lane assignments for eastbound traffic are not apparent. It is recommended that overhead Lane-Use Control signs, including a left turn only arrow (R3-5) over the center lane and a thru and right turn arrow (R3-6) over the curb lane be erected 75 ft in advance of the intersection. Additionally, the overhead signing should be supplemented by painted arrows and a 30 in. roadside sign (R3-8) to give advance warning of the lane assignments. Furthermore, a lane line should be applied to divide the two approach lanes for eastbound traffic.

Lastly, southwestbound Langley Avenue is offset to the west in relation to northeastbound Langley Avenue. Due to this alignment, it is recommended that a left turn only arrow (R3-5) be erected over the left turn lane and a thru and right turn arrow (R3-6) be erected over the curb lane. This overhead signing should be located 75 ft in advance of the intersection. These signs should eliminate confusion at this intersection by giving all motorists an unobstructed view of the required lane assignments.

these tests indicate that resurfacing is necessary, it is recommended that the project be included in the City's construction program and completed at the earliest feasible date.

Furthermore, it is recommended that the lane assignments be changed to prohibit left turns from the southeast leg of Napier Avenue. A capacity analysis was performed at this intersection during the p.m. peak. The following results were obtained.

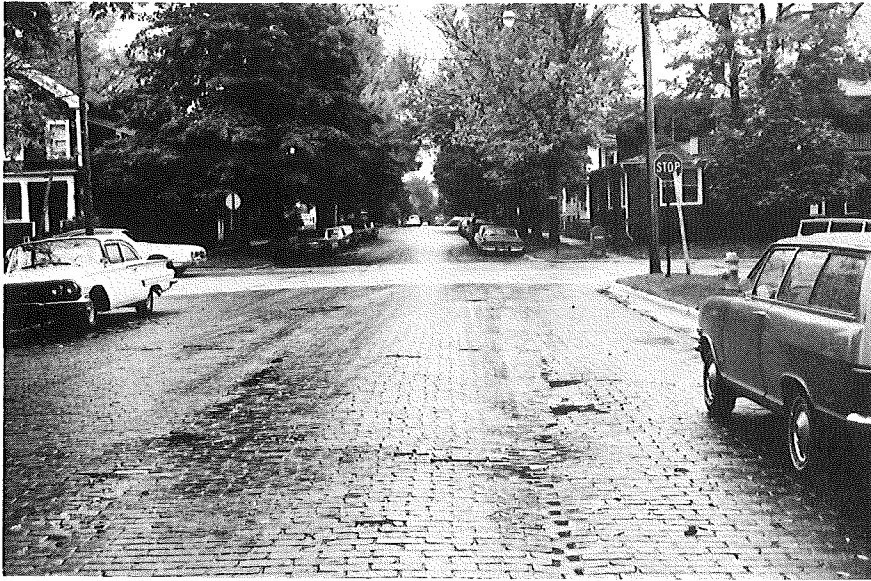
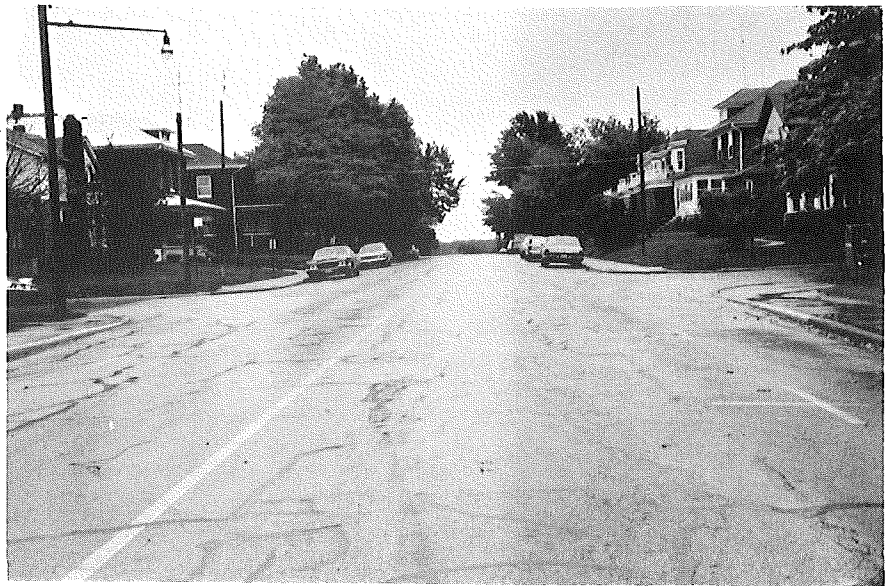
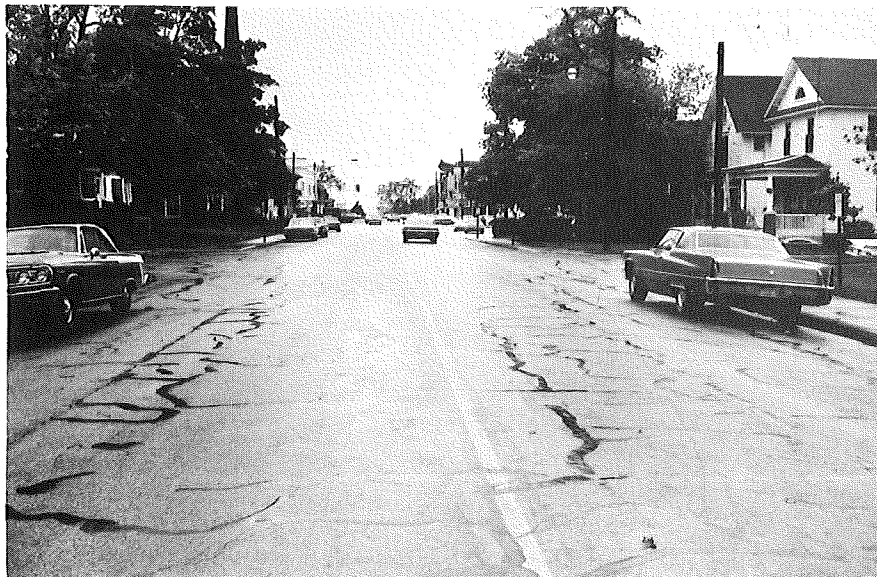
FIGURE 11

Lastly, the signs on Broad Street that state "No Parking Here To Corner" are positioned perpendicular to Broad Street. It is recommended that these signs be turned to face east and westbound Broad Street traffic. The parking signs with arrows should be set at an angle of not less than 30 nor more than 45 degrees with the line of traffic flow to be visible to approaching traffic. Parking signs without an arrow can be erected an an angle of 90 degrees to the curb line.

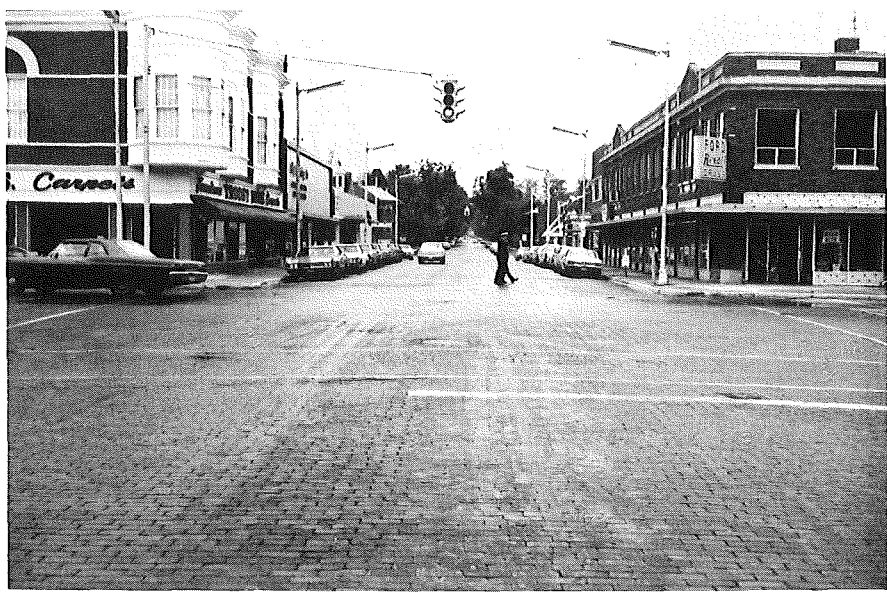
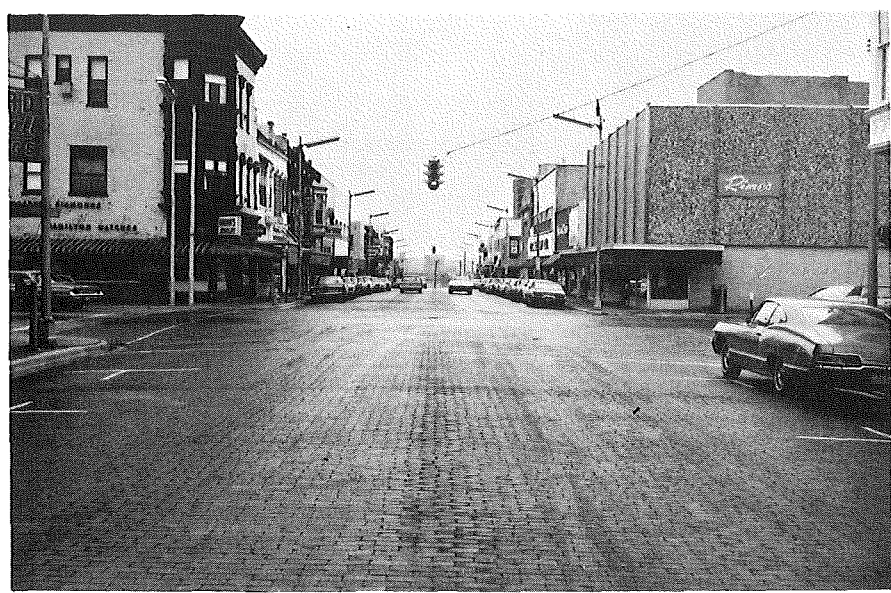
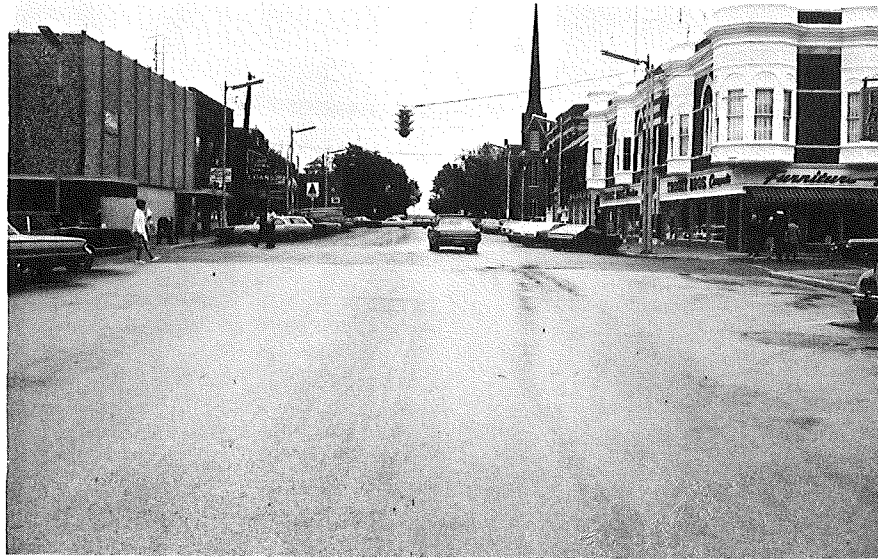
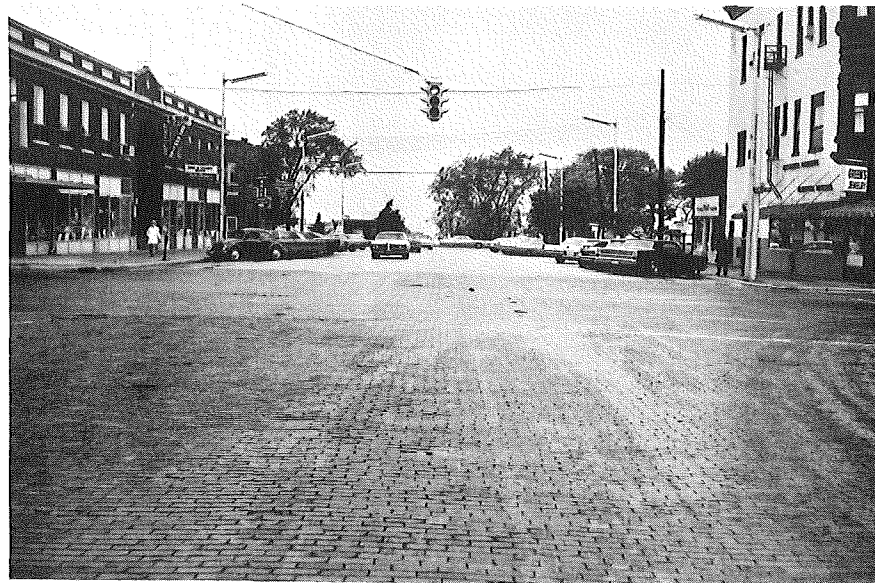
Another problem at this intersection involves the single signal head which provides only one visible signal face per approach. If this intersection remains signalized then a second signal head should be erected to provide two visible signal faces per approach.

Lastly, 31 percent of the accidents occurred on wet pavement. Furthermore, three of the four legs of this intersection have brick surfaces which produce a low coefficient of friction as they age. Therefore, it is recommended that skidometer tests be conducted.

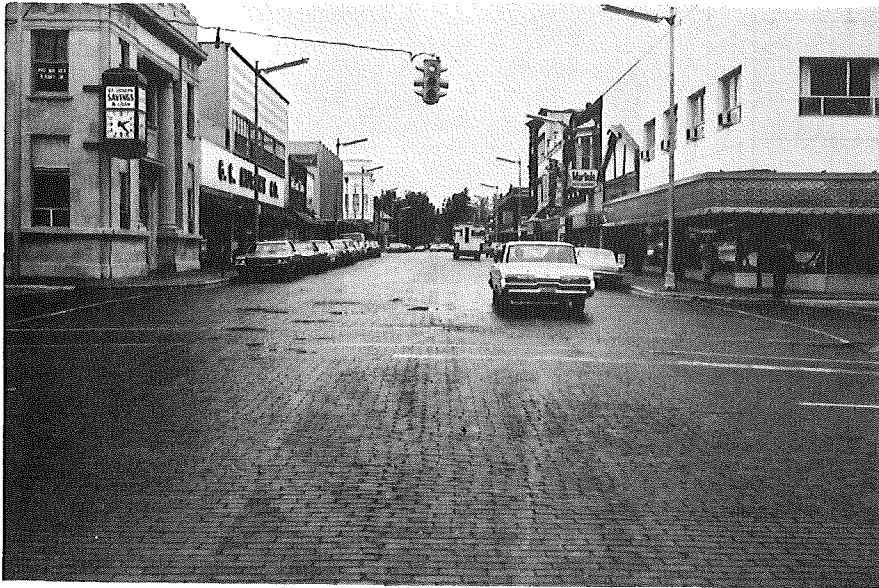
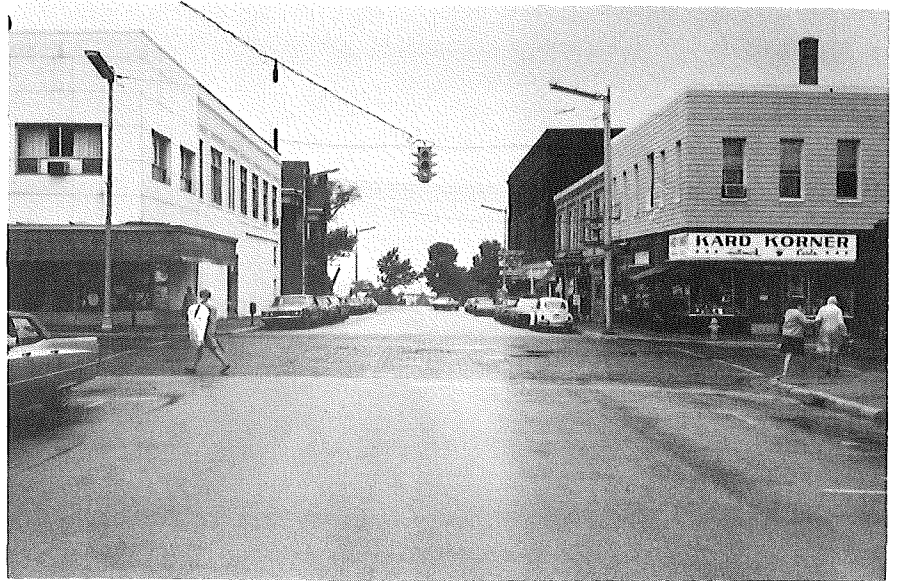
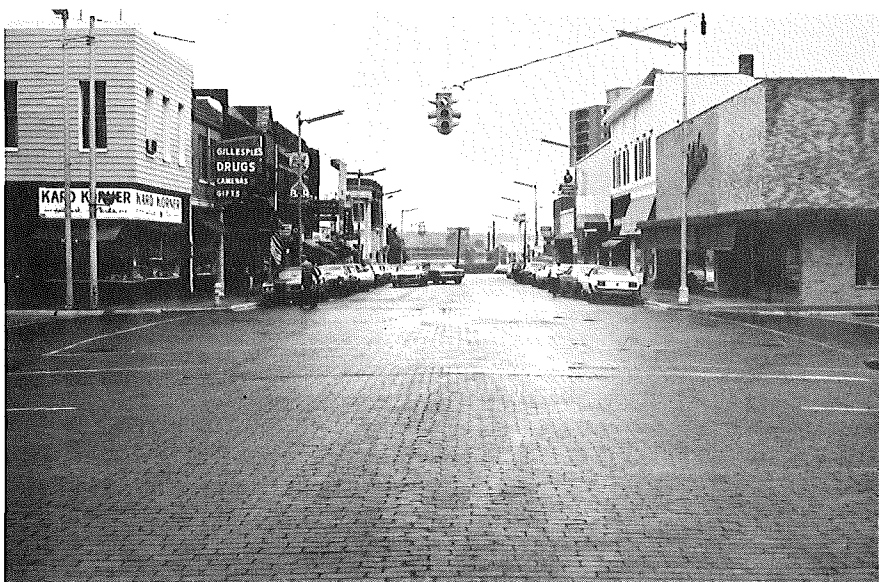
There were five sideswipe accidents during the study period, four of which were caused by a vehicle leaving a parking place. Neither State Street nor Pleasant Street have center line markings. Thus, it is recommended that center lines be applied to both streets. Center line markings will help reduce the conflict between vehicles entering or exiting a parking place and moving traffic by giving moving traffic an indication of the available pavement width.

Lastly, this intersection has only one overhead vehicular signal face visible to traffic on each approach. If this intersection remains signalized then a second signal head should be erected to provide two visible signal faces per approach.

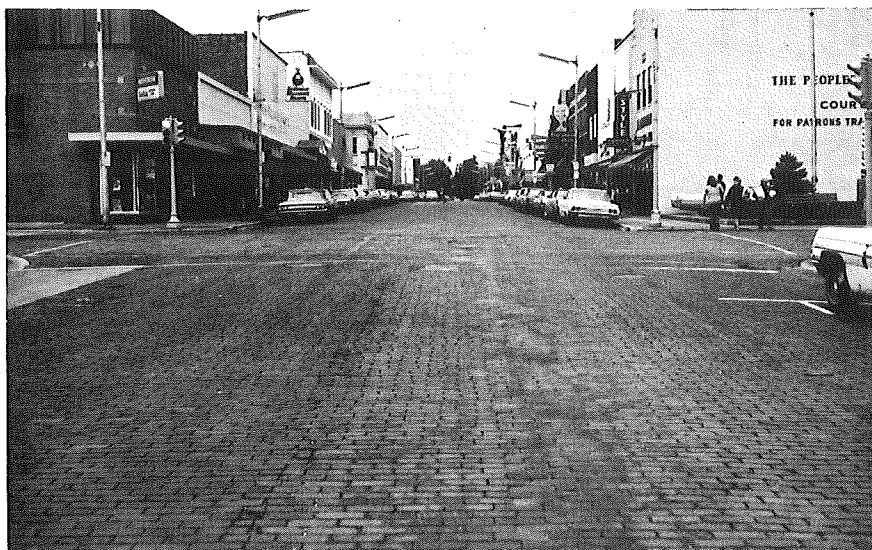
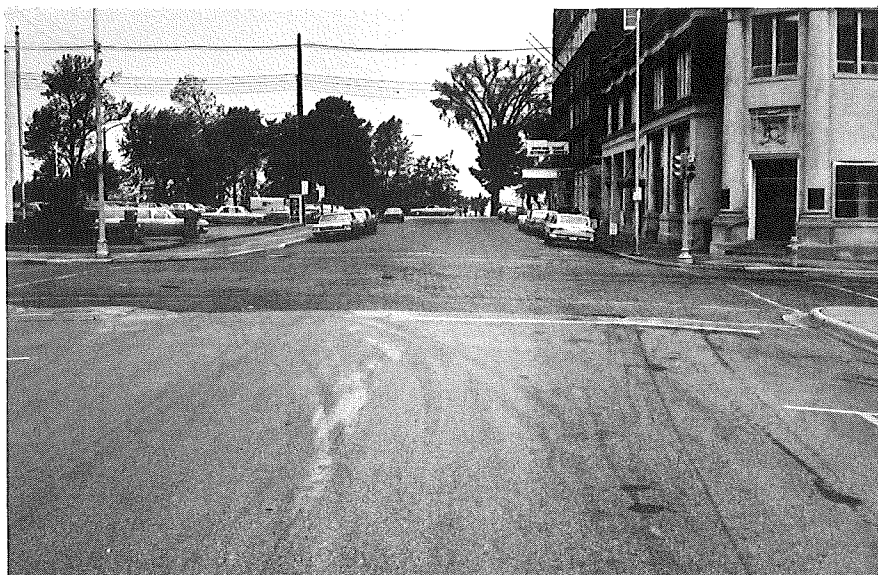
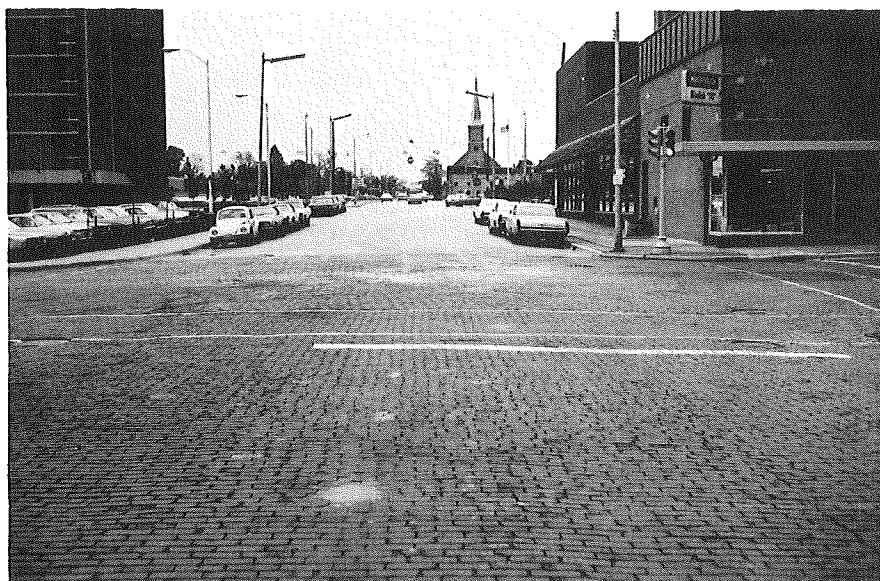
FIGURE 21

A signalized intersection would be expected to cause a reduction in right-angle accidents and an increase in rear end accidents. However, at this signalized location during the five-year study period there were six right-angle accidents and no rear-end accidents. The fact that rear-end accidents did not occur over the past five years is very good. However, the fact that there were six right-angle accidents, with five of the operators involved reporting that they did not see the pedestal mounted traffic signals, indicates that a potential hazard does exist. According to the Michigan Vehicle Code (Revision of 1968, p. 103) at least one signal shall be located over the traveled portion of the roadway. Thus, it is recommended that this intersection conform to the law as set down in the Michigan Vehicle Code. In regard to the pedestal mounted traffic signals, it is felt that they do not have to be removed. Pedestal mounted traffic signals can be used as a supplement to overhead signals, but should not be used by themselves. Furthermore, it is recommended that this intersection eventually have two signal faces visible for each approach. If the pedestal signals are not removed one overhead signal will provide two visible signal faces per approach. If the pedestal signals are removed two overhead signals will have to be installed to provide two visible signal faces per approach. These recommendations will apply only if it is determined that this signal is warranted. If a signal is not warranted at this location, the pedestal mounted signals should be removed.

Also, it is recommended that State Street and the northwest leg of Ship Street be skid tested as part of the city-wide check of all brick surfaces. If these surfaces are found to have an unsatisfactory coefficient of friction, consideration should be given to resurfacing.

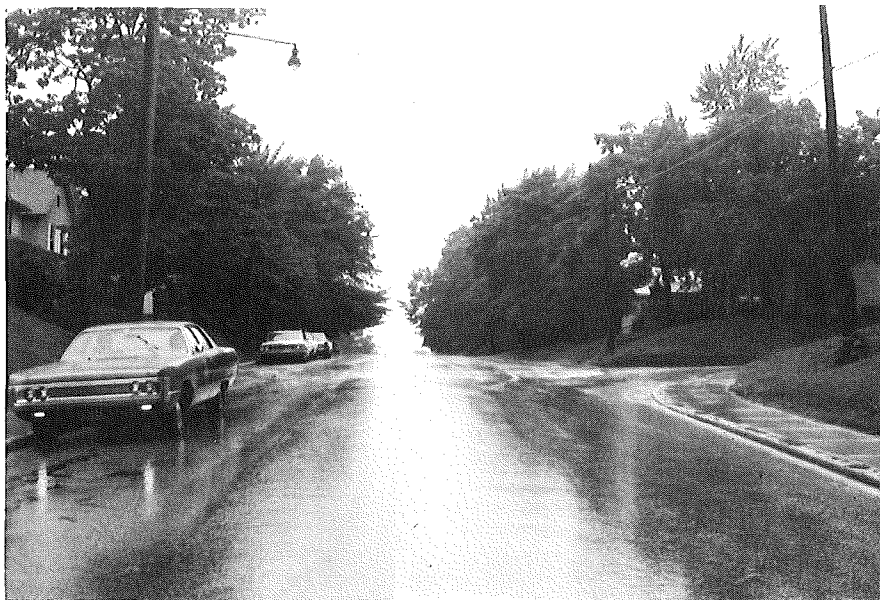
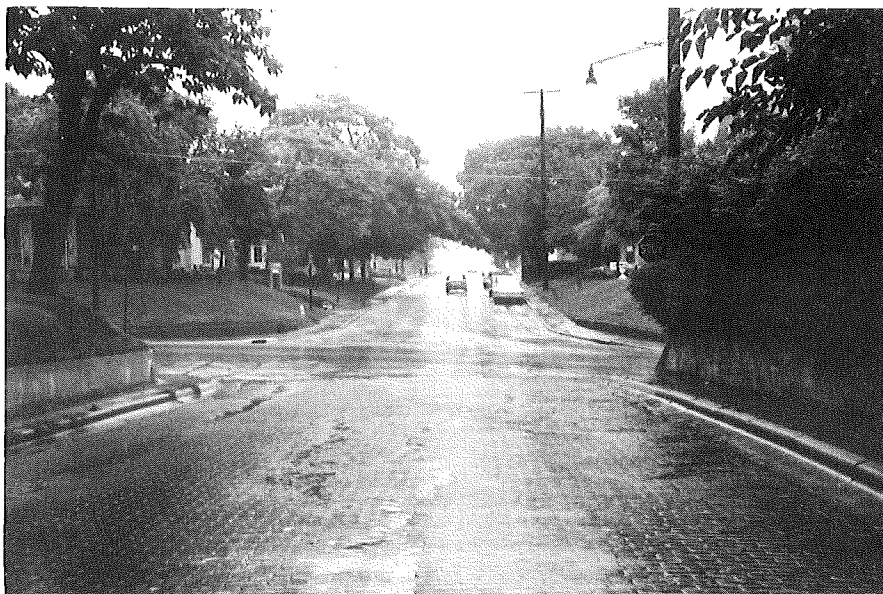
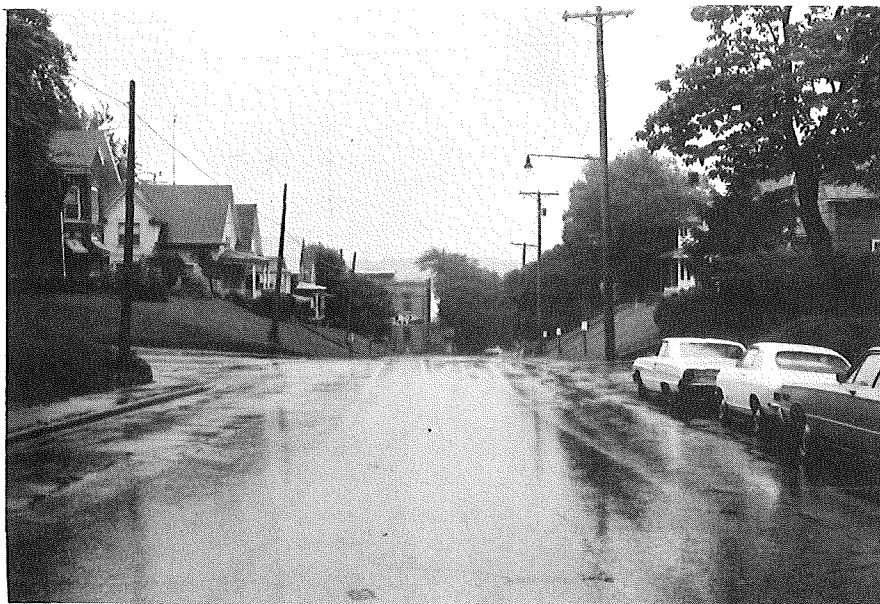
FIGURE 24

There were three operators who reportedly did not stop for the "Stop" signs on Wayne Street. The "Stop" sign for northbound Wayne Street is connected to an arm brace that protrudes from the bushes that are located above the retaining wall (See the middle picture on p. 45). Since this sign is obscured by the bushes, it is recommended that the bushes be maintained so that the "Stop" sign is completely visible to northeastbound Wayne Street traffic. There is also a tree located approximately 100 ft from the intersection that hangs over the roadway and also blocks an operator's view of the "Stop" sign. This tree should be trimmed and then maintained so that it doesn't hang over the roadway.

The "Stop" sign for southbound Wayne Street is located about 20 ft from the intersection. It is recommended that this sign be located at the point of obedience.

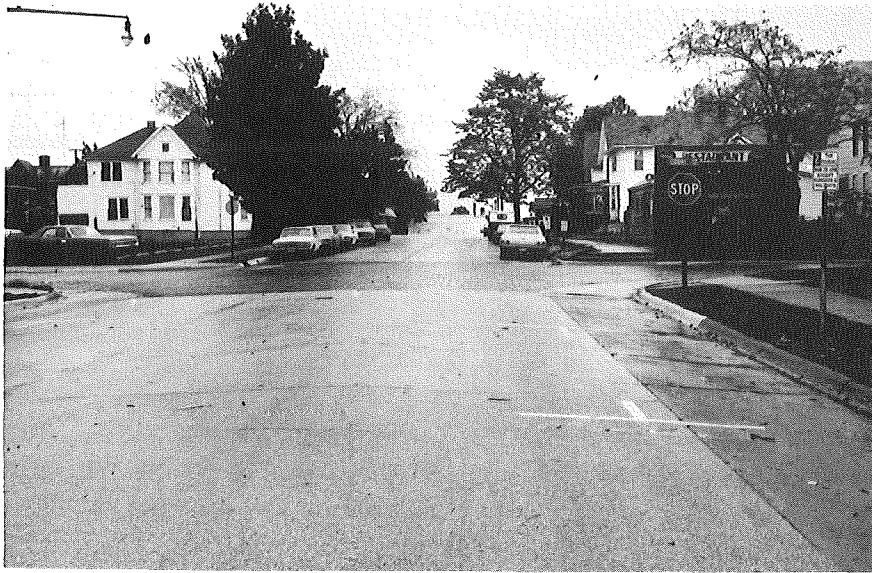
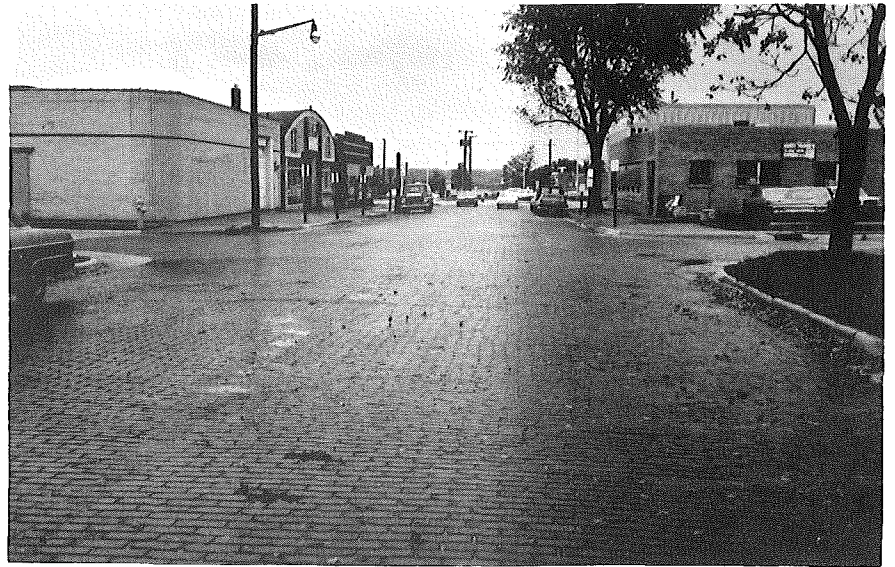
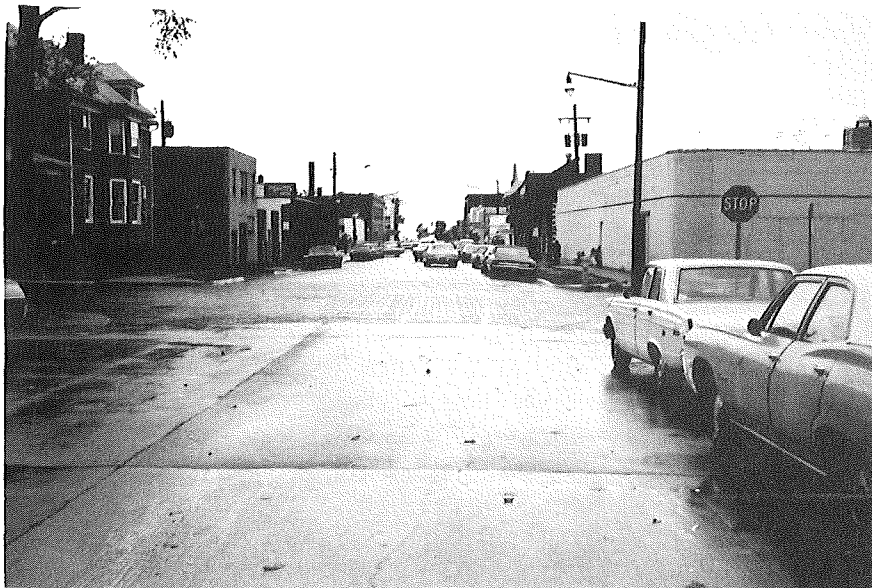
FIGURE 26

Fifty-three percent of the accidents at this intersection occurred on wet pavement while altogether almost 70 percent of the accidents occurred on either wet, snowy or icy pavement. All but one of the accidents that occurred during inclement weather happened on the brick surface. Thus, it is recommended that skidometer tests be conducted on Court Street.

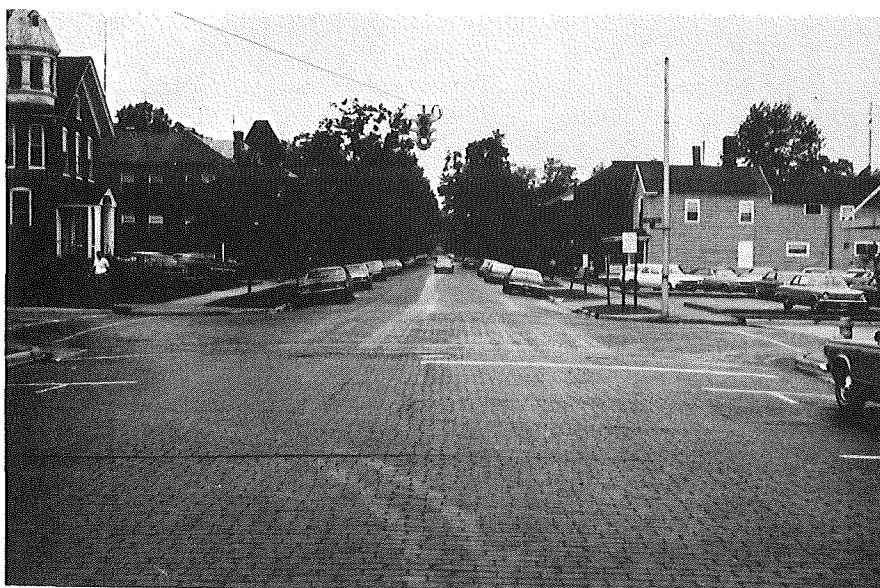
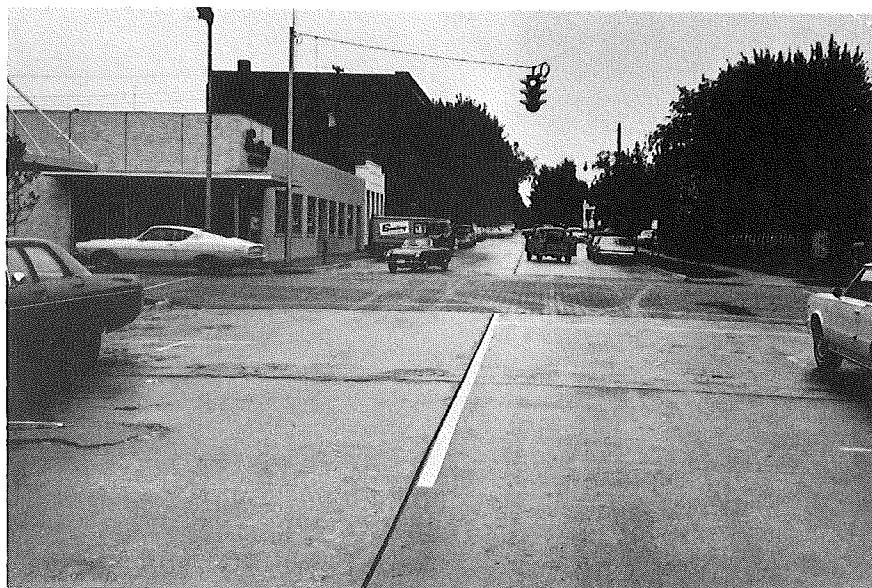
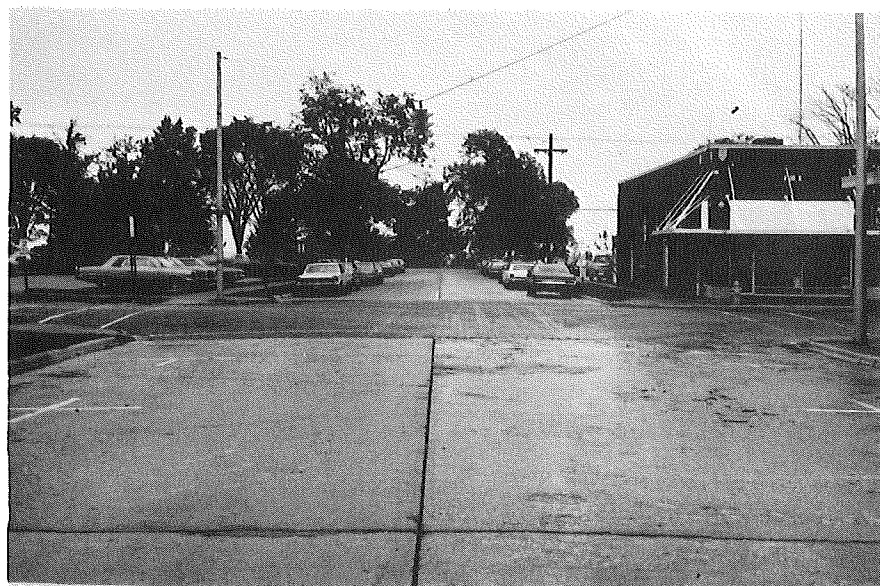
FIGURE 37

Lastly, this intersection has only one overhead vehicular signal face visible to traffic on each approach. If this intersection remains signalized then a second signal head should be erected to provide two visible signal faces per approach.

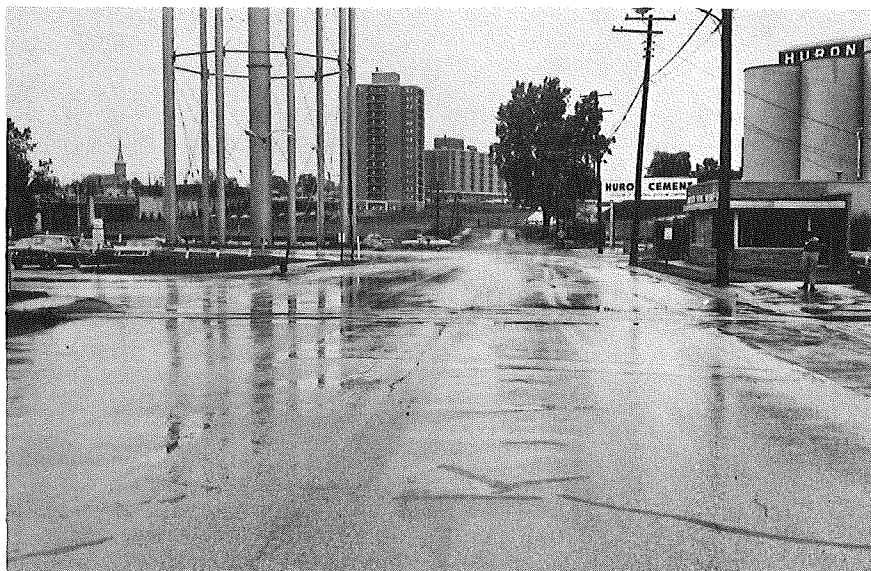
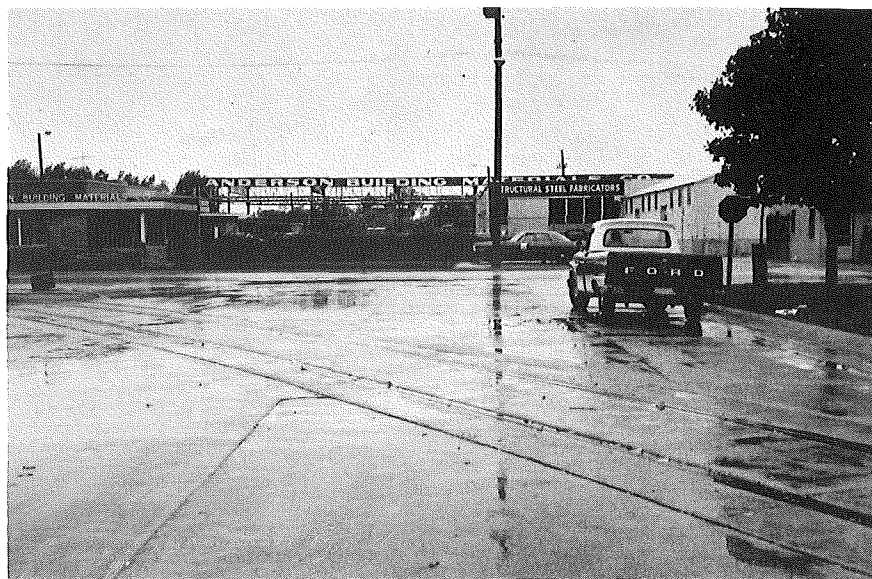
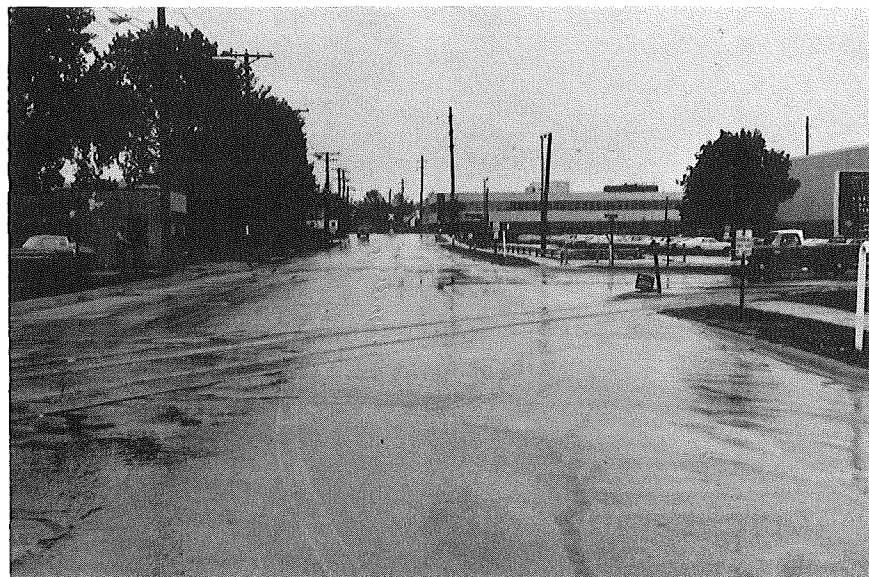
FIGURE 40

Furthermore, the Manual suggests that all four lane undivided pavements have center line markings. Thus, it is recommended that a painted center line be applied to Upton Drive.
