MICHIGAN

STATE HIGHWAY DEPARTMENT

July 9, 1965

Subject: Experimental Shoulder Stabilization on US 23 North of Alpena (Mn 04032, C6).
Research Project 62 E-25. Research Report No. R-535.

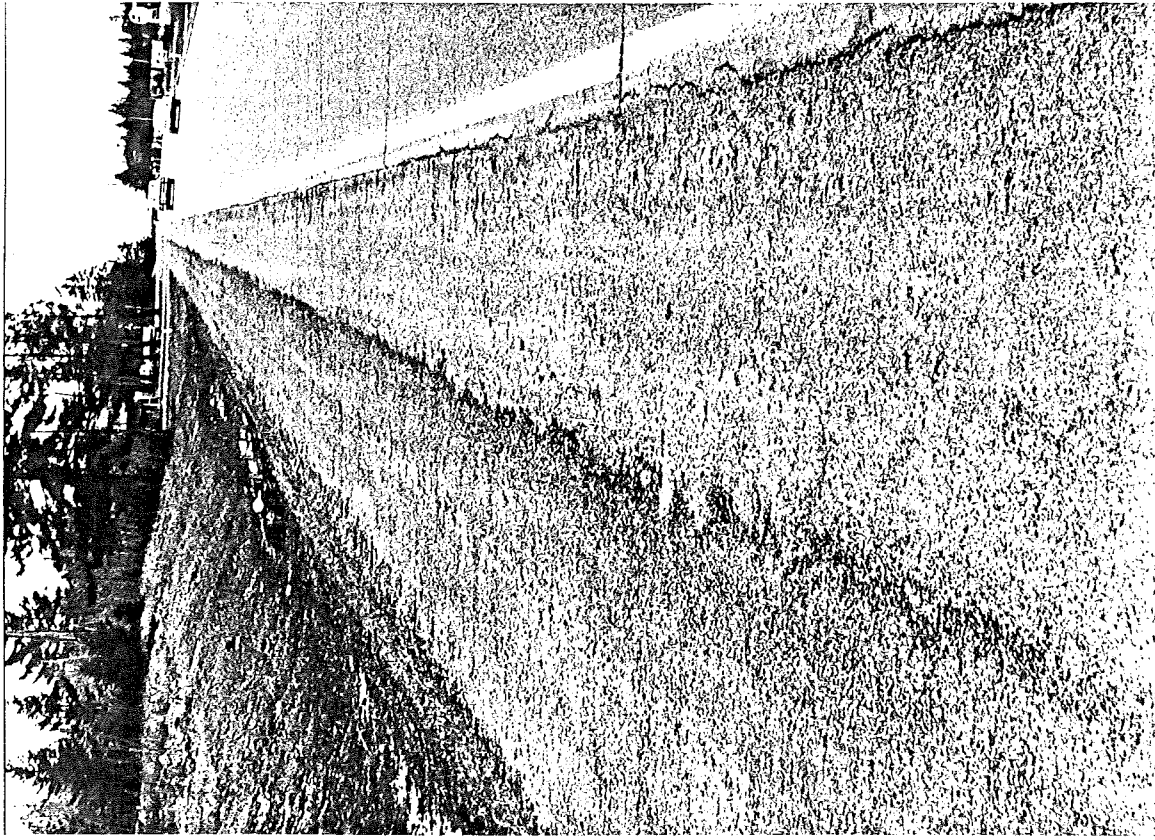
12 lb per ton

Figure 2. Sodium chloride sections with prime and single seal coat.

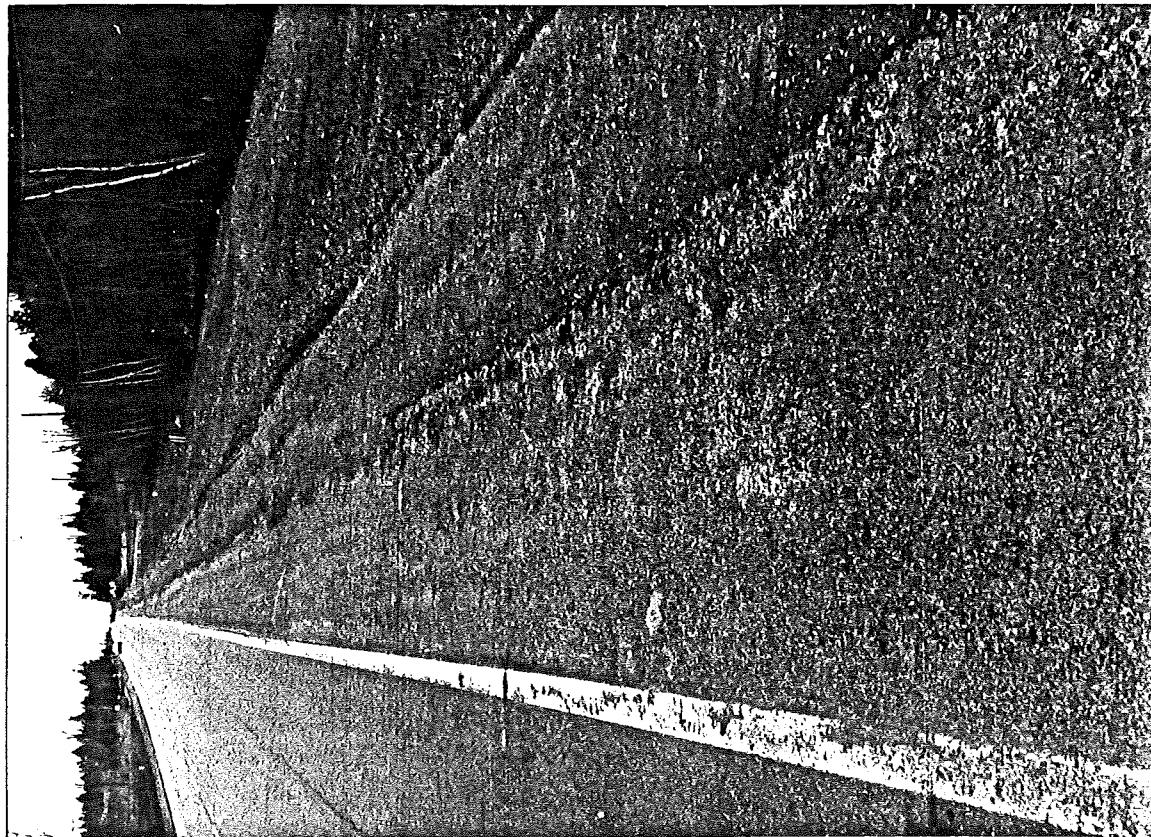
With prime and single seal coat

Figure 3. Asphalt emulsion sections (2.0 gal per sq yd).

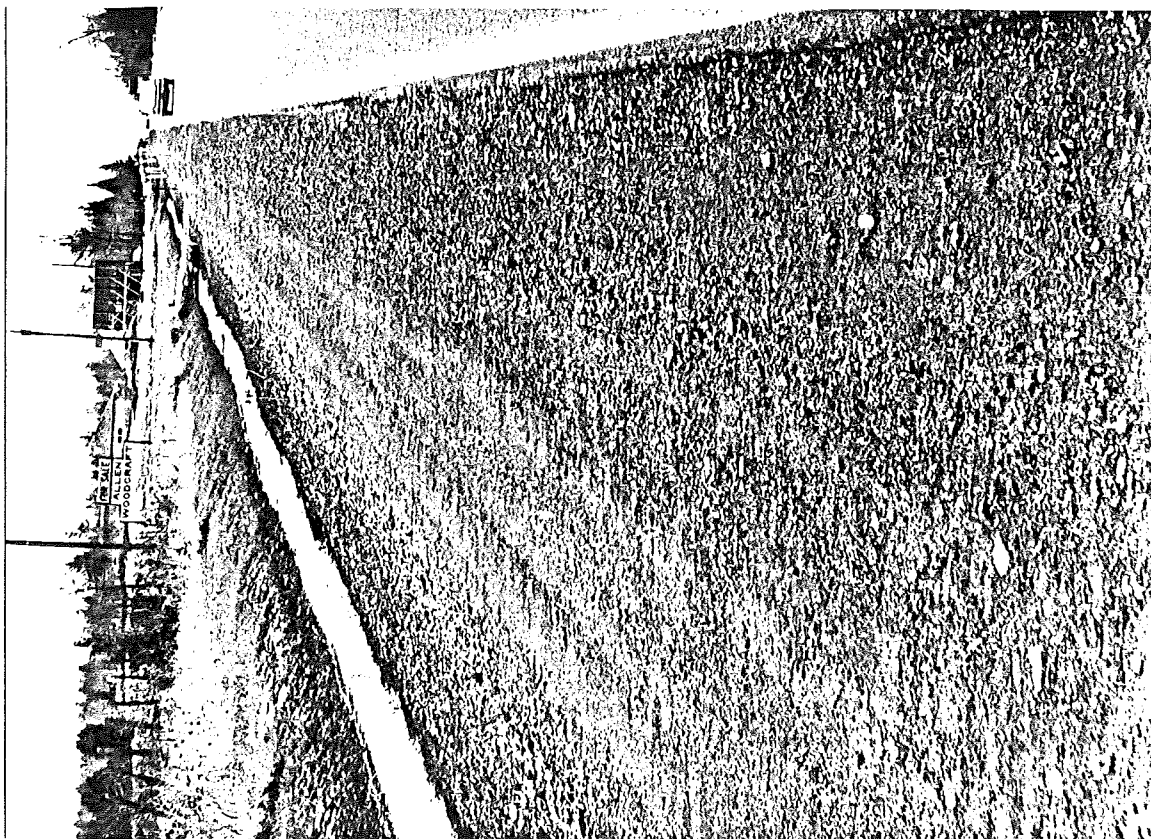
Without prime or seal coat

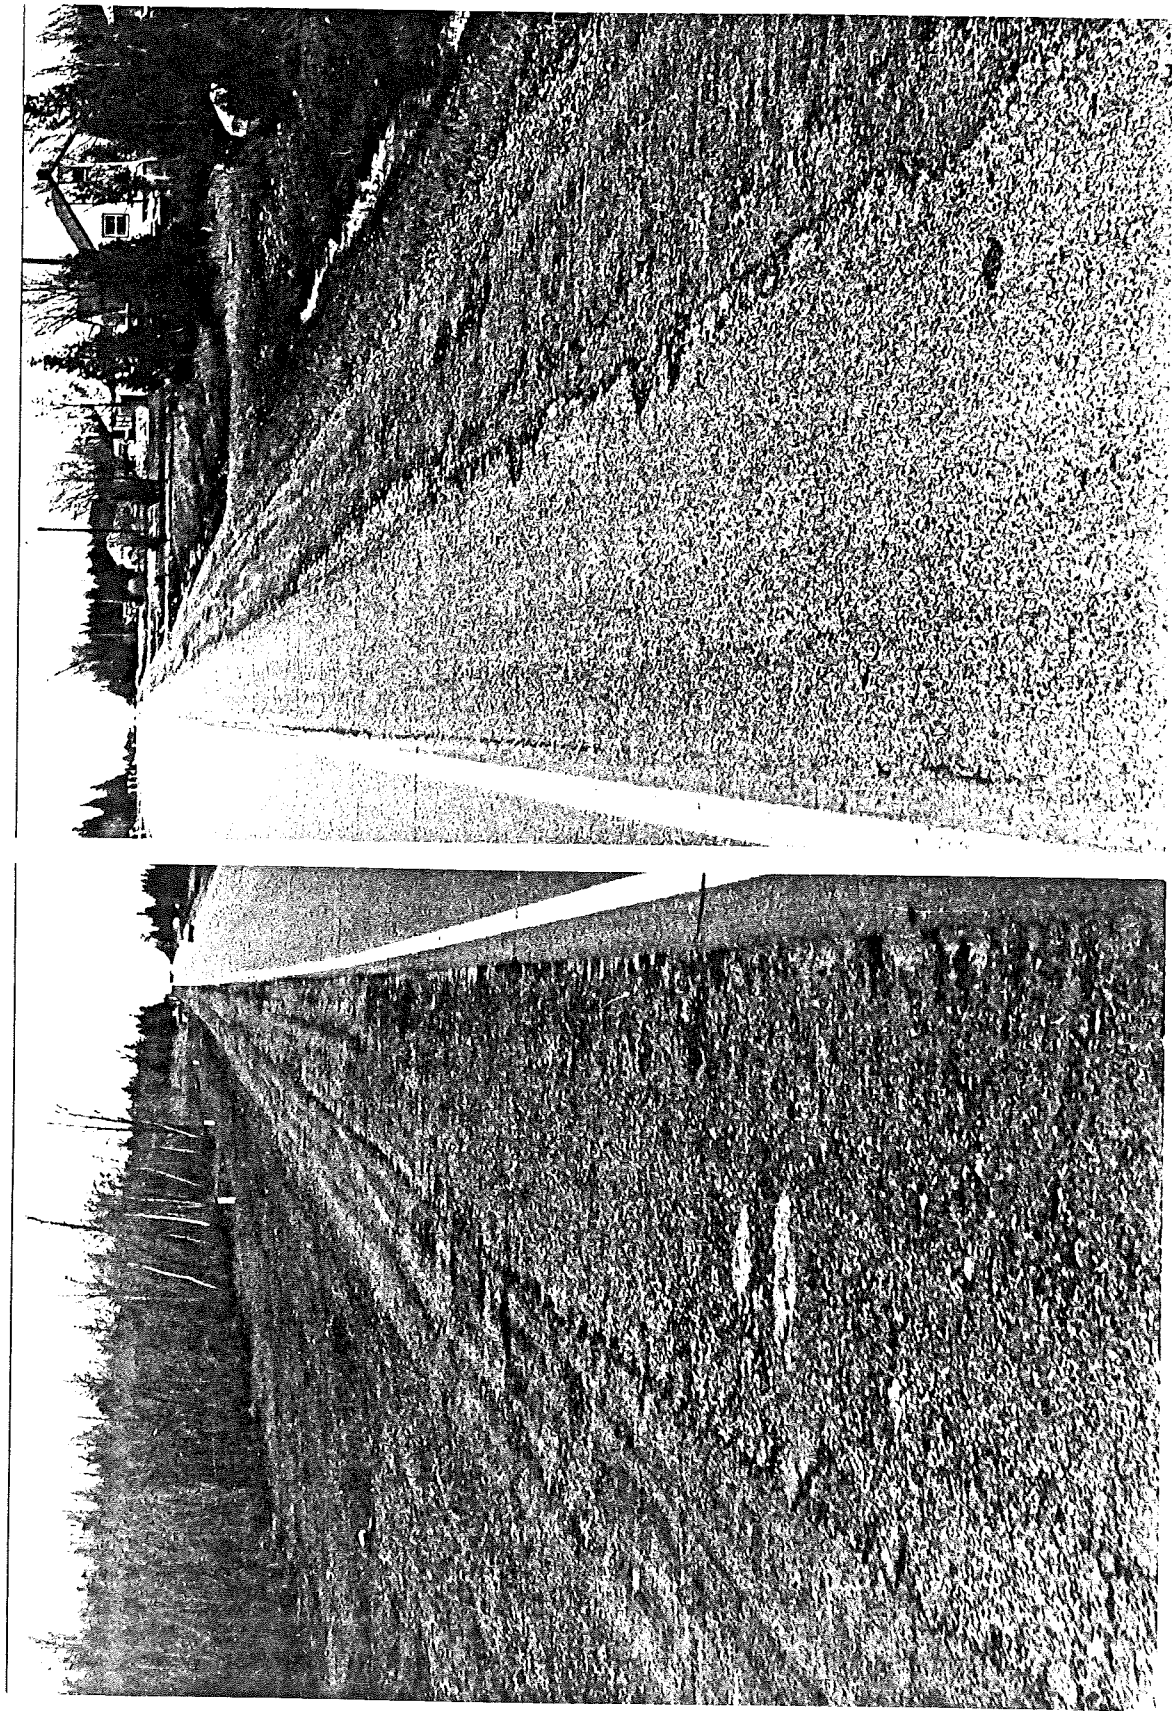
Figure 4. Asphalt emulsion sections (2.6 gal per sq yd).

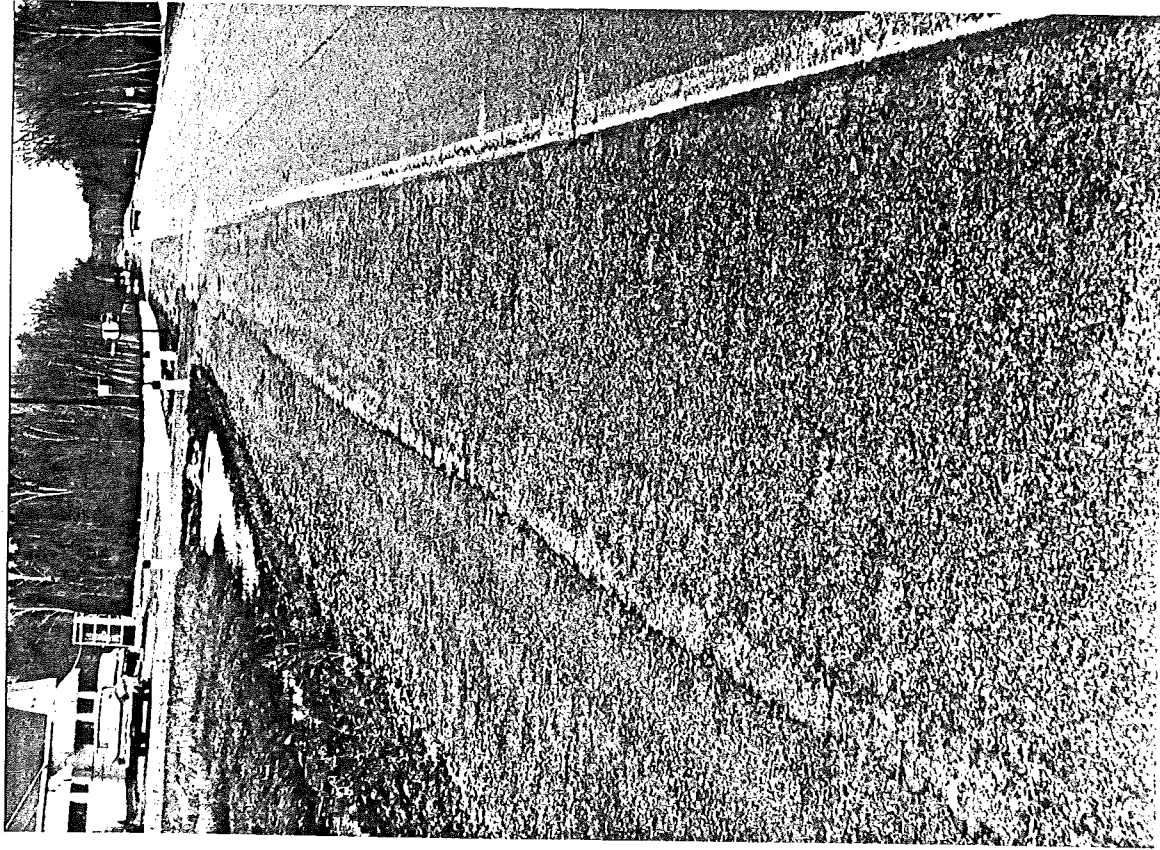
With prime and single seal coat

Figure 5. Slow-curing asphalt sections (2.3 gal per sq yd).

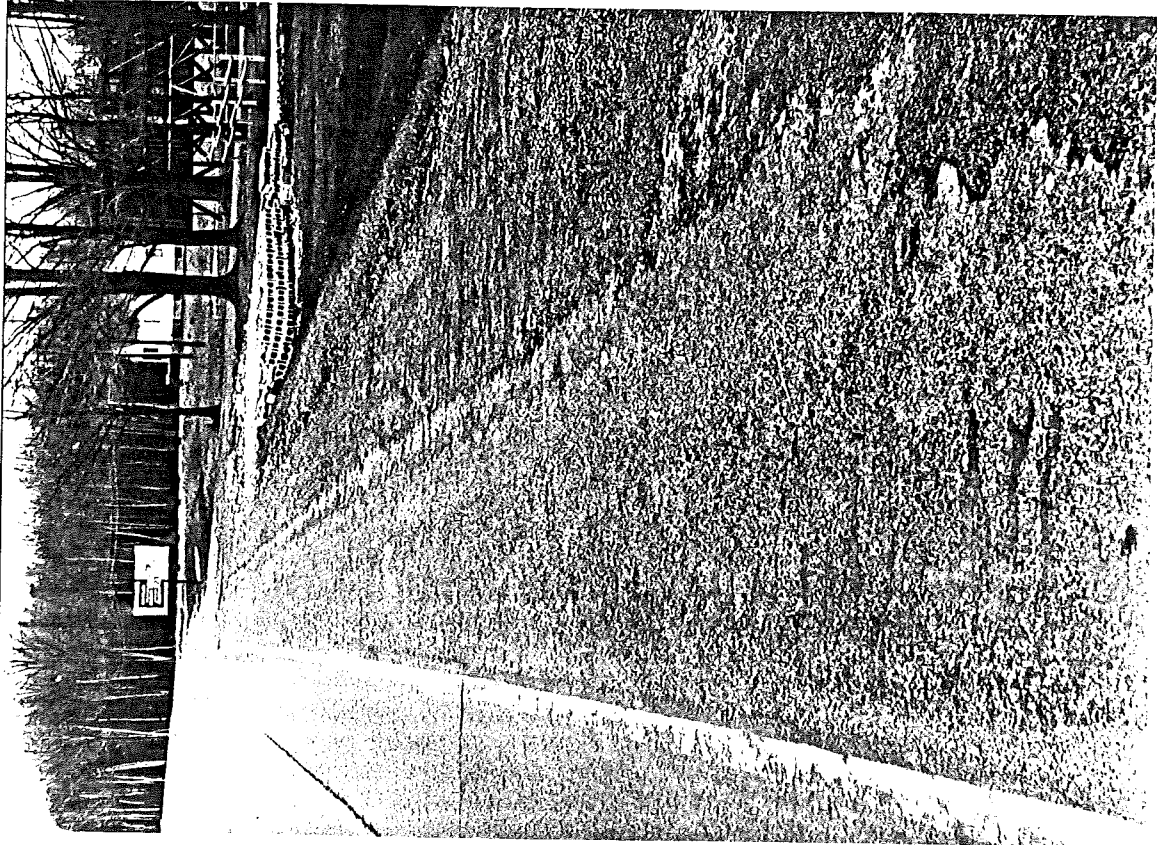
Without prime or seal coat

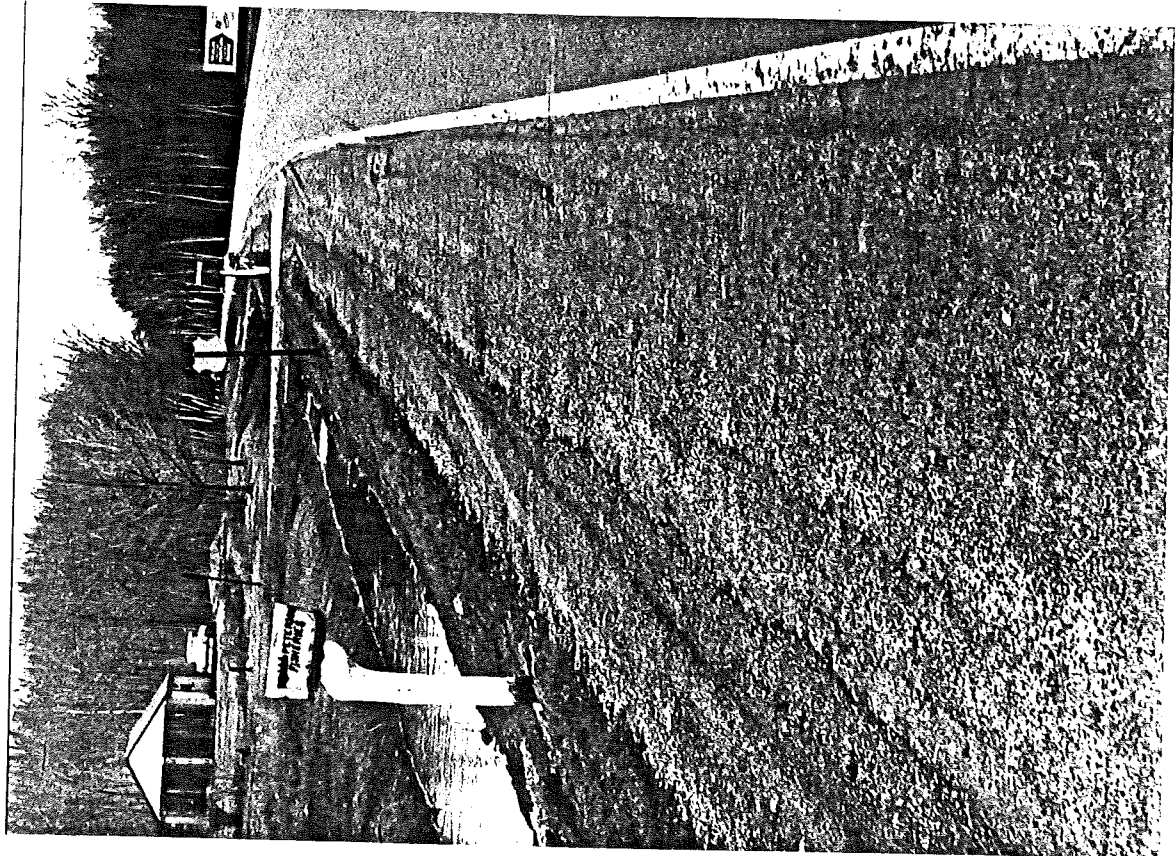
Without prime or seal coat

Figure 6. Slow-curing asphalt sections (2.6 gal per sq yd).

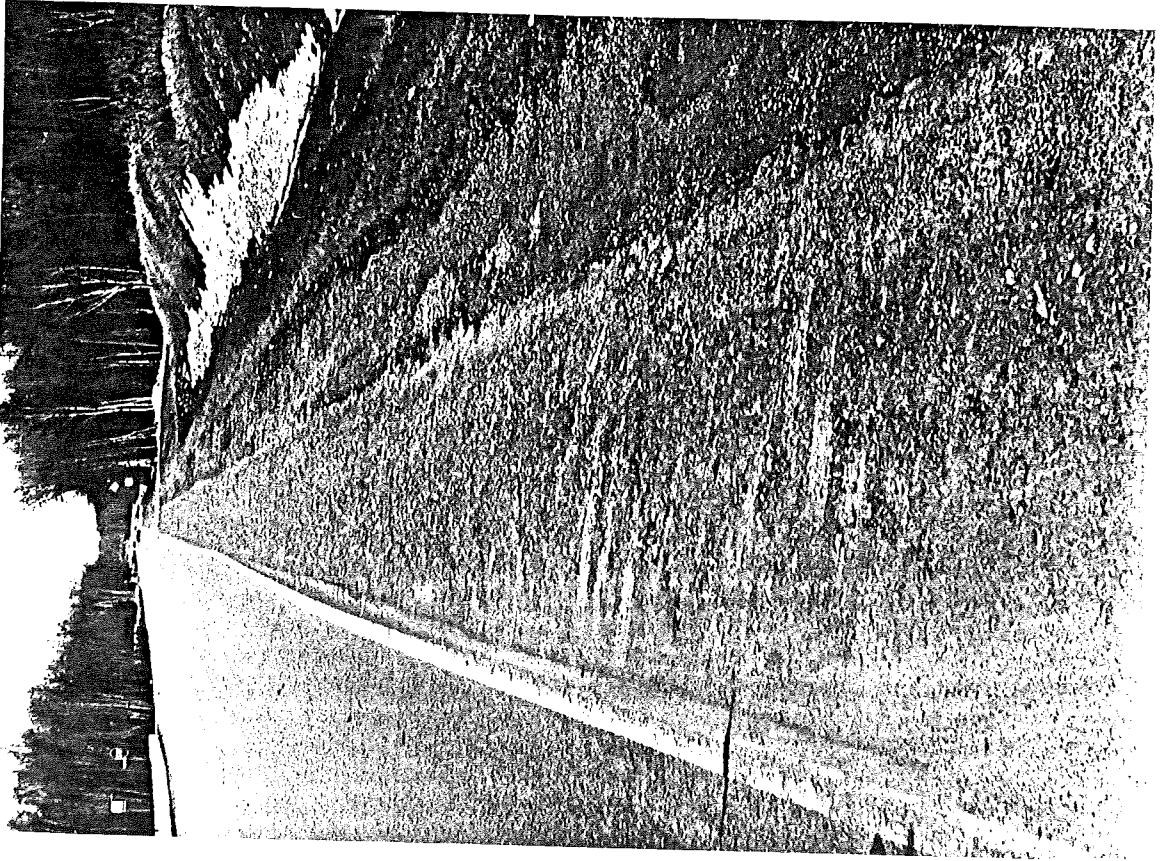
With prime and single seal coat

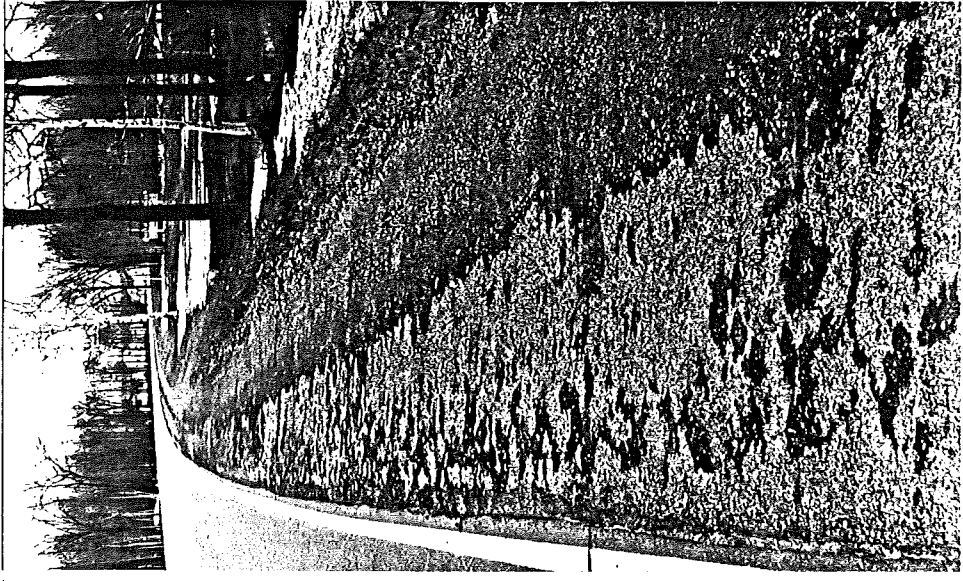
8-percent cement

Figs. 2 through 8 show shoulder conditions at the time of this year's inspection. Generally, there is very little change since the previous survey (August 1964). All treatments appear to be satisfactory with the possible exception of the soil cement sections (Fig. 7), where the surface seals have continued to deteriorate. The 8- and 6-percent treatments are worse than the 4 percent. Except for about 1/2-in. at the surface, however, the soil cement treatment itself is still quite firm.

Figure 7. Soil cement sections with prime and single seal coat.

In comparing these values it should be remembered that half of the asphalt-treated sections did not have a seal coat, resulting in a naturally rougher surface and that deterioration of the soil cement seals has increased the roughness of these areas. Based on appearance and roughness measurements, the best sections are the untreated (with double seal) and the two salt sections. However, although rougher than the sealed areas, the unsealed asphalt treatments (both asphalt emulsion and slow-cured asphalt) are in excellent shape and appear to be entirely suitable shoulders. The soil cement areas definitely should be re-sealed in the near future.

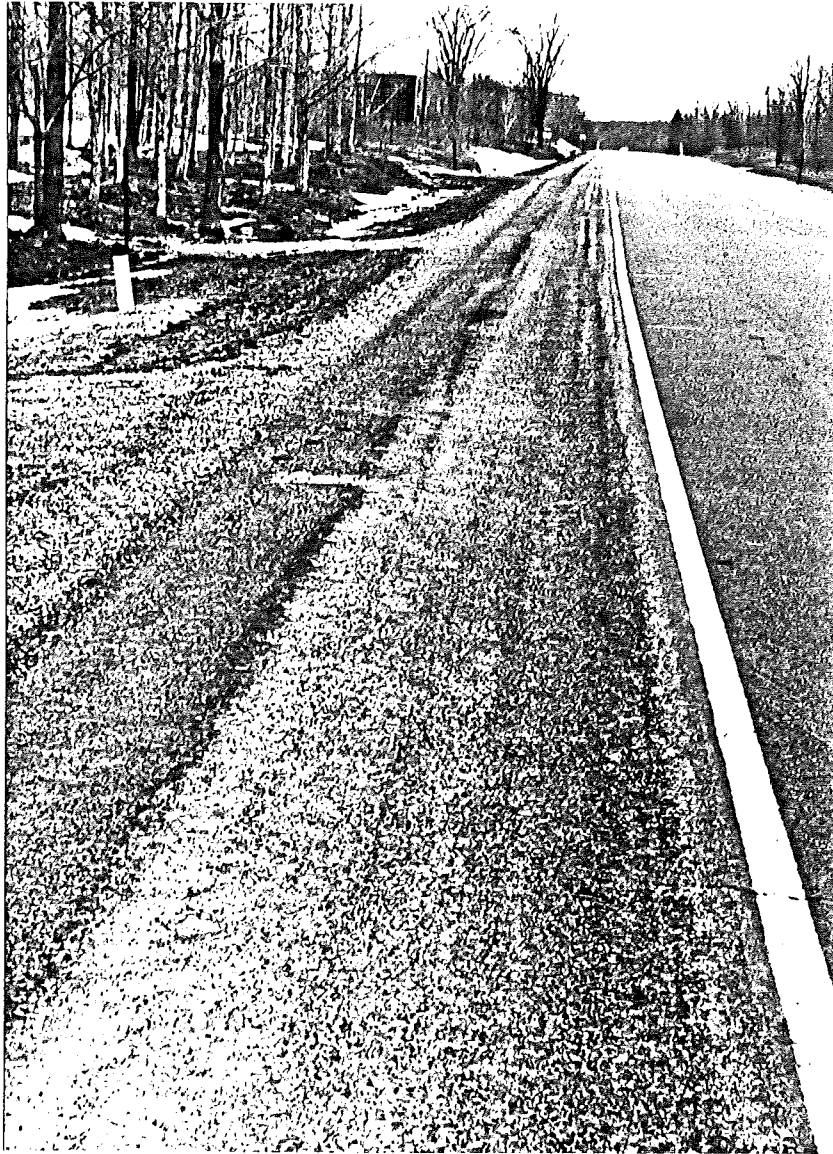
Figure 8. Unstabilized section with prime and double seal.

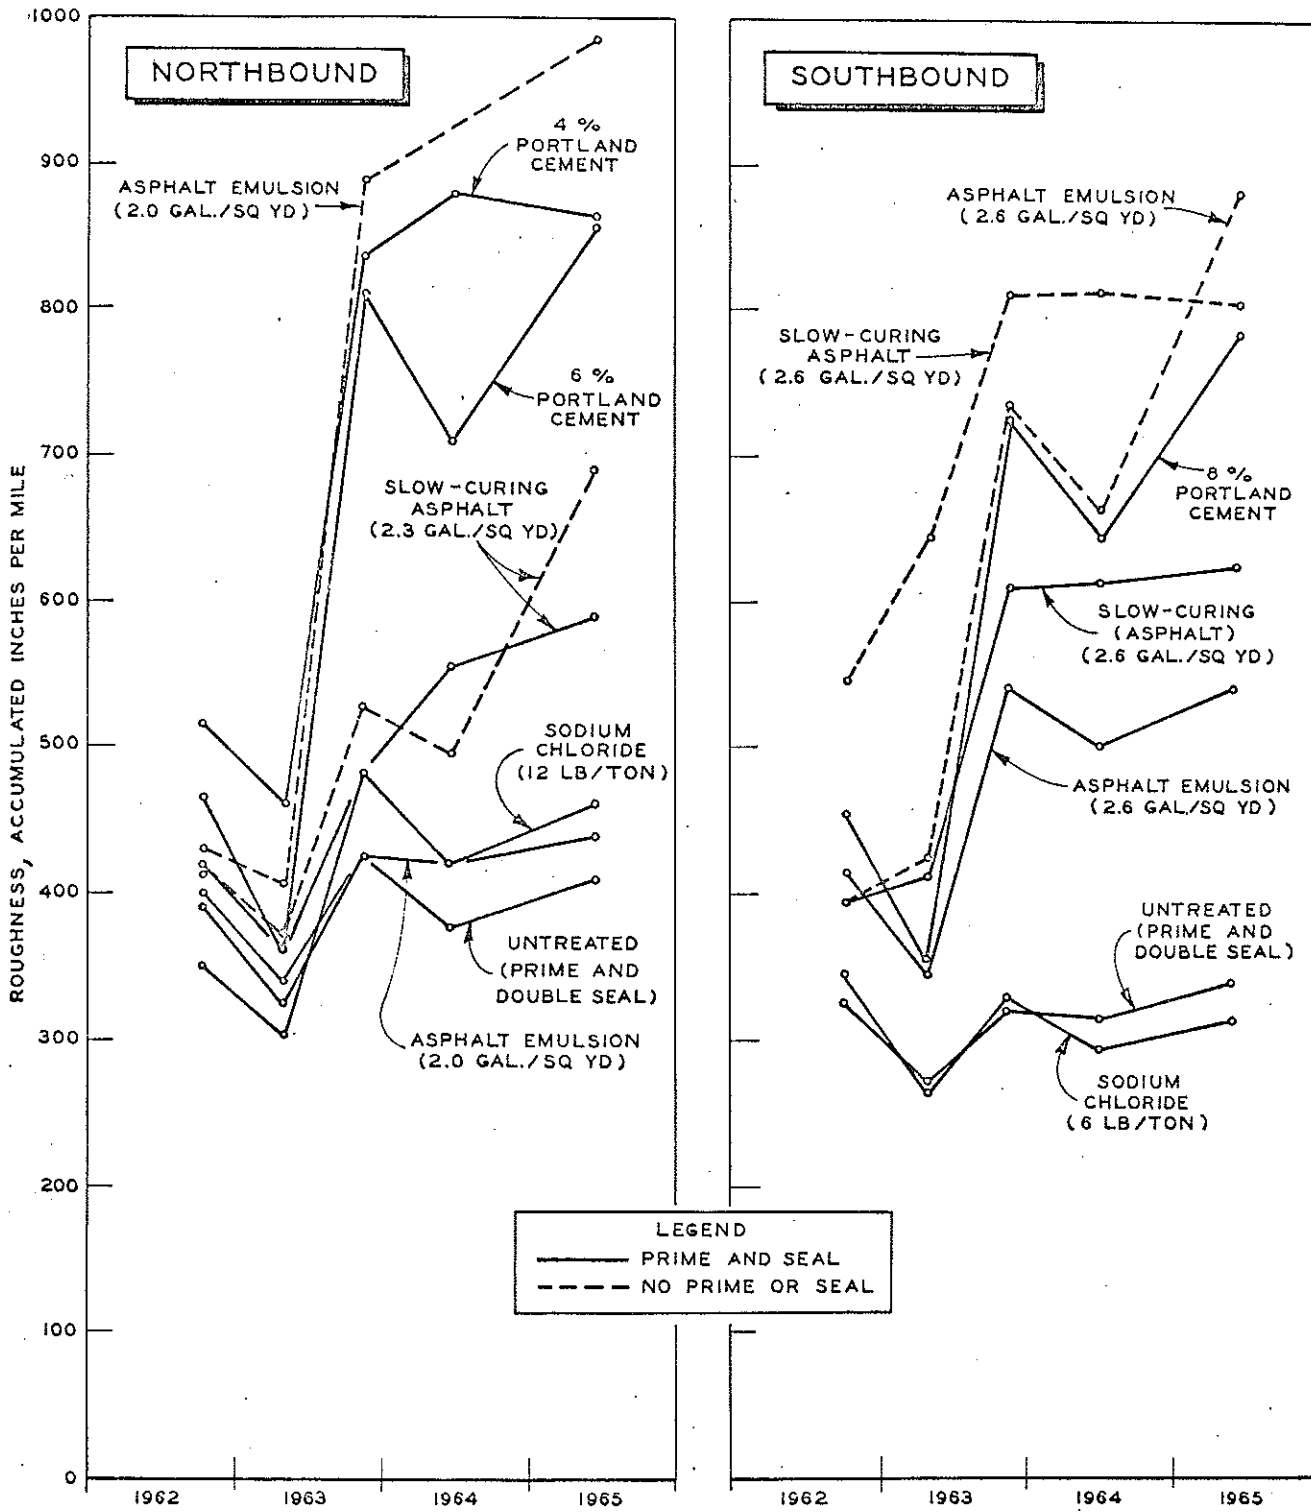
Figure 9. Roughness summary of the test areas, September 7, 1962 to May 5, 1965.

Fig. 9 shows a plot of roughness values for each section, as obtained periodically since the construction of the project.
