***INSPECTION OF PAVEMENT
PROBLEMS ON I-275 AND ON I-75
FROM THE OHIO LINE NORTHERLY
TO THE HURON RIVER***

V. T. Barnhart

**Testing and Research Section
Construction and Technology Division
Research Project 97 TI-1862
Research Report R-1390**

**Michigan Transportation Commission
Barton W. LaBelle, Chairman;
Jack L. Gingrass, Vice-Chairman;
Betty Jean Awrey, John W. Garside
Ted B. Wahby, Lowell B. Jackson
Gregory J. Rosine, Director
Lansing, February 2001**

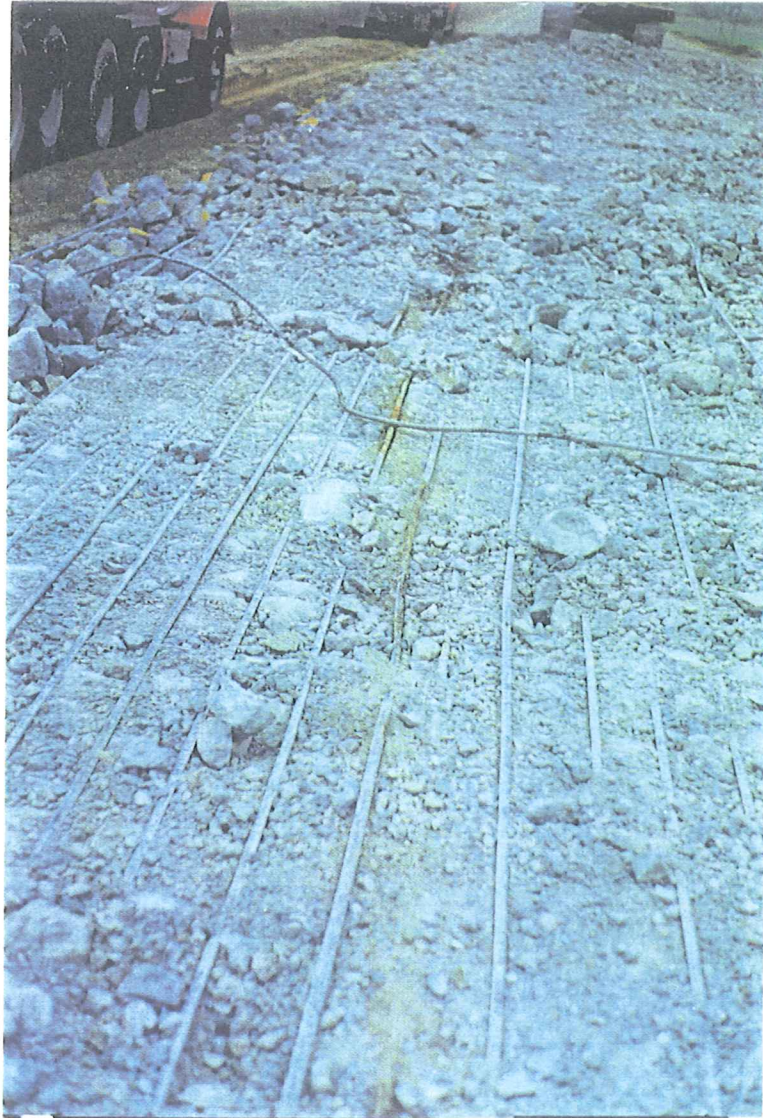
Figure 4

Showing the alignment and spacing of the reinforcing steel bars for the CRC pavement on the reconstruction project on I 275 after the removal of the concrete down to the reinforcement.

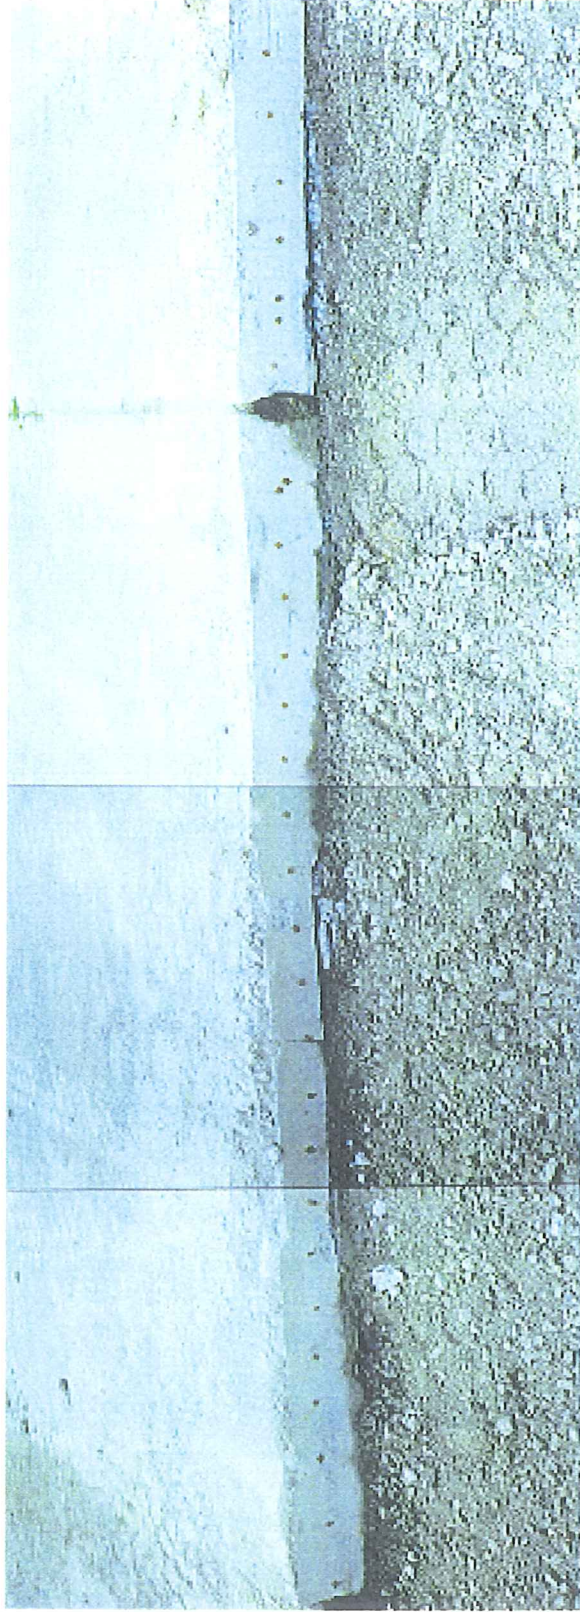
Figure # 5

Showing how depth of the steel reinforcement bars for the CRC Pavement varies across the width of a 12 foot lane at the P.O.B. of the Removal and Replacement Project.

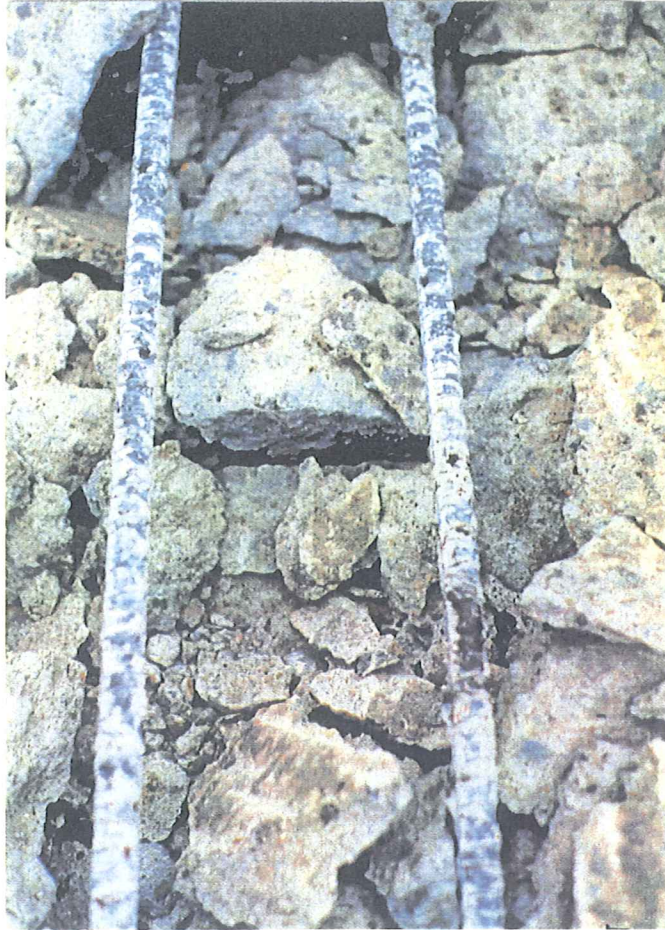
Figure 6

Showing the cement still attached to the reinforcement bars for the CRC pavement after the top layer of the Concrete Pavement had been removed in the Removal and Replacement Project.

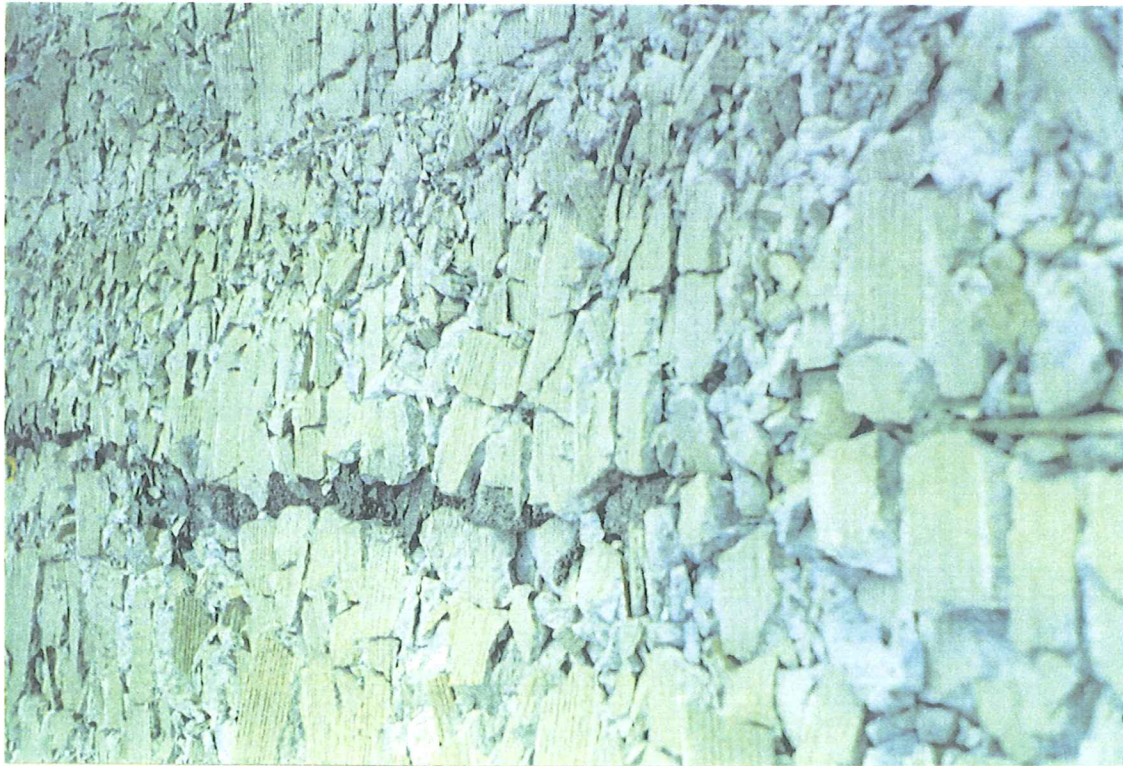
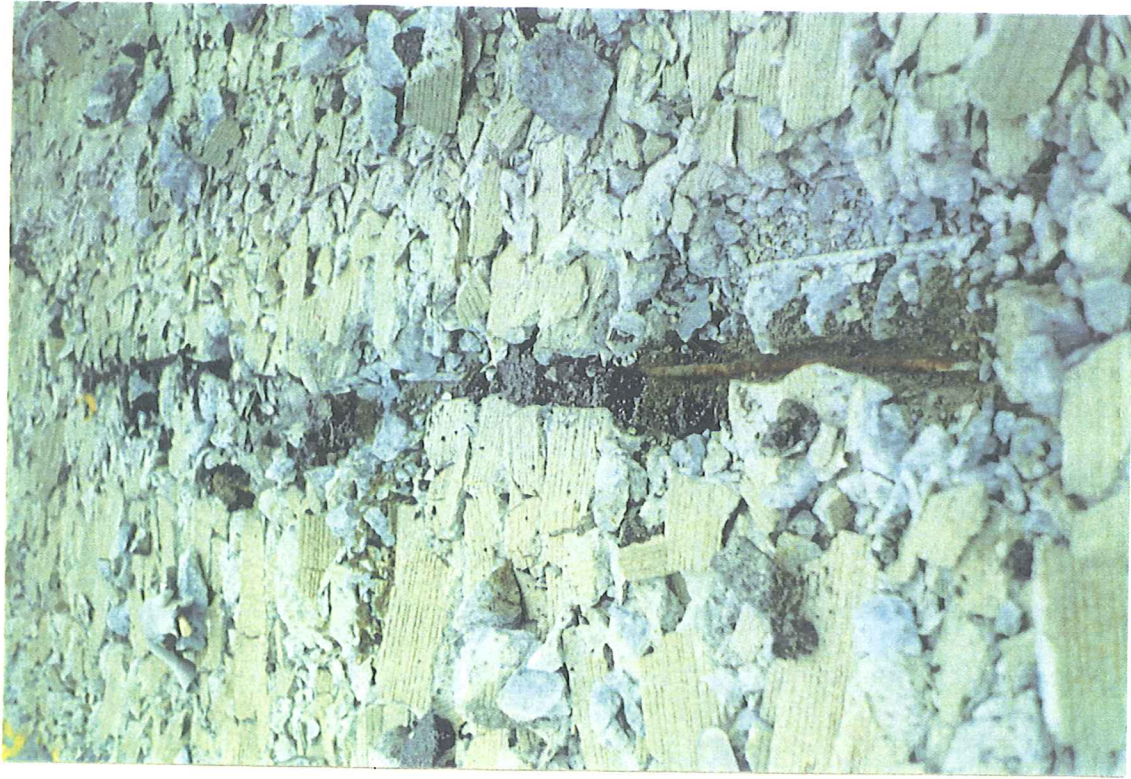
Figure 7
The Picture on the right shows the crack after being cleaned out down to the reinforcement bars

CRC pavement followed the longitudinal reinforcement bars (either directly on top of the bars or directly along side of the bars) as shown in Figure #7.

Showing how the CRC reinforcement bars followed the Longitudinal Cracks that had developed in the Concrete Pavement.
The Picture on the left shows a crack filled with Bituminous Cold Patch prior to clean out to check location of the reinforcement bars

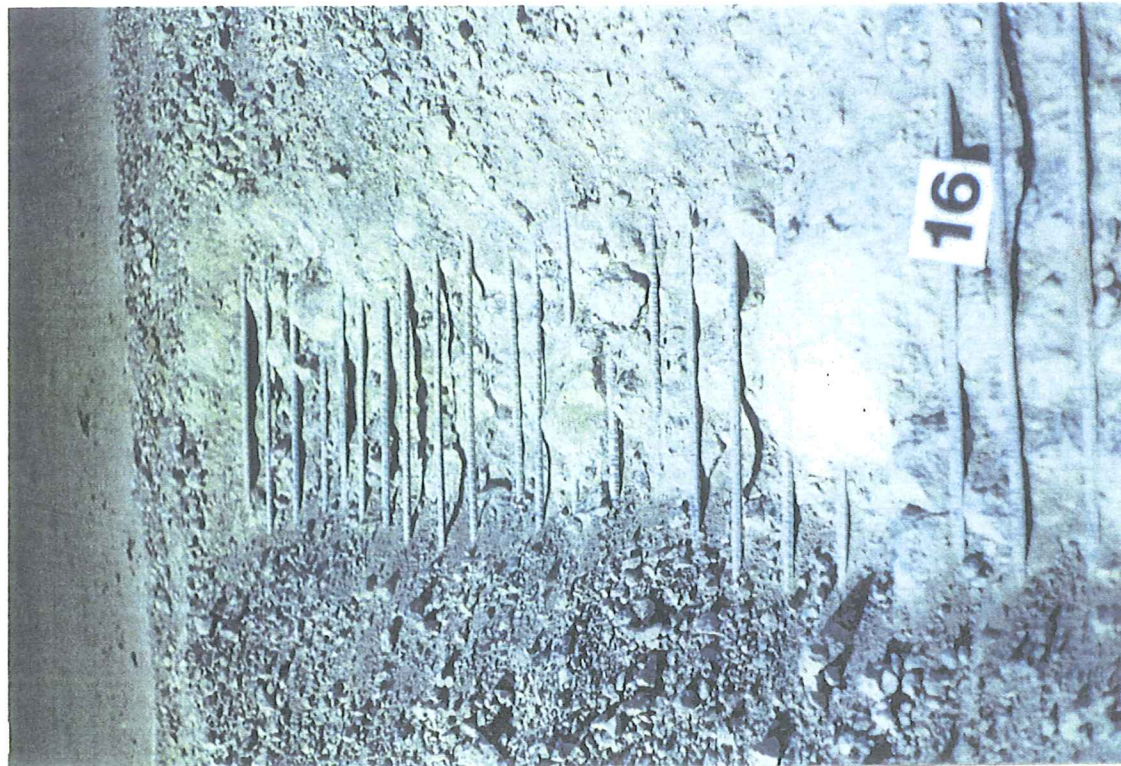
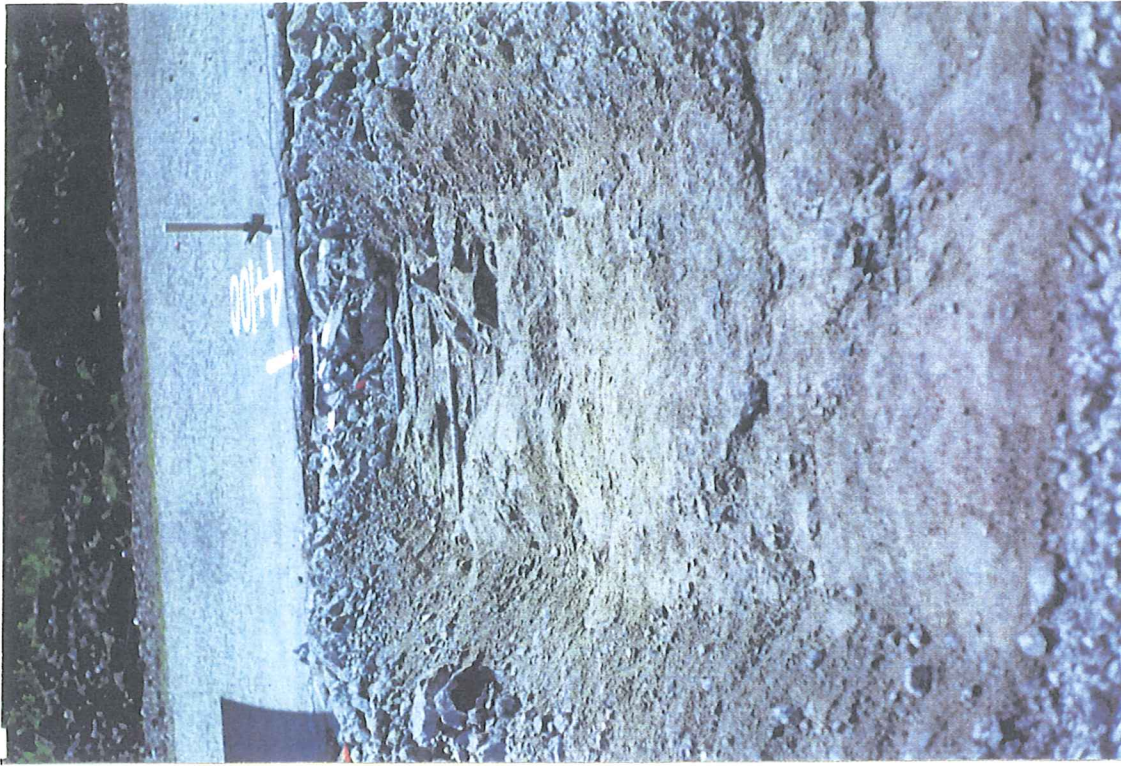
Figure 8

The rubblizer used on this project was a multiple headed guillotine breaker. The rubblizing was not uniform. There were areas where the concrete rubblized easily down to or below the CRC reinforcement, and there were areas where the concrete hardly rubblized at all, as can be seen in Figure #8. However, the problems with the rubblization did not appear to have been caused by the longitudinal CRC reinforcement. There appeared to be no difference in the rubblization of the good concrete and the areas where there were delaminations or punch-outs. The longitudinal CRC reinforcement bars bowed up out of the rubblized concrete. It appeared to be from relieving the tension that the longitudinal reinforcement bars were under, due to thermal forces in the concrete slab. A similar condition occurred on projects 3, 4, 5, 6 and is shown in Figure #10.

Showing how in one area the concrete rubblized down to or below the CRC reinforcement steel all across the lane and in another area for approximately 3/4 of the lane width only the top 3/4 inch to 1 inch of the concrete was rubblized and the outside 2 to 3 feet of the lane rubblized down to or below the CRC reinforcement bars.

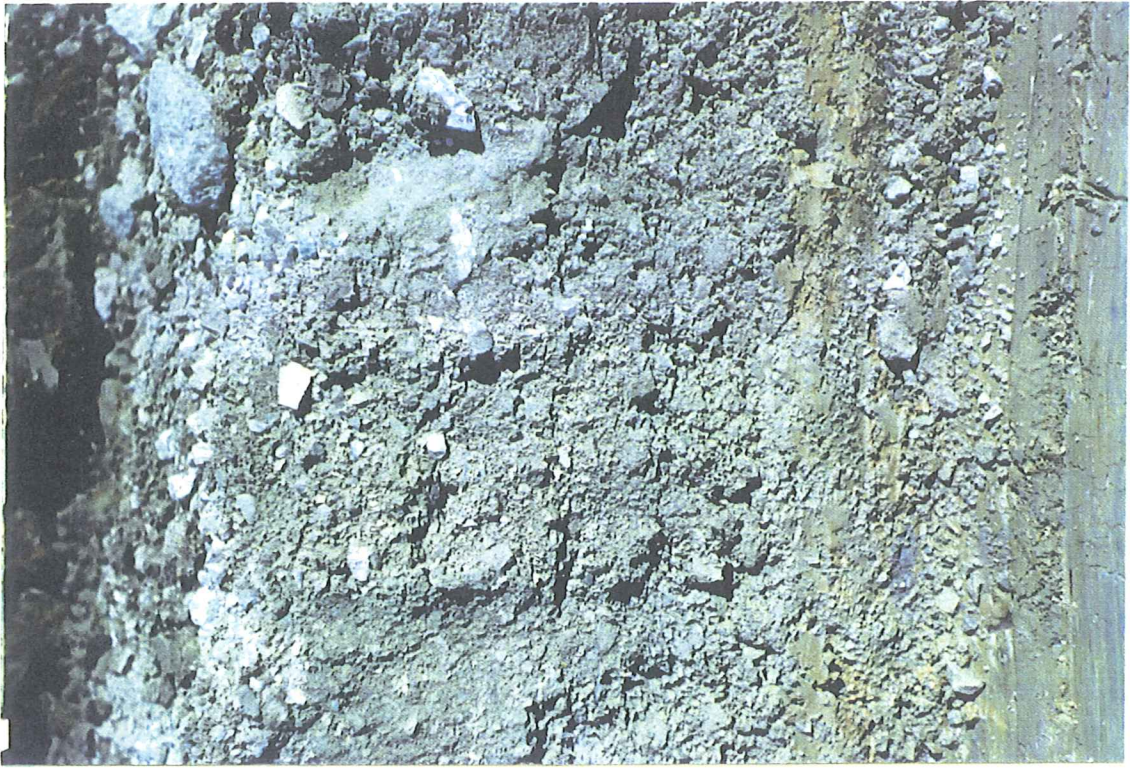
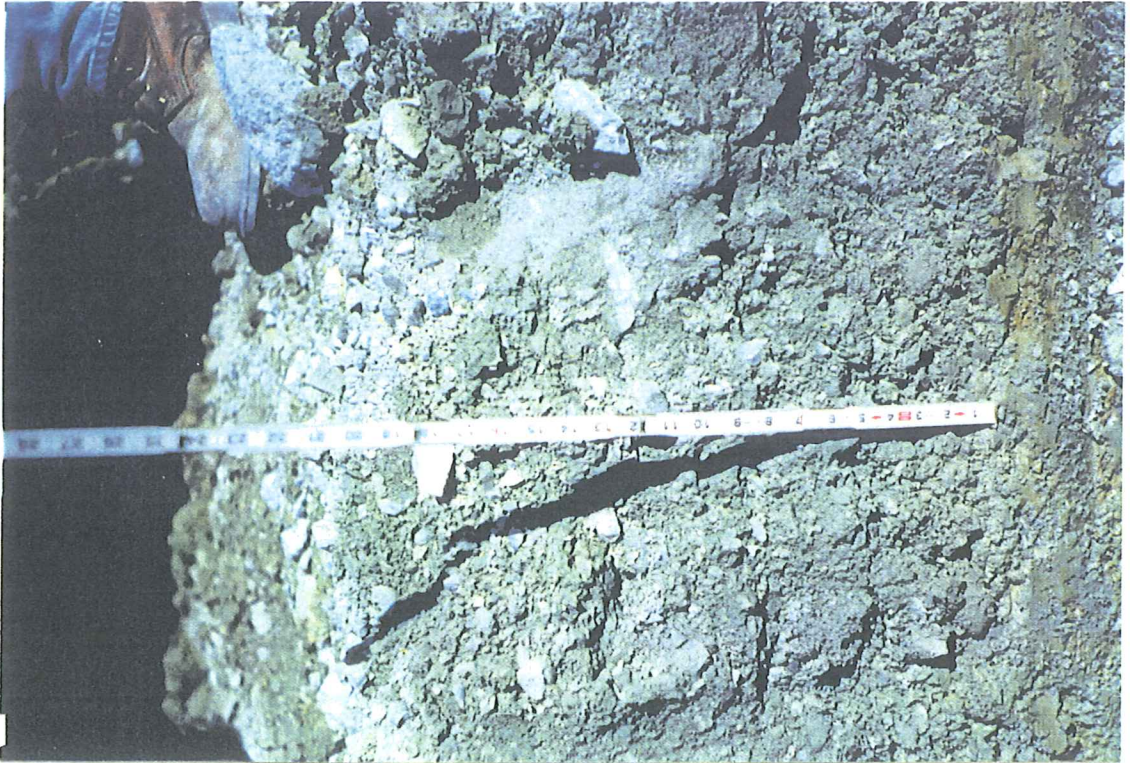
A 22A limestone from Pit # 58-1 (France Stone) was used as the crushed stone on this project for the subbase and base. Figure #9 shows that the limestone appears to have a large fine content (specifications allowed a maximum of 10% loss by wash). By observation, the base and subbase did not appear to drain very well. Also, as can be seen in Figure #9, there appears to be some pumping of the subgrade into the crushed stone.

Showing the 22A Lime Stone used as base and subbase for Project #1 on I 275

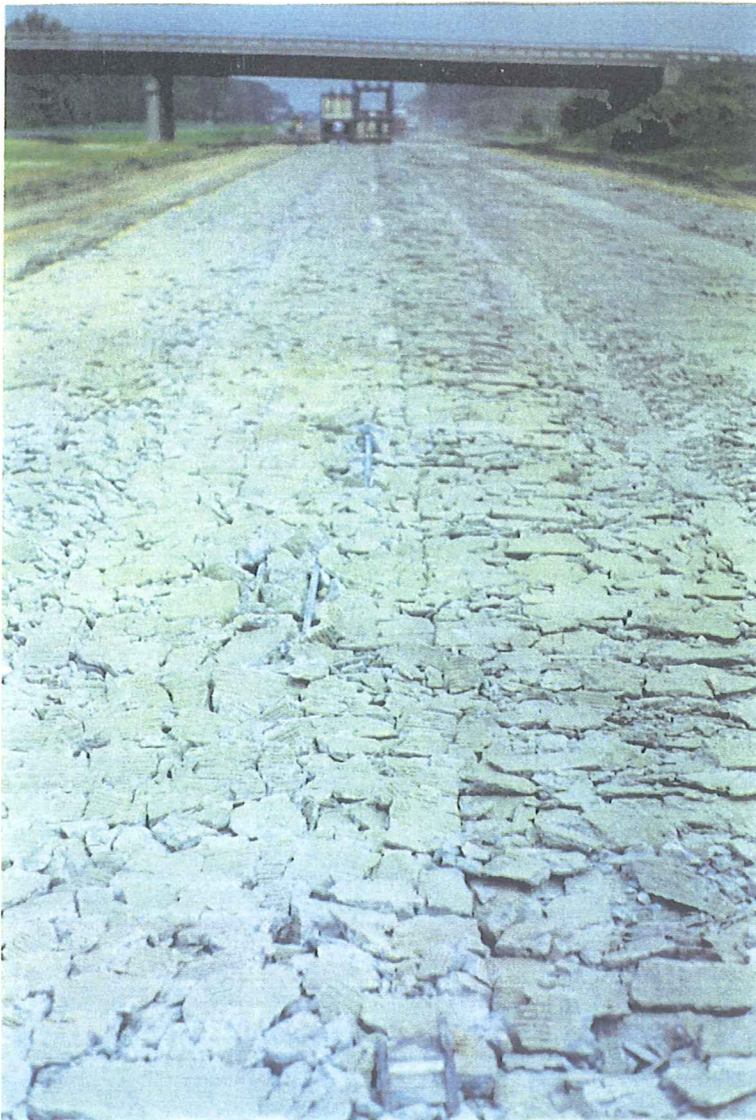
A guillotine breaker was used to break up the concrete prior to removal and there was no vibrating of the reinforcement out of the concrete. Figure #10 shows that the reinforcement bowed up out of the concrete due to relieving the tension in the longitudinal reinforcement bars. The bowing took place when the bond was not completely broken between the reinforcement and the concrete during the breaking process, and the reinforcement met resistance within the concrete after it had been broken.

Showing the reinforcement bars bowing up through the broken CRC concrete pavement on the I 275 reconstruction project

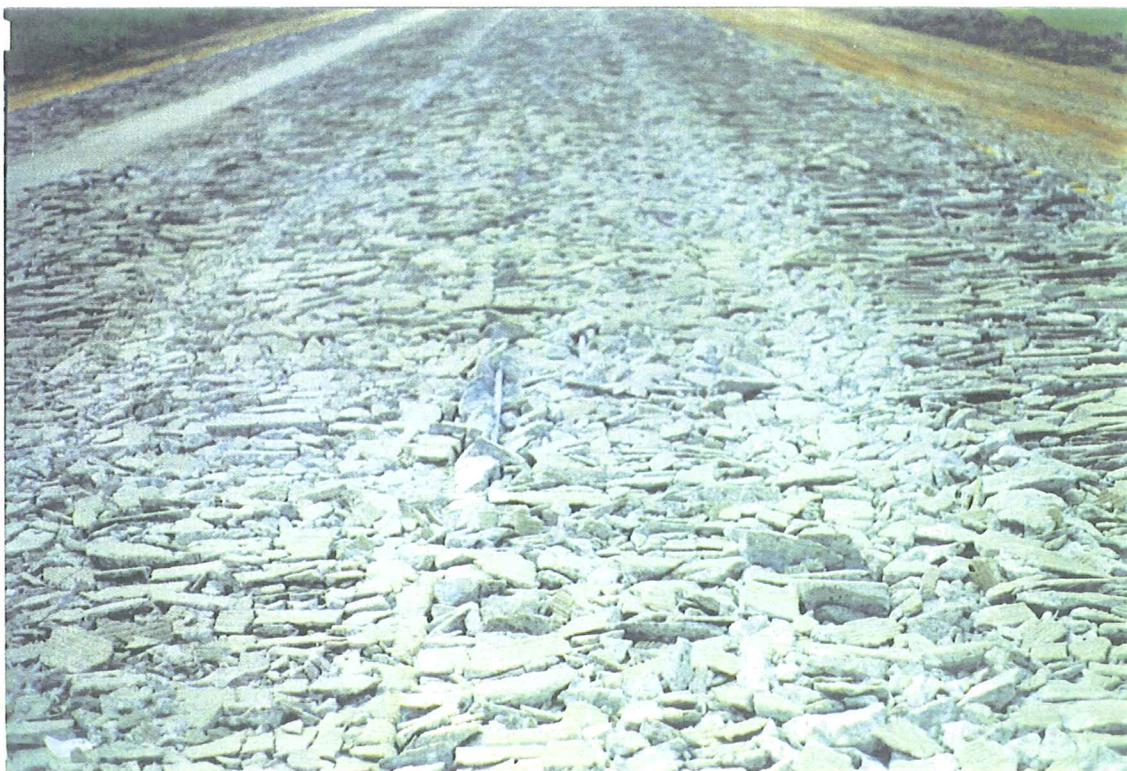
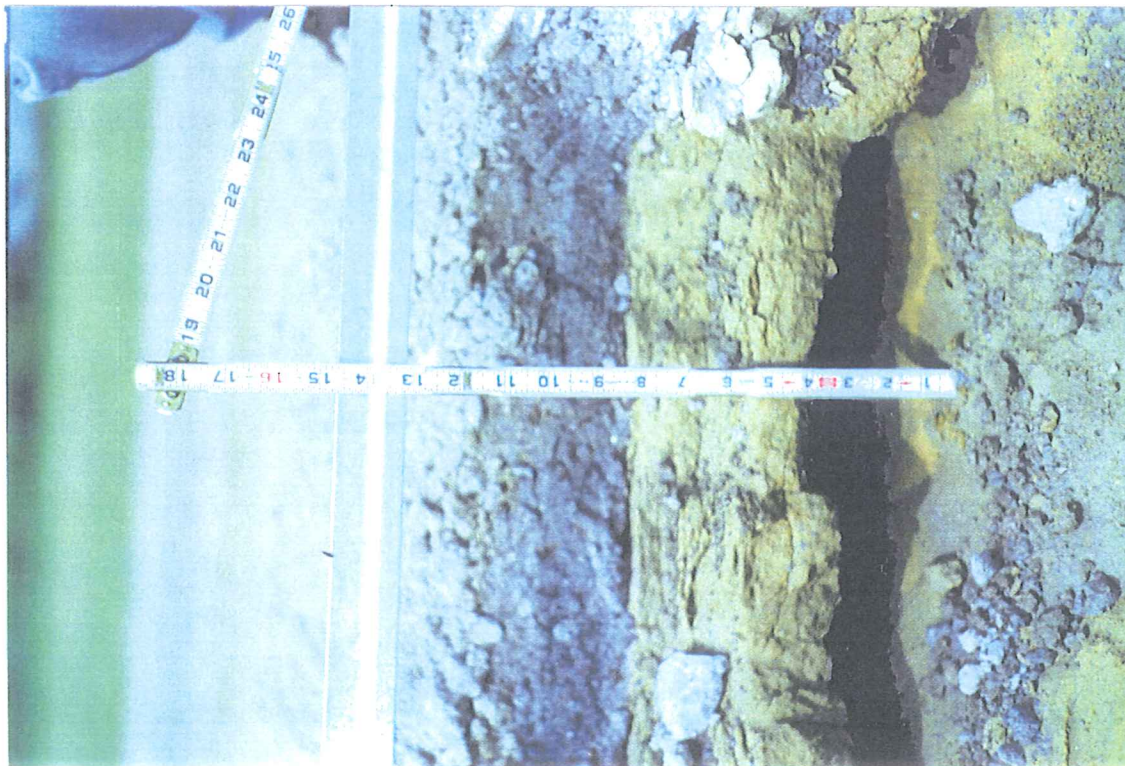
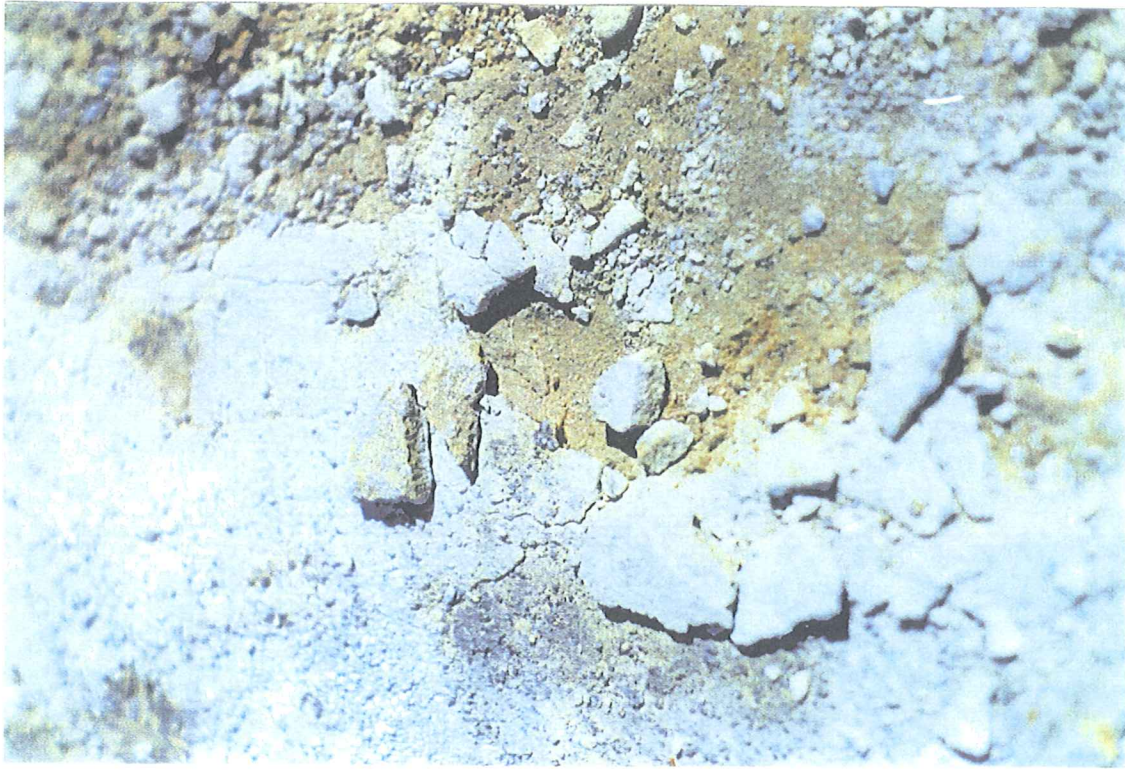
Figure #11

During the original construction of I-275, steel furnace slag was used as an aggregate base for concrete on projects 3, 4, 5. The reconstruction provided the opportunity to inspect the slag aggregate prior to its removal and the placement of a dense-graded aggregate separator and an open-graded drainage course. The 4-inch slag aggregate base had turned into a material similar to a weak concrete and the sand subbase turned into a material similar to a weak sandstone varying in depth from 1/4 to 6 inches. This condition occurred due to the unhydrated lime component of the slag aggregate leaching out and forming a calcium carbonate deposit as shown in Figure # 11. The depth of the sand subbase that turned into a weak sandstone depended on the amount of moisture present. The more moisture the deeper the sand subbase became like a weak sandstone.

Showing Steel Furnace Slag used as Aggregate Base that had turned to a weak concrete and the sand subbase 4"-5" deep and an area where some of the sand subbase had washed out from under the sand subbase that had turned to a weak sand stone

The sand subbase which had turned to a weak sand stone because of the unhydrated lime component of the slag aggregate which forms a calcium carbonate deposit

The Picture on the right shows a thin layer of the sand subbase that had turned to a weak sand stone

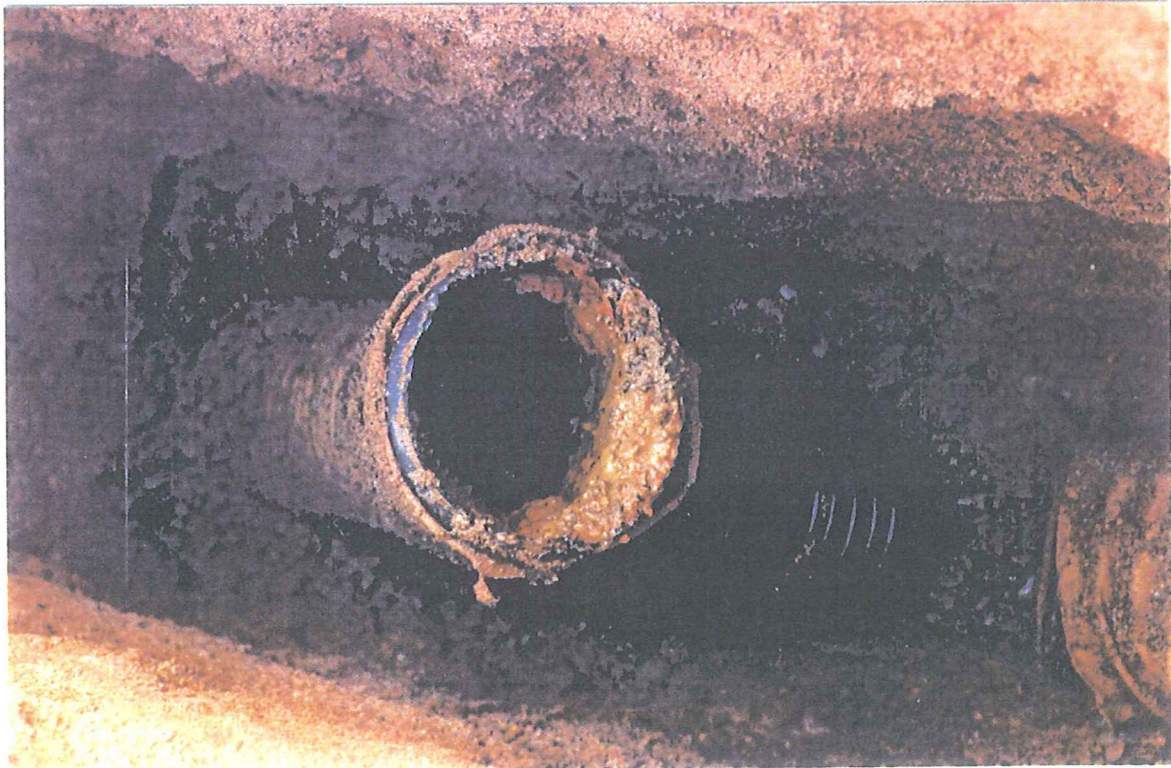
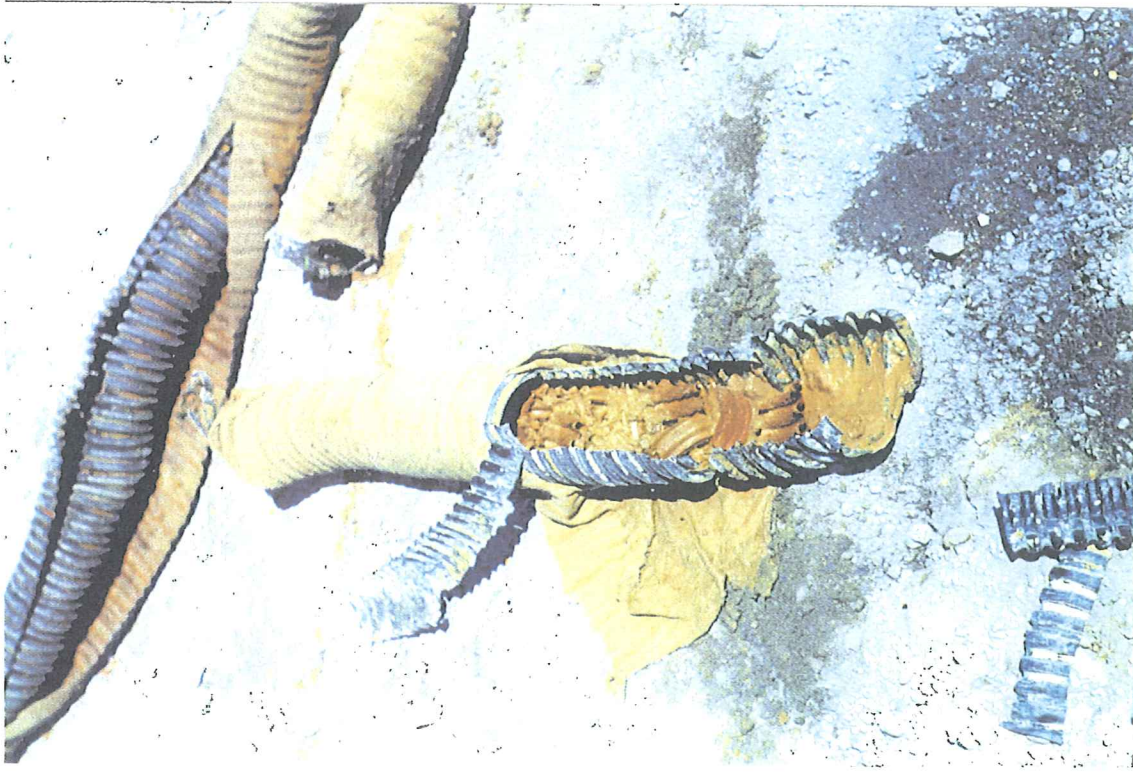
Figure #12

The retrofit edgedrains placed on Projects 4 and 5 in 1980 were removed during this reconstruction providing an opportunity to check their condition after 17 years of service to determine how well they had been functioning. The geotextile cover sock was extremely dirty and partly blinded off and the inside of the pipe was approximately 1/8 to 1/4 full of silt and leachate. Leachate also formed in the grooves on the inside and outside of the pipe. In 1991, a NCHRP study was conducted on the *Long Term Performance of Geosynthetics in Drainage Applications*. A site on S.B. I-275 (in project #5) south of North Huron River Dr. (Sta. 780+00) was chosen for inclusion in that study. As shown in Figure #12, the amount of silt and leachate inside and outside the pipe has increased in the six years since the NCHRP study.

The Picture on the left shows the inside of the pipe and the outside of the sock wrap in 1991.

Showing the retrofit edgeline drain that was placed on Projects 4 and 5 on I 275 in 1980.

The Picture on the right shows the inside and outside of the pipe and sock wrap after removal in 1997.

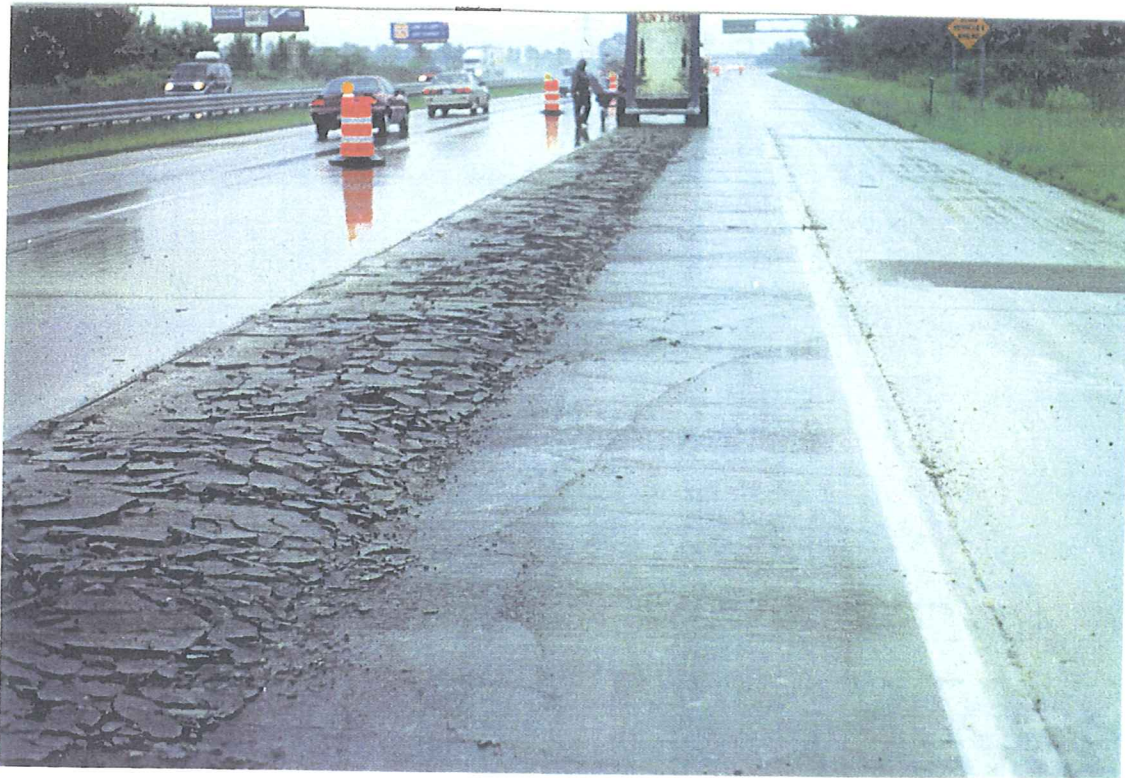
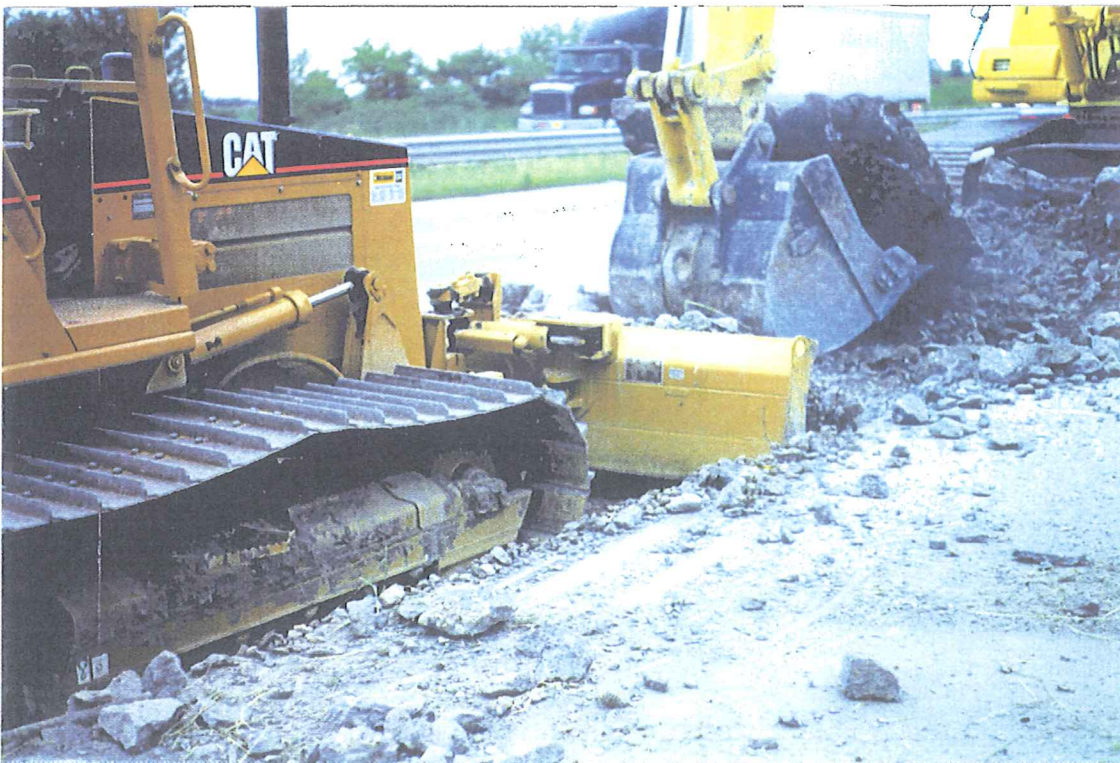
Figure #13

Due to the process that was used to remove the pavement (Figure #13) and grade the OGDC base for the pavement inlay project on northbound I-75, no conclusive comparison could be made with the condition of the base for the inlay project with the condition of the base at the time of pavement removal for the pavement patching projects let by the Maintenance Division, which were done in 1995 and 1996. The pavement patches ranged in size from 12-foot x 12-foot to 36-foot x 12-foot.

Showing pavement being broken by Guillotine Breaker prior to removal by backhoe

Showing pavement being removed by backhoe and OGDC and broken pieces of concrete being graded by bulldozer

Showing Removal Process for Travel Lane on North Bound I 75

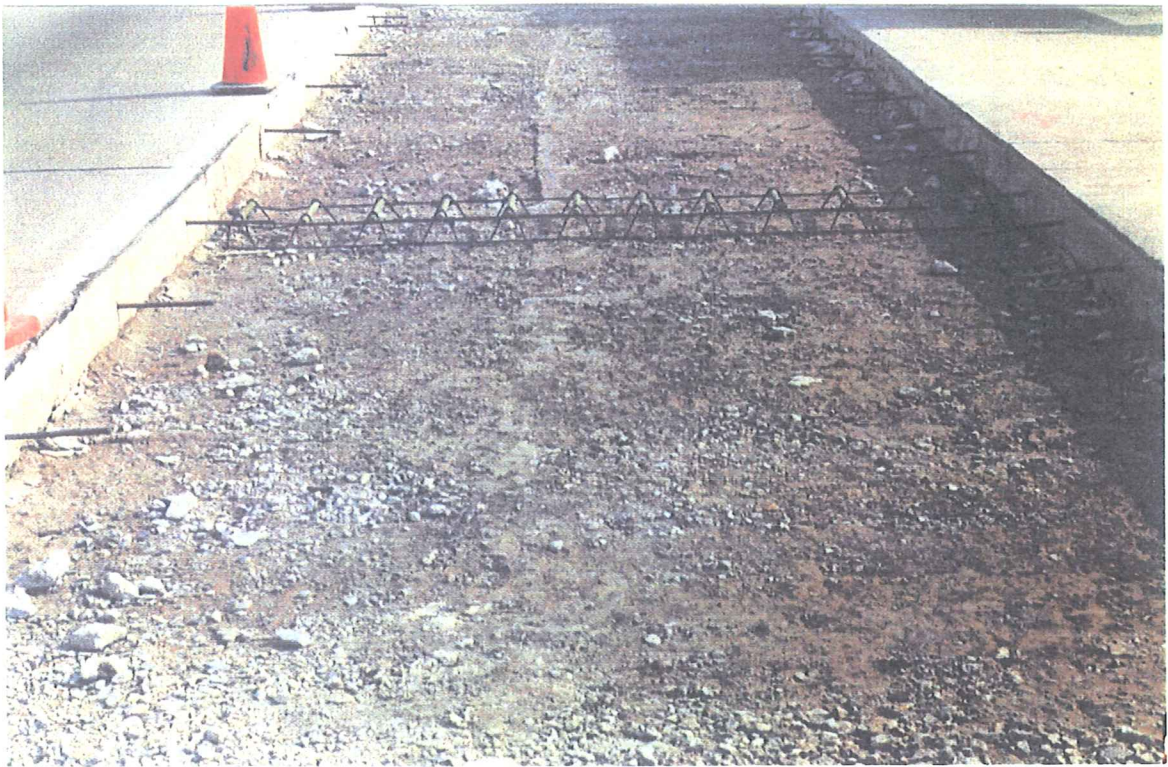
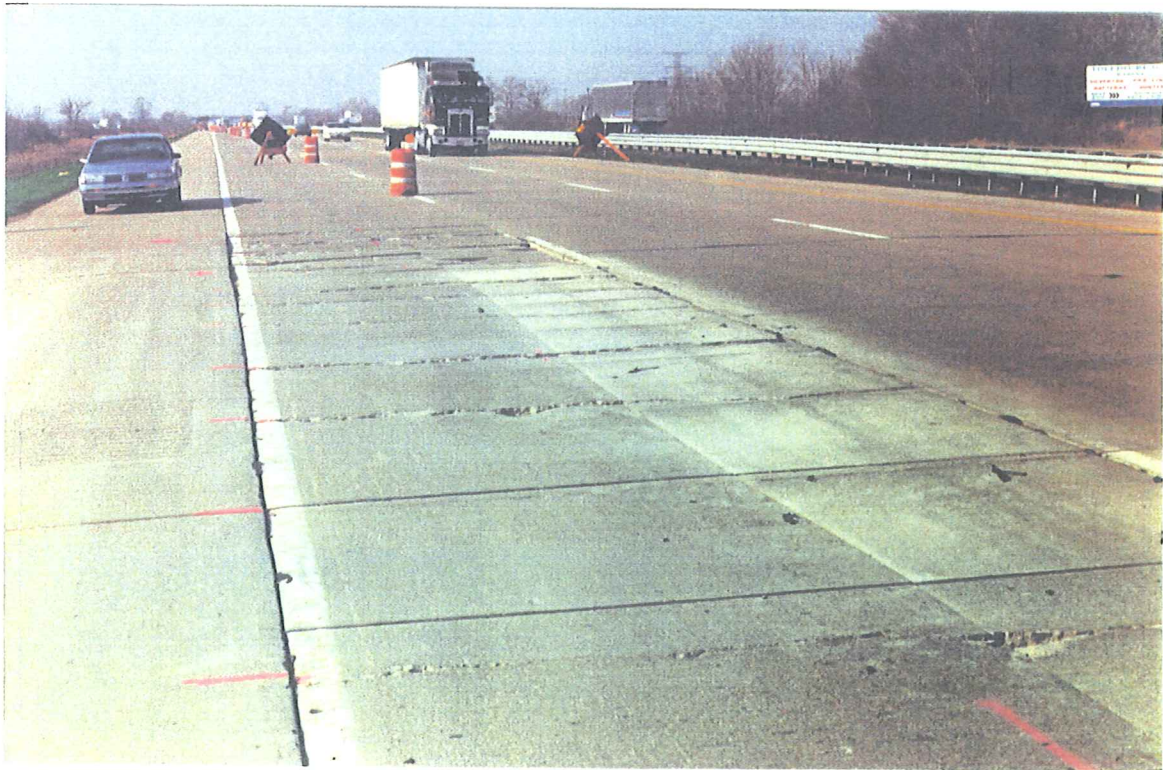
Figure #14

From observations made during the pavement patching projects, it was concluded that the amount of distress (cracking and/or faulting) in the travel lane might be directly proportional to the amount of mixing of the sand subbase and the OGDC (Figure #14). Also, it was concluded that the probability for material to migrate toward the retrofit underdrain would increase with the amount of distress present in the travel lane. However, because of the way the concrete was removed and the OGDC was graded (Figure #13) only a general verification of these conclusions could be made. Figure #15 shows the condition of the pavement before the removal process and the condition of the base after the pavement was removed at Station 371+00. The *before* picture shows that there is considerable faulting of the outside edge of the travel lane which would indicate that there was mixing of the subbase and the OGDC and possible migration of material toward the underdrain. However, the condition of the base (OGDC) in the *after* picture does not show what was expected to be found, probably because of the removal process (Figure #13).

Showing faulted and cracked pavement and the condition of the OGDC and subbase that was observed during a pavement patching project on I 75 in 1994.

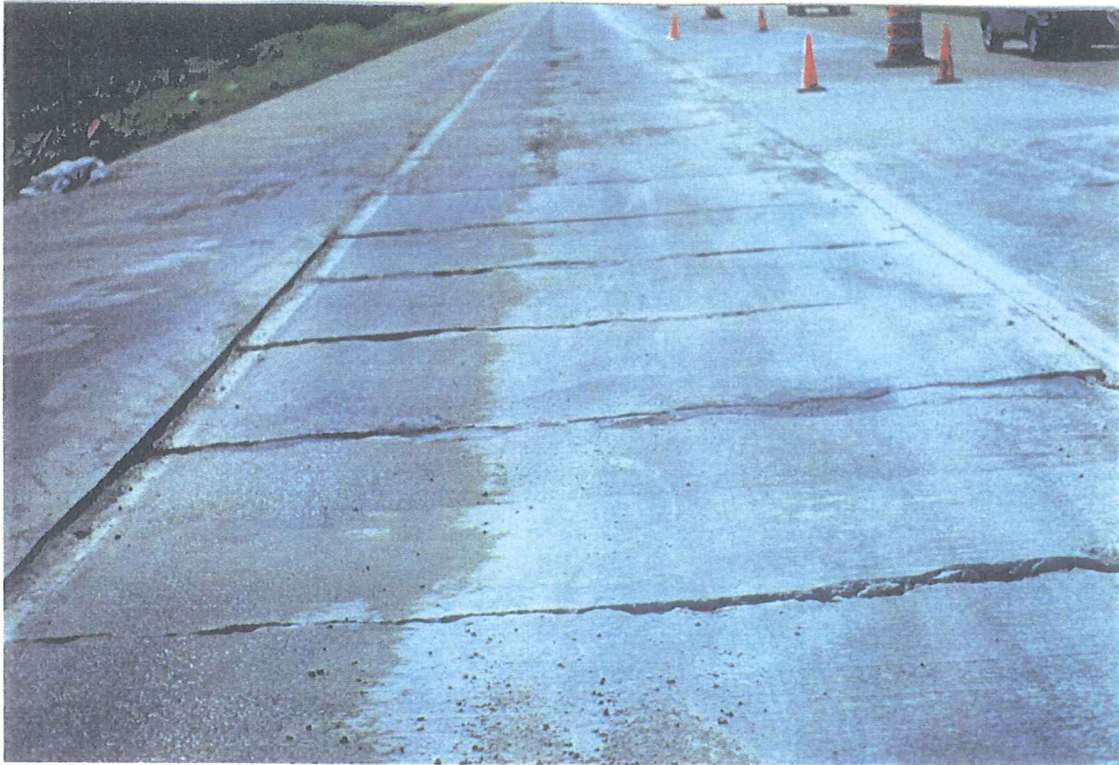
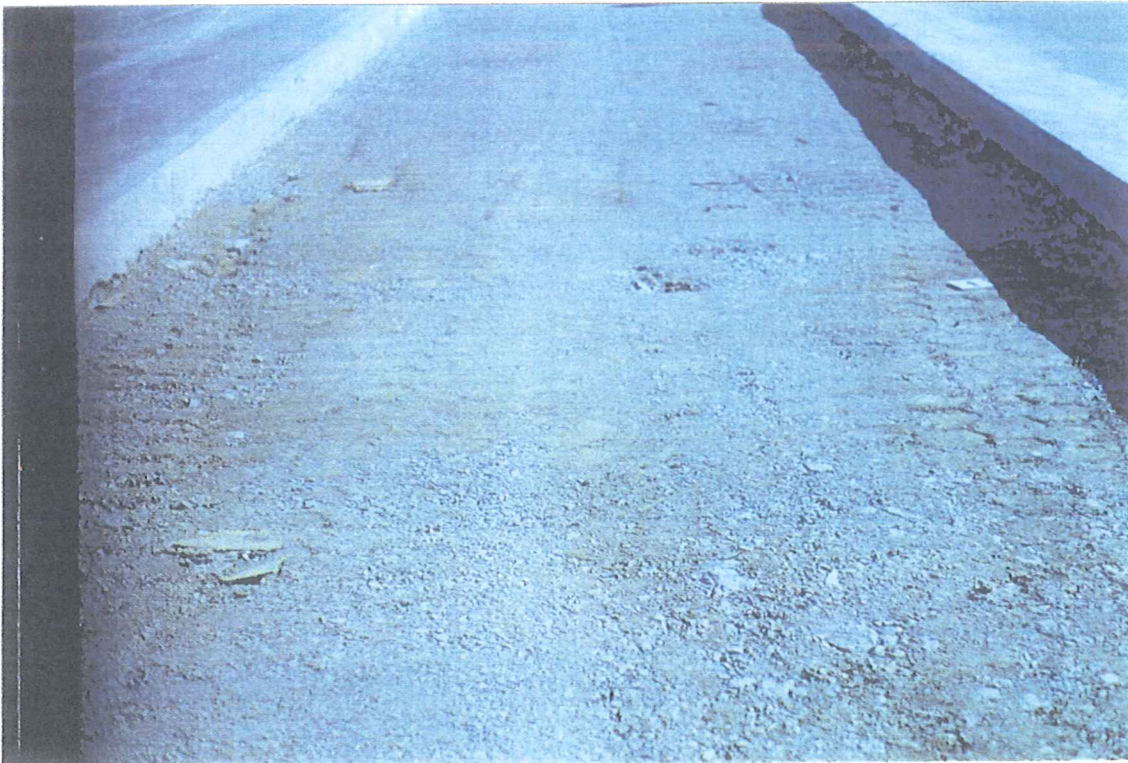
Figure #15

Showing faulted and cracked pavement at station 371+00 before pavement removal and the condition of the OGDC after the removal of the pavement

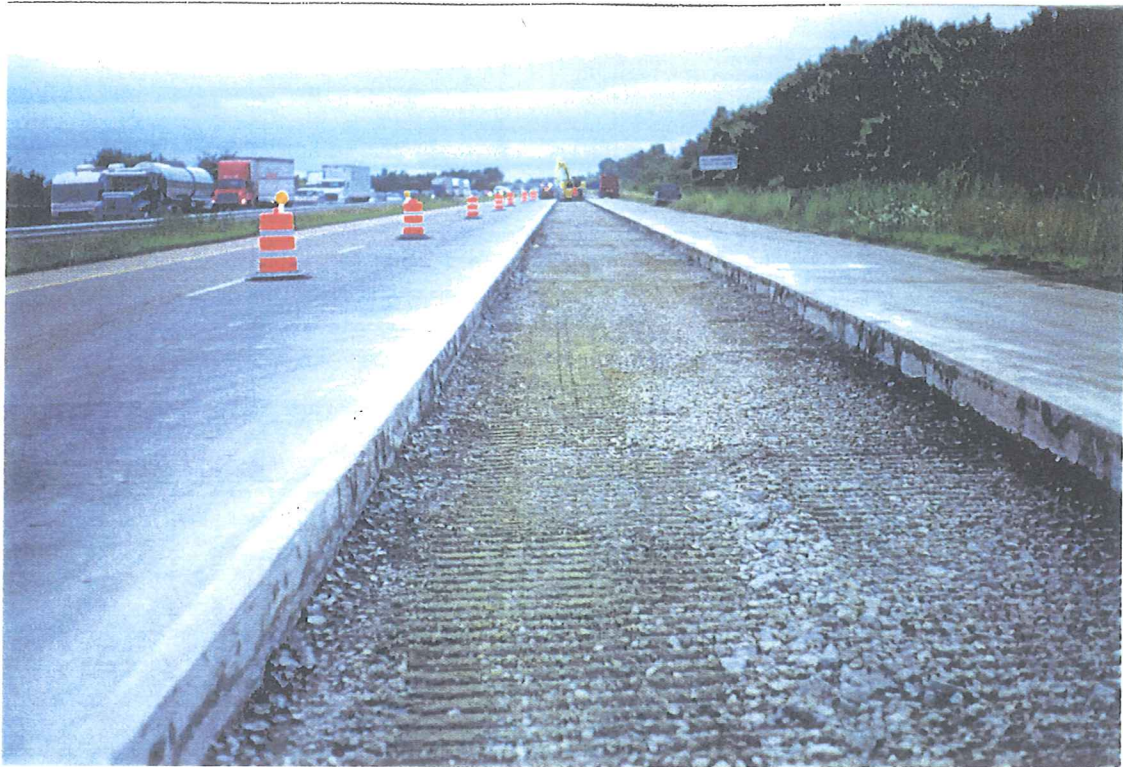
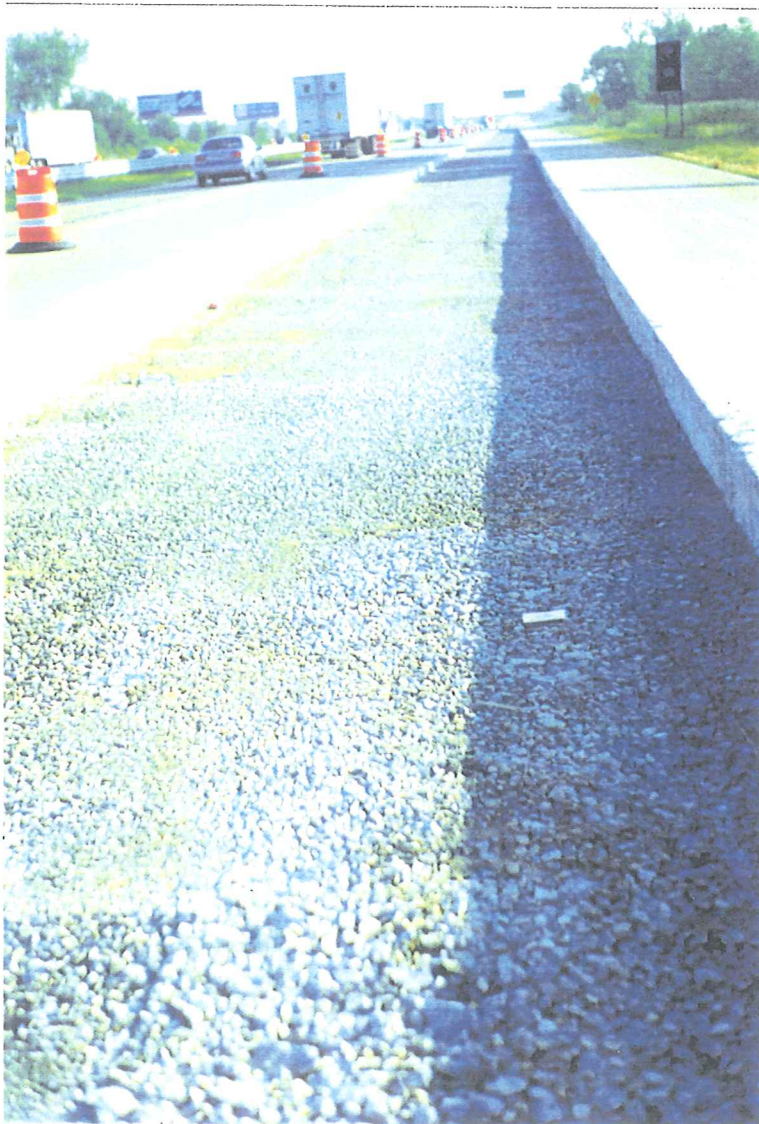
Figure #16 shows that there are indications that there may have been mixing of the sand subbase and OGDC. However, due to the removal process no definite conclusions could be reached to substantiate that there was wide spread mixing of the subbase and the OGDC. Also, no verification could be made that the OGDC had broken down due to traffic loading.

Showing indication that there may have been mixing of the OGDC and the sand subbase
