INVESTIGATION OF SLIPPERY CONDITION
of
STONE SAND CONCRETE PAVEMENT
by
E. A. Finney

Highway Research Project 48 G-41

Research Laboratory
Testing and Research Division
Report 117
December 1, 1948

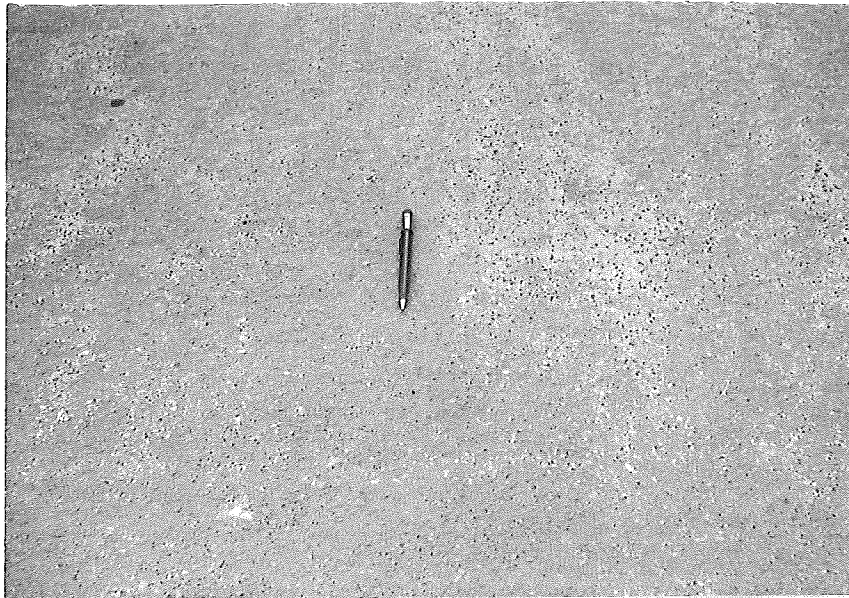
Figure 4. Stone sand concrete. Light gray areas have become exceedingly smooth and polished under service.

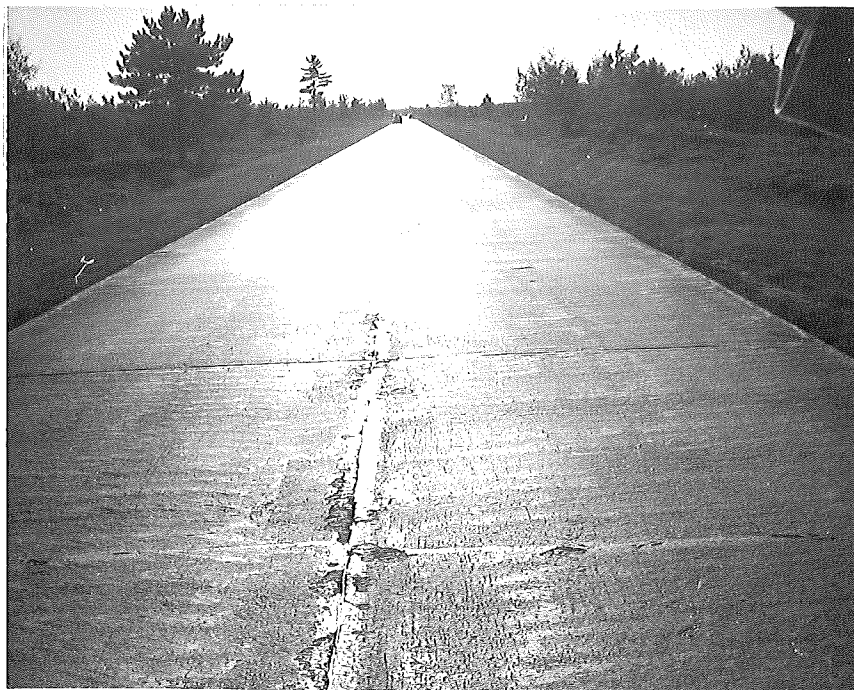
Figure 5. Stone sand concrete. Typical appearance of smooth surfaces under reflected light.

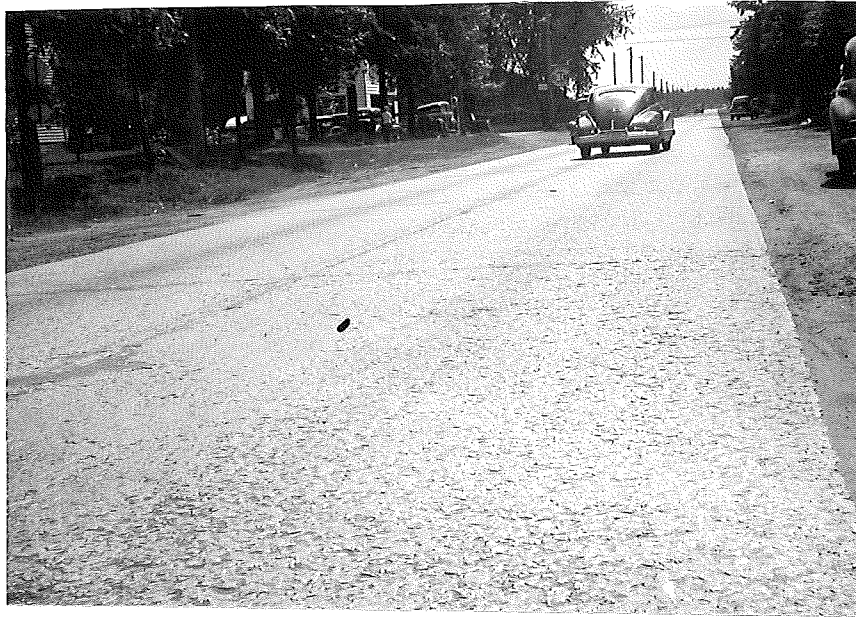
of the parent concrete. See Figure 6. In such cases the coarse aggregate particles have become smooth and glazed under the action of the traffic. See Figure 7. These areas proved to be exceedingly slippery when wet. The completely scaled areas are generally found at curves and intersections where chloride salts applied for ice control have encouraged scaling action.

Figure 6. View of Inland stone sand concrete. Completely scaled area. US-2 in Manistique.

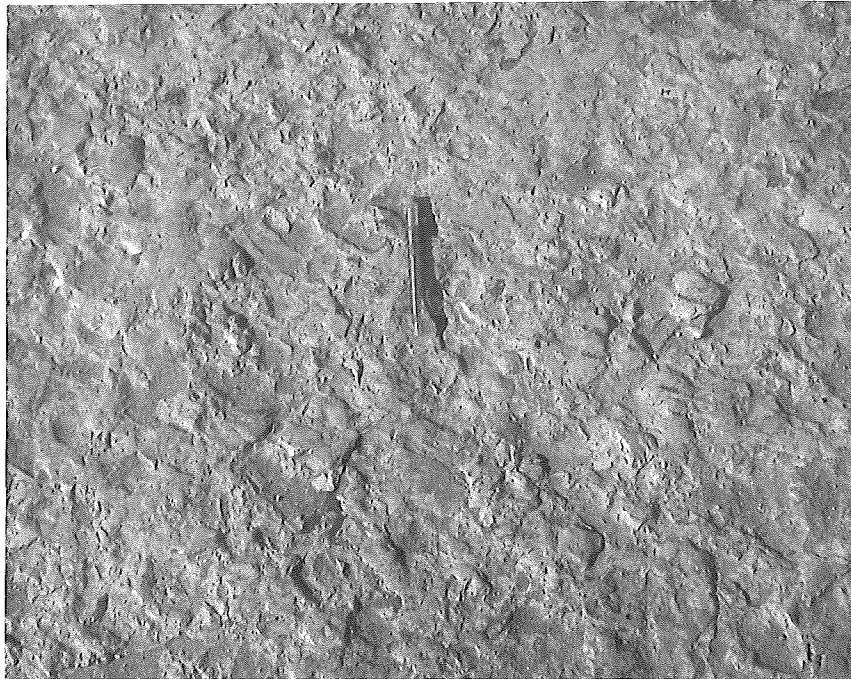
Figure 7. Close view of scaled surface. Note smooth texture of coarse aggregate particles.

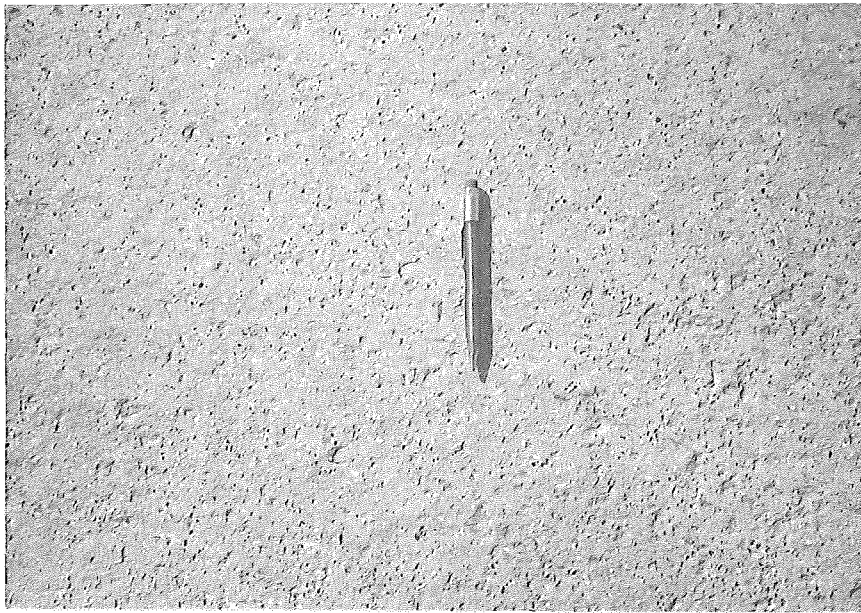
Test Area 7: Test No. 7 was made on a straight section of pavement just east of Thompson Corners on Project 75-30,C7. This particular stone sand pavement surface had no scale and appeared less glossy than other stone sand projects. The coefficient of friction was 0.42, which was the highest value found on any of the stone sand projects tested. Figure 10 presents a view of the texture of the surface. You will note in Figure 10 that the pavement surface has a large amount of small indentations. These surface voids may account for the fact that the friction factor is higher on this stone sand project than on others, since they provide drainage space for displaced water by passing tires.

Figure 10. Texture of stone sand surface
Project 75-30, C7.

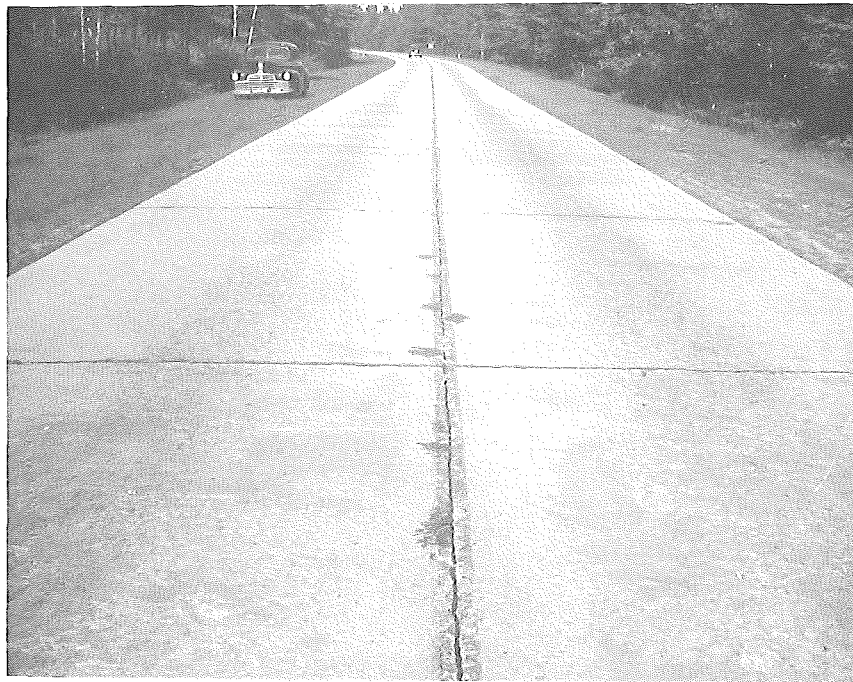
Test Area 8: Test No. 8 was made on a straight section of pavement just east of a curve at Cook's Corners on Project 75-30, C5. See Figure 11. The concrete surface in this area was badly scaled and apparently very smooth. This location was reported to be dangerously slippery when wet. The coefficient of friction was very low, 0.24.

Figure 11. General view of curve at Cooks
Corners. F 75-30, C5.

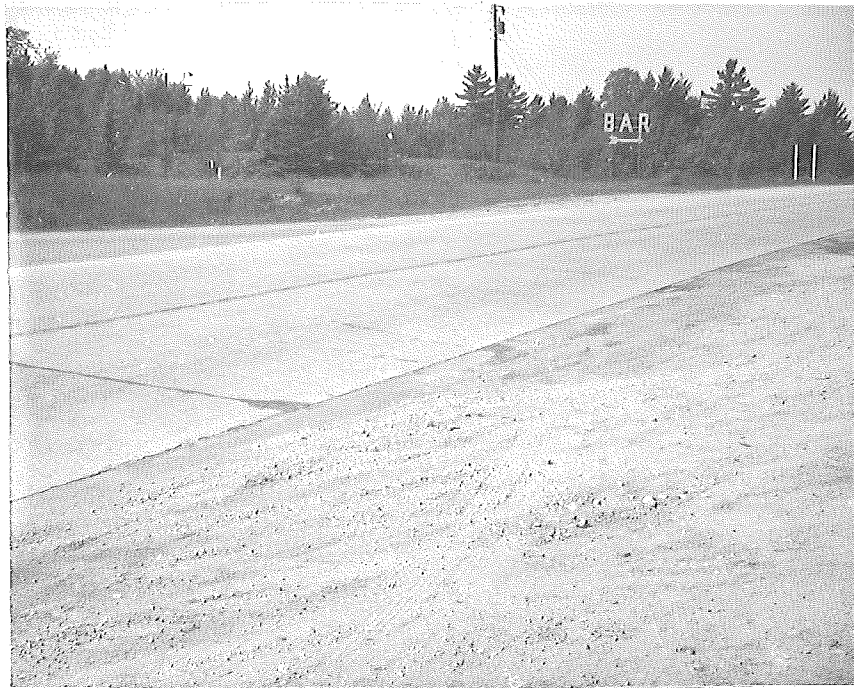
Test Area 9: Test No. 9 was made on the curve at Garden Corners on Project 21-29, C8. This area was reported by State Police to be one of the extremely bad spots. The concrete surface was badly scaled and the exposed coarse aggregate was worn smooth. The coefficient of friction was very low, being 0.23.

There are certain design features which could influence skidding accidents at this point. In the first place, the curve is superelevated .07 foot per foot of width, which is sufficient to cause any skidding car in the east bound lane to skid sideways into the oncoming westbound traffic. During the skidding tests the test car invariably would skid from the high side to the low side of the curve before coming to a stop. Furthermore, the curve is intersected near its east tangent by Garden Road. If fast-moving vehicles on US-2 are suddenly required to reduce speed due to the entrance of slow traffic from the Garden Road, the results are obvious. The tracking of dust onto the highway from the gravel side road and shoulders at the intersection will also tend to lower the friction factor. A picture of this area is shown in Figure 12.

Figure 12. General view of road conditions at Garden Corners.

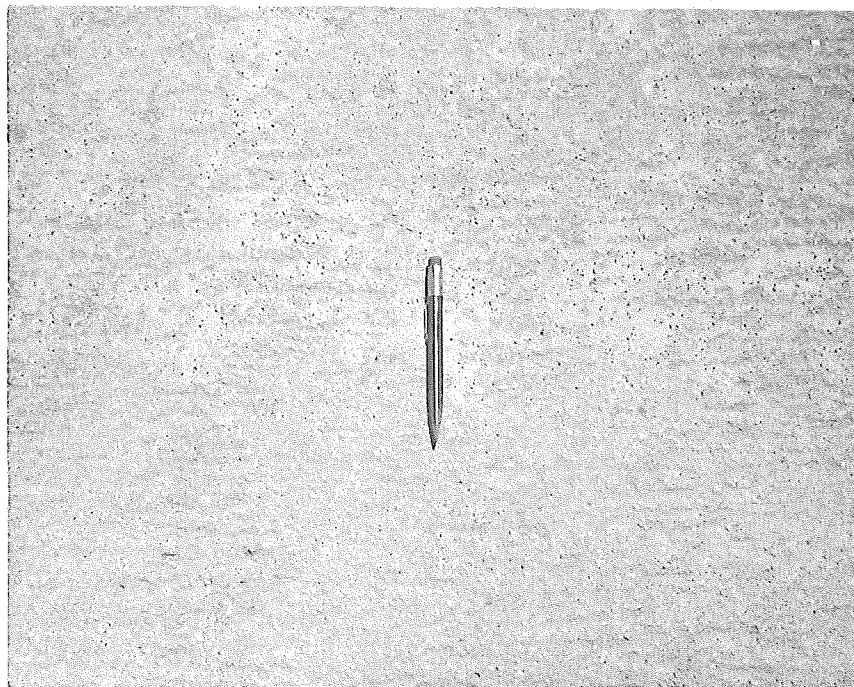
Figure 13. Texture of surface project 75-31, C7. Test area 13. Note smooth condition of concrete.

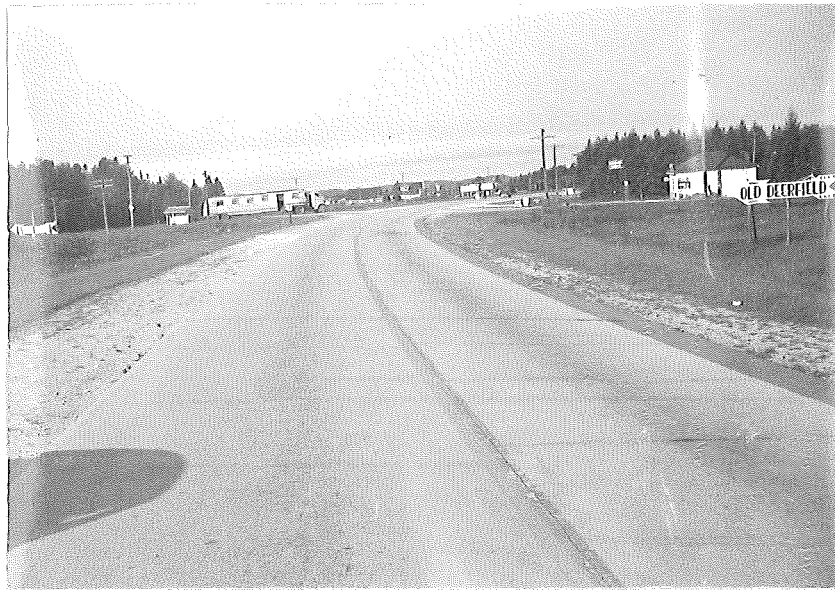
Other factors besides slippery pavement may influence the accident rate in this particular area. The curve is superelevated at .06 per foot of width and there is a cross road near the center of the curve. Also this is a local trading community and consequently local traffic cutting in and off the highway could create a hazard to fast-moving traffic on US-2 when pavement is wet. A general view of the curve at Gulliver Village is shown in Figure 14.

Figure 14. General view of test area 14 on Project 75-31, C4. Gulliver Village.

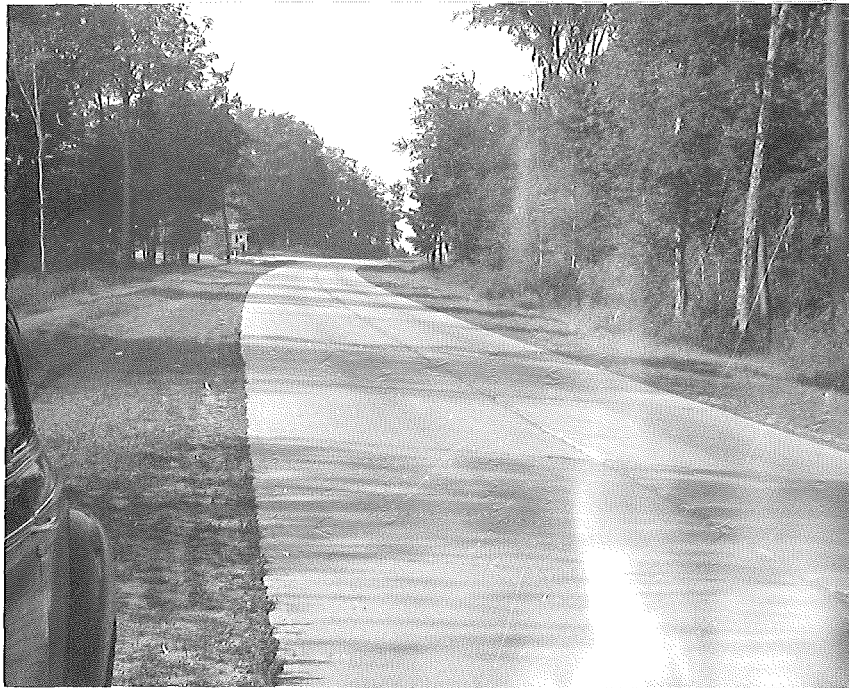
Test Area 15: This area is located at Bear Creek approximately 3 1/2 miles west of Blaney Park on Project 75-31, C3. The coefficient of friction was .20, the lowest value obtained on any of the stone sand projects tested. The pavement surface on the entire project extending from just west of M-77 at Blaney Park to the end of the curve west of Bear Creek was badly cracked transversely. The surface was scaled sporadically and especially at cracks. State Police stated that this was an unusually bad area for skidding accidents, and it is believed that the abnormal roughness of the pavement due to cracking may increase the tendency for cars to skid on the wet surface. The curve is also partially obscured by trees as well as a cross road at the center of the curve. See Figure 15.

Figure 15. General view of curve at Bear Creek test area 15, Project 75-31, C3.

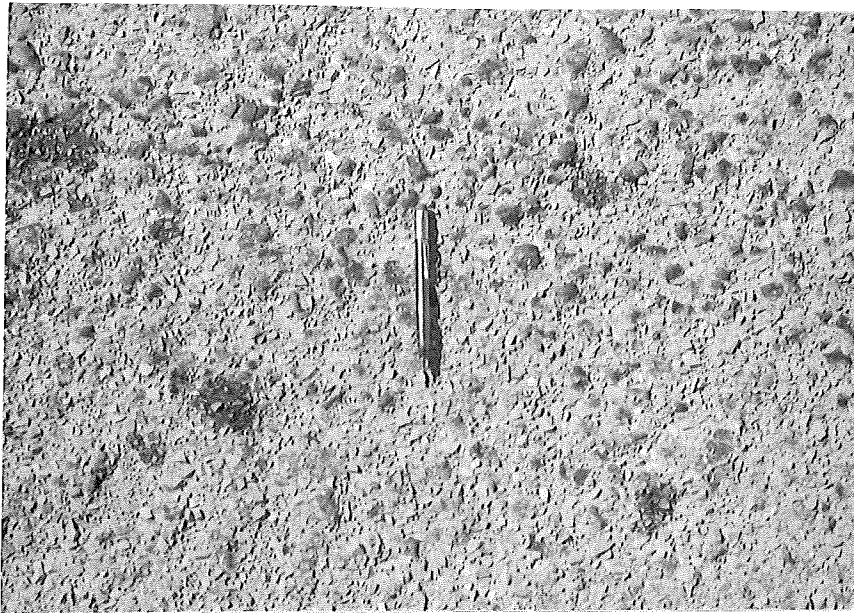
Test Area 19: This test area is on Project CS 53-26, C2 in Mason County on Center Riverton Road. The surface consists of a bituminous double seal with Inland stone chips over oil aggregate. This test area was selected as one of several bituminous resurfacing projects to determine the influence of Inland limestone aggregates on the skidding properties of bituminous surfaces. The average coefficient of friction was 0.55. The surface was unusually rough textured due to the fact that the coarse stone was exposed.

Figure 17. Texture of surface at last area 19.
Project CS 53-26, C2.

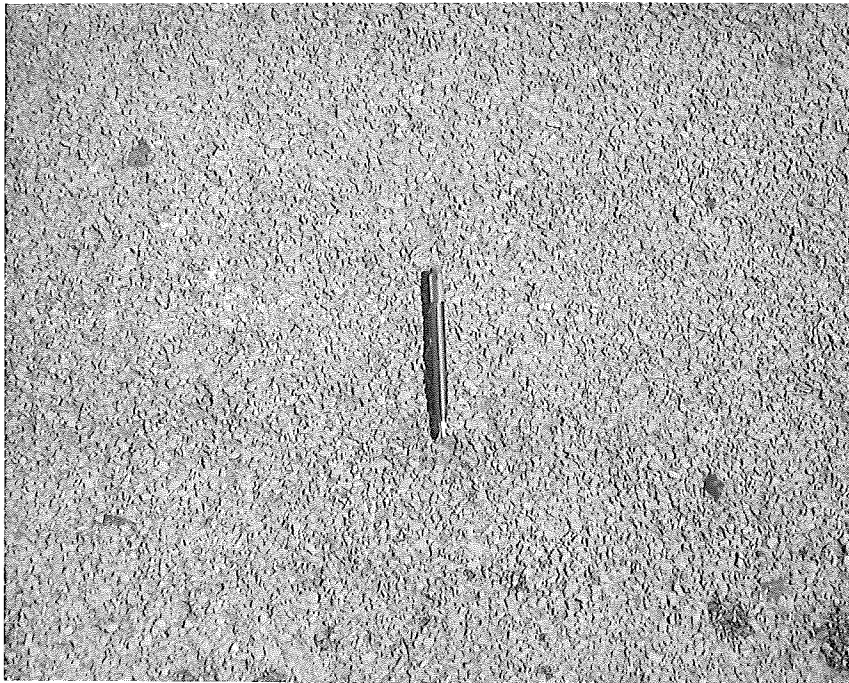
Test Area 20: This test area lies a short distance north of Project CS 53-26, C2 on Center Riverton Road. The surface consists of an old single seal job using Inland limestone chips. The surface was well worn, smooth and typical of such surfaces. See Figure 18. The average coefficient of friction was 0.47.

Figure 18. Texture of surface at test area 20.

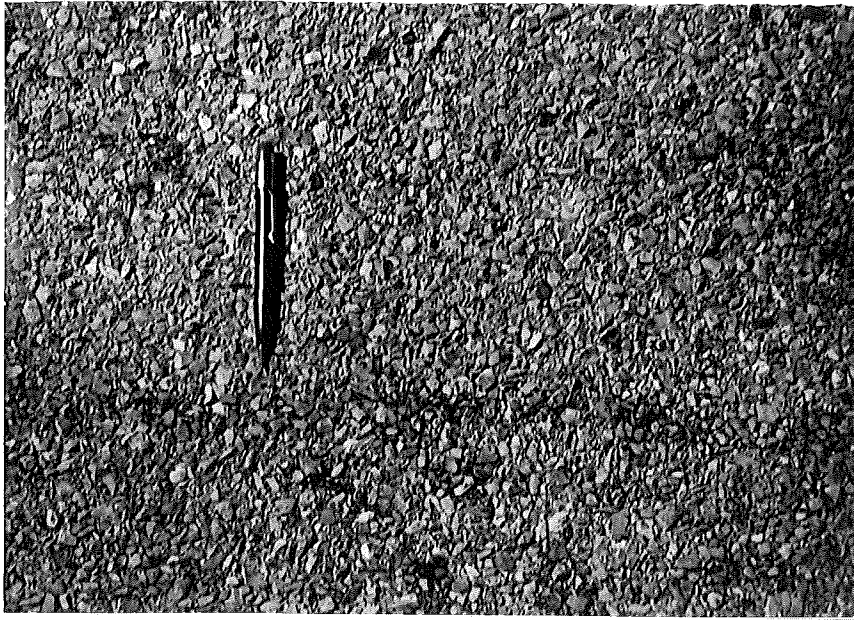
Test Area 21: This test area is also on Center Riverton Road, approximately 200 feet north of test area 20. The road surface in this particular area was recently treated with a single bituminous seal and Inland stone chips. The surface was so loaded with chips that no bituminous material was exposed. See Figure 19. Skidding tests were made at this location to determine the effect of age and influence of construction conditions. The coefficient of friction was 0.36.

Figure 19. Texture of surface at test area 21.

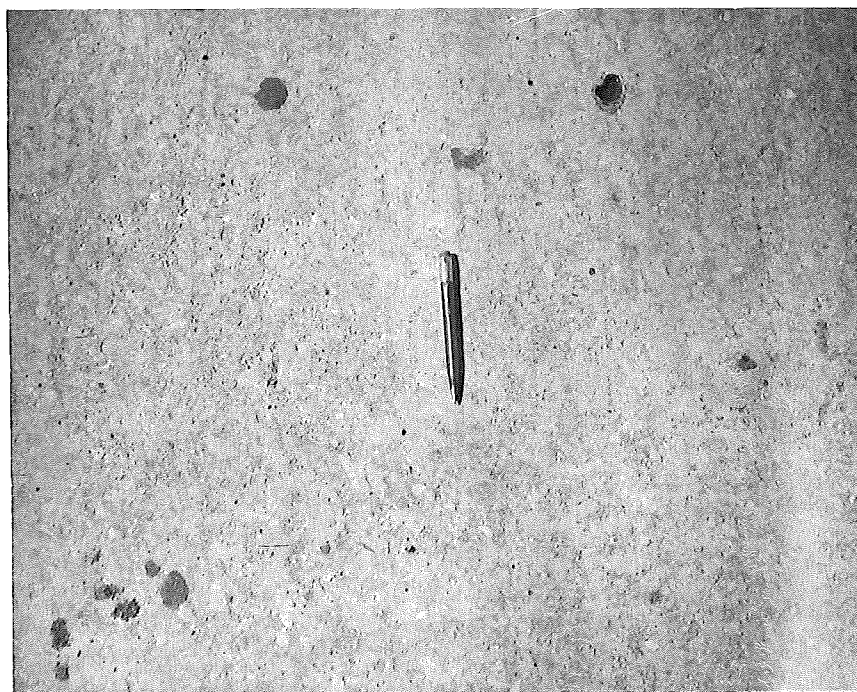
Test Area 30: This area is located on US-31 on concrete pavement project 24-25, C1 in the city of Petoskey just west of the intersection at M-131. Inland coarse and fine aggregate and Petoskey cement were used in the construction of this con-

Figure 26. Stone sand surface, Project 24-25, C1, Test area 30. Note smooth texture of surface.

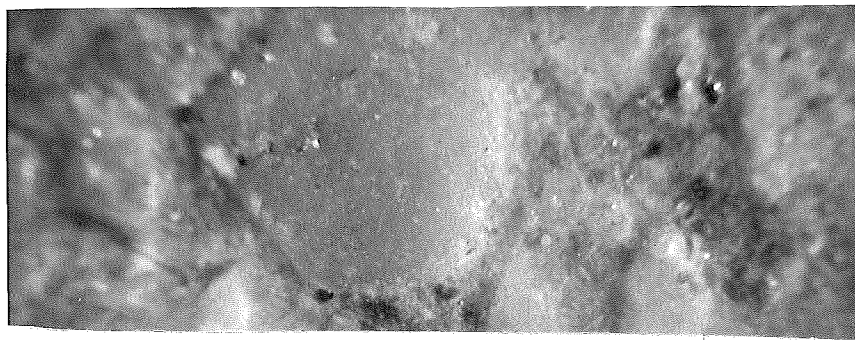
75-30
2880

Typical examples of stone sand surfaces are presented in Figures 31 to 40. In Figures 31, 32, 33 it may be observed that the stone sand particles extend slightly above the cement mortar, but are well-rounded and polished by traffic action. This condition of aggregate had no noticeable effect on skid-resistant characteristics of the different limestone surfaces. Figures 34, 35, and 36 present views of scaled and unscaled areas of stone sand concrete. In both instances the aggregates and matrix are quite smooth in appearance, much unlike natural sand concrete. Figures 37 to 40 show that the aggregates and matrix have become equally polished to a smooth glossy surface which offers practically no mechanical interlocking for the tires.

Figure 31. Texture of stone sand concrete surface. Project 75-30, C3. Note smoothness of exposed aggregate. Magnification, 24X. Core 635.

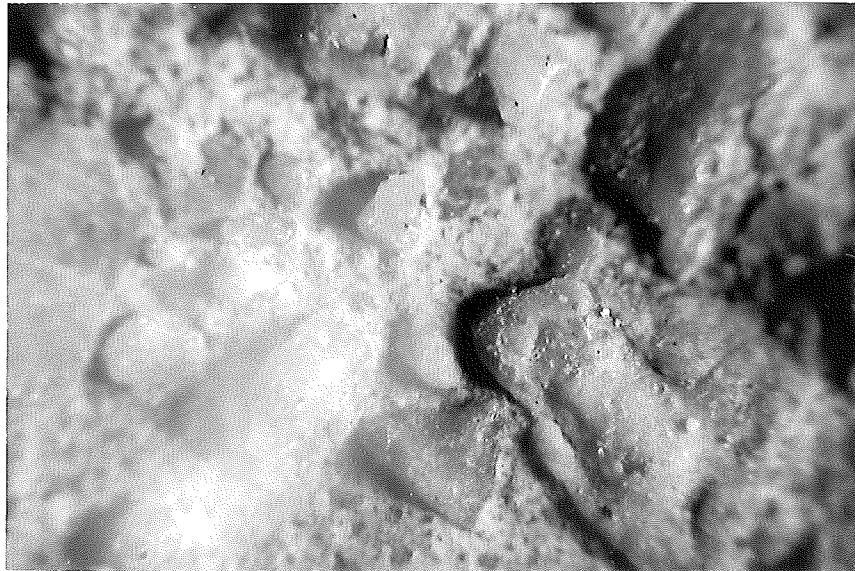
21-29
2814

Figure 32. Texture of stone sand concrete. Project 21-29, C7. Core 633. Similar to Figure 31. Magnification, 24X.

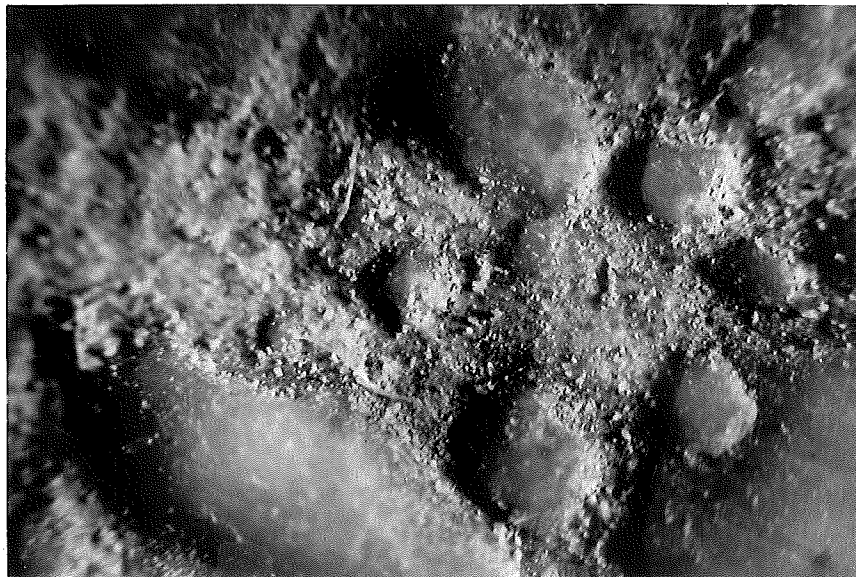
75-31
2832

Figure 33. Texture of stone sand concrete surface. Project 75-31, C4. Core 668. Similar to Figures 31 and 32. Magnification, 24X.

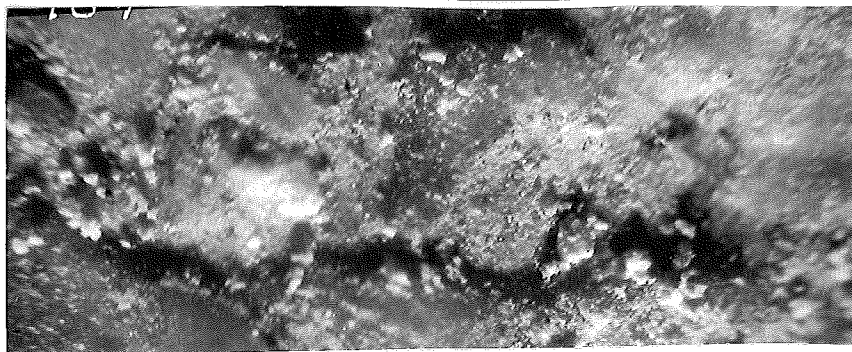
Figure 34. Texture stone sand concrete surface project 25-30, C3.
Core 634. Magnification, 24X.

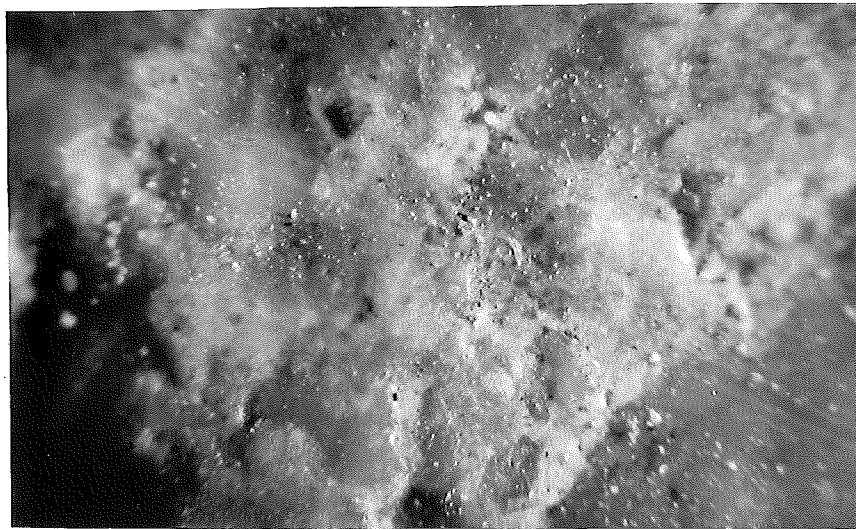
Figure 35. Texture of stone sand concrete surface project 21-29, C7.
Core 630. Scaled area. Magnification, 24X.

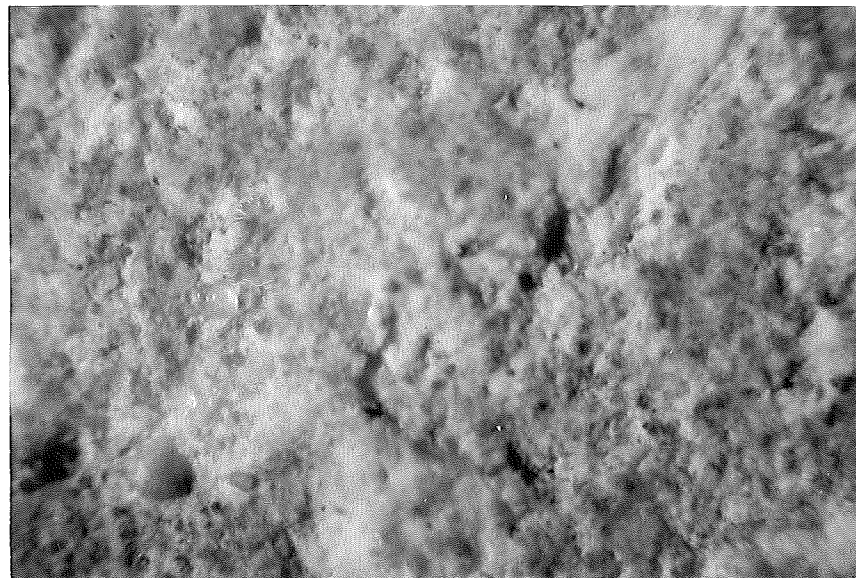
Figure 36. Texture of stone sand concrete surface, project 21-29, C7.
Core 631. Unscaled area. Magnification, 24X.

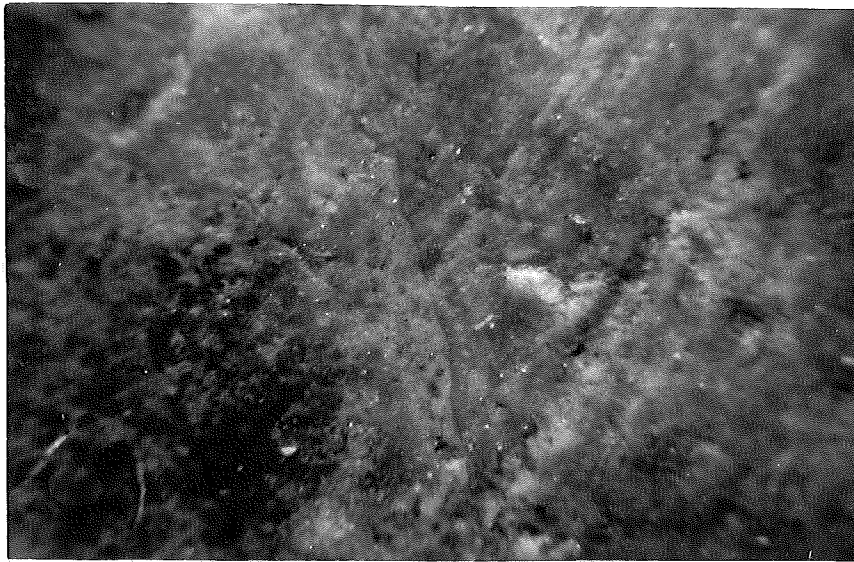
75-31
C3
669

Figure 37. Texture of stone sand concrete pavement project 75-31, C3. Core 669. Note smooth condition of matrix and stone particles. Unscaled surface. Magnification, 24X.

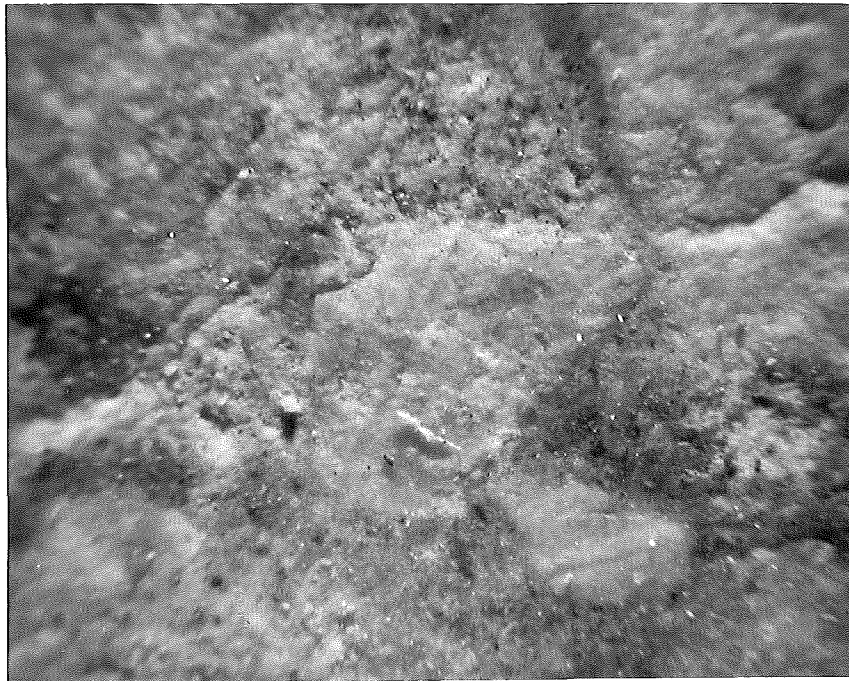
49-30
C9
670

Figure 38. Texture of stone sand concrete pavement project 49-30, C9. Core 670. Unscaled surface. Magnification, 24X.

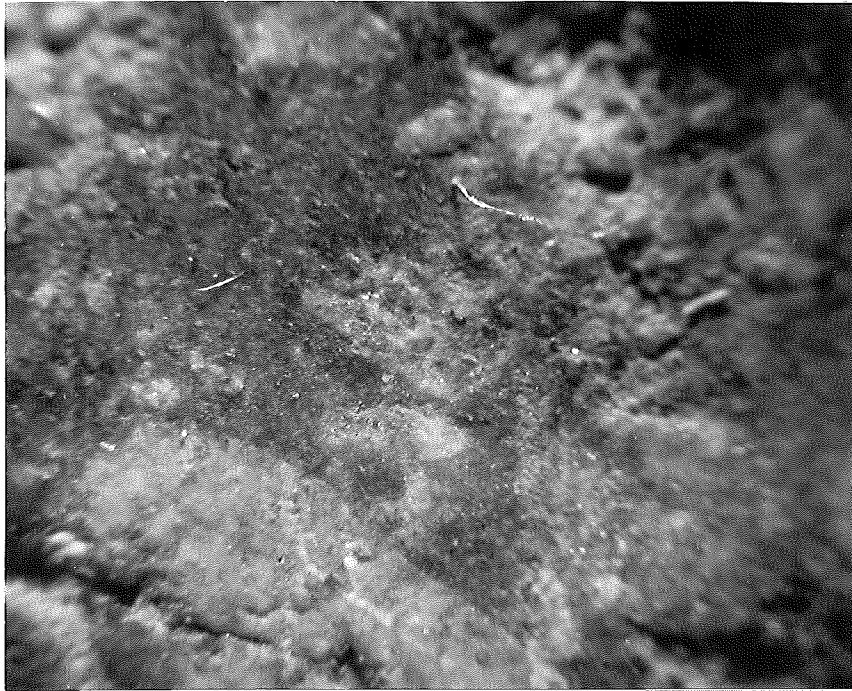
Figure 39. Texture of stone sand concrete pavement project 49-28, C2. Core 672. Unscaled surface. Magnification, 24X.

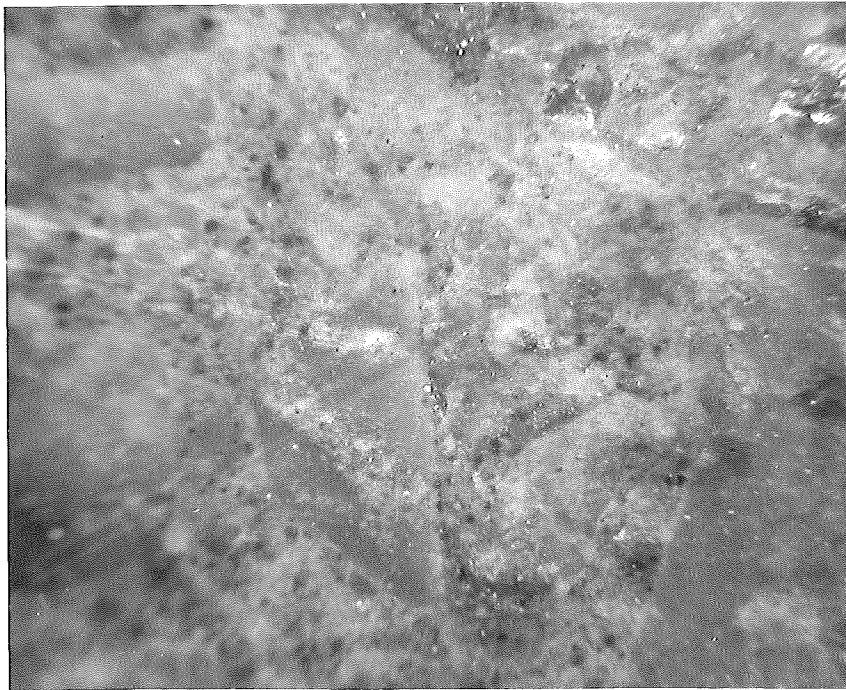
Figure 40. Texture of stone sand concrete surface at Elk and Maple St. in Manistique. Core 636. Scaled surface. Magnification, 24X.
