EVALUATION OF SAWED-SEALED LONGITUDINAL JOINTS
BETWEEN BITUMINOUS SHOULDERS AND RIGID PAVEMENT
AS A MEANS OF REDUCING
LONGITUDINAL SHOULDER CRACKING

MICHIGAN DEPARTMENT OF STATE HIGHWAYS

Research Laboratory Section
Testing and Research Division
Research Project 66 E-37
Research Report No. R-683

State of Michigan
Department of State Highways
Lansing, September 1969

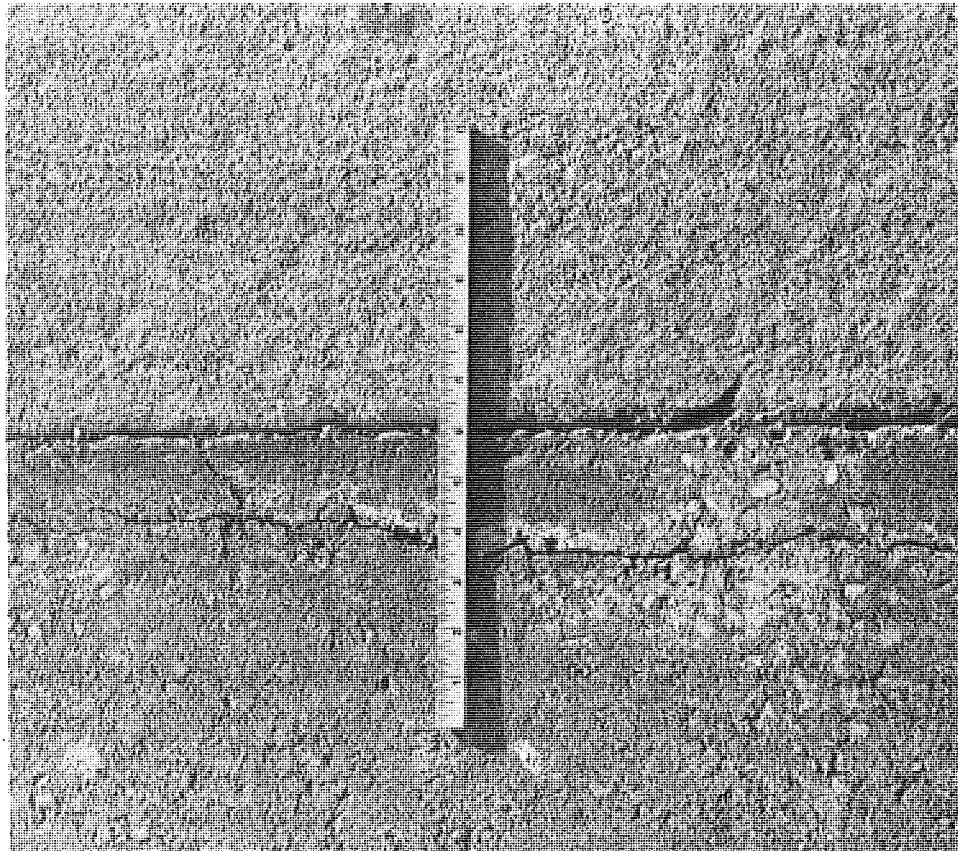
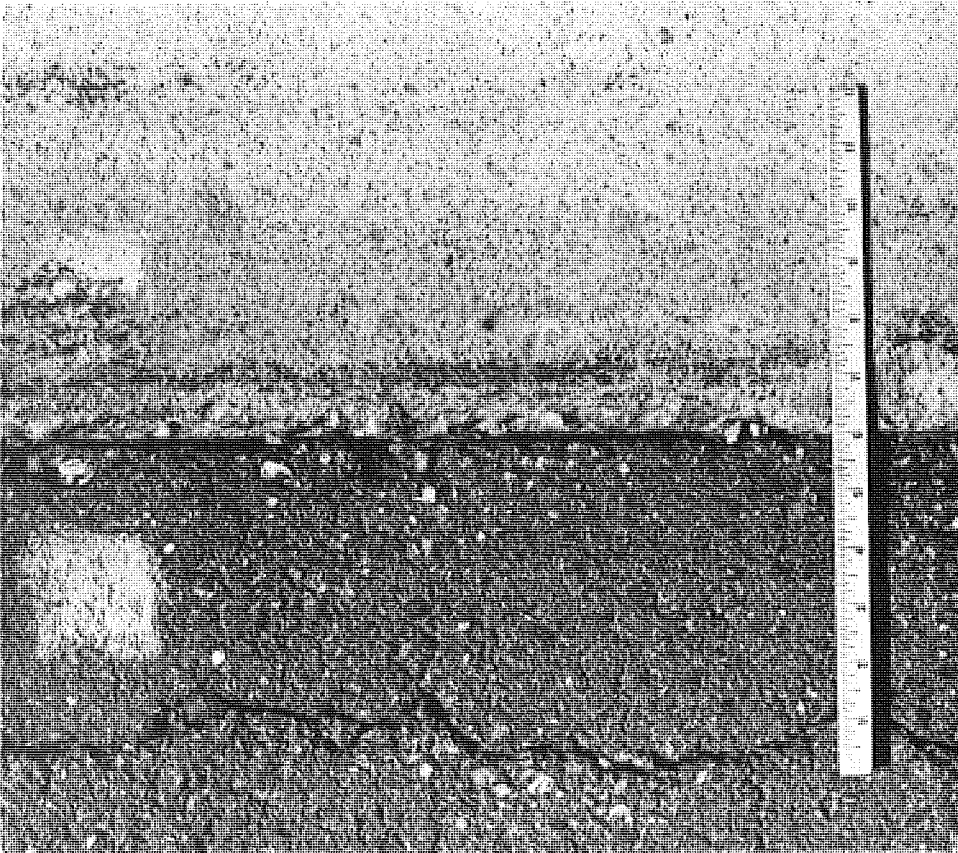
Station 516+30
Project 5 - SB Roadway
Age - 2 months
(December 1966)

Station 462+65
Project 5 - NB Roadway
Age - 1 year 5 months
(March 1968)

Figure 3. Typical longitudinal shoulder cracks 4 to 8 ft in length, located 3 to 9 in. from unsealed conventional longitudinal joints. Cracks were open less than 1/4 in.

This experimental joint was used in an attempt to eliminate, or significantly reduce, longitudinal shoulder cracking, shown typically in Figure 3, which occurs in varying lengths, spacings, and widths.

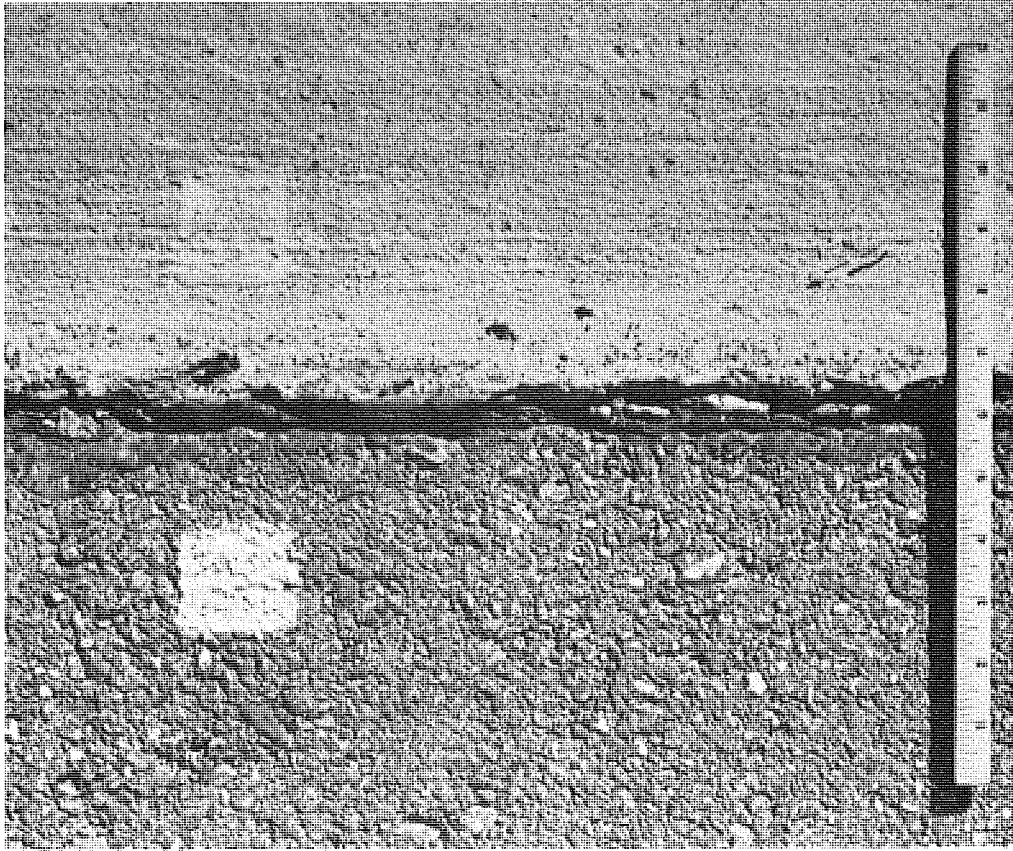
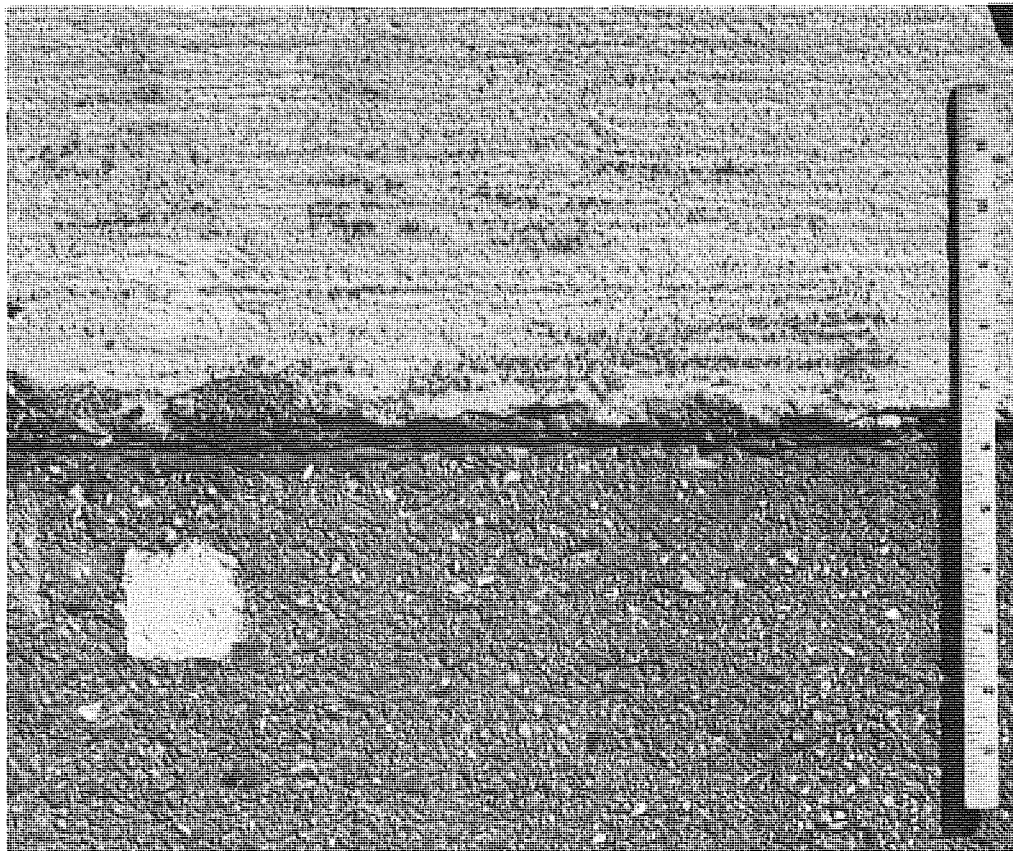
In Project 5, two types of interface joint failures were apparent: sealer failure caused by excessive tension in the sealing material, leaving opened joints wide enough for infiltration of water, sand, gravel, and salt (Fig. 11), and joint spalling caused by separation and removal of concrete at the pavement edge parallel to the experimental joint (Fig. 12).

Station 406+60
SB Roadway
Age - 1 year 5 months

Station 404+60
SB Roadway
Age - 1 year 5 months

Figure 11. Typical tension failure of sawed-sealed joints at two project 5 locations. Joints are open wide enough to allow infiltration of water, sand, gravel, salt, or other incompressible material. March 1968 survey.

Sawing or cutting and sealing of shoulder-pavement interfaces should be discontinued. Even though, in some cases, the seal-treated joint is effective in reducing shoulder cracking by a small percent, the effectiveness is soon lost because of joint sealer failure. Consequently, the additional cost of this operation is not justified.

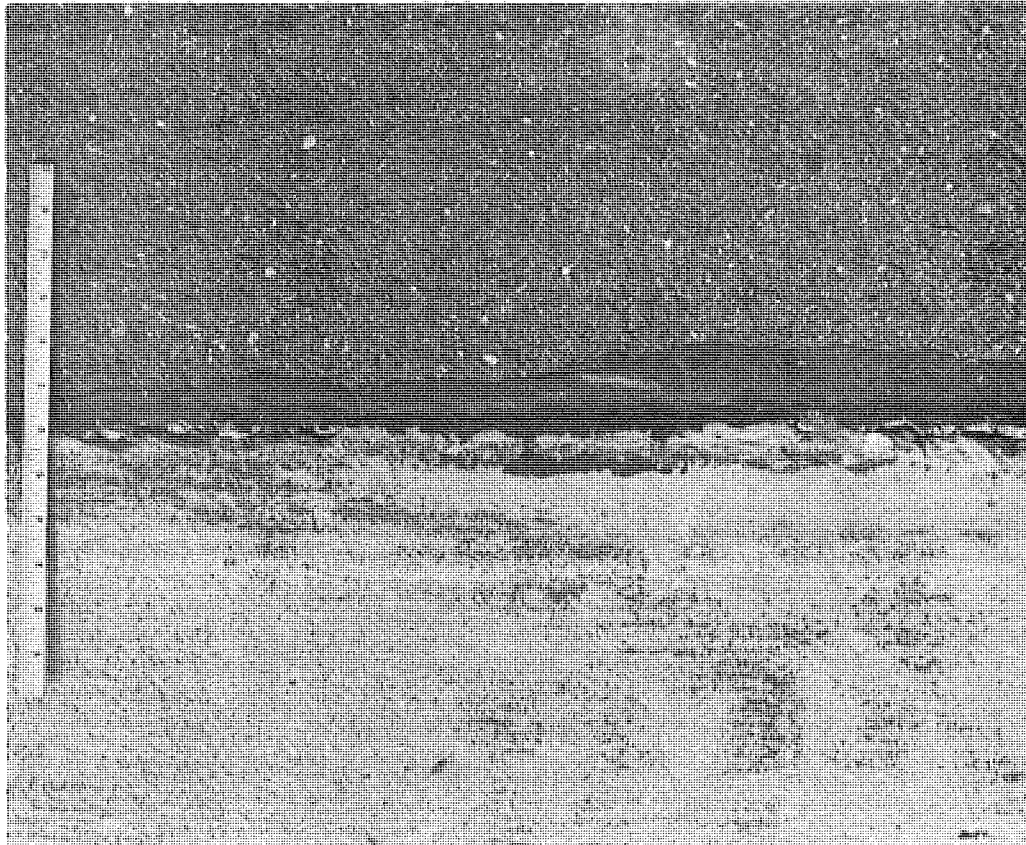
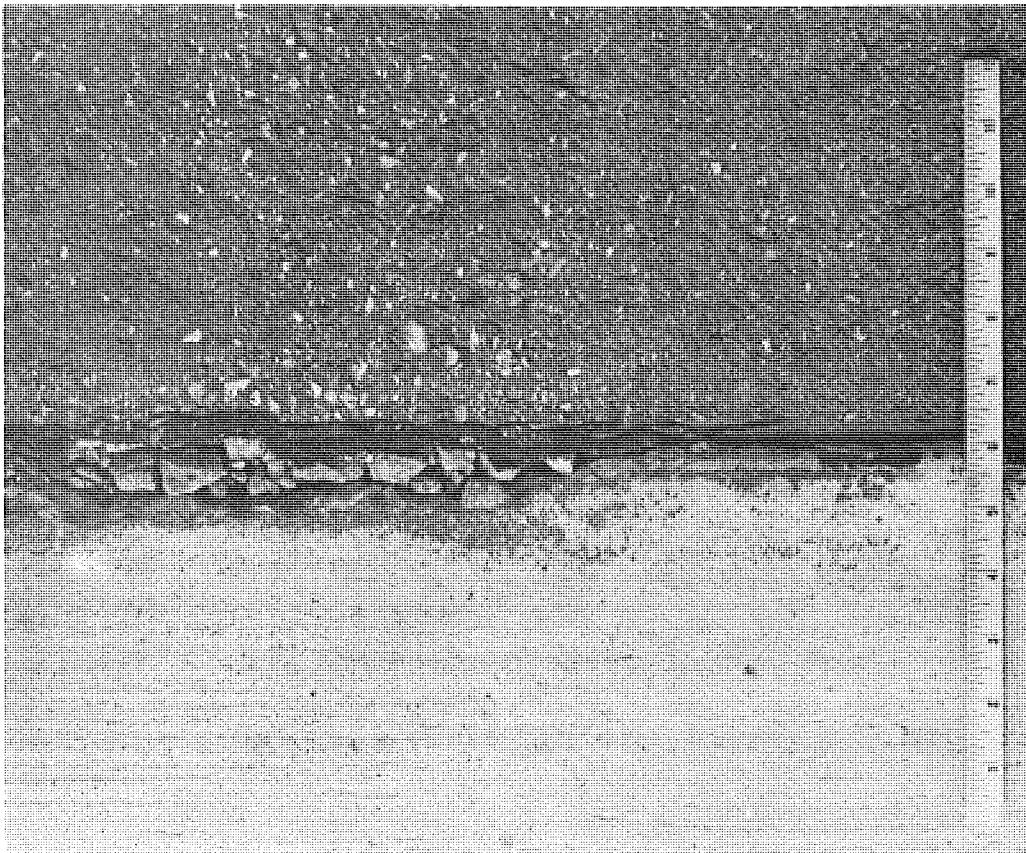
Station 493+04
Project 5 - SB Roadway
Age - 1 year 8 months

Station 554+47
Project 5 - SB Roadway
Age - 1 year 8 months

Figure 12. Typical joint spalling (Project 5, June 1968).
