CONSTRUCTION AND IMPACT TESTING OF
A SHORT SECTION OF EXPERIMENTAL CONCRETE
GLARE SCREEN

MICHIGAN DEPARTMENT OF STATE HIGHWAYS

Research Laboratory Section
Testing and Research Division
Research Project 73 F-135
Research Report No. R-879

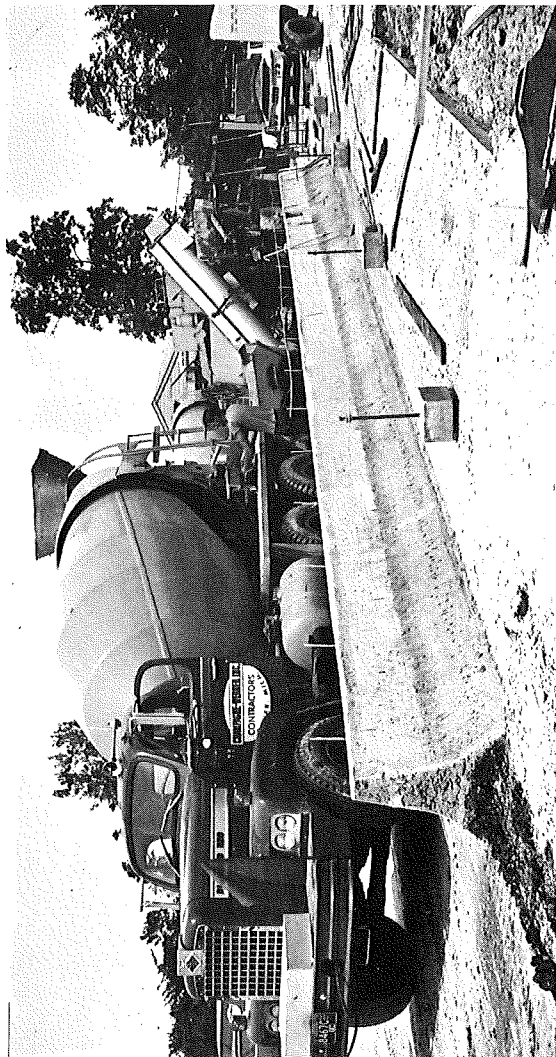
Figure 2. Median barrier ready for placement of concrete glare screen. Note that longitudinal reinforcement has been left out of the section in the foreground.

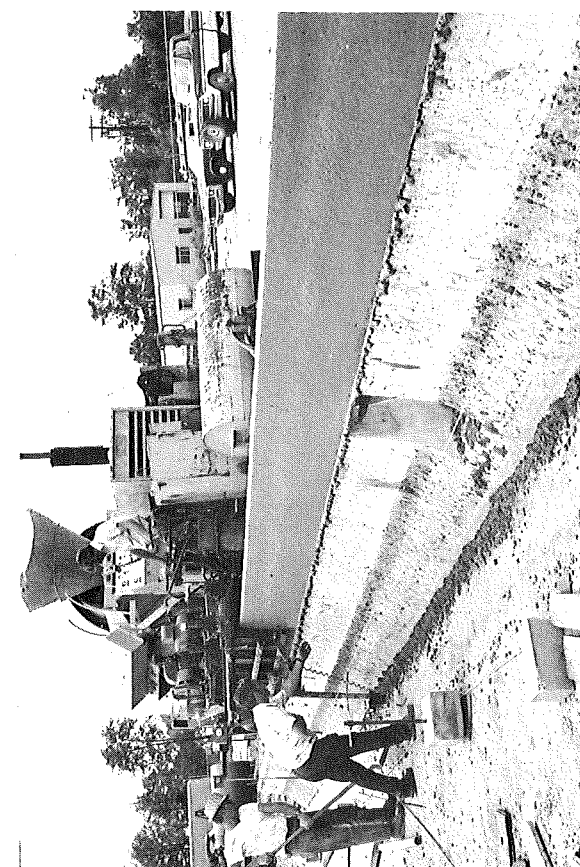
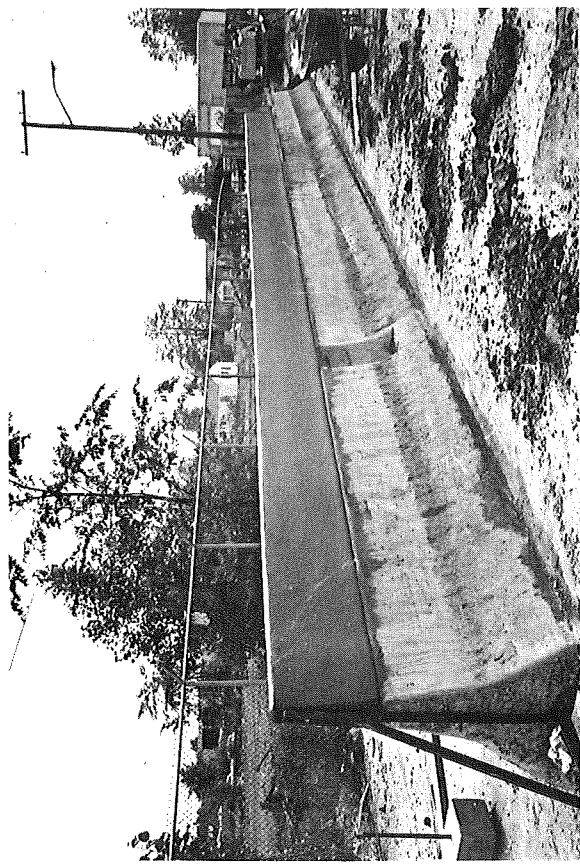
It was found during construction that the second No. 3 longitudinal rebar proposed for addition near the top of the barrier (Fig. 1) could not be placed effectively. The bar tended to travel with the machine, causing tearing of the top portion of the screen. Also, due to the small cross-sectional area near the top, it was very difficult to maintain correct alignment of the bar. Therefore, the final section that was placed for testing had only one longitudinal bar, approximately 8 in. above the top of the barrier.

Figure 3. Construction of the glare screen (left) and finished product (right).

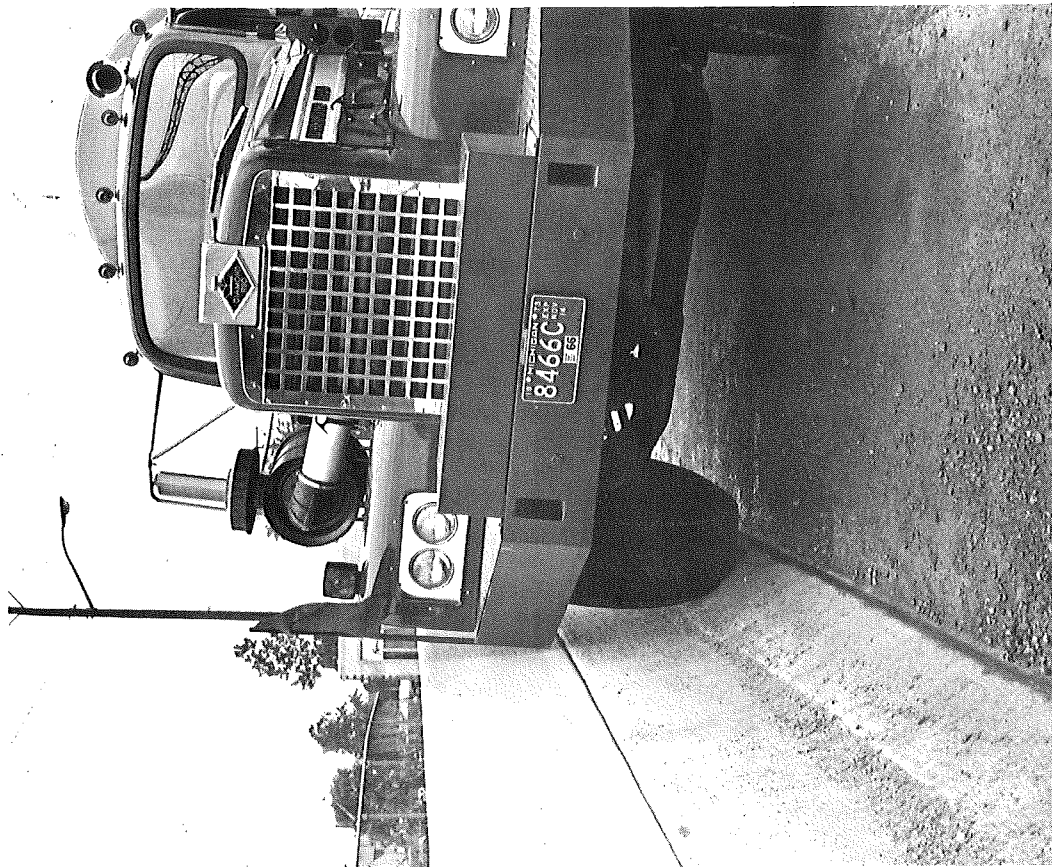
It was generally agreed that most impacts from traffic probably would be on the lower portion of the screen. Figure 4 shows a concrete truck positioned against the barrier to show probable point of contact of the front of such a vehicle. The rack portion of flat-bed trucks could be expected to be slightly higher. It was decided to attempt to hit the screen near the top, to subject it to the most severe condition. A wrecking ball, estimated to weigh 2,000 lb, was used to break the barrier. It was swung by a crane, and not controllable to hit a precise location. Greater impact was provided by swinging the ball through a greater arc. Figure 5, shows the ball at contact with the screen. Results were as follows:

Figure 4. Concrete truck positioned against barrier to show probable height of contact for such a vehicle.

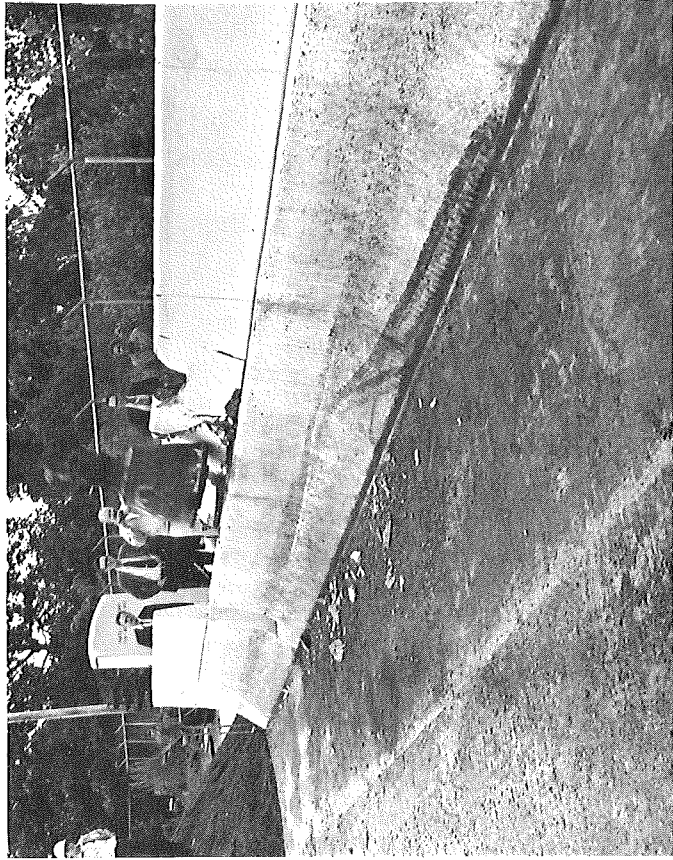
1. First section, with longitudinal reinforcement. Swing approximately 10 ft, hit 6 in. from bottom of screen, no damage. Swing of about 15 ft, developed a crack. After about six 15-ft swings, a large piece was broken from the end. The screen stayed together, and no large loose pieces flew more than 3 or 4 ft. A hit near the top with about a 25-ft swing knocked 6 to 8-in. pieces about 10 ft, while the same impact down lower caused only a crack.

Figure 5. Wrecking ball estimated to weigh about 2,000 lb, used to break glare screen.

2. Second section, with only vertical tiebars. A hit approximately half way down the screen, with a 20-ft swing caused only cracking. The third swing broke the screen off the wall, in pieces approximately 2 ft long.

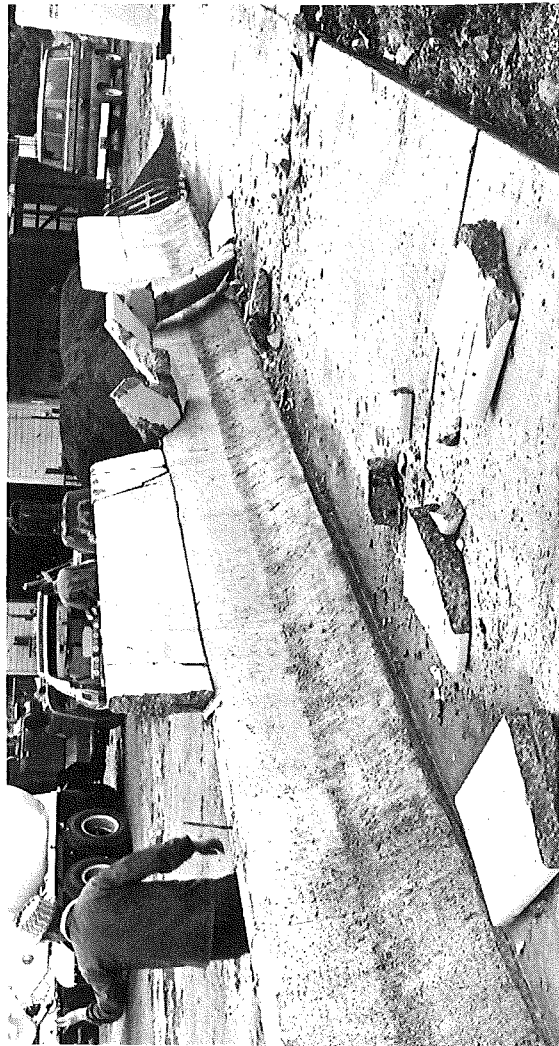
Figure 6 shows the pieces of the two types of screen, and indicates the effectiveness of the rebar in holding larger fragments of concrete together.

Figure 6. Fragments of screen after repeated impacts. Pieces in foreground had only vertical tiebars, while those in rear were held together by the longitudinal reinforcement.

Representatives of the Department and FHWA observed the demonstration. They agreed that the concrete glare screen appeared to be a reasonable alternate to presently specified screen, and that one longitudinal rebar should be included in any future construction. Based on this limited evaluation of the feasibility of the construction method, and the behaviour of the concrete under impact, it was agreed that the second phase of the experiment should proceed.

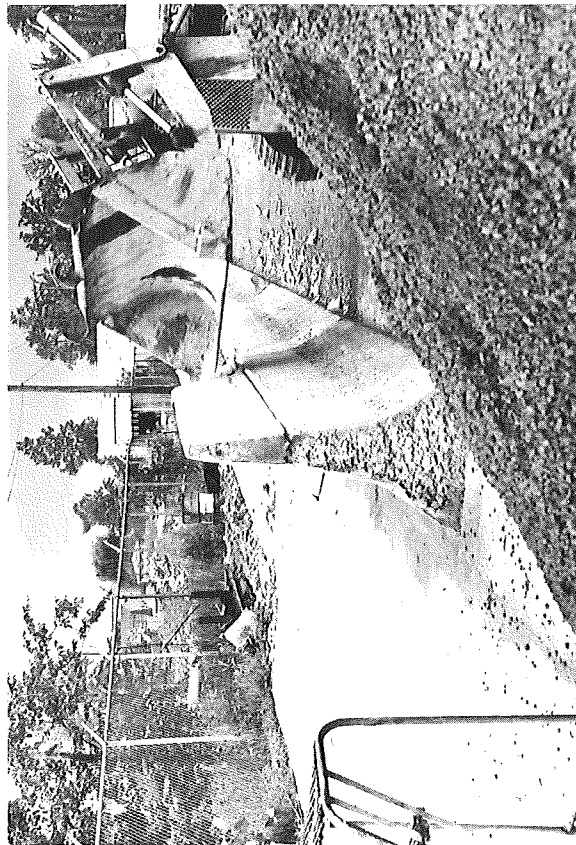
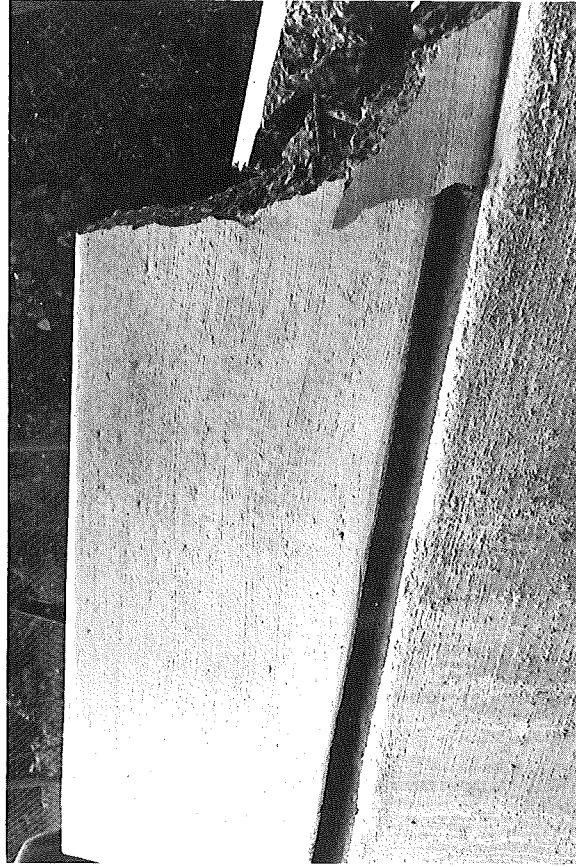
3. A small remaining section of reinforced screen was rammed by an end loader, as shown in Figure 7, and fractured in a manner similar to the other longitudinally reinforced portion.

Figure 7. Results of end-loader impact on longitudinally reinforced screen.
