ACTION PLAN FOR CANTILEVER SIGN PROBLEM

Report To Management

Michigan Department of Transportation

April 1990

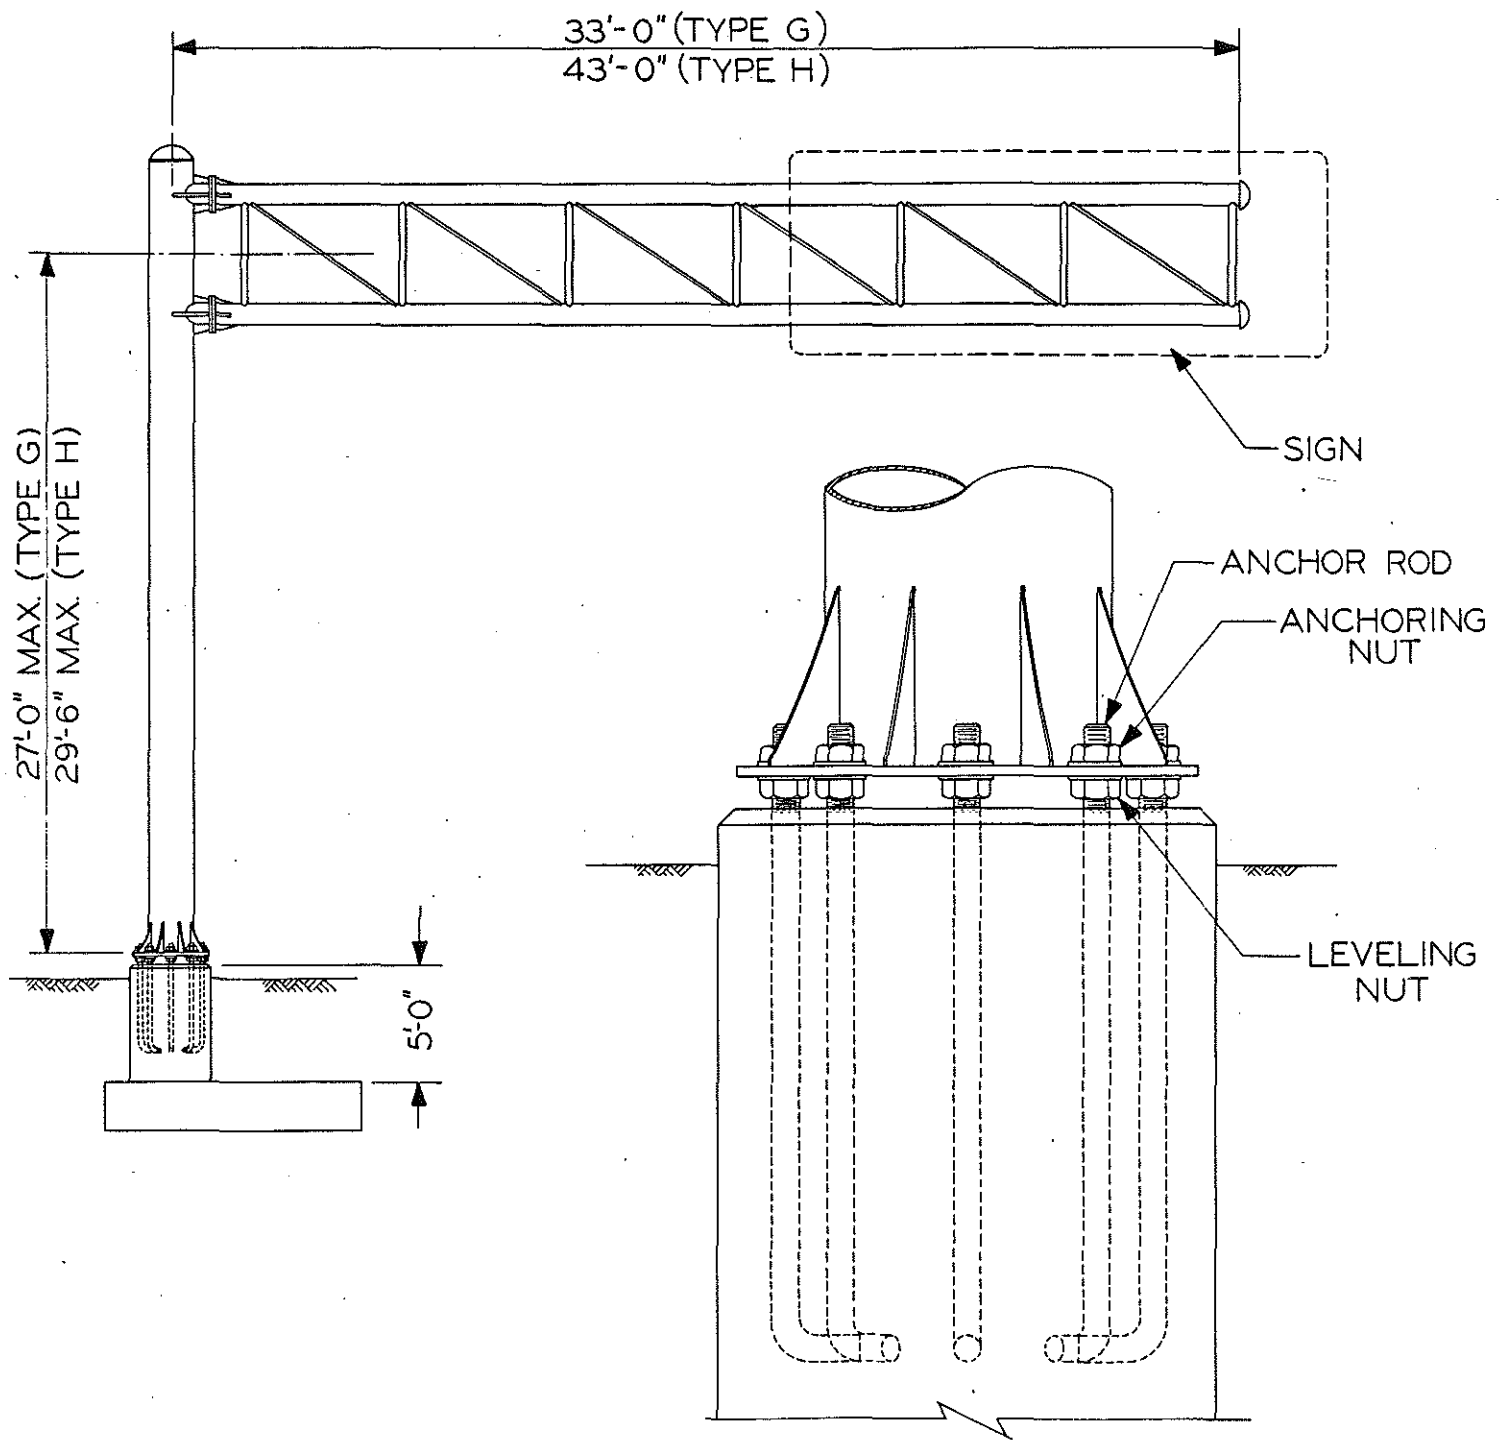
Figure 1. Cantiliver type G & H.

In January 1978 the Research Laboratory Section of the Testing and Research Division (now the Materials and Technology Division) initiated a Research Project 77F-153, "Static and Dynamic Properties of Anchor Bolts for Sign Supports." This study was to investigate the occurrence of fatigue cracking and fracture of the large diameter anchor rods that were used to position and hold the bases of cantilever sign structures (Fig. 1).
