ALLEGED DAMAGE TO THE RESIDENCE OF S. D. FRALICK  
DUE TO TRAFFIC INDUCED VIBRATIONS

MICHIGAN DEPARTMENT OF STATE HIGHWAYS

Research Laboratory Section  
Testing and Research Division  
Research Project 70 F-120  
Research Report No. R-773

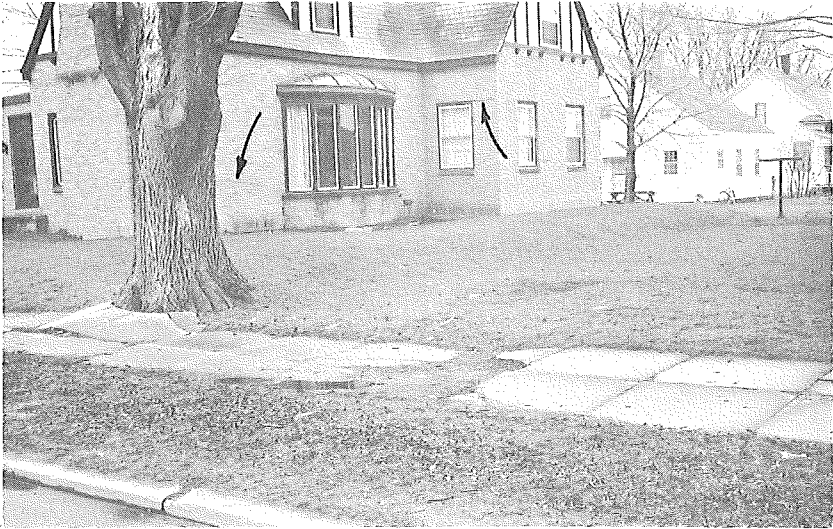
The Fralick house has been severely damaged by differential settlement. In general, the north corner of the house, including the fireplace, has settled and rotated away from the remainder of the building. Figure 1 gives an indication of the condition of the exterior of the house. Interior walls show similar cracking. The basement floor is cracked and faulted (Fig. 2). The soil problem is illustrated to some extent by the condition of the sidewalk immediately north of the house (Fig. 3).

General view showing some major fractures

Fracture of brick veneer, north corner.

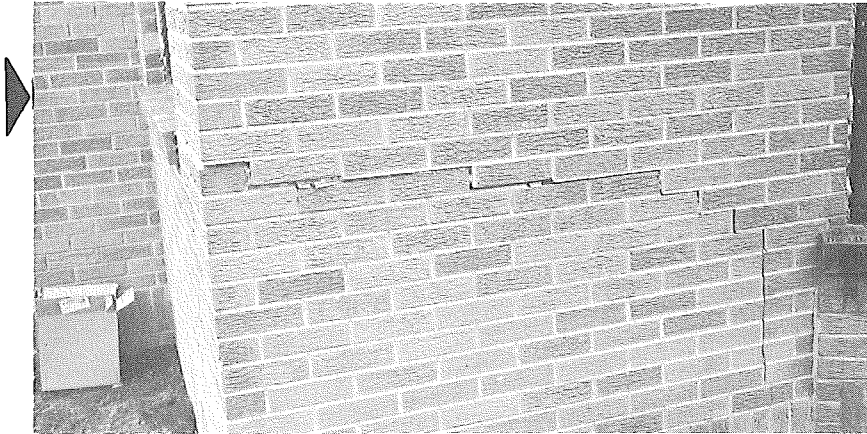
Failure of brick veneer, northwest side.

Figure 1 shows that the surface of the ground along the northwest side of the house has subsided. It also shows that the house has no eaves trough, so that water from the roof would be dropped into the depression adjacent to the house. Although the backfill reportedly was granular, and the footings drained, it would seem that excess water in soil of the type at the site could be a constant source of trouble. Figures 1 and 3 show the area of sidewalk

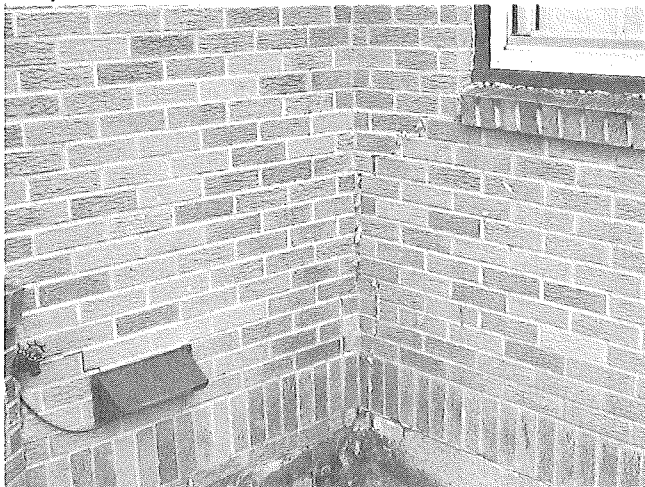
Failure of front wall and porch.

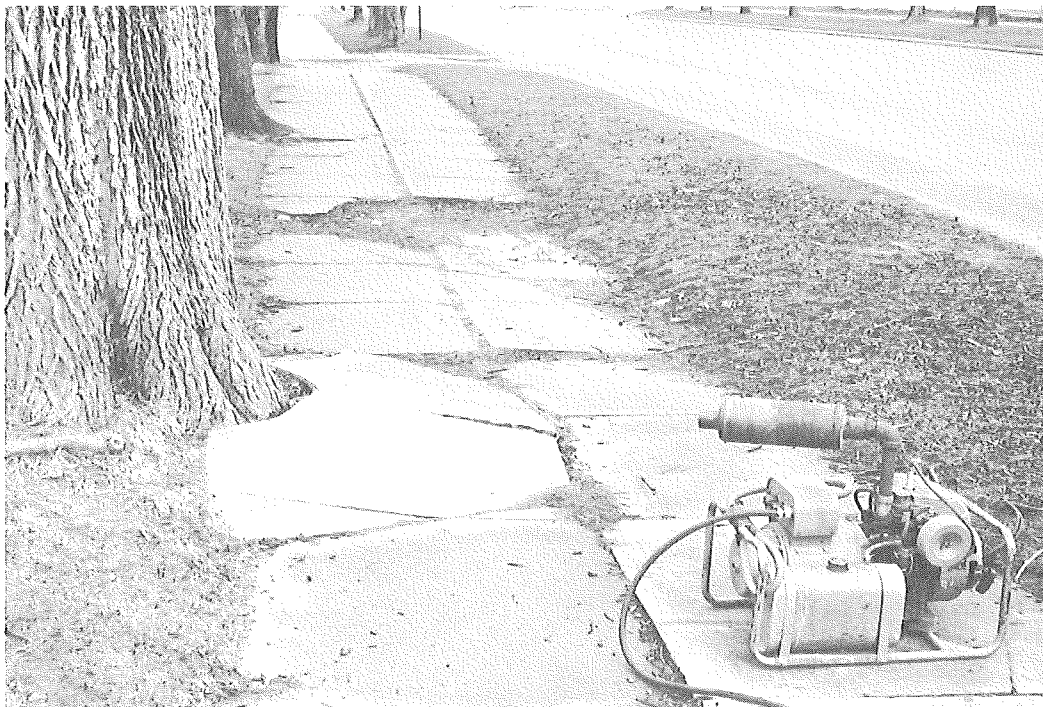
Figure 3. Sidewalk settlement immediately north of house.

that has subsided, immediately north of the house. For these reasons, a request was made to the Laboratory's Soils Unit for a limited sampling of the soil around the house, and also near the school across the street.

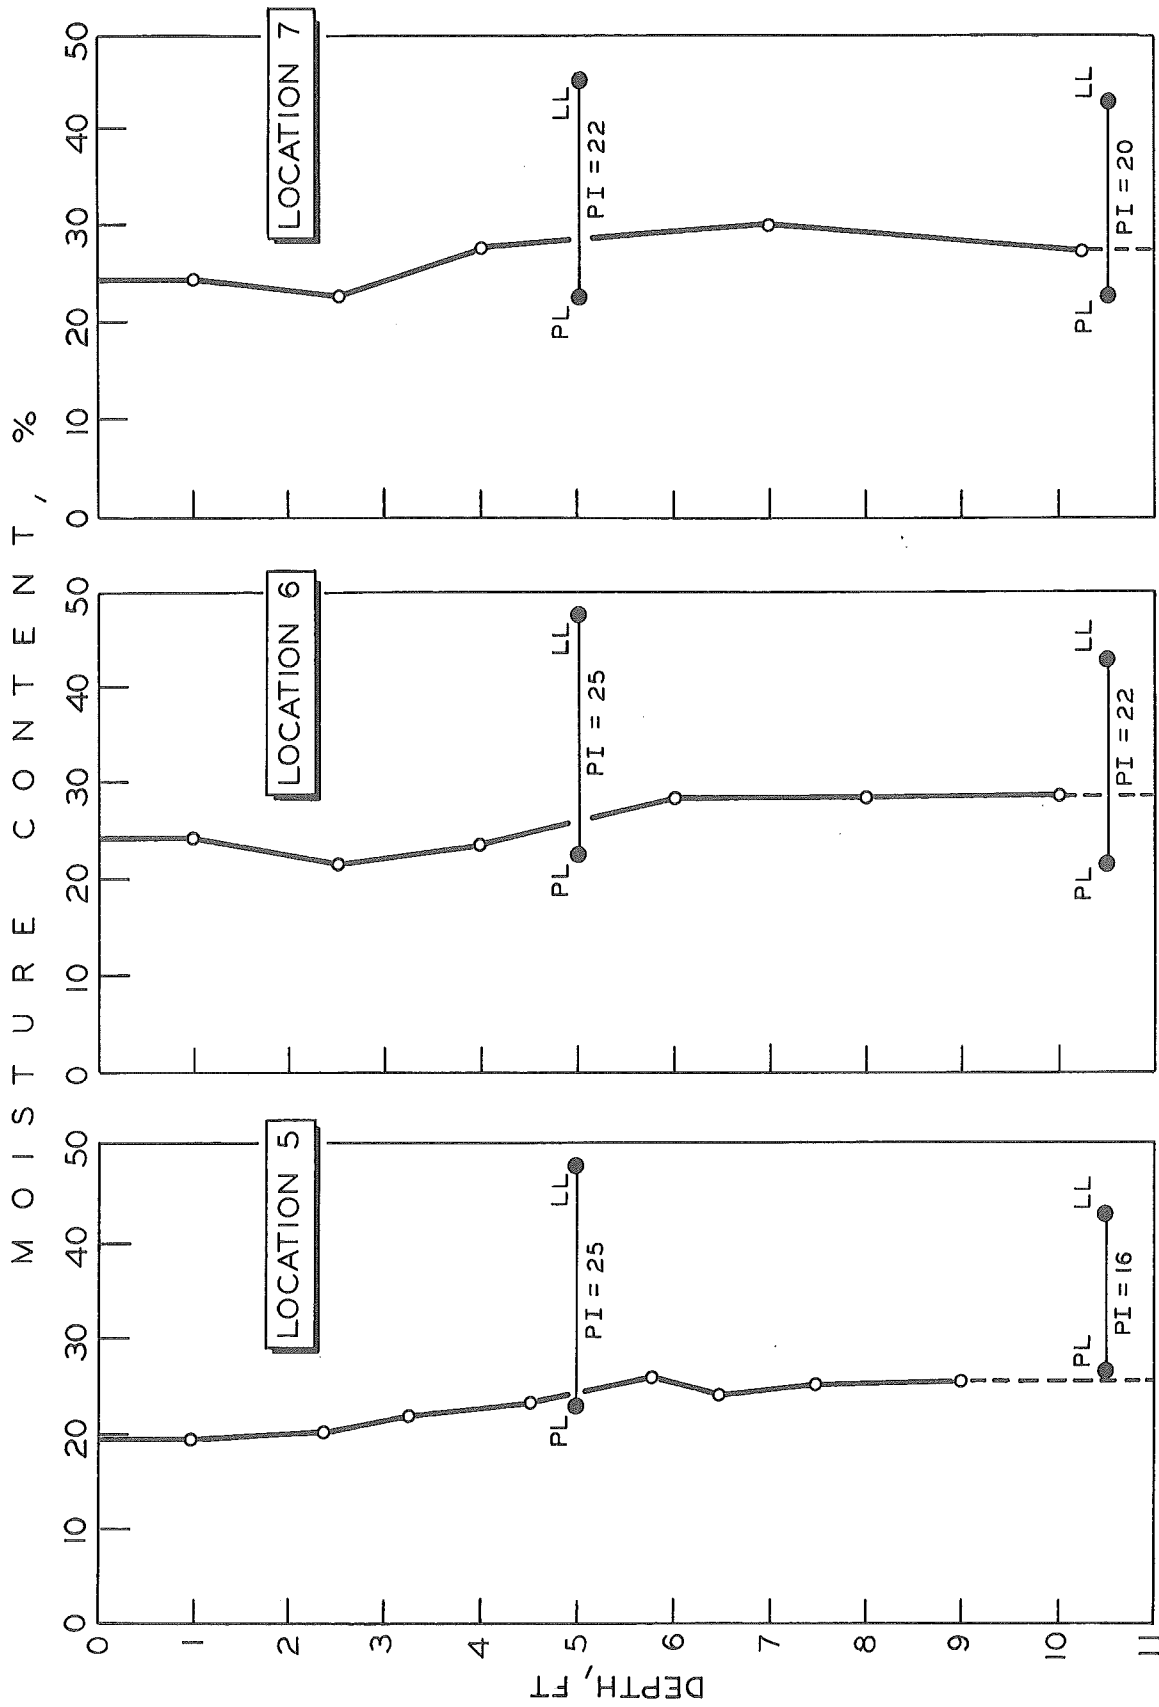
Atterberg Limits—liquid limit (LL), plastic limit (PL) and plasticity index (PI)—were measured for samples obtained at depths of 5 ft and 10 ft from borings ④ , ⑤ , and ⑥ . These values, along with a moisture content profile, are shown in Figure 8. The reported values of Atterberg limits would classify the soil as an inorganic plastic clay. The water content in the borings ranged between 20 and 30 percent.

Figure 8. Liquid limit, plastic limit, plasticity index, and moisture profile for borings taken on Fralick property.
