REPAIR OF PLASTIC SHRINKAGE CRACKS IN THE DECK  
OF THE NINE MILE ROAD BRIDGE OVER I 75

Research Laboratory Section  
Testing and Research Division  
Research Project 59 F-53(3)  
Research Report No. R-667

State of Michigan  
Department of State Highways  
Lansing, March 1968

**Subject:** Repair of Plastic Shrinkage Cracks in the Deck of the Nine Mile Road Bridge over I 75 (S27 of 63174). Research Project 59 F-53(3). Research Report No. R-667.

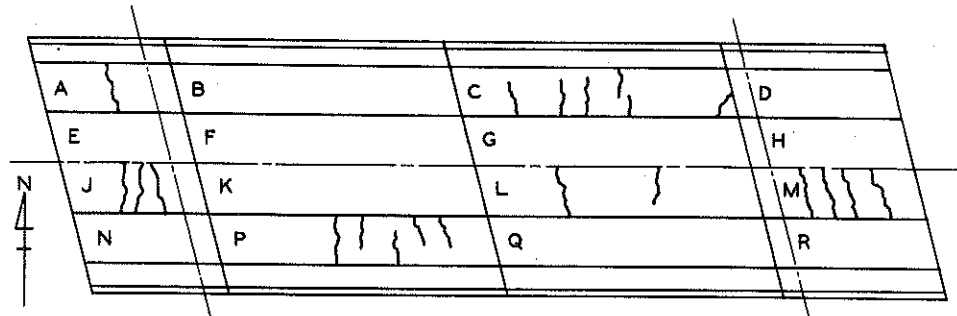
Detailed information was obtained concerning the fresh concrete and weather conditions that existed at the time of the pour. From that information it was discovered that when cracks formed for three of the six pours, the temperature differential between concrete and air was greater than 40 F, which would have caused extensive evaporation of mix water from the surface of the concrete. This excessive evaporation from the surface would be one of the main factors contributing to the crack formation. The type of membrane curing compound used would have been immaterial since the cracks would have started forming prior to the application of the membrane. Both the white and the clear Euco curing sealant met standard water retention tests. From the information available, there were no other obvious factors contributing to the formation of the cracks.

The cracks developed in pours A, C, L, and P, which were sealed with white Euco curing compound the day they were poured, and in pours J and M, sealed with white Euco the day after pouring. It was also noted that some of the cracks traversed partially, and others fully, across the width of the pour. Most of them were full depth and none of them crossed into adjacent pours (Fig. 1).

Figure 1. Plastic Shrinkage Cracks in Bridge Deck of Nine Mile Road Over I 75 S27 of 63174A.

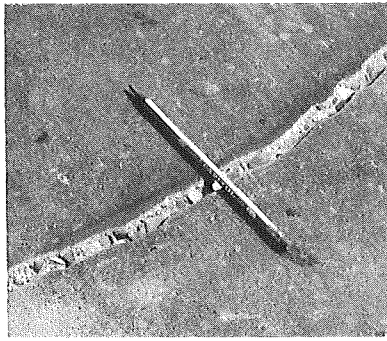
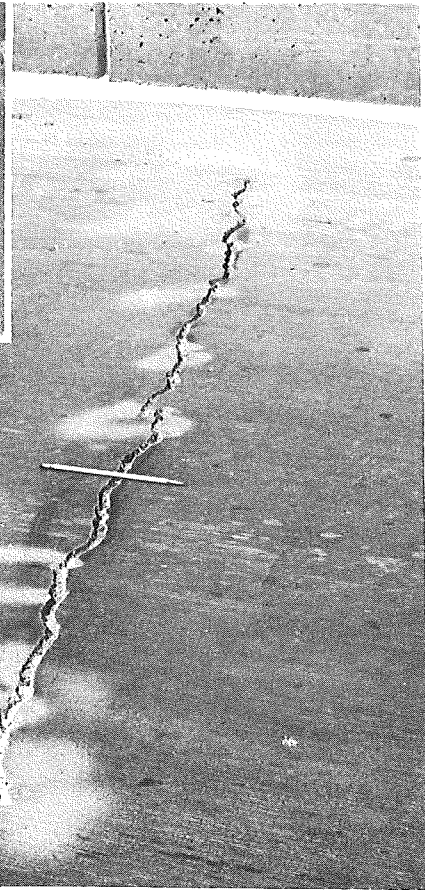
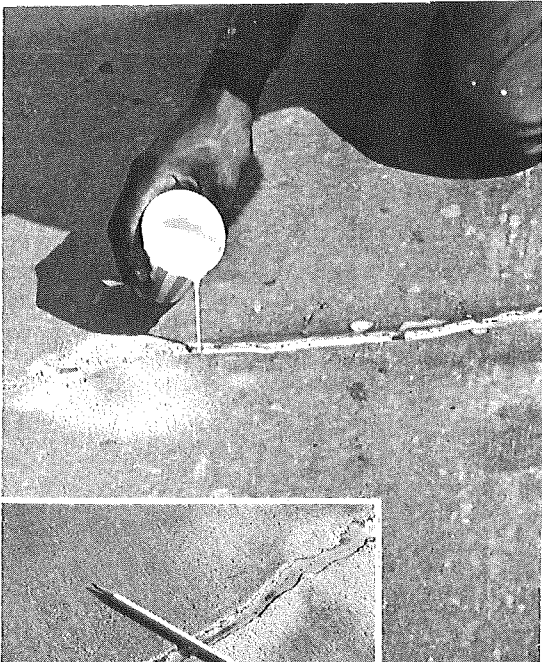
Close-up and overall view of a typical routed-out crack prior to filling.

All the deck cracks were marked with a line of paint such that they could be easily followed by the sand-blast operator. A groove was cut approximately 1/2-in. wide and 1/4-in. deep. The grooves were filled to half-depth with a low viscosity solvent-free epoxy called Colma-Dur LV, manufactured by the Sike Chemical Corp.

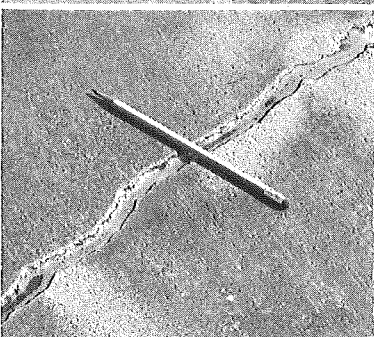
Unfilled epoxy is poured to half-depth of groove.

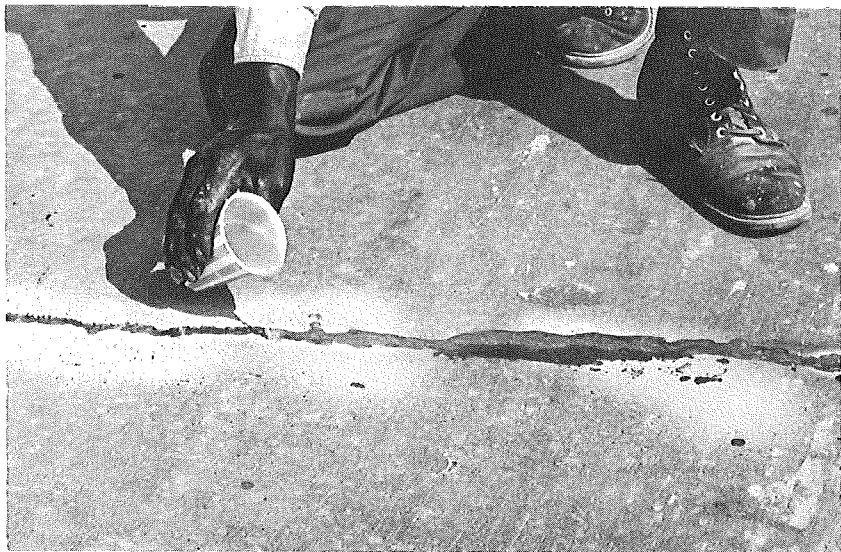
Filled epoxy is poured to deck level.

After this epoxy had set, the groove was filled to full-depth with the same epoxy in which a silica-flour filler had been added. The filler epoxy was added to the top in order to blend more harmoniously with the surrounding concrete. It was mentioned by the Laboratory personnel present that the filled epoxy should probably be added before the unfilled epoxy had set, since some epoxies will not bond to themselves. Laboratory tests later, however, proved that Colma-Dur LV bonds well to itself, so in future work with this material this precaution is not necessary. Figure 2 shows the routed groove and the procedure for sealing the surface groove above the crack.

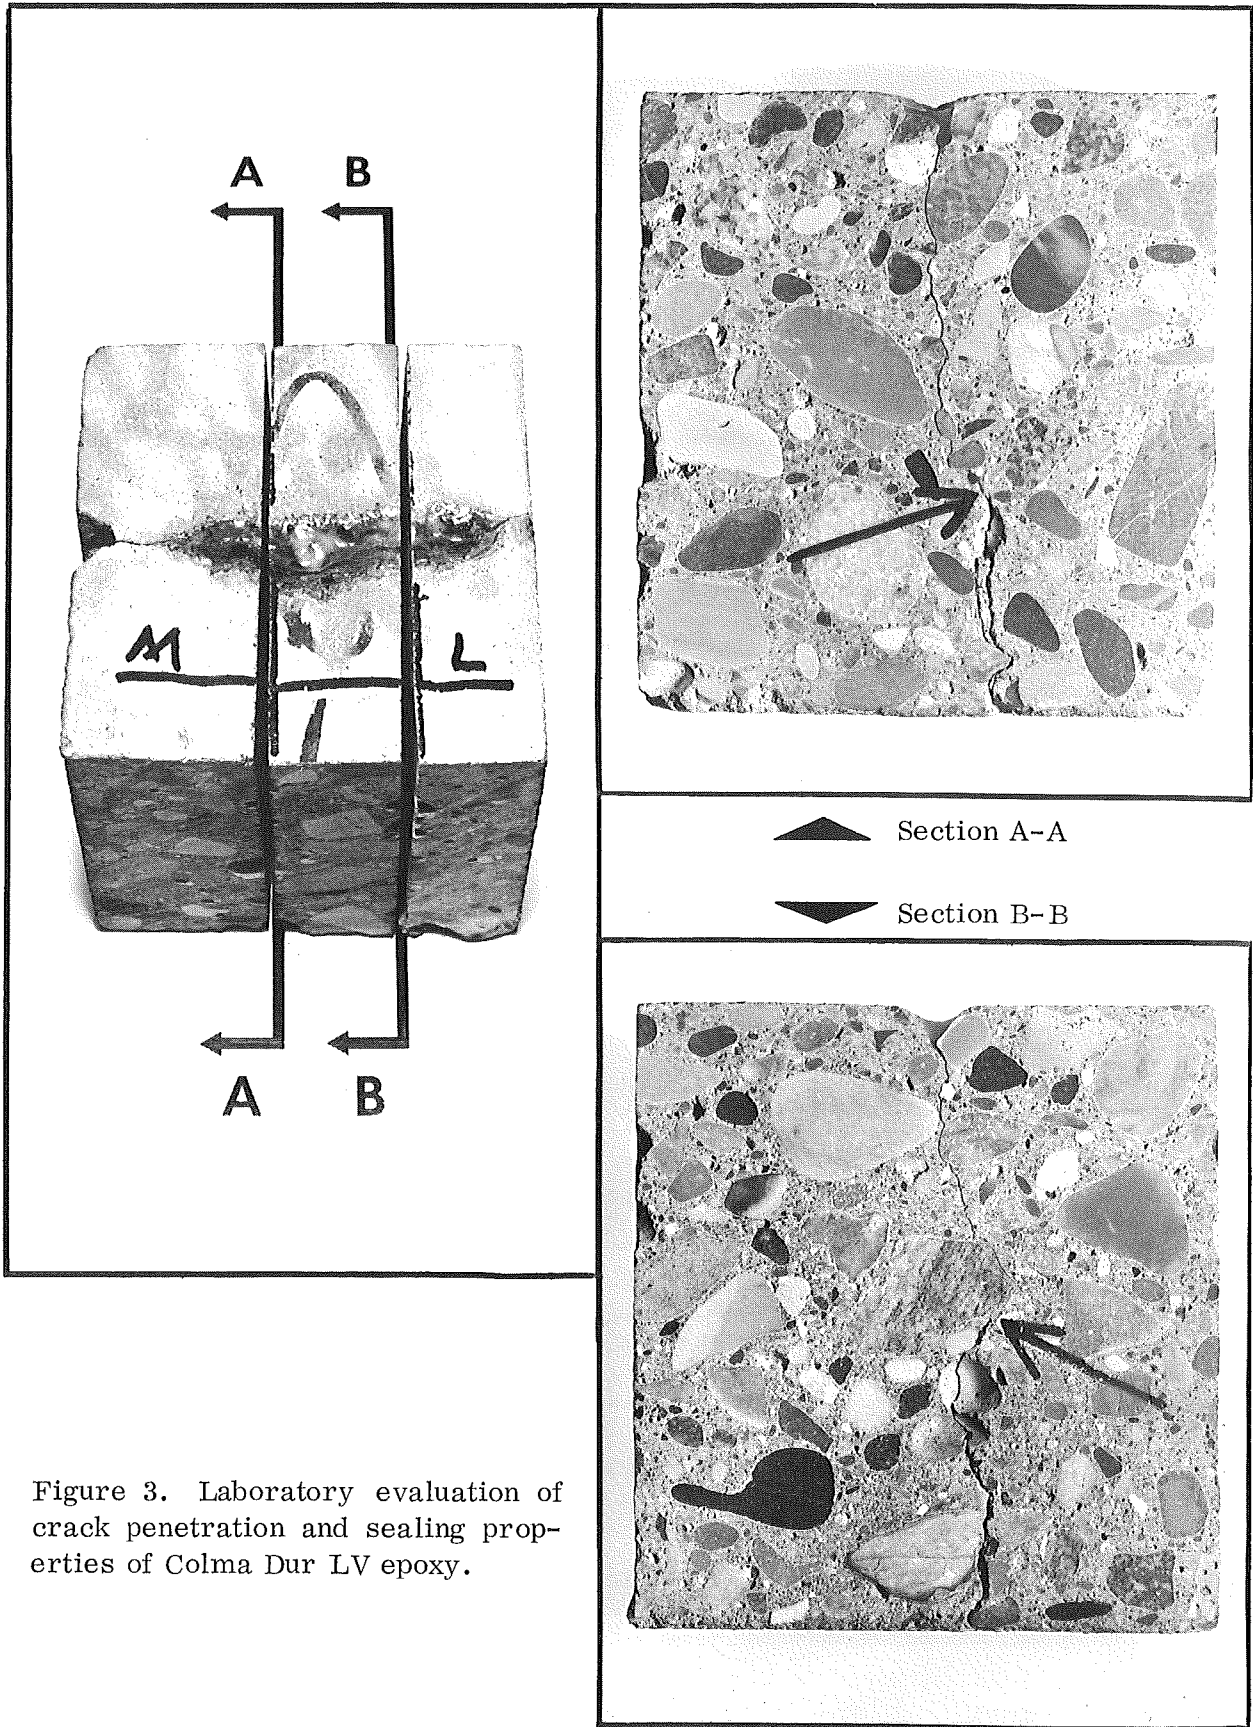
To evaluate the depth to which this epoxy will penetrate a fine crack, a broken section was cut from a tested flexure beam; then the broken portions were held together securely while a groove was sandblasted along the crack; finally, the Colma-Dur LV was poured into the routed-out crack. At room temperature (77 F) it had a viscosity similar to that of honey and appeared to penetrate the crack slowly; requiring about 15 minutes for the level, which was poured flush with the top of the concrete, to drop noticeably. It set in about 30 minutes. The following day, sections were cut through the crack and polished such that the depth of epoxy penetration could be visually determined. The portion of the flexure beam used, along with the cut sections, are shown in Figure 3. The figure shows that in Section A-A the epoxy penetrated a crack of an average width of 0.010 to a depth of 2.7 in. In section B-B, a crack of an average width of 0.008 in. was penetrated to a depth of 2.0 in. The arrows show the maximum penetration point.

Figure 3. Laboratory evaluation of crack penetration and sealing properties of Colma Dur LV epoxy.
