MICHIGAN
STATE HIGHWAY DEPARTMENT

Subject: Survey of Substructures on Edsel Ford Freeway. Research Project
63 B-69(4). Research Report No. R-510.

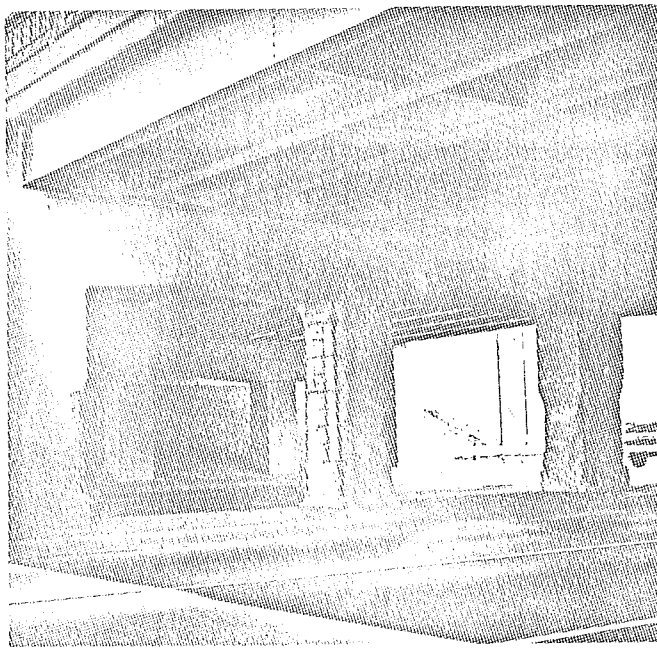
Martin (S06 of 82023)

Figure 1. Typical conditions of bridge piers encountered in survey; cracking at pier corners shown upper left and right, and spalling of pier surfaces lower left and right.

S06 of 82023 "is a four-span structure. Disintegration has occurred at all three piers, but is most serious at the center pier. There are five columns in each pier. Numbering is from the west:

Column No.	Location	Area of Disintegration
<u>South Pier</u> (cont.)	2	Northwest corner	Cracked from 0' to 10' above grade
		Southwest corner	1' to 2'
		Southwest corner	8' to 9'
	3	Northwest corner	Cracked & spalled 0' to 5'
		Southwest corner	Cracked & spalled 0' to 3'
5	Northwest corner	Cracked from 0' to 4'	
<u>Center Pier</u>	1	Southeast corner	Spalled from 1' to 5' above grade
		Northeast corner	1' to 6'
	2	West side	0' to 10'
		Southeast corner	0' to 5'
		Northeast corner	0' to 7'
	3	Southwest corner	0' to 5'
		Northwest corner	1' to 5'
		Southeast corner	1' to 6'
		Northeast corner	1' to 7'
	4	Northwest corner	0' to 9'
		Northeast corner	0' to 8'
	5	Southwest corner	0' to 10'
		Northwest corner	0' to 9'
		Northeast corner	Disintegrated from 1' to 3'
	<u>North Pier</u>	1	Northeast corner
2		Southeast corner	1' to 2'
		Northeast corner	1' to 2'
4		Southeast corner	0' to 3'
	Northeast corner	0' to 2'
