EVALUATION OF THERMOPLASTIC PAVEMENT MARKINGS  
APPLIED IN THE LANSING AREA IN 1968 AND 1969

A. J. Permoda  
A. R. Gabel

Research Laboratory Section  
Testing and Research Division  
Research Projects 47 G-36 (21a) and (22a)  
Research Report No. R-813

Michigan State Highway Commission  
Charles H. Hewitt, Chairman; Louis A. Fisher, Vice-Chairman  
Claude J. Tobin; E. V. Erickson; Henrik E. Stafseth, Director  
Lansing, April 1972

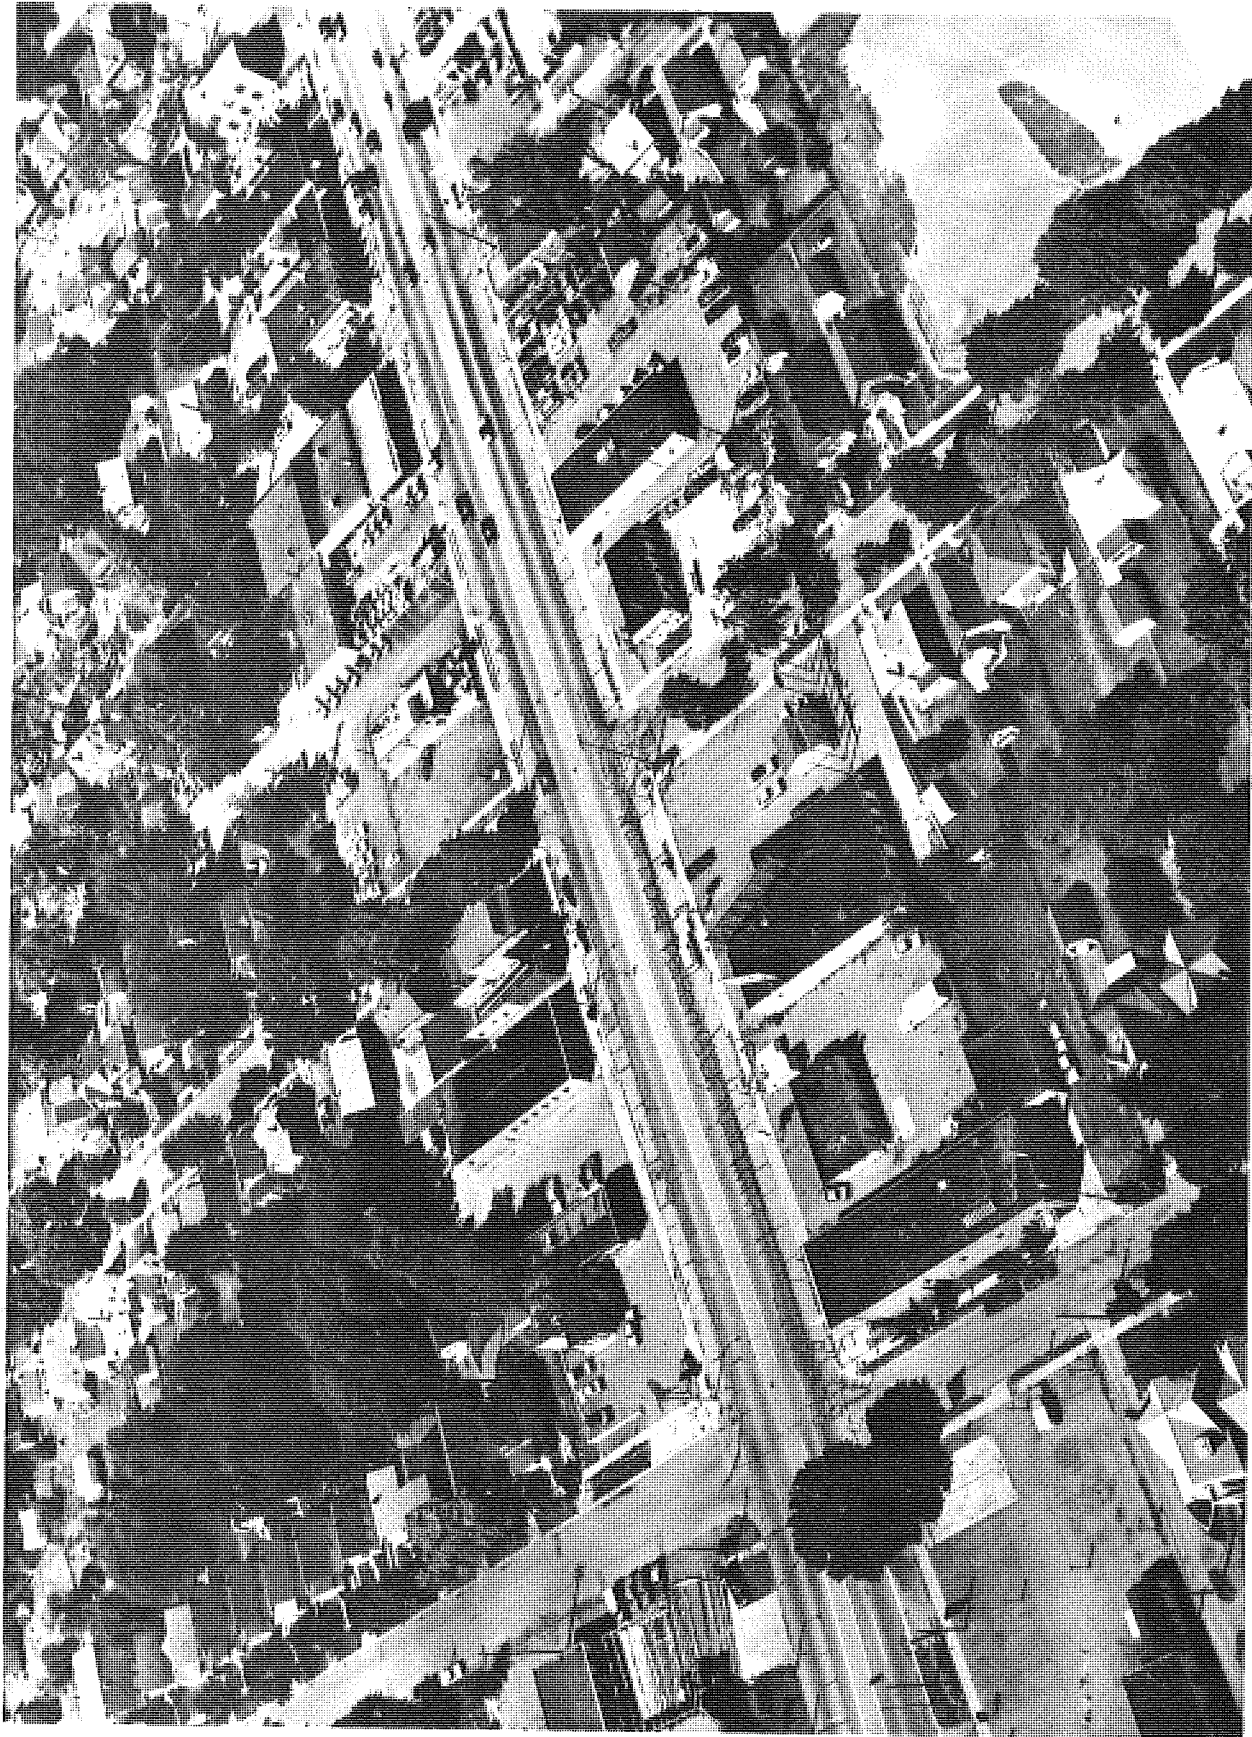
Figure 4. Aerial view of W end of test section on Michigan Ave (areas (d) and (e)). Extensive crack sealing, especially on lower (WB) roadway, shortens effective service life of markings (8-12-71).

| Map Coding | Lane | Type of Line | Stripe Width | Rating | Rating Date | Remarks |
|---|---|---|---|---|---|--|
| Ⓓ | WB | N. Lane line | 4-in. | 2.1(0-7.0) | 8-24-71 | Average was lowered by extensive joint and crack sealing (Fig. 4). |

7. Sealing of reflection cracking of bituminous resurfacing, can shorten the effective service life of the markings (Fig. 4).

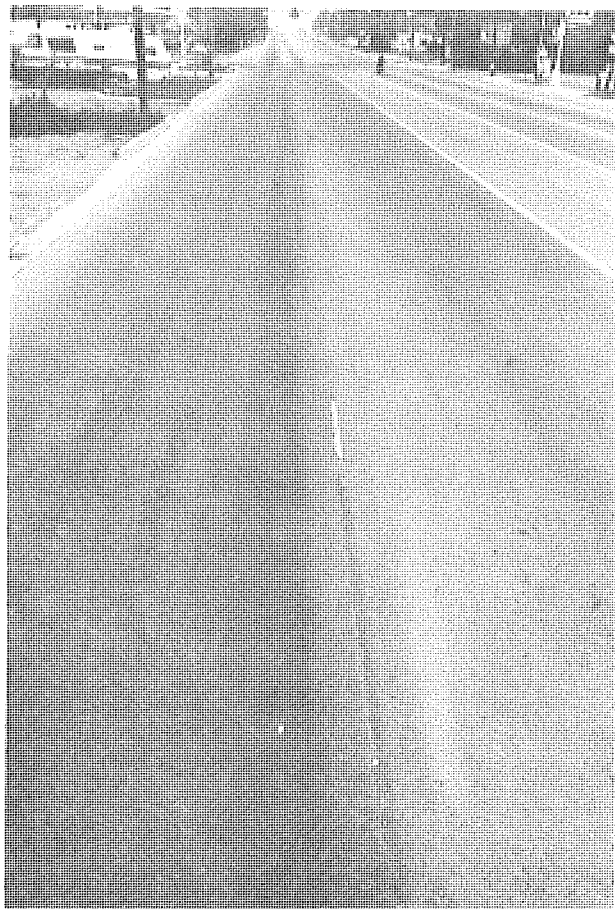
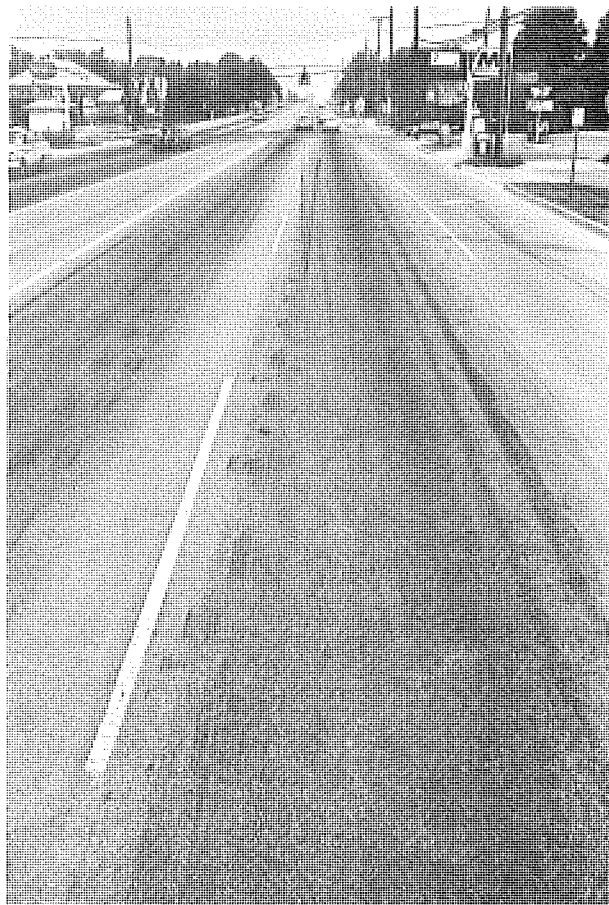
| Map Coding | Lane | Type of Line | Stripe Width | Rating | Rating Date | Remarks |
|---|---|---|---|---|---|--|
| Ⓑ <sup>3</sup> | NB | Solid right-turn | 4-in. | 8.0 | 7-28-71 | See Figure 5. |

Figure 5. Markings ( (b) type) shown looking N on US 27 just S of State Rd after minus three years service. Left-turn lane lines and right-turn lane lines are still good. SB lane segments (left) are ostensibly gone, while NB lane segments are still present and effective: note shrinkage cracking in foreground segment (7-23-71).

5. The 6-in. solid left-turn lane markings have a known service life of four winters (per inspection of March 1972) which can probably be extrapolated to two more. Minor repair or replacement may be required in a few spots before then, see photo in Figure 5.

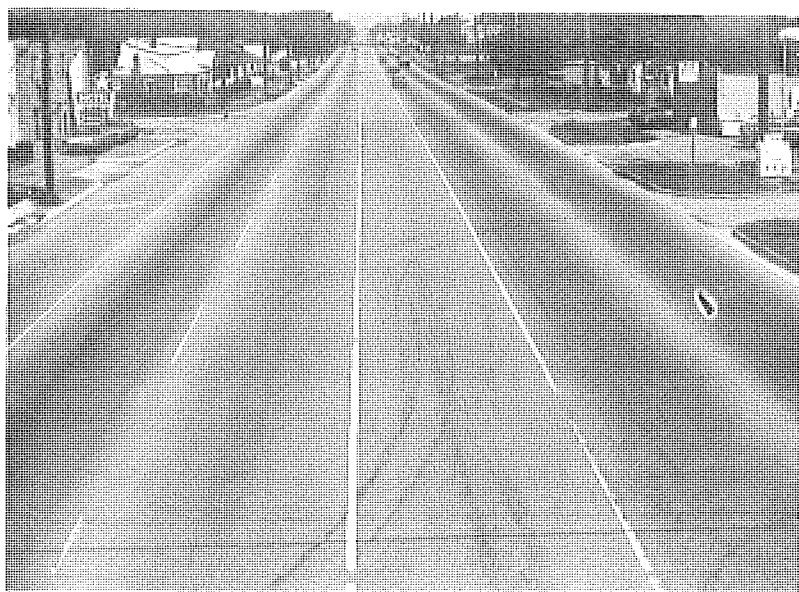
| Map Coding | Lane | Type of Line | Stripe Width | Rating | Rating Date | Remarks |
|---|---|---|---|---|---|--|
| Ⓐ <sup>2</sup> | SB | Solid right-turn | 4-in. | 6.0 | 8-19-71 | See Figure 6. |

Figure 6. Markings ( (a) type) looking N on US 27 off Sheridan St overpass after minus three years service. The solid right- and left-turn lines are generally still good, as are the SB broken lane lines. The NB lane lines are eroded. The right left-turn lane line (foreground) shows some erosion by traffic making left-turns off Sheridan St onto NB US 27 (8-26-71).

4. Loss from snow plow damage was considered as a minor deteriorating factor, as evidenced by the good condition, after three years of service, of the left-turn lane lines. See values in Table 4 and photos of Figures 5 and 6. There is some indication that the solid markings are more resistant to snow plow damage than the broken lane lines, and perhaps that 6-in. lines are more resistant than 4-in. lines.

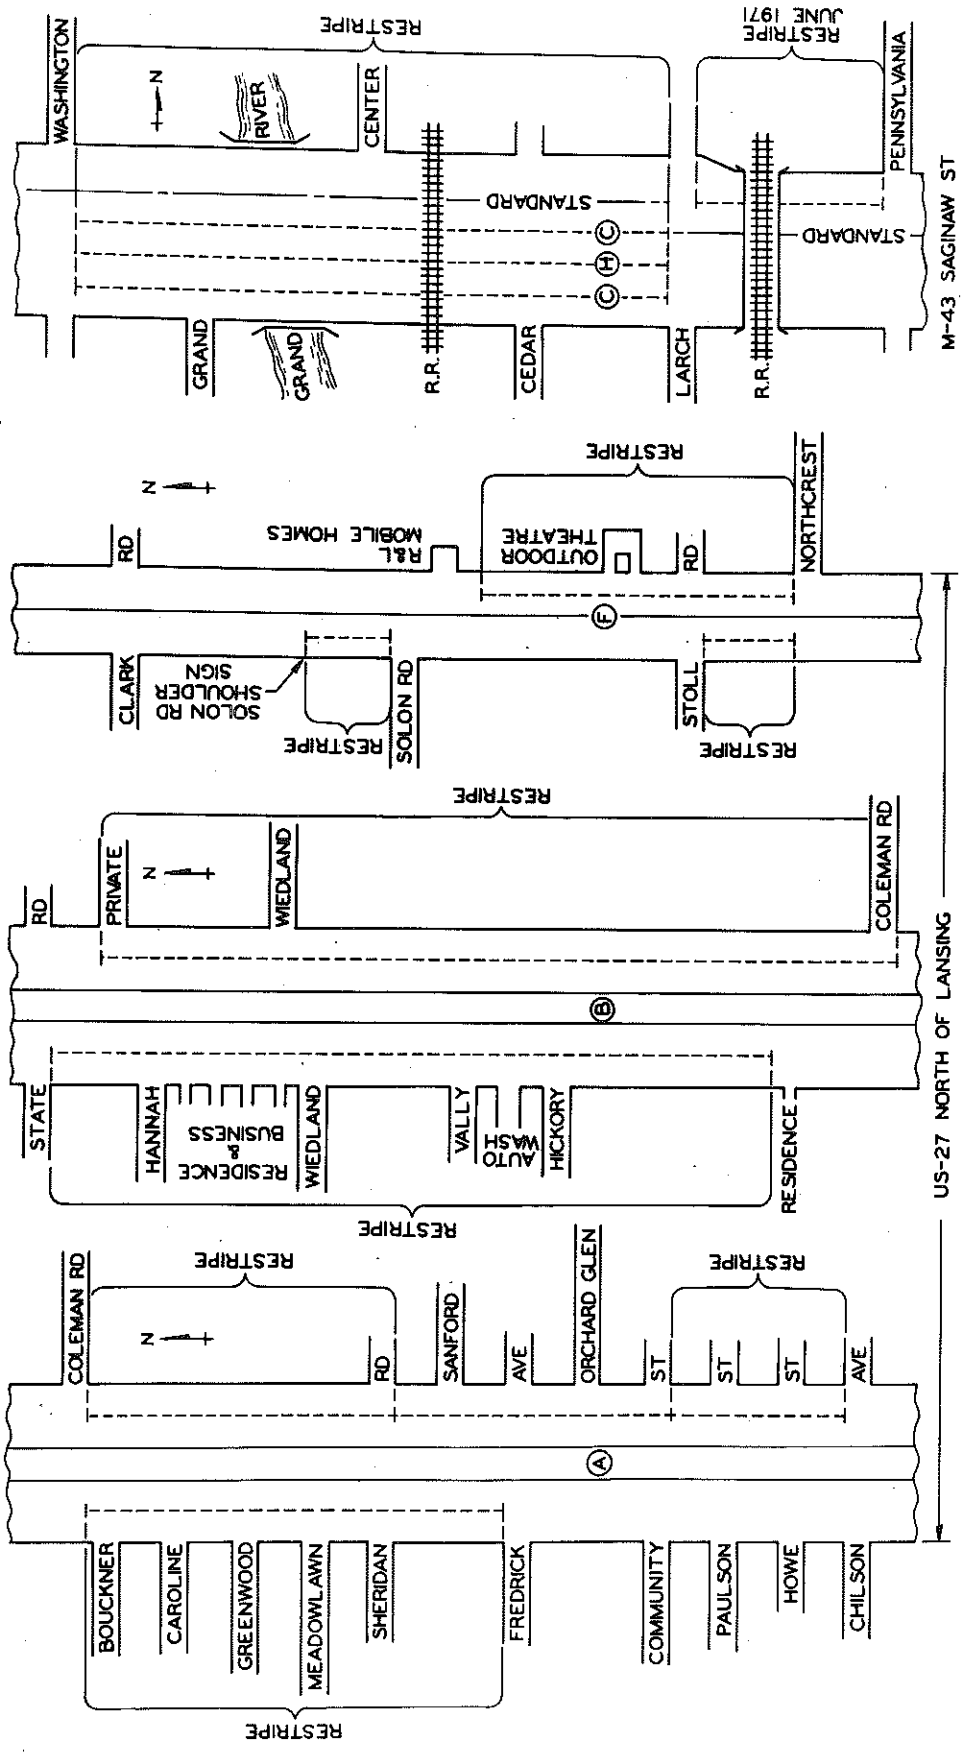
Figure 7. Sketches showing broken lane-lines that were partially restriped with paint in the fall of 1971 because they were eroded. Markings were about three-years old, except for (f) and (h) that were about two-years old.

Subsequent to above ratings, a supplemental inspection was made in early October 1971 which indicated that some areas of broken lane-lines would provide poor delineation over the 1971-72 winter and these should be restriped with paint. These are shown in the "Remarks" column in Table 5 and Figure 8. All of the solid (f) type edge lines and (f) type double yellow centerlines and (g) type gore lines) and broken (g) type lane lines) lines were still providing adequate delineation and were not to be touched-up with paint restriping.

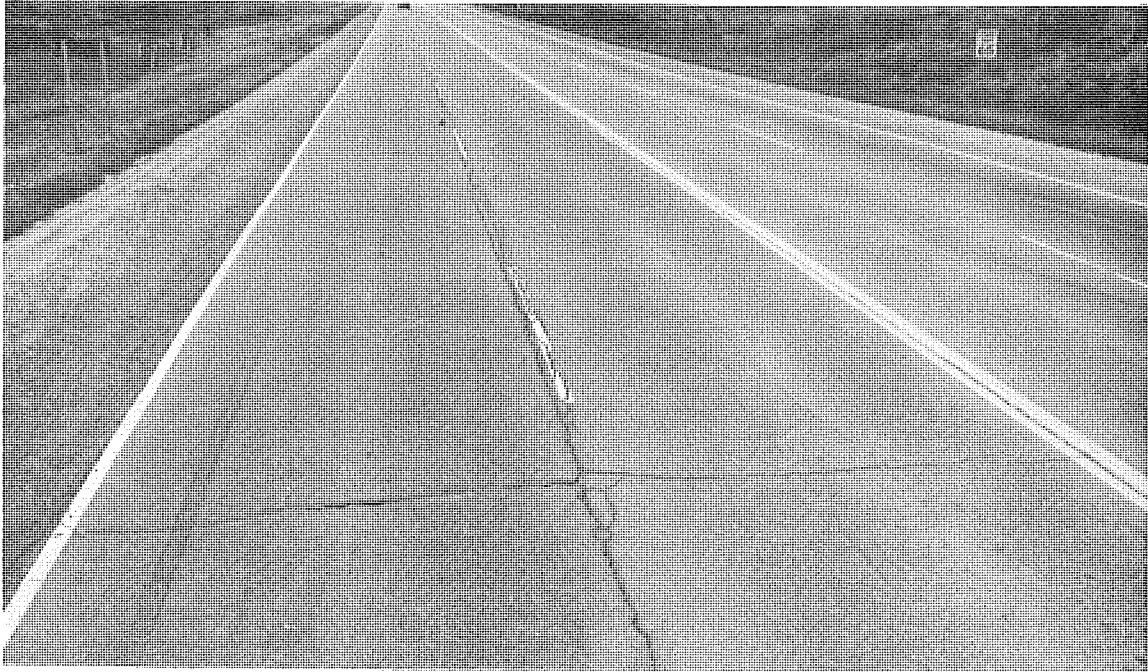
| Map Coding | Lane | Type of Line | Stripe Width | Rating | Rating Date | Remarks | |
|---|---|---|---|---|---|---|--|
| f | NB | Edge line | 4-in. | 6.8(0.5-8.5) | 9-14-71 | Partially restriped with paint in October 1971. Low ratings due in part to reflection cracking (Fig. 8) | |

Figure 8. Markings ( (f) type) looking S on US 27, S of Clark Rd after two years of service. The NB lane lines (left) are affected by reflection cracking of the bituminous surface (9-14-71).

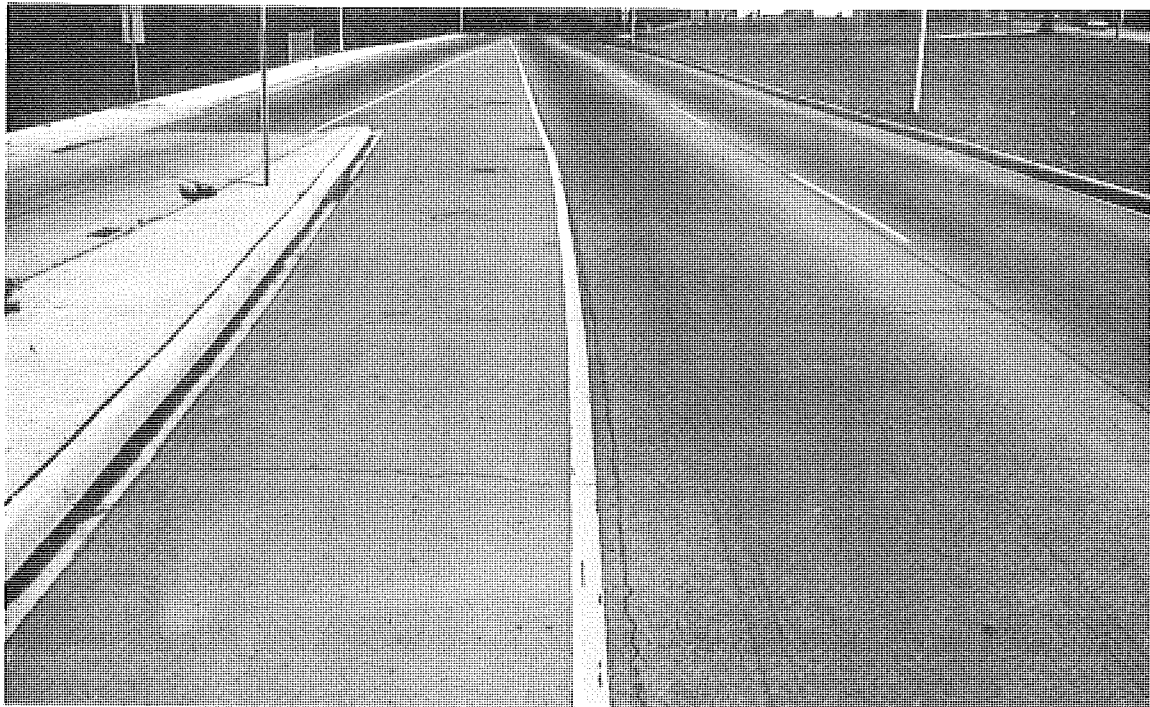
| Map Coding | Lane | Type of Line | Stripe Width | Rating | Rating Date | Remarks | |
|---|---|---|---|---|---|---|--|
| g | SB | Lane line | 4-in. | 5.7(3.5-7.5) | 8-25-71 | | See Figure 9. |

Figure 9. Markings ( (g) type) looking N on Cedar St after two years of service. Durability is still good; which is a plus for the lane lines on the most curved area in the tests (8-26-71).

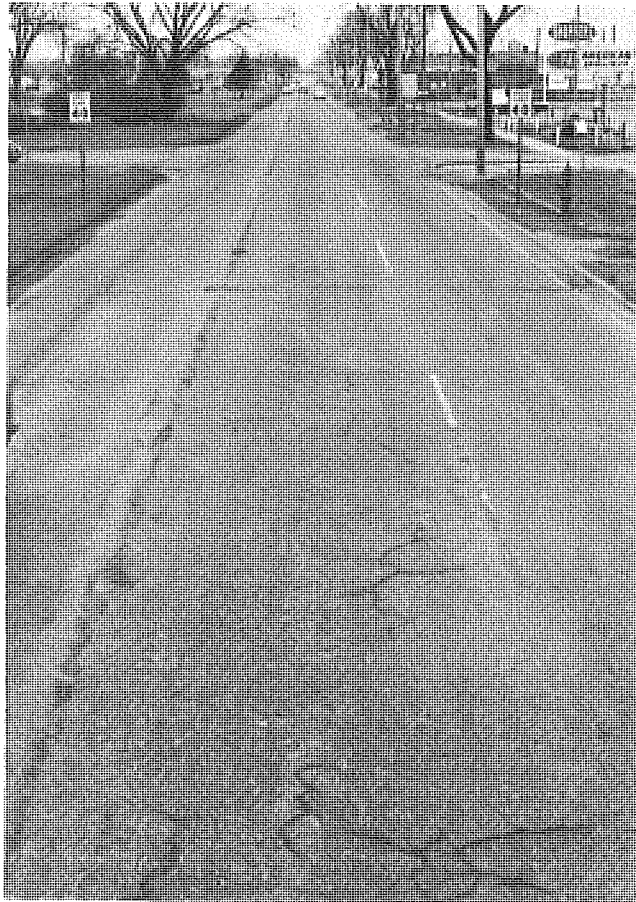
Figure 10. Looking W on M 143 (Michigan Ave) near Shopper's Fair. The residue from the broken thermoplastic lane segments (right) still guides traffic after four winters of service. The left lane segments striped with paint in October 1971 are completely worn away before one winter's service. The thermoplastic based line was also overstriped with paint at the same time for the first time (3-21-72).
