PROGRESS REPORT
CONCRETE PAVEMENT JOINT REPAIR
WITH PRE-CAST SLABS

MICHIGAN DEPARTMENT OF STATE HIGHWAYS

Research Laboratory Section
Testing and Research Division
In Cooperation with the Maintenance Division
Research Project 68 F-102
Research Report No. R-762

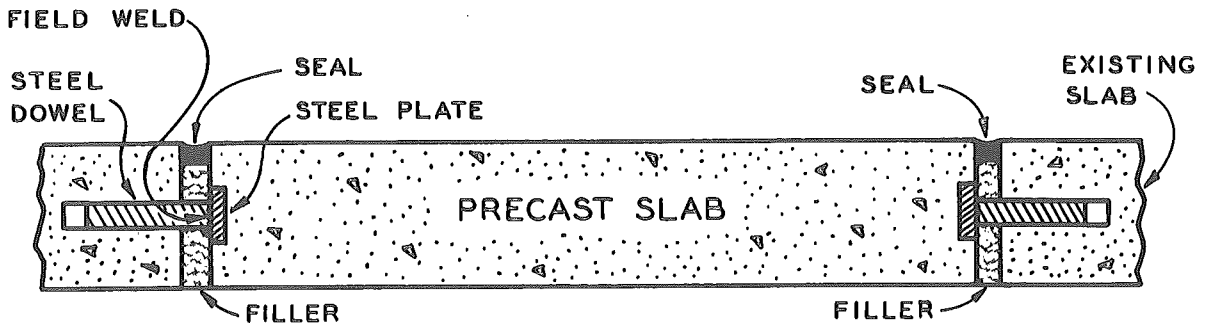
Figure 1. Methods of joining precast slab with existing slab.

A. Doweled joints with expansion - contraction provision at both joints.

Two distressed joints were replaced with pre-cast slabs utilizing doweled joints as shown in Figure 1A. One joint was replaced with slabs joined to the existing slab in the manner shown in Figure 1B, and at the remaining joint the two slabs were joined as shown in Figure 1C.

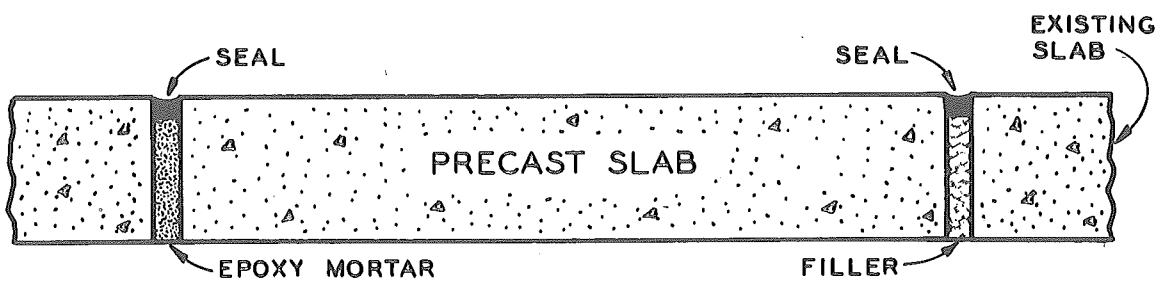
B. Non-doweled joints with expansion - contraction provision at one joint.

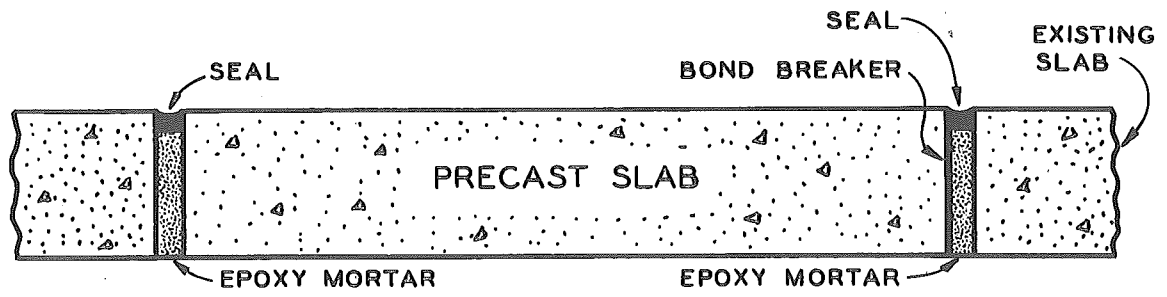
C. Non-doweled joints with contraction provision at one joint.

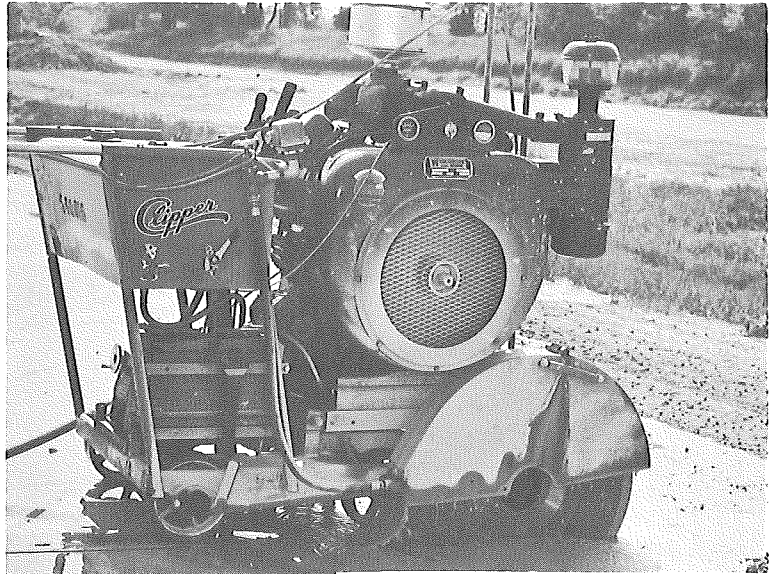
Figure 1. Sawing full-depth saw cut in 8-in. reinforced concrete slab with 60 hp self-propelled saw equipped with 26-in. diameter diamond blade. (Sawing speed 0.6 ft/min)

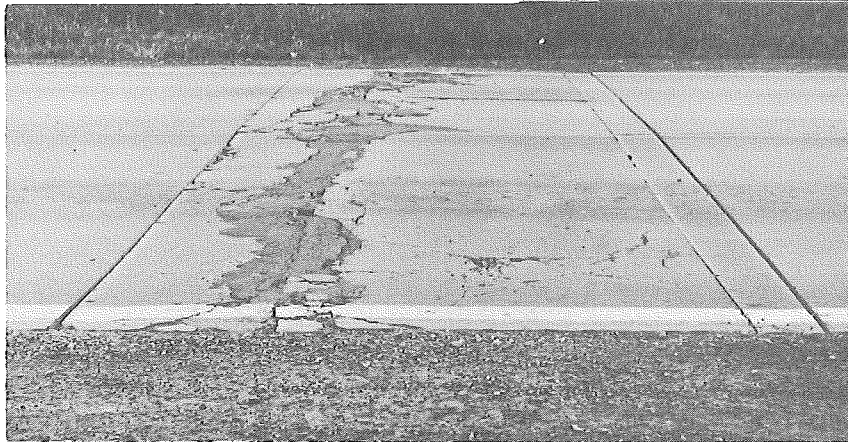
Figure 2. Transverse saw limits. The second saw cut, about 8 in. inside the repair limits at one end, was made to facilitate removal of the distressed pavement.

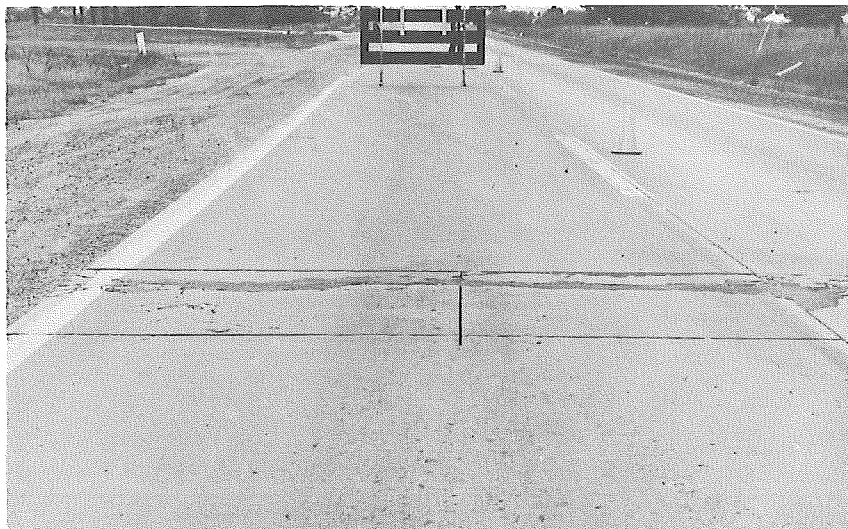
Figure 3. Longitudinal saw cuts. A full-depth saw cut was made in the center of the roadway and also in the center of each lane.

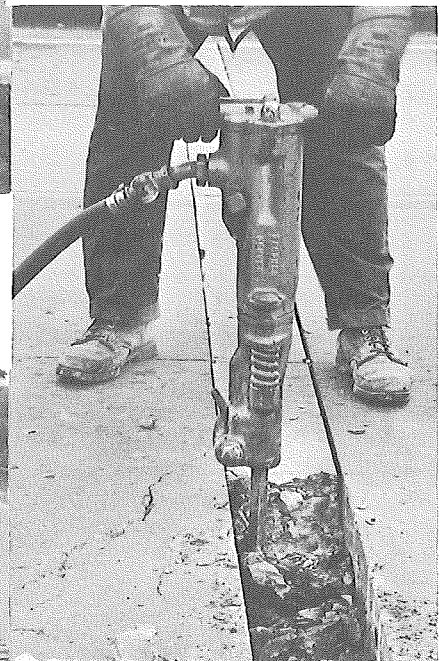
Figure 4. Removing concrete between narrowly spaced saw cuts with air hammer.

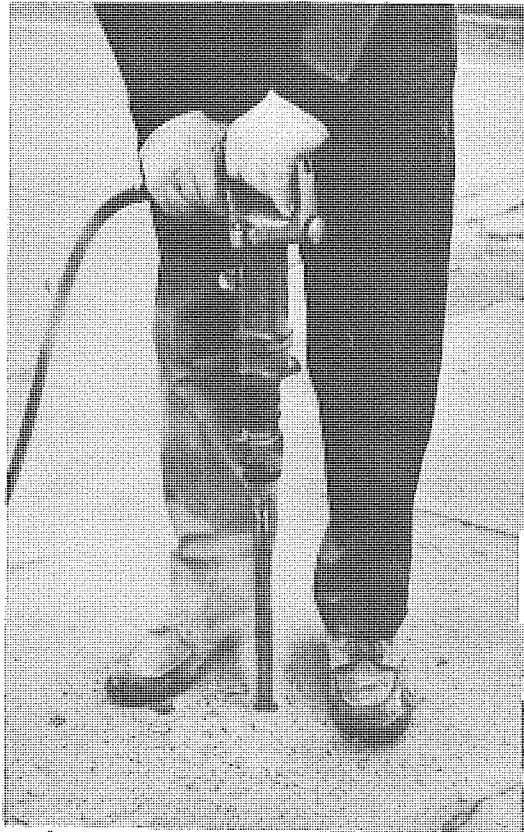
Figure 5. Drilling 1-1/4-in. diameter holes, full-depth, for insertion of lift pins. Three holes were drilled in each half-lane slab to be removed.

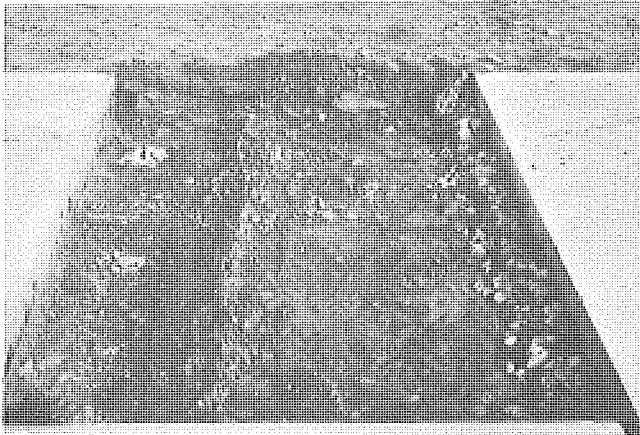
Figure 10. A typical repair after the old slab was removed. A few shovels full of deteriorated or broken concrete remain to be removed by hand. Note the subbase has not been disturbed during removal operations. By using the procedure shown above, a lane repair could be cleaned of the old concrete in 30 to 40 minutes.

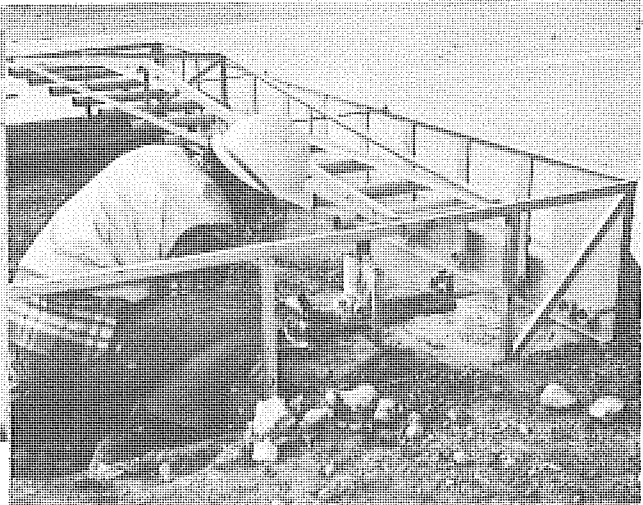
Figure 11. Drilling 9-in. deep by 1-1/4-in. diameter holes on 12-in. centers for dowels, using a guide frame and air drill with carbide bit. The time required to drill one hole was approximately 2 minutes.

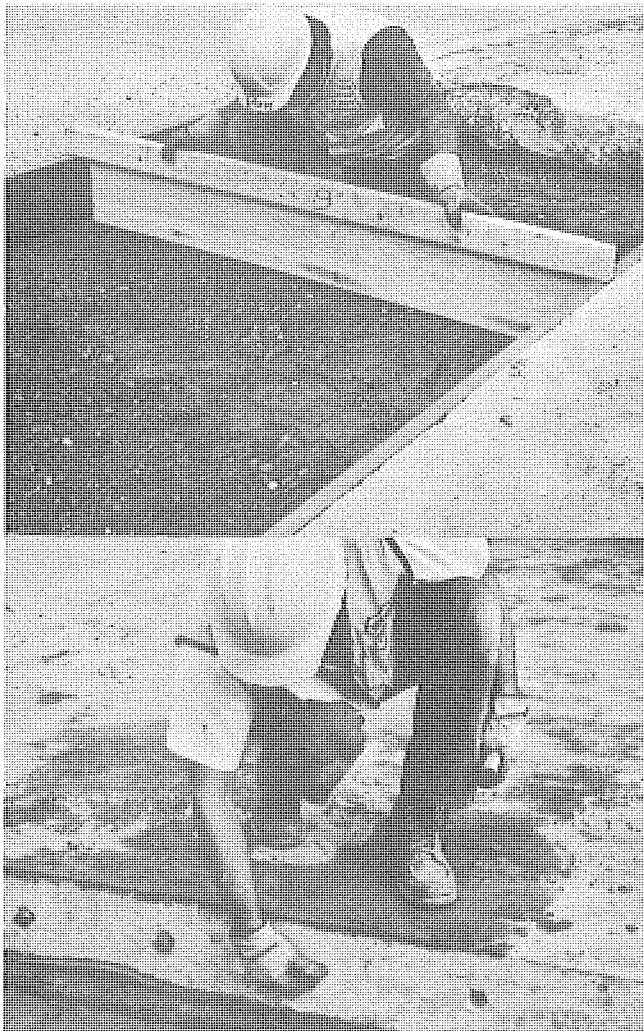
Figure 12. The elevation of the pre-cast slab was established with planks set at each repair end. The elevation of the subbase was established by sliding a template across the planks.

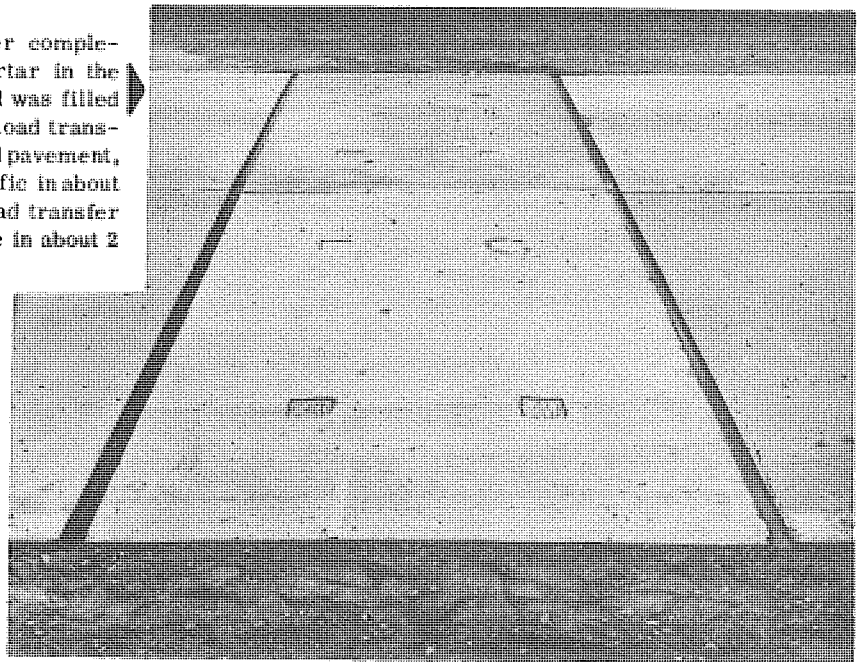
Figure 22. Appearance of repair after completion. Lift holes were filled with mortar in the bottom two-thirds and the top one-third was filled with epoxy mortar. A lane repair with load transfer, including removal of the distressed pavement, can be accomplished and opened to traffic in about 3 to 3-1/2 hours. A repair without load transfer can be completed and opened to traffic in about 2 to 2-1/2 hours.
