MICHIGAN  
STATE HIGHWAY DEPARTMENT  
Charles M. Ziegler  
State Highway Commissioner

PERFORMANCE OF HOT-POUR RUBBER-ASPHALT JOINT SEALING  
COMPOUNDS IN 50-FT. SPACED JOINTS

Highway Research Project 53 G-71(1)

Research Laboratory  
Testing and Research Division  
Report No. 248  
February 16, 1956

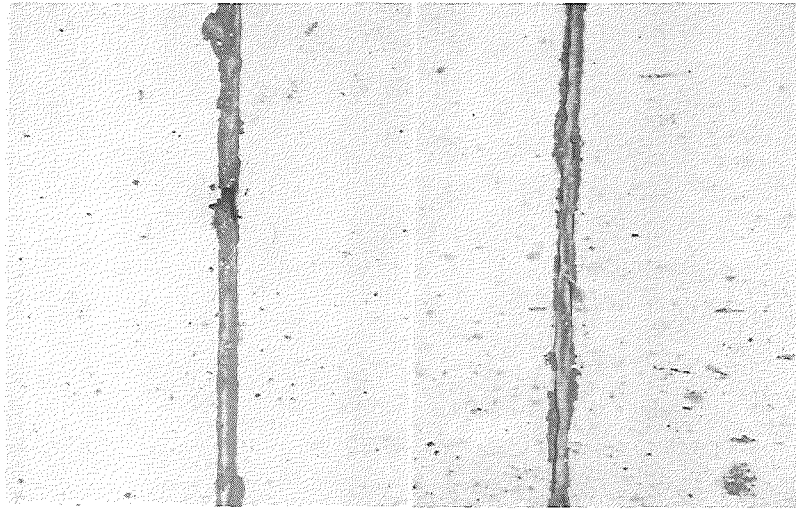
A. STA. 359+75

B. STA. 363+25

FIGURE 1. PROJECT 73-46 C 4: ADHESION LOSSES OF JOINT SEAL IN 50 FOOT SPACED JOINTS, M-47 SOUTH OF SAINT CHARLES.

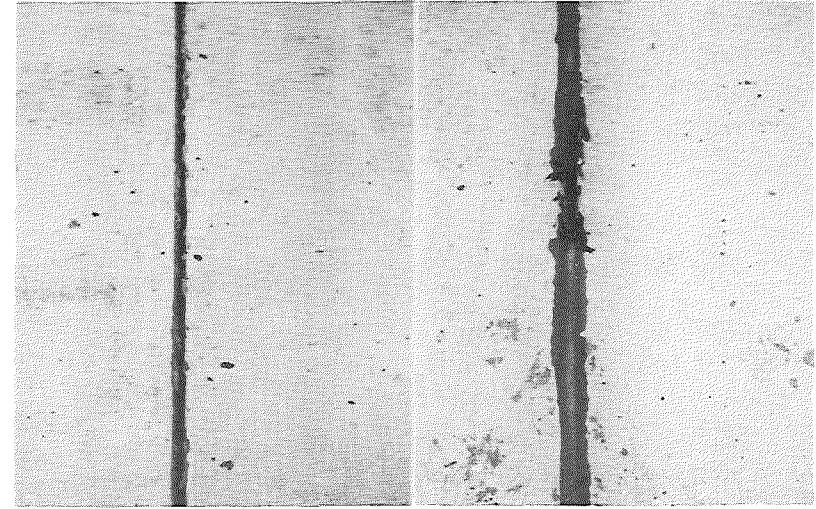
A. STA. 368+50 EXPANSION JOINT NEAR BRIDGE

B. STA. 391+97 APPEARS SEALED AT SURFACE BUT LACKS ADHESION

FIGURE 2. PROJECT 73-46, C 4: JOINT SEAL FAILURES IN 50 FOOT SPACED JOINTS, M-47 SOUTH OF SAINT CHARLES

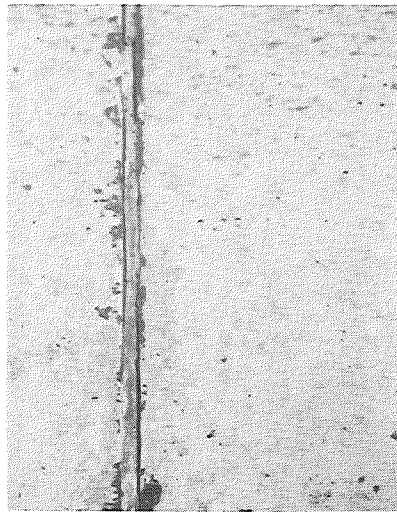
A. STA. 113+50 CLOSEUP

FIGURE 3. PROJECT 44-34 C1: VARIOUS DEGREES OF ADHESION FAILURE IN 50 FOOT SPACED M-24 NORTH OF LAPEER.

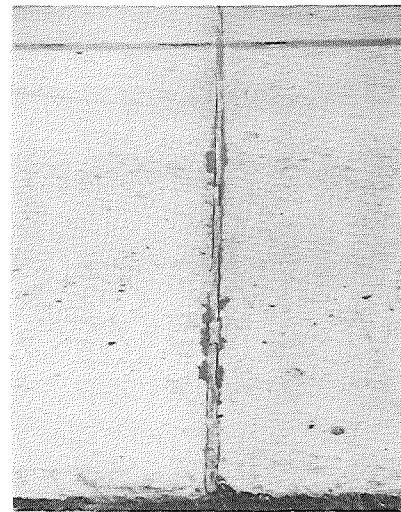
B. STA. 113+50 OVERALL

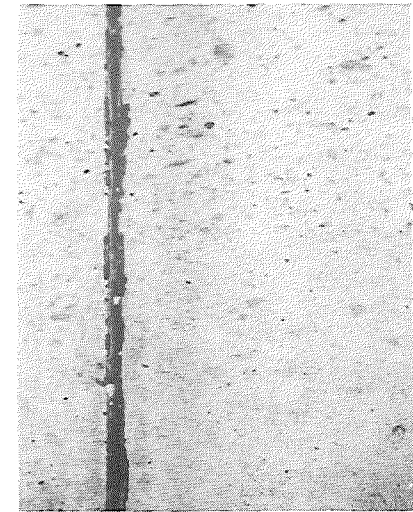
C. STA. 96+15

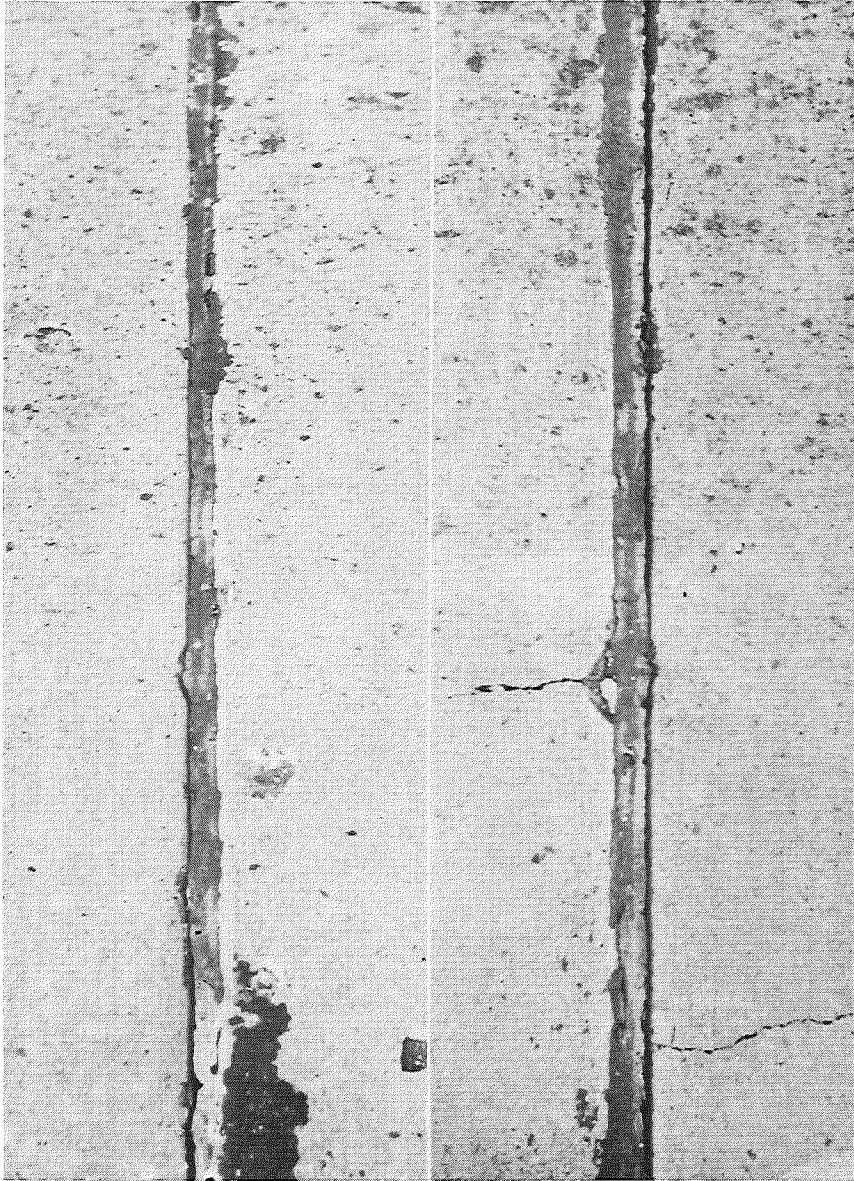
A. STATION 712+50 TYPICAL FAILURE

B. STATION 710+05 EXTREME FAILURE

FIGURE 4. PROJECT 50-22, CI: ADHESION FAILURE IN 50 FOOT SPACED JOINTS, M-97 SOUTH OF M-59.

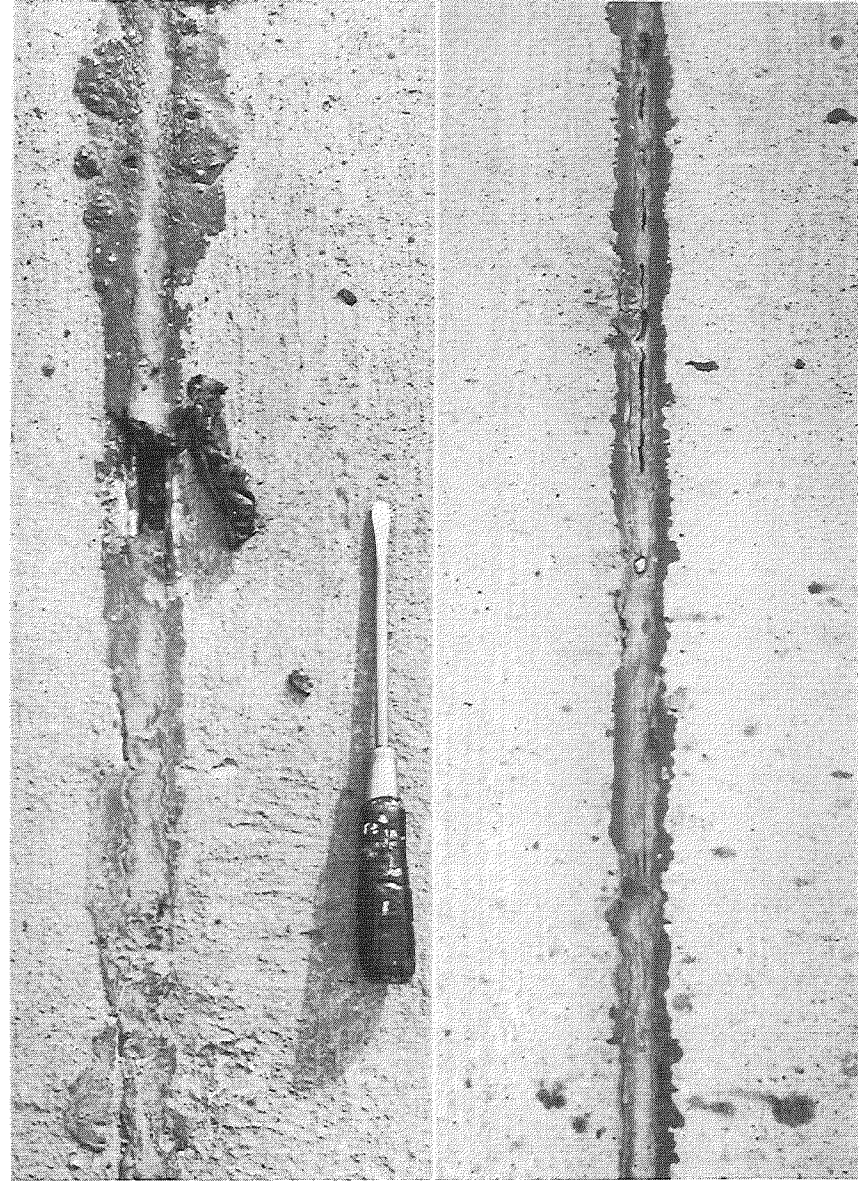
The joint seal had failed in all five of the projects that were surveyed, (Figures 1 through 6). The failures were typical of those found in joints spaced 99 feet apart. In every case the joint seal was no longer adhered to the joint faces and sand or other foreign material was usually found in the joint groove. In one project a large number of joints contained sealer which showed both adhesion and cohesion failure, (Figure 5-B).

A. STATION 337+60 APPEARANCE FAIR AT SURFACE BUT SEALER LACKS ABHESION AND JOINT CONTAINS SAND AND DIRT.

B. STATION 408+60 ADHESION AND COHESION FAILURES NEAR WEST END OF PROJECT.

FIGURE 5. PROJECT 50-53 CI: JOINT SEAL FAILURES IN 50 FOOT SPACED JOINTS METROPOLITAN PARKWAY SOUTH OF MOUNT CLEMENS.

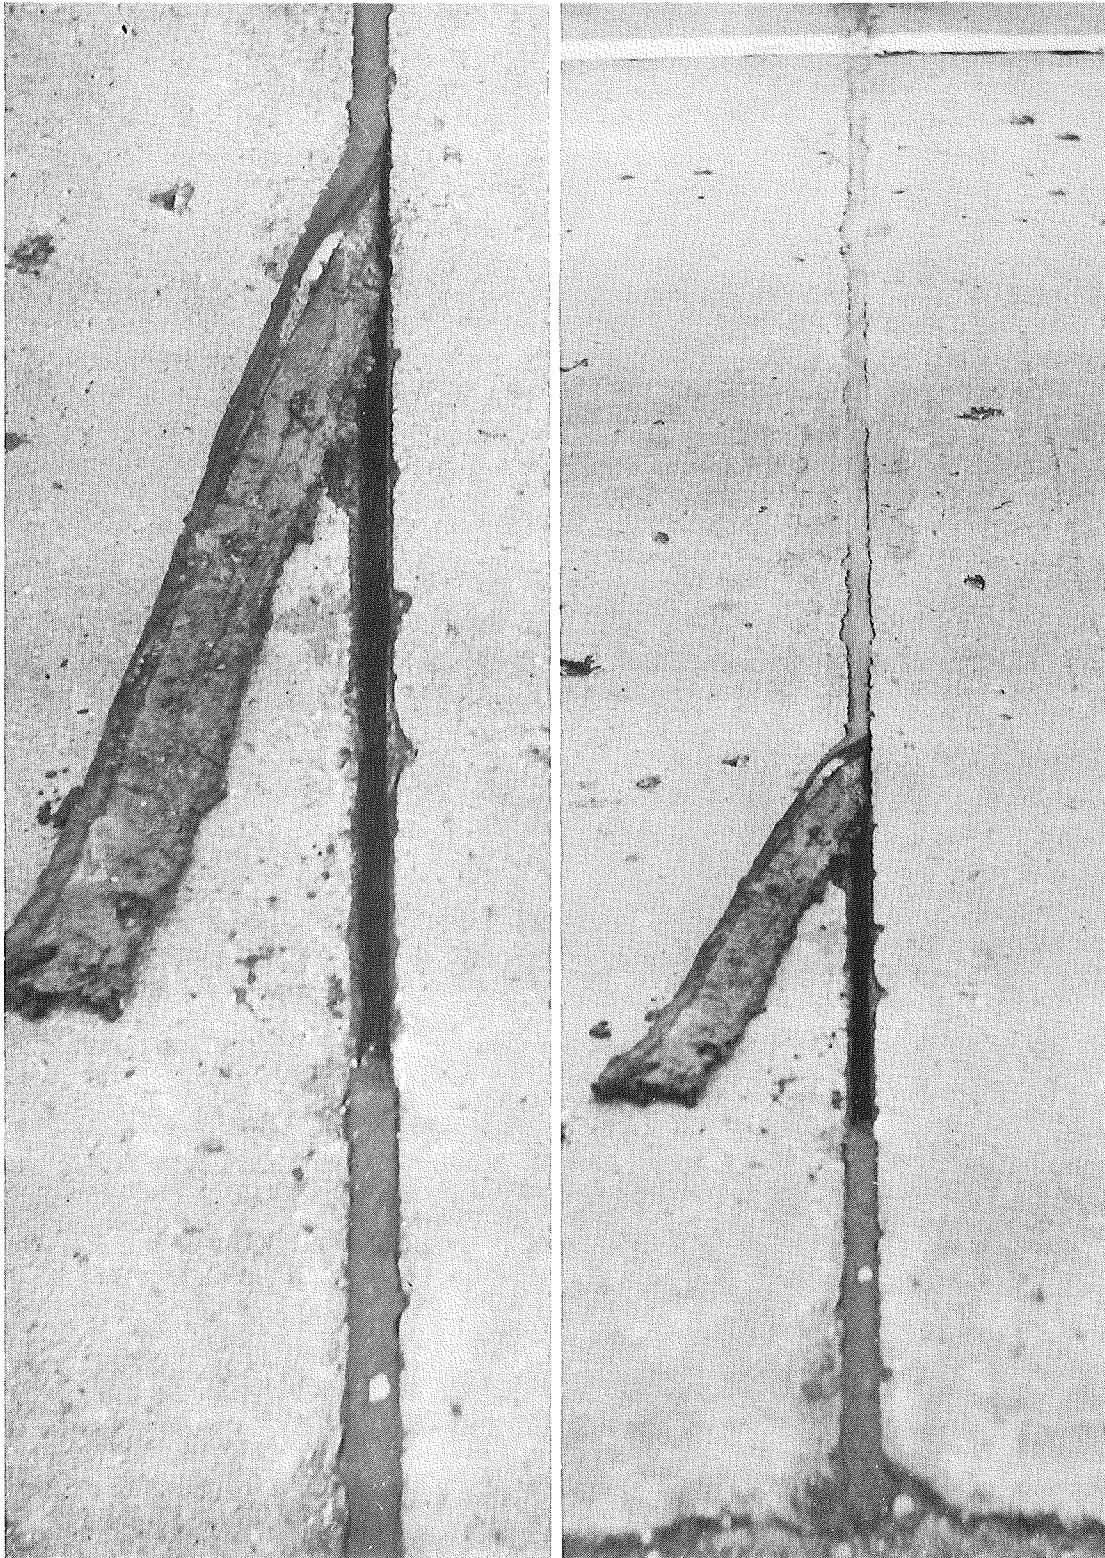
A. CLOSEUP

B. OVERALL VIEW

**FIGURE 6. PROJECT 38-48, C2, STATION 913+47: COMPLETE JOINT SEAL ADHESION FAILURE IN 50 FOOT SPACED JOINTS US-12 EAST OF JACKSON.**
