MICHIGAN
STATE HIGHWAY DEPARTMENT

December 9, 1966

Subject: Field Test Applications of "Speed Crete" Patching Mixtures.
Research Project 65 NM-140. Research Report No. R-618.

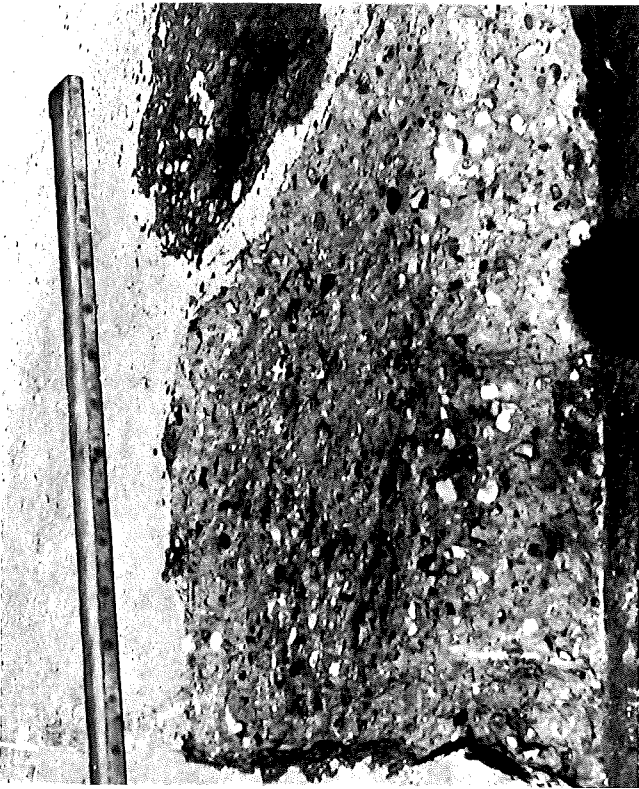
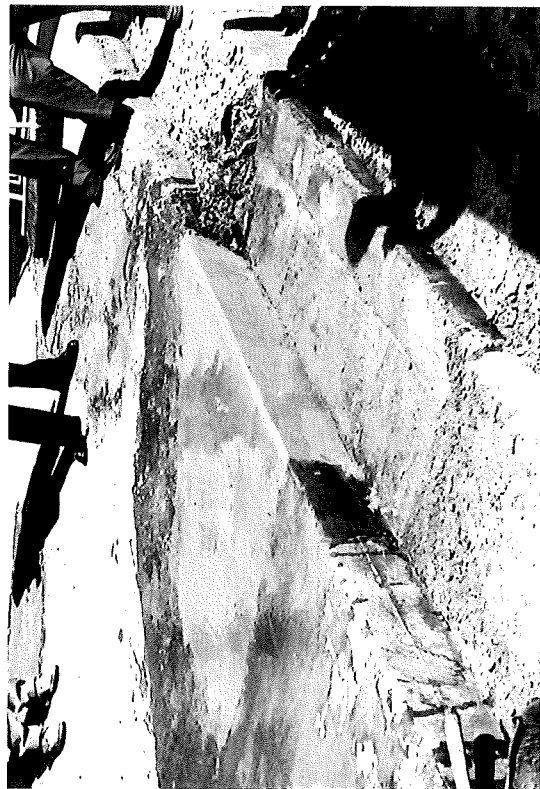
The second test patch being observed was placed the morning of April 29, 1966, in a sidewalk and curb area in front of the Gladmer Theater on N. Washington Ave. in Lansing. The area was chipped out and prepared by Lansing DPW forces and is about 3 ft by 2-4 ft and varies in depth up to about 2-1/2 in. (Figure 1). A total of three bags (150 lb) of Speed Crete was mixed, by hand, in a wheelbarrow and placed by W. Hayes and K. Williams of CMP. The stiff Speed Crete mixture was packed in the pre-wet area, screeded, shaved to grade, and hand rubbed with a wet sponge. The finished patch is also shown in Figure 1.

Figure 1. Chipped and pre-wet area before Speed Crete placement (top), and after shaving off excess material and rubbing with wet sponge (bottom). Sidewalk patch on N. Washington Ave., Lansing (4-29-66).

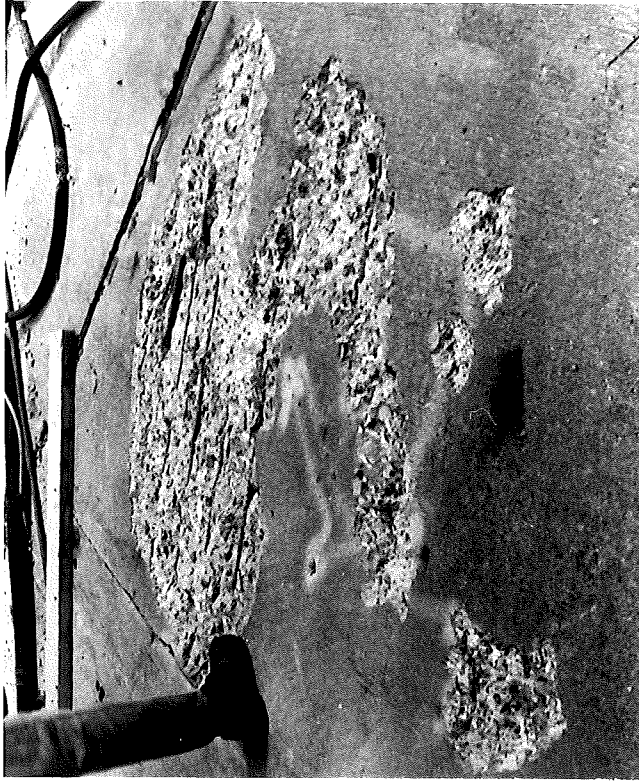
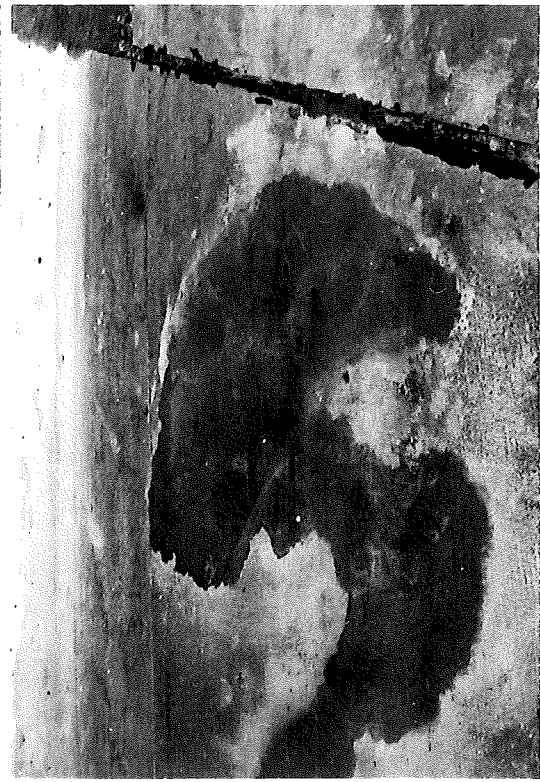
The third field application was primarily arranged and planned by the Research Laboratory and Office of Maintenance as a field test. The northbound structure carrying US 127 over the NYC RR about 3.4 miles north of Jackson contained a number of spalled areas over high steel and one deeply scaled area near the east curb. District maintenance forces under Dave Hodges chipped and removed unsound concrete early on May 17, 1966, beginning at the north end of the deck. Figure 2 shows the first prepared area in the northwest corner of Span 3 just before wetting with water and application of the Speed Crete mixture, and the finished patch about five hours after placement and four hours of traffic.

Figure 2. Spalled area over high steel after chipping (top), and after about four hours of traffic (bottom). The patched lane was closed for one hour after placement. Northwest corner of passing lane, US 127 bridge over NYC RR, north of Jackson (5-17-66).

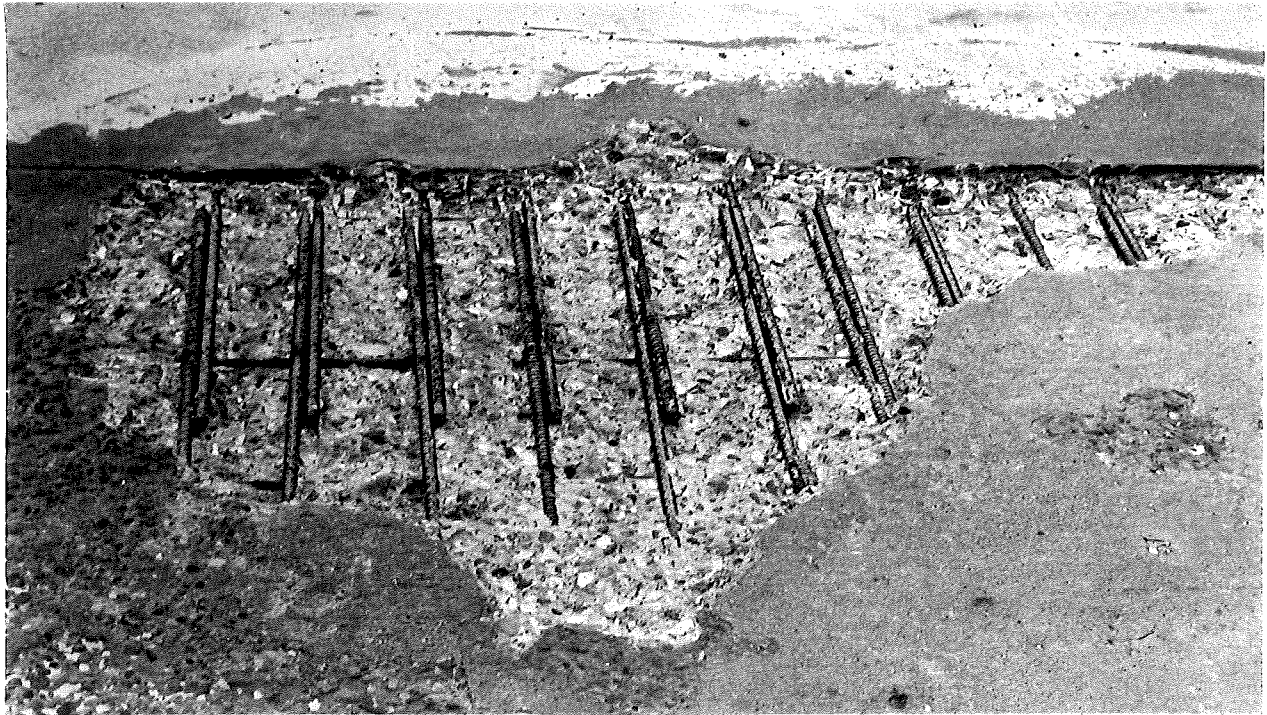
A patched area about 2-ft square and 1-1/2-in. deep was placed along the center construction joint at the south end of Span 1 and smaller patches along the steel expansion dam over Pier 2. A large deeply scaled and spalled area near the east curb toward the north end of Span 3 was patched with about five bags of Speed Crete. The prepared area is shown in Figure 3. The bottom 1-1/2 in. was filled with three bags of a mixture containing 25 lb of pea gravel to a 50-lb bag of Speed Crete. The top inch was filled with straight Speed Crete mix. A total of about nine bags of Speed Crete was hand mixed in a wheelbarrow and placed in the various patches. All patches were cured with a spray application of clear membrane curing compound.

Figure 3. Deeply scaled and spalled area prior to patching near east curb of Span 3 on US 127 bridge over NYC RR, north of Jackson (5-17-66).

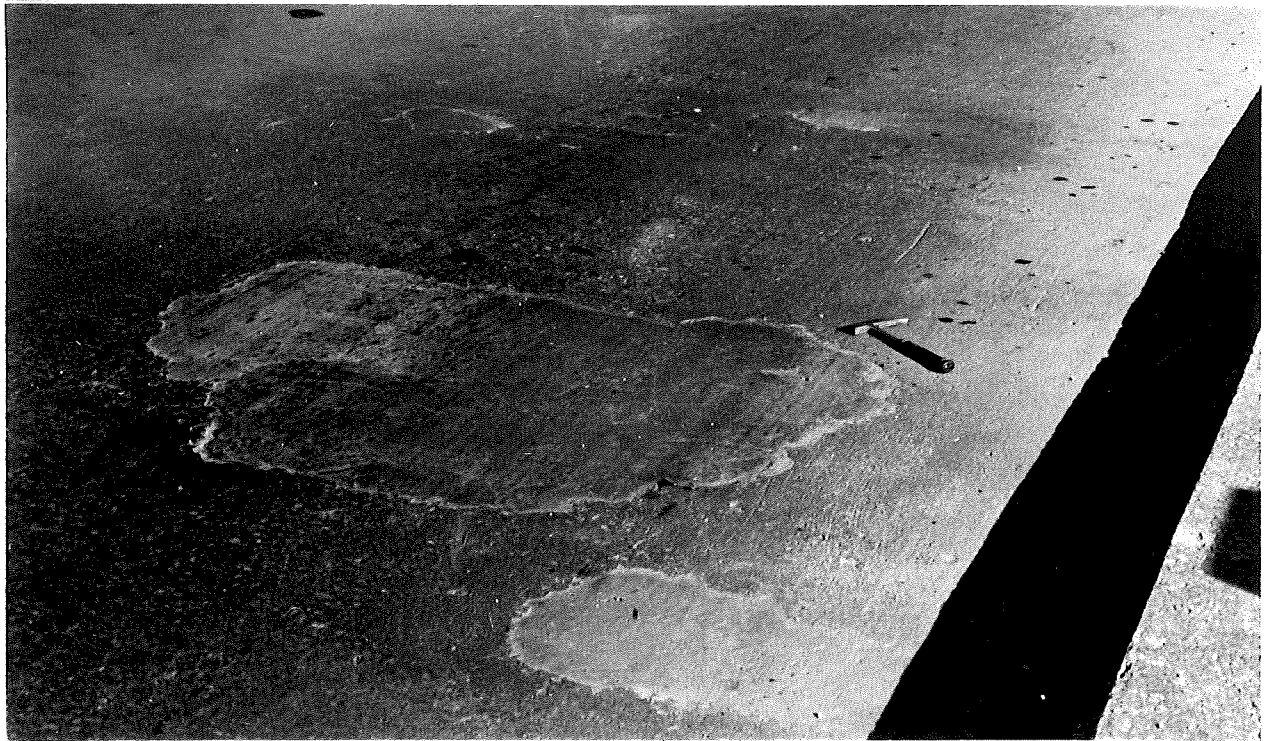
The last of the four test areas to be mentioned was placed on July 27, 1966, by Lansing DPW forces supervised by CMP and Holmes Associates personnel. One large and one small patch were placed near the east curb toward the north end of the structure. The prepared areas were etched with muriatic acid and flushed with water prior to patching. About six or seven bags of Speed-Crete were hand mixed and placed in the two patches. The larger patch contained some pea gravel in the mixture in the bottom portion of the 1-1/2 in. depth. To date the patches appear quite sound except for a small hollow region at the eastern end of the larger patch. The completed patches are shown in Figure 4 after about 1-1/2 months of traffic.

Figure 4. Two patches near east curb, toward north end of S. Pennsylvania structure over NYC RR, Lansing (9-8-66).
