PERFORMANCE OF  
MAYARI R WEATHERING STEEL (ASTM A242)  
IN BRIDGES

EIGHT MILE ROAD

JOHN LODGE EXPRESSWAY

DETROIT, MICHIGAN

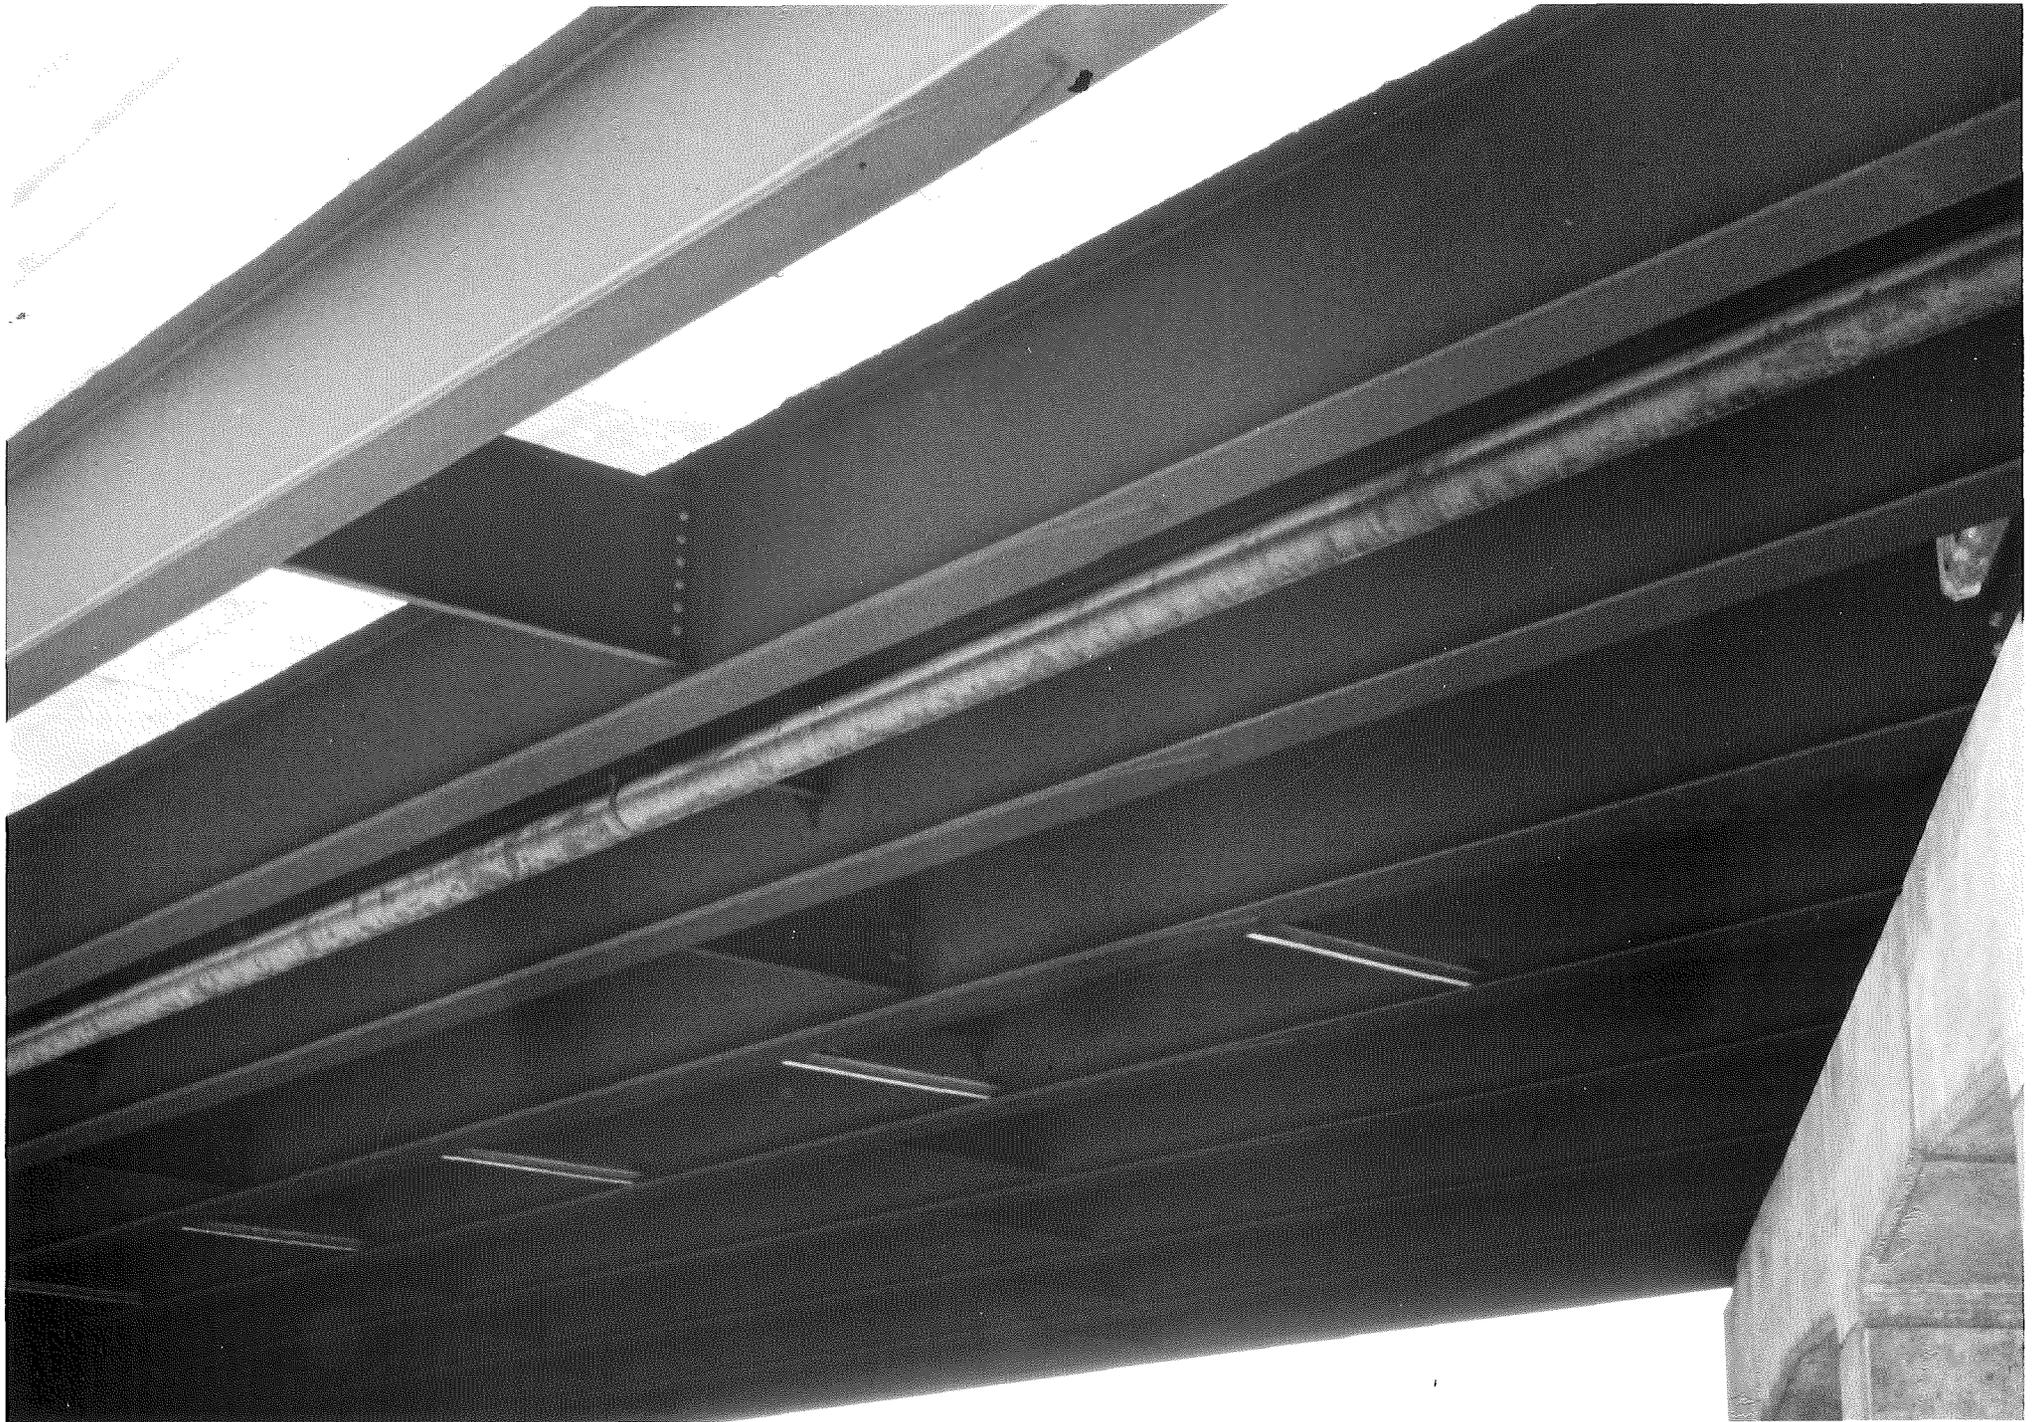
FIGURE 3

CLOSE-UP VIEW OF THE STRUCTURAL BEAMS  
ON THE EASTBOUND SERVICE BRIDGE ABOVE THE NORTHBOUND LANE  
OF THE EXPRESSWAY AFTER 5+1/2 YEARS OF SERVICE

The area shown is typical of the appearance of bridge  
members above the northbound lanes of the expressway.

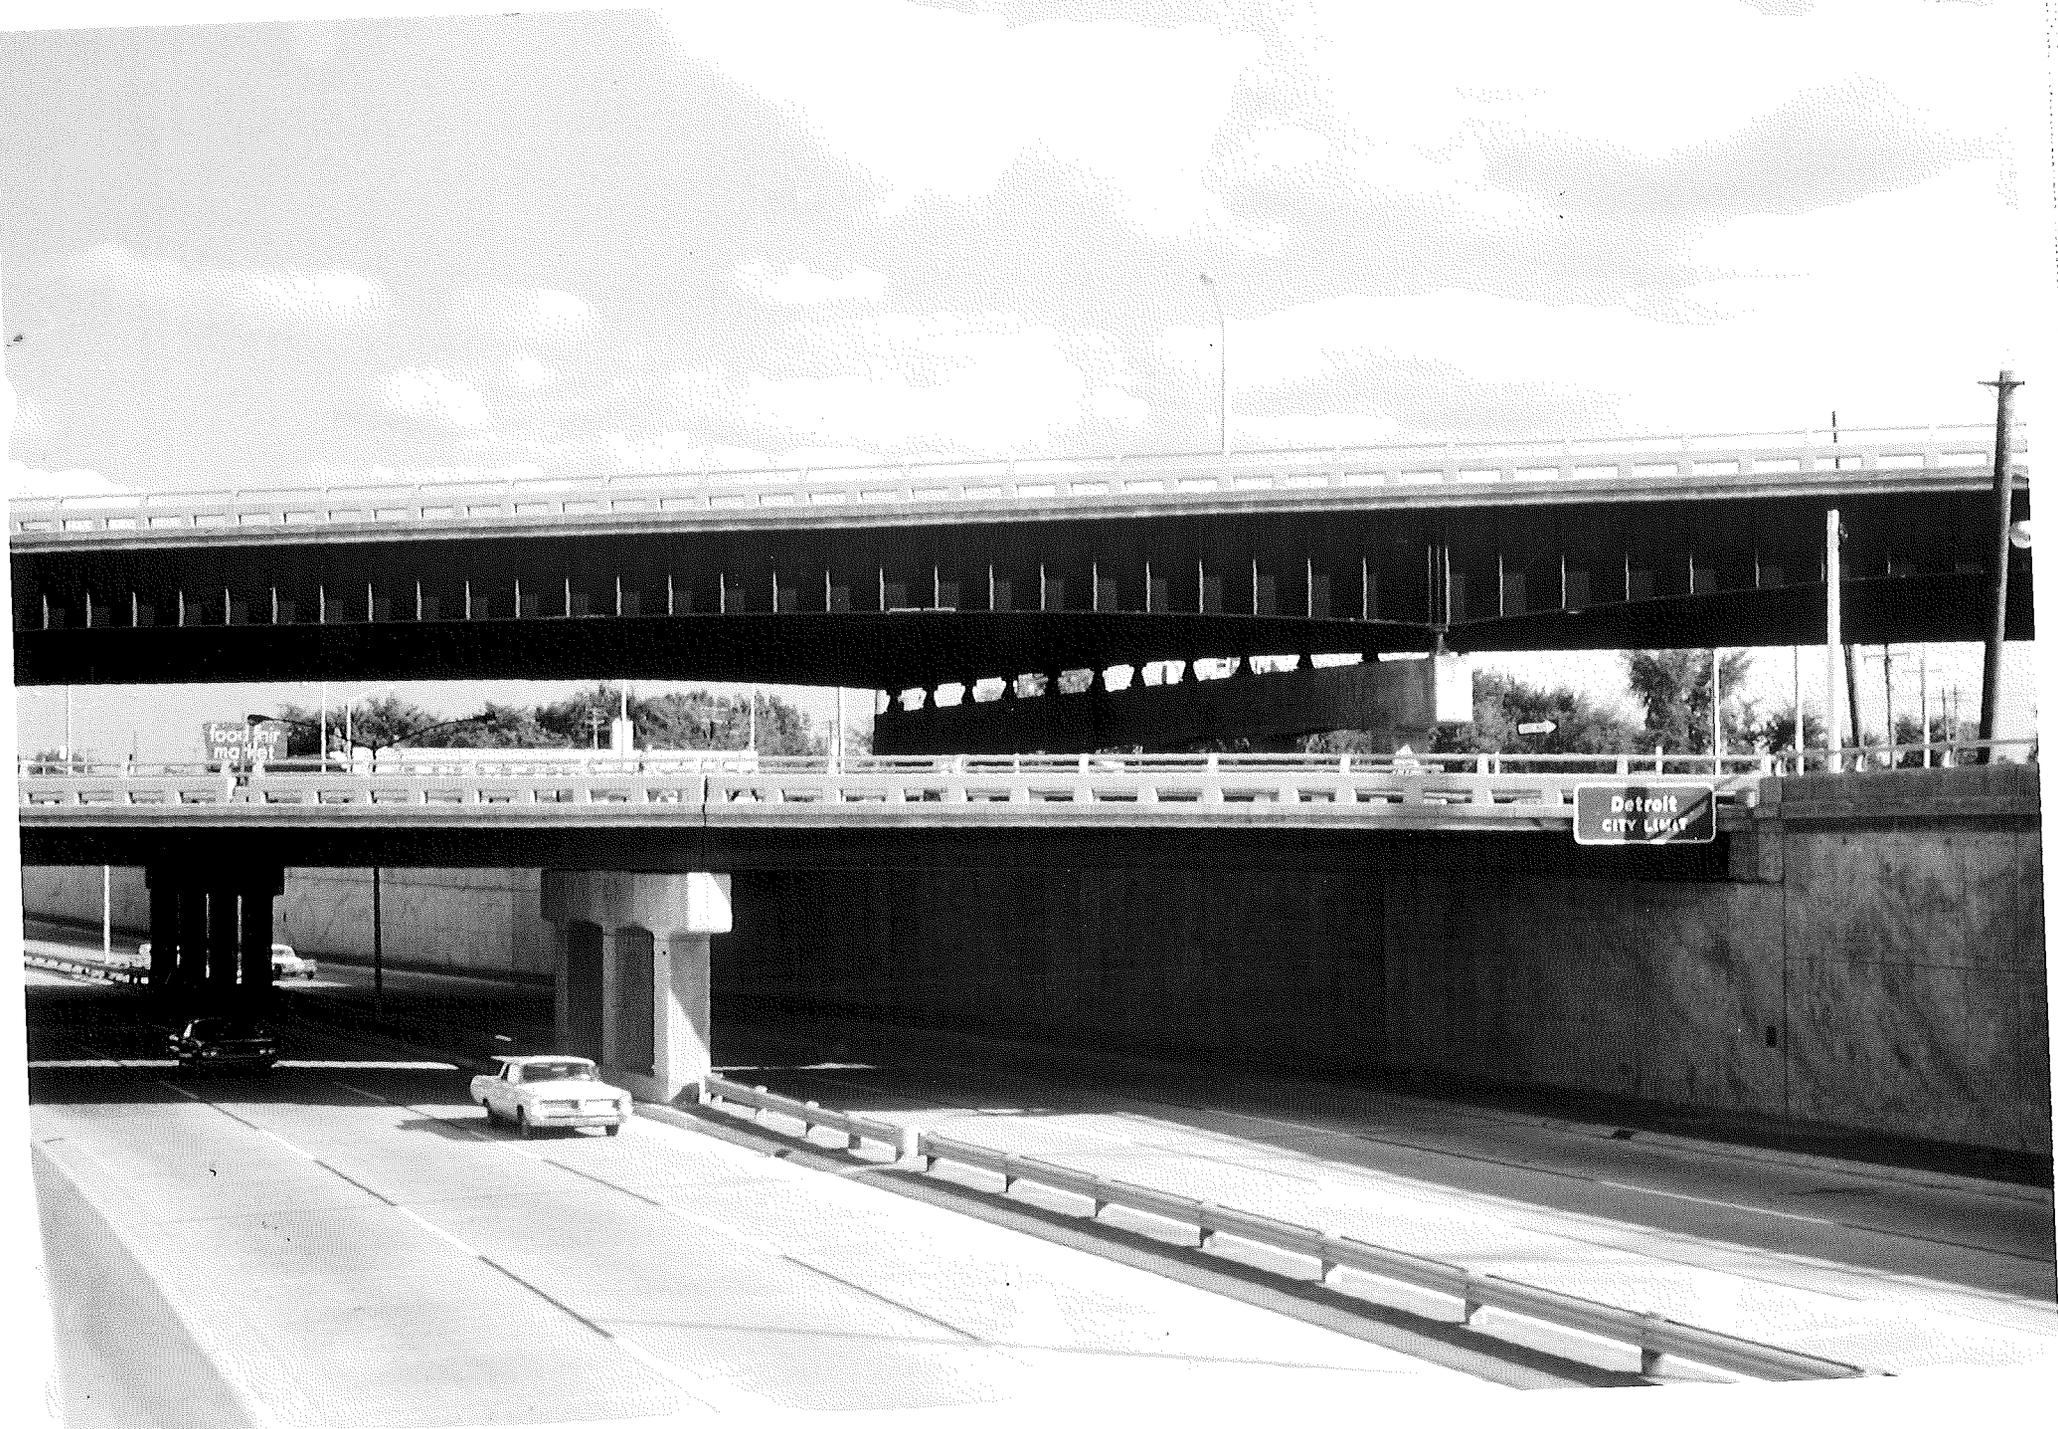
FIGURE 4

Figure 4 shows the viaduct and the westbound service bridge looking south. Though not visible in the photograph, our corrosion specimens are facing the southbound traffic and are located on the service-bridge beams near the concrete retaining wall. The area was considered to be the one most susceptible to corrosion, and this was later found to be the case. This type of area receives the most road spray, dirt and traffic fumes.

A study of Figure 4 shows why the bridge beams in this type of area receive more road spray and accumulate greater amounts of road dirt than other areas. In this area, seen in the right half of the photograph there is a confined, tunnel-like configuration resulting from a combination of low bridge-clearance and high retaining wall. These conditions intensify the effect of the heavy air blast produced by fast-moving trucks and cars passing under the bridge. In the partly contained space under the bridge, the air blast carries road spray and other substances up to the relatively low bridge beams as well as against the high concrete retaining wall from which the materials are deflected upward to the beams. These conditions prevail on bridge beams beneath the west end of the low service bridges facing southbound traffic of the expressway.

WESTBOUND SERVICE BRIDGE AND SOUTH SIDE OF VIADUCT

RIGHT HALF OF PHOTOGRAPH ILLUSTRATES THE  
CONFINED, TUNNEL-LIKE EFFECT CREATED  
BY A HIGH RETAINING WALL AND A  
LOW BRIDGE CLEARANCE ABOVE AN EXPRESSWAY

The fact that the accumulations of caked soil and the like are restricted to confined areas suggests several corrective maintenance or design measures. For example, flushing the bridge members in such areas, especially after a winter of heavy use of deicers, may effectively prevent the build up of dirt and salts. Furthermore, when inspection reveals appreciable flaking on some sections, these areas could be grit-blasted and painted with the realization of greater paint life on the weathering steel

In terms of design possibilities, even modest increases in present overhead and lateral clearances should provide additional space for the effective dissipation of road spray and faster drying. In any event, greater clearances would be more realistic when one considers the height and bulk of modern earthmoving equipment, to name only one example of items that are now transported over our public highways.

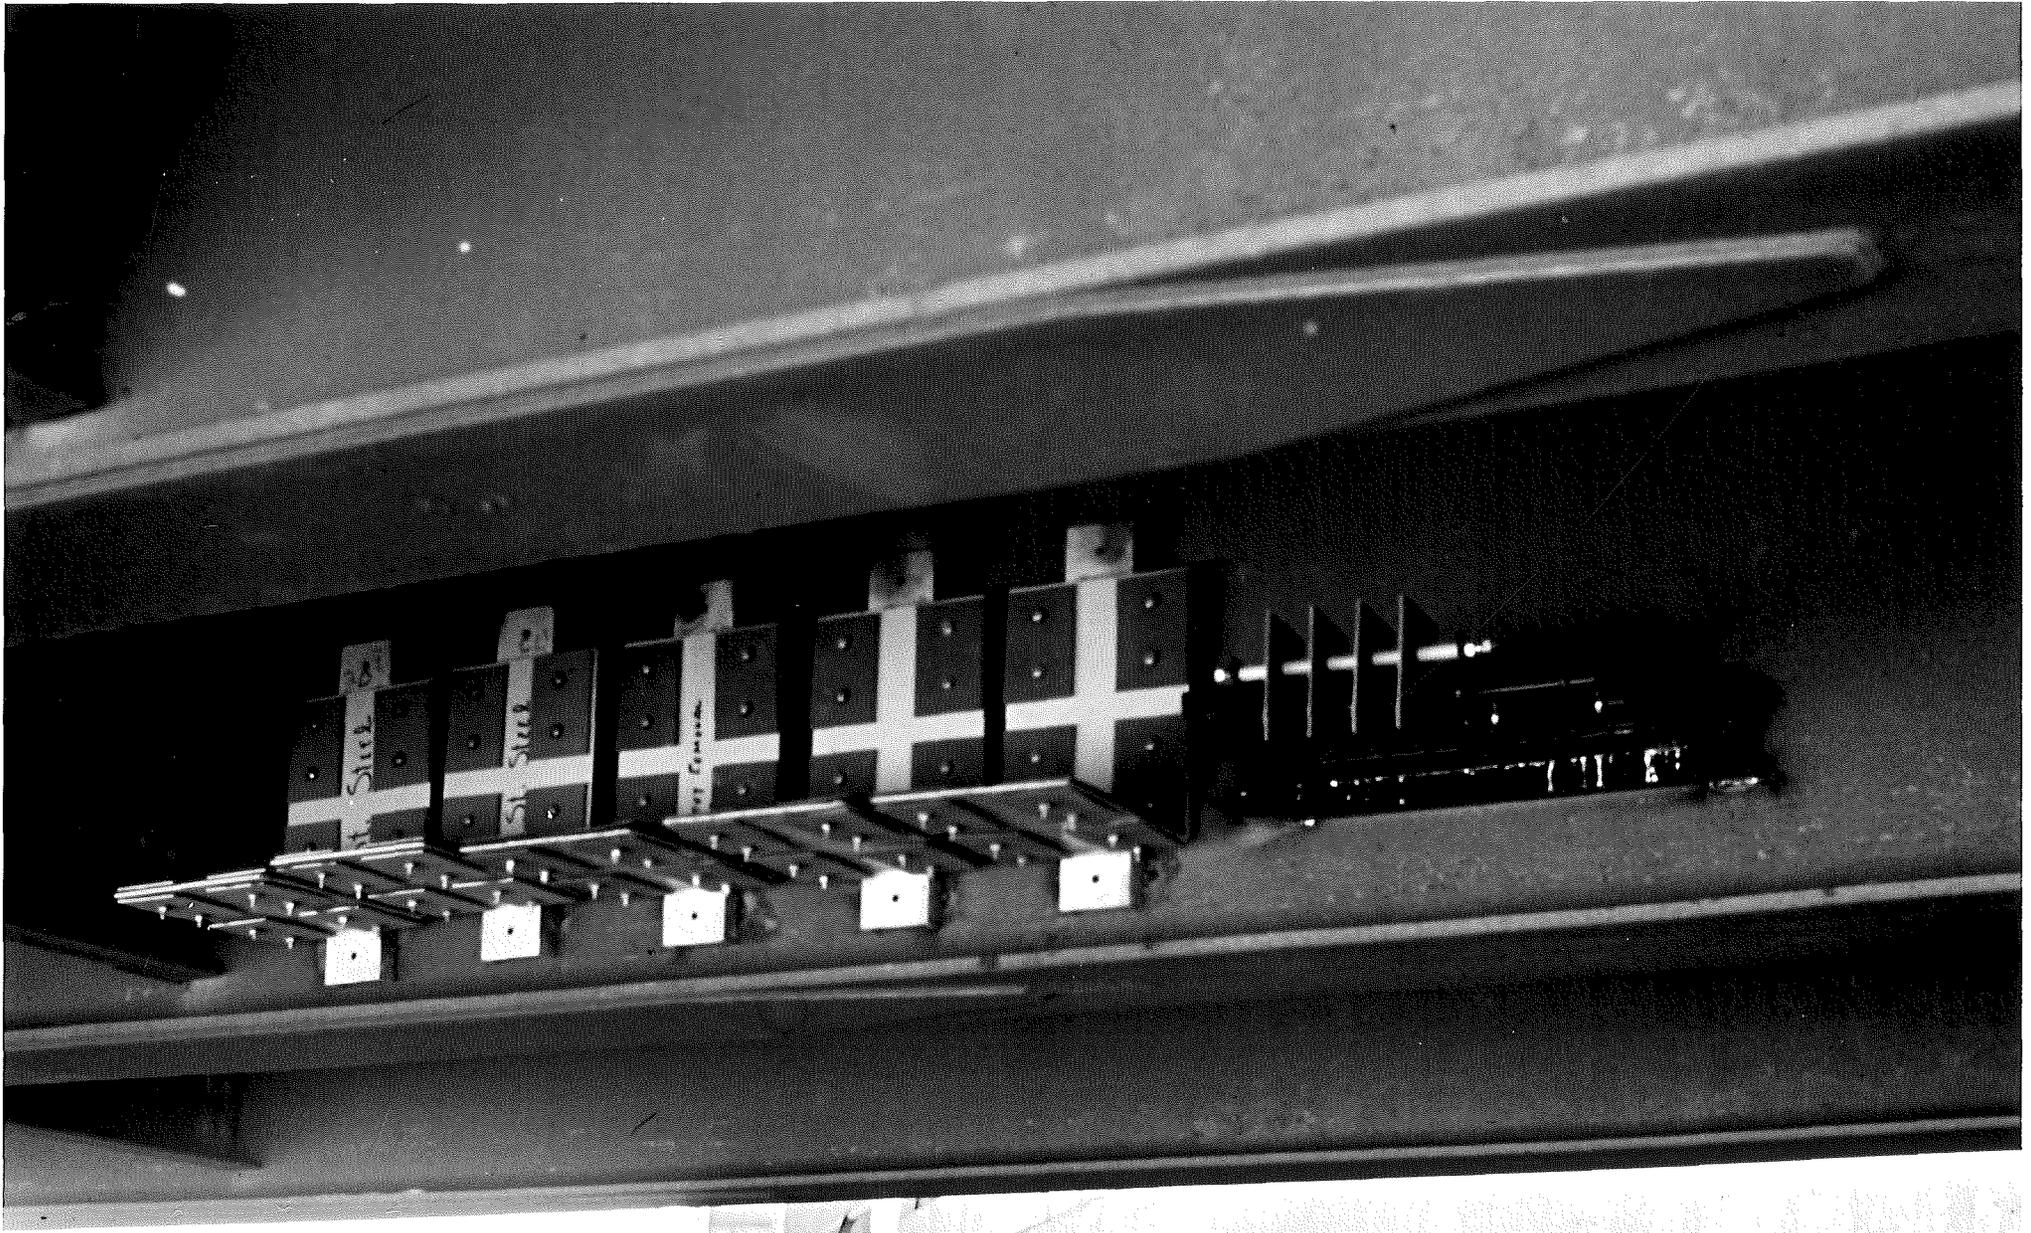
FIGURE 5

Inspection of the beams three years after the bridge was opened to traffic showed some accumulation of road dirt but very little scaling as yet. The condition of these beams is shown in Figure 5.

CONDITION OF BRIDGE BEAMS AFTER THREE YEARS OF SERVICE

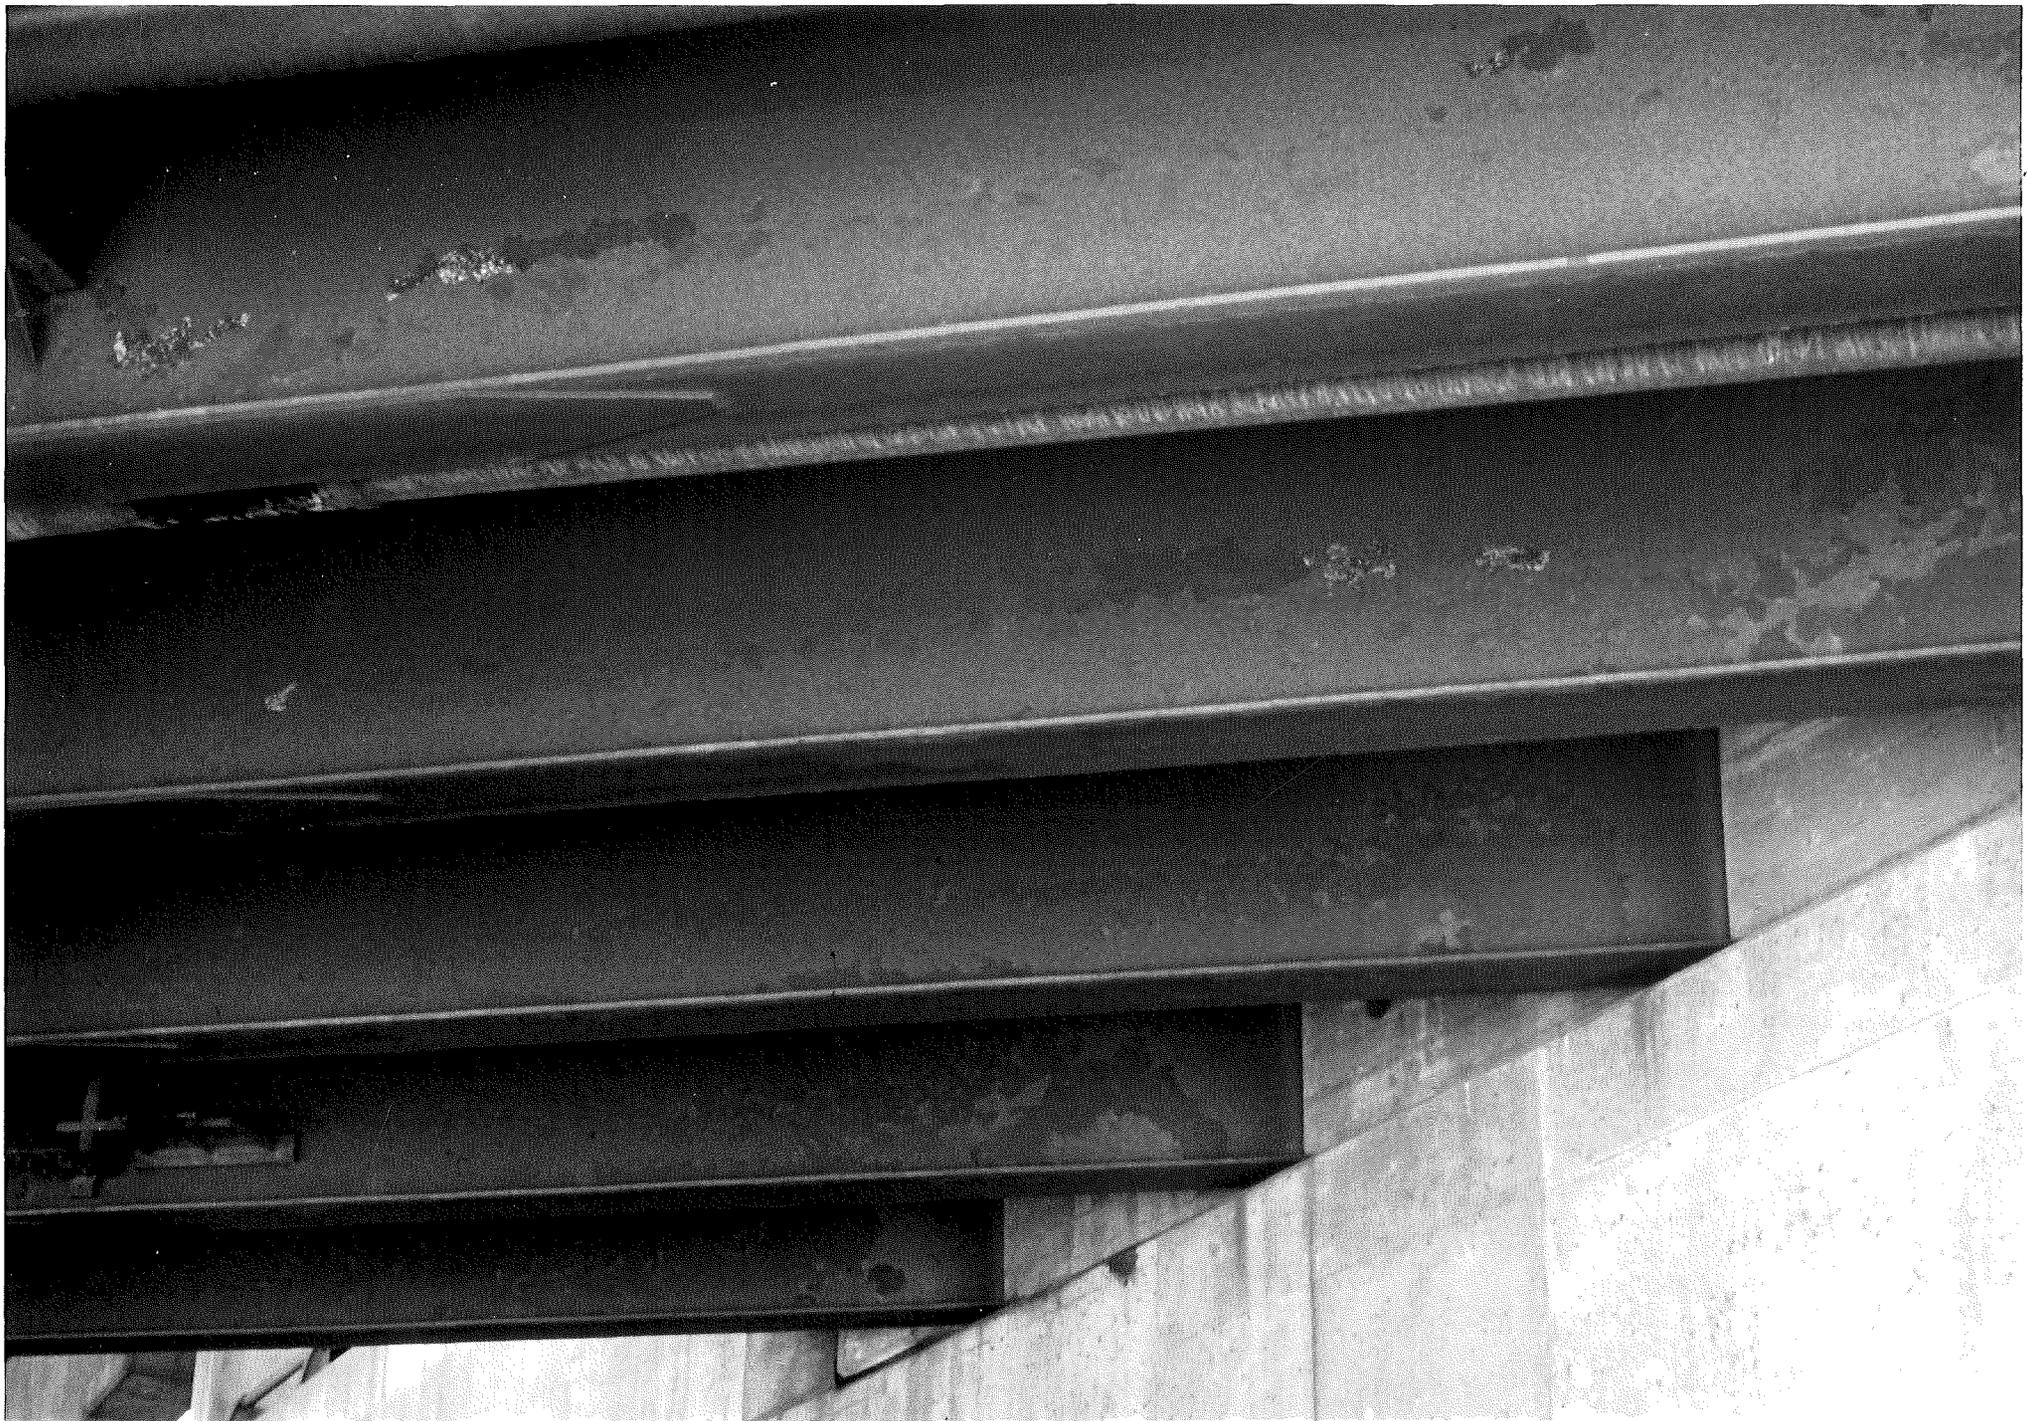
FIGURE 6

An inspection of the same bridge beams after 5-1/2 years (4 years for the corrosion specimens) showed a considerable accumulation of caked roadway soil and rust, some of it flaking from the surface of the beams. Beneath the scaly rust and soil we often found small amounts of a white deposit consisting mainly of chlorides and carbonates. Figure 6, taken at the close of the 5-1/2 year period, shows the scaling condition on the rolled beams of the service bridges above the southbound lanes of the expressway. Figure 7 is a close-up view of the scaling road dirt and rust on the beams and on the corrosion specimens that had been on the structure for four years.

The top surfaces of the flanges have the heaviest flaking soil and rust, with the webs having the least amount. Scaling is heavier over the right lane, adjacent to the shoulder, than over the center or left lanes, but there is some scaling over all three lanes.

FLAKING SOIL AND RUST ON STEEL MEMBERS  
OF THE WESTBOUND SERVICE BRIDGE  
AFTER 5-1/2 YEARS OF SERVICE

Note that the most extensive flaking appears on the steel closest to the concrete abutment, and the beams most affected are the innermost ones. Corrosion specimens can be seen in the lower left-hand corner of the photograph.

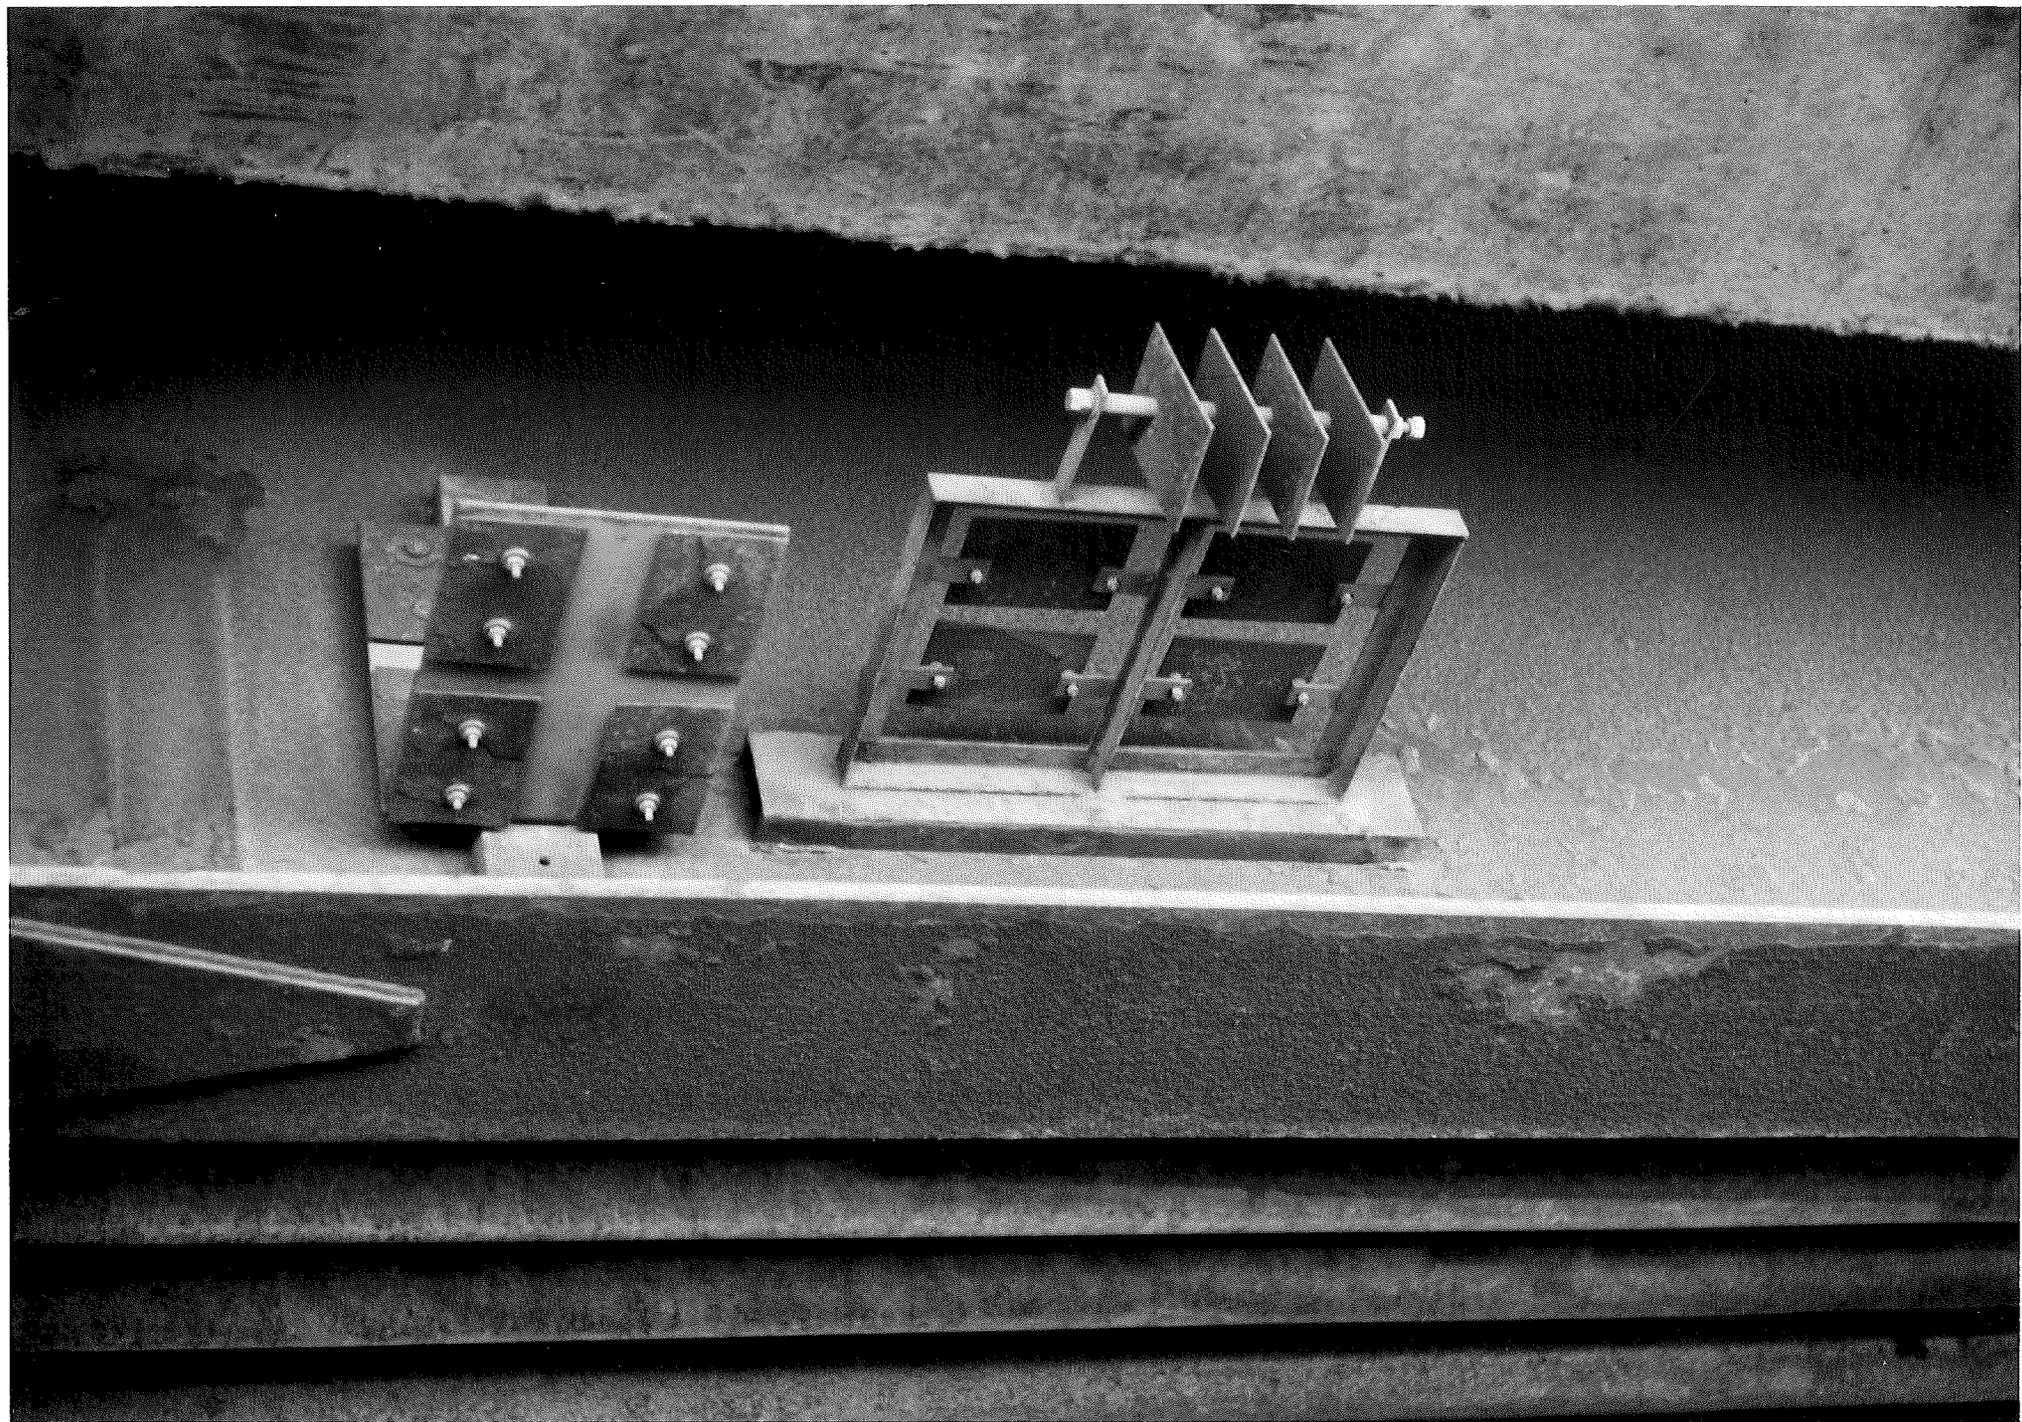
FIGURE 7

As will be explained in the ANALYSIS OF SCALY ROAD SOIL AND RUST section, the scales are caked road dirt and rust which have built up on the bridge-member surfaces until flaking initiated. This condition is not too noticeable from ground level, especially from vehicles, unless one is looking specifically for it. However, the condition is unsightly when viewed close-up, three or four feet away on a platform or scaffold, as was the case in Figure 7.

CLOSE-UP VIEW OF THE FLAKING SOIL AND RUST  
ON THE BRIDGE BEAMS AND ON THE CORROSION SPECIMENS

Some of the scaly road soil and rust was removed from the surface of the four-year corrosion specimens from the bridge for visual examination and thickness measurement. The soil was a gray, cement-like material intermingled with brown rust. Intermittent spots of a white powder were often found beneath the scale. The scale, as removed from the surface, was 25 to 35 mils thick. Underlying these scales was a smooth, light rust layer with an occasional white deposit. No significant pitting was evident. The scale was apparently a mixture of caked roadway soil and rust that had gradually built up on the surface until flaking occurred.

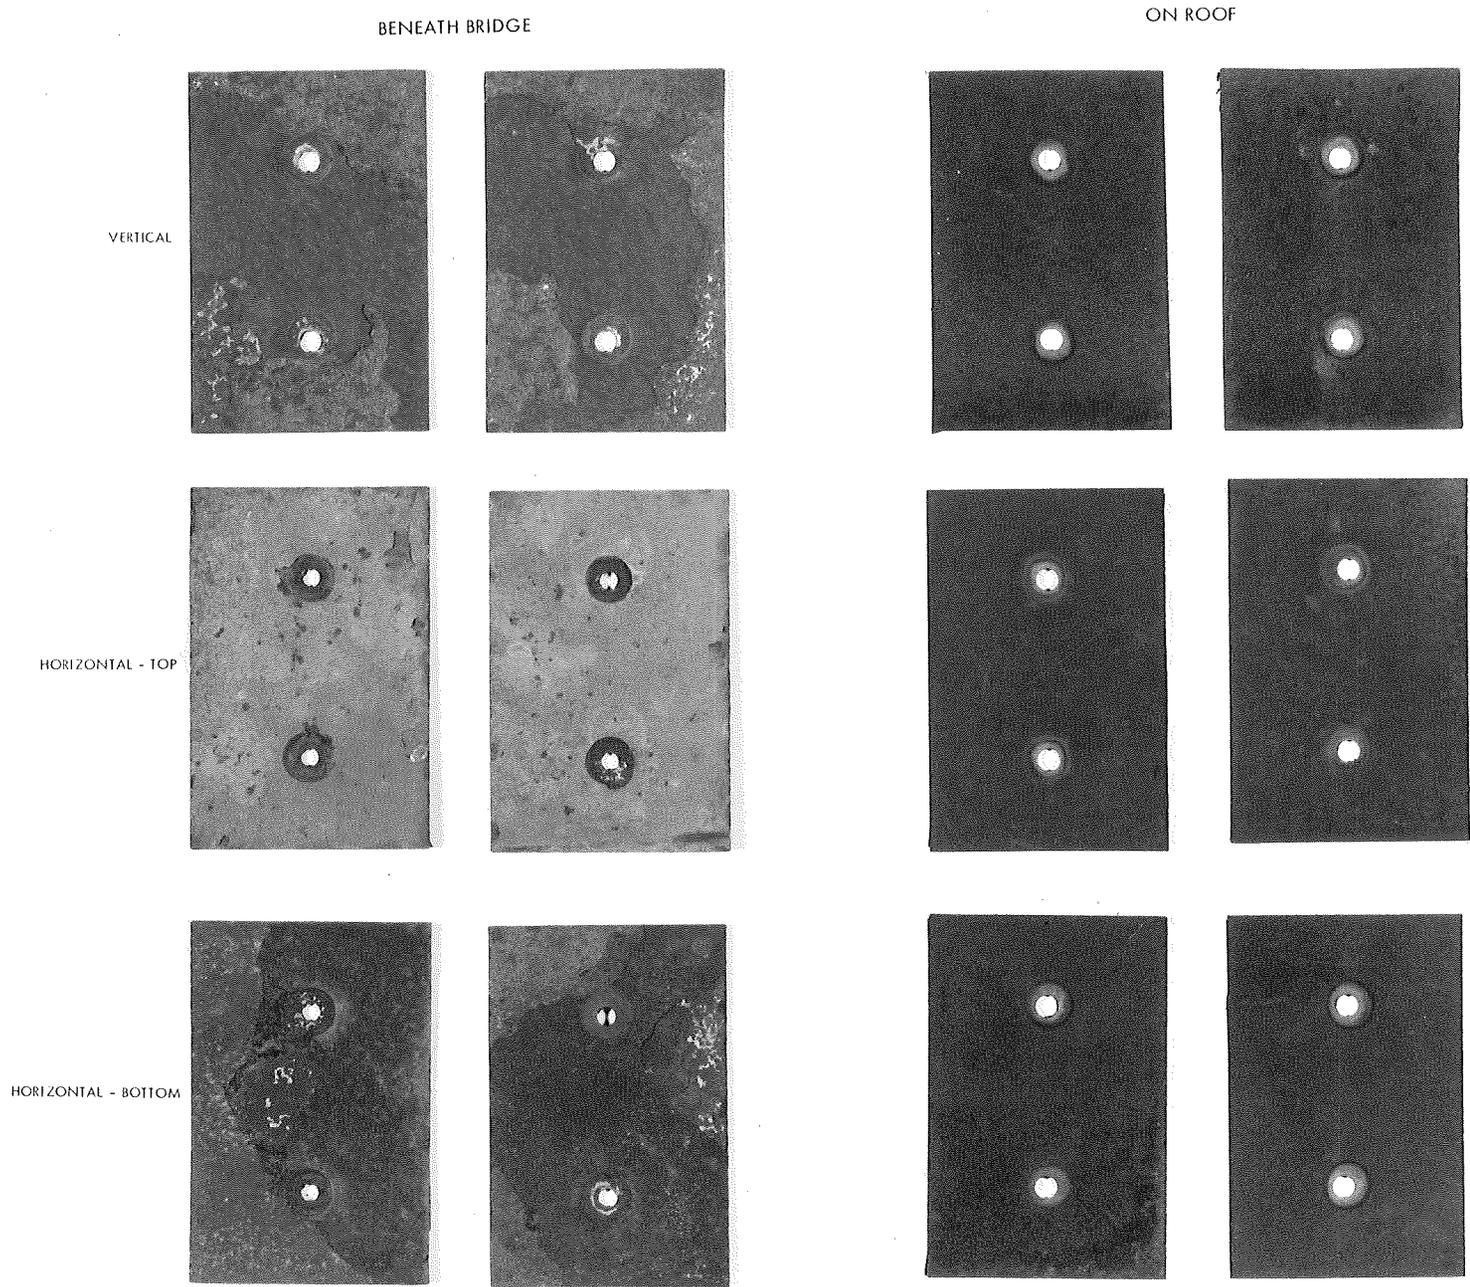
FIGURE 10

Figure 10 shows the condition of the four-year specimens beneath the bridge and on the roof before cleaning. Although the bridge specimens had an unsightly scaliness, when this was removed, the surface was smooth and proved to be free of any significant pitting.

MAYARI R STEEL SPECIMENS AFTER FOUR YEARS' EXPOSURE  
BENEATH THE BRIDGE AND ON THE ROOF, DETROIT, MICHIGAN
