Final Report RC-1526

Estimate of Cliff Recession Rates for the Baraga Cliffs

Michigan Department of Transportation

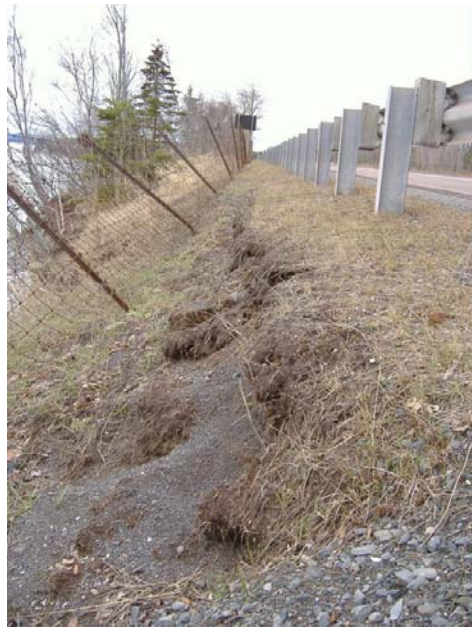
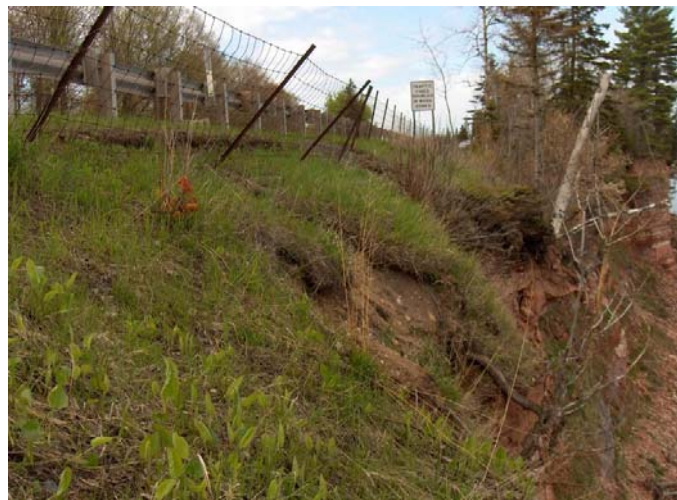
Unfortunately, due to cliff recession the cliff has eroded and has started to undermine the stability of the highway. Figure 2 shows the shoulder of the highway with the overburden material slumping towards the cliff. Figure 3 shows the cliff just below the slumping section, while Figure 4 shows a view of the cliff from the water. In the fall of 2007 the guardrail was moved several feet toward the highway, however, this spring additional slumping was observed close to the new guardrail.

Figure 2: Two views of overburden slumping on the top of the cliff adjacent to the highway (a) south view and (b) north view.

process. Since the recession of the cliff has advanced to a point where it is beginning to affect the stability of the highway, it is recommended that action be taken as soon as possible to relocate the road to a more stable position with respect to the cliff. Survey data of talus slope angles as well as stable slopes to the south of the cliff indicate that stable slopes develop at between 30° and 33° slopes. It is likely that the Baraga Cliffs will naturally evolve to this slope angle similar to the slopes to the south of the cliffs. It is recommended that the highway be relocated to a position beyond where this stable slope will develop. This recommendation, however, is premised on a stable talus slope forming and successful vegetation developing on the slope. This also assumes that the lake levels remain at their current level or near the long term lake average.

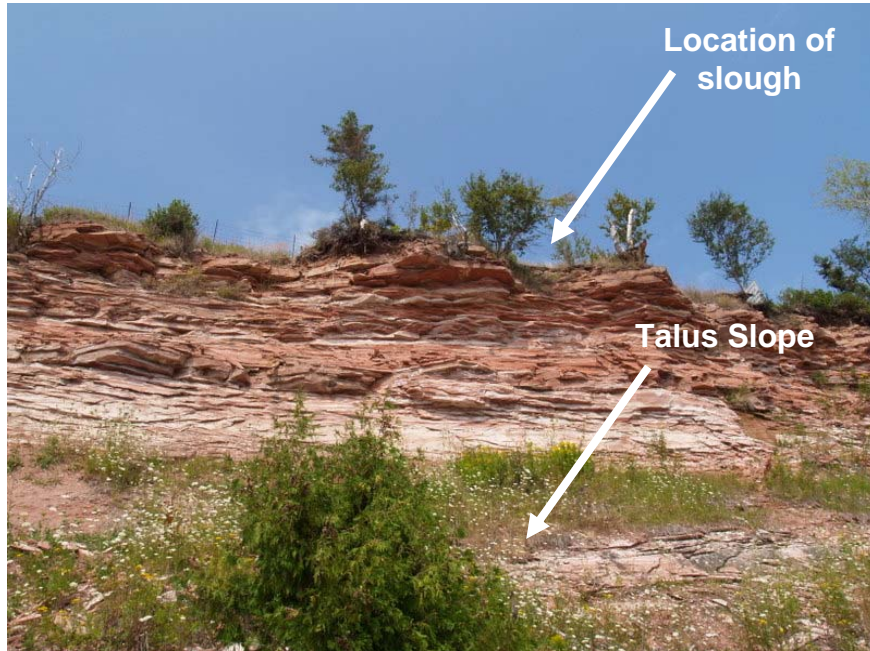
Figure 3 View of cliff just below the area shown in Figure 2. Note the talus slope with vegetation forming towards the base of the cliff.

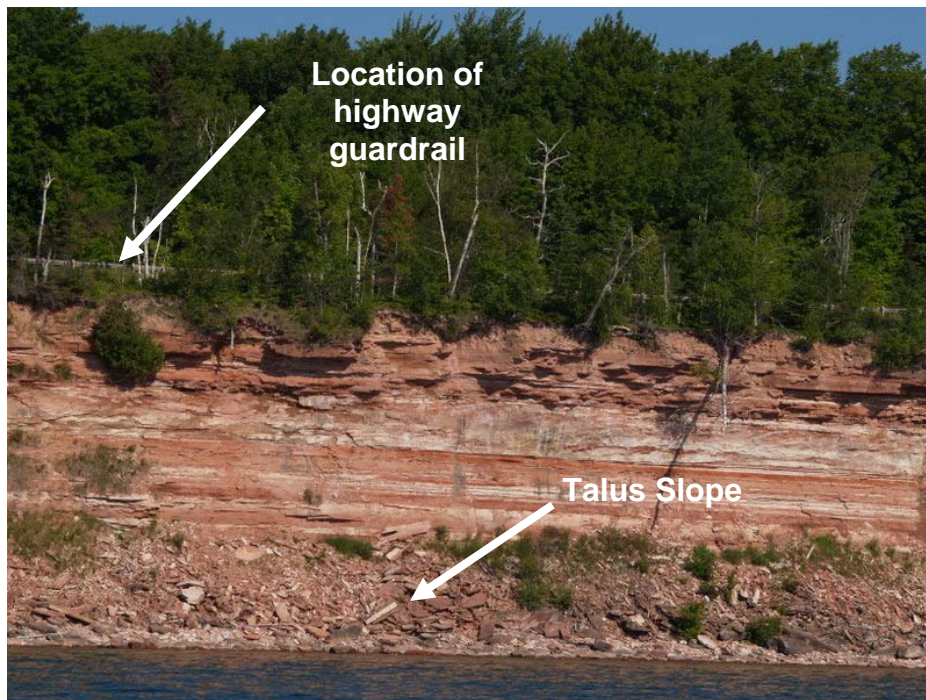
Figure 4 View of the cliff from the water. Note the highway guardrail on top of the cliff.

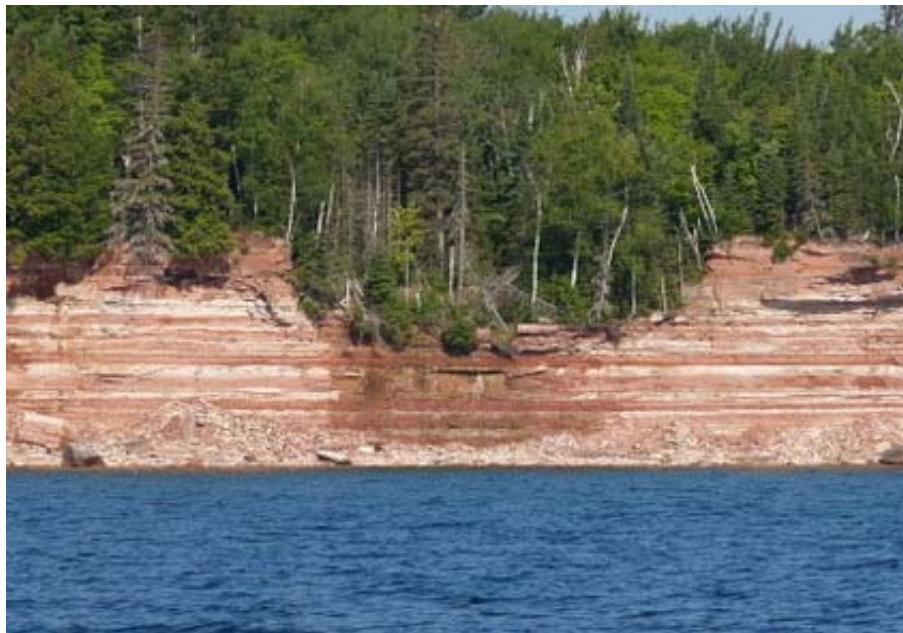
Figure 5: Seasonal stream causing accelerated erosion.

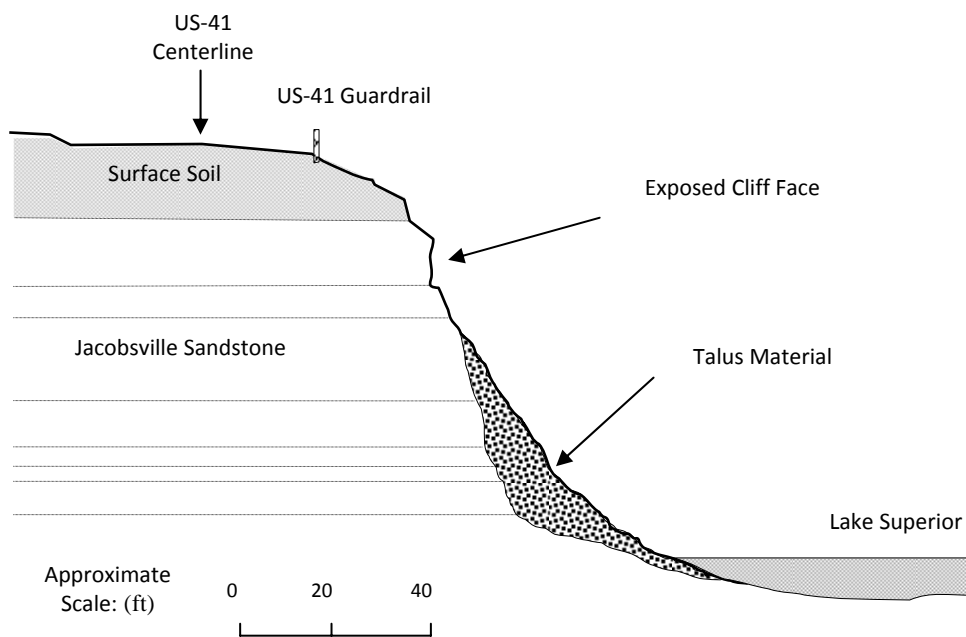
Figure 11: Cliff cross-section of at location of slough.

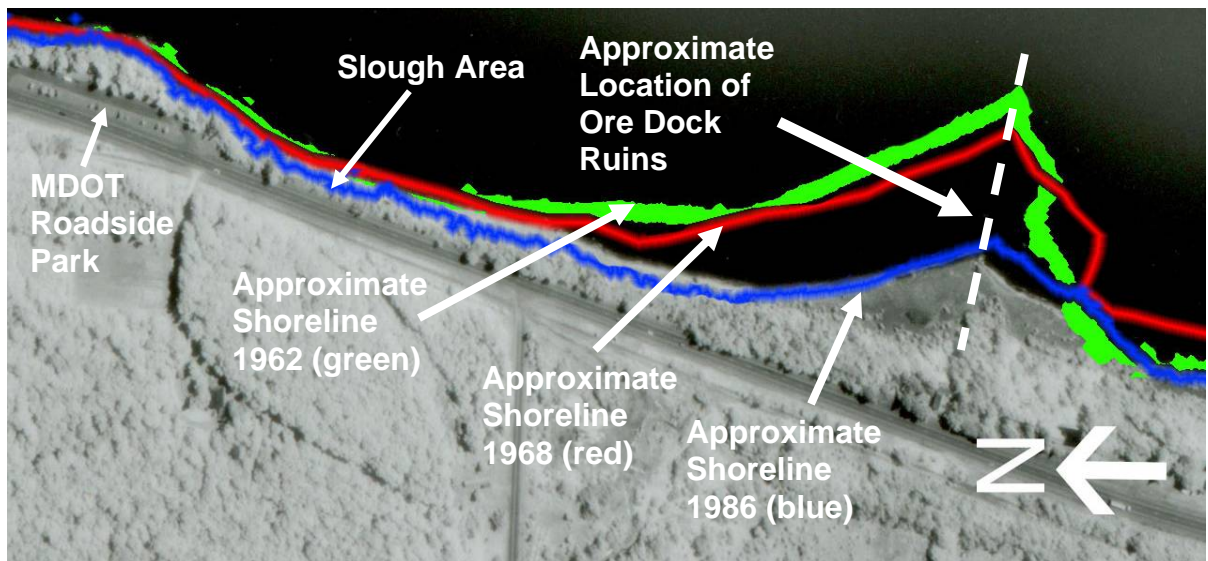
Aerial photography of the cliffs indicates that a beach, which is currently located to the south of the cliffs, was comprised of mine tailings (called stamp sands, which are discussed below). It appears that these mine tailings, which were deposited 80 to 100 years ago, were also deposited in front of the cliffs and protected the cliffs from long-shore currents. However, over time these tailings were removed by long shore currents moving to the south. Figure 18 illustrates the extent of movement of tailings southward over the forty year period of the photographs shown in Figure 8. Traces of the beach extent in 1962, 1968, and 1986, are overlaid on a photograph taken in 1997.

Figure 18: Erosion of stamp sands over a forty year period.

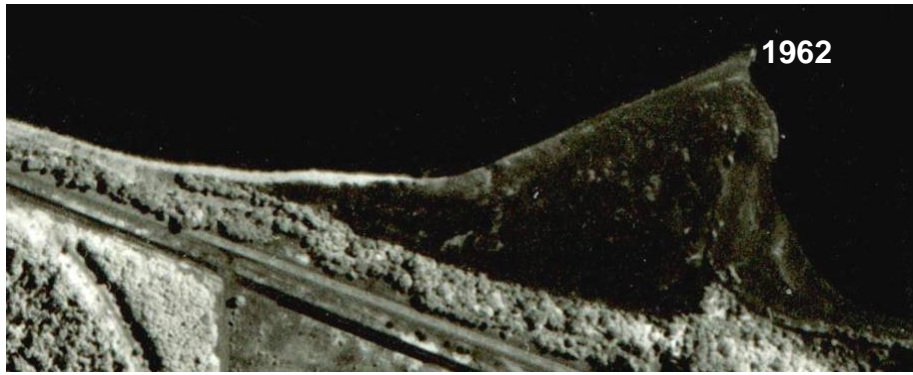
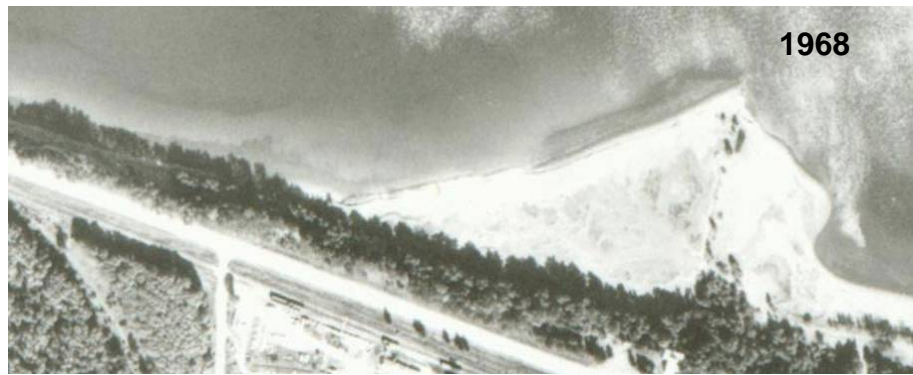
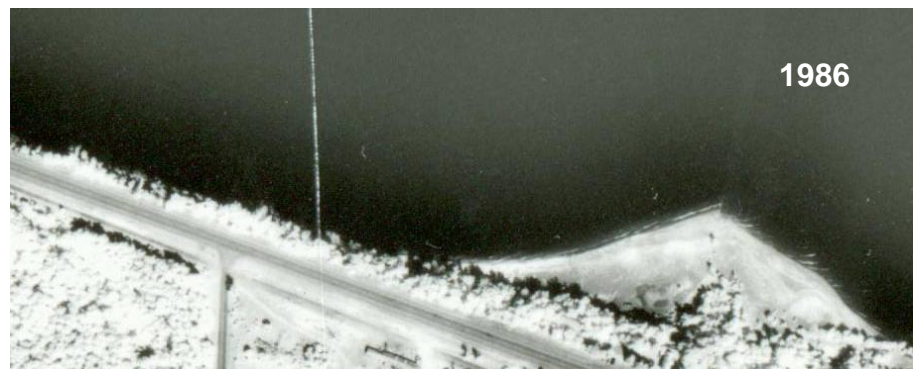
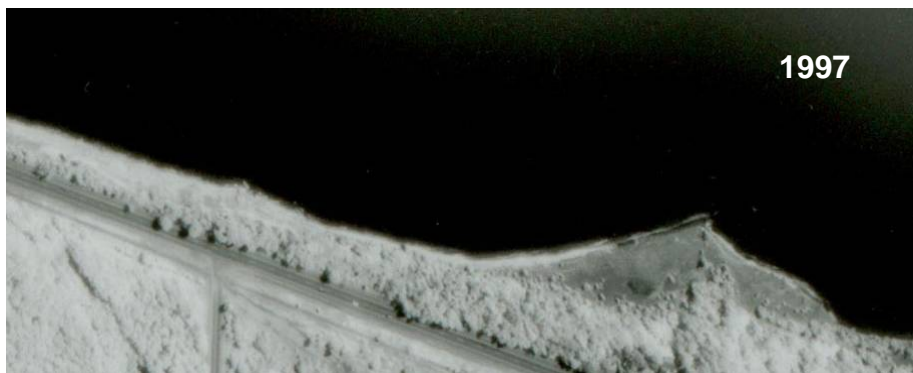
in this area, it is likely that the stamp sands were originally deposited north of the dock in this cove, which would have formed an artificial beach in front of the cliffs. It is possible that one reason for US-41 to have been located as close to the cliffs as it was is that the cliffs were then more protected from the long shore currents and wave action, which would have prevent or at least reduced the rate of cliff recession.

Figure 21: Protective beach recession seen in 1962, 1968, 1986, and 1997.

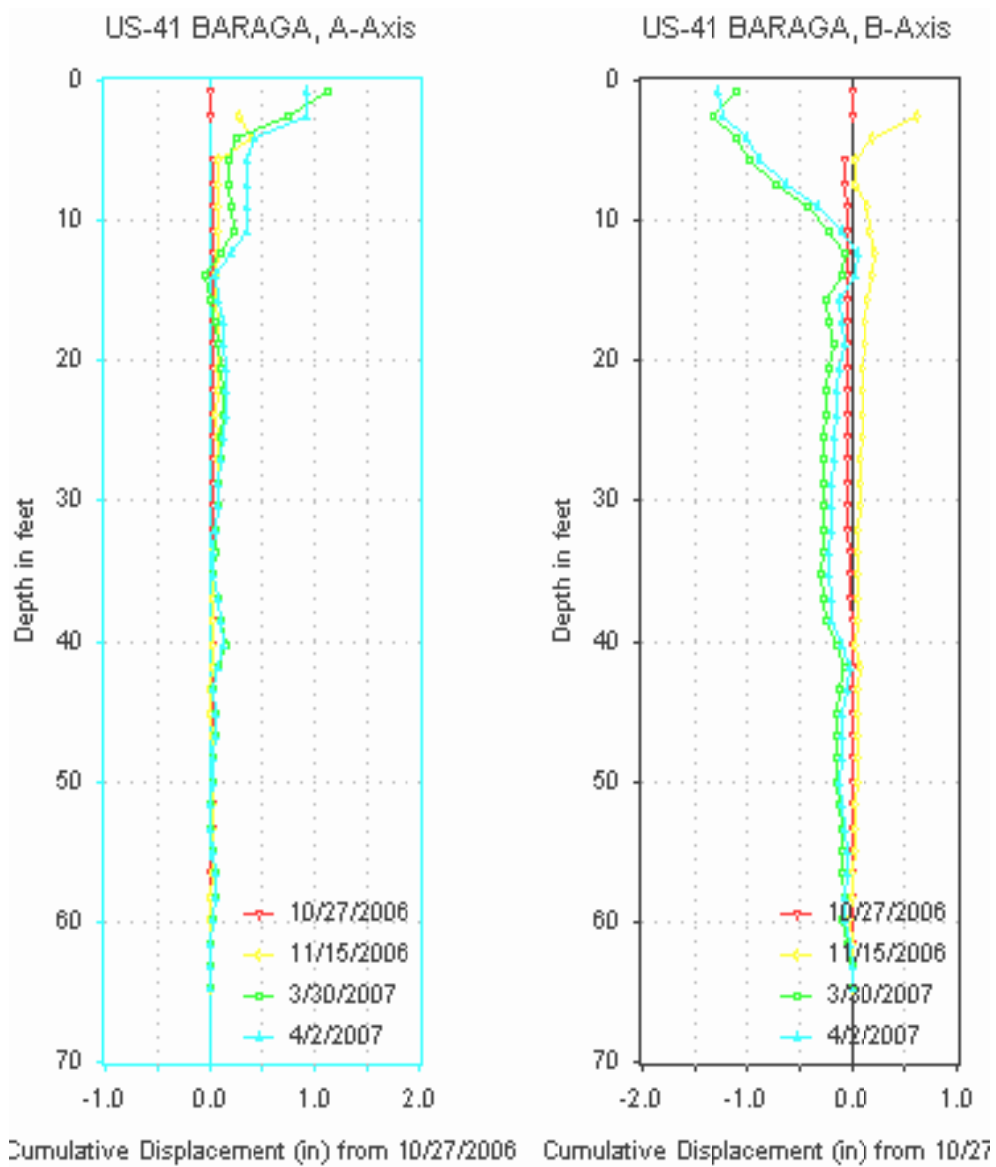
An inclinometer tube was installed by MDOT at the south end of the cliffs in borehole No. 3 (BH3). The inclinometer was monitored regularly from the fall of 2006 through the spring of 2008. An example of the inclinometer data is shown in Figure 26. Relatively little movement was detected over the majority of the tube.

What little movement was noted was in a direction away from the cliff. What movement was detected also occurred near the top of the borehole was likely due to changes in moisture content and freeze-thaw action. An example of the inclinometer data is shown in Figure 26. This figure shows the quality of the measurements near the top of the holes was less reliable than the bottom. Though little to no movement was detected, however, this installation can provide vital warning in the unlikely event of the large scale failure of the cliff.

Figure 26: Inclinometer tube results

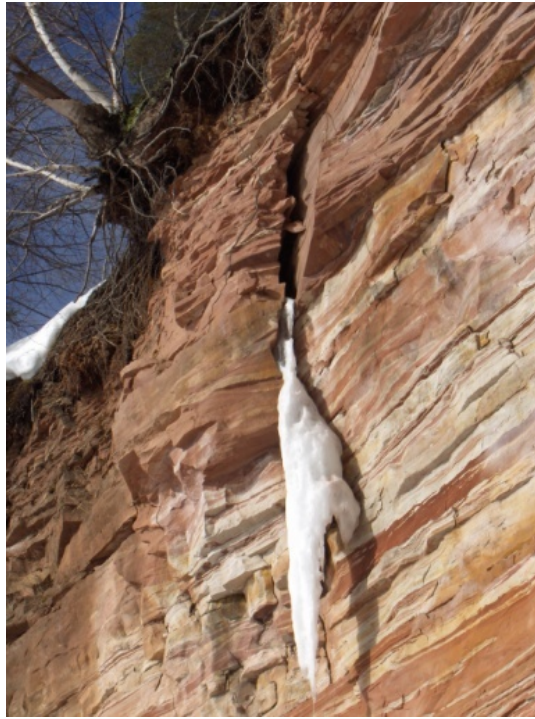
Figure 27 Ice jacking on the cliff face.

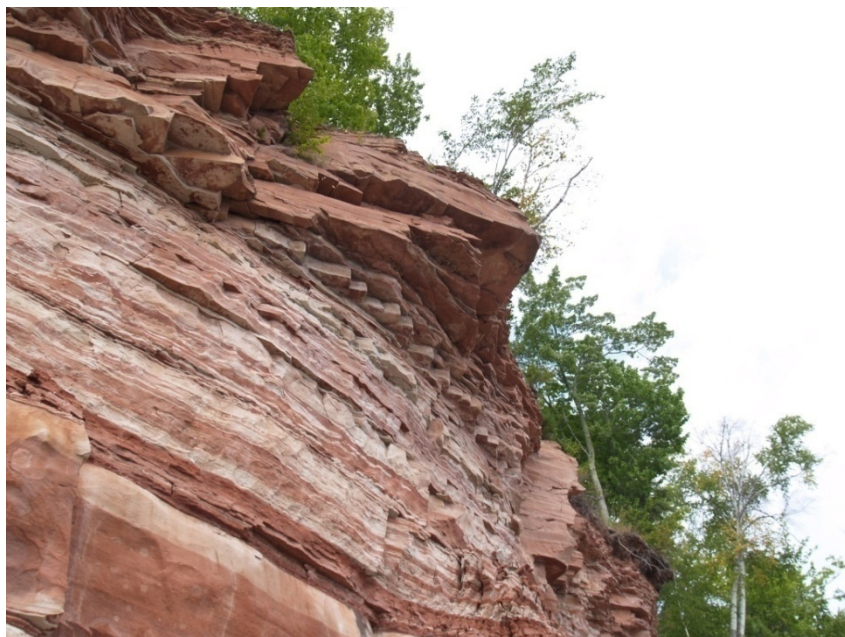
Overhanging rock ledges as shown in Figure 28, which is caused by the erosion of the underling rock, is also common at the Baraga Cliffs. Sections of the cliffs with overhanging ledge rock are clearly visible from below and are due mainly to the undercutting of the less resistant rock below the ledge rock. As the rock below these ledges continue to erode, stress fractures are generated from the tension forces in the overhanging rock. Figure 29 shows a large rock fragment that recently dropped from a mid-section of the cliff. While fragments as large as 30 ft can fall from the cliff face, these events tend to be relatively localized and present in general a small amount of the cliff recession when considering the total volume of rock erosion each year.

Figure 28 Overhanging section of rock.

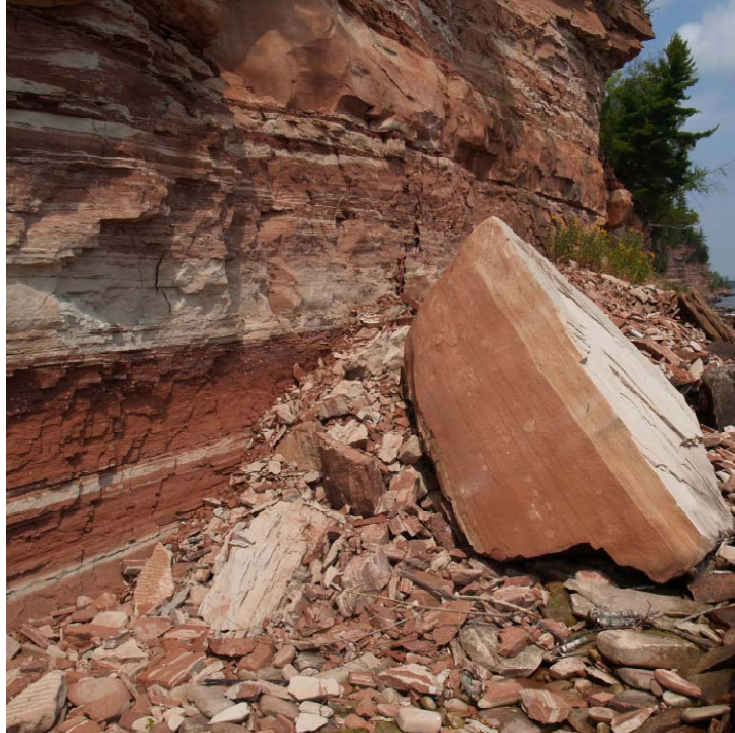
Figure 29: Eroded section from runoff and heavily undercut area.

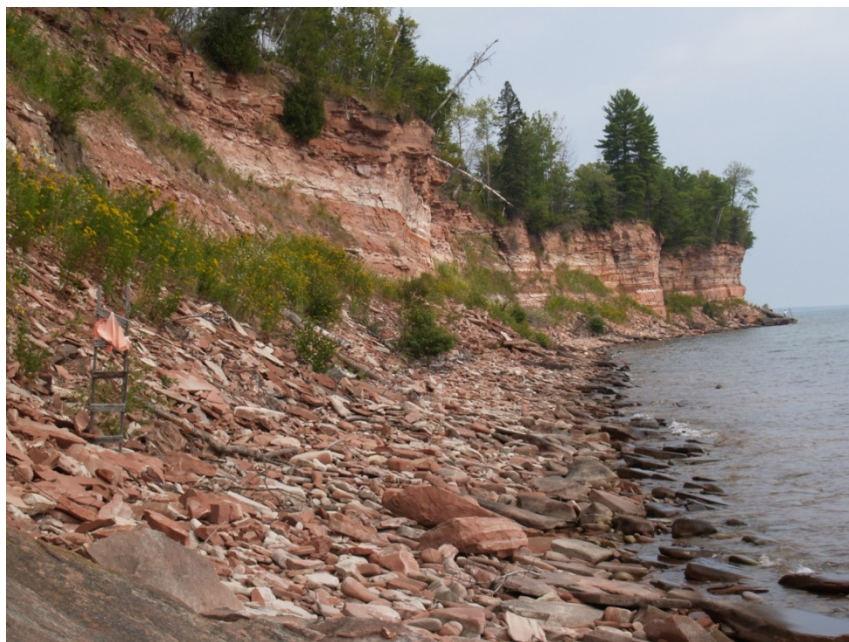
Figure 30 Talus slope just below the section of cliff threatening the highway.

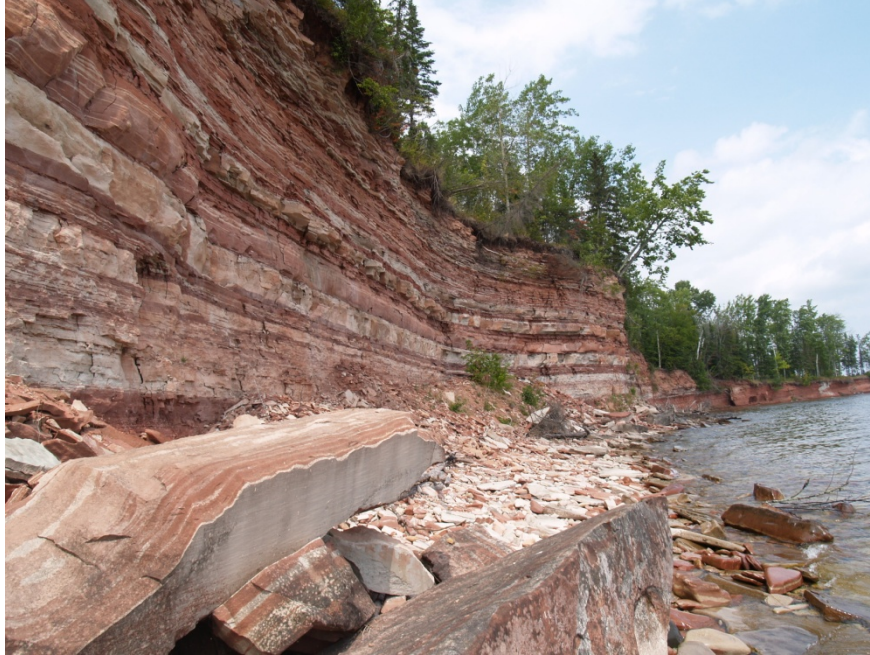
Figure 31 Section of cliff just north of the MDOT Roadside Park.

3. MDOT Roadside Park, at the north end of the cliff, affords a buffer for the highway. The cliff at the park has not been protected by stamp sands but appears to be of more competent rock. The cliff also has no talus slope below it at this point and large blocks litter the water below. This area will have to be studied further before recommendations for the remediation of the park can be made. Since the park structures and area are not immediately threatened, further investigation into how this area could best be remediated are possible and would allow for methods to be studied that may be applicable to other Sandstone cliffs such as those found in Pictured Rocks National Lakeshore.

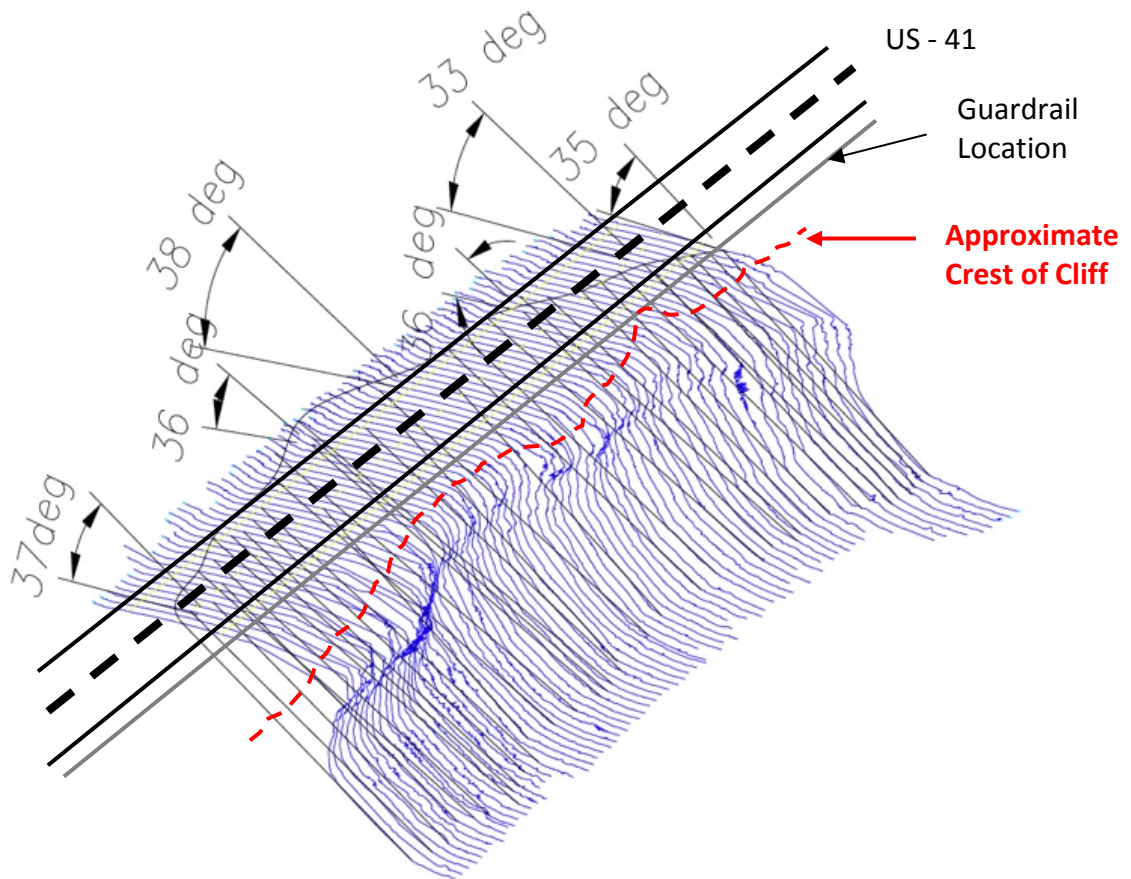
Figure 35: Wire-frame model with slope projections of talus slope

slope would be stable so that an estimate of the set-back distance that the highway should be moved to. The model seen in Figure 35, shows that the talus slope at the base of the cliff rests at an angle between 33 and 38°; this angle is somewhat higher than the angle of the slope south of the cliff. Using an estimate of a 33° slope angle the highway would need to be moved away from its current location by about 66 feet.
