"SEALZ" JOINT SEAL STUDY

Research Project 36 G-4 (3)

Research Laboratory  
Testing and Research Division  
Report No. 49  
January 12, 1944

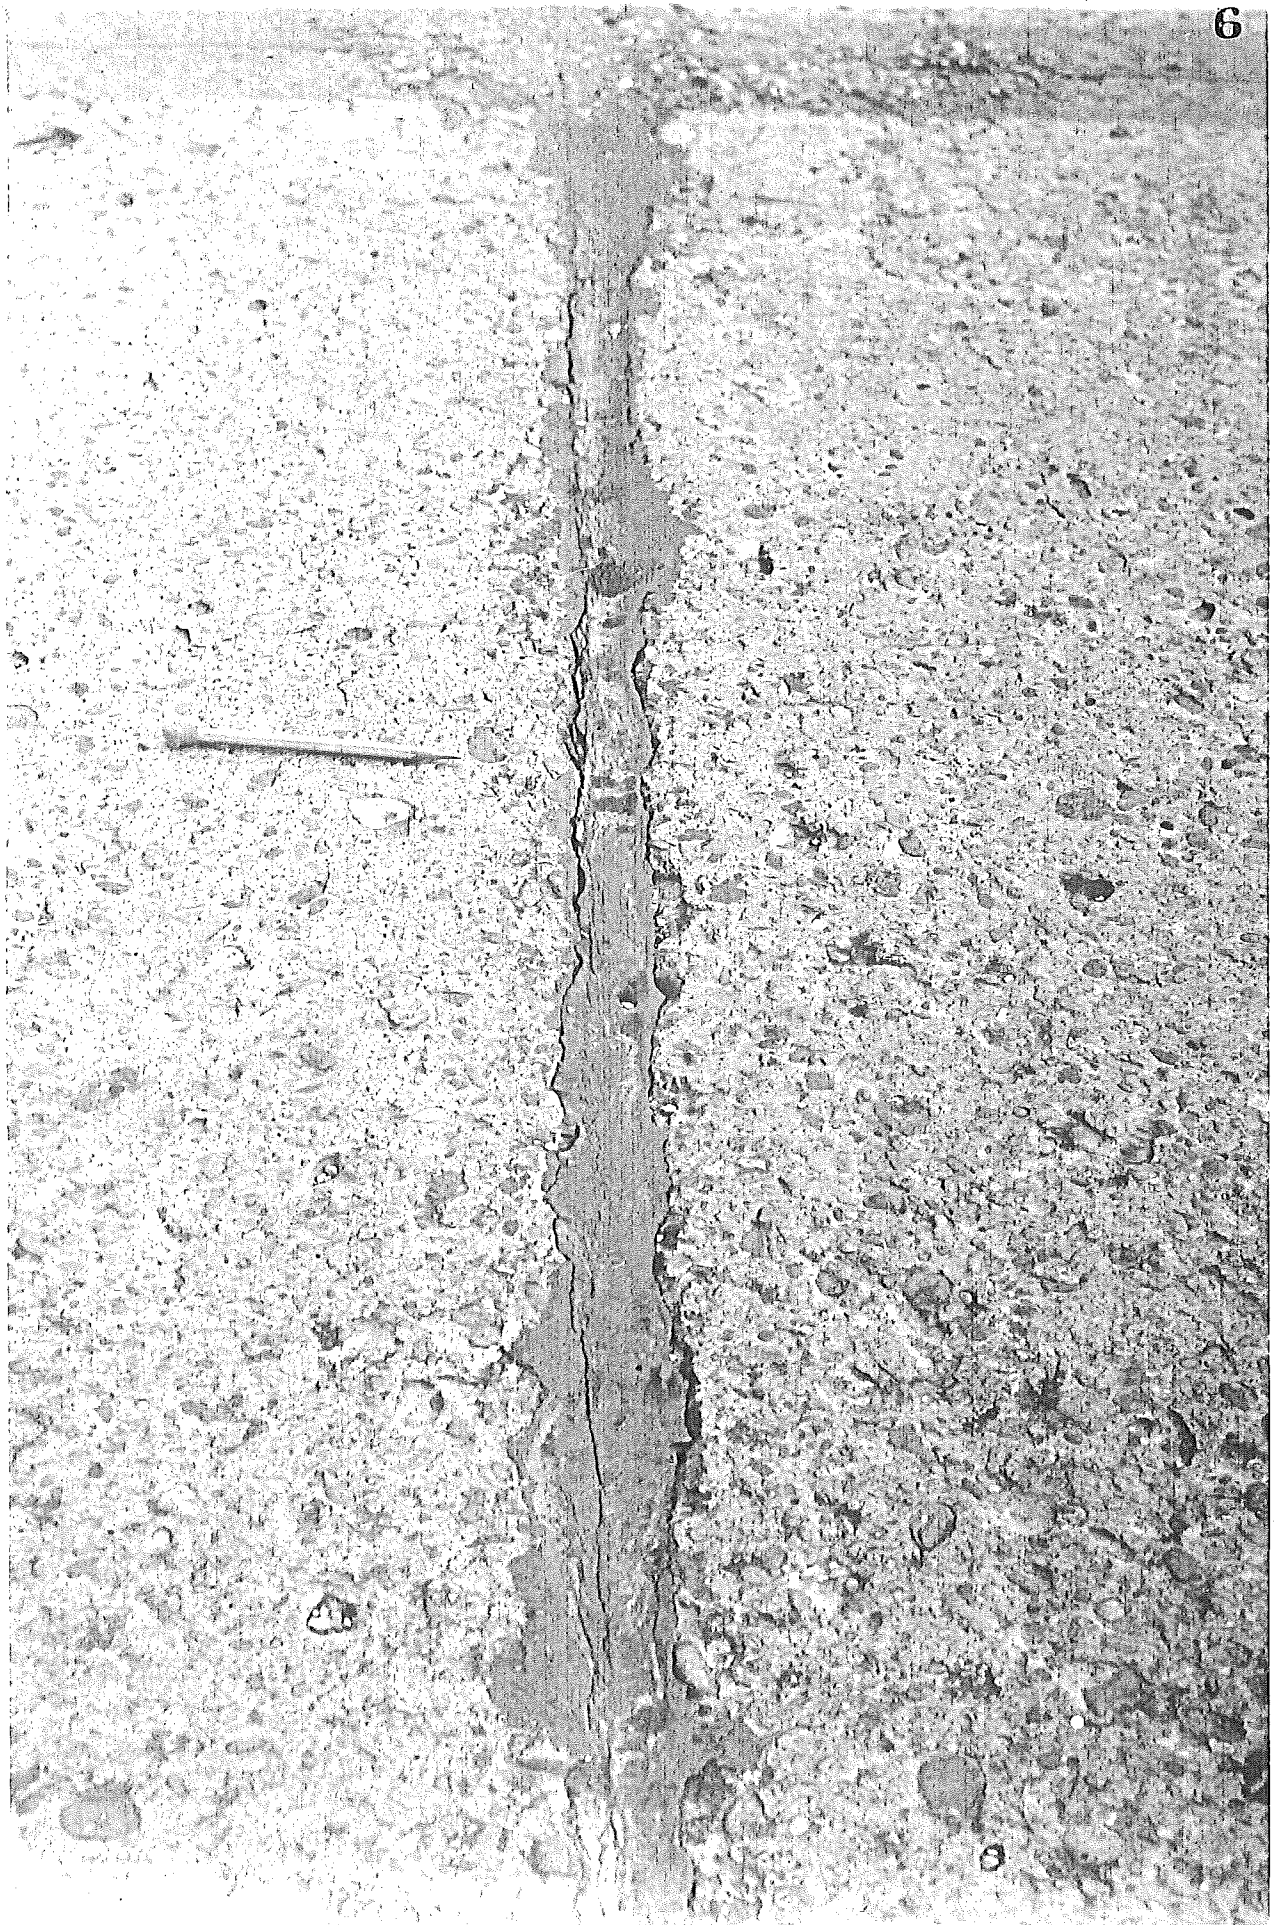
The most significant conditions revealed by the inspection are as follows: First, in general throughout the entire test installation of "Sealz" material, the joint seal material had begun to crack and develop bond failure at edge of concrete joint as illustrated in Figure 1. Second, where there was no curb section along the slab edge the joint material had failed completely in some instances for a distance of approximately one foot in from the edge of the slab. The joint opening had become filled with fine shoulder material. This condition is illustrated in Figure 2. Third, where there is a curb section it was noted that a large deposit of joint seal material had formed near the curb. See Figure 3. It is not known whether this condition was caused by poor workmanship in pouring the joint originally, or whether it developed subsequently due to high summer temperatures which caused the material to flow laterally to the curb.

Figure 1. Typical condition of Sealz joint seal material December 2, 1943. Installed May 19, 1940.

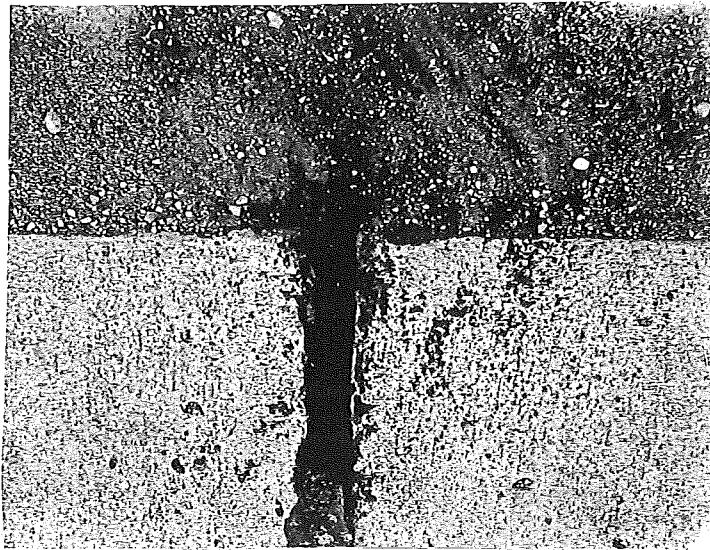
Figure 2. Failure of Sealz at joint edge  
Station 122+50.

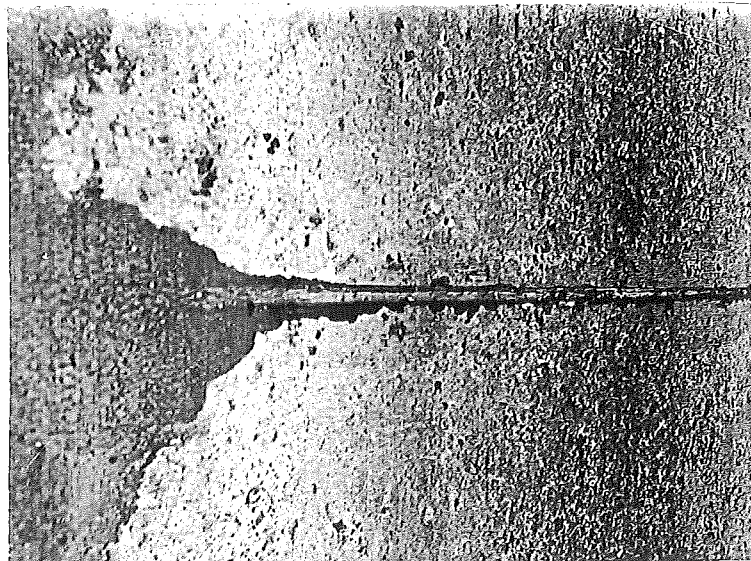
Figure 3. Excess material at gutter.
