MICHIGAN
DEPARTMENT OF STATE HIGHWAYS

August 4, 1971

Subject: Epoxy Mortar Surfacing on the Crietz Rd Bridge over I 496, Lansing (S05 of 23081A): A Report on the First and Second Annual Field Inspections. Research Project 67 G-157. Research Report No. R-778.

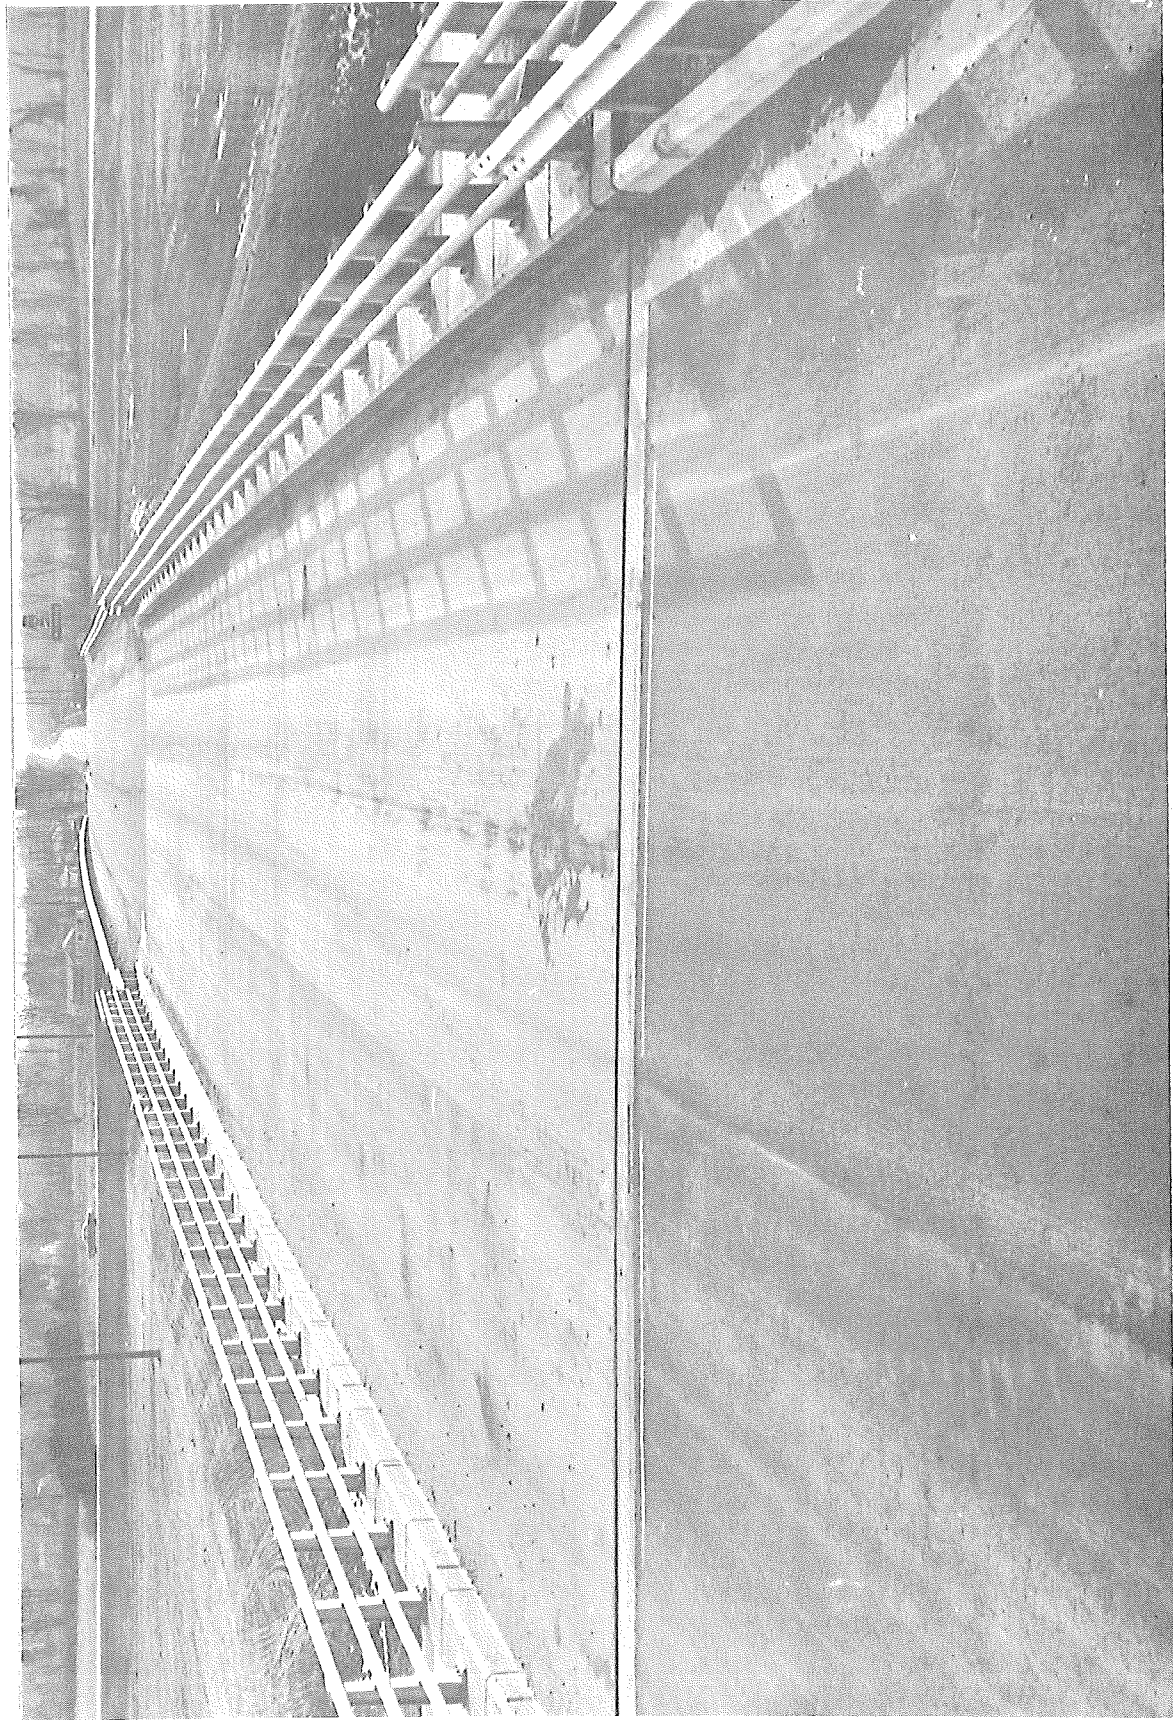
Figure 1 shows the overall view of the deck looking south at the time the initial set of oblique photographs were taken; approximately one month after the bridge was opened to traffic.

Figure 1. View looking south over Crietz Rd Bridge, December 1969.

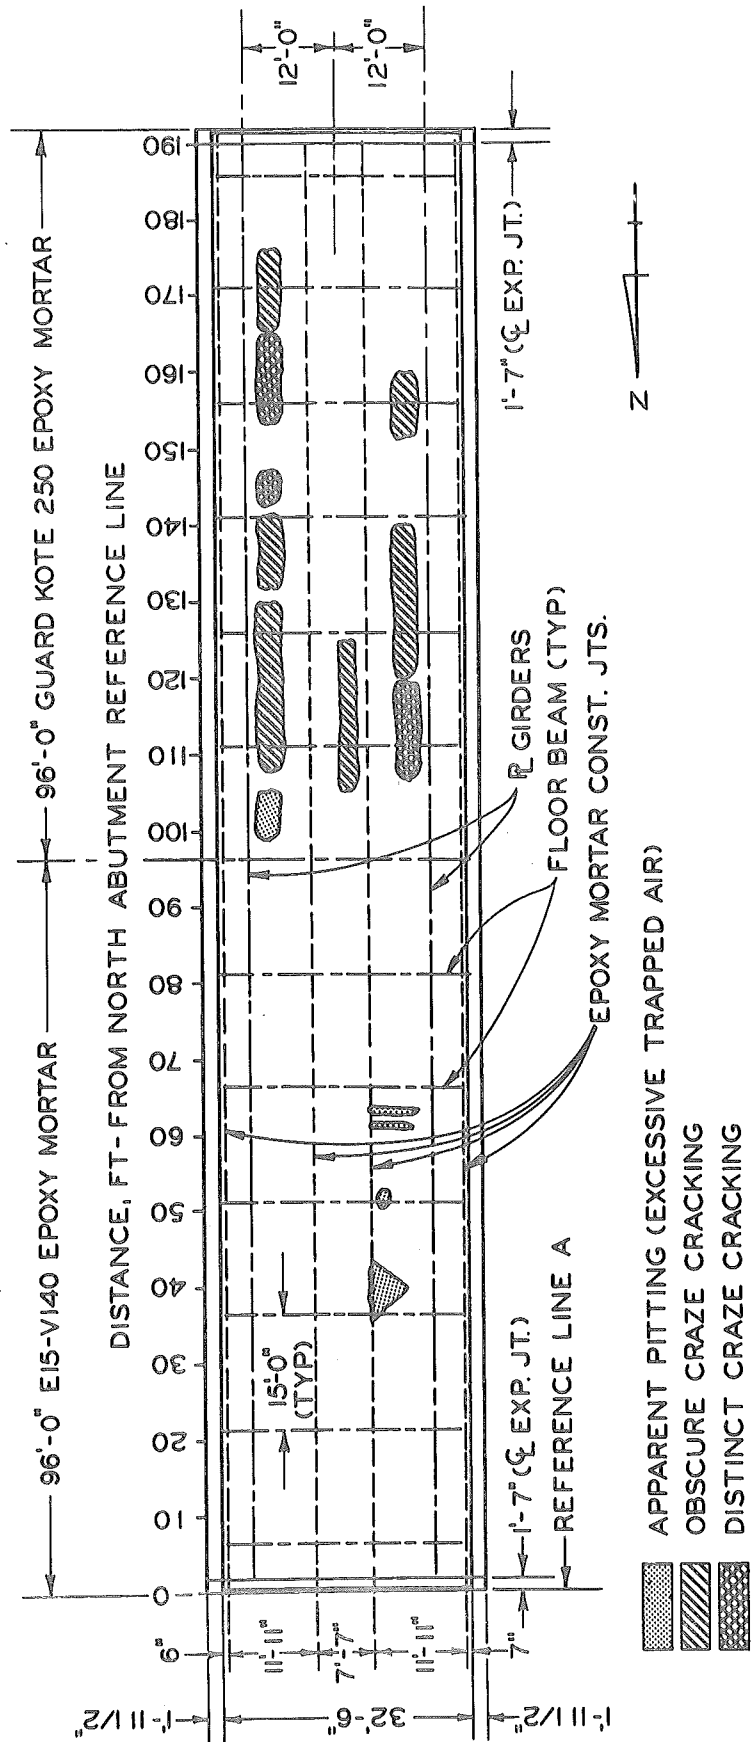
In the latter part of April 1970, the deck was closely inspected and all types of deterioration were shown and noted on a scaled plan drawing. Figure 2 is a diagram of the deck which shows the signs of deterioration found at the time of this inspection.

On the west strip of the north half, where some screeding difficulties were encountered with cold E15-V140 epoxy mortar, several badly pitted areas were observed. This problem was later solved by heating the epoxy. We believe that an excessive amount of air had been trapped during mixing by the cold, higher viscosity binder in these areas. Traffic soon removed the thin cover over the voids, and in their exposed condition they resembled pitting instead of air bubbles.

On the south half of the bridge, the weather was warmer when the Guardkote 250 mortar was placed, and this binder had a lower viscosity so excessive trapped air did not become a problem. However, it appeared that the mor-

tar wearing surface was developing a pattern of craze cracking. Reference to Figure 2 shows that the present pattern was not random but seemed to be developing under the outside wheel track of both the northbound and southbound traffic lanes. Many of these craze crack areas appeared to coincide with live-load negative moment areas over the transverse floor beams.

Figure 2. Deterioration features in the epoxy mortar wearing surface as observed on April 29, 1970.

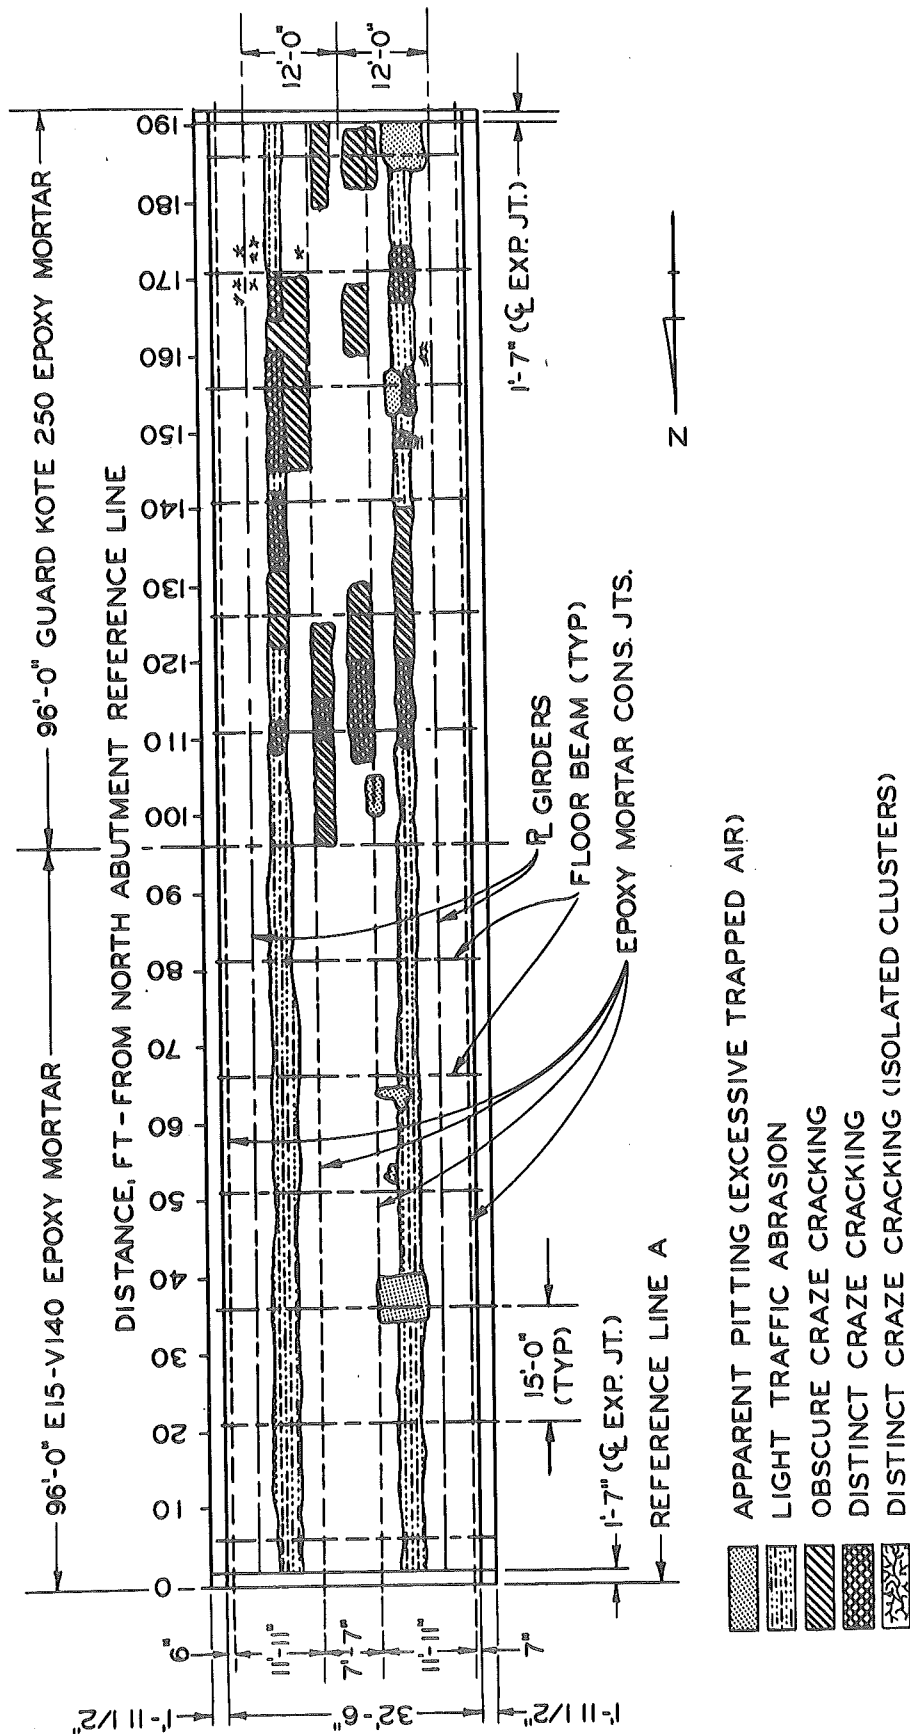
In mid-May 1971, the deck was again closely inspected and all types of deterioration were noted and recorded as before. Figure 3 is a diagram of the deck which shows the deterioration features found at the time of this inspection.

The light traffic abrasion shown in the diagram in Figure 3 is probably responsible for the loss of traction that is apparent in Table 1. There also appears to be a greater accumulation of road oils and dirt in the surface of the south half. It is believed that the coefficients of friction as measured on June 3, 1971 should be about the minimum that will be reached; additional tests will confirm if any further polishing should develop. Another winter's exposure may require some remedial measures for the fine cracking in the south half, but no recommendations are being made at this time.

Figure 3. Deterioration features in the epoxy mortar wearing surface as observed on May 6, 1971.

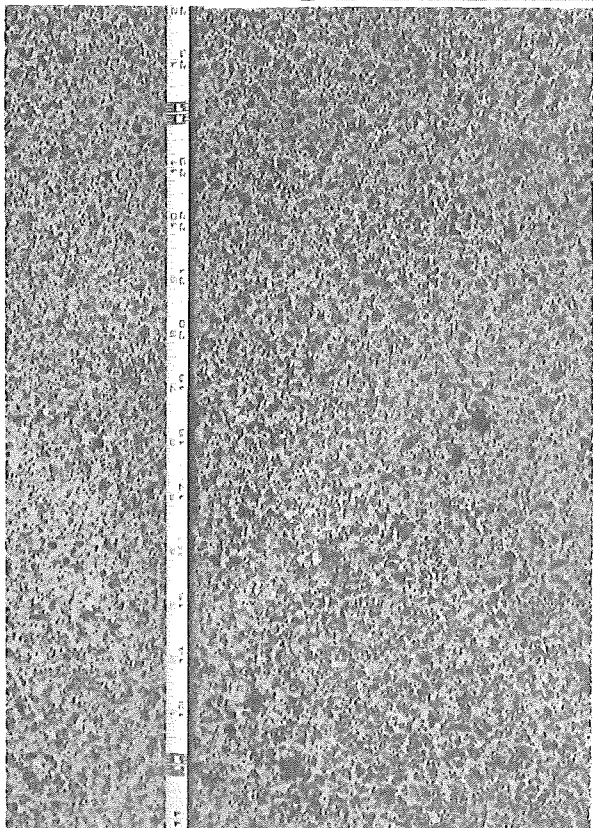
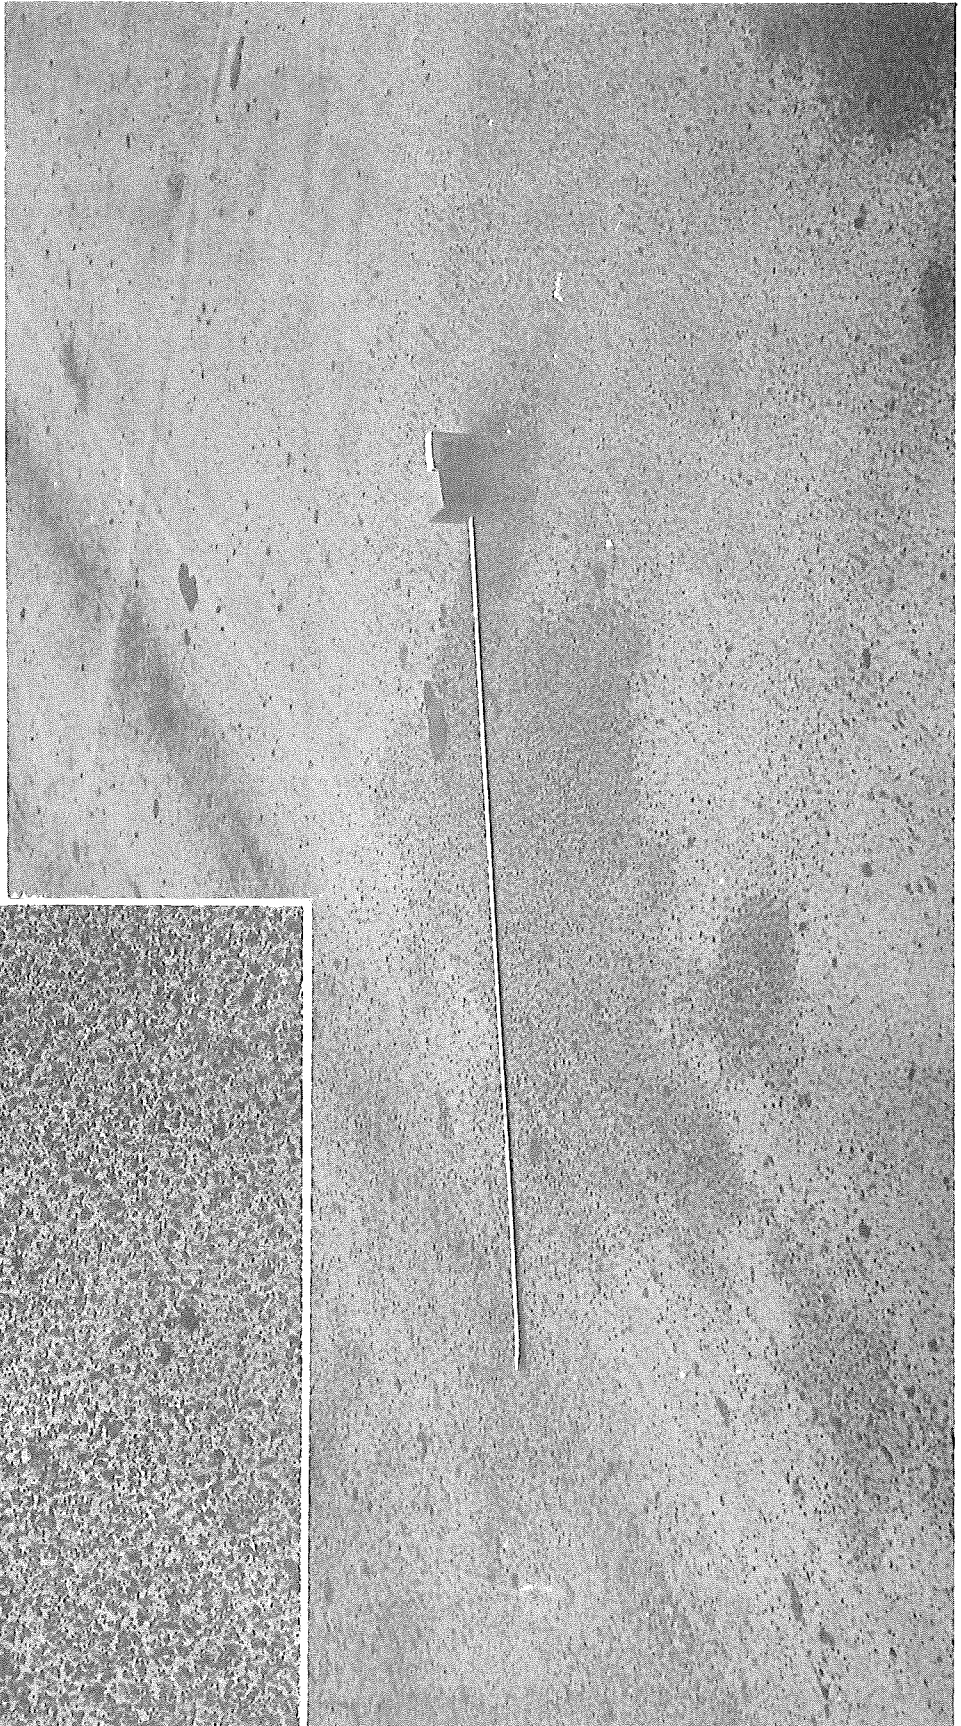
On the north half of the bridge, where the E15-V140 epoxy mortar was placed, the condition of the mortar surface had changed very little. Some light traffic abrasion had occurred and the west side "pitted" area, located about 35 ft from the north abutment, had enlarged about 50 percent. This pitting, as previously explained, is merely the exposure of large (1/16 to 1/8 in.) air bubbles that were trapped by the cold viscous epoxy binder. Although this is a distinct feature, it appears to be superficial (Fig. 4).

Figure 4. General area and close-up view of apparent pitting in E15-V140 epoxy mortar about 6 ft from the west curb line and at the 40-ft mark from the north abutment reference line.

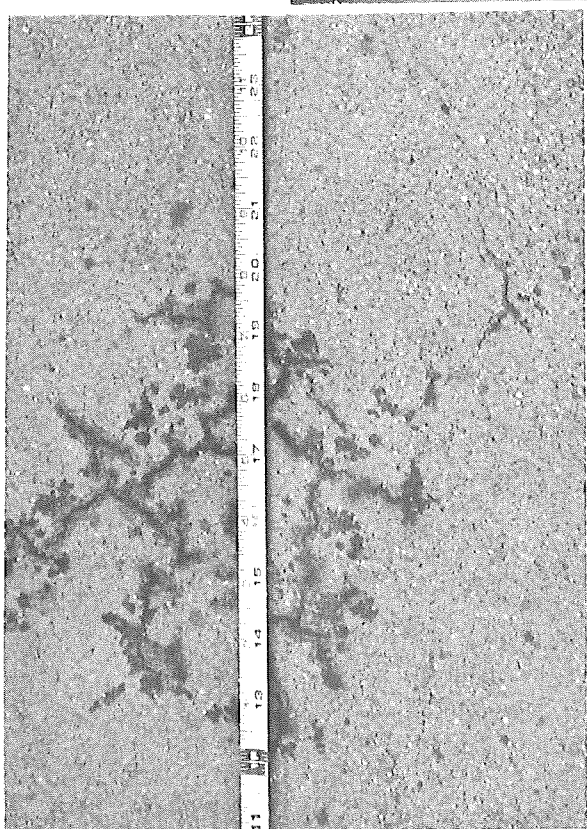
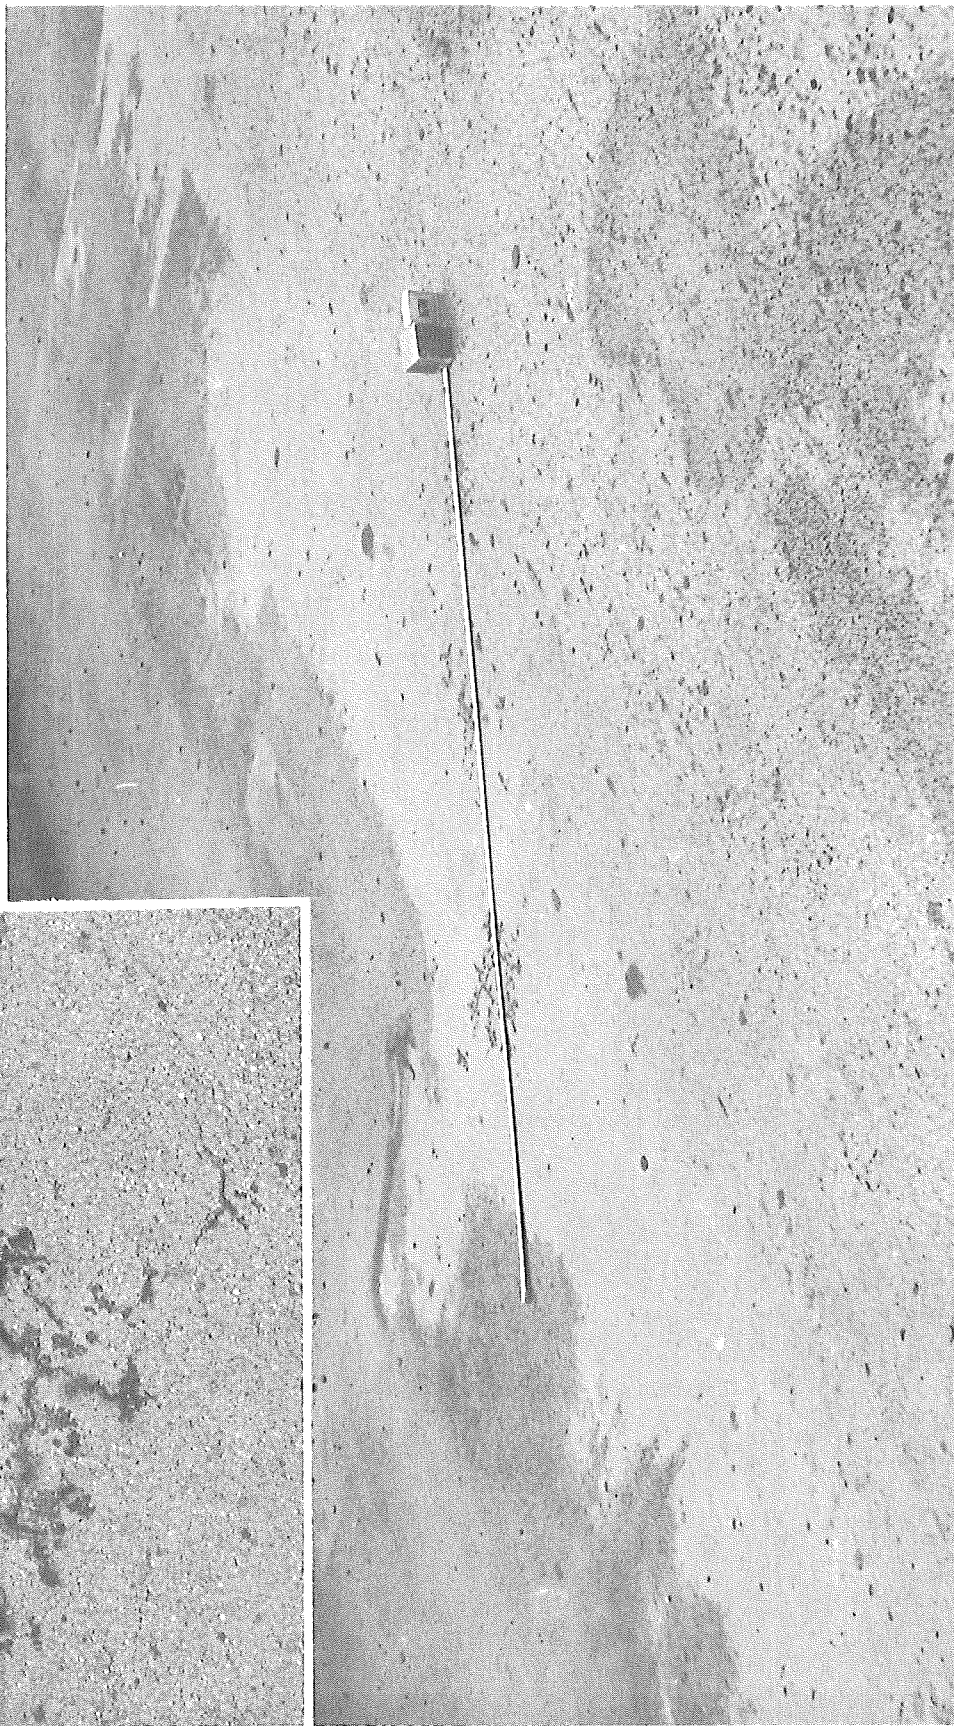
On the south half of the bridge, where the Guardkote 250 mortar was placed, the condition of the mortar surface has continued to deteriorate. Many of the areas that were observed to have obscure craze cracking in 1970 have now become distinct, thus expanding the total area now exhibiting craze cracking. On the east side of the bridge around the 170-ft mark, and on the west side near the 160-ft mark, clusters of craze cracked spots have developed. At first it appeared that this cracking had gone full-depth through the epoxy mortar, because dark "rusty" spots were apparent; however, further investigation established these "rust streaks" to be embedded asphalt. Figure 5 is a view of these clusters around the 170-ft mark on the east side of the deck.

age. It was theorized in the report¹ that the shrinkage was caused by a volatilization of the oil with which the epoxy was extended. It would appear from the development of craze cracked areas on this bridge that the Guardkote 250 epoxy mortar surfacing is undergoing the same shrinkage as was observed in the laboratory, but it appears to be a surface feature and does not go full depth.

Figure 5. General area and close-up view of isolated distinct craze cracking in the Guardkote 250 epoxy mortar surfacing located 5 ft from the east curb line and at 172 ft from the north abutment reference line. The black streaks originally thought to be rust are actually embedded asphalt probably from approach paving operations.

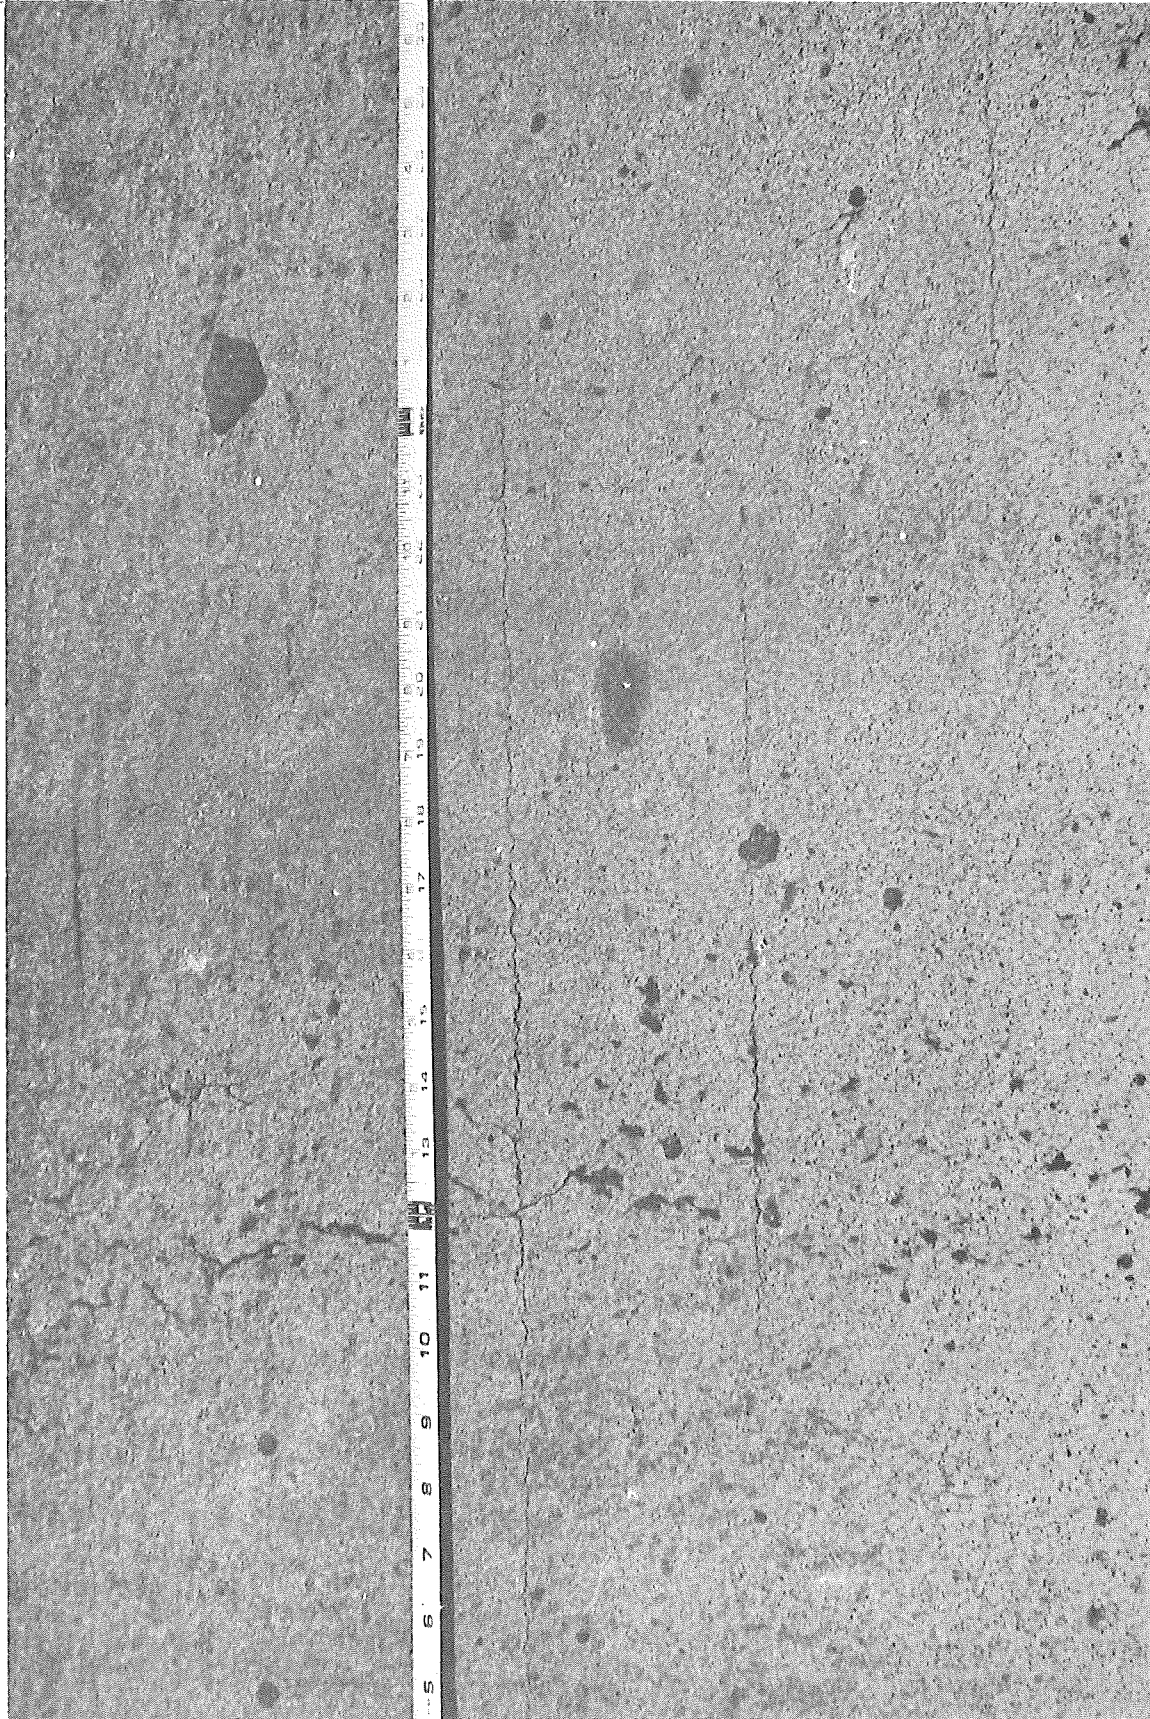
On the west side of the deck near the 150-ft mark, a longitudinal crack pattern is developing about 7 ft from the curb line; presently it consists of three parallel cracks which apparently are the result of flexure in the steel deck. These cracks are located directly above the east edge of the second rib from the west girder. This crack pattern is shown on the diagram in Figure 3 and a close-up view of it appears in Figure 6.

The parallel longitudinal cracks which were previously described, are probably the result of a combination of stresses. One of the contributing stresses, since the cracks occurred midway between two floor beams, was probably tension caused by differential flexure of the longitudinal ribs as live loads moved across the bridge. Other contributing stresses were caused by shrinkage and thermal contraction.

Figure 6. Close-up view of parallel longitudinal cracks which are developing along with a distinct craze crack pattern in the Guardkote 250 epoxy mortar surfacing about 7 ft from the west curb line and at the 150-ft mark from the north abutment reference line.
