NEOPRENE PREMOLDED JOINT SEAL STUDY
CONSTRUCTION PROJECT F 34-15, C4 on M-66
Progress Report No. 4

Research Laboratory
Testing and Research Division
Report No. 210
July 1, 1954

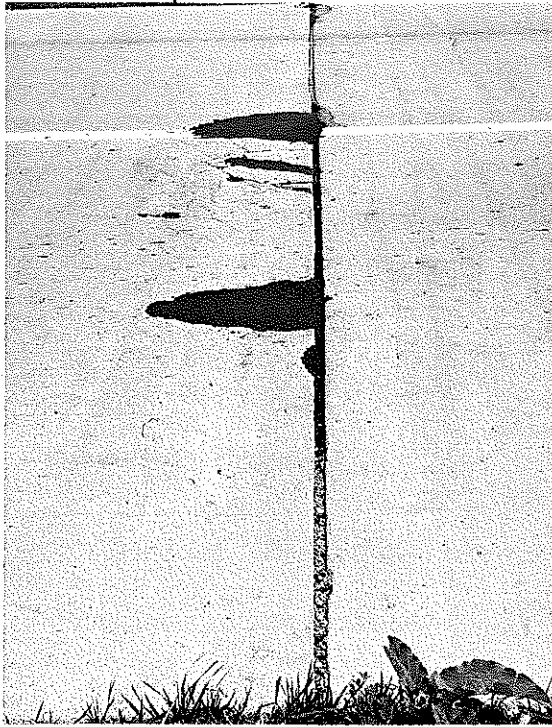
NEOPRENE JOINT NUMBER 16

▲ FIGURE 1. SHOWING DISINTEGRATION AS OF AUGUST 3, 1953. STATION 113+21. LOOKING WEST TO EAST.

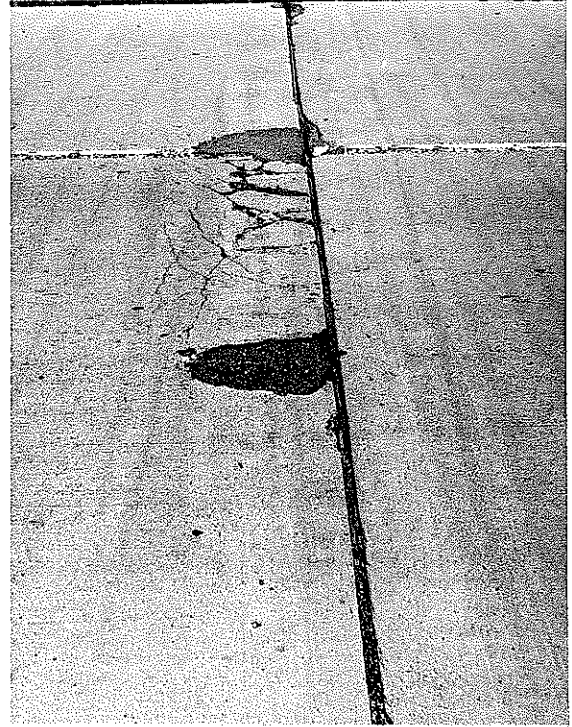
▲ FIGURE 2. THE SAME JOINT, JUNE 9, 1954. SHOWING PROGRESSIVE CHECKING WHICH HAS OCCURRED SINCE 1953 SURVEY.

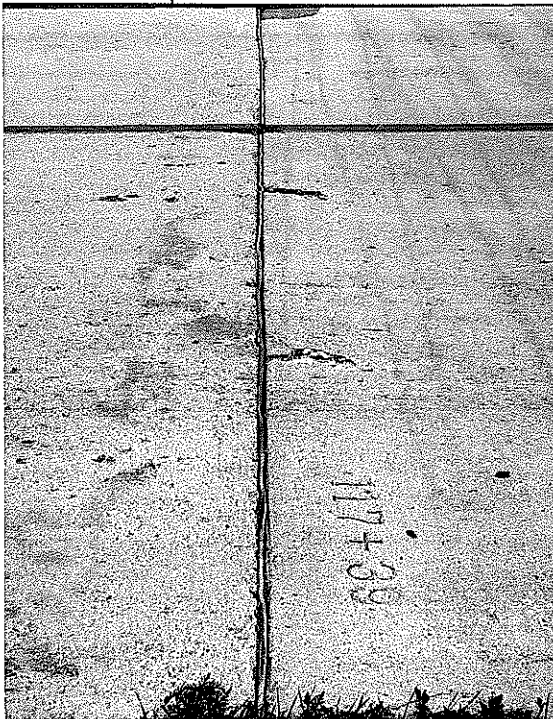
NEOPRENE JOINT NUMBER 19

▲ FIGURE 3. SHOWING PAVEMENT CONDITION AS OF AUGUST 3, 1953. STATION 117+39. LOOKING EAST TO WEST.

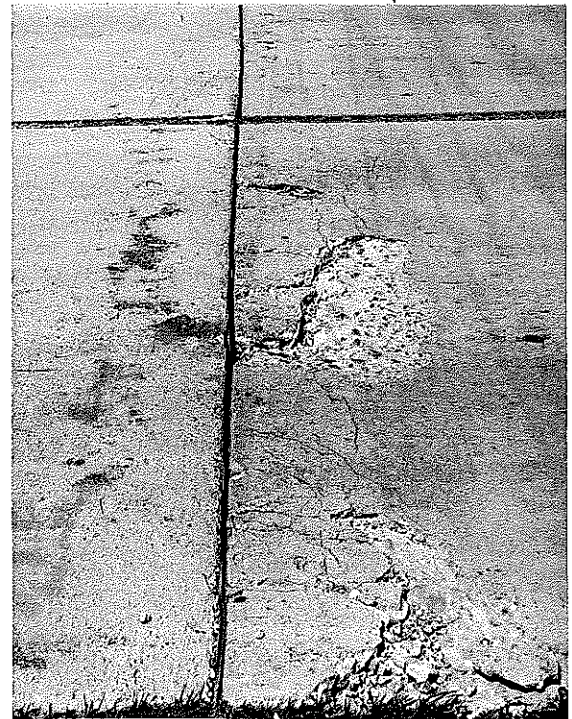
▲ FIGURE 4. THE SAME JOINT, JUNE 9, 1954. NOTE THE GREAT INCREASE IN DISINTEGRATION OF THE SLAB WHICH HAS TAKEN PLACE SINCE 1953 SURVEY.

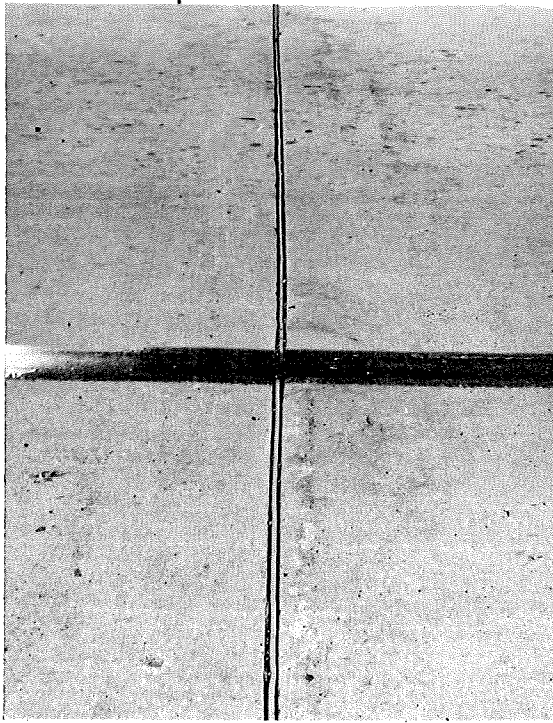
NEOPRENE JOINT NUMBER 25

▲ FIGURE 5. SHOWING JOINT AS OF AUGUST 3, 1953. NOTE EXCELLENT CONDITION OF THE INSTALLATION AT THIS TIME. STATION 125+31. LOOKING WEST TO EAST.

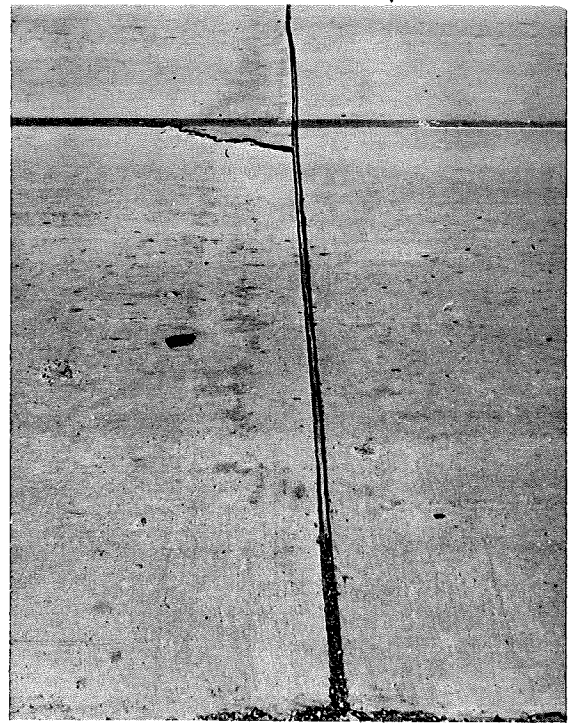
▲ FIGURE 6. THE SAME JOINT, JUNE 9, 1954. SINCE THE 1953 SURVEY A BAD CORNER BREAK HAS DEVELOPED.

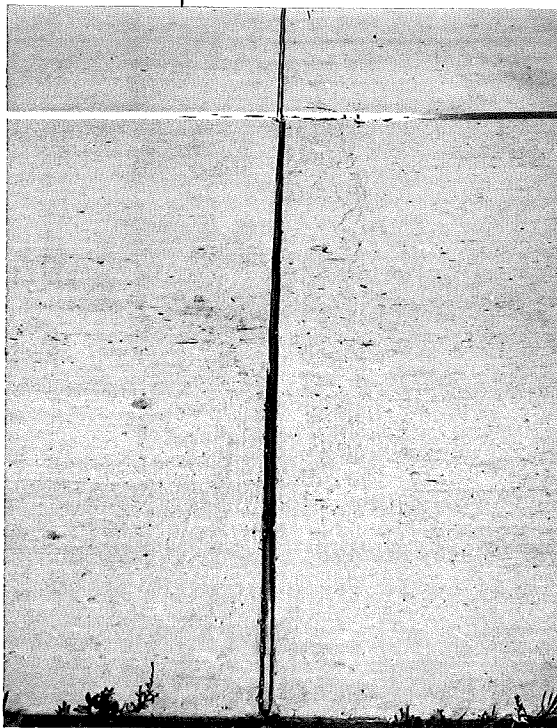
NEOPRENE JOINT NUMBER 28

▲ FIGURE 7. SHOWING JOINT AS OF AUGUST 3 1953, THIS JOINT DISPLAYS THE SAME AMOUNT OF CRACKING AS SHOWN IN THE 1952 SURVEY. STATION 129+27. LOOKING WEST TO EAST.

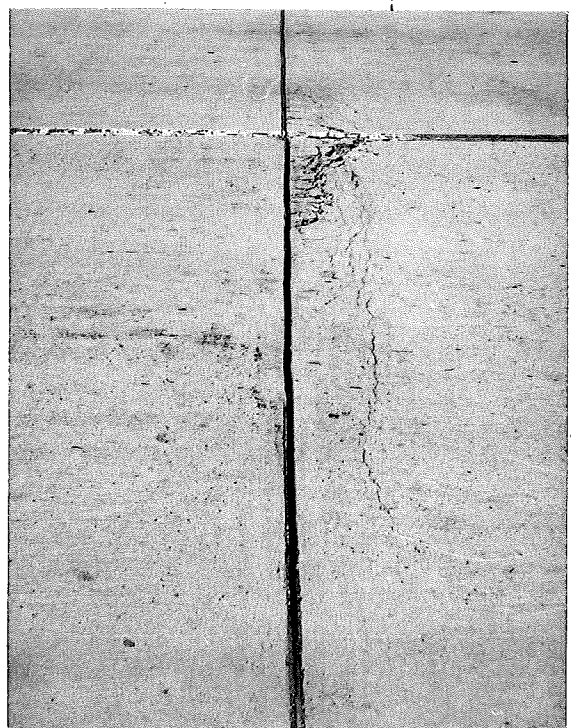
▲ FIGURE 8. THE SAME JOINT, JUNE 9, 1954. SHOWING ADDITIONAL SPALLING WHICH HAS TAKEN PLACE SINCE THE 1953 SURVEY.
