MICHIGAN DEPARTMENT
OF
STATE HIGHWAYS AND TRANSPORTATION

FINAL REPORT
SYLVAX U.P.M. PATCHING MATERIAL
JANUARY, 1977

Maintenance Division
Methods Unit
Harold Lemon, Supervisor

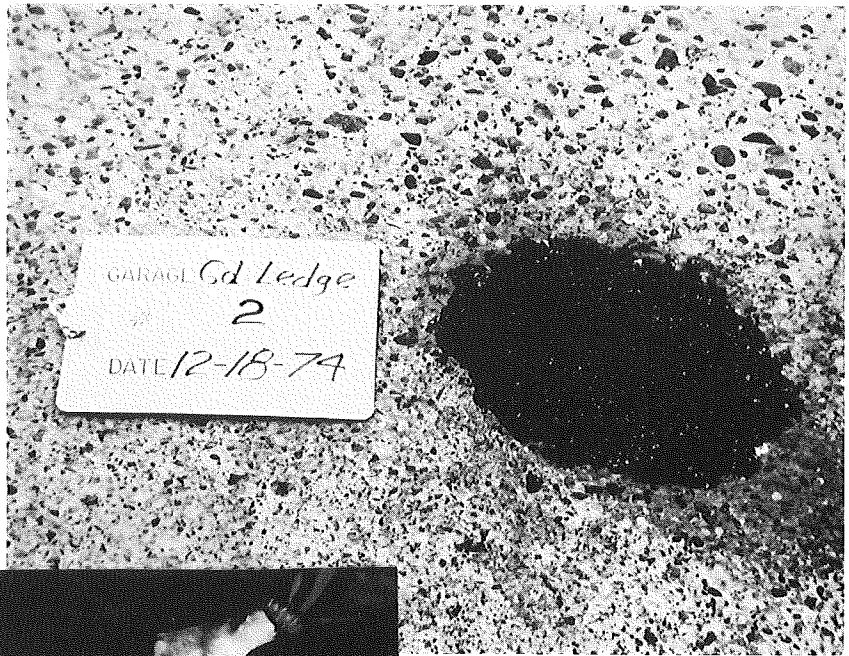
GOOD EXISTING SURFACE

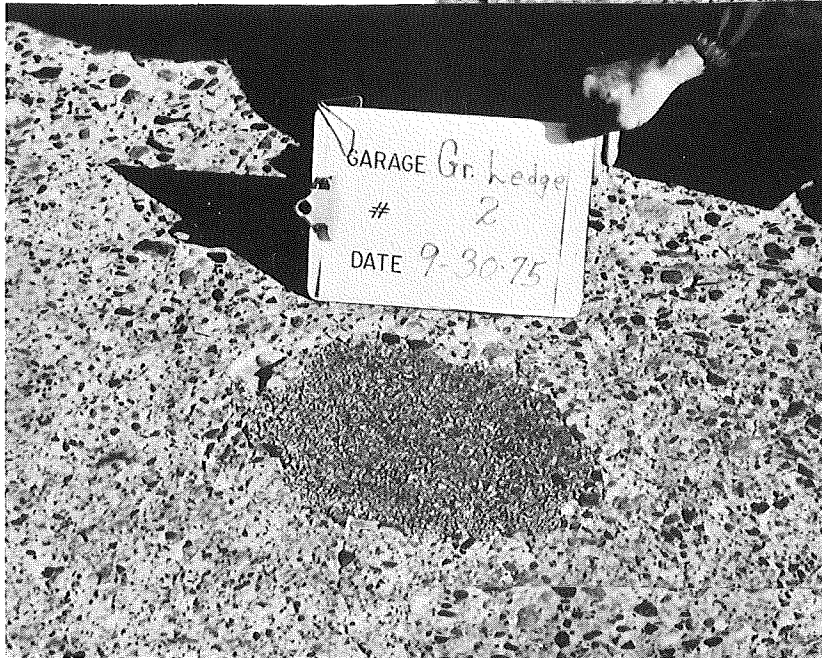
SOME CHANGE

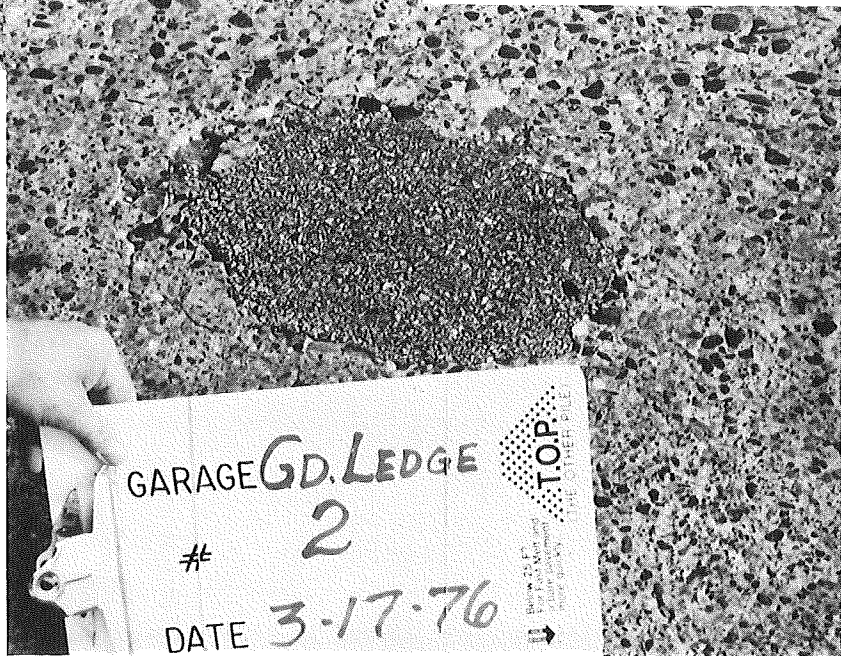
FIGURE 3

After two years of service, the survival rate of the original 69 test patches had been reduced to 6 patches (approximately 9%). The six patches can be classified as acceptable condition and the identification positively established. The balance of the patching cannot be declared a failure of the patching material but rather the identity had been lost through one of the previously described repairs. The 9% survival of the original patches were all placed on sound existing surfaces on which additional failures had not occurred (see Figure 3).

Throughout the tests, it was observed that emergency patching is required in areas where the pavement is in a general unsound condition. The area usually has been patched repeatedly and will require permanent repairs when time and weather permits, and hot mix or concrete is available. The important staying period for emergency patching material is from a 1 to 7 day period. If an emergency patch which is placed during adverse weather conditions survives the first week after installation, it will usually make the 6 month to 1 year period. Beyond the 1 year period, corrections are usually part of construction or one of the maintenance repair programs. An emergency patch which remains for this period usually will remain until the adjacent surface fails (see Figure 3).

SAME - STILL GOOD AFTER 2 YEARS

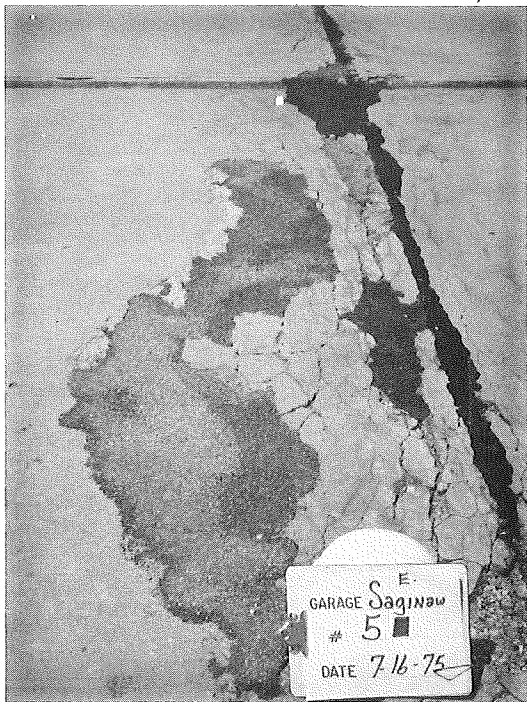
TYPICAL EMERGENCY PATCHES

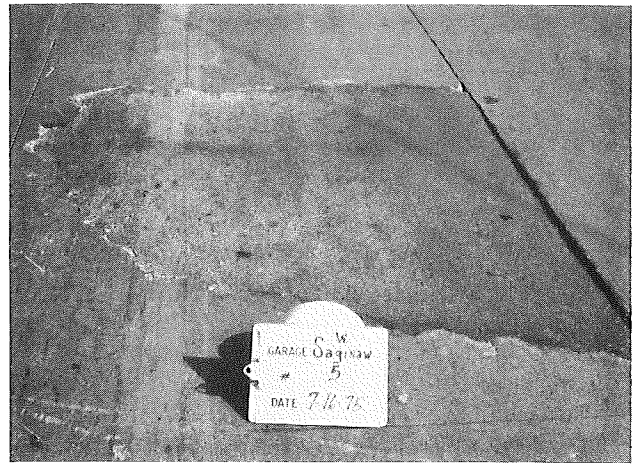
From our observations, proper compaction is a crucial factor. Without adequate compaction, the patches will settle 10% to 20%. Low patches are common throughout the test program. Patches that have settled to the point that they require wedging can be corrected with the addition of more Sylvax. The edge will adhere well and blend in with the original patch. The best results have been obtained when the patches have been rolled with truck tires. The combination of pneumatic rolling and repeated luting will result in a smooth surface and well compacted patch. It is our impression that the slow constant pressure of the rubber tired wheel is advantageous to the sharp impact caused by a hand tamp or compaction with a shovel.

LOW PATCHES COMMON

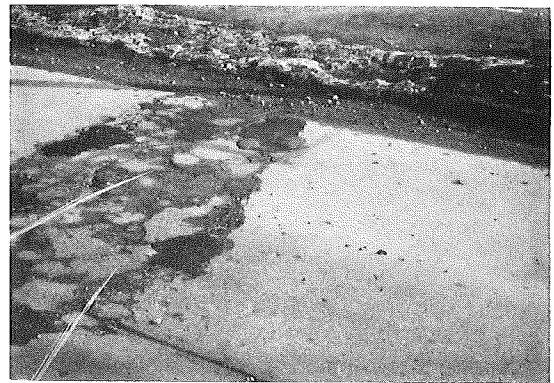
There is still a problem maintaining a consistent material (see Figure 4 tracking) from the various producers. The variation is less than earlier experience but is still a factor to consider. From information available from factory representatives and thorough contact with other agencies, the production of Sylvax can be accomplished on a limited basis with portable type equipment. A program in which we would produce our own emergency material appears possible and should be investigated.

INCONSISTANT MIX
- NOTE TRACKING

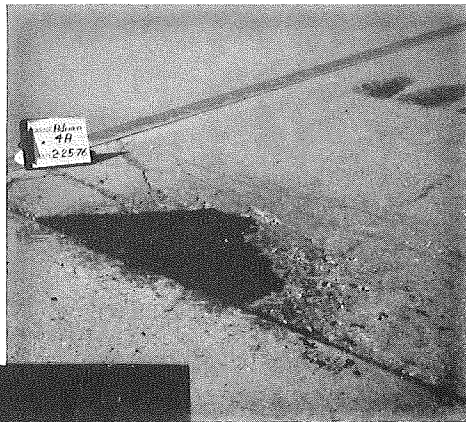
LOST PATCHES EXPECTED

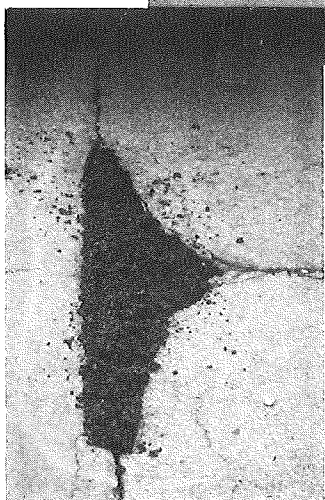
WORKABLE MATERIAL
STOCKPILED 1 YEAR

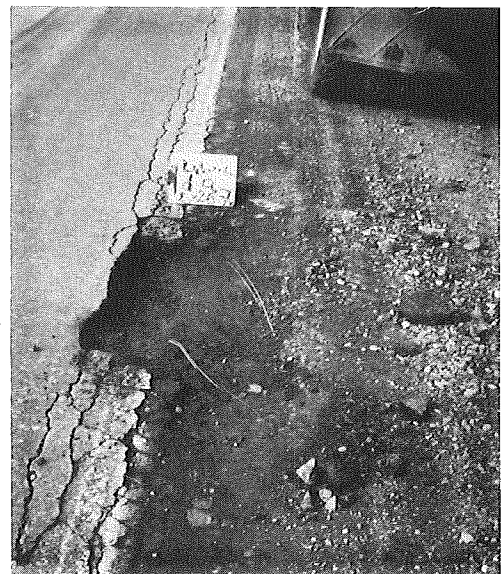
FIGURE 4

EDGE PATCH -
USE CHEAP MATERIAL

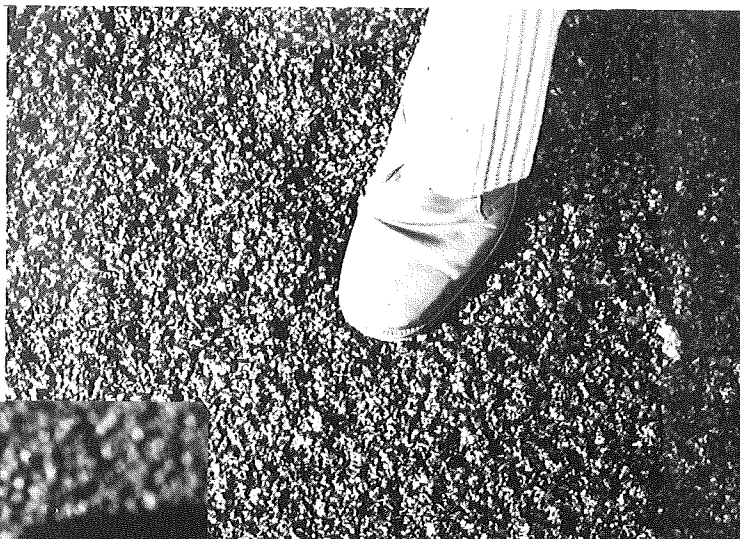
On January 31, 1975, an inspection was made to evaluate the material's workability below freezing temperatures. In 30° weather and bright sunshine the square point shovel can be thrust into the material in a matter of a few seconds. This permits hard-loading of an exposed pile if desired. In the direct sunlight, the material feels soft under foot and with a little pressure and with a rotating motion, the material will appear to move easily.

Pliable
Under
Pressure

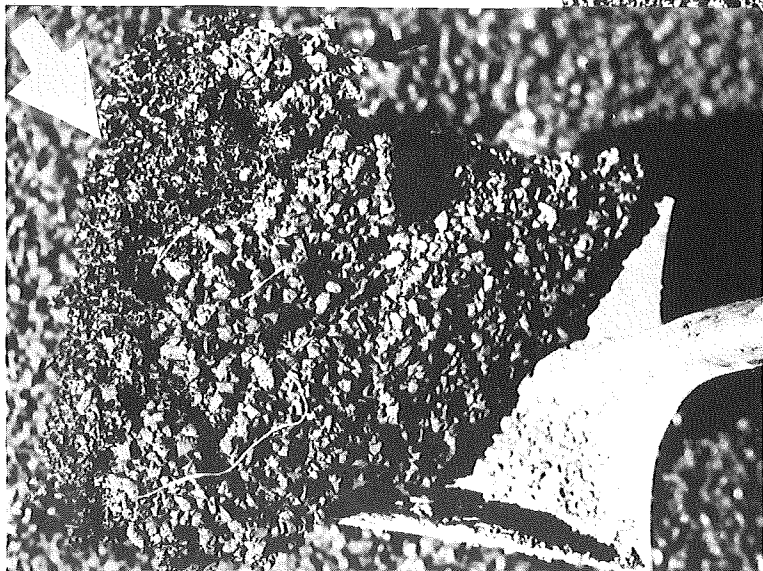
To evaluate Sylvax abilities to be stored during the winter season, a stockpile was placed at Battle Creek garage on December 11, 1974 (see Figure 7). Shortly after, the height of the pile was measured to determine the degree of settlement. This measurement was checked at various times throughout the winter with little or no change of height. Apparently no settlement had taken place or the pile had not spread out. The original pile remained intact throughout the winter months with little change in general appearance. The slight crust which formed on the outside is only about 1" in depth, and while it has lost its outside gloss, it is still flexible and can be shoveled with a minimum of effort.

Little Change
in Appearance

No Settling

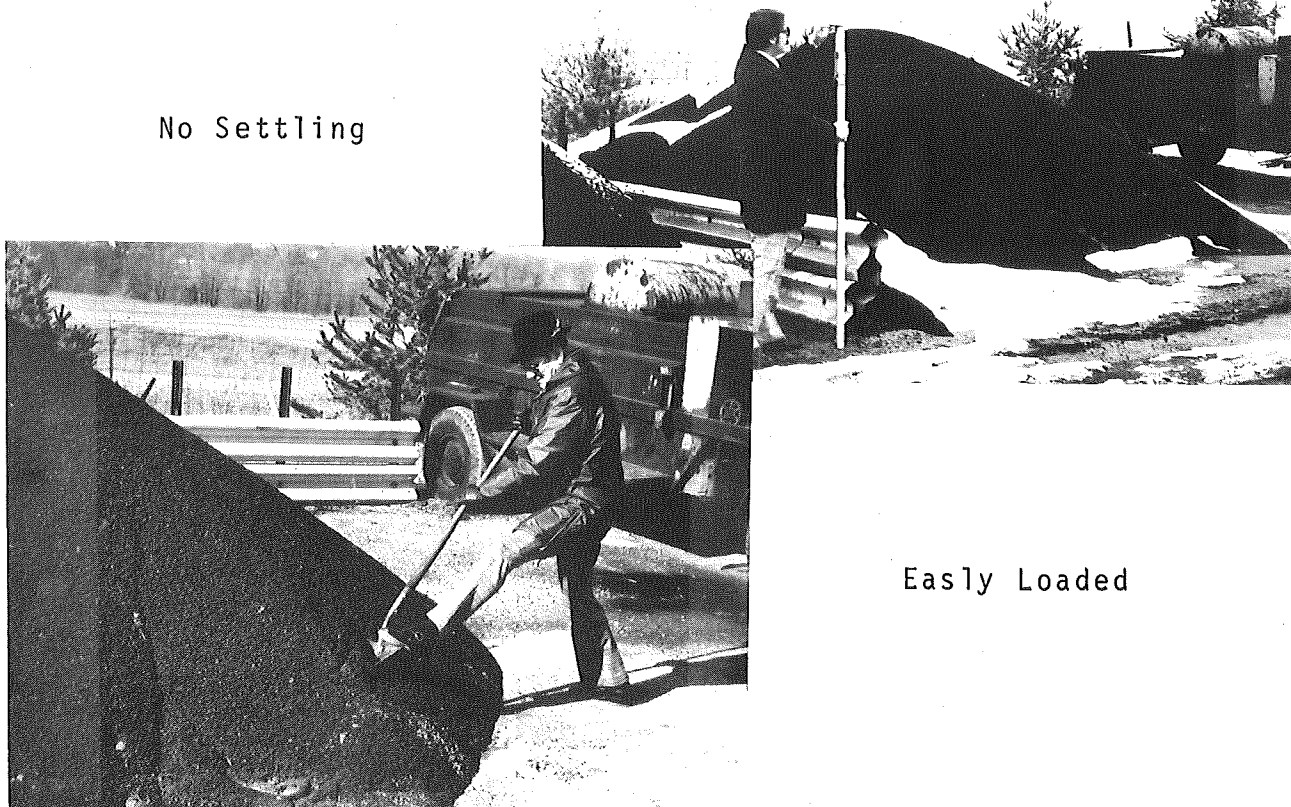
Fig. 7

Under these conditions, a front end loader can also be used and can pick up a full bucket by exerting a little pressure and operating slowly. At lower temperatures and without the direct sun, the action is the same but material is firmer and requires a little more time to get the same reaction.

Easily Loaded

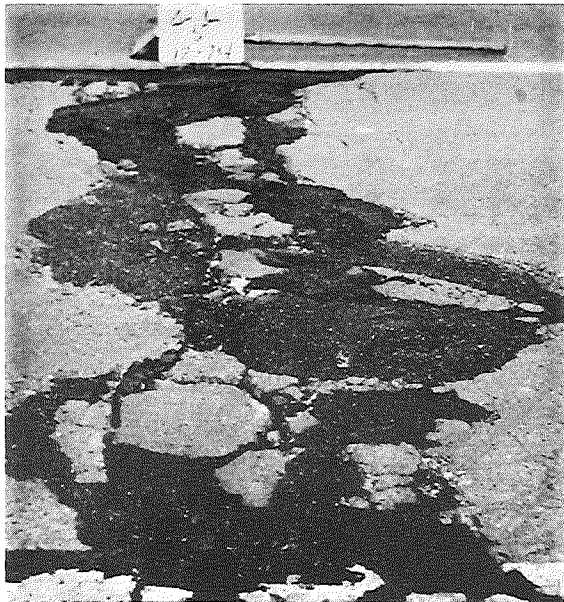
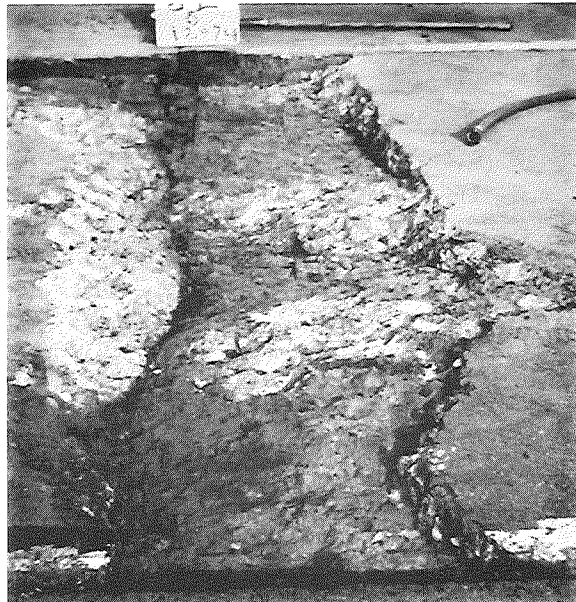
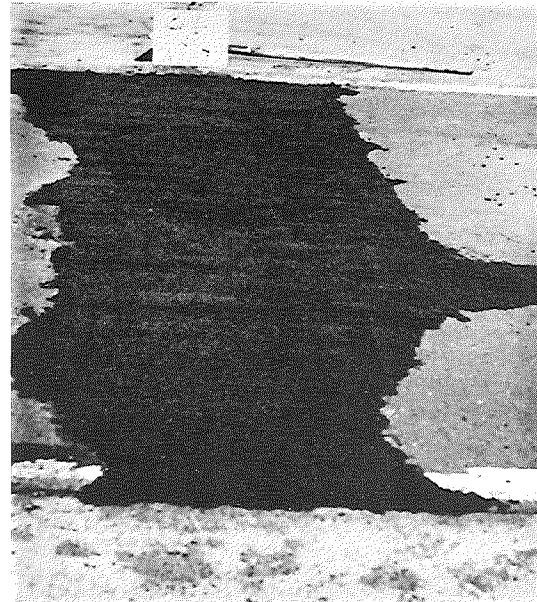
An extensive failure which has been properly prepared and compacted on a reasonably sound base will provide a serviceable patch for one year or more (see Figure 8).

PROBLEM

PREPARED

REPAIRED

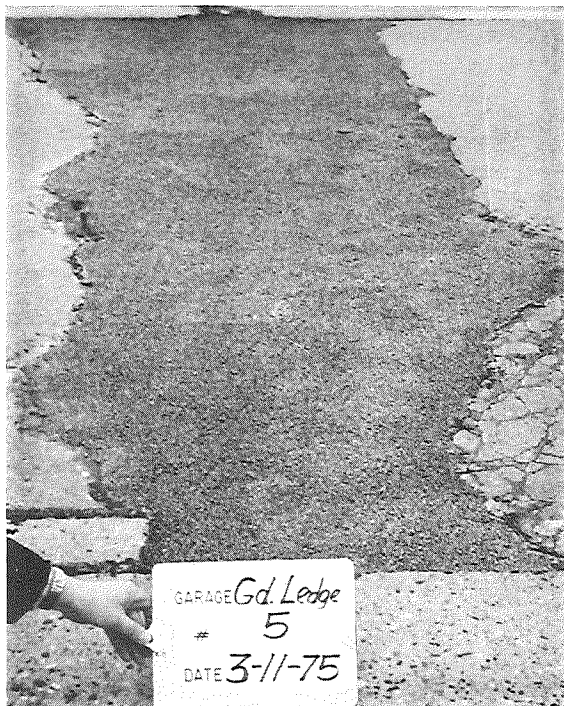
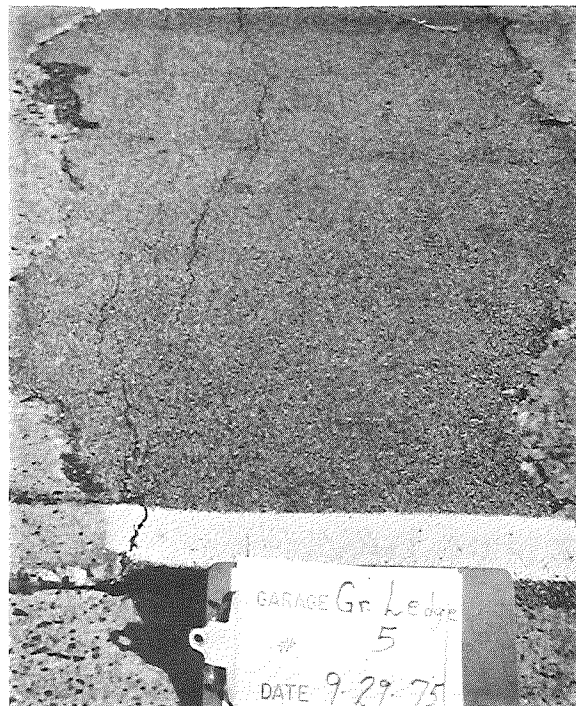
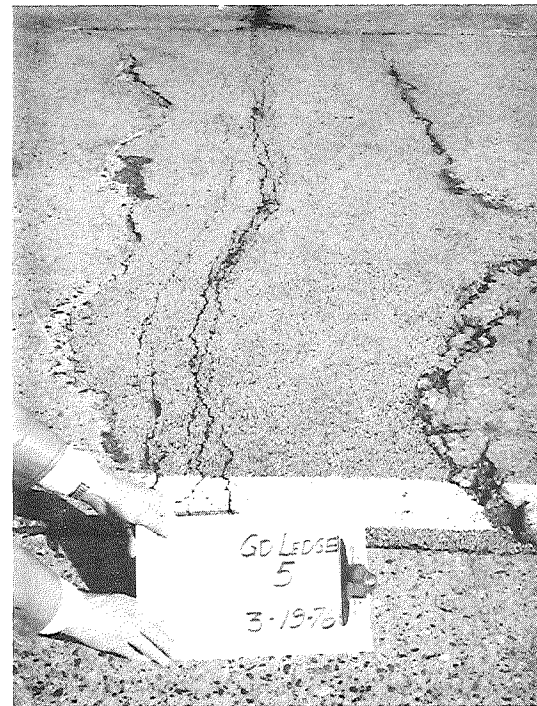
FIGURE 8

GOOD

FAIR

16 MONTH
