OFFICE MEMORANDUM

MICHIGAN
DEPARTMENT OF STATE HIGHWAYS

Subject: Polyethylene Center Strip. Research Project 68 NM-221. Research Report No. R-712.

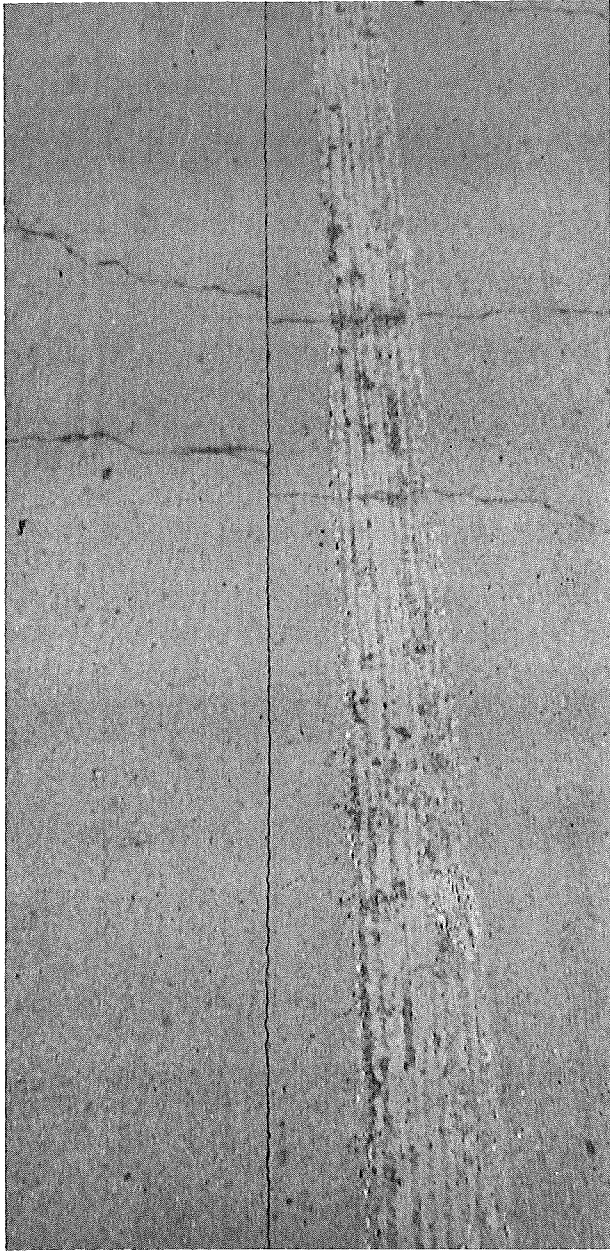
The inspection included an 8-in. continuously reinforced portion of Interstate 80 east of Joliet and a 10-in. standard pavement project on Illinois 131 southwest of Waukegan. Both projects were constructed in 1967 and were open to traffic at the time of our inspection. On the I 80 project, the joint was straight and appeared very neat (Fig. 1), but in some areas the strip had failed to perform its function of controlling random longitudinal cracking (Fig. 2). The straightness of the joint on the standard pavement project was good, but it had a zig-zag appearance (Fig. 3). This was apparently caused by the strip being installed too deep. Longitudinal cracking had occurred parallel to the joint at some locations and in some areas the strip had failed to initiate the intended fracture in the pavement (Fig. 4).

Figure 1. Neat appearing joint in continuously reinforced concrete pavement on I 80, Illinois.

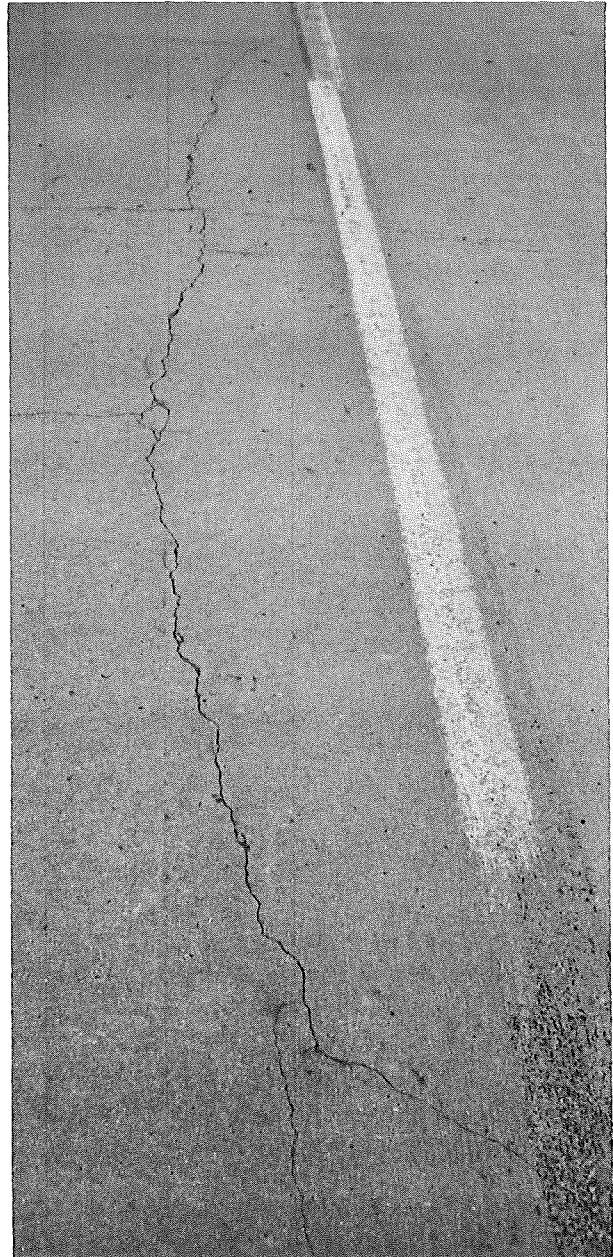
The amount of longitudinal cracking is estimated to be between 2 and 8 percent. Although the areas of failure have been inspected and some cores taken by Illinois personnel, they have been unable to determine why these longitudinal cracks have formed. In some cases it appeared that the longitudinal crack was caused by factors other than the plastic strip. The median performance for

Figure 2. Random longitudinal cracking in continuously reinforced concrete pavement on I 80, Illinois.

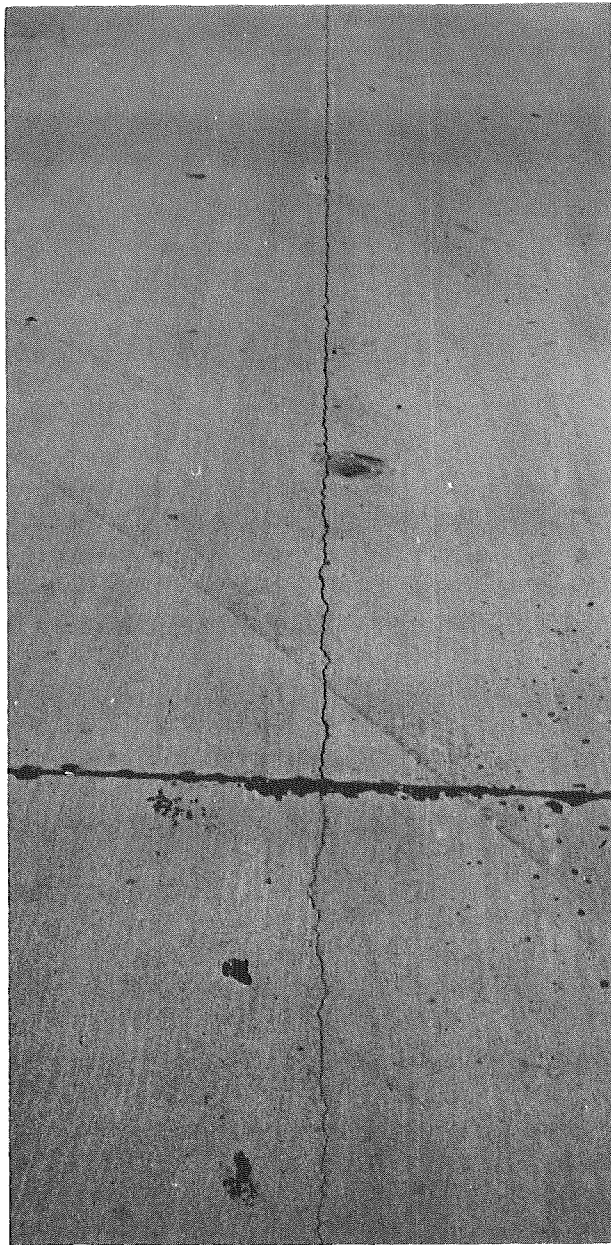
Figure 3. Condition of joint in standard pavement on Ill. 131. Note zig-zag appearance.

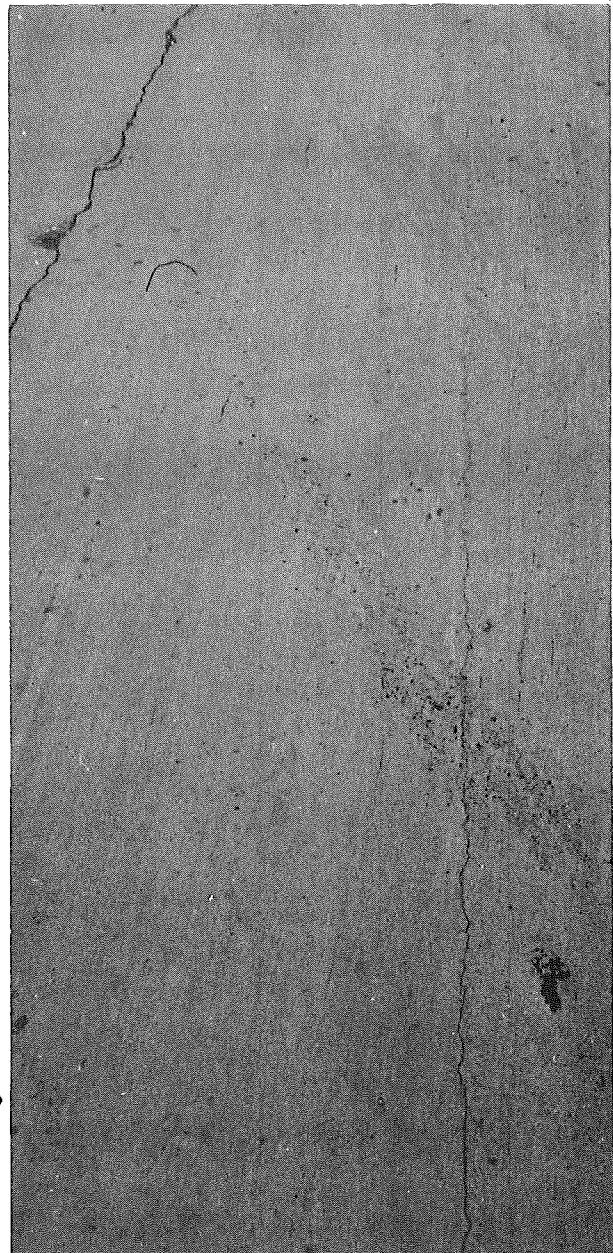
Figure 4. Random longitudinal crack (upper left corner) in standard pavement on Ill. 131. Note that the plastic strip failed to cause crack to form (upper center of photograph).

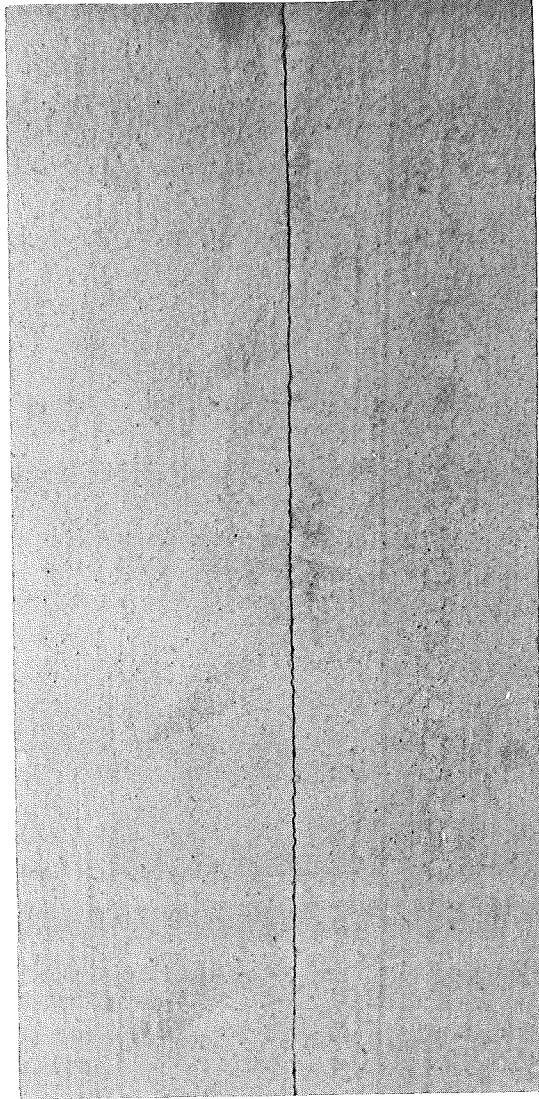
The joints on both projects appeared very neat and no random longitudinal cracking was observed anywhere (Fig. 5). At a few locations, small spalls had occurred along the strip but none appeared to have any detrimental effect on the joints performance (Fig. 6). One short length of joint was found where the concrete apparently had not been completely consolidated around the plastic strip (Fig. 7). According to Mr. Dixon, the polyethylene strip has performed satisfactorily. On only one project in the southern part of the state have they experienced problems with longitudinal cracking. They are investigating to determine the cause, but as yet have not been able to find the reason why cracking occurred on this particular project.

Figure 5. Neat appearing joint in standard pavement on I 70, Ohio.

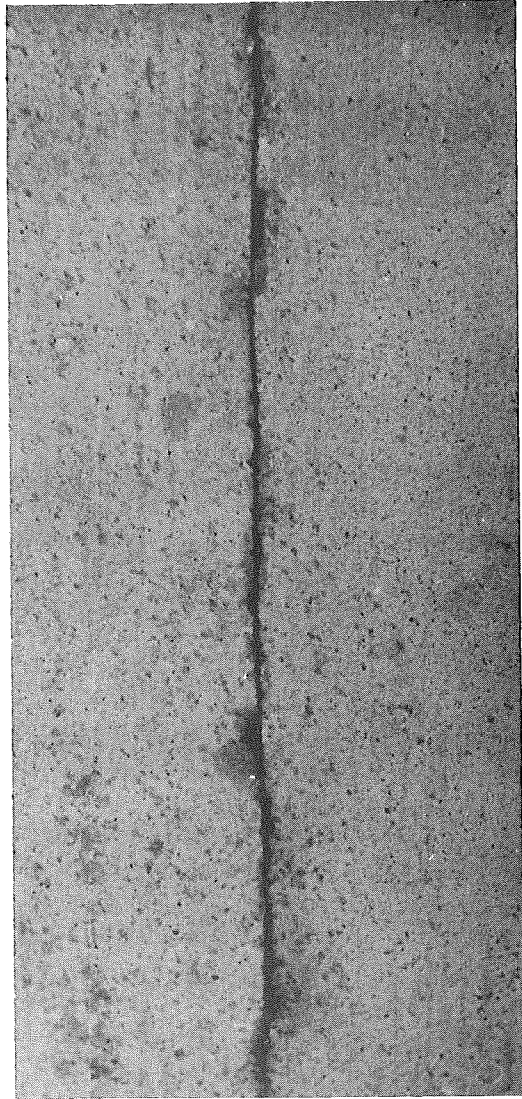
Figure 6. One of the few areas where small spalls had occurred along strip on I 70, Ohio.

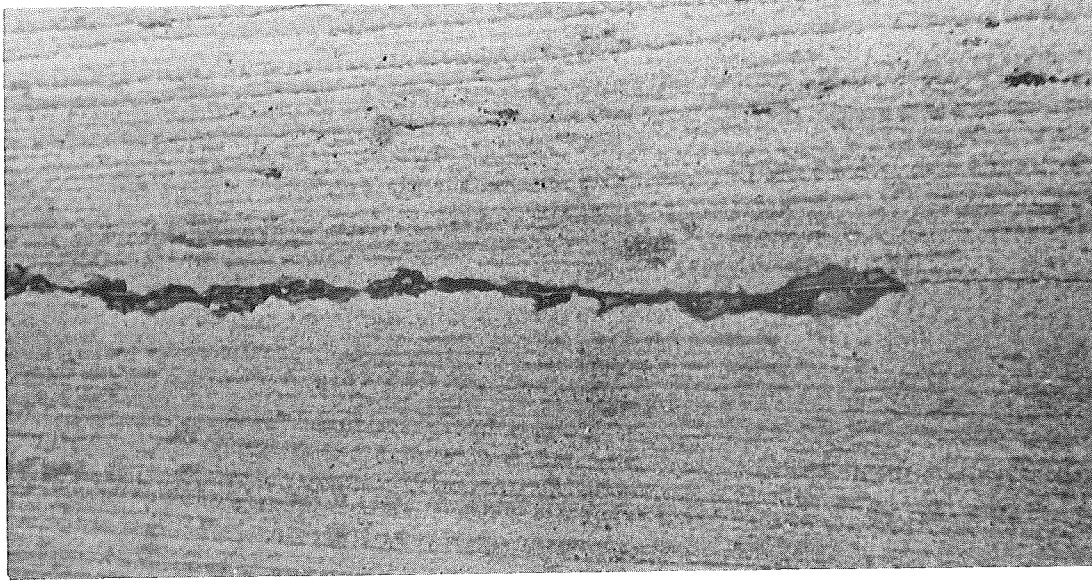
Figure 7. Condition along strip in area where concrete had not been consolidated around strip; I 70, Ohio.
